June 24, 2024

Re: Former Brookdale Golf Course Groundwater Assessment

2024 Groundwater Assessment

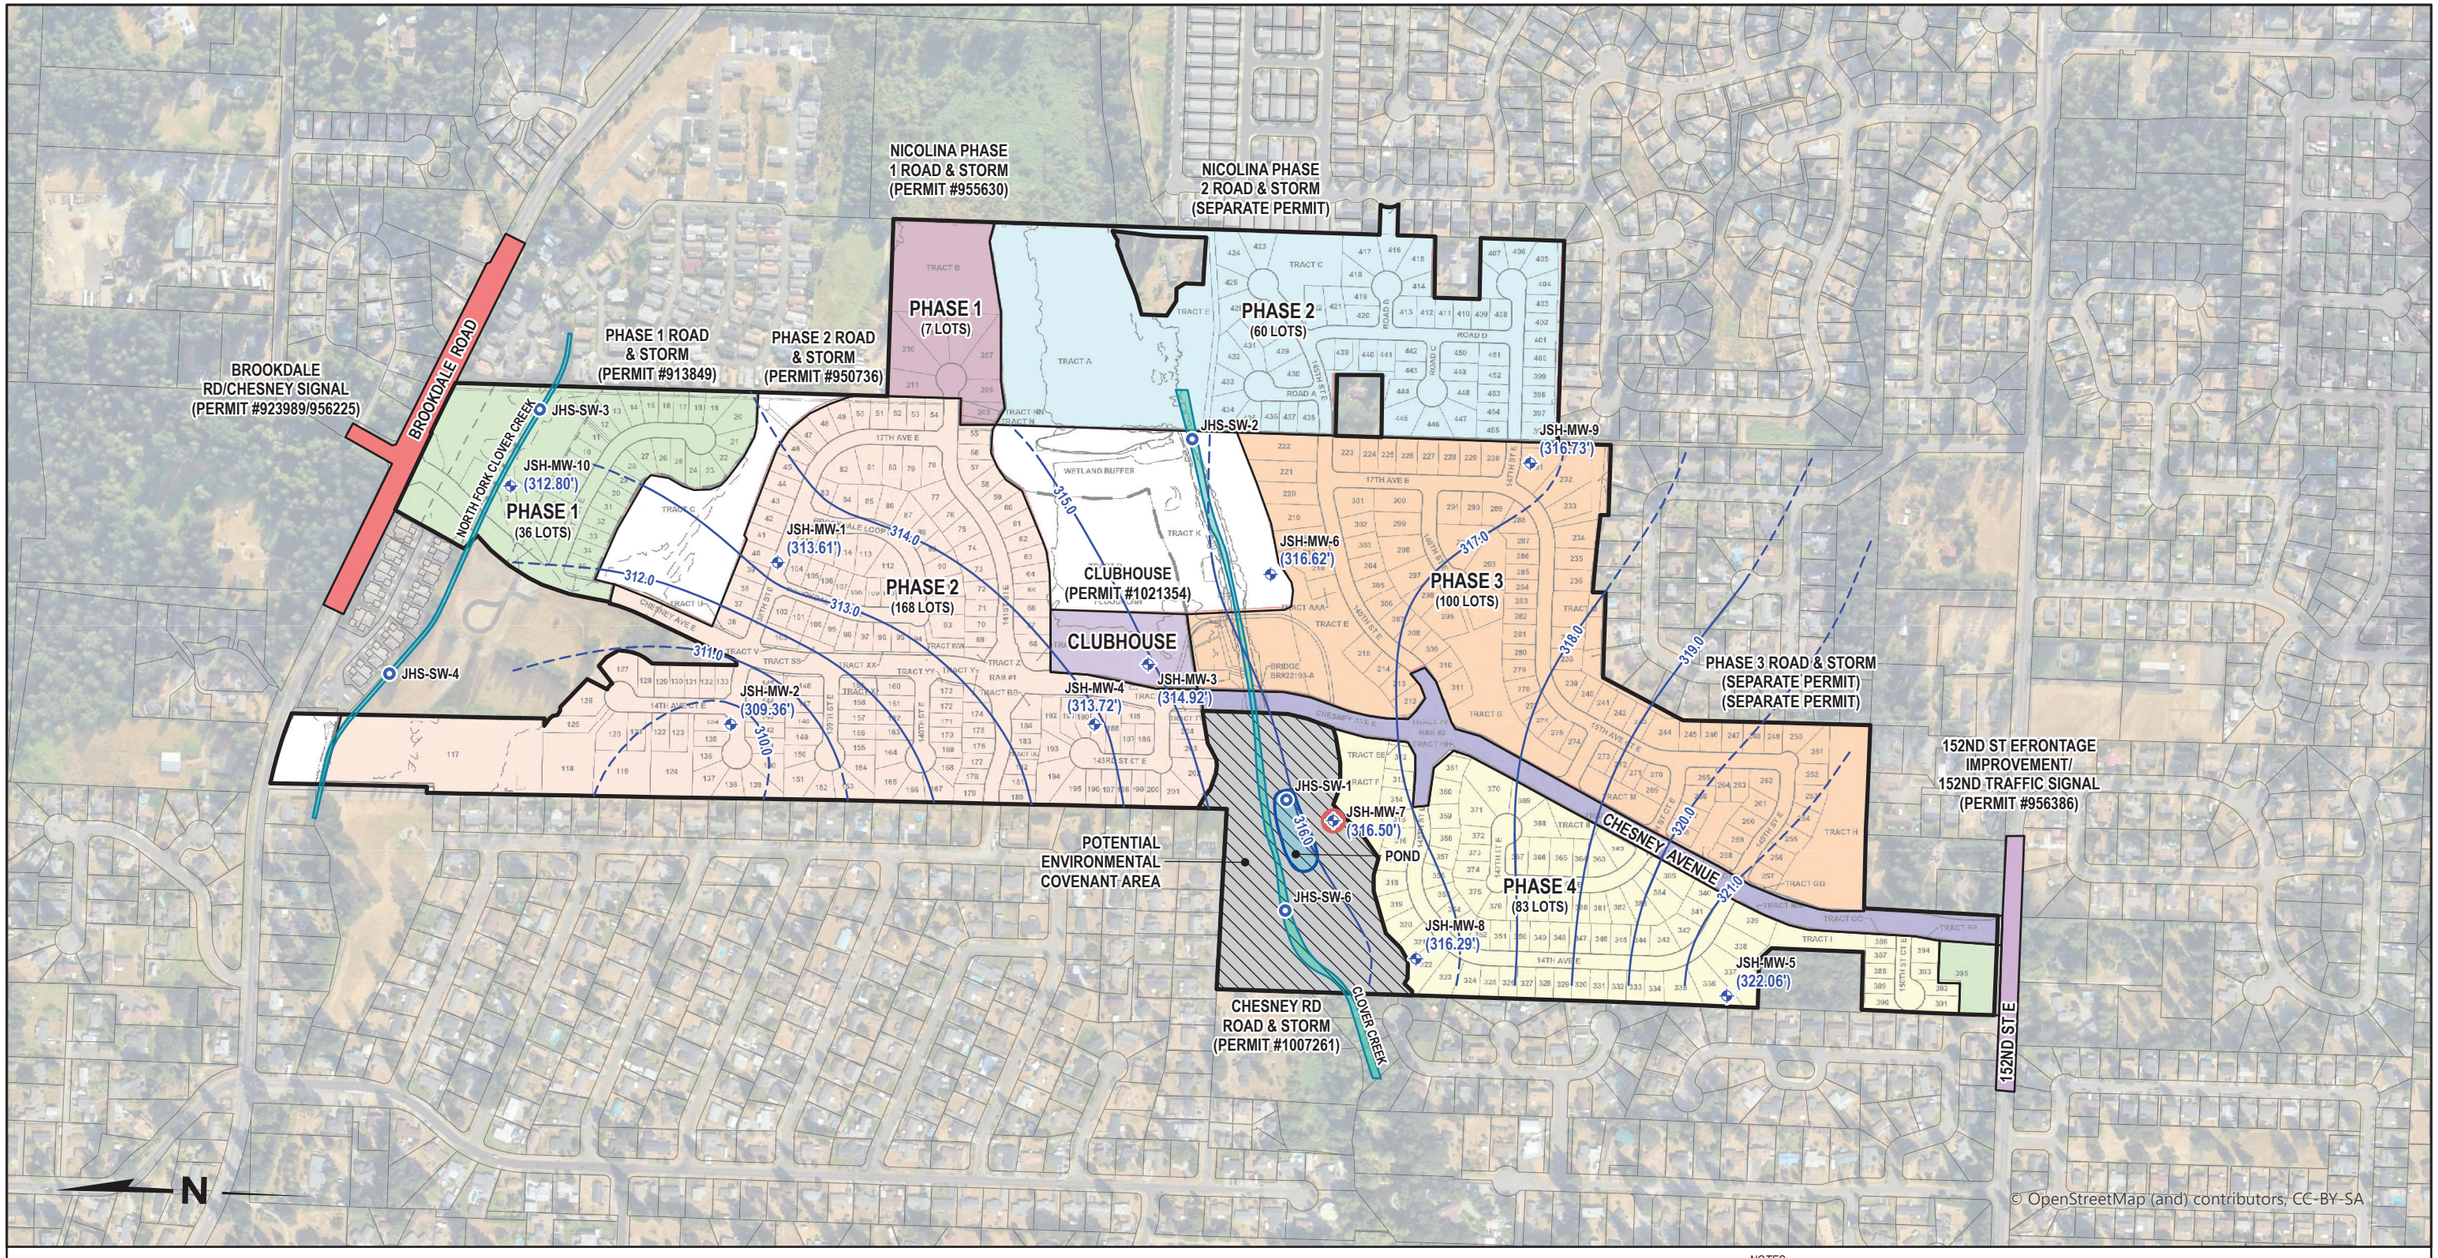
FIGURE 2
GROUNDWATER AND SURFACE WATER ANALYTICAL RESULTS AND PIEZOMETRIC CONDITIONS

During the March 5 sampling event, a total of 10 groundwater samples were initially submitted for analysis. Dieldrin was detected in only one location (JSH-MW-7) at a concentration of 0.084 micrograms/Liter (µg/L). The detected concentration exceeded the cleanup level of 0.0055 µg/L. Based on this finding, a field-filtered sample was also analyzed from JSH-MW-7. Dieldrin was not detected at a concentration exceeding the laboratory reporting limit in the field-filtered sample.

On March 29, 2024, JSH returned to the site to resample JSH-MW-7 to confirm conditions. During the March 29 sampling event, dieldrin was detected at a concentration of 0.030 µg/L. The detected concentration exceeded the cleanup level of 0.0055 µg/L. Based on this finding, a field-filtered sample was again analyzed. Dieldrin was not detected at a concentration exceeding the laboratory reporting limit in the field-filtered sample.

Following the purging described above, one groundwater sample was collected from JSH-MW-7 on May 5, 2024. The groundwater analytical results from the sample collected following the purging indicated that dieldrin concentrations were reduced from 0.030 µg/L to 0.014 µg/L. Based on this result, an additional field-filtered sample was submitted for analysis. Dieldrin was not detected in the field filtered sample at a concentration exceeding the laboratory reporting limit.

The environmental covenant would be restricted to groundwater only. Groundwater analytical results at JSH-MW-7 demonstrate decreasing concentration trends of dieldrin in unfiltered groundwater. The reduction in concentrations of dieldrin indicate that impacts are likely limited and localized to the area around JSH-MW-7.

The area governed by a potential environmental covenant will be proximate to monitoring well JSH-MW-7 and would encompass the "open space" south of Chesney Avenue East, Tract EE, and Tract F. The proposed environmental covenant area is depicted in **Figure 2**.

- Would Ecology allow for an environmental covenant for the parcels outlined on Figure 2 based on current site data?
