Phase I Environmental Site Assessment
Volume I

Bakker Properties
Barrier Pre-Owned Sales and Parking Lot
(Former Dry Cleaner Plant and Office)
11855 NE Bellevue-Redmond Road
Bellevue, Washington

April 27, 2012

File No. 0526-170-01

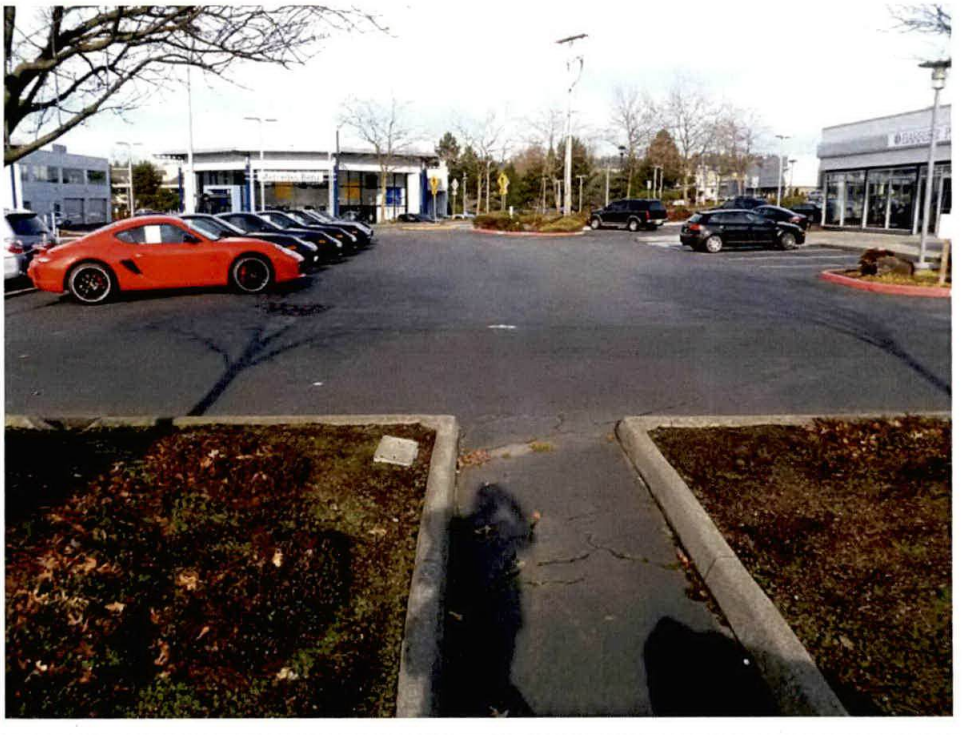
LOOKING SOUTHEAST ACROSS THE SUBJECT PROPERTY TOWARD EXISTING BUILDING

LOOKING NORTHWEST ACROSS WEST SUBJECT PROPERTY PARCEL

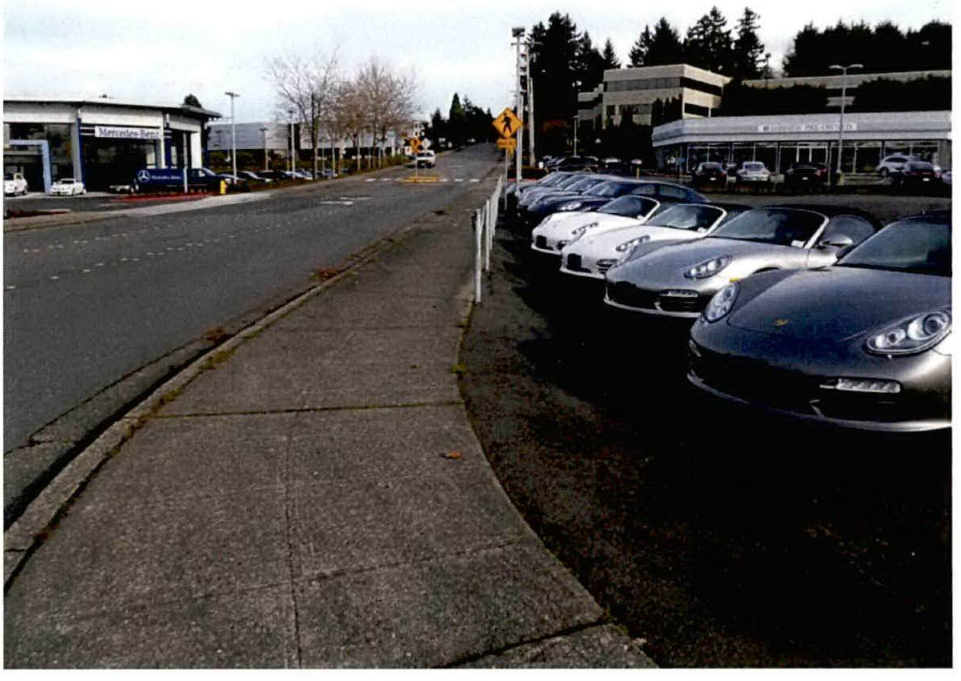
LOOKING NORTH ALONG EAST SUBJECT PROPERTY BOUNDARY

LOOKING NORTHEAST ALONG BELLEVUE-REDMOND ROAD
ADJACENT FORMER GAS STATION PROPERTY (TRIANGLE PARKING LOT)
IN RIGHT FOREGROUND

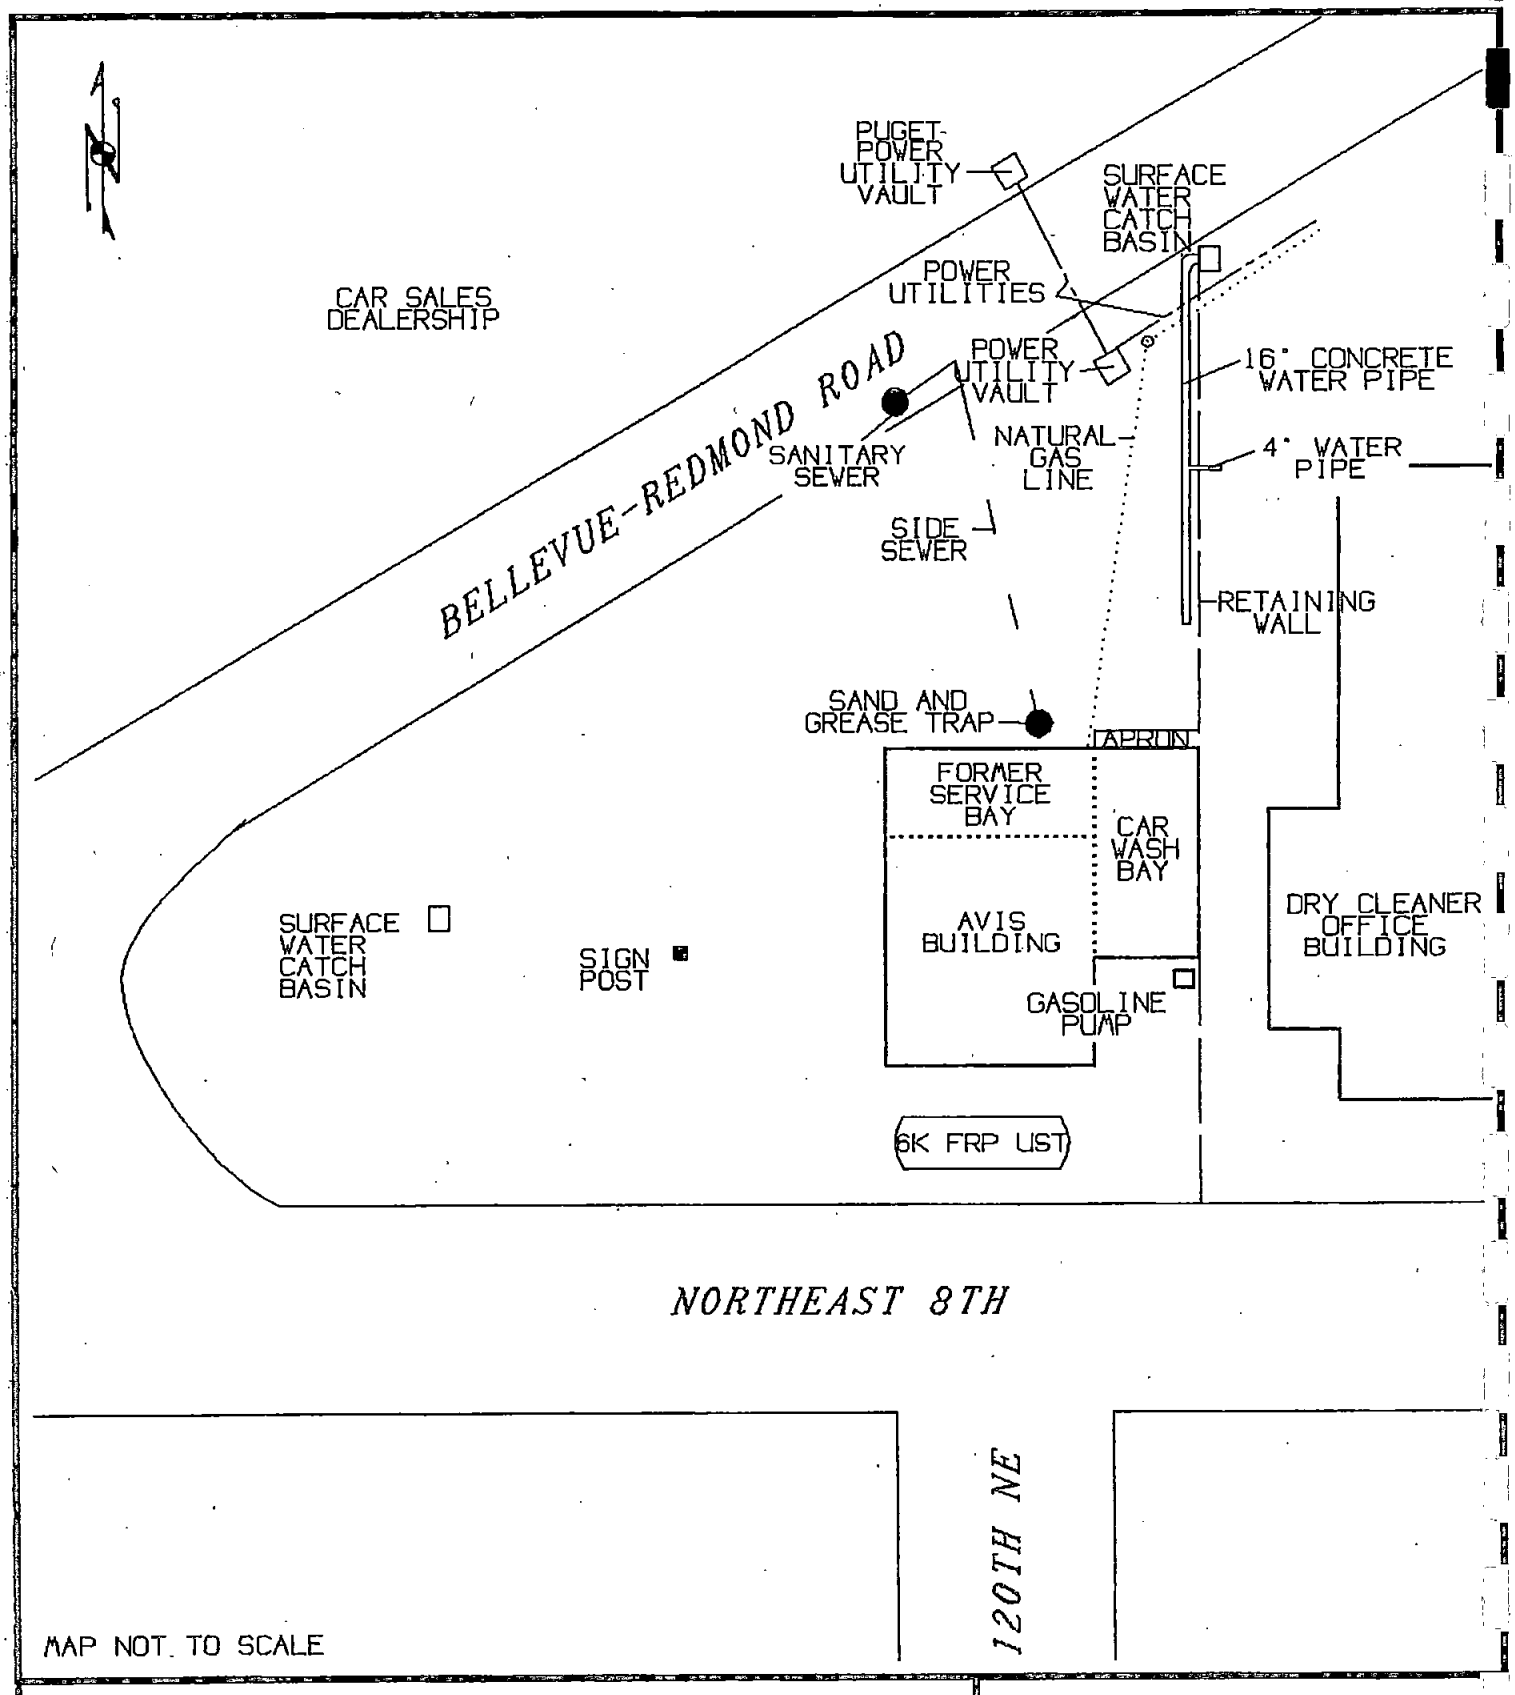
FIGURE 3

Washington Natural Gas Washington Natural Gas service to the Avis building from the north east corner of the lot was to be exposed in the area to be excavated. The location of the gas line is shown on figure 3. On 23 September, 1991 this line was capped and cut and the service to the Avis building disconnected by Washington Natural Gas.

Puget Sound Power and Light Company A Puget Power Utility vault is located in the north east corner of the property as shown on figure 3. The cover to the vault was not marked. During surface asphalt excavation, the vault cover was knocked loose. Some damage to the electric cables occurred. Puget Power was notified of the mishap. A representative of Puget Power visited the site and assessed that the coating on two of the three electric cables had been scraped.

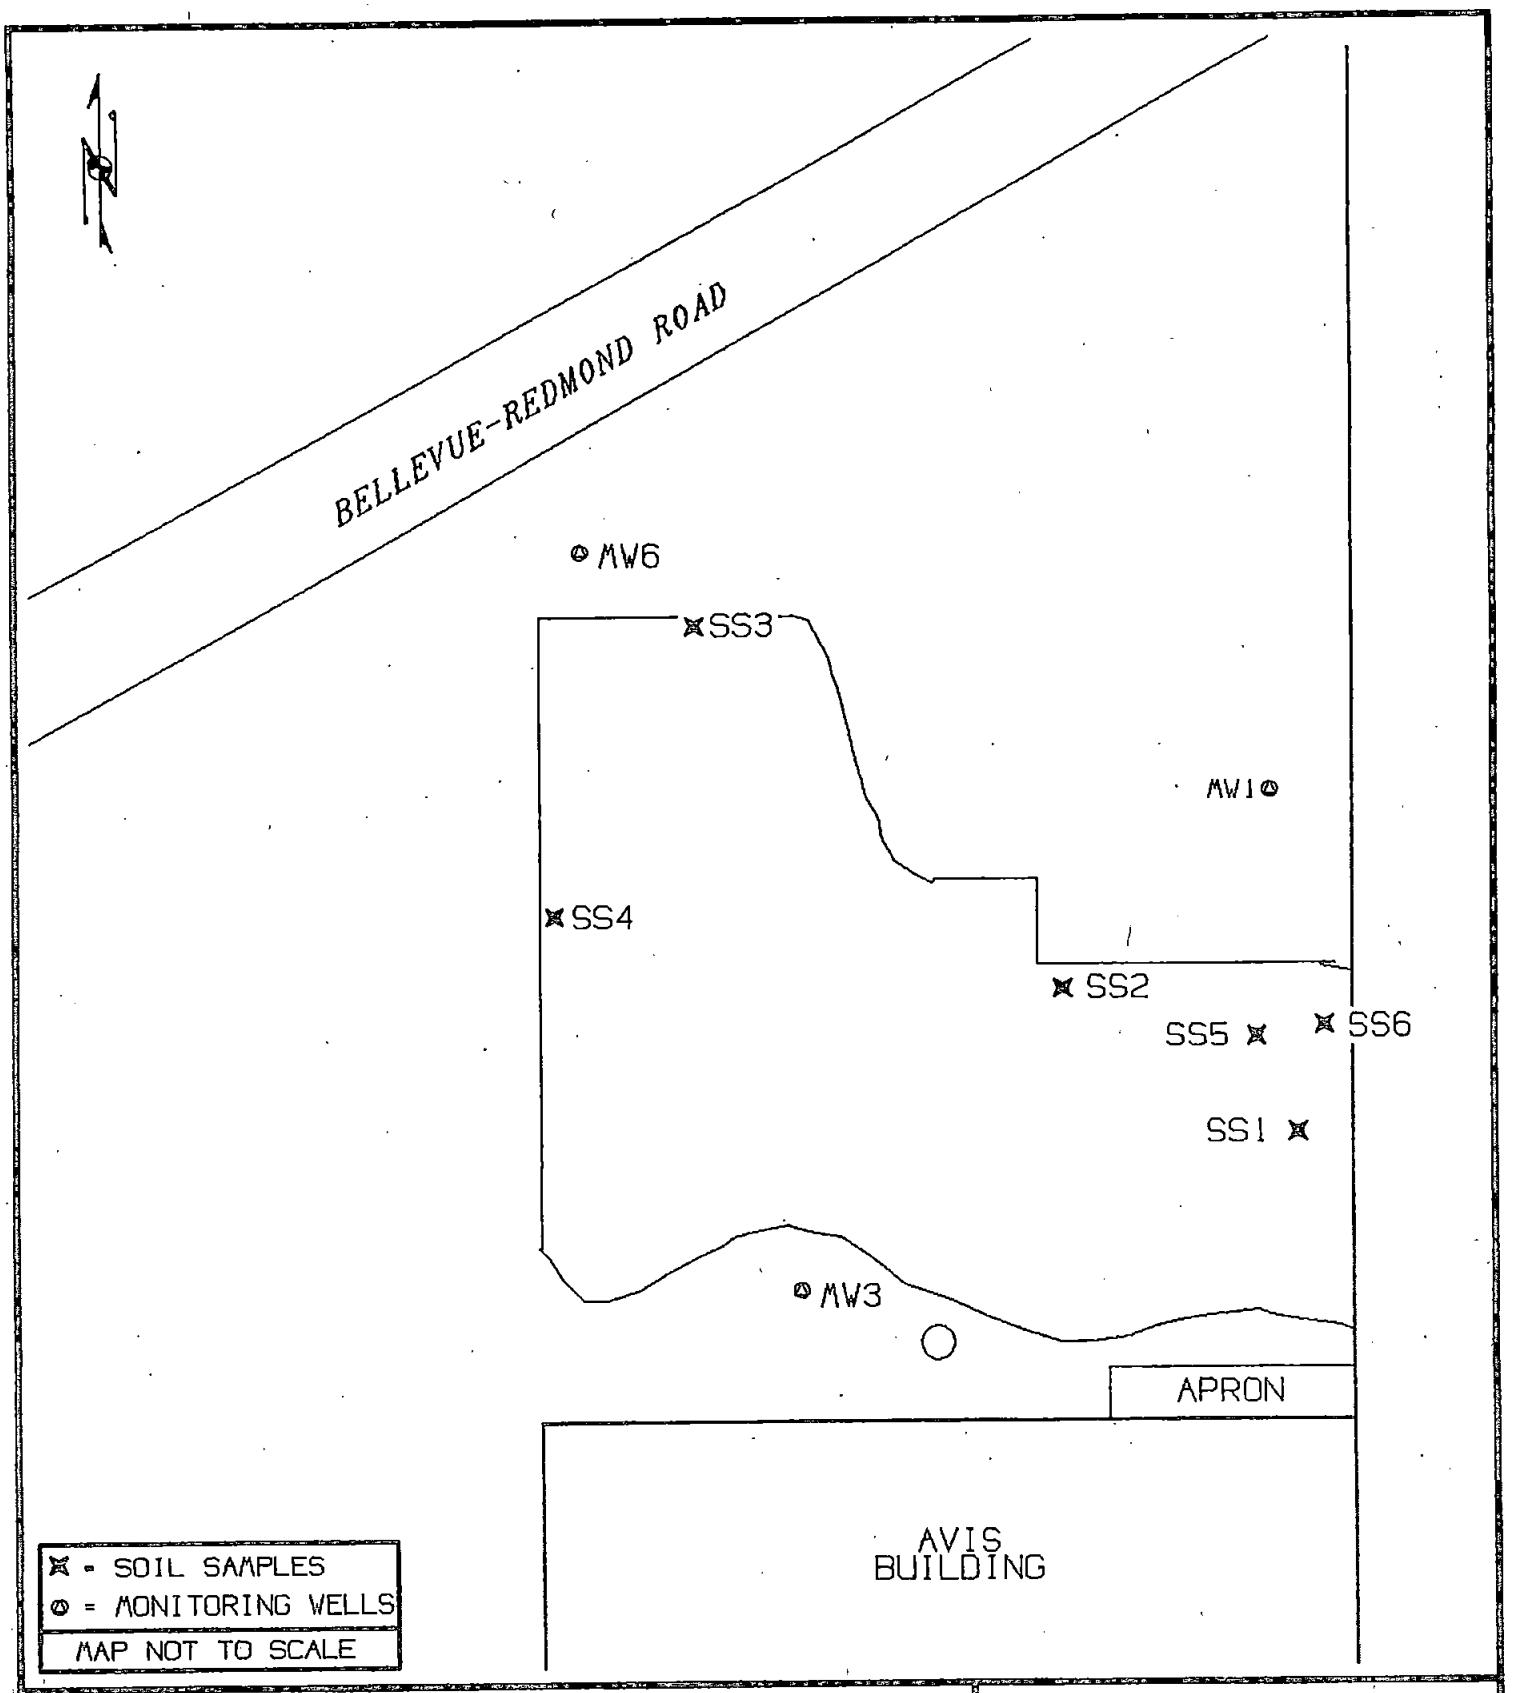
FIGURE 4

o Confirmation soil samples were collected from the cleanup excavation side walls after field detectable contaminated soils had been removed (refer figure 4 for soil sample locations). A discussion of soil sampling methods is attached to this report. Initially, the confirmation samples were analyzed for WTPH-HCID. This sampling protocol was modified to EPA Method 8015 for Diesel #2 because the initial WTPH-HCID samples and previous investigations indicated the presence of diesel in the soils. Table 2 presents the sample identification numbers, location, and the analytical results of the confirmation samples;

o After excavation in this area, confirmation samples were collected from the clays in the east side wall and from the floor of the excavation in native peat soils. The sample locations are shown on figure 4. The samples were analyzed for diesel #2 by Modified EPA Method 8015. Table 3 presents the sample identification numbers, location, and the analytical results. Analytical results of the samples indicate that the contamination identified in PCA-SSI-6.5' was removed by this subsequent excavation.

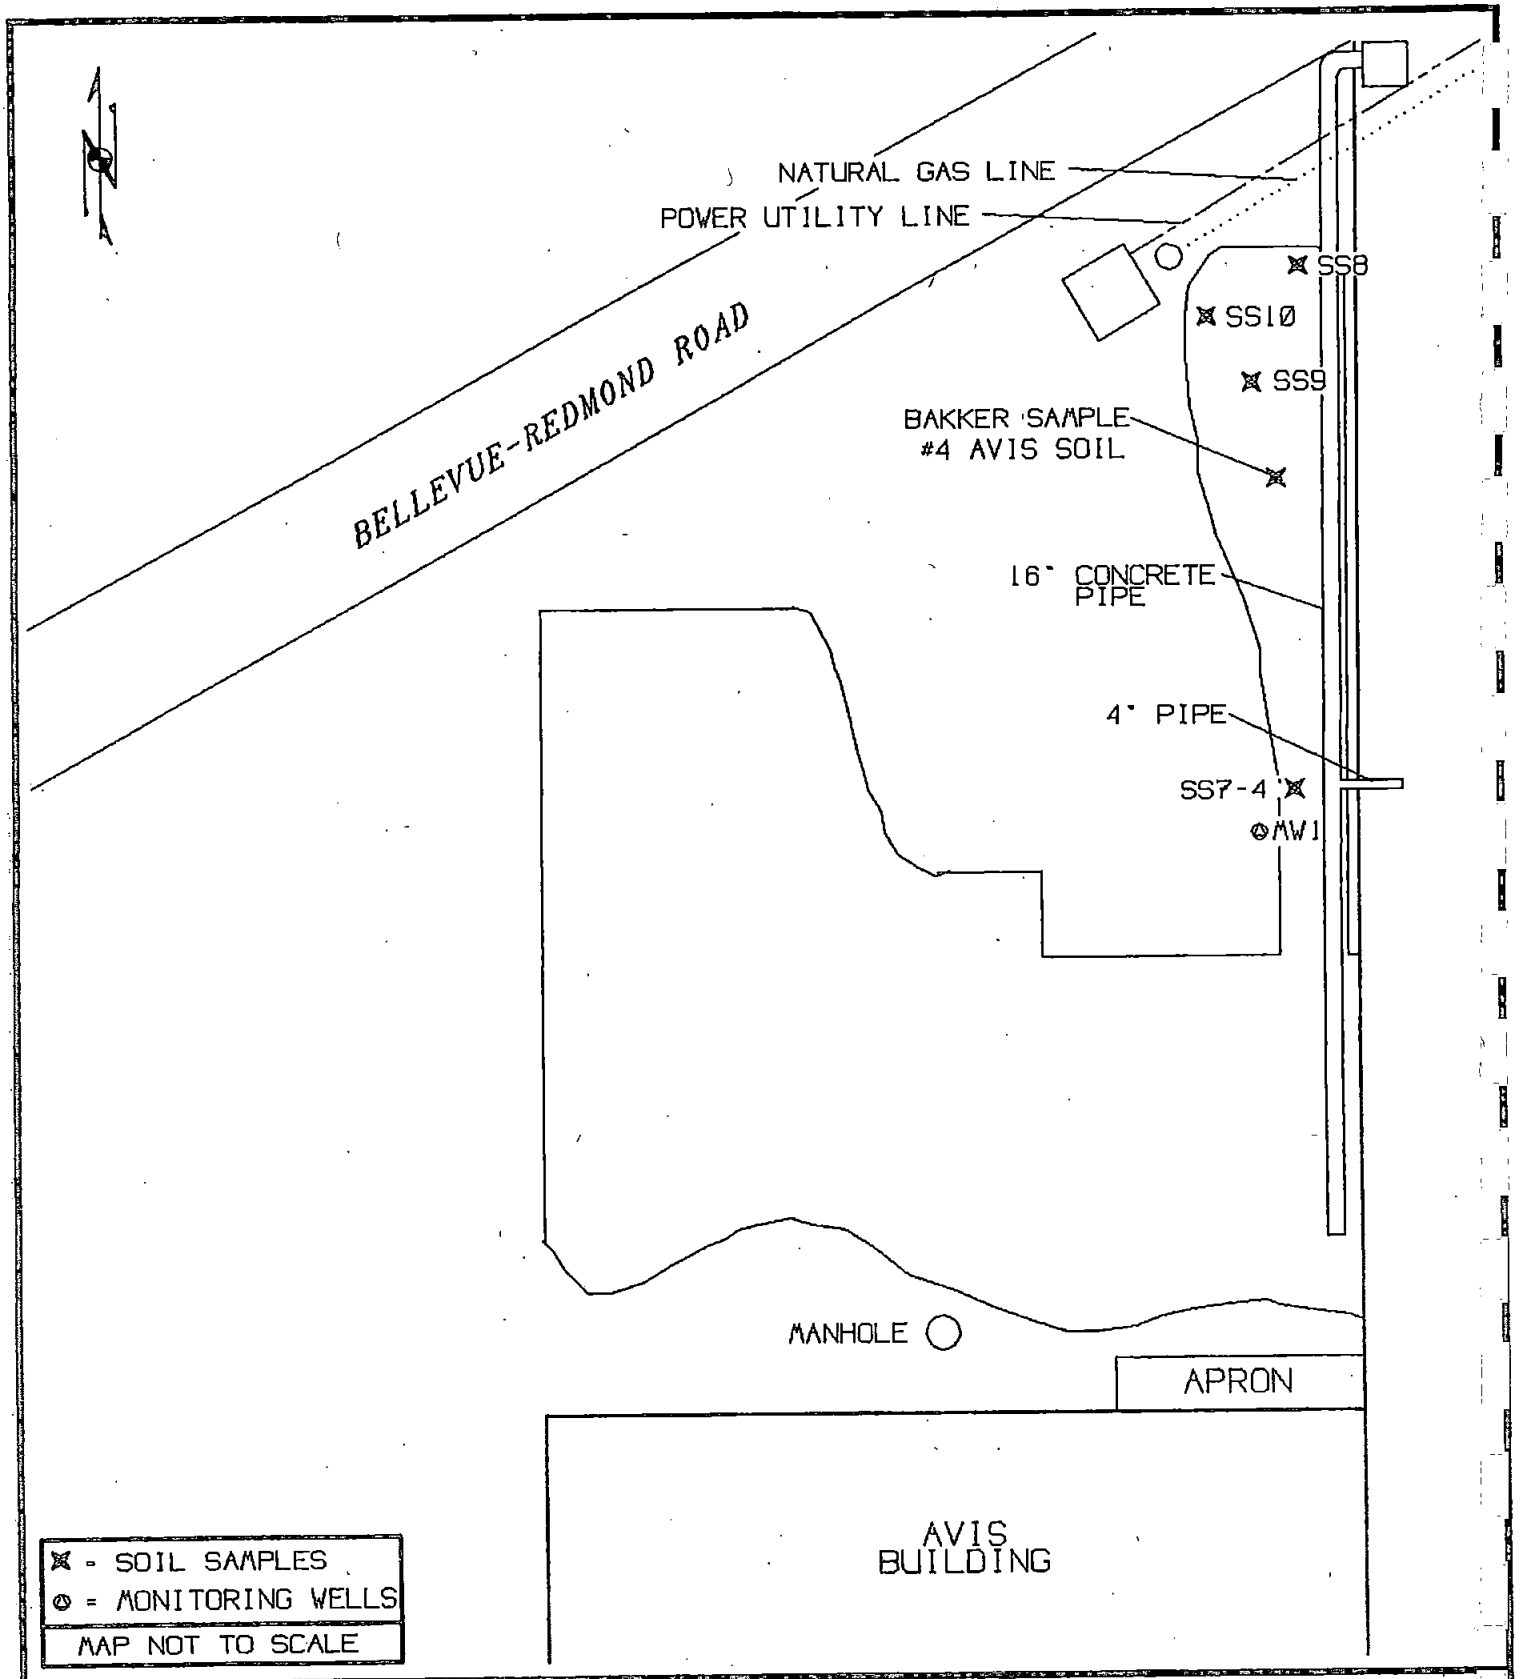
FIGURE 5

o During excavation on 23 September, 1991 a 16 inch outside diameter concrete sewer pipe was uncovered. The sewer pipe had not been identified during utilities locating at the site (locate #91383960). As shown on figure 5, the pipe runs along the east property boundary adjacent to a concrete retaining wall that separates the Avis Sales Lot and the neighbor to the east, Bakker's Fine Dry Cleaning. Upon discovering the sewer pipe, Petroleum Services notified the City of Bellevue Storm and Surface Water Utility (SSWU);

o As shown on figure 5, approximately 40 feet north from the Avis building, a 4" concrete pipe was connected to and discharging a steady stream of water into the 16" concrete pipe.

o Native soils from beneath the 16" pipe in the vicinity of where the 4" pipe was connected had a petroleum odor with photo-ionization detector measurements of 92 ppm. The odor was dissimilar to the diesel odors emanating from the previously excavated soils. A sample (PCA-SS7-4') of the soils was collected for chemical analysis by WTPH-HCID from the location shown in Figure 5. Table 5 presents the sample number, location and analytical results of the sample collected;

o The 16" pipe and field detectable contaminated soils were excavated in a northerly direction until the Washington Natural Gas line was encountered. No further excavation was done in this direction due to the gas line and the underground electrical utility (refer to figure 5). Approximately 20 yards of the mineral spirits contaminated soils were removed and subsequently disposed of at Hillsboro Landfill in Oregon. The disposal was delayed for several days until this unexpected contamination could be adequately characterized and assesses by the disposal facility;
