SNOHOMISH HEALTH DISTR
3020 Rucker, Suite 104
Everett, WA 98201
425.339.5250

FIELD INVESTIGATION REPORT

Address_of_Complaint: 18306 Hwy 99

ERTS # 600700 See attached re Self-Service auto wrecking yard. Stream runs thru the yard in a pipe. They are not draining the fluids adequately & the site is heavily contaminated. All the pollutants drain into Scriber Creek.

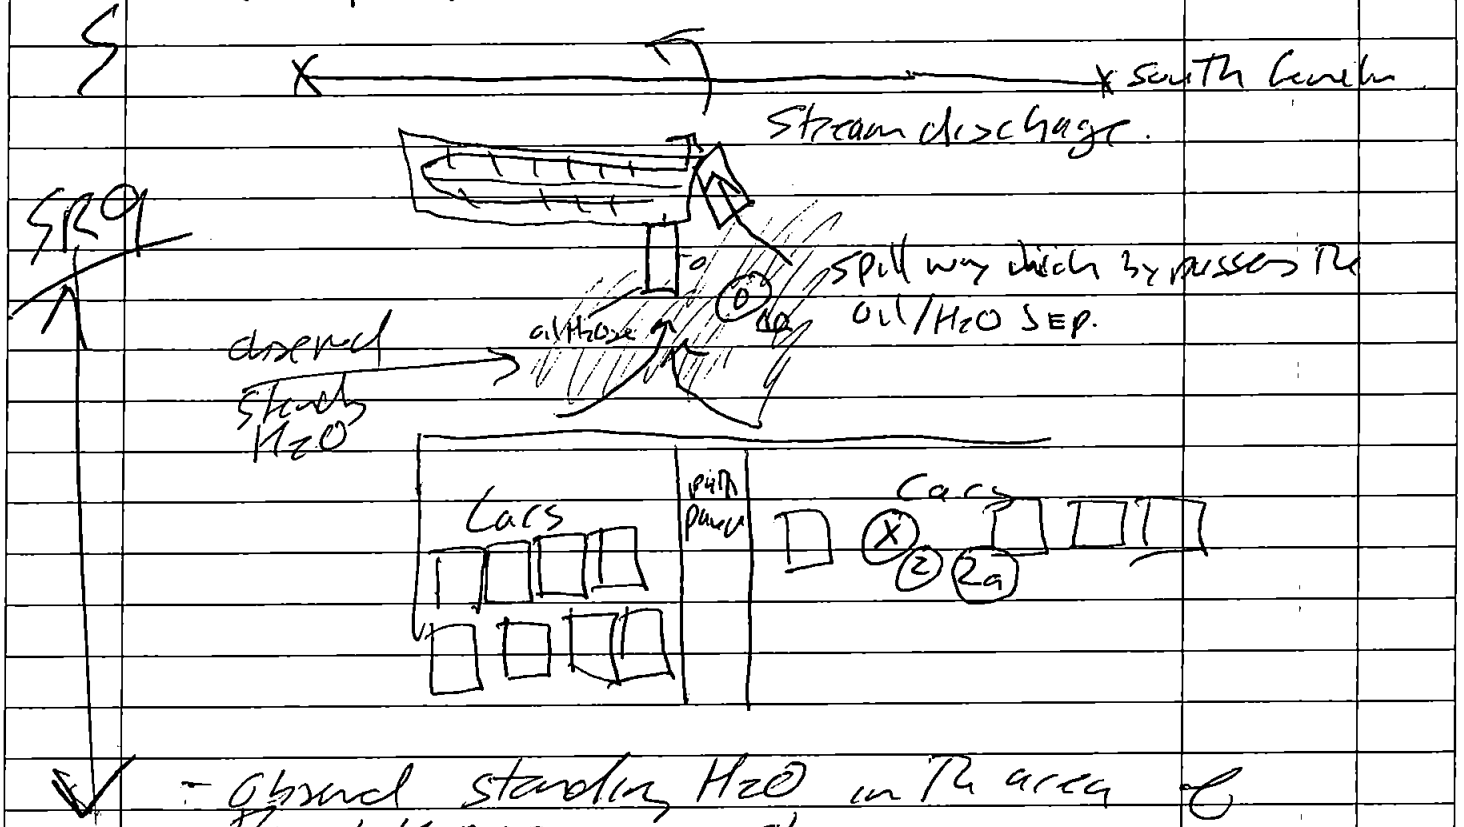
1) Fan area just N. of oil/H_2O sep.
2) NTA of oil/H_2O sep by 30 feet.
2) a same location as #2, 2a sampled for VOC. gas/BTEX

- Observed standing H_2O in TA area & TA oil H_2O/seeping sheen.
- Spoke w/ Brad Thompson who

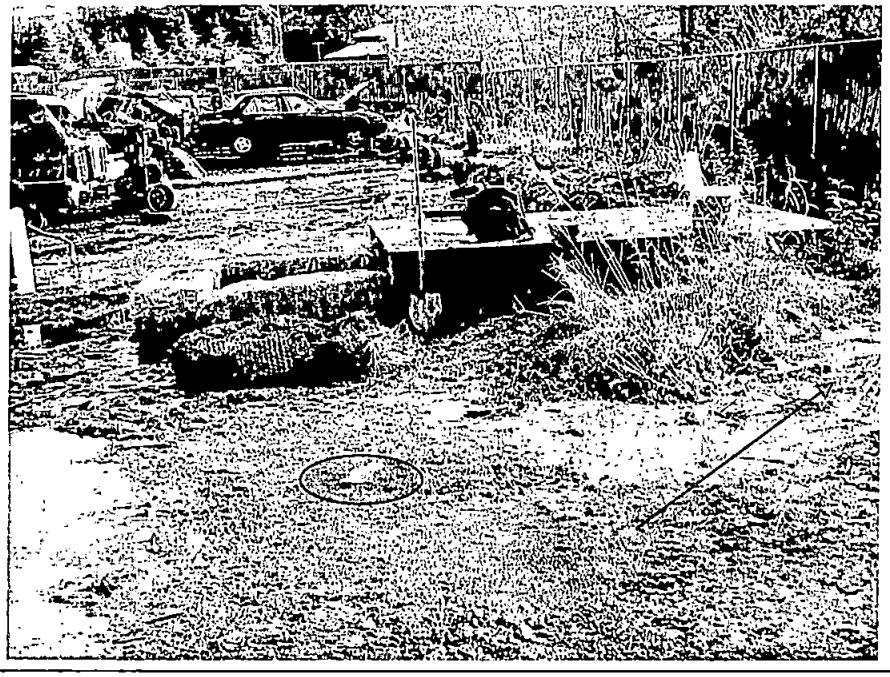
PHOTO NO.	2
DATE	11/13/2007
TIME	
COMPL. NO.	600700
ADDRESS	18306 Hwy 99
	Lynnwood wa
	98037
CAMERA	Cannon s300
TAKEN BY	GWC
WITNESS	Pete Jorgenson

Date	Notes	Recorded by	Title
11/27/07.	CCS 7 due to no ~~test~~ results on This Date. CCEHS.		
12/3/07.	Test Results indicate ↑ levels of Cd + ↑ levels of TPH heavy oil. See results. Recommend listing on CSCS for MTCA Exceedance of Cd + TPH Heavy Oil. CCEHS		
12/14/07	TC to Bruce Thompson @ Pull apart. Informed Bruce of my plans to Recommend The Site to be listed on The CSCS Bruce plans for The contact w/ WDOE Site mgr. advised also to contact The VCP. Sent VCP Contact via Email. Also sent Public Request for info Form via Email. CCEHS.	12/18/07

DESCRIPTION /COMMENTS:
Depicts the location sample 2 and 2a. This area is similar to other areas on the site in that it is unprotected with a pad and contained various chemical contaminants as well as various part from cars.

Recomend listing on CSCS Due to confirmed Exceedances of MTCA Method A standards
