PERIODIC REVIEW

Garden Plaza
Facility Site ID#: 2475

500 and 535 Park Avenue North
Renton, Washington 98055

April 2014

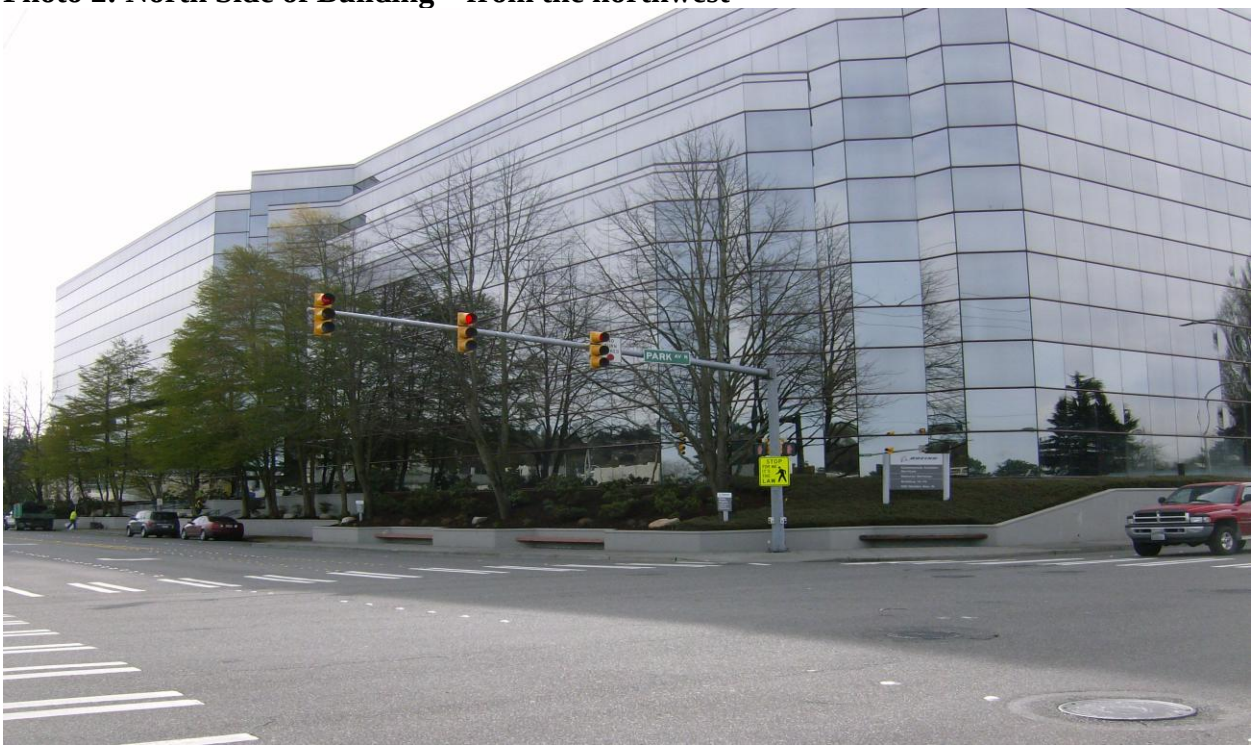
Photo 2: North Side of Building – from the northwest

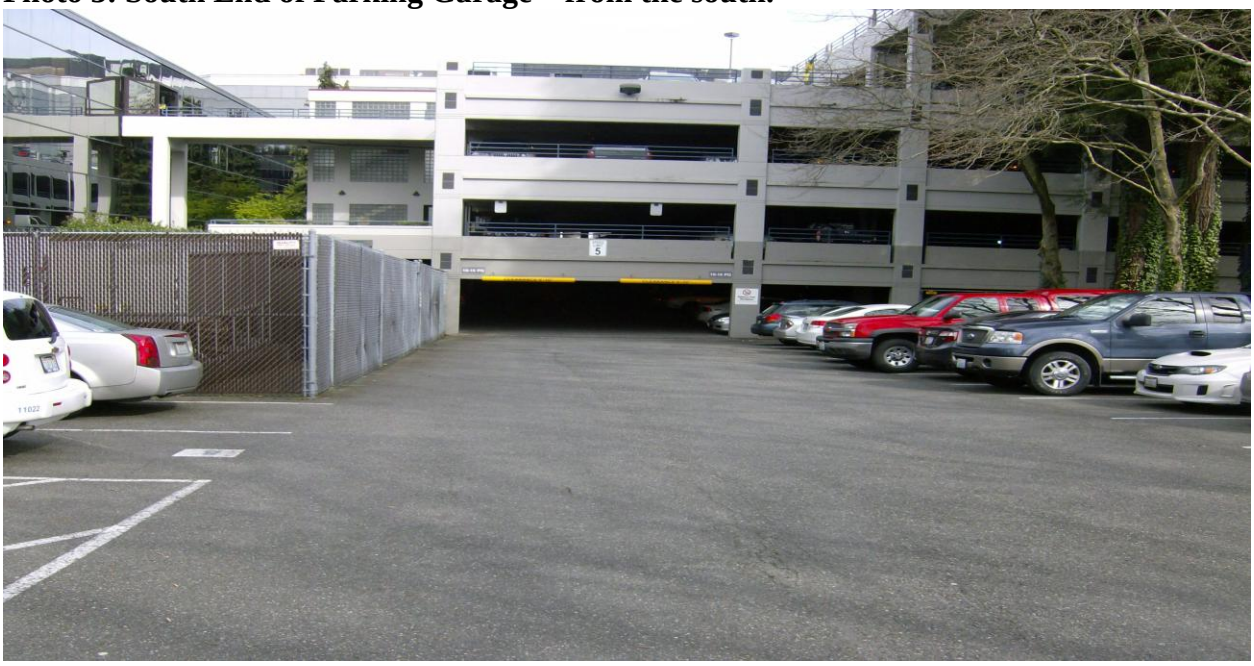
Photo 3: South End of Parking Garage – from the south.
