Semi-Annual Groundwater Monitoring Report 2014

Former Chevron Bulk Plant No. 100-1327
Facilities North / King County (Metro)
Seattle, Washington

August 15, 2014

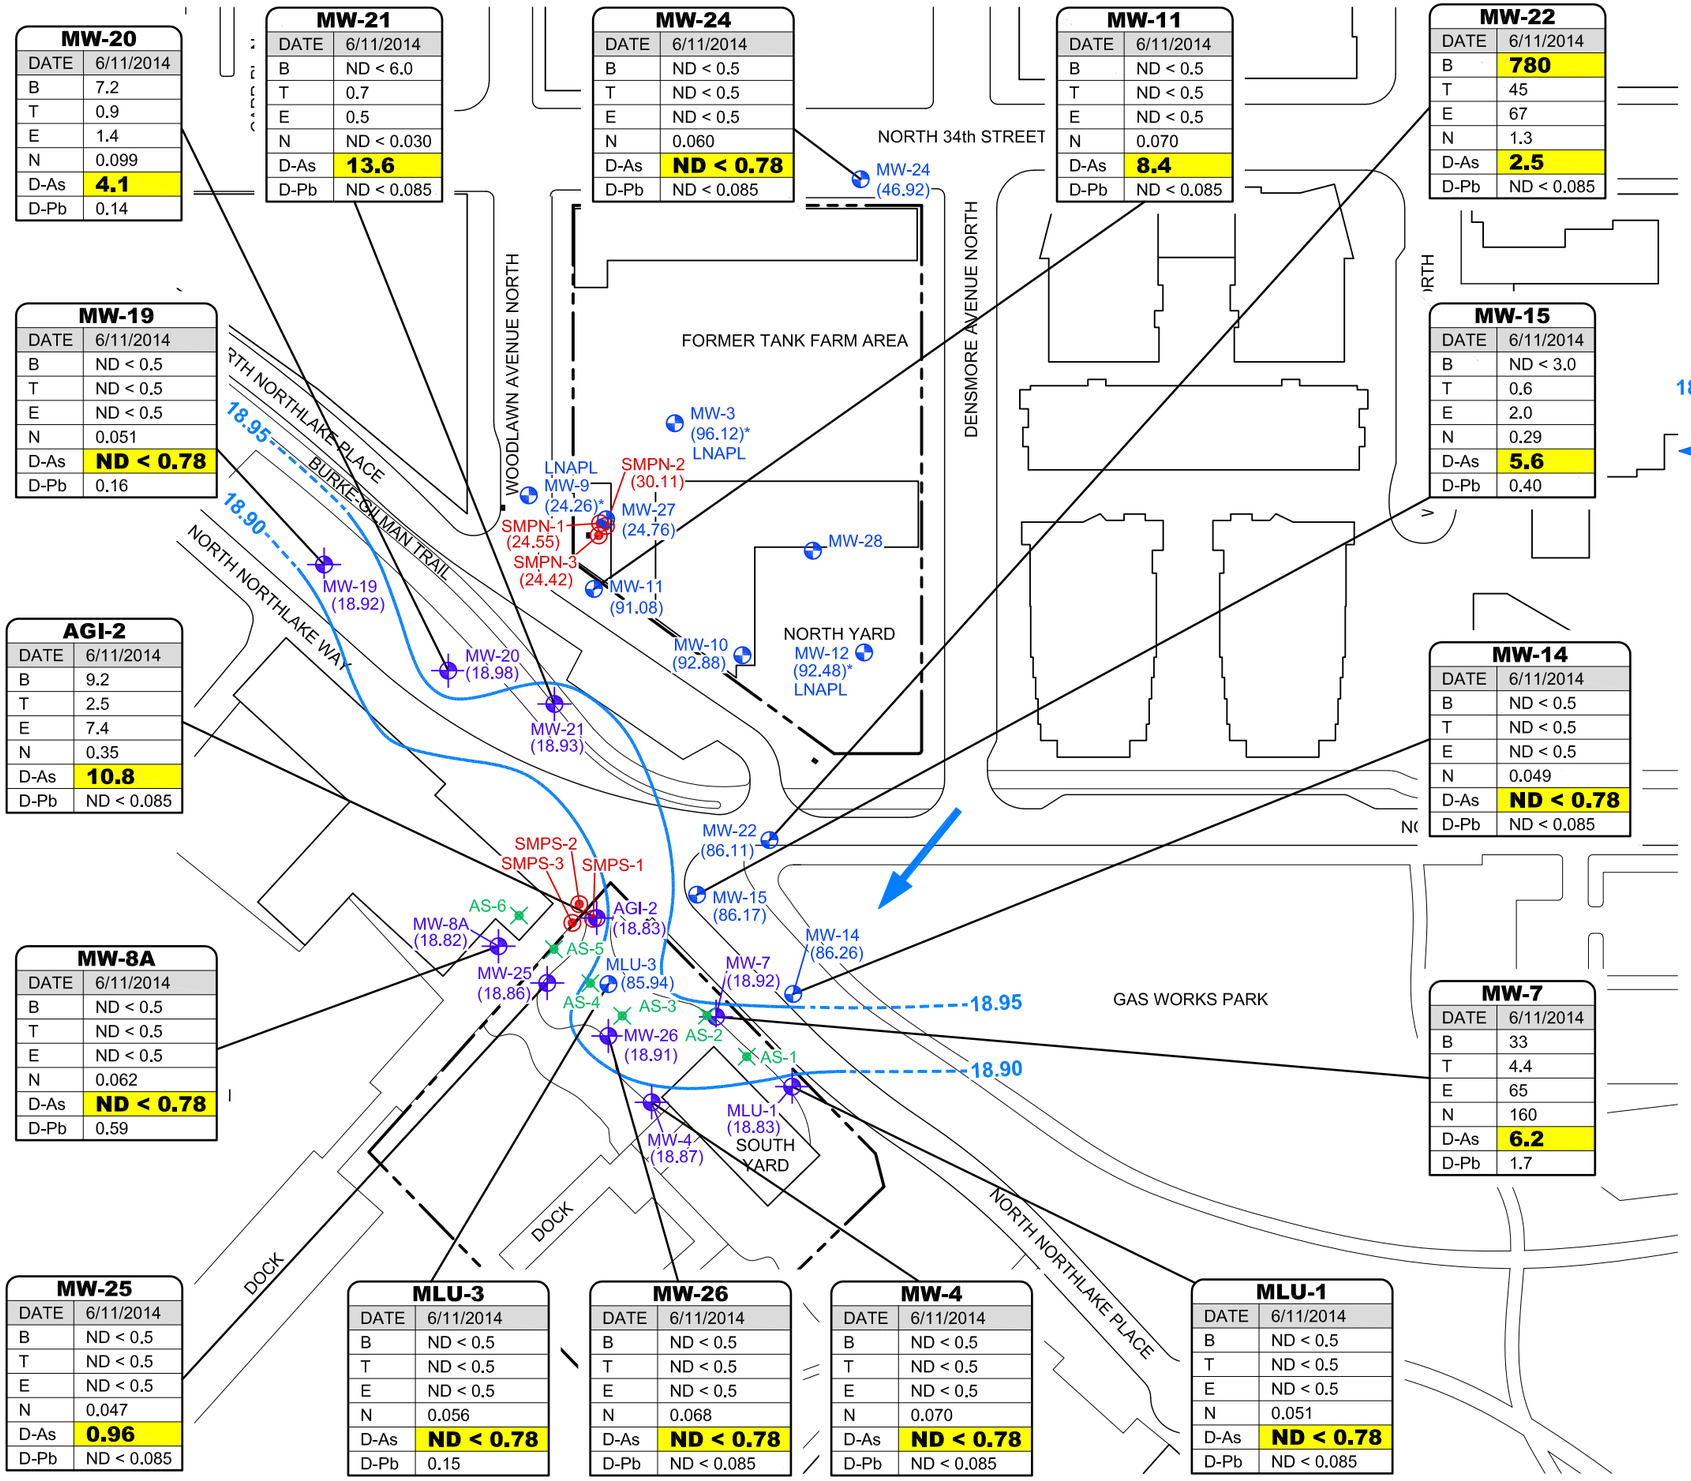
FIGURE 2

Groundwater elevation data at the site during the June 10, 2014, event indicate groundwater flow direction is toward the southwest. The historical groundwater flow direction has seasonally fluctuated from the southeast toward the southwest.

The horizontal hydraulic gradient for the North Yard was calculated to be 0.046 feet per foot (ft/ft) based on the groundwater elevations calculated at monitoring wells MW-3, MW-10 and MW-11 with a flow direction to the southwest. The horizontal hydraulic gradient for the South Yard was calculated to be 0.00125 ft/ft based on the groundwater elevations calculated at monitoring wells MW-1, MW-4 and MW-7 with a flow direction to the southeast. A potentiometric groundwater elevation figure for June 10, 2014 monitoring well gauging data is included on **Figure 2**.

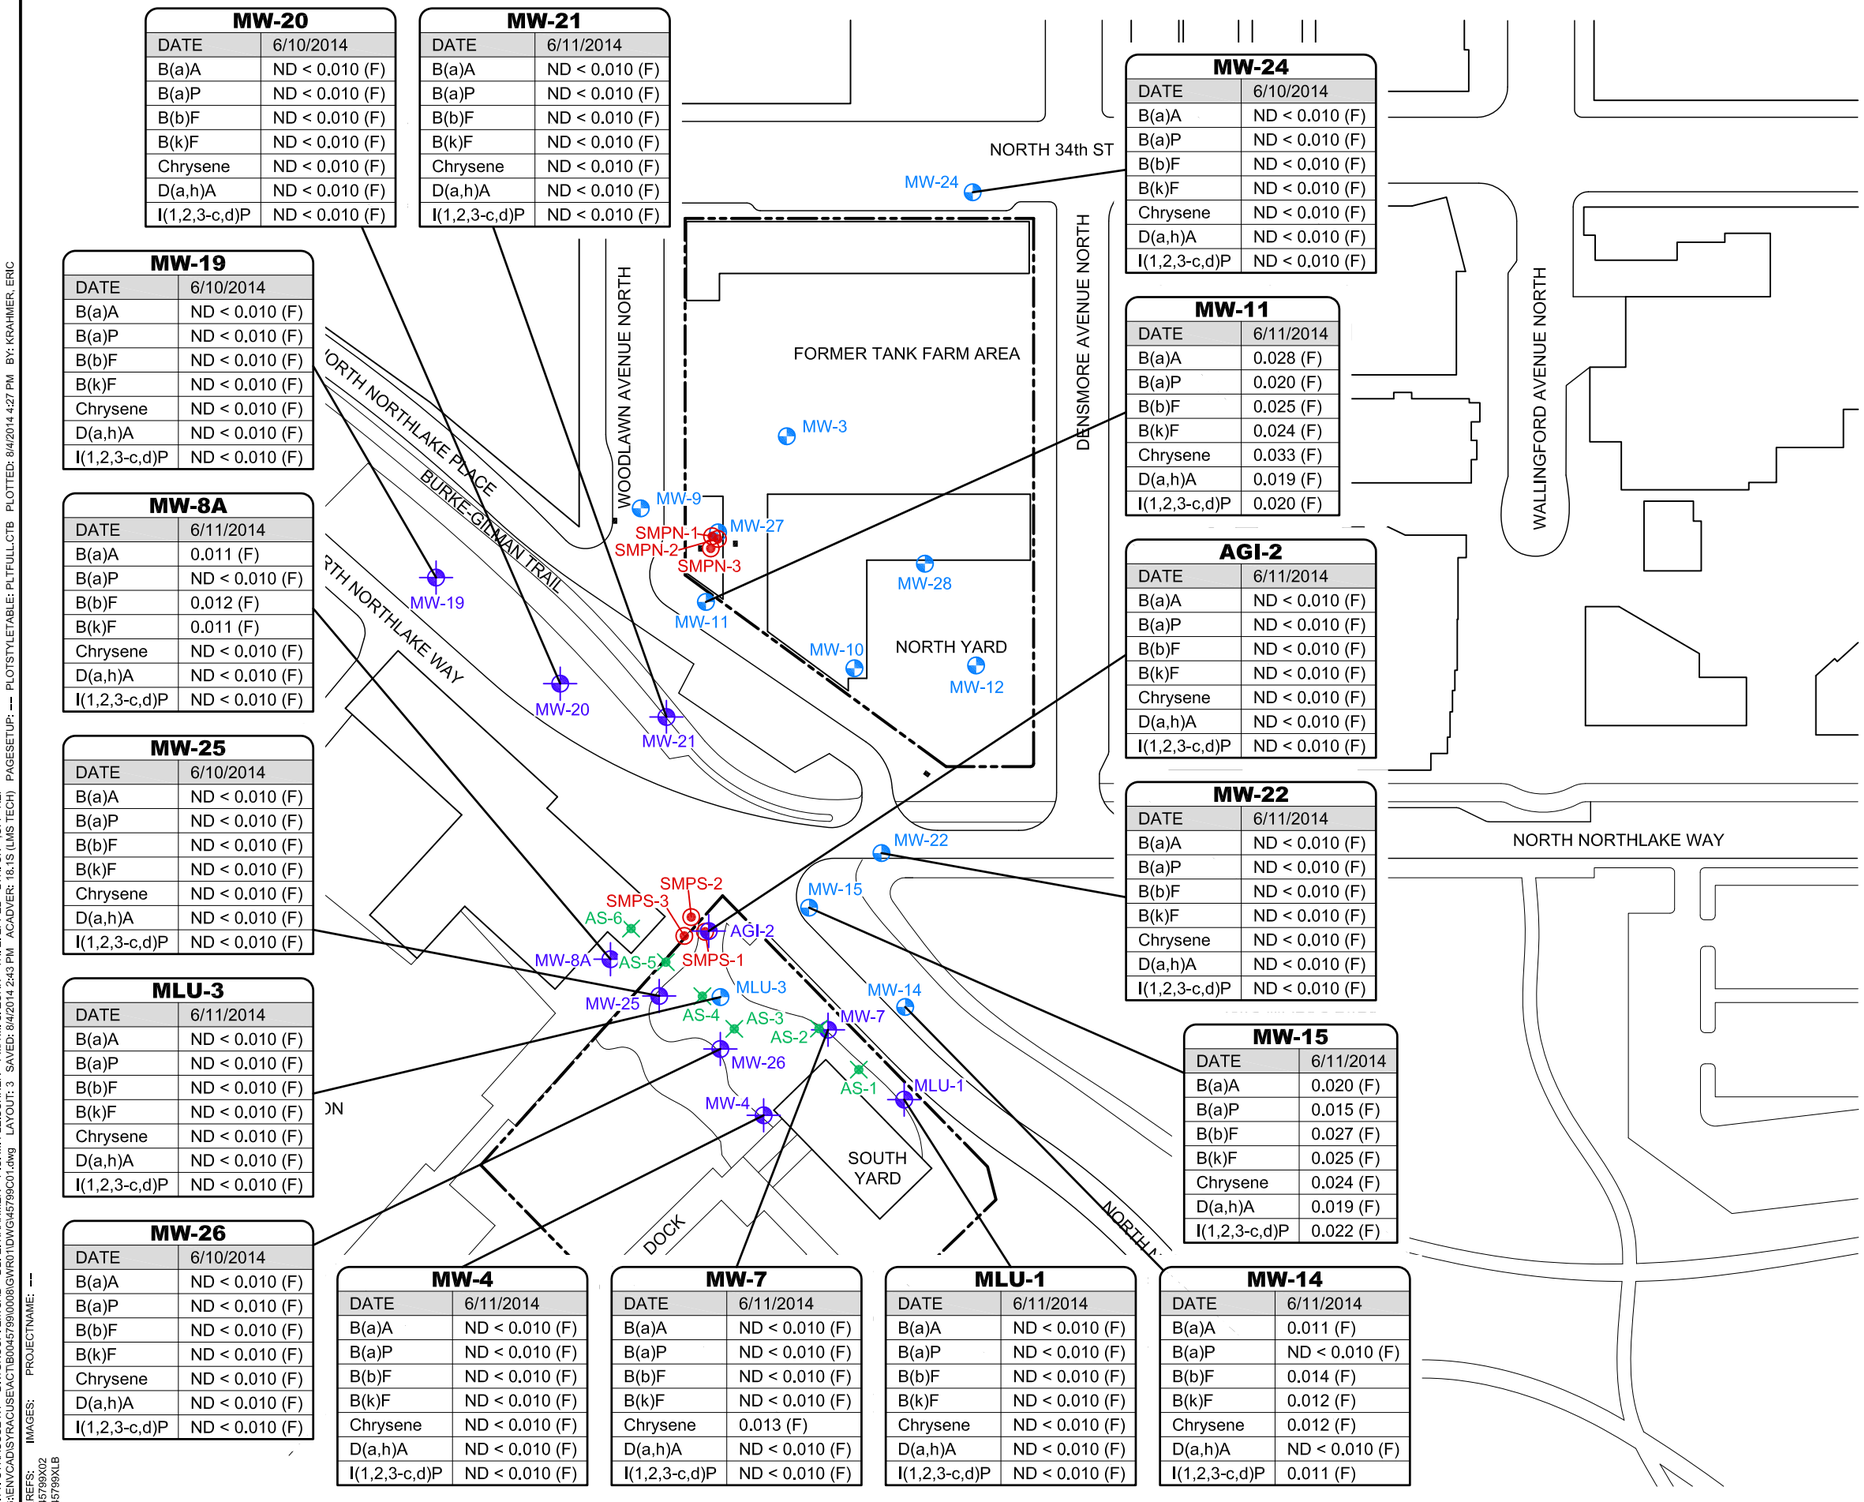
During the semi-annual sampling event conducted on June 10 and 11, 2014, groundwater was sampled for benzene, toluene, ethylbenzene, filtered cPAHs, naphthalene, arsenic and lead, from monitoring wells MW-4, MW-7, MW-8A, MW-11, MW-14, MW-15, MW-19, MW-20, MW-21, MW-22, MW-24, MW-25, MW-26, AGI-2, MLU-1, and MLU-3. Dissolved arsenic was detected above the MTCA Method B surface water CUL of 0.0982 µg/L in groundwater samples from monitoring wells MW-7, MW-11, MW-15, MW-20, MW-21, MW-22, MW-25 and AGI-2 at concentrations ranging from 0.96 µg/L (MW-25) to 13.6 µg/L (MW-21). The laboratory detection limit (DL) for dissolved arsenic exceeded the MTCA Method B surface water CUL in samples collected from wells MW-4, MW-8A, MW-14, MW-19, MW-24, MLU-1 and MLU-3. Benzene was detected in MW-22 at 780 µg/L, however MW-22 is not a point of compliance (POC) well for either the North Yard or South Yard. No other COCs were detected at concentrations greater than the respective CULs. The laboratory analytical report is included in **Appendix B** and the laboratory analytical results are presented on **Figure 2** and **Figure 3** and in **Table 2**.
