May 23, 2011
Project 101.00173.00010

Re: Quarterly Groundwater Sampling Report – March 2011 Event
Former Arco Service Station #0855, Longview, Washington

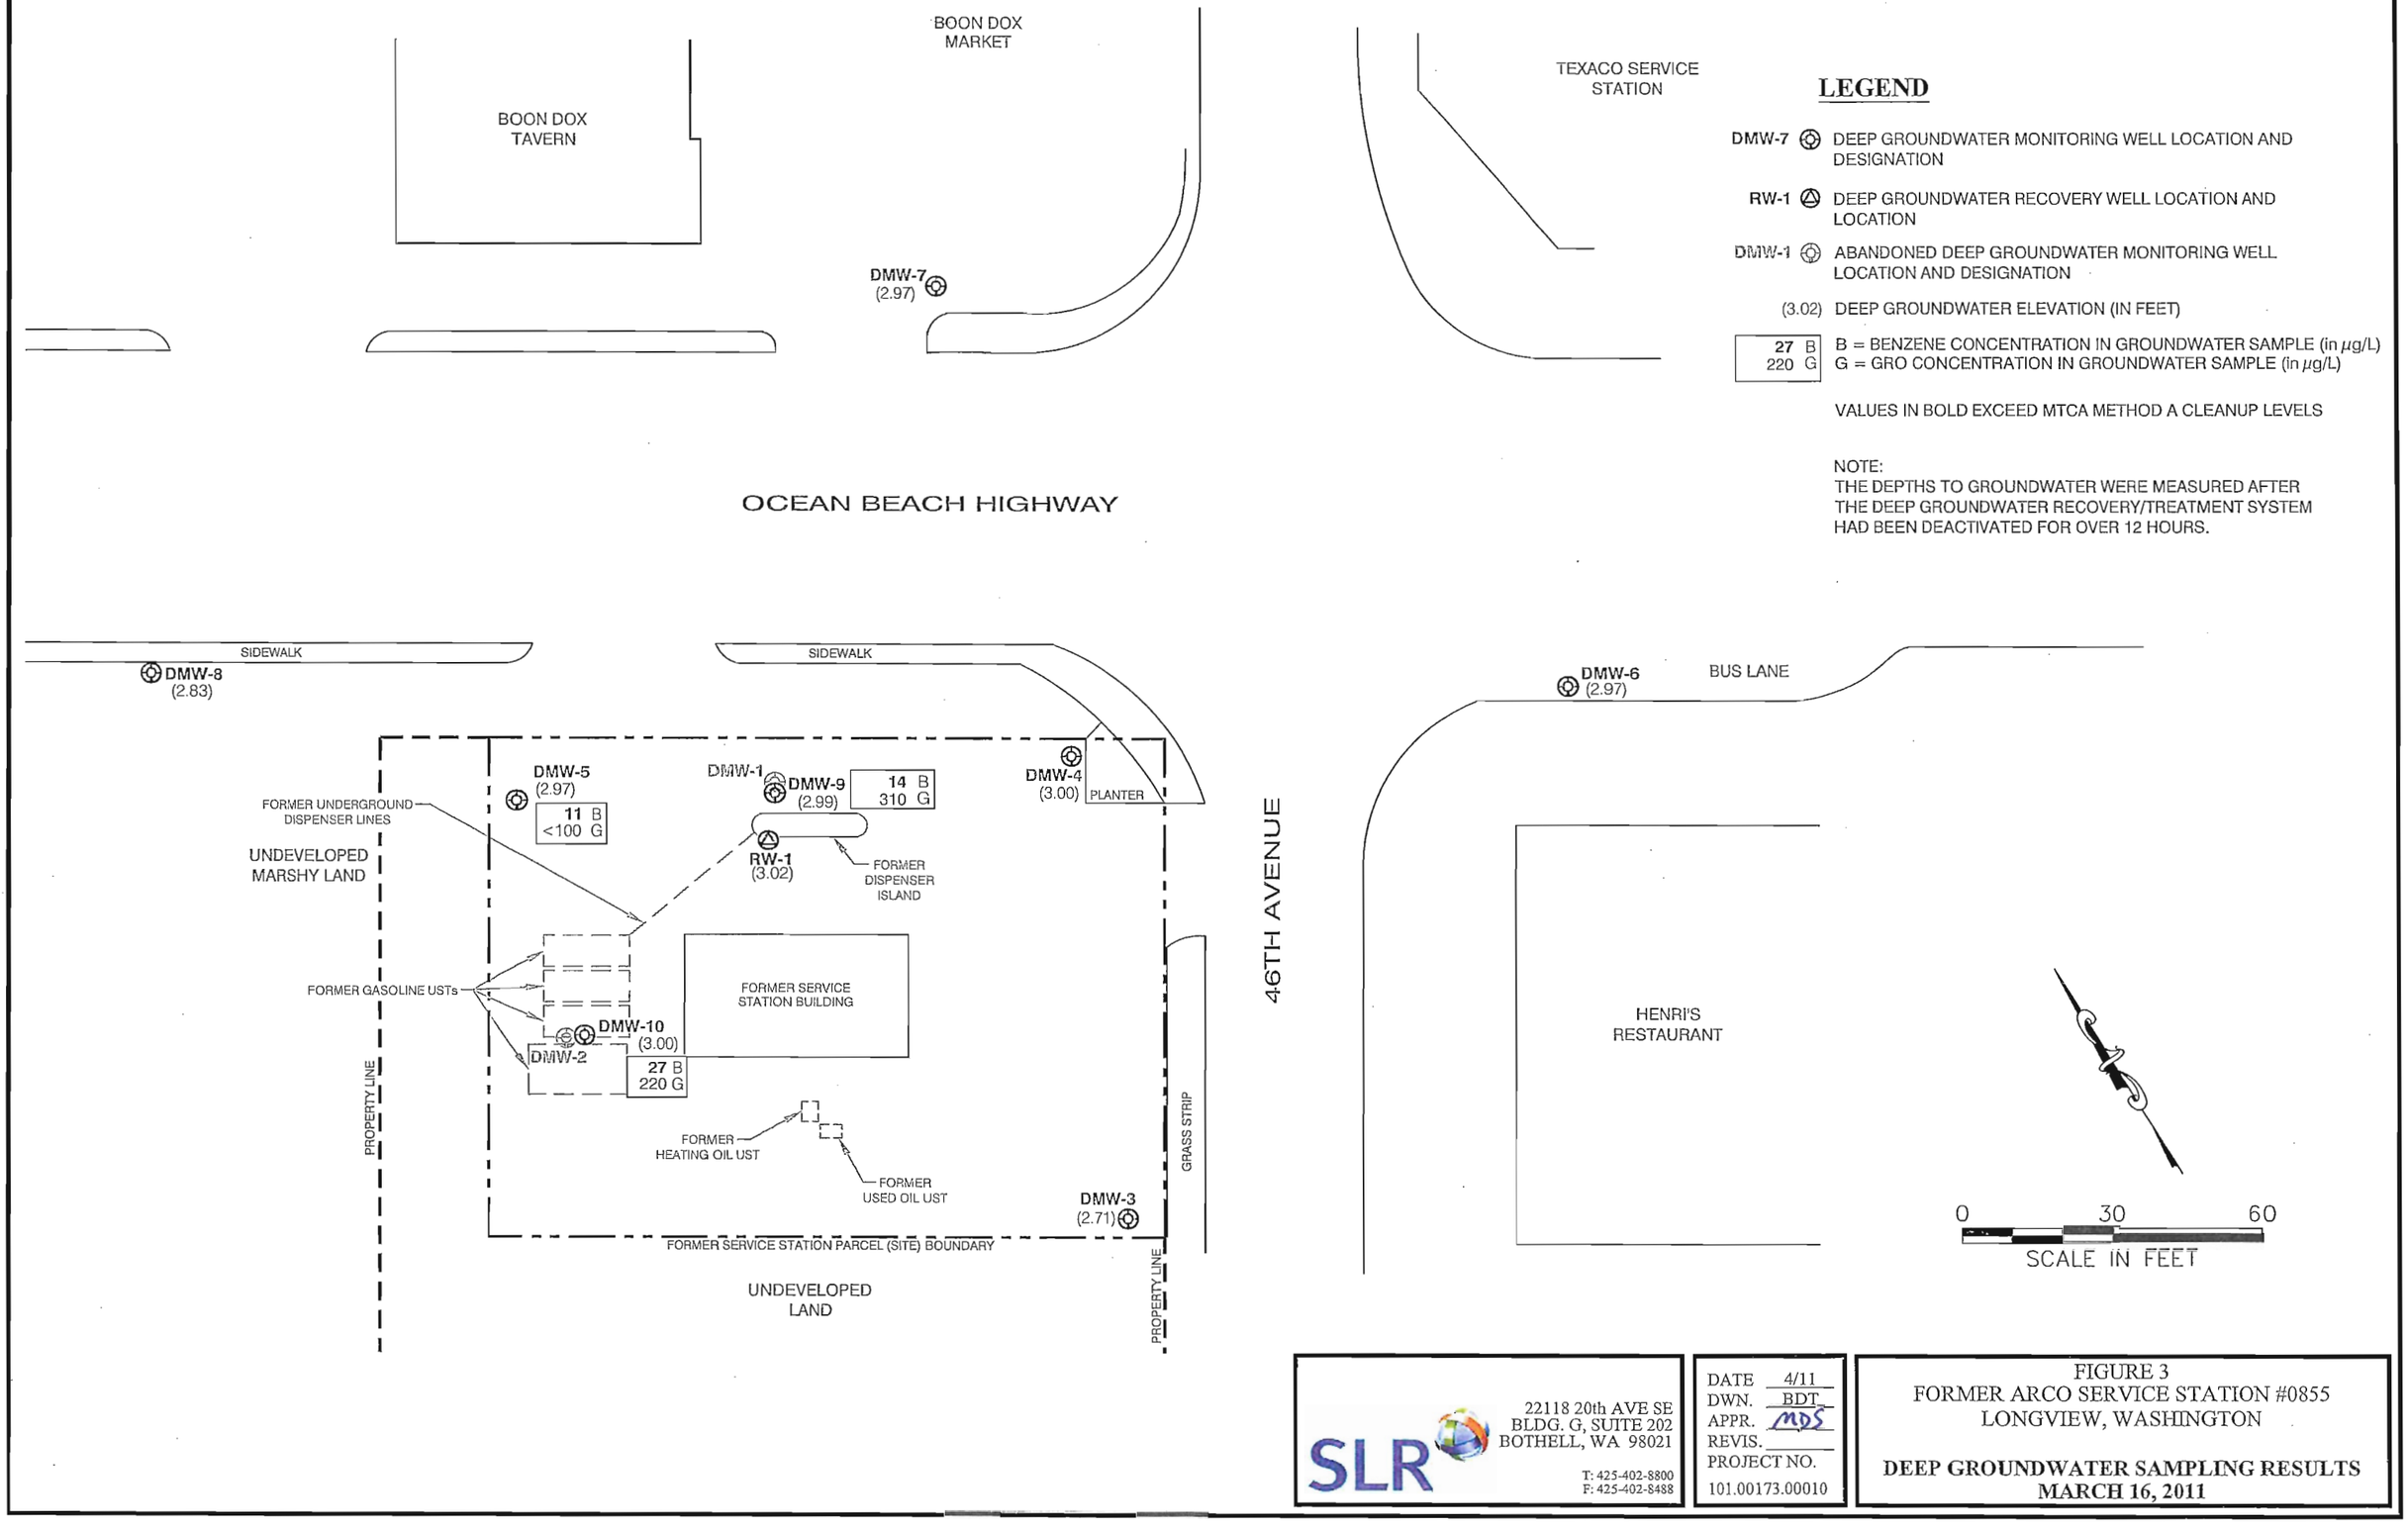
FIGURE 3
FORMER ARCO SERVICE STATION #0855
LONGVIEW, WASHINGTON

benzene and GRO concentrations in the March 2011 samples are shown on Figure 3. A copy of the laboratory analytical report is attached.

The 2008 groundwater sampling results from the deep wells showed that the 2007 remediation activities had limited short-term affects on the deep groundwater concentrations (SLR, 2008a; SLR, 2008b; and SLR, 2008c). However, the petroleum hydrocarbon concentrations were decreasing with distance away from the primary source area (the former dispenser island area) due to natural attenuation. To actively remediate the impacted deep groundwater, a deep groundwater recovery/treatment system has been operating since June 2009. Based on the groundwater sampling results from December 2009 through December 2010 sampling results (SLR, 2010a; SLR, 2010b; SLR, 2010c; SLR, 2010d; and SLR, 2011), as well as the March 2011 sampling results, the benzene and GRO concentrations in the deep groundwater are decreasing due to the operation of the system. At the source area well (DMW-9), the benzene and GRO concentrations in March 2011 were 3,286 and 8,290 µg/L, respectively, less than the concentrations in October 2008 (the last sampling event prior to activating the deep groundwater recovery/treatment system). In March 2011, the benzene concentration (14 µg/L) at DMW-9 exceeded the MTCA Method A cleanup level; however, the GRO concentration (310 µg/L) was below the Method A cleanup level (800 µg/L) for the second consecutive quarter.
