SLR

January 9, 2012
Project 101.00173.00010

Re: Quarterly Groundwater Sampling Report – December 2011 Event
Former Arco Service Station #0855, Longview, Washington

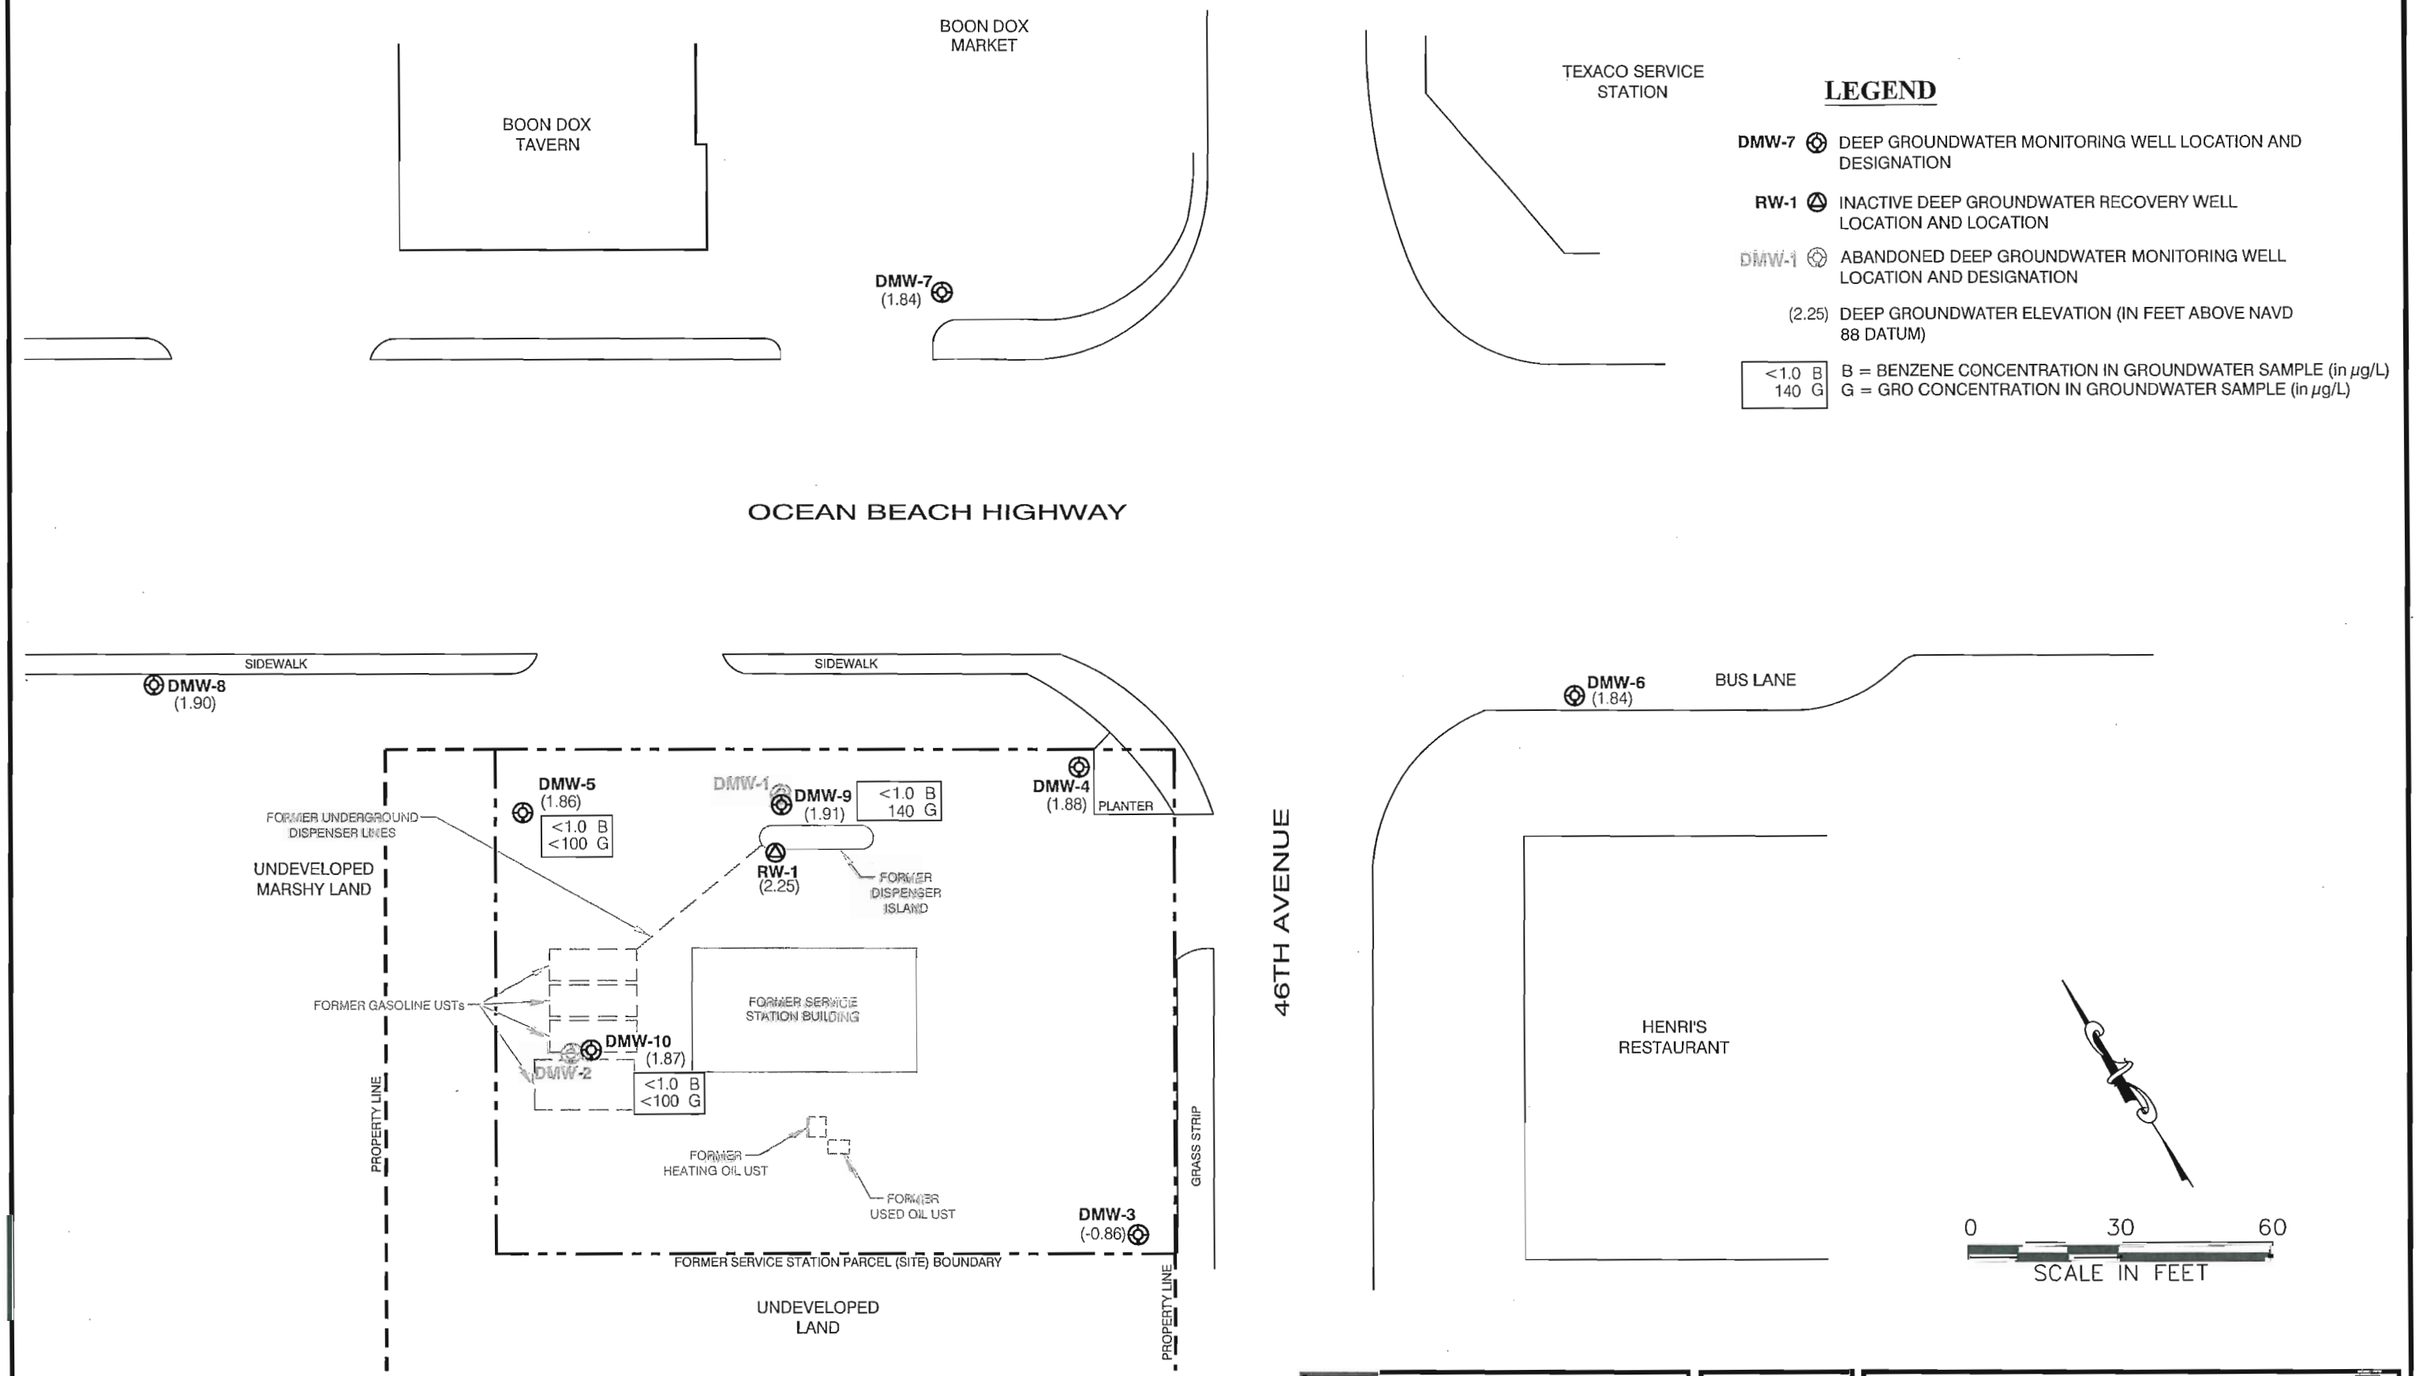
FIGURE 3
FORMER ARCO SERVICE STATION #0855
LONGVIEW, WASHINGTON

SLR personnel collected groundwater samples from deep wells DMW-5, DMW-9, and DMW-10 for laboratory analysis. SLR purged the wells by using a peristaltic pump with dedicated tubing at a flow rate of approximately 0.33 liters per minute. During purging, field parameters of temperature, conductivity, dissolved oxygen, pH, and oxidation-reduction potential were measured every three to five minutes. Each groundwater sample was collected following the stabilization of the field parameter measurements.

The groundwater samples were submitted to Friedman & Bruya, Inc. (F&B) in Seattle, Washington, for analysis of benzene, toluene, ethylbenzene, and total xylenes (BTEX) by EPA Method 8021B, and gasoline-range organics (GRO) by Ecology Method NWTPH-Gx. The analytical results indicated that the sample from DMW-9 contained a GRO concentration [140 micrograms per liter (µg/L)] that was below the MTCA Method A groundwater cleanup level (800 µg/L). The sample from DMW-9 did not contain BTEX concentrations greater than the method reporting limits (MRLs). The samples from

DMW-5 and DMW-10 did not contain BTEX or GRO concentrations greater than the MRLs. The groundwater sample analytical results from the December 2011 event, as well as from the previous sampling events, are presented in Table 2. The benzene and GRO concentrations in the December 2011 samples are also shown on Figure 3. A copy of the laboratory analytical report is attached.

In December 2011, the BTEX and GRO concentrations were below the MTCA Method A cleanup levels in all of the deep groundwater samples. The concentrations in the sample from well DMW-10 were below the Method A cleanup levels for the first time; however, the concentrations in the samples from wells DMW-5 and DMW-9 have been below the Method A cleanup levels for three and two consecutive quarterly events, respectively.

DEEP GROUNDWATER SAMPLING RESULTS DECEMBER 8, 2011
