Wyckoff Sheet Pile Wall – Nonaqueous Phase Liquid and Plume Migration Barrier Effectiveness Evaluation

PREPARED FOR: Howard Orlean/EPA

PREPARED BY: Robert Healy/CH2M HILL

DATE: December 18, 2013

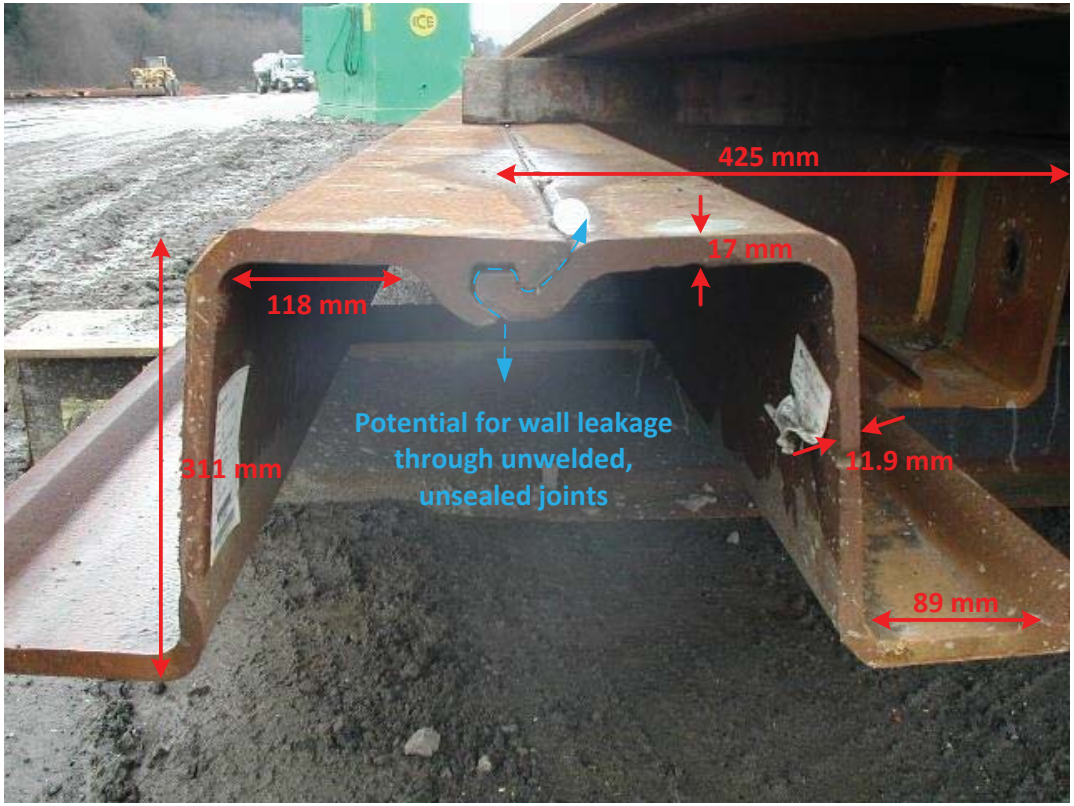
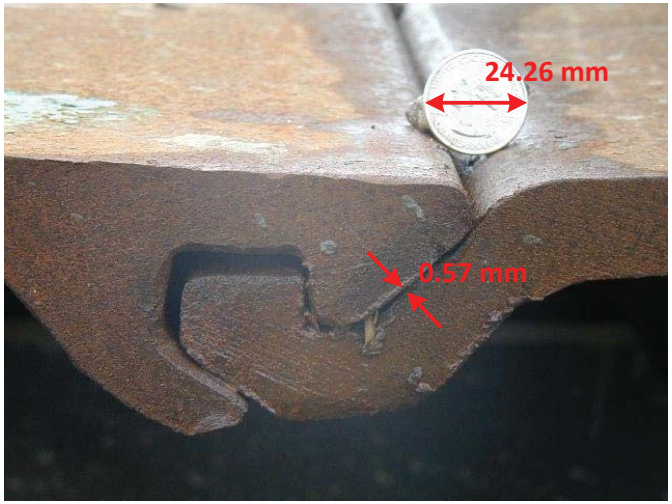
The sheet pile wall was constructed of British Steel Z '5'section sheet piling—also referred to as Frodingham #5 sheet pile. Figure 1 displays a schematic of a typical individual pile with interlocking joints, displaying dimensions (all figures are provided at the end of the main text). The sheet pile wall consists of 674 piles, with two interlocking joints per pile. One of the joints was welded prior to installation of each pile. The unwelded interlocking joint has a seam width estimated at approximately 0.6 millimeters (mm). The unwelded seams are not sealed, and therefore, the potential for leakage through the seams may exist (Arcelor, 2006). The entire sheet pile wall has a surface area of approximately 3 acres (130,598 square feet [ft^2]), and the seams represent approximately 0.07 percent (92 ft^2) of that area. Table 1 summarizes the sheet pile wall as-builts segregated into 13 segments (all tables are provided at the end of the main text). Figure 2 shows the location of the sheet pile wall, the sheet pile wall segments, and the production and monitoring wells at the site. During installation of the sheet pile wall, six sheet pile wall seams were encased on the exterior of the wall with a welded channel. Each welded channel measures approximately 5.25 by 4.5 inches and is capped to prevent direct precipitation into the top. The channels were installed for future monitoring of potential seam leakage.

Schematic of Typical Individual Pile with Interlocking Joints

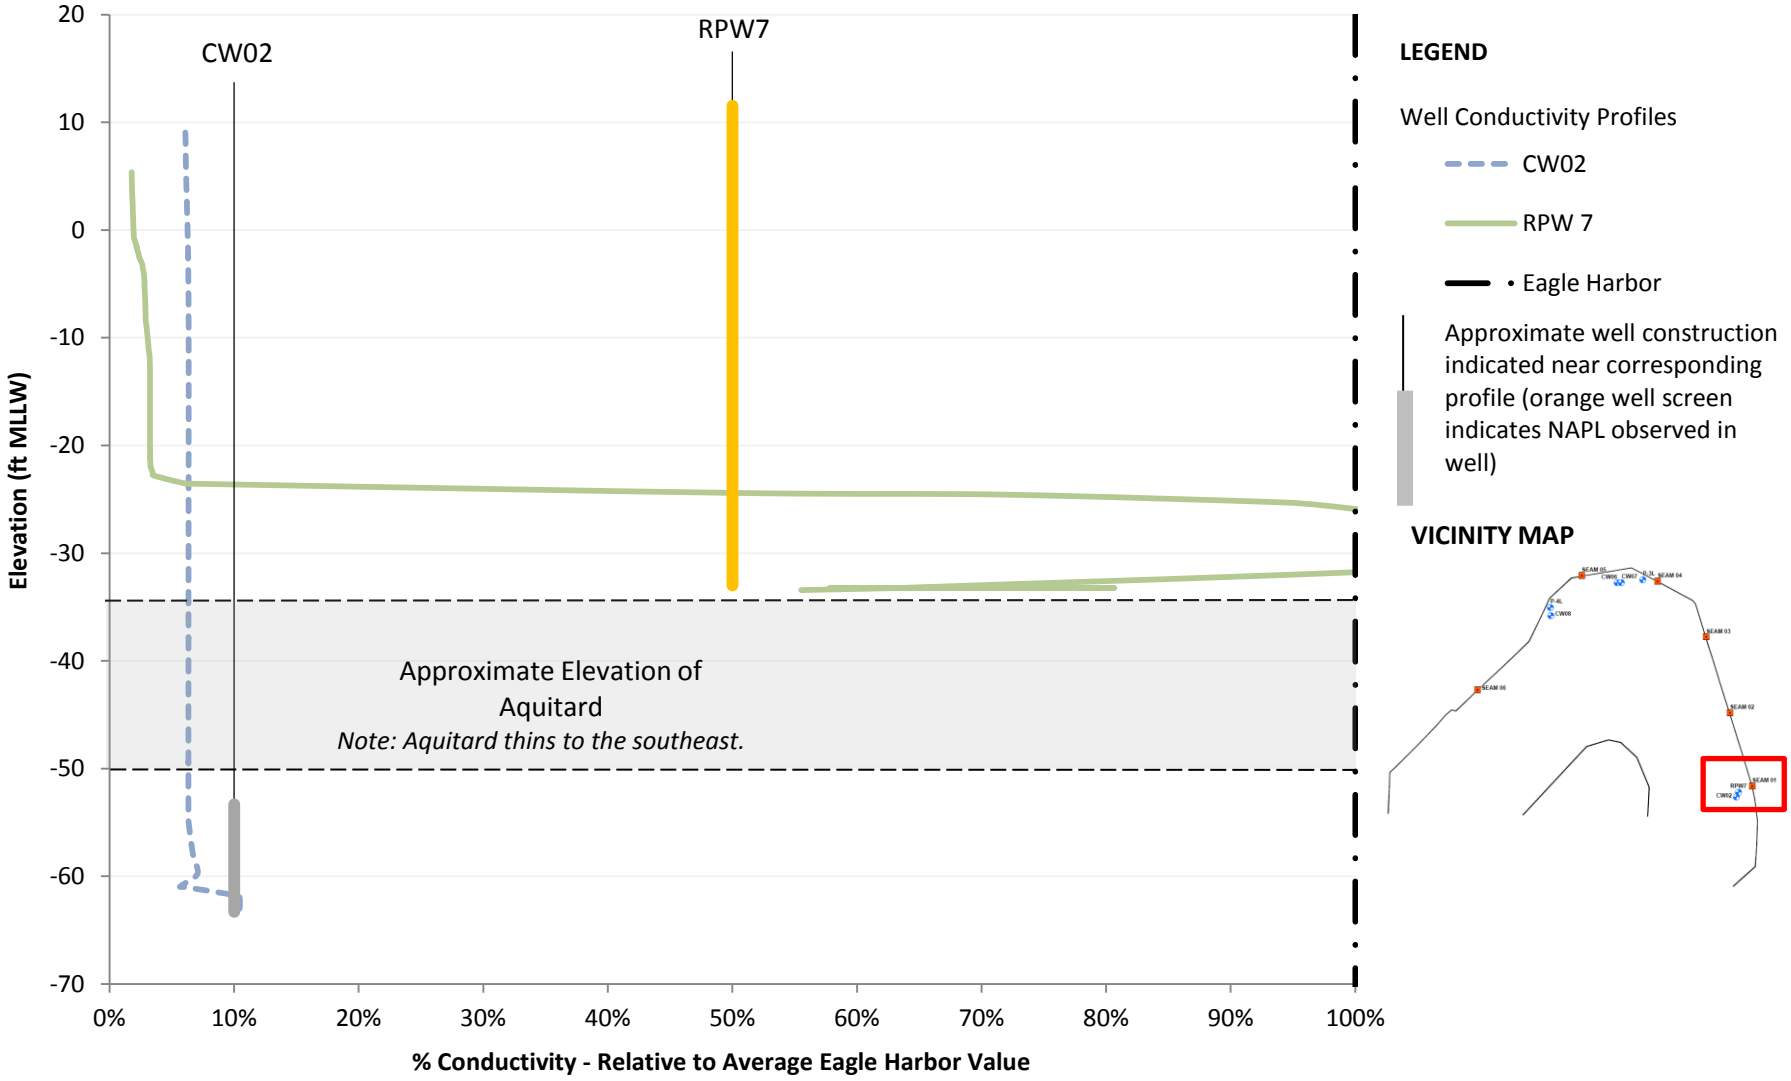
Figure 3 displays the conductivity profile for the well cluster RPW7 and CW02 located to the southeast along sheet pile wall segment 10. In this case, RPW7 is screened across the entire Upper Aquifer. Below an elevation of -22 feet MLLW, the percent salinity readings at RPW7 increase above those from CW02 screened in the Lower Aquifer. The elevated salinity observed at the base of RPW7, which is comparable with levels present in the harbor, does not match the expected pattern (i.e., salinity less than 100 percent) for a perfect low-permeability hydraulic barrier. The elevated salinity observed at RPW7 in comparison with the lower salinity at CW02 suggests there is increased hydraulic exchange with Eagle Harbor either through the sheet pile wall or directly beneath it,

depending on how the wall is keyed into the aquitard. The salinity profile for Deep Aquifer monitoring well CW02, which was lower than expected based on the observed thinning of the aquitard in its vicinity, suggests this well might lie at the margin of the freshwater-saltwater interface. This interface can be a diffused or sharp boundary that shifts laterally in response to tidal fluctuations. Depending on where the well lies relative to this front, there might be marked differences in salinity between measurement events performed during low and high tide periods.

Conductivity Profiles for Wells, May 2013 - Eastern well cluster (CW02 and RPW7)

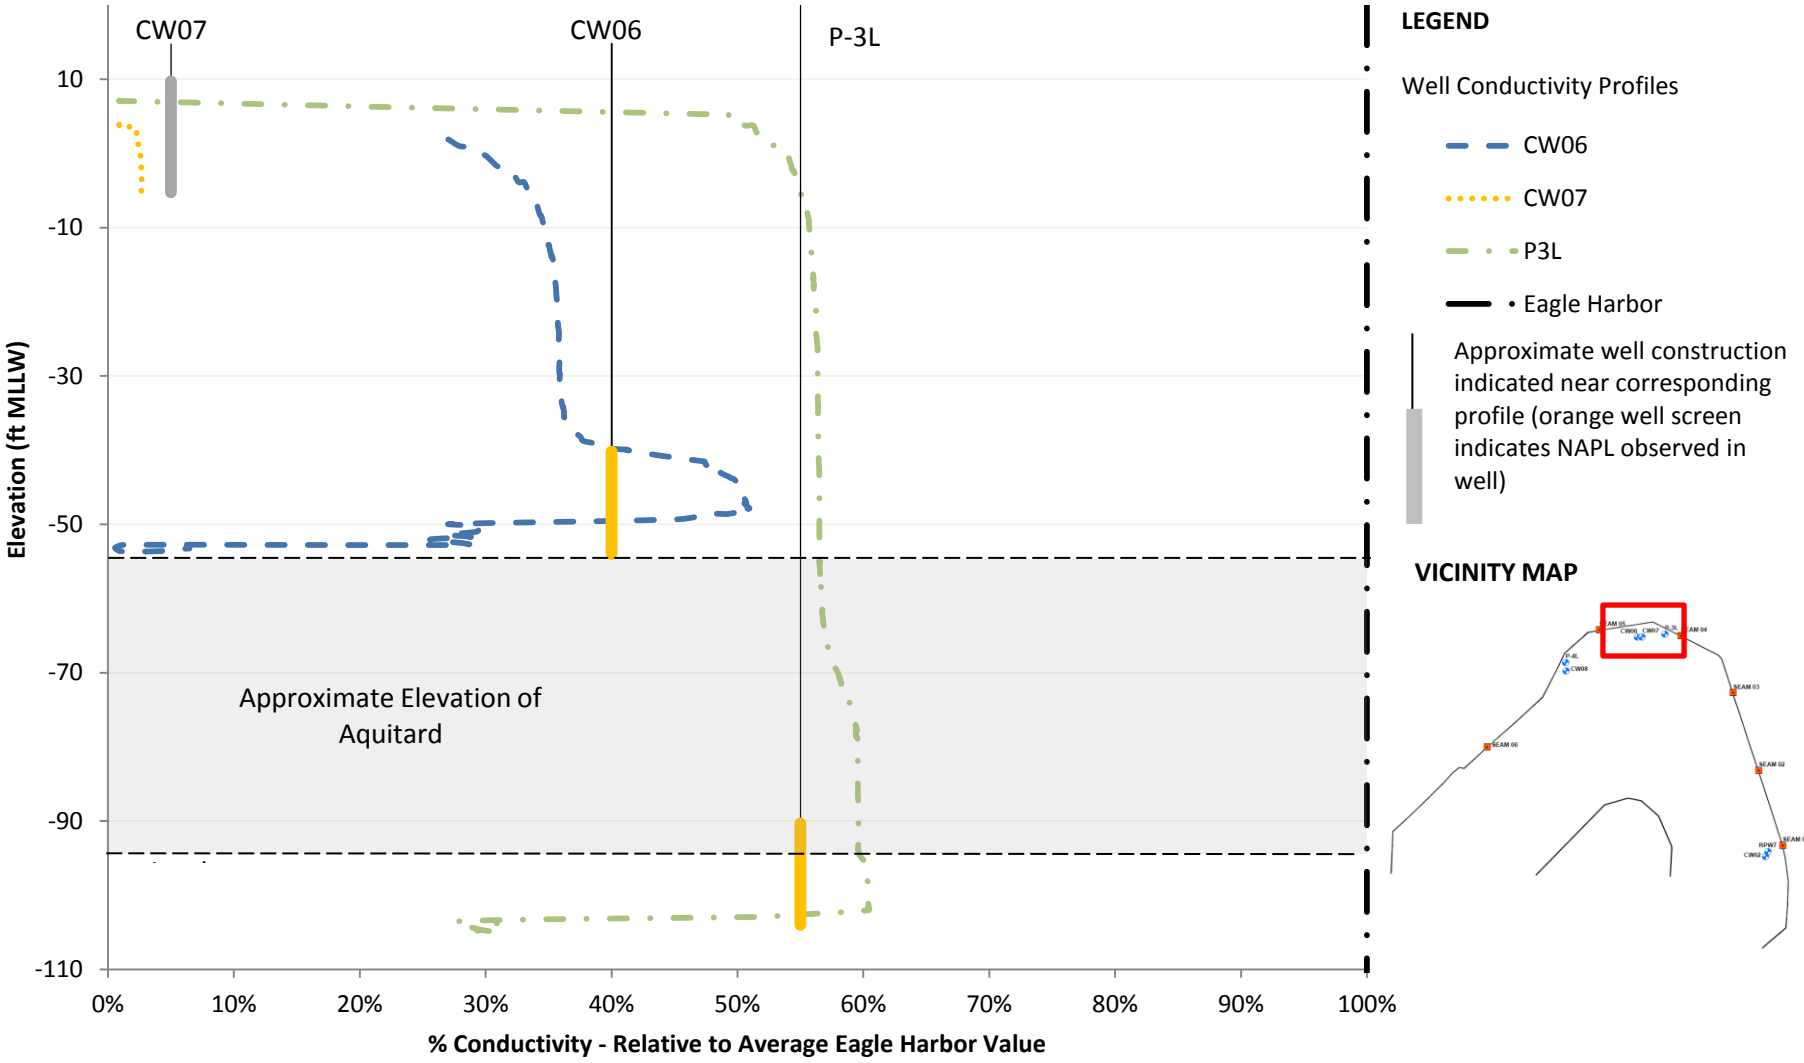
Figure 4 displays the conductivity profile for the well cluster set CW06, CW07, and P-3L located to the north. The conductivity profile matches the expected pattern for a perfect low-permeability hydraulic barrier. It should be noted that NAPL was observed in at Upper Aquifer well CW06 and Lower Aquifer Well P-3L. Recent TarGOST results also indicate NAPL presence along the top of the aquitard inside the sheet pile wall in this vicinity.

Conductivity Profiles for Wells, May 2013 - Northern well cluster (CW06, CW07, and P-3L)

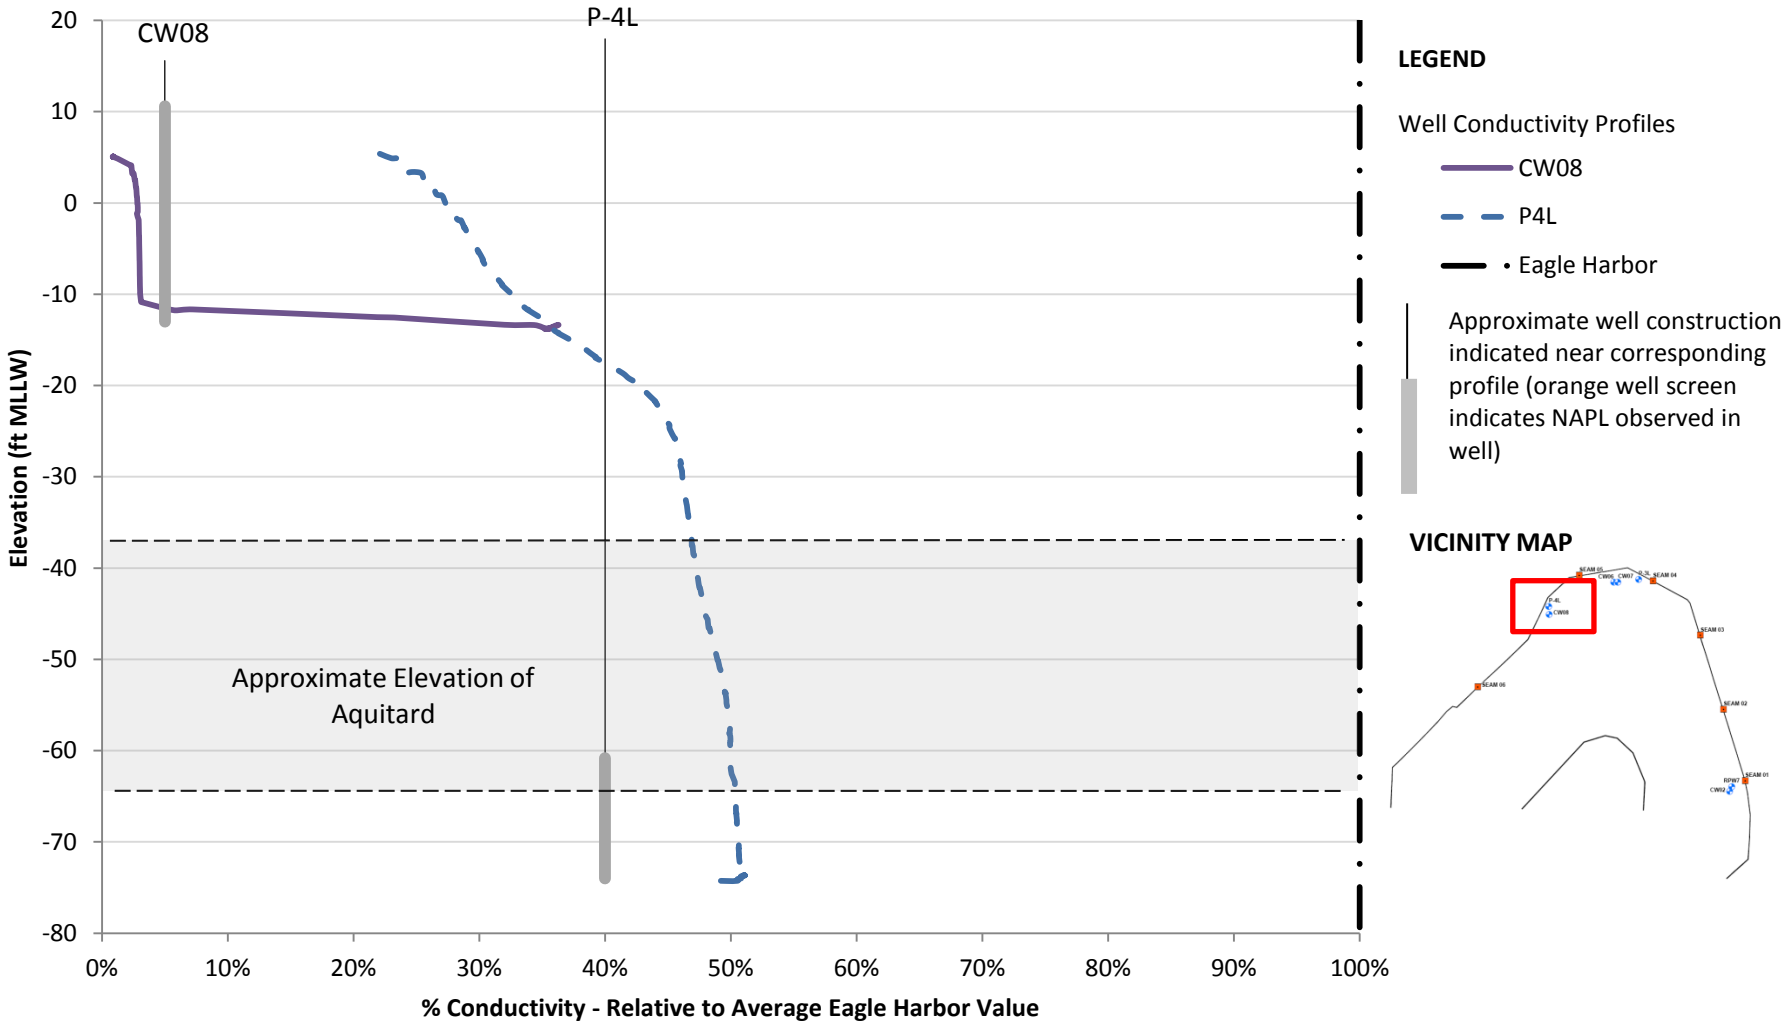
Figure 5 displays the conductivity profile for the well cluster set CW08 and P-4L along Segment 4 of the sheet pile wall to the northwest. In this case there is no Upper Aquifer well screened directly above the aquitard. Below an elevation of -10 MLLW, the percent salinity readings increase and match the readings from well P-4L screened in the Lower Aquifer. If a deeper Upper Aquifer well was present at this location, the CW08 salinity profile suggests that it would have a higher percent salinity than CW08 and most likely be comparable with well P-4L. Consequently, this well cluster's salinity pattern likely does not match the expected pattern for a perfect low-permeability hydraulic barrier. Instead this pattern of higher salinity present in the Upper Aquifer suggests a more direct hydraulic exchange with Eagle Harbor, either through the sheet pile wall beneath it depending on how the wall is keyed into the aquitard or lateral migration around the ends of the wall.

Conductivity Profiles for Wells, May 2013 - Northwestern well cluster (CW08 and P-4L)

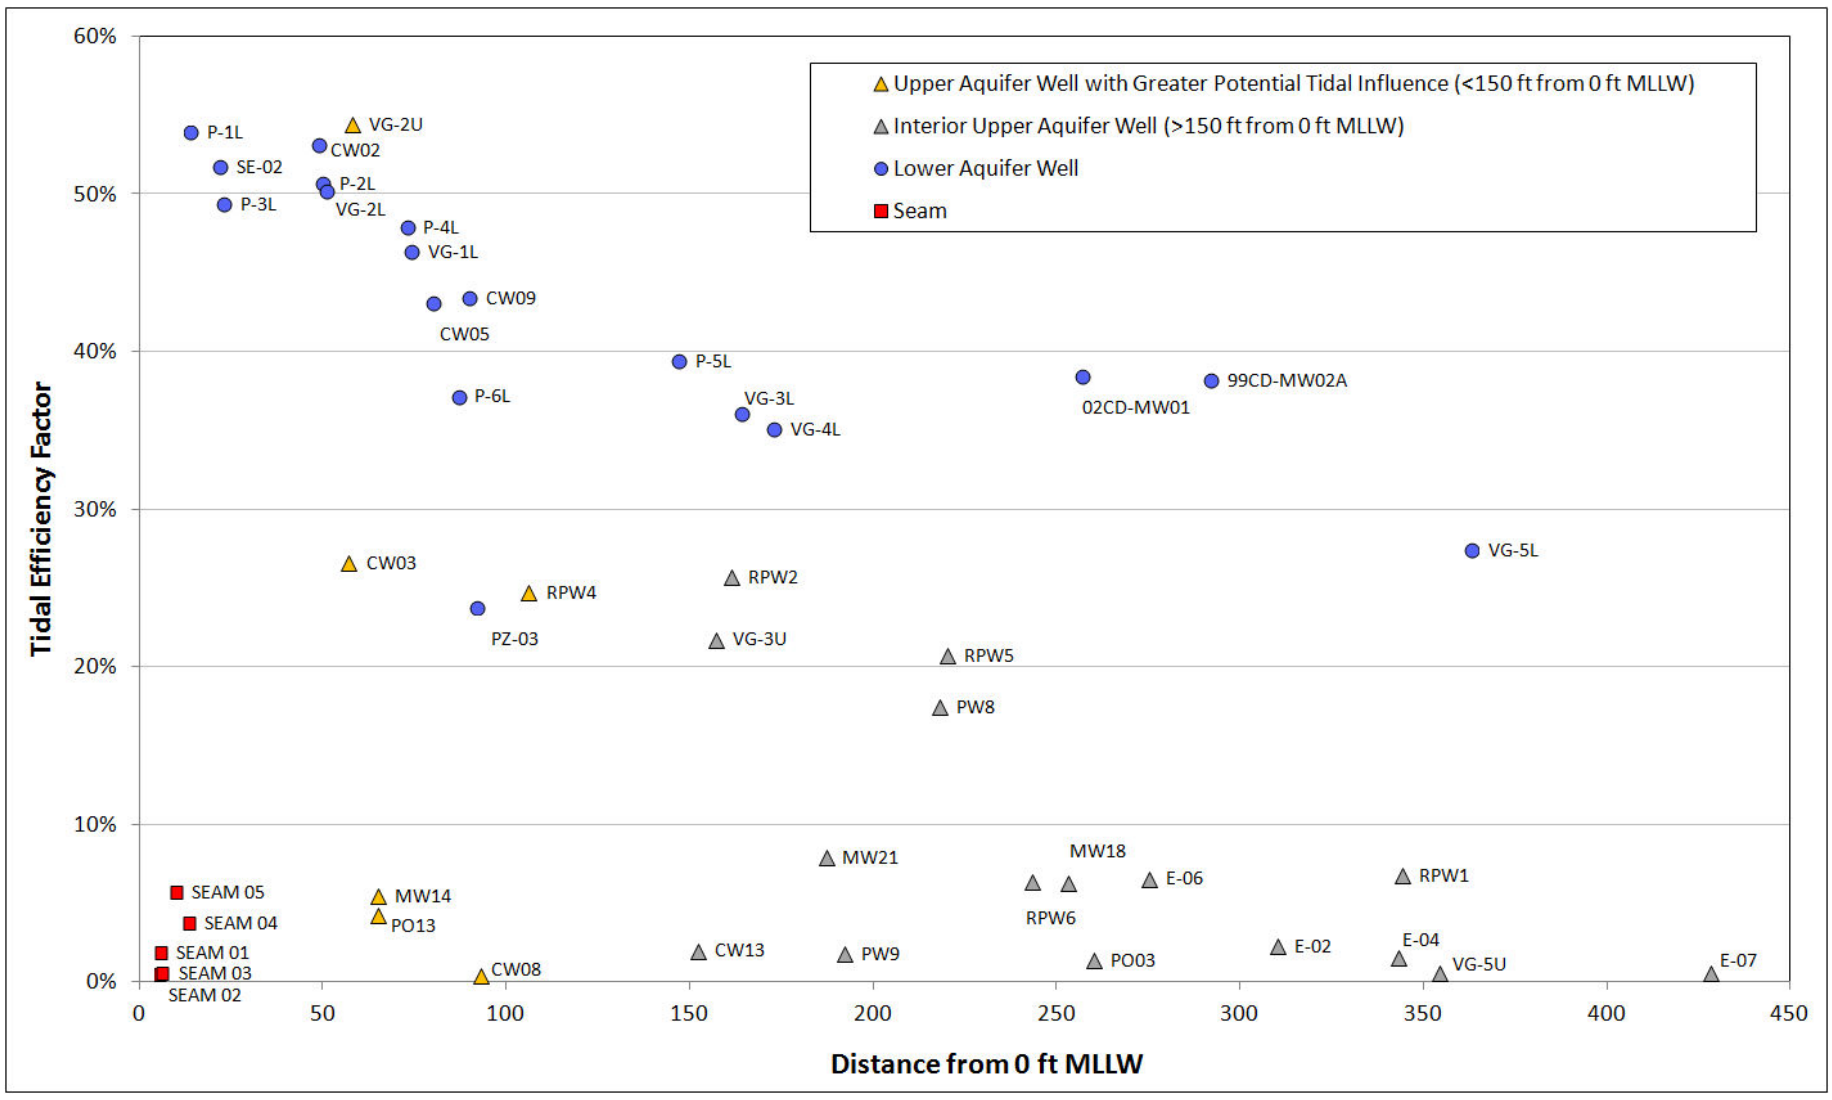
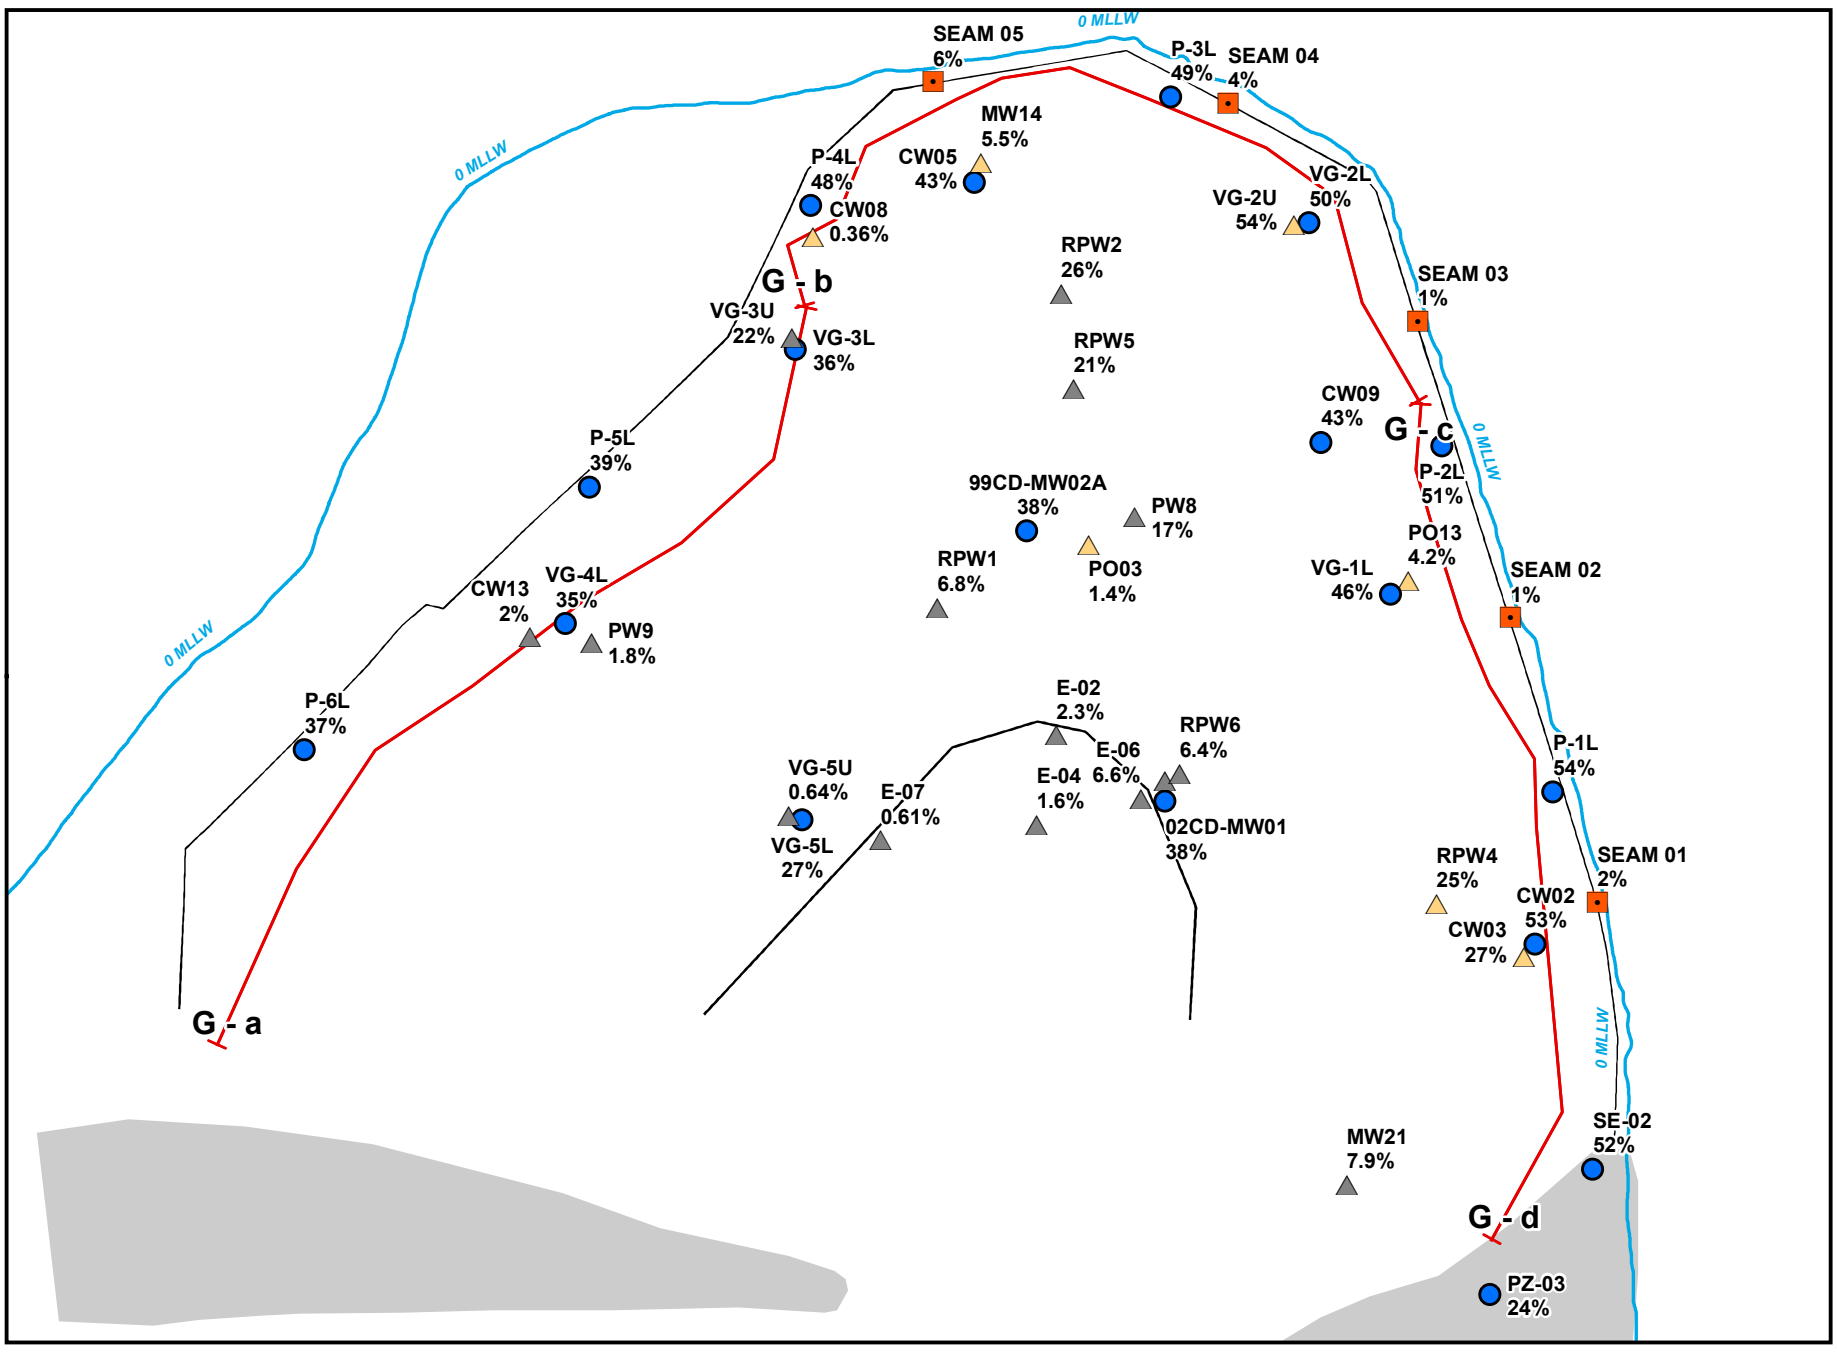
Figure 6
Tidal Efficiency Factor for Selected Wells and Seams

Figure 6 displays the tidal efficiency factors posted on a site map. A scatter plot depicting tidal efficiency factors (Y-axis) versus the distance from the 0 MLLW tidal elevation (X-axis) is also shown. The tidal efficiency calculations are provided on CD in Attachment 2. Tidal efficiencies in the seam channels ranged from less than 1 percent

(seam 2) to 6 percent (seam 5). Tidal efficiencies in Upper Aquifer monitor wells ranged from 0.4 percent (CW08) to 54 percent (VG-2U) while Lower Aquifer wells ranged from 24 percent (PZ-03) to 54 percent (P-1L).

Presuming the sheet pile wall acts as an effective hydraulic barrier (note: the joints provide 0.14 percent open area), the Upper Aquifer wells should have similar tidal efficiencies to the seams, while the Lower Aquifer wells are expected to have the greatest tidal efficiencies. In general, the tidal efficiency factor results follow the expected pattern with a few notable exceptions. There are three Upper Aquifer wells within 150 feet of 0 feet MLLW that exhibit tidal efficiencies that are greater than the seams: CW03 at 27 percent, VG-2U at 54 percent, and RPW4 at 25 percent. These results suggest greater hydraulic connection to Eagle Harbor near these three wells.

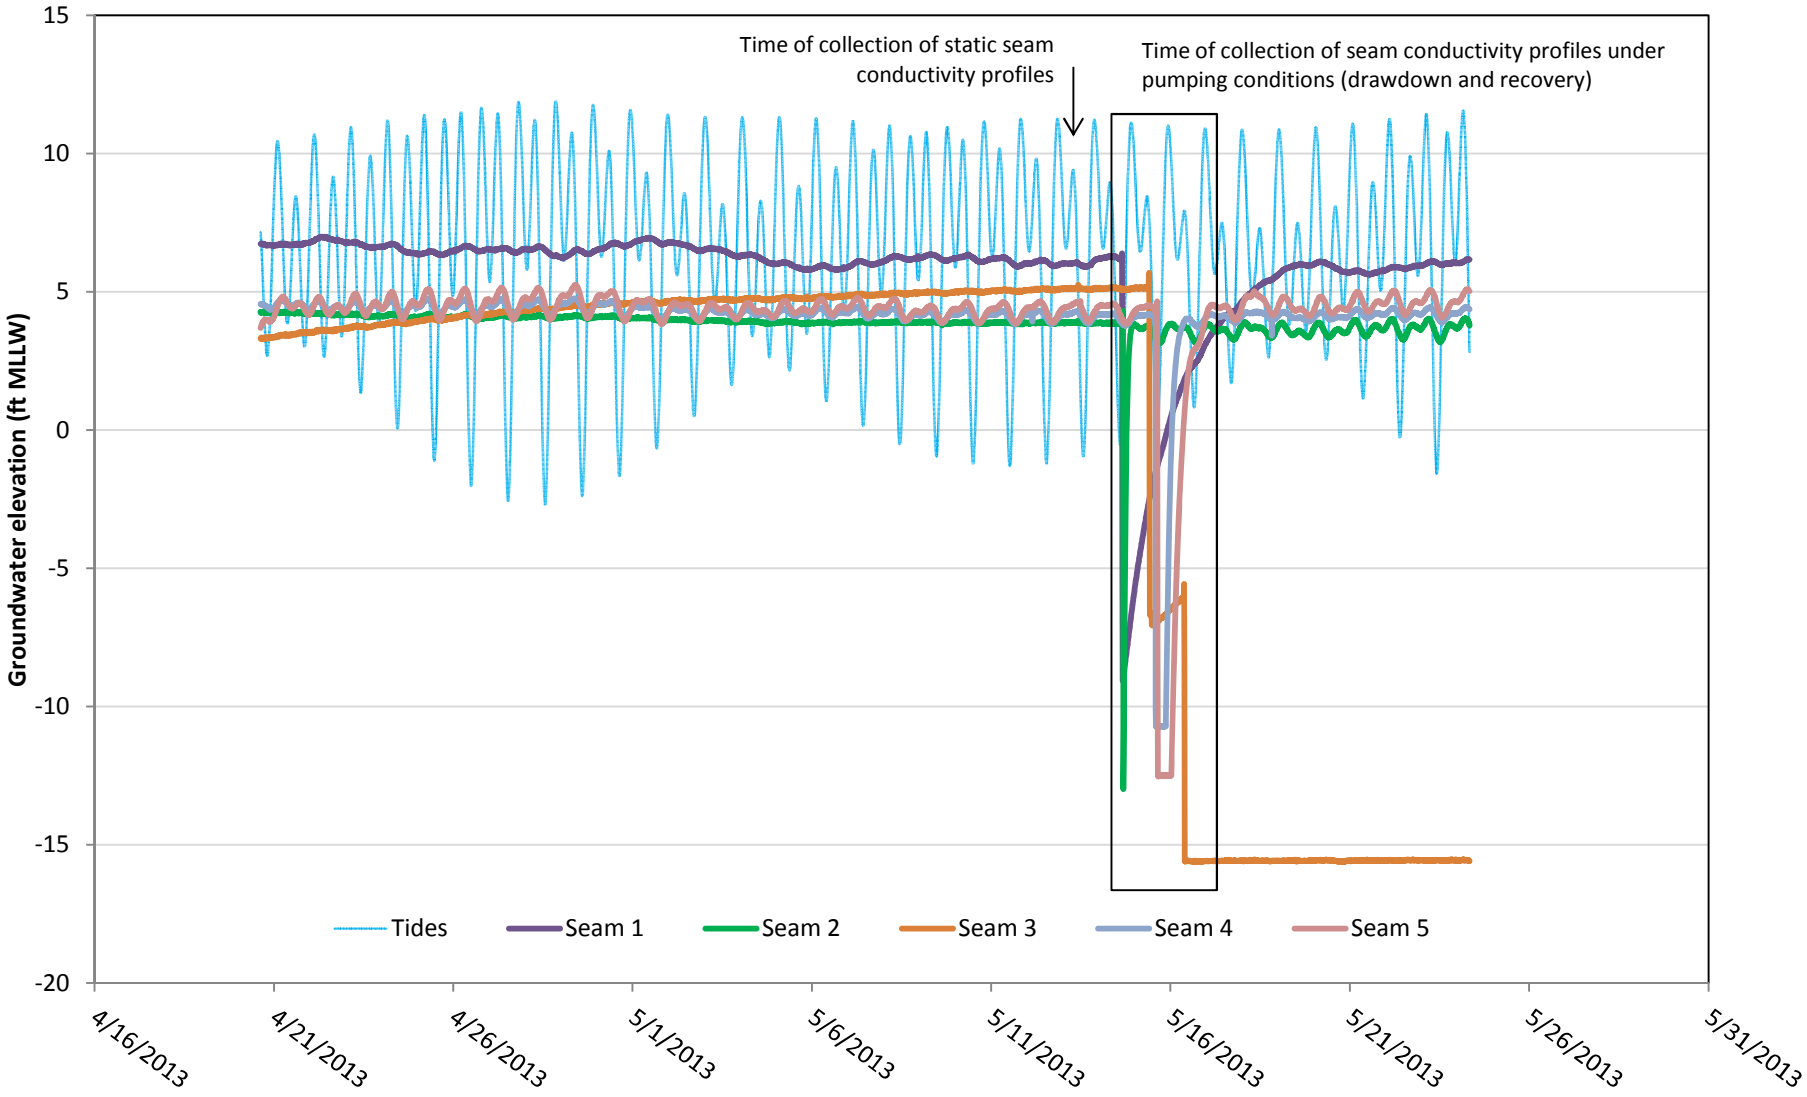
Continuous water level data were measured using pressure transducers installed in the five sheet pile wall seams, while most of the seam investigation activities were conducted. Figure 7 displays the resulting hydrographs for each seam. The hydrographs exhibit the resulting drawdown and recovery from when the seams were pumped, and the arrow indicates when the corresponding seam salinity and conductivity profiles were conducted. This figure is presented because the sequence of the seam investigation activities could influence the data interpretation.

Seam Hydrographs and Tides from April 20 through May 25, 2013

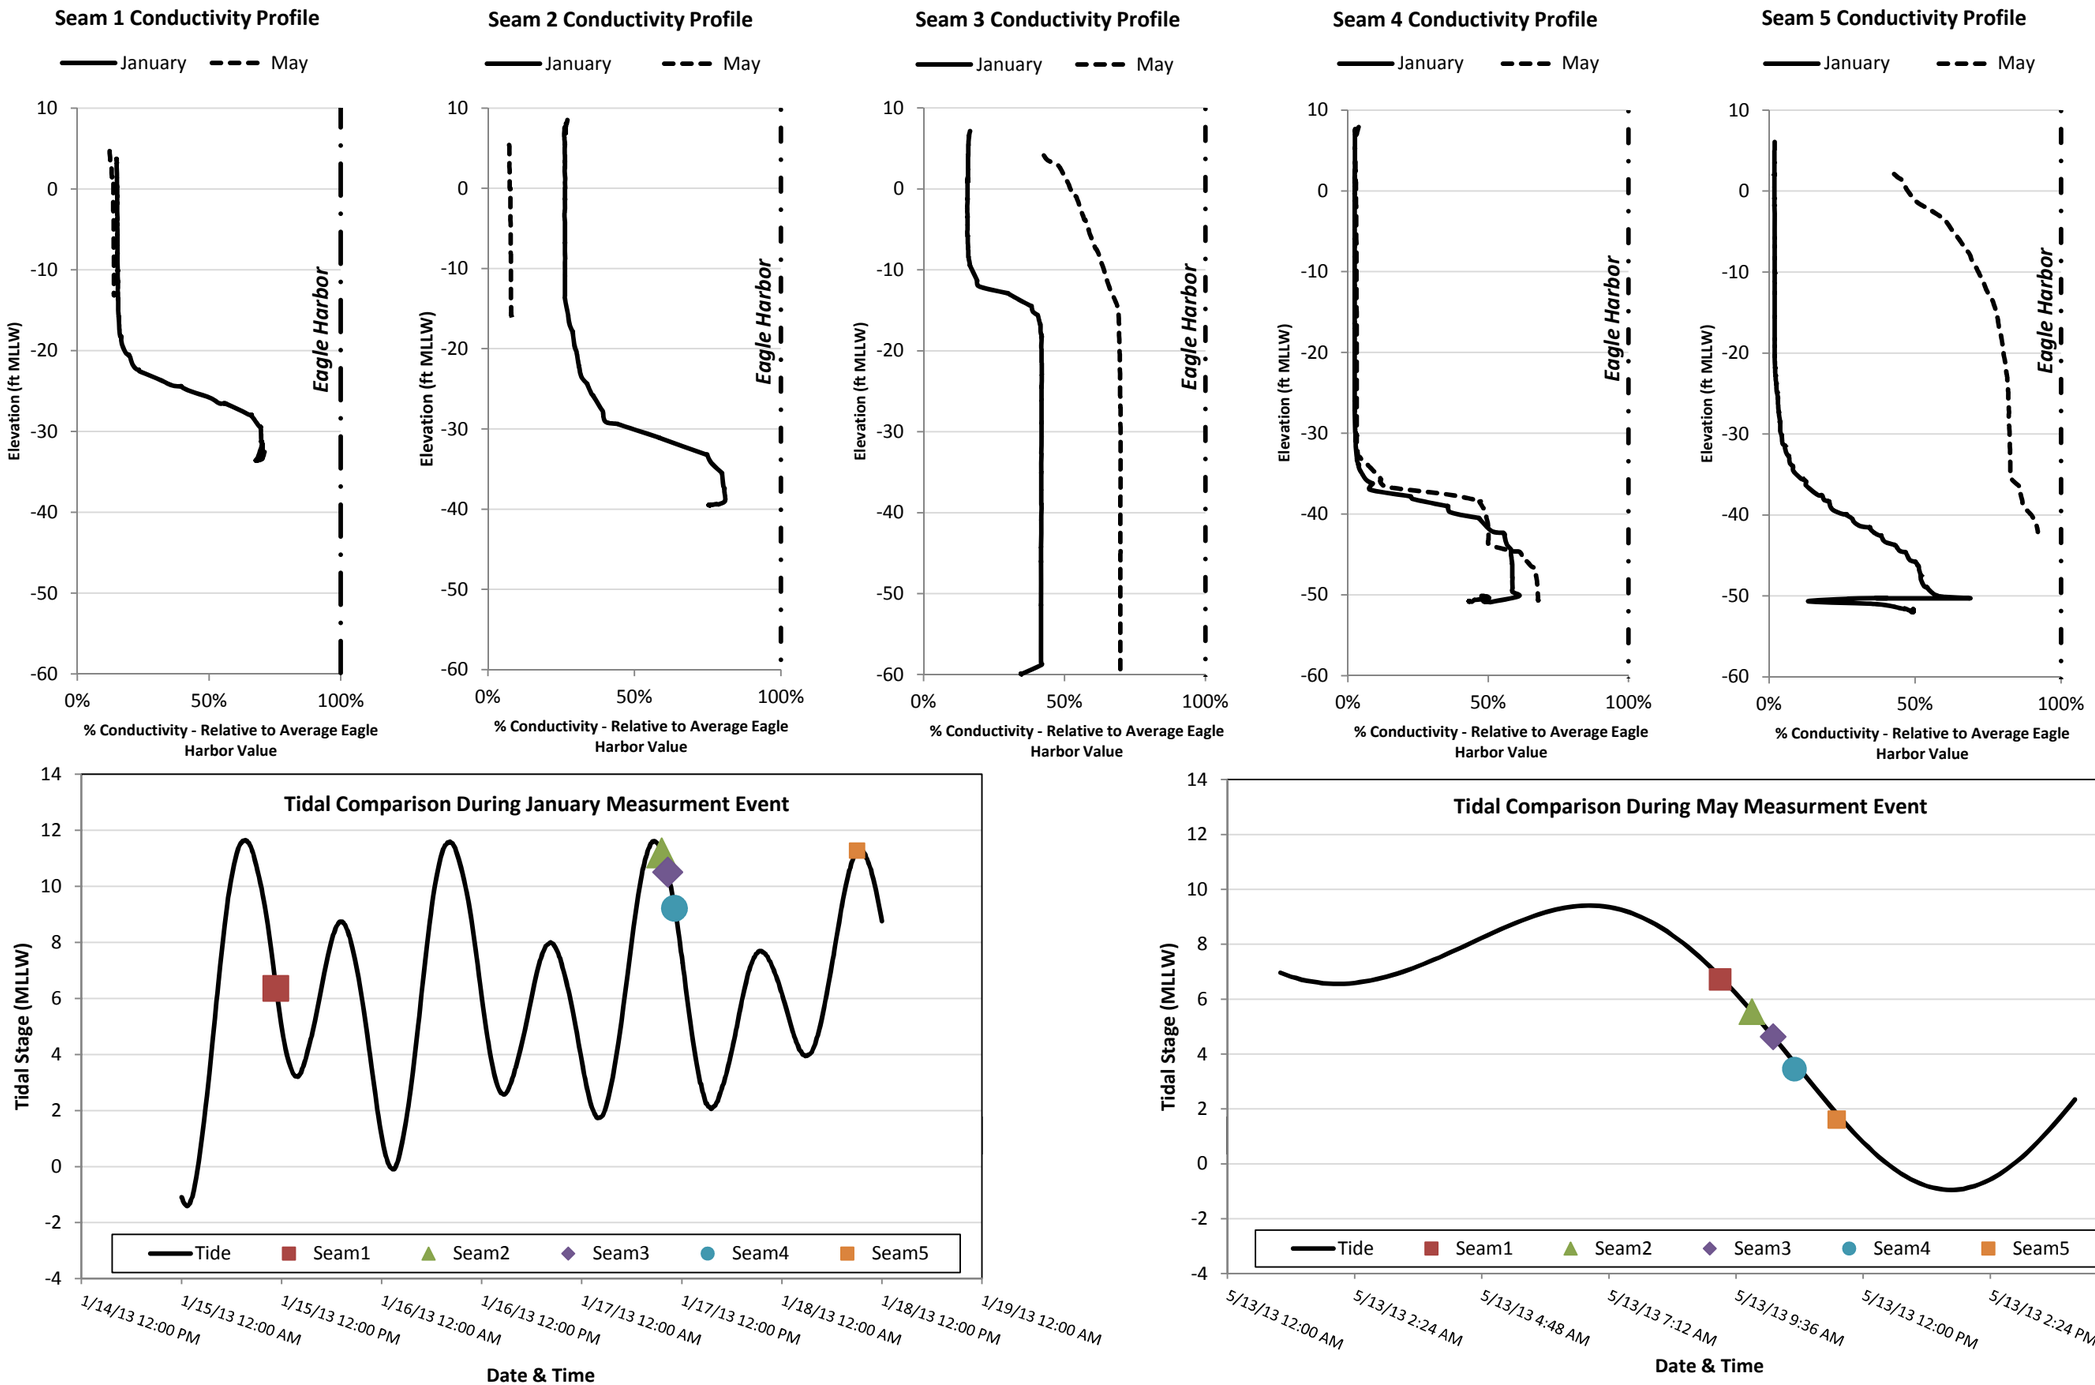
The first data class attempts to differentiate the source of water in the seams by measuring its conductivity as a function of depth and by monitoring percent salinity of the water discharged during pumping of the seam. Figure 8 displays the vertical conductivity profiles for the five seams and the timeframe each profile was measured relative to the tidal stage. The seam conductivity profiles are plotted in the five upper charts. In the two lower charts, the times when the profiles were conducted are plotted against tidal stage (tidal fluctuation could affect conductivity profile results). Figures 9A to 9E display conductivity versus time while the seams were being pumped on May 14, 2013. Vertical conductivity profiles for the individual seams are also displayed for comparative purposes. Table 5 summarizes some of the seam data discussed in this analysis.

Seam Conductivity Profiles and Comparison with Tide Stages for January and May Measurement Events

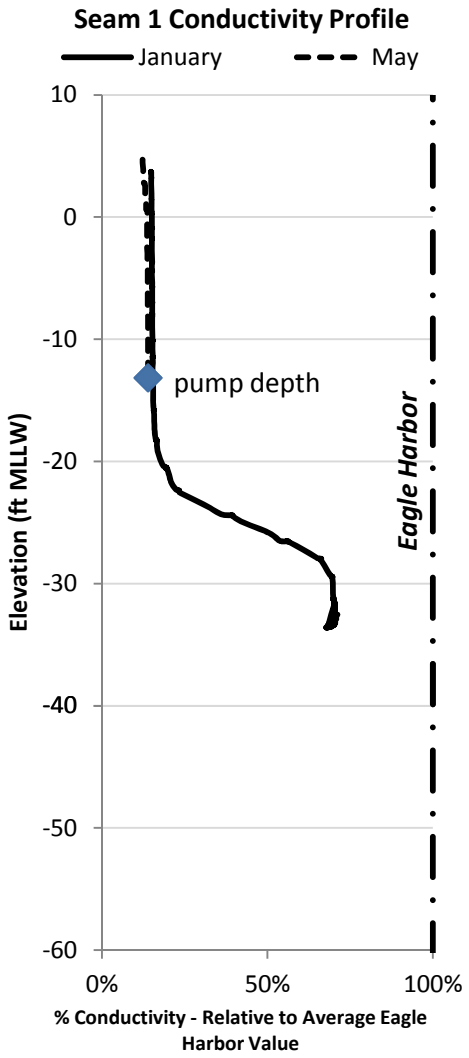
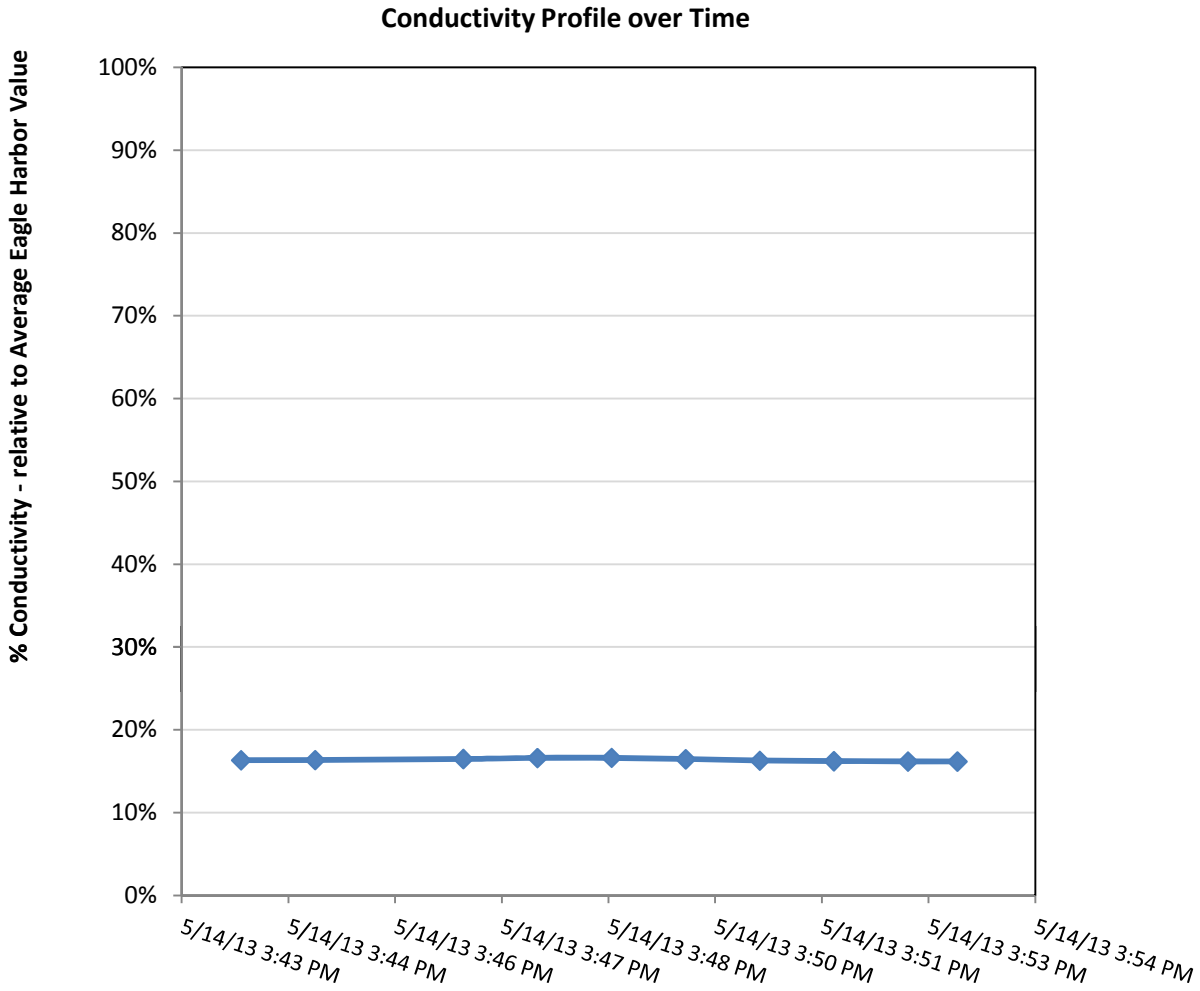
Figure 9A

Conductivity Profiles and Drawdown for Seam Pumping conducted May 2013 - Seam 1

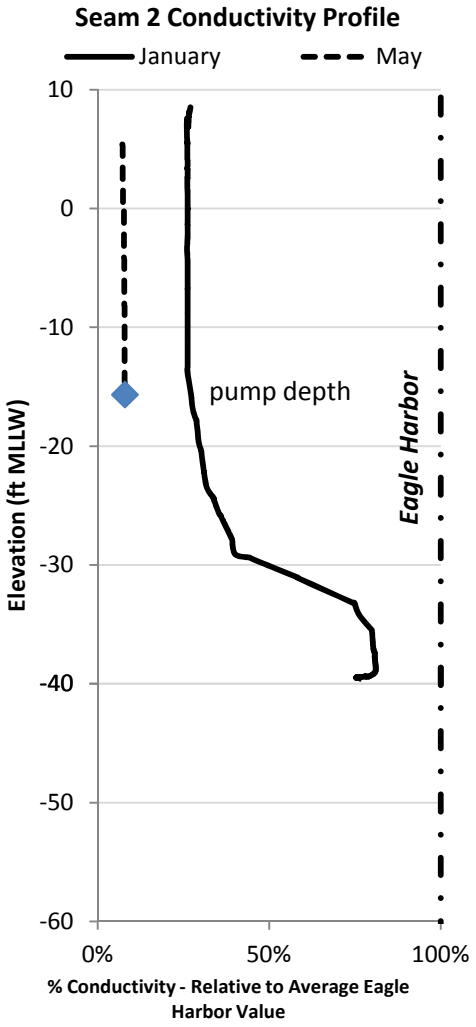
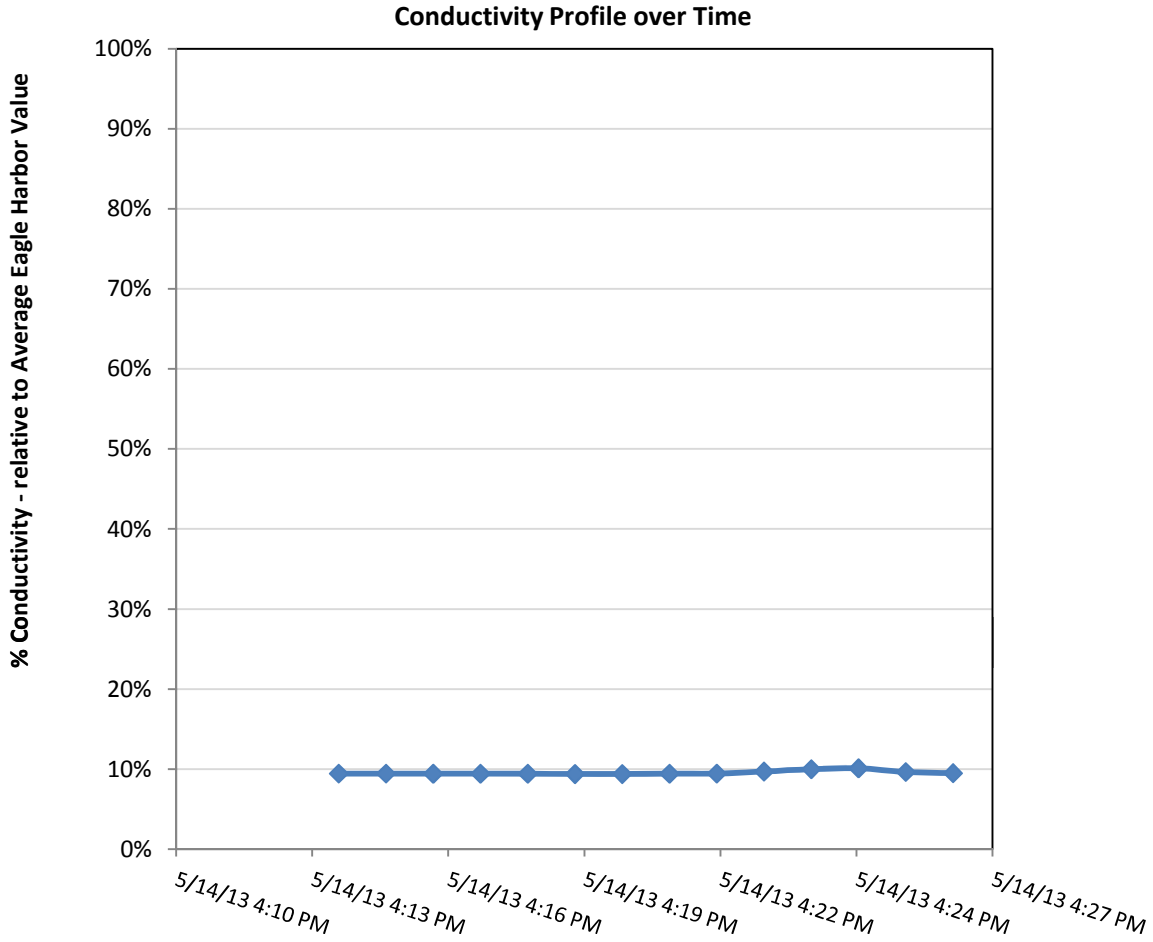
Figure 9B

Conductivity Profiles and Drawdown for Seam Pumping conducted May 2013 - Seam 2
