Wyckoff Sheet Pile Wall – Nonaqueous Phase Liquid and Plume Migration Barrier Effectiveness Evaluation

PREPARED FOR: Howard Orlean/EPA

PREPARED BY: Robert Healy/CH2M HILL

DATE: December 18, 2013

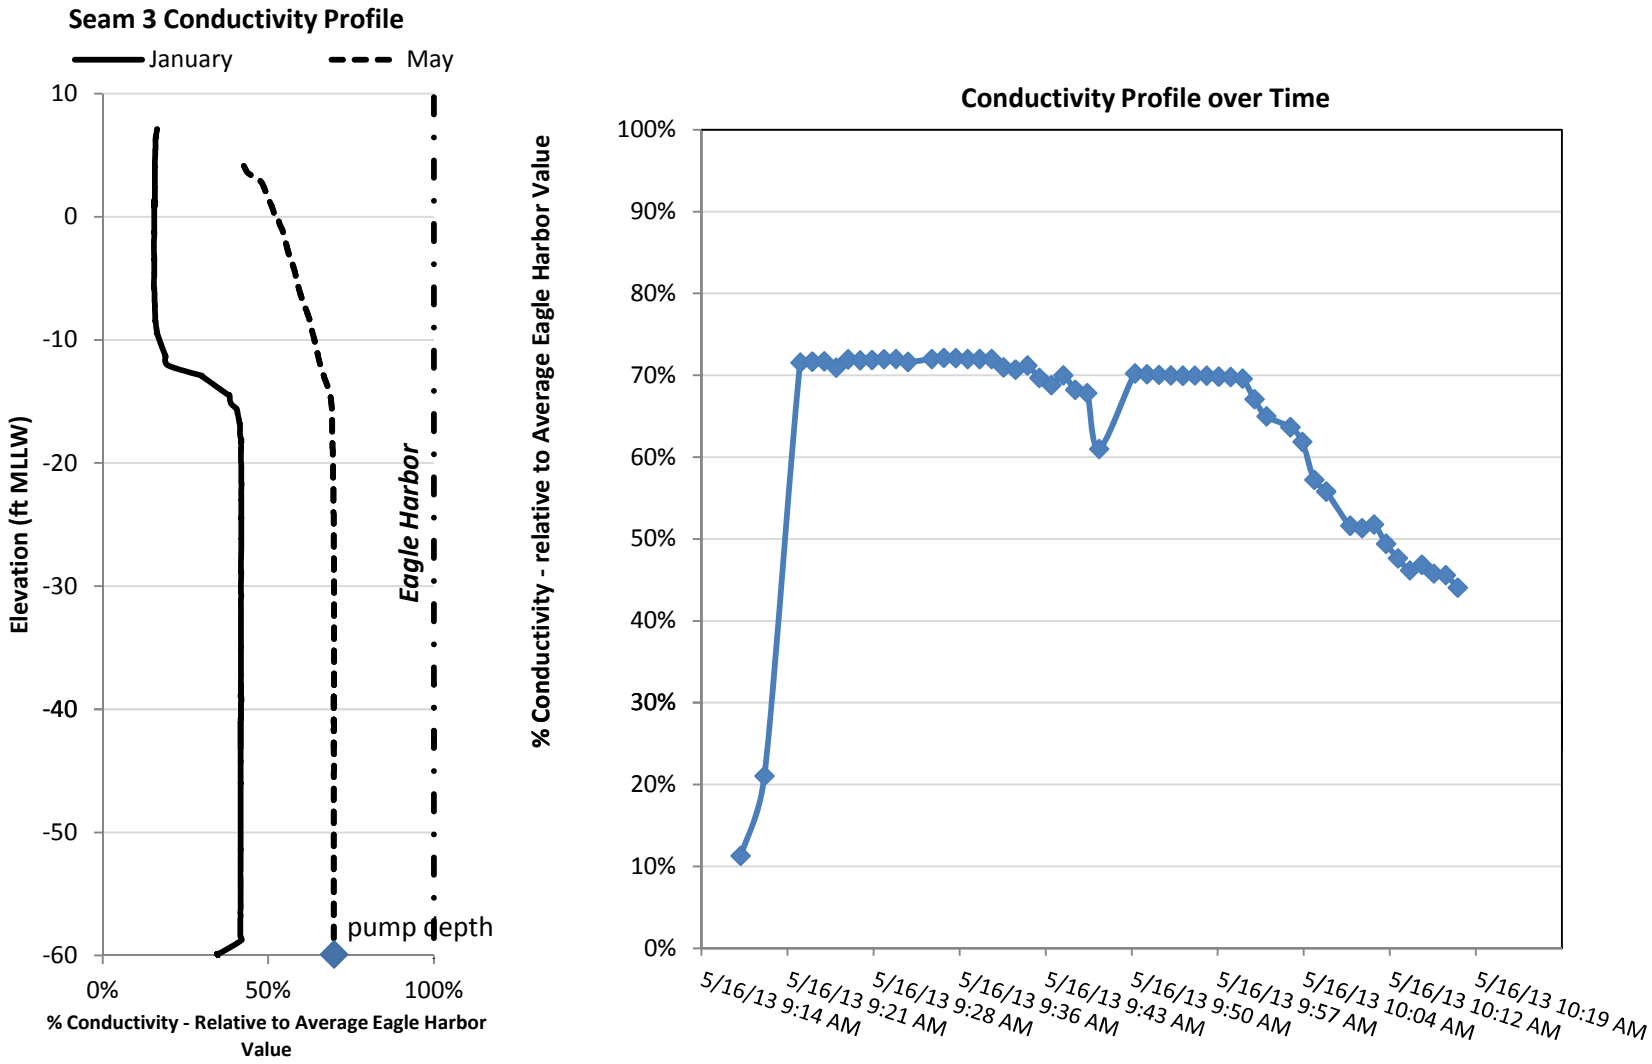
Figure 9C

Conductivity Profiles and Drawdown for Seam Pumping conducted May 2013 - Seam 3

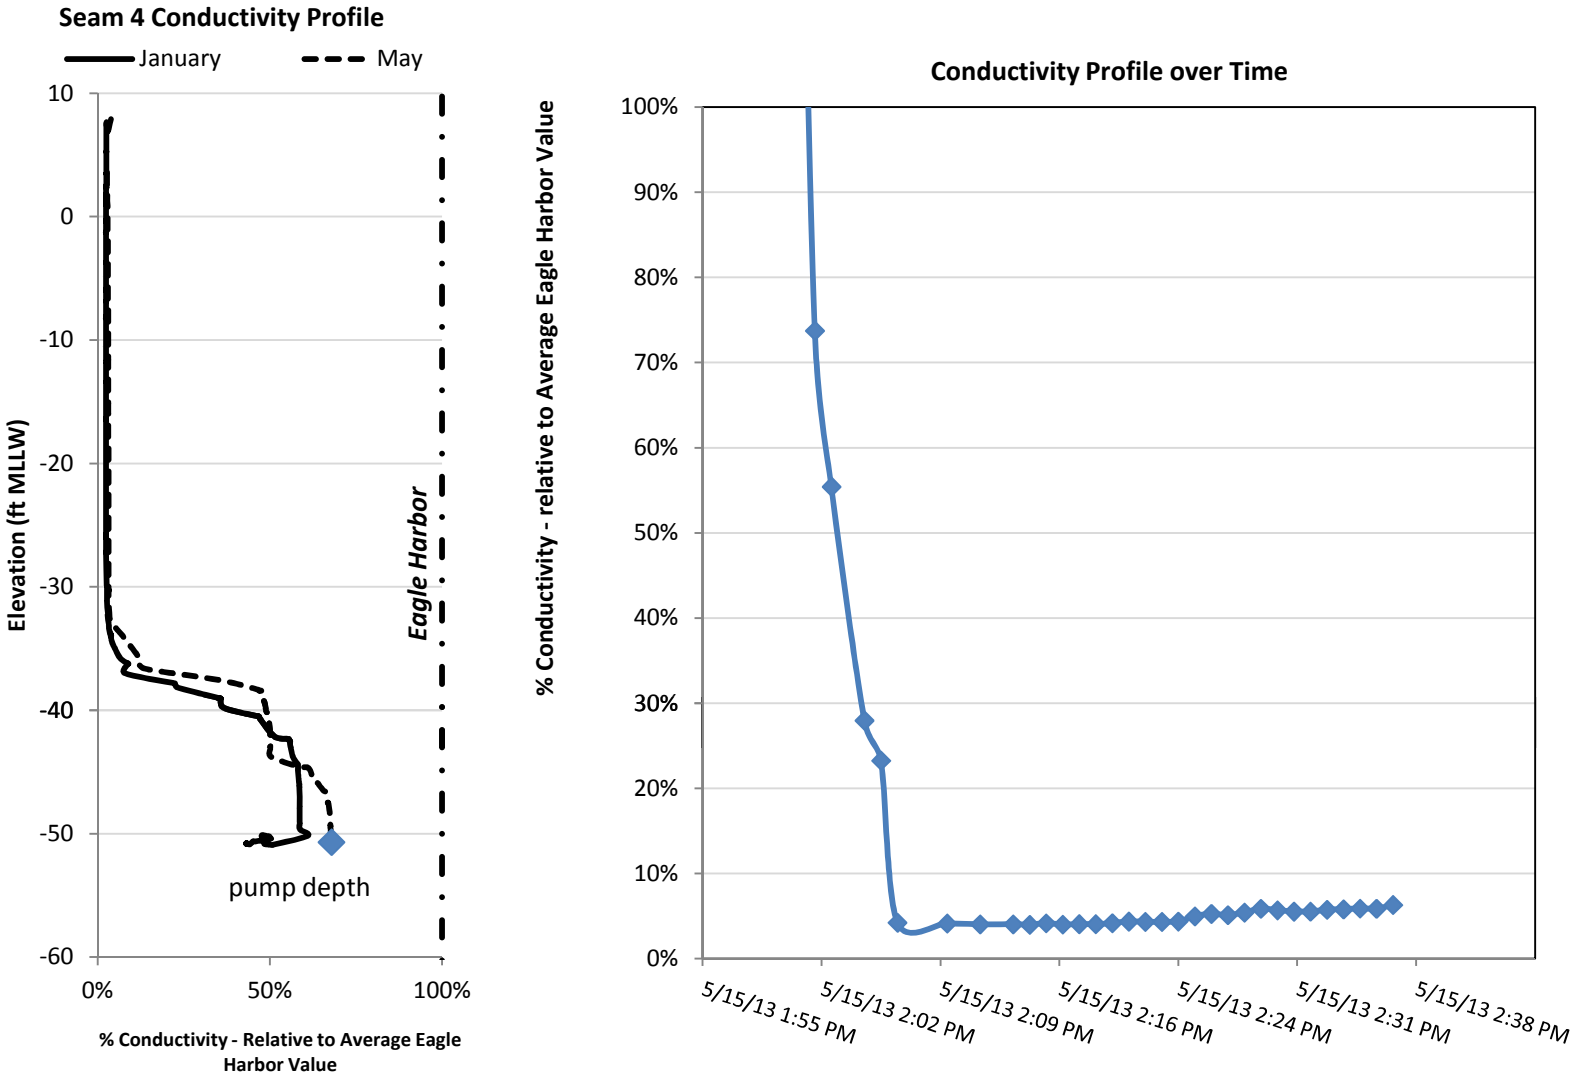
Figure 9D

Conductivity Profiles and Drawdown for Seam Pumping conducted May 2013 - Seam 4

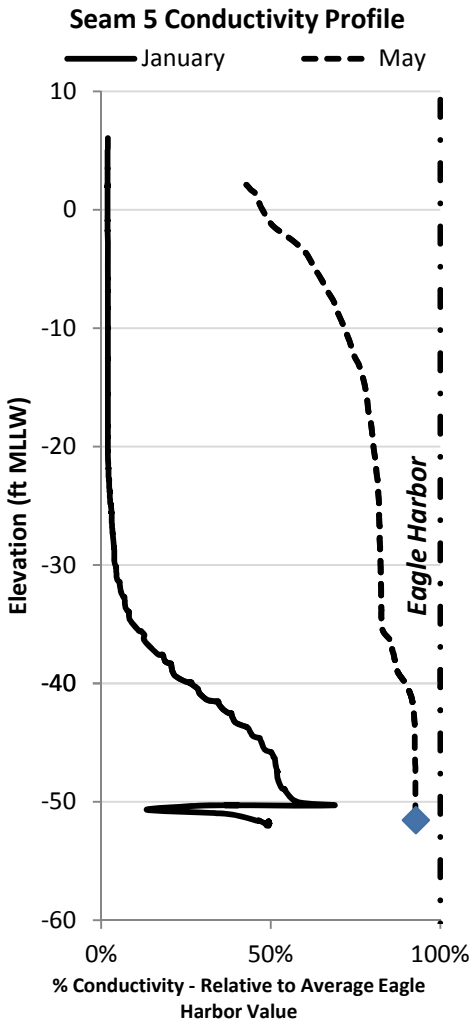
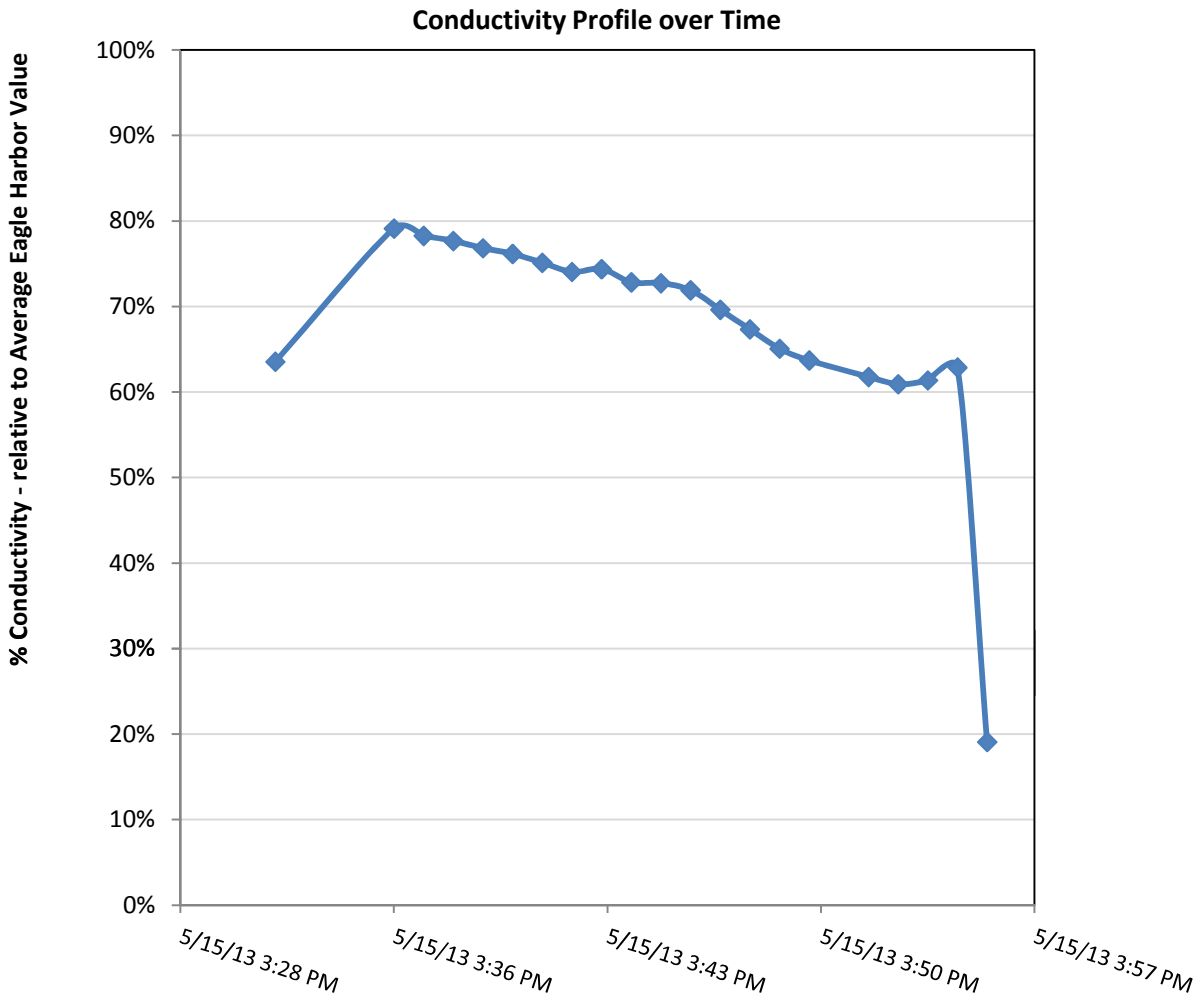
Figure 9E

Conductivity Profiles and Drawdown for Seam Pumping conducted May 2013 - Seam 5

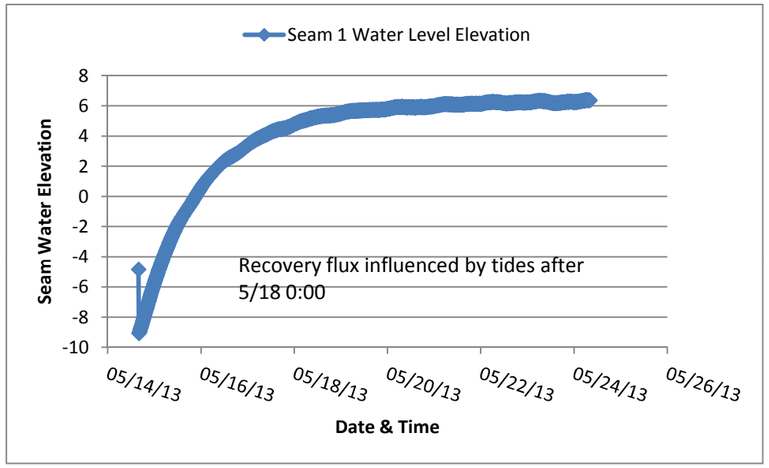
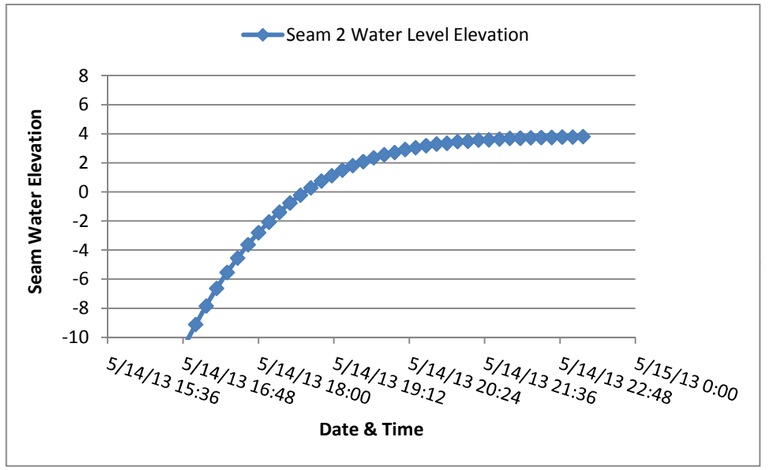
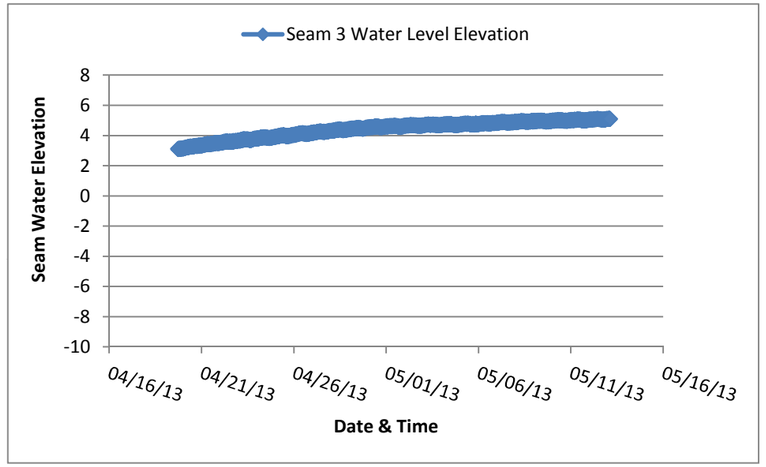
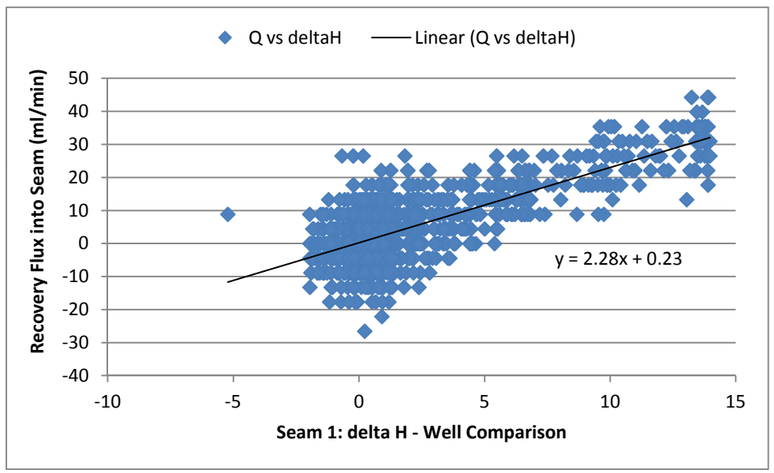
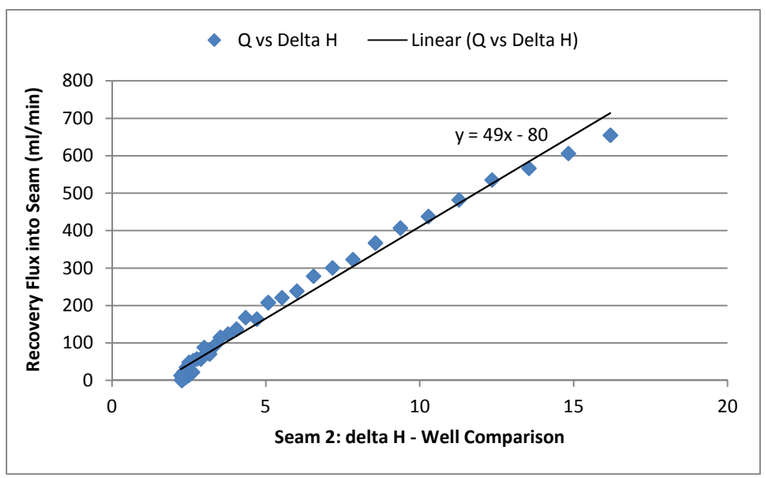
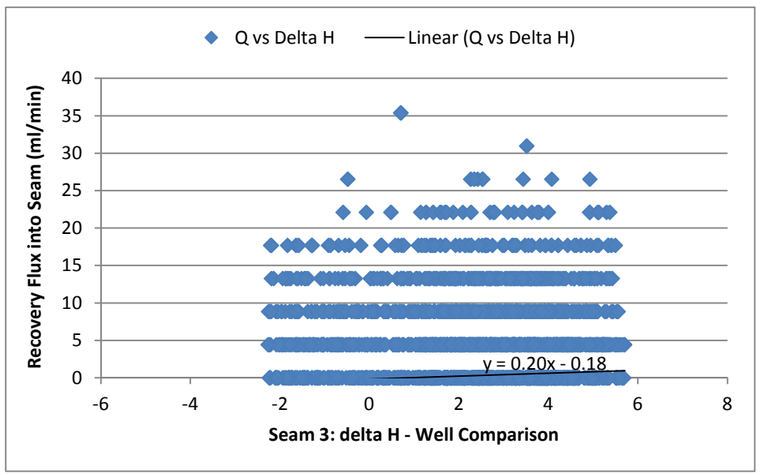
Figure 10A

The second data class evaluates water level recovery rates following pumping of the seams in an effort to quantify the potential flux across the sheet pile wall. The data collected indicate the fastest recovery rate occurred in seam 2 and the slowest recovery occurred in seam 3. After the pump was shut down, the water level was measured in each seam, and the volumetric flux (milliliters per minute) was calculated by multiplying the change in water level between pressure transducer readings (every 10 minutes) by the total seam area. This results in an estimated flux rate every 10 minutes. The water level in each seam was compared with a concurrent water level measurement from a nearby Upper Aquifer monitoring well to estimate the change in water level across the sheet pile wall. The estimated volumetric flux into the seam was plotted against the change in head across the wall, and a linear interpolation was applied. Figures 10A and 10B present the results for the trend analysis for each of the seams. Using the line equation from the trend analysis, quarterly average water levels for the associated Upper Aquifer wells (see Table 4), and mean sea level, the flux across each of the five seams can be estimated for average conditions.

Seam Recovery Flux Analysis - Seams 1, 2, and 3

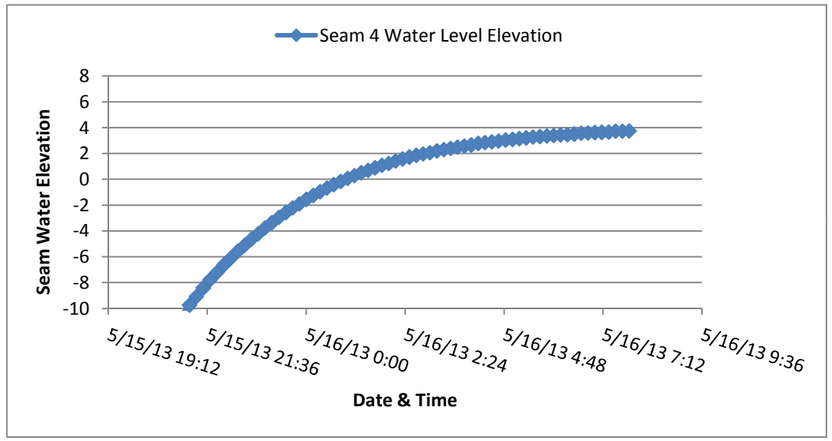
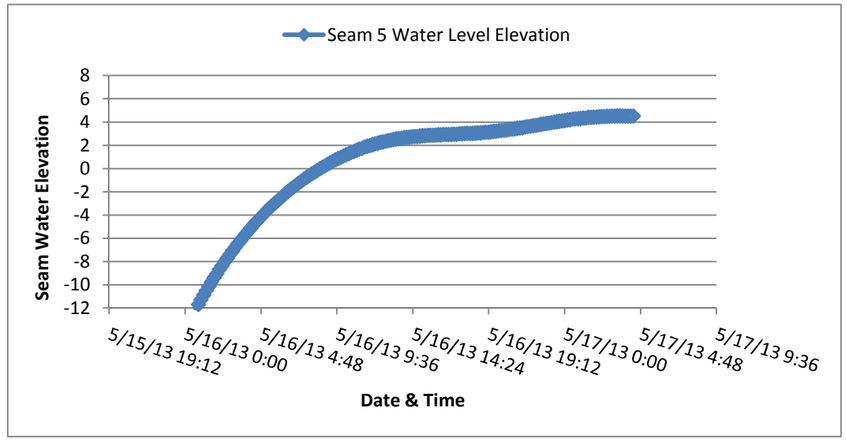
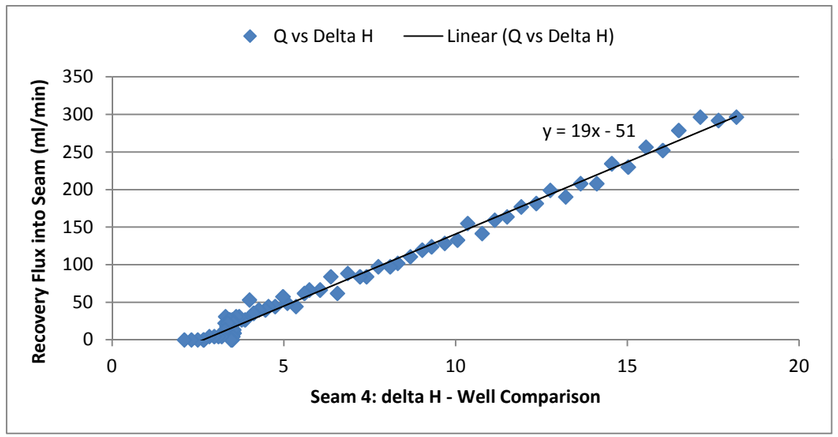
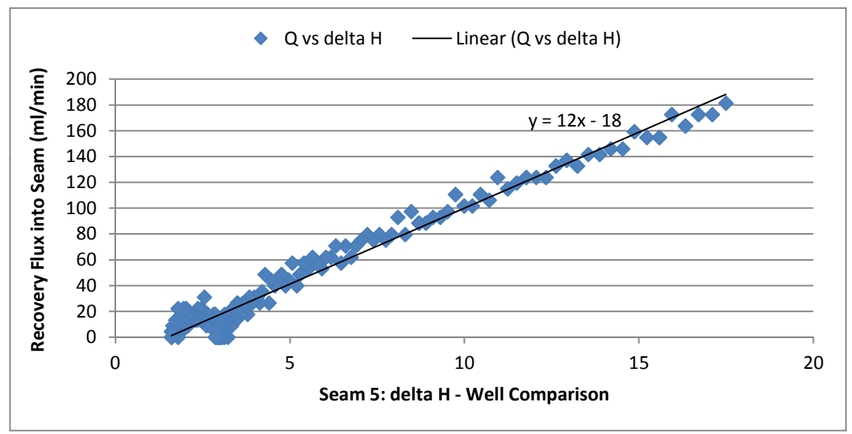
Figure 10B

Seam Recovery Flux Analysis - Seams 4 and 5

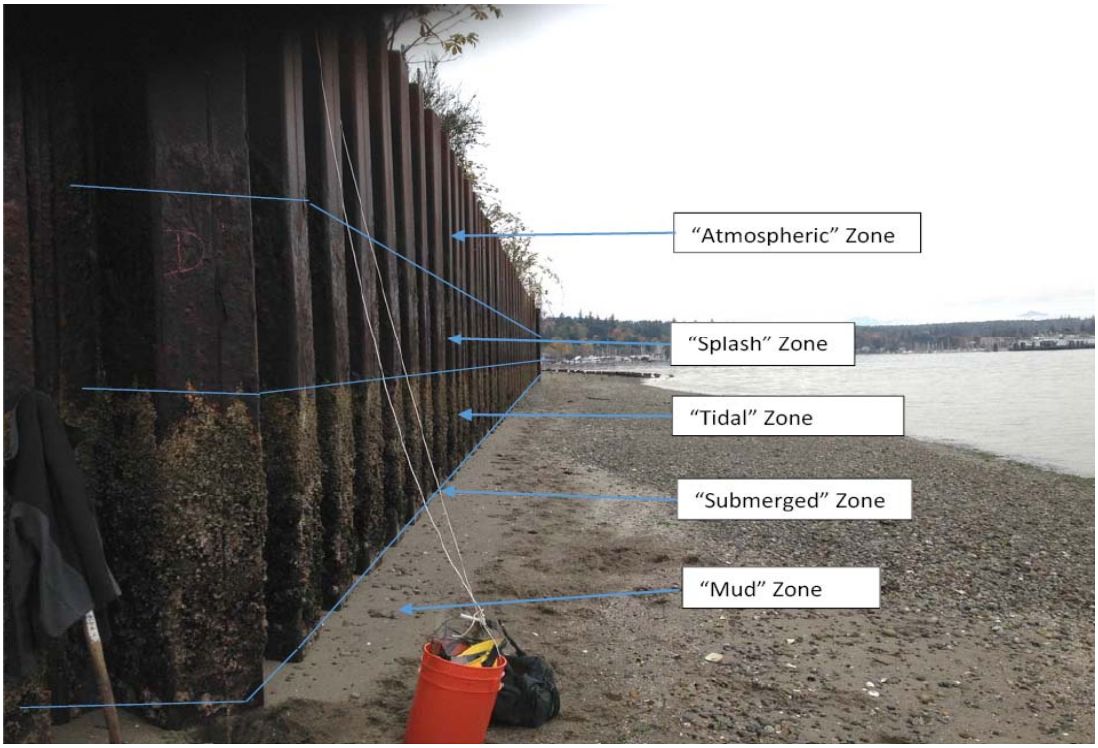
1. The atmospheric exposed portion of the wall is experiencing relatively rapid corrosion. The relatively high corrosion rate in this zone is attributed to soil-side corrosion due to salt accumulation in the fill near the surface (very little corrosion was observed on the seaside surfaces in the atmospheric zone).
2. The most significant corrosion is occurring in the “splash” zone. The highest pitting rates were measured in this zone; the most rapid “time-to-penetration” of the wall is expected in this zone.

3. The corrosion rates in the "tidal," "submerged," and "mud" zone are relatively low when compared with the "splash" zone. The time-to-penetration of the wall in these zones will be much longer than that expected for the "splash" zone.

Zone	Typical Distance from Top of Wall to Test Spot (ft)	General Condition, As Found
"Atmospheric"	3	Surface rust
"Splash"	6	Heavy corrosion products (up to 1 inch thick); orange stains on north side
"Tidal"	9.5 - 11.5	Marine growth; tightly adhered corrosion products, moderately thick
"Submerged"	11 - 13.5	No corrosion products or marine growth
"Mud"	12 - 14.5	Thin, tightly adhered corrosion product

General condition of the sheet pile wall, Wyckoff (Bainbridge Island), with exposure "zones" shown. North face.

Based on the both the observed and probable pitting rates pin hole leaks are anticipated to develop between 6 and 24 years as measured from late 2013 current conditions. With periodic inspection, these pinhole leaks can be detected and repaired, thereby extending the lifespan of the sheetpile wall.
