Transaction Screen

13th and Howell – ISOLA REAL ESTATE VI LLC
1803 and 1809 13th Avenue
Seattle, King County, Washington

May 18, 2016
Terracon Project No. 81167305
RIMS Project No. 16-001883-02-1

Re: ASTM E1528-14 Transaction Screen
13th and Howell – ISOLA REAL ESTATE VI LLC
1803 and 1809 13th Avenue
Seattle, King County, Washington 98122
Terracon Project No. 81167305
RIMS Project No. 16-001883-02-1

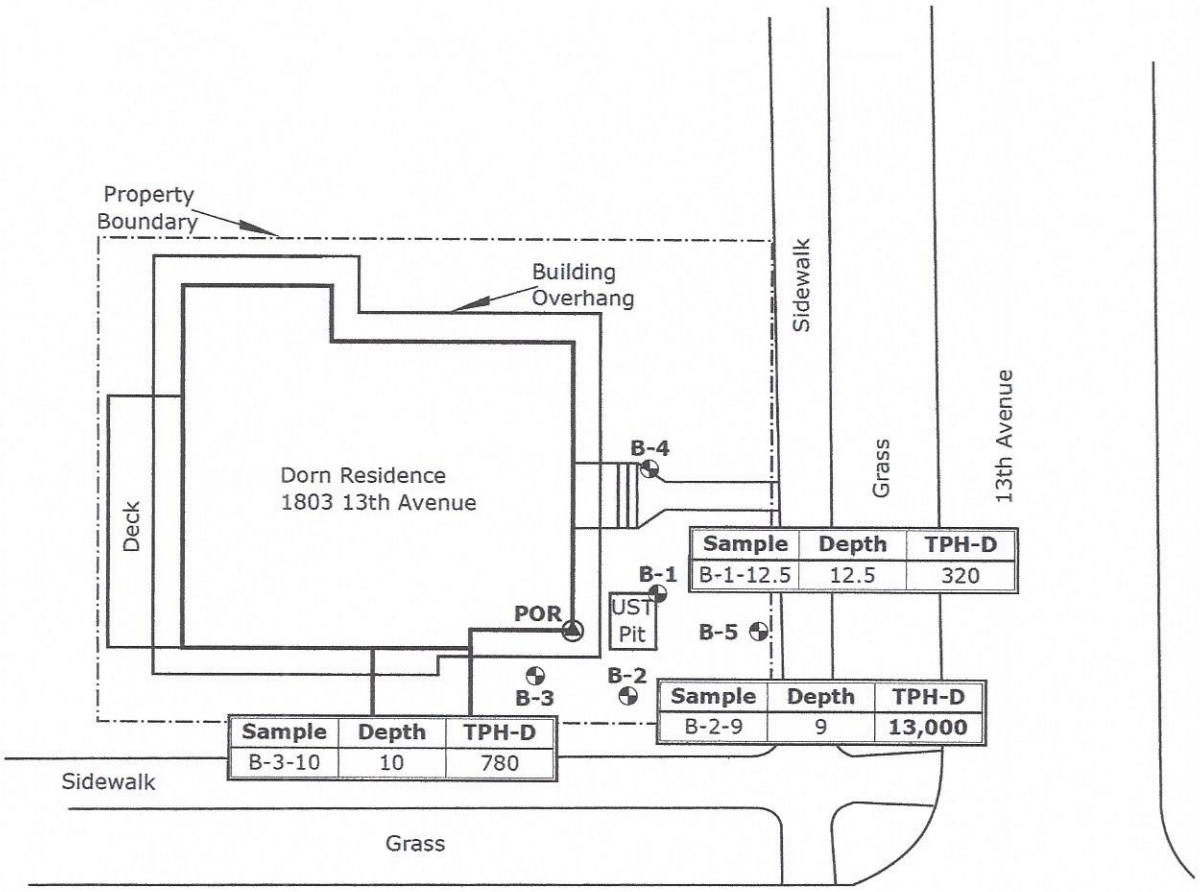
FIGURE 2
BORING LOCATIONS

Sample	Depth	TPH-D
B-1-12.5	12.5	320
