ASSOCIATED ENVIRONMENTAL GROUP, LLC

RE: ***August 2016 Quarterly Groundwater Sampling Results Report***
H&H Property
407 Porter Way
Milton, Washington 98354-9686
Ecology Facility/Site ID: 89863773
Ecology Cleanup Site ID: 4629

Associated Environmental Group, LLC (AEG) has prepared the enclosed ***Quarterly Groundwater Sampling Results Report*** presenting results of groundwater sampling conducted on August 5, 2016, at the above-referenced Site in Milton, Washington (Figure 1, *Vicinity Map*). Figure 2, *August 2016 Groundwater Contour Map*, shows the locations of Site features and monitoring wells.

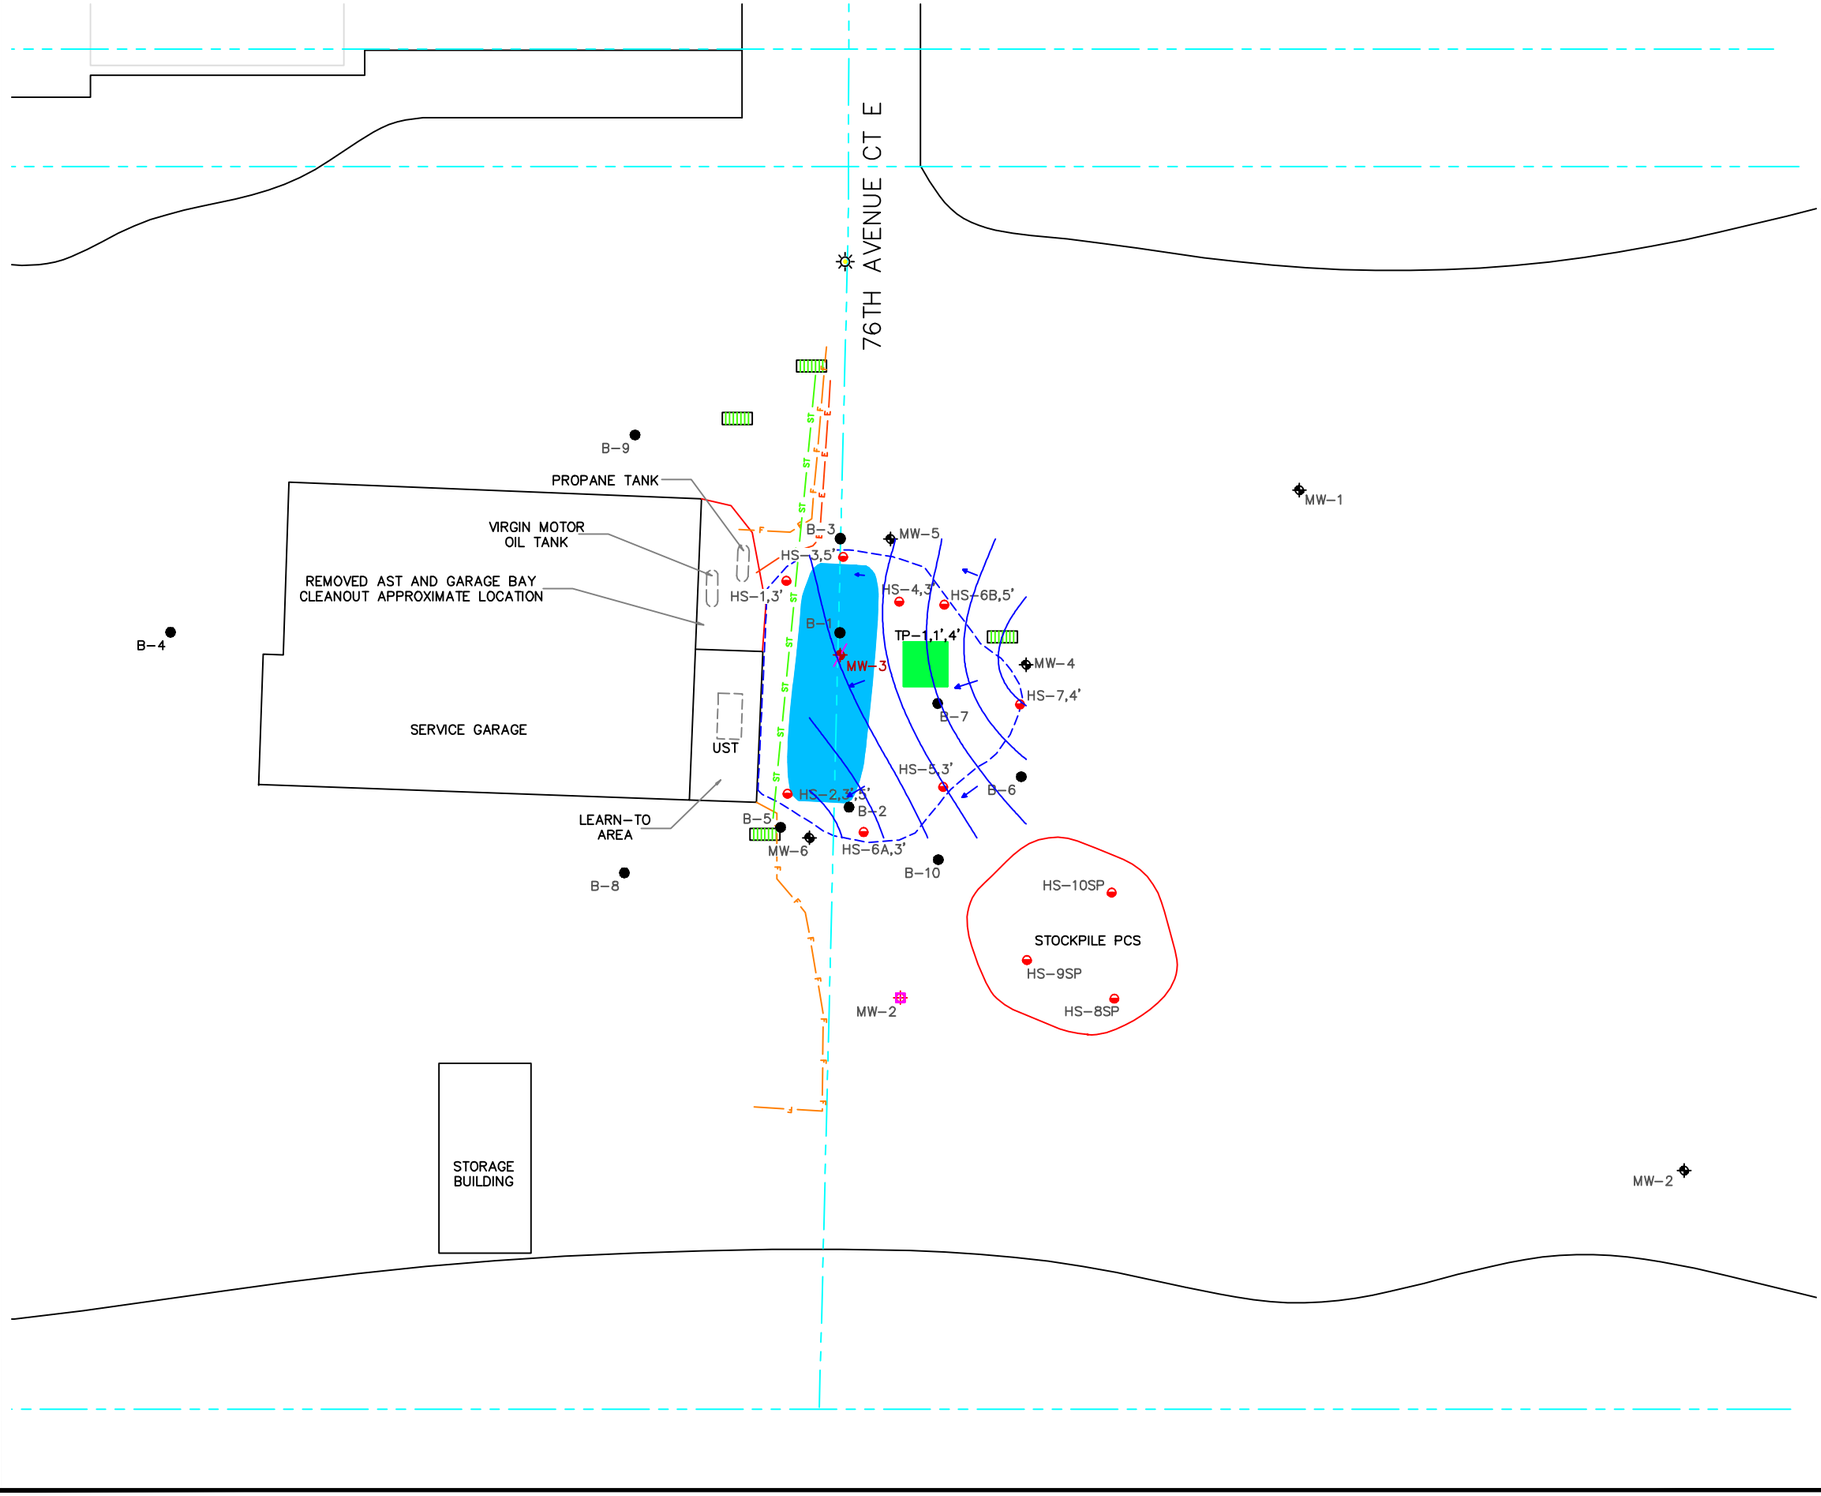
FIGURE 2
AUGUST 2016
GROUNDWATER CONTOUR MAP

Relative groundwater gradients were determined using depth to water measurements from monitoring wells MW-4, MW-5, and MW-6, which have not been professionally surveyed. AEG determined top-of-casing elevations for these wells relative to MW-4, which was assigned an arbitrary elevation of 100.00 feet. The resulting groundwater gradient for the August 2016 sampling event is primarily towards the west with an approximate gradient of 0.018 ft/ft (Figure 2, *August 2016 Groundwater Contour Map*).
