Soil Remediation Report

Proposed Wenatchee #2187 Expansion

2000 North Wenatchee Avenue

Terracon Project No. 81087036

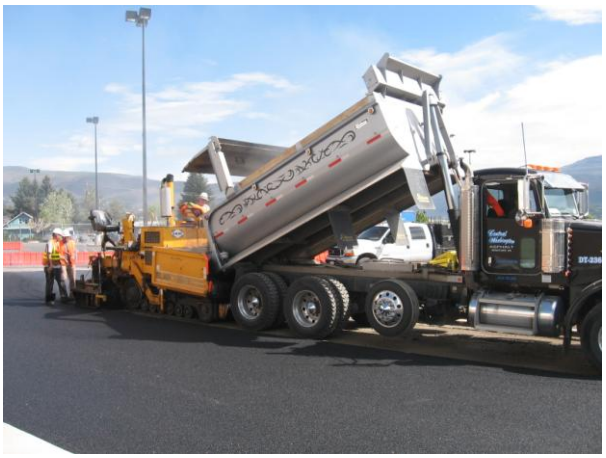
Photo #41 View asphalt paving in Phase D parking area – 5/5/11

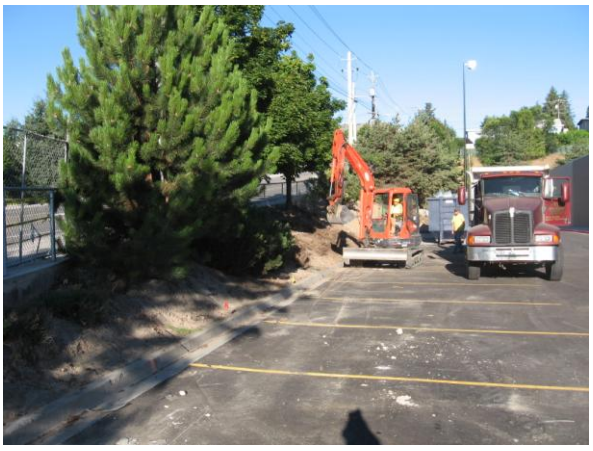
Photo #68 View of contractor grubbing south hot spot area – 7/29/11
