ENVIRONMENTAL PARTNERS INC

June 7, 2019

Re: Quarterly Groundwater Monitoring and Remediation System Status Report – December 2018
Whitney's Chevrolet, Inc.
Agreed Order No. DE 11121
123 West Pioneer Avenue
Montesano, Washington

EPI Project Number: 51201.19

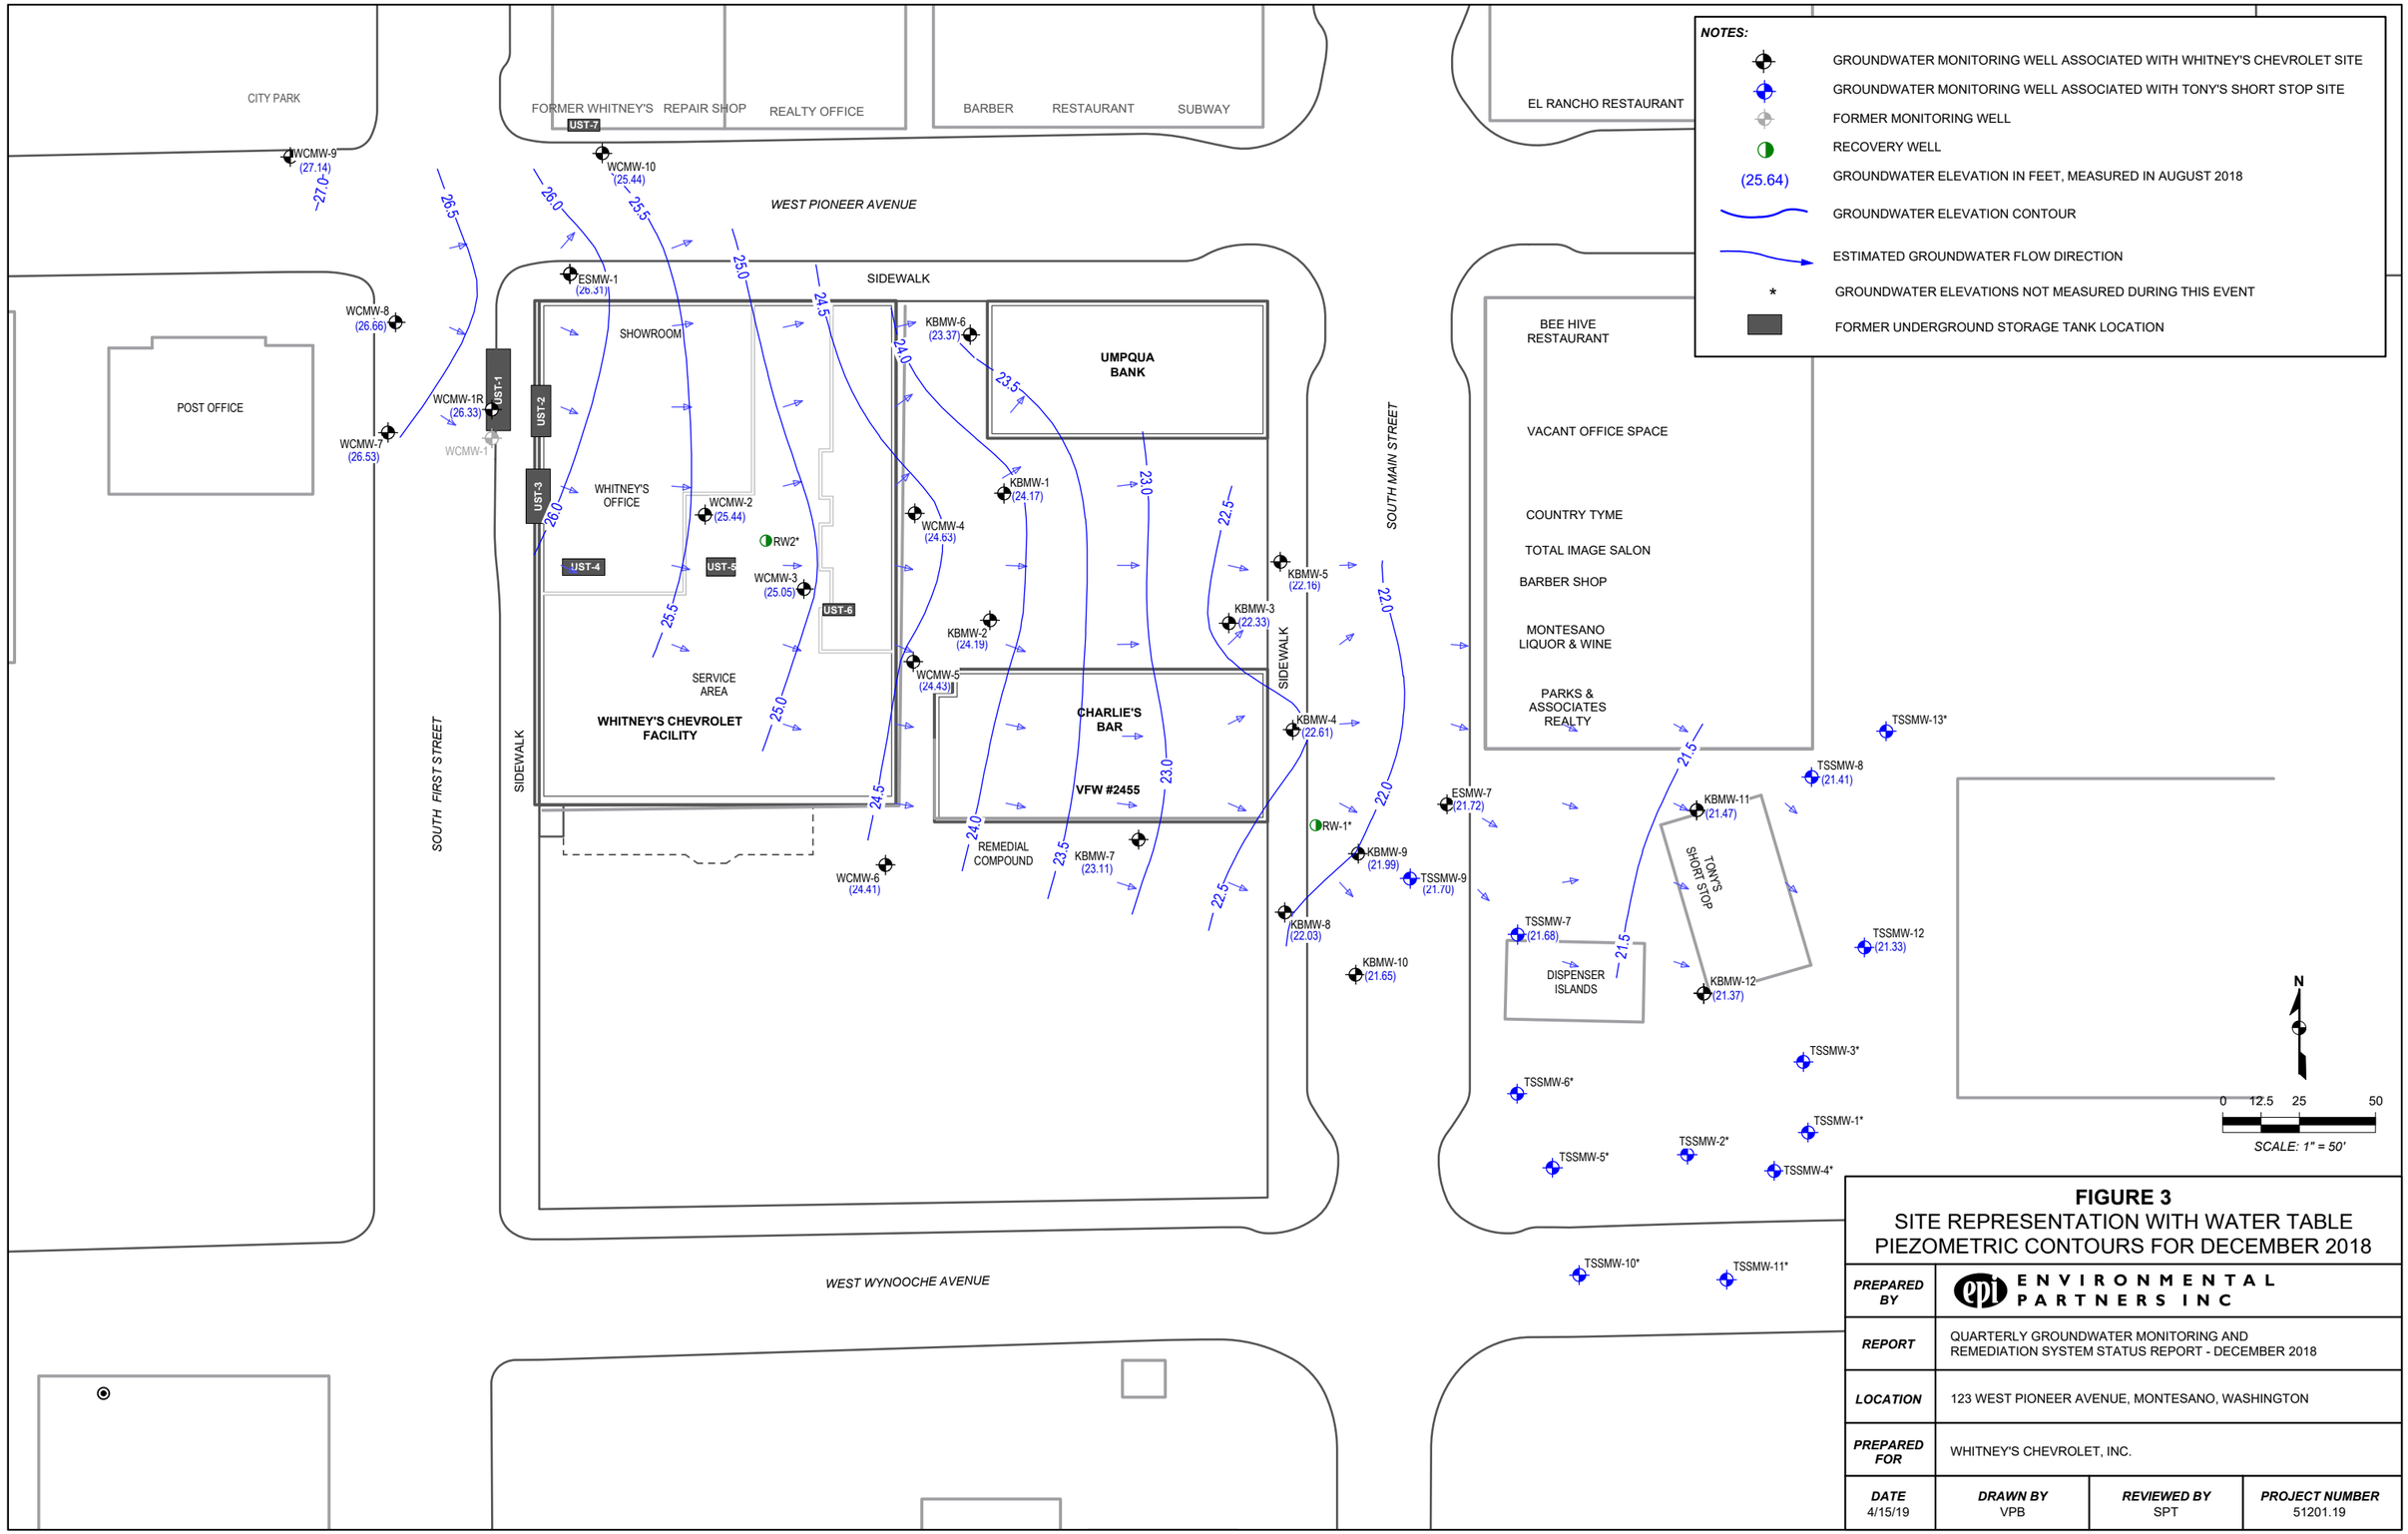
The piezometric elevation data indicate that groundwater migrates toward the southeast with an average hydraulic gradient of approximately 0.011 foot/foot, as measured between monitoring wells WCMW-9 and KBMW-12. These piezometric conditions are consistent with previous findings at the Site. A summary of groundwater elevation data for the Site is included in Table 1. A site representation with groundwater elevations and piezometric contours measured is included as Figure 3.

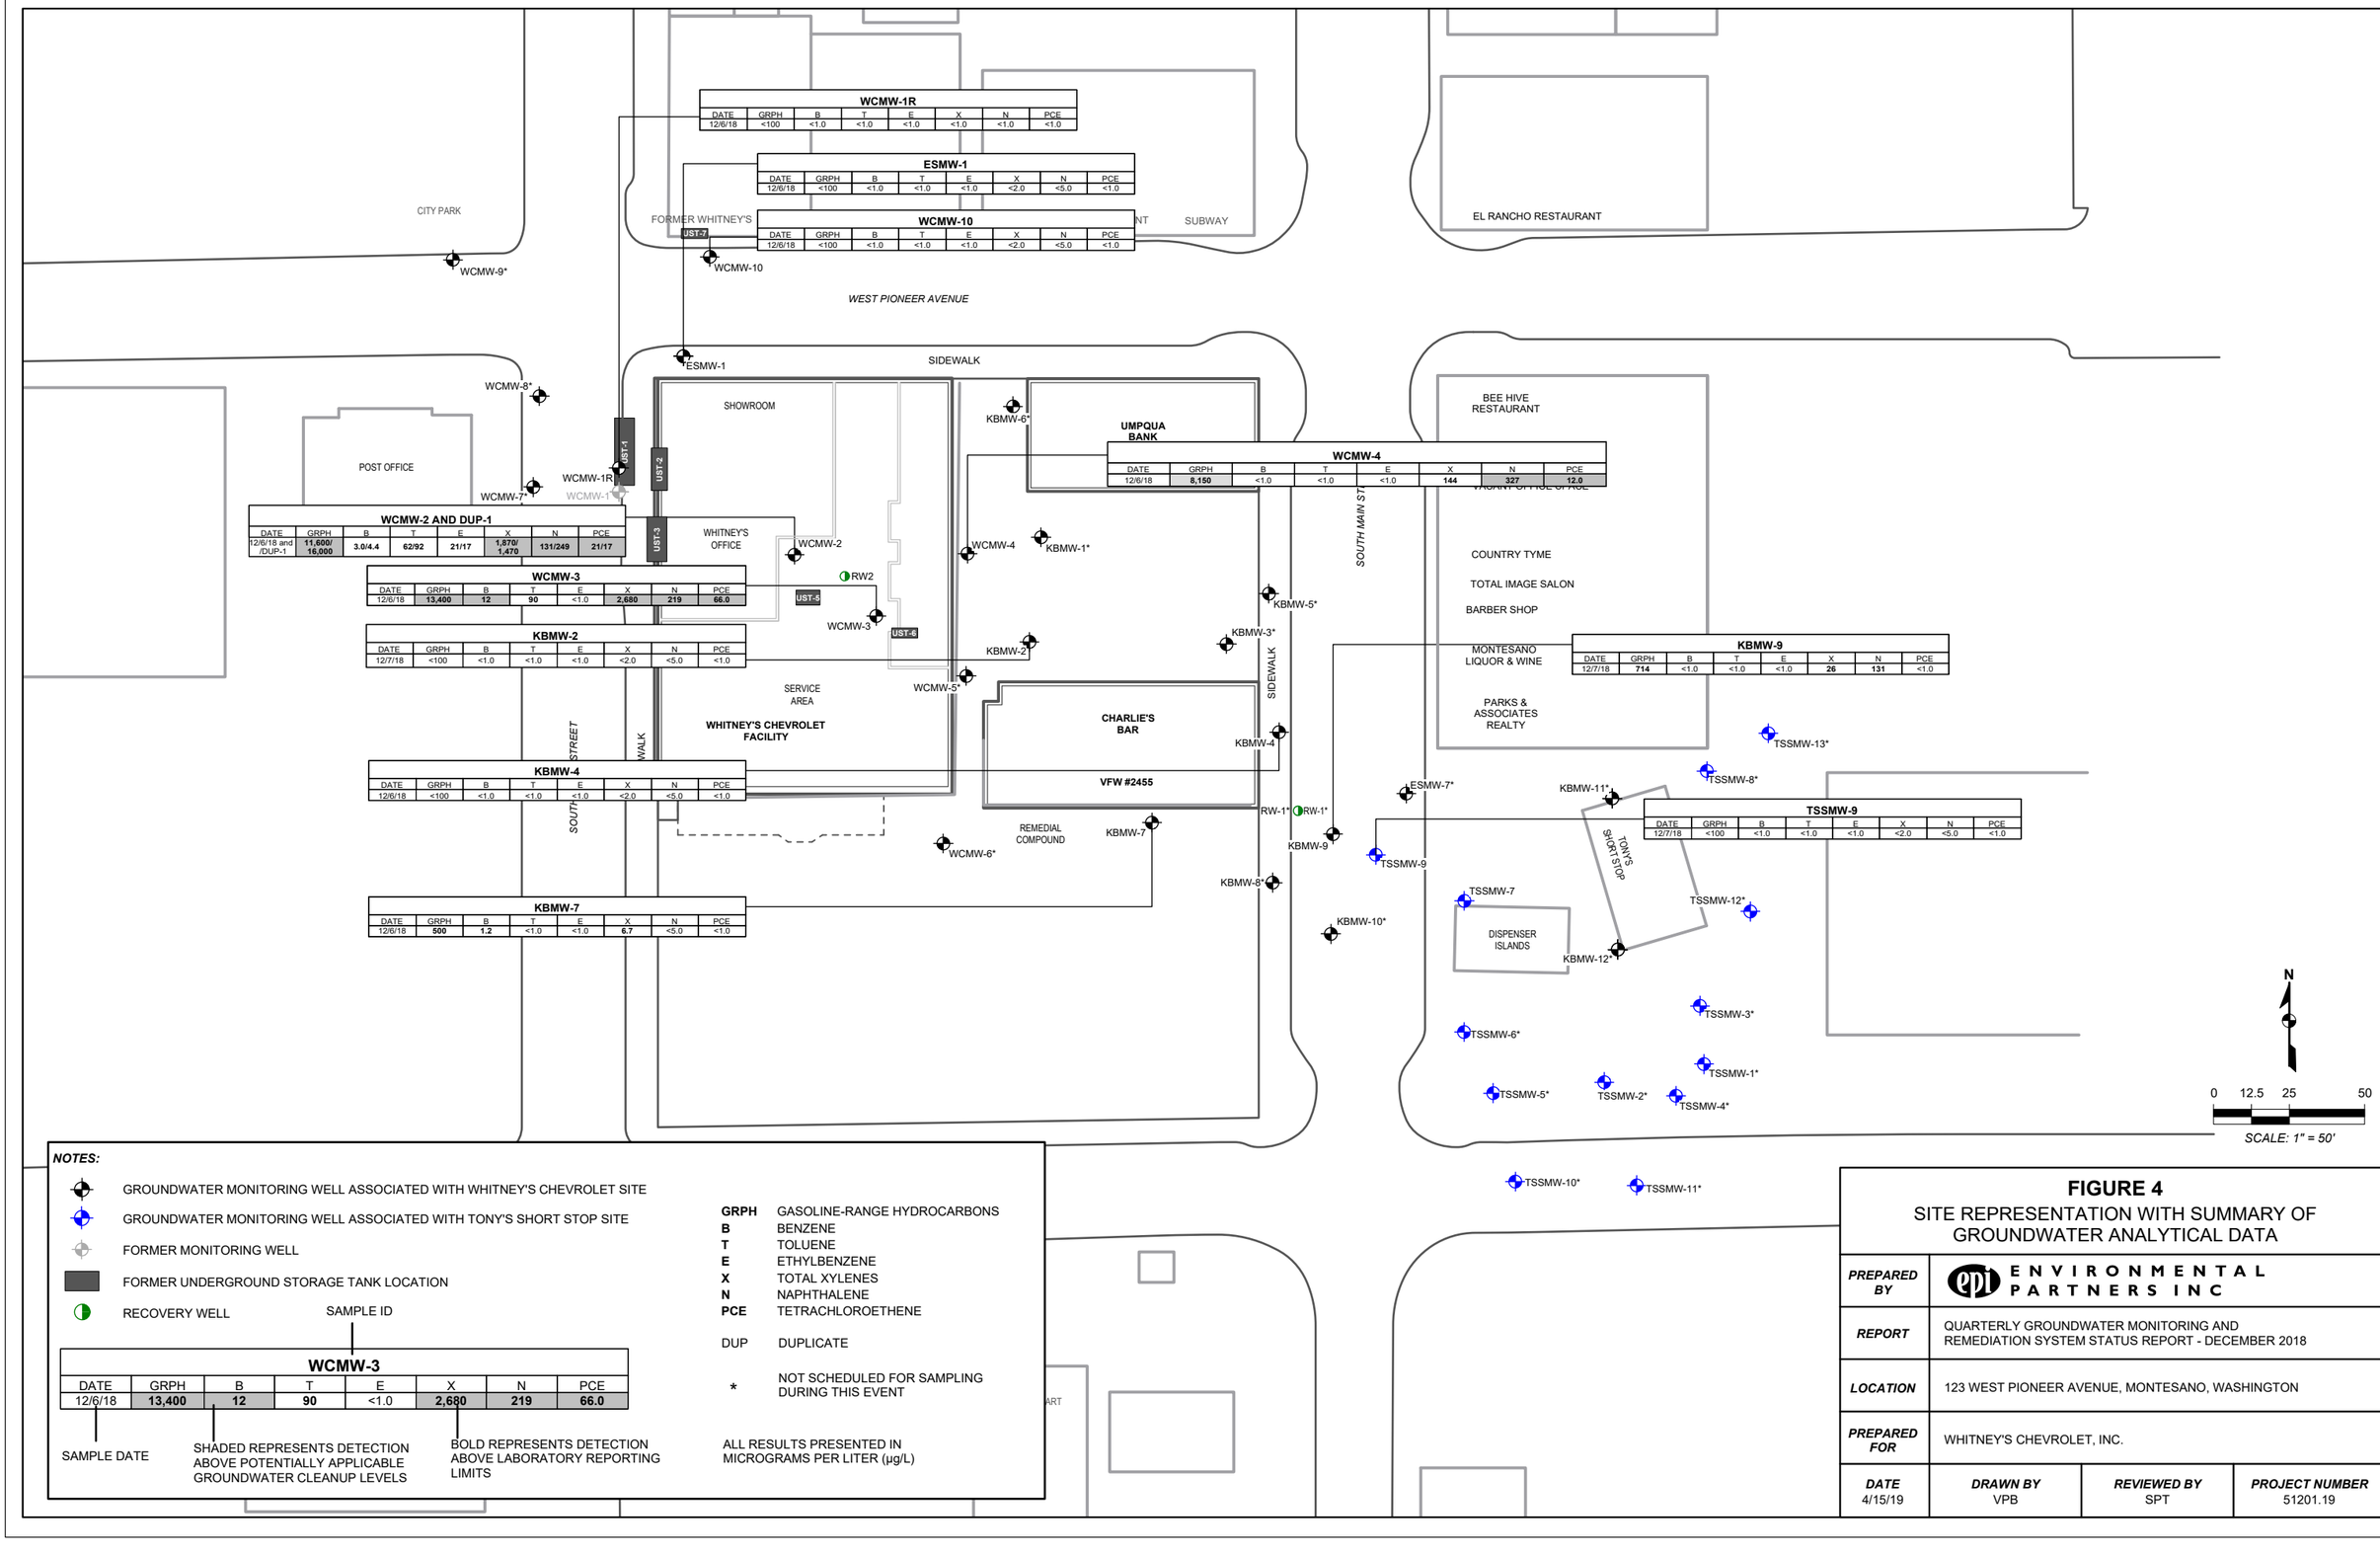
Laboratory-reported chemical analytical data are presented in Table 2 and summarized on Figure 4. Final laboratory analytical reports are included as Attachment A.

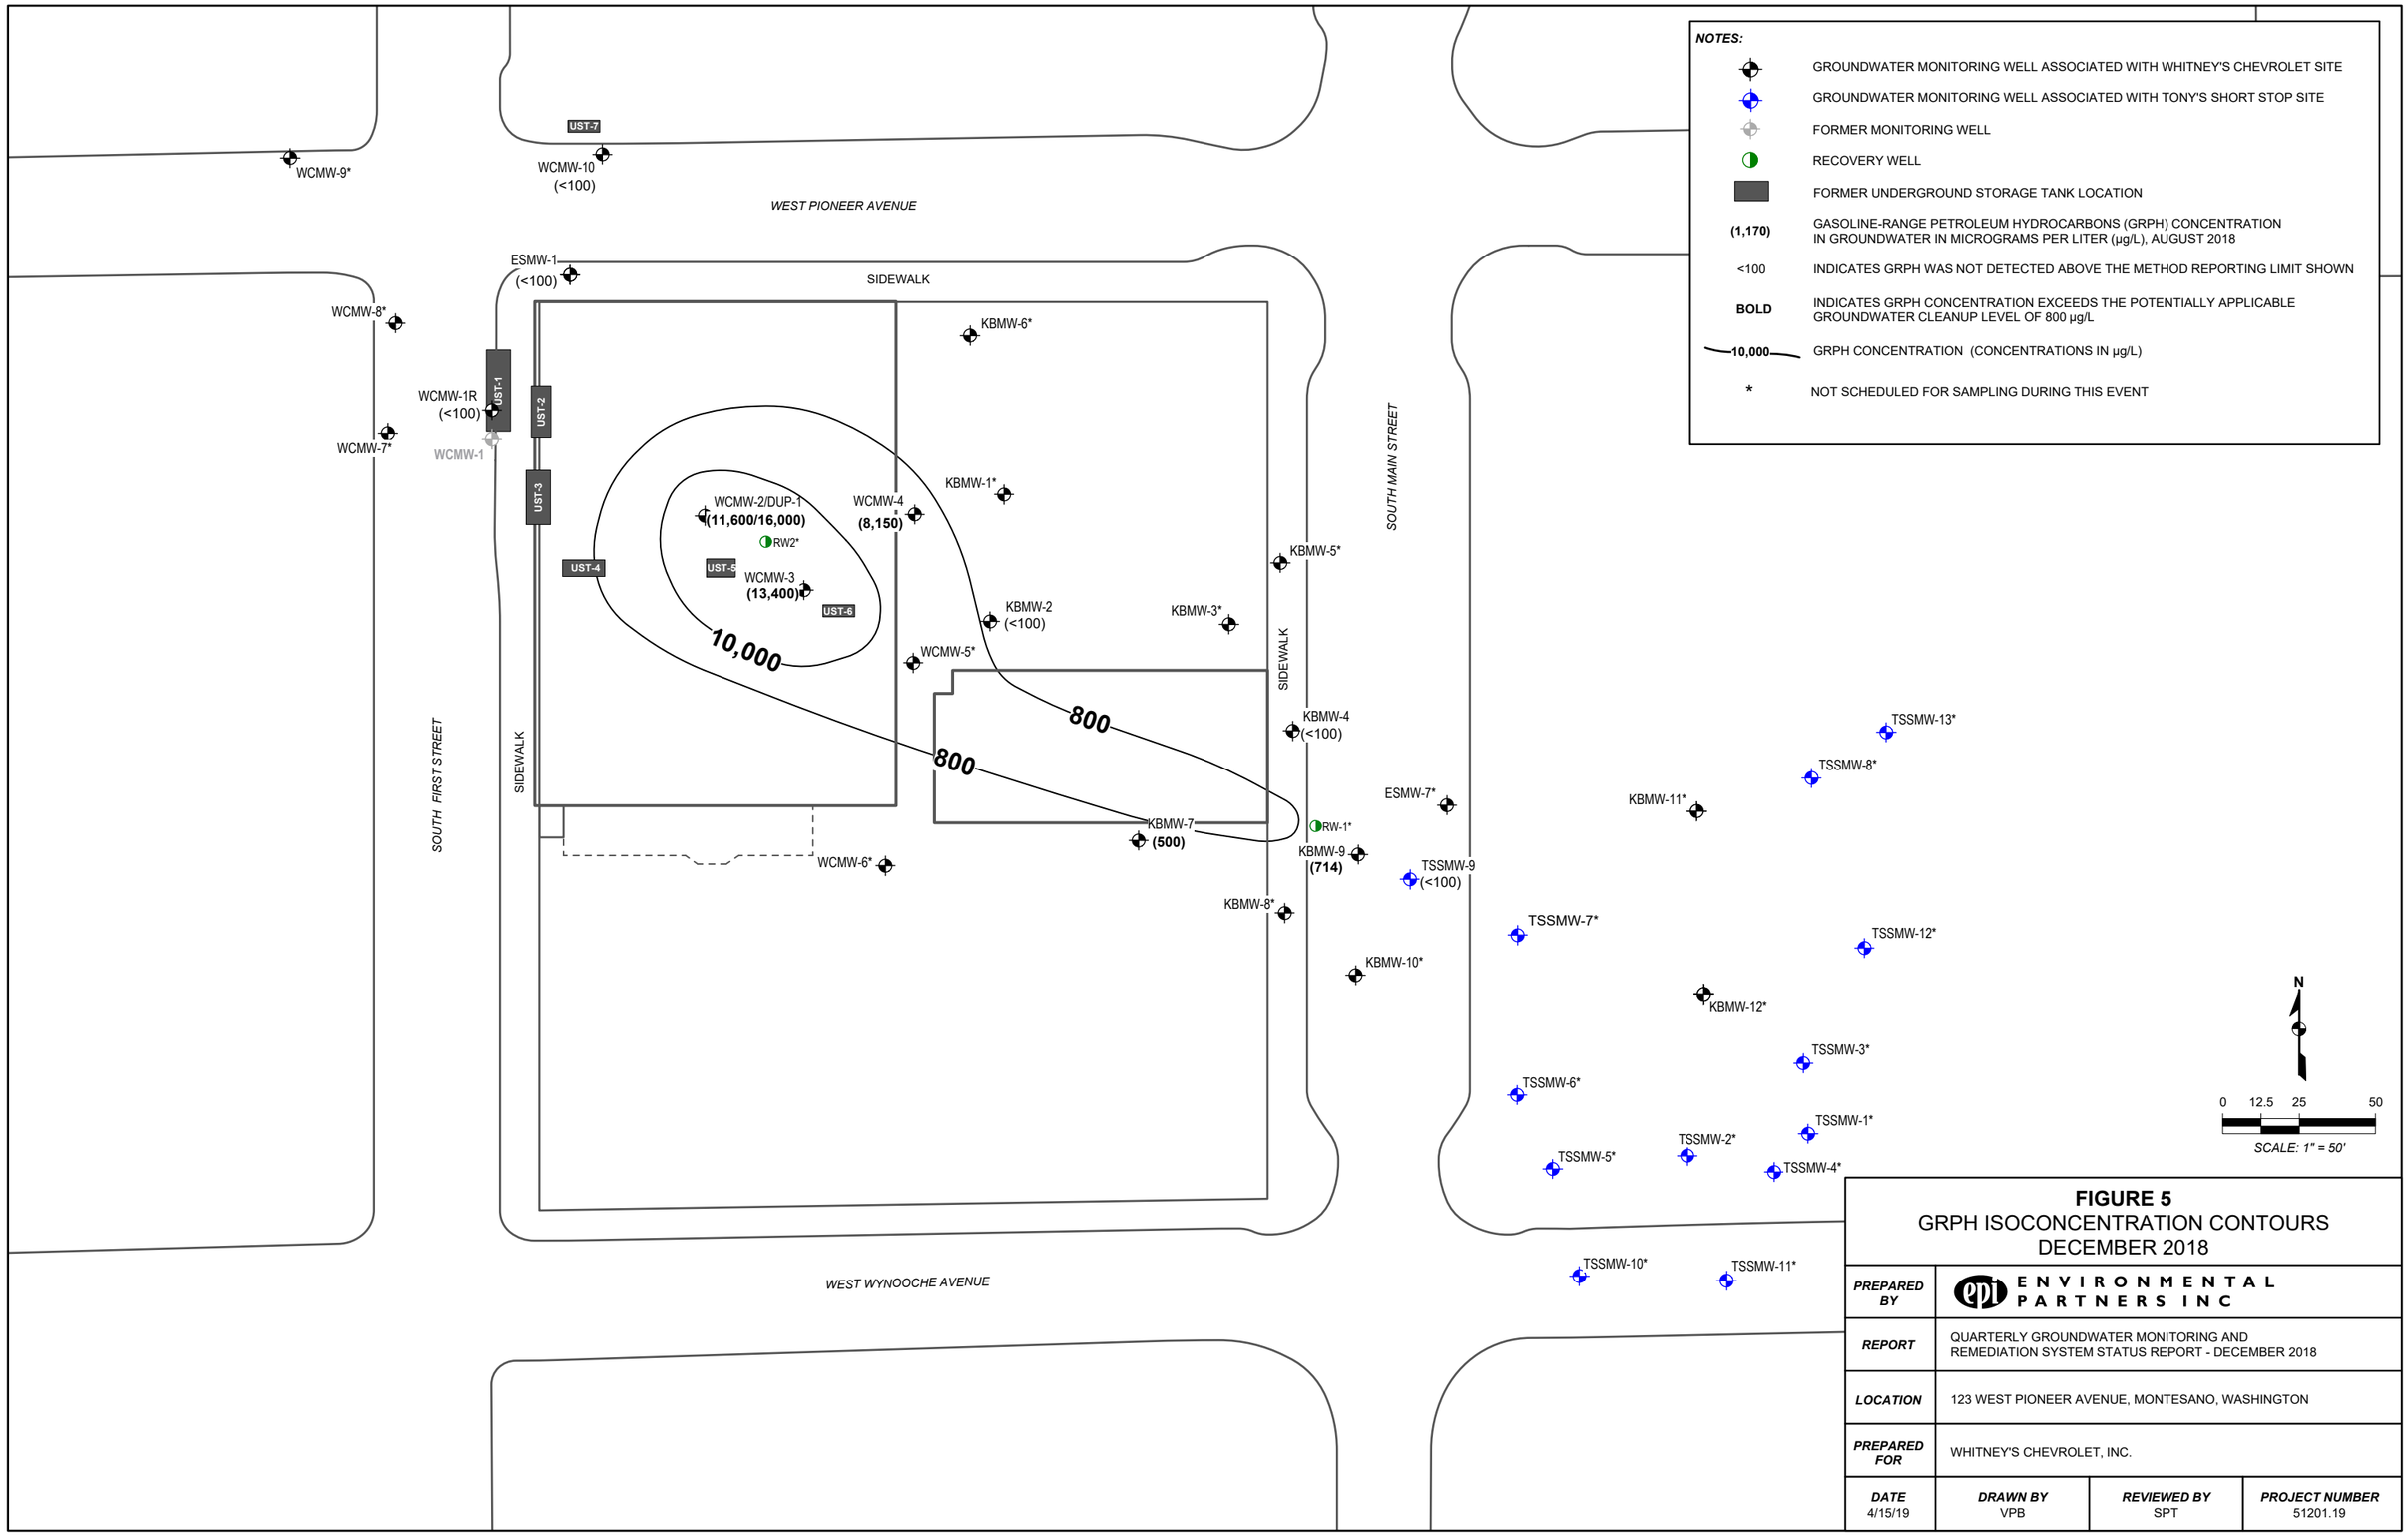
FIGURE 5
GRPH ISOCONCENTRATION CONTOURS
DECEMBER 2018

GRPH was identified in samples collected from 5 of the 11 monitoring wells sampled during this event. Reported concentrations of GRPH ranged from 500 micrograms per liter (µg/L) in the groundwater sample collected from monitoring well KBMW-7 to 16,000 µg/L in the sample collected from monitoring well WCMW-2. GRPH isoconcentration contours for the December 2018 sampling event are presented on Figure 5.

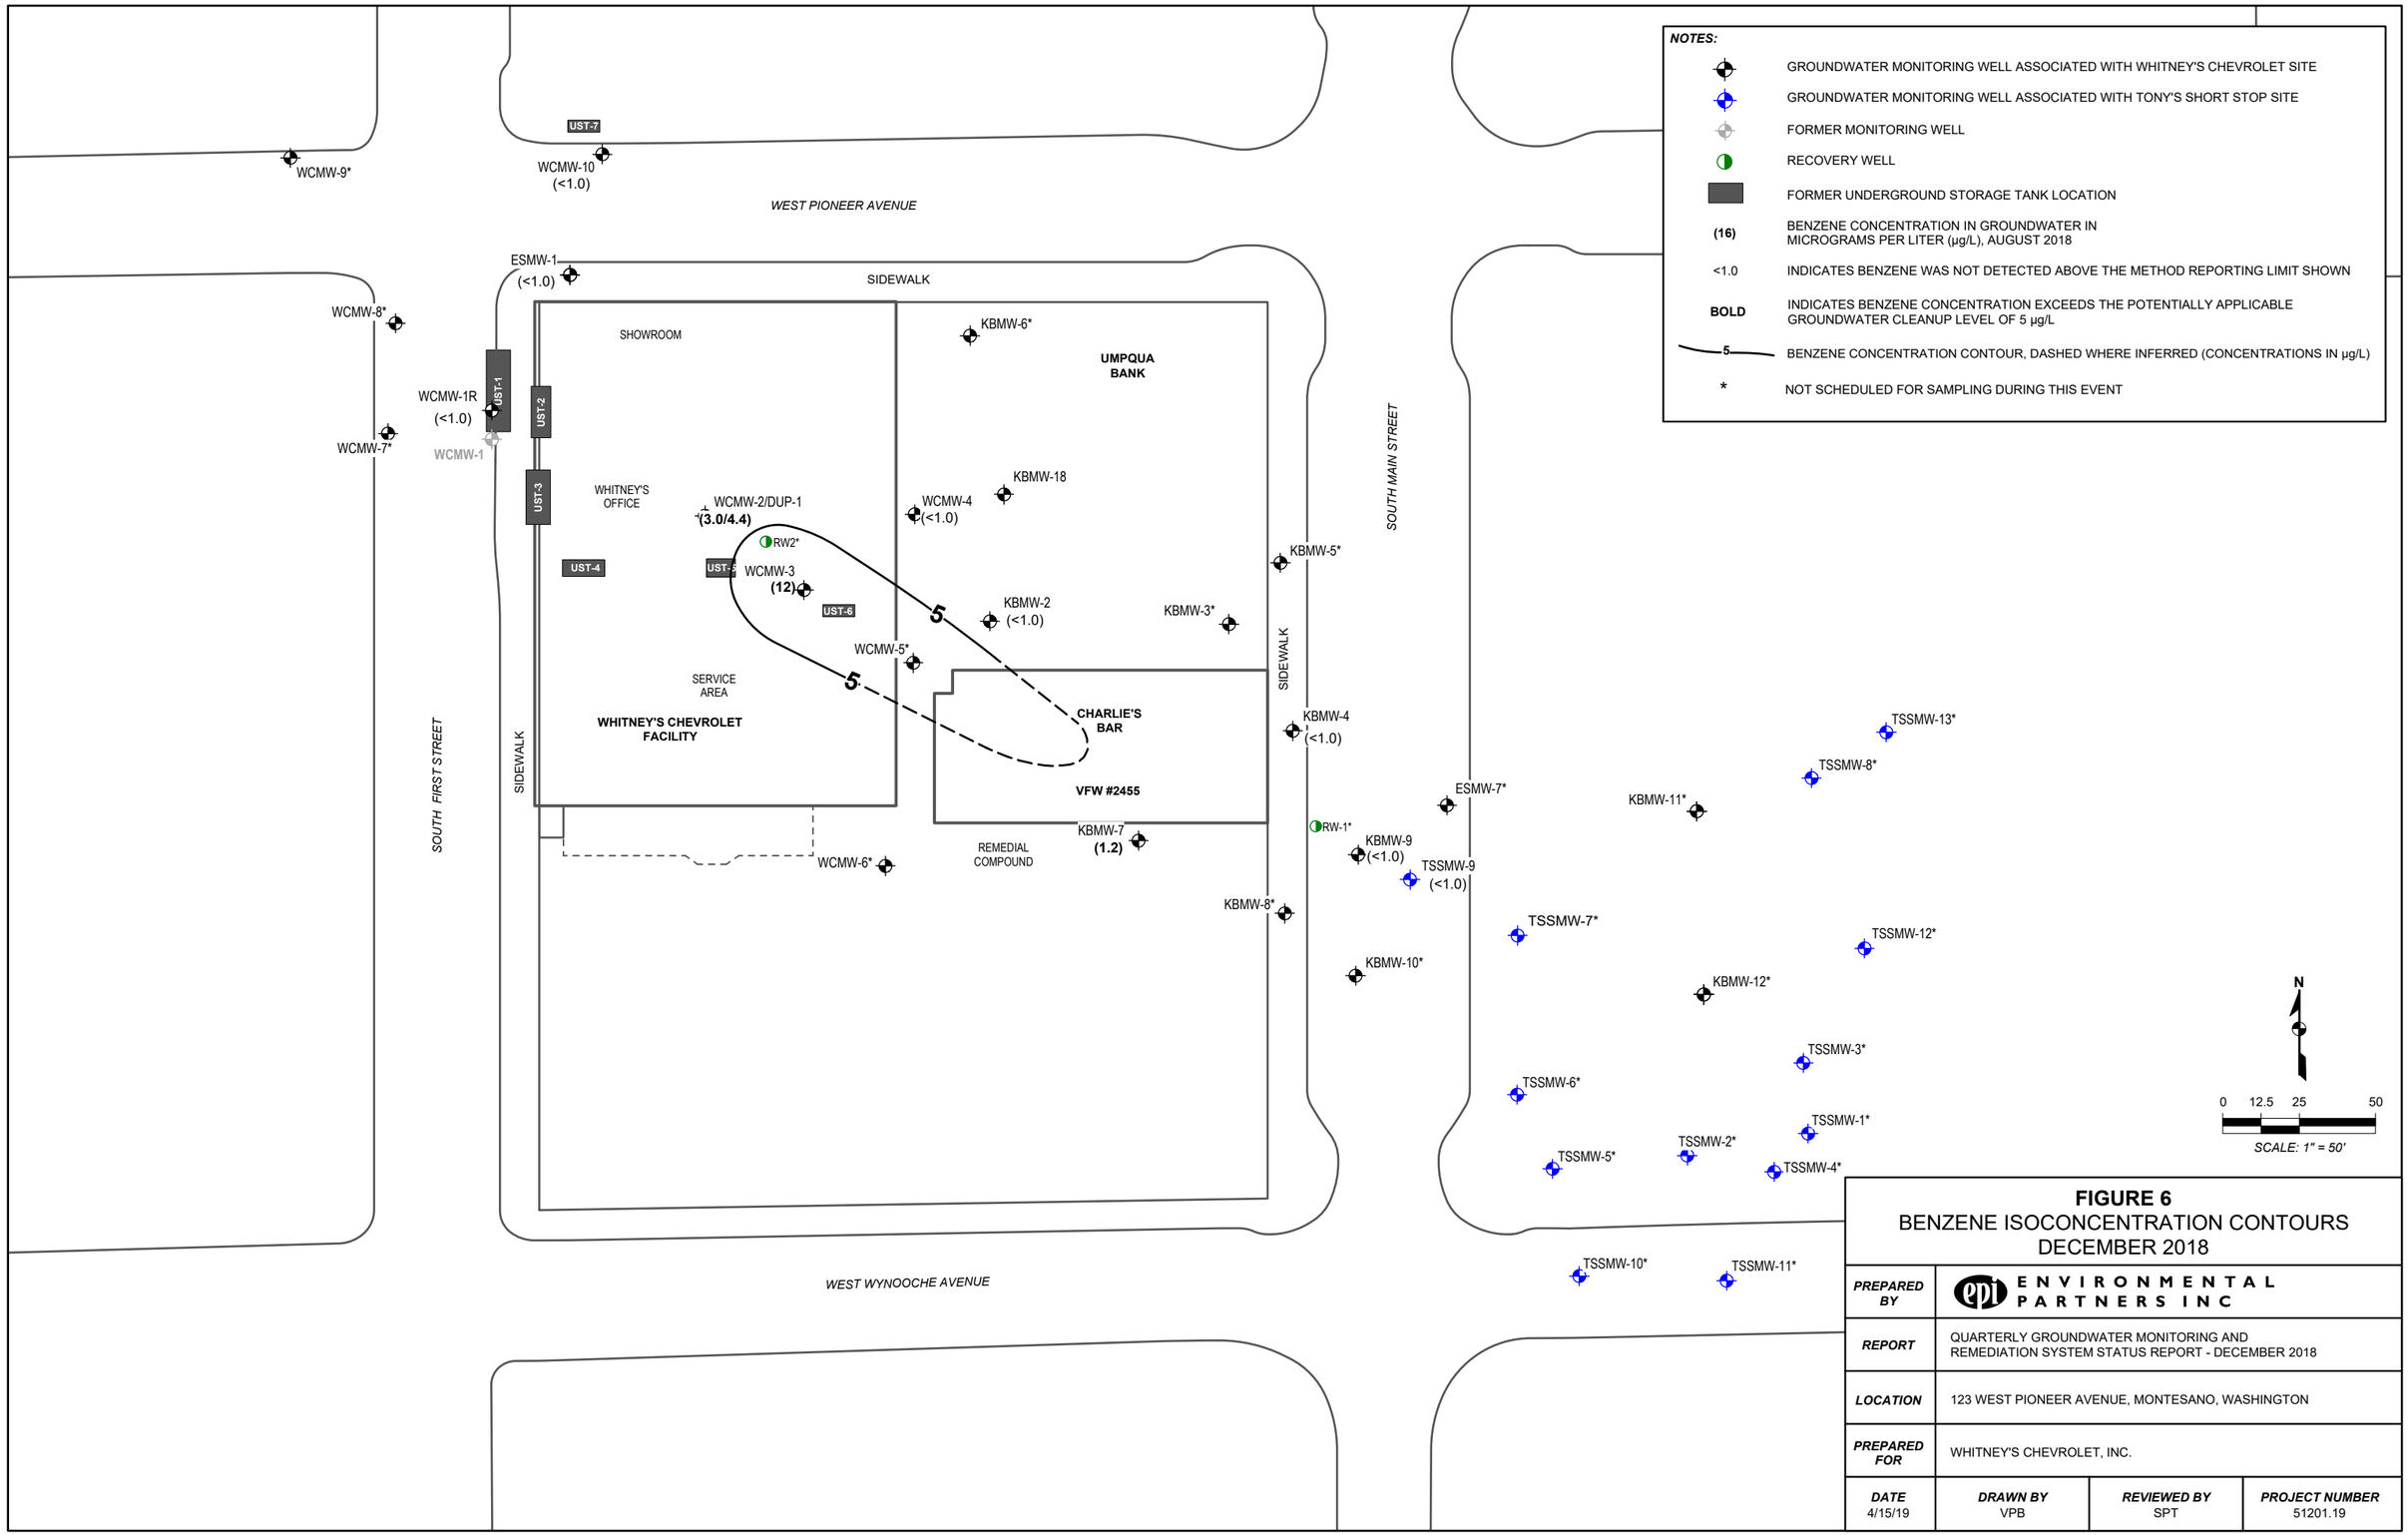
FIGURE 6
BENZENE ISOCONCENTRATION CONTOURS
DECEMBER 2018

Benzene was identified in samples collected from 3 of the 11 monitoring wells sampled during this event. Reported concentrations of benzene ranged from 1.2 µg/L in the sample collected from monitoring well KBMW-7 to 12 µg/L in the sample collected from monitoring well WCMW-3. Benzene was not identified in the groundwater sample collected from monitoring well TSSMW-9. This finding continues to support a conclusion that benzene impacts originating from releases on the Whitney's Chevrolet, Inc. Site decrease to less than the MTCA Method A Groundwater Cleanup Level of 5 µg/L upgradient of the Tony's Short Stop property. Benzene isoconcentration contours for the December 2018 sampling event are presented on Figure 6.

The GRPH and benzene data presented herein directly contradict prior representations to Ecology by the potentially liable persons (PLPs) for the Tony's Short Stop site that GRPH and benzene impacts previously observed at KBMW-12, immediately adjacent to, downgradient of, the former remedial excavation on the Tony's Short Stop property, are the result of impacts from the Whitney's Chevrolet, Inc. Site.

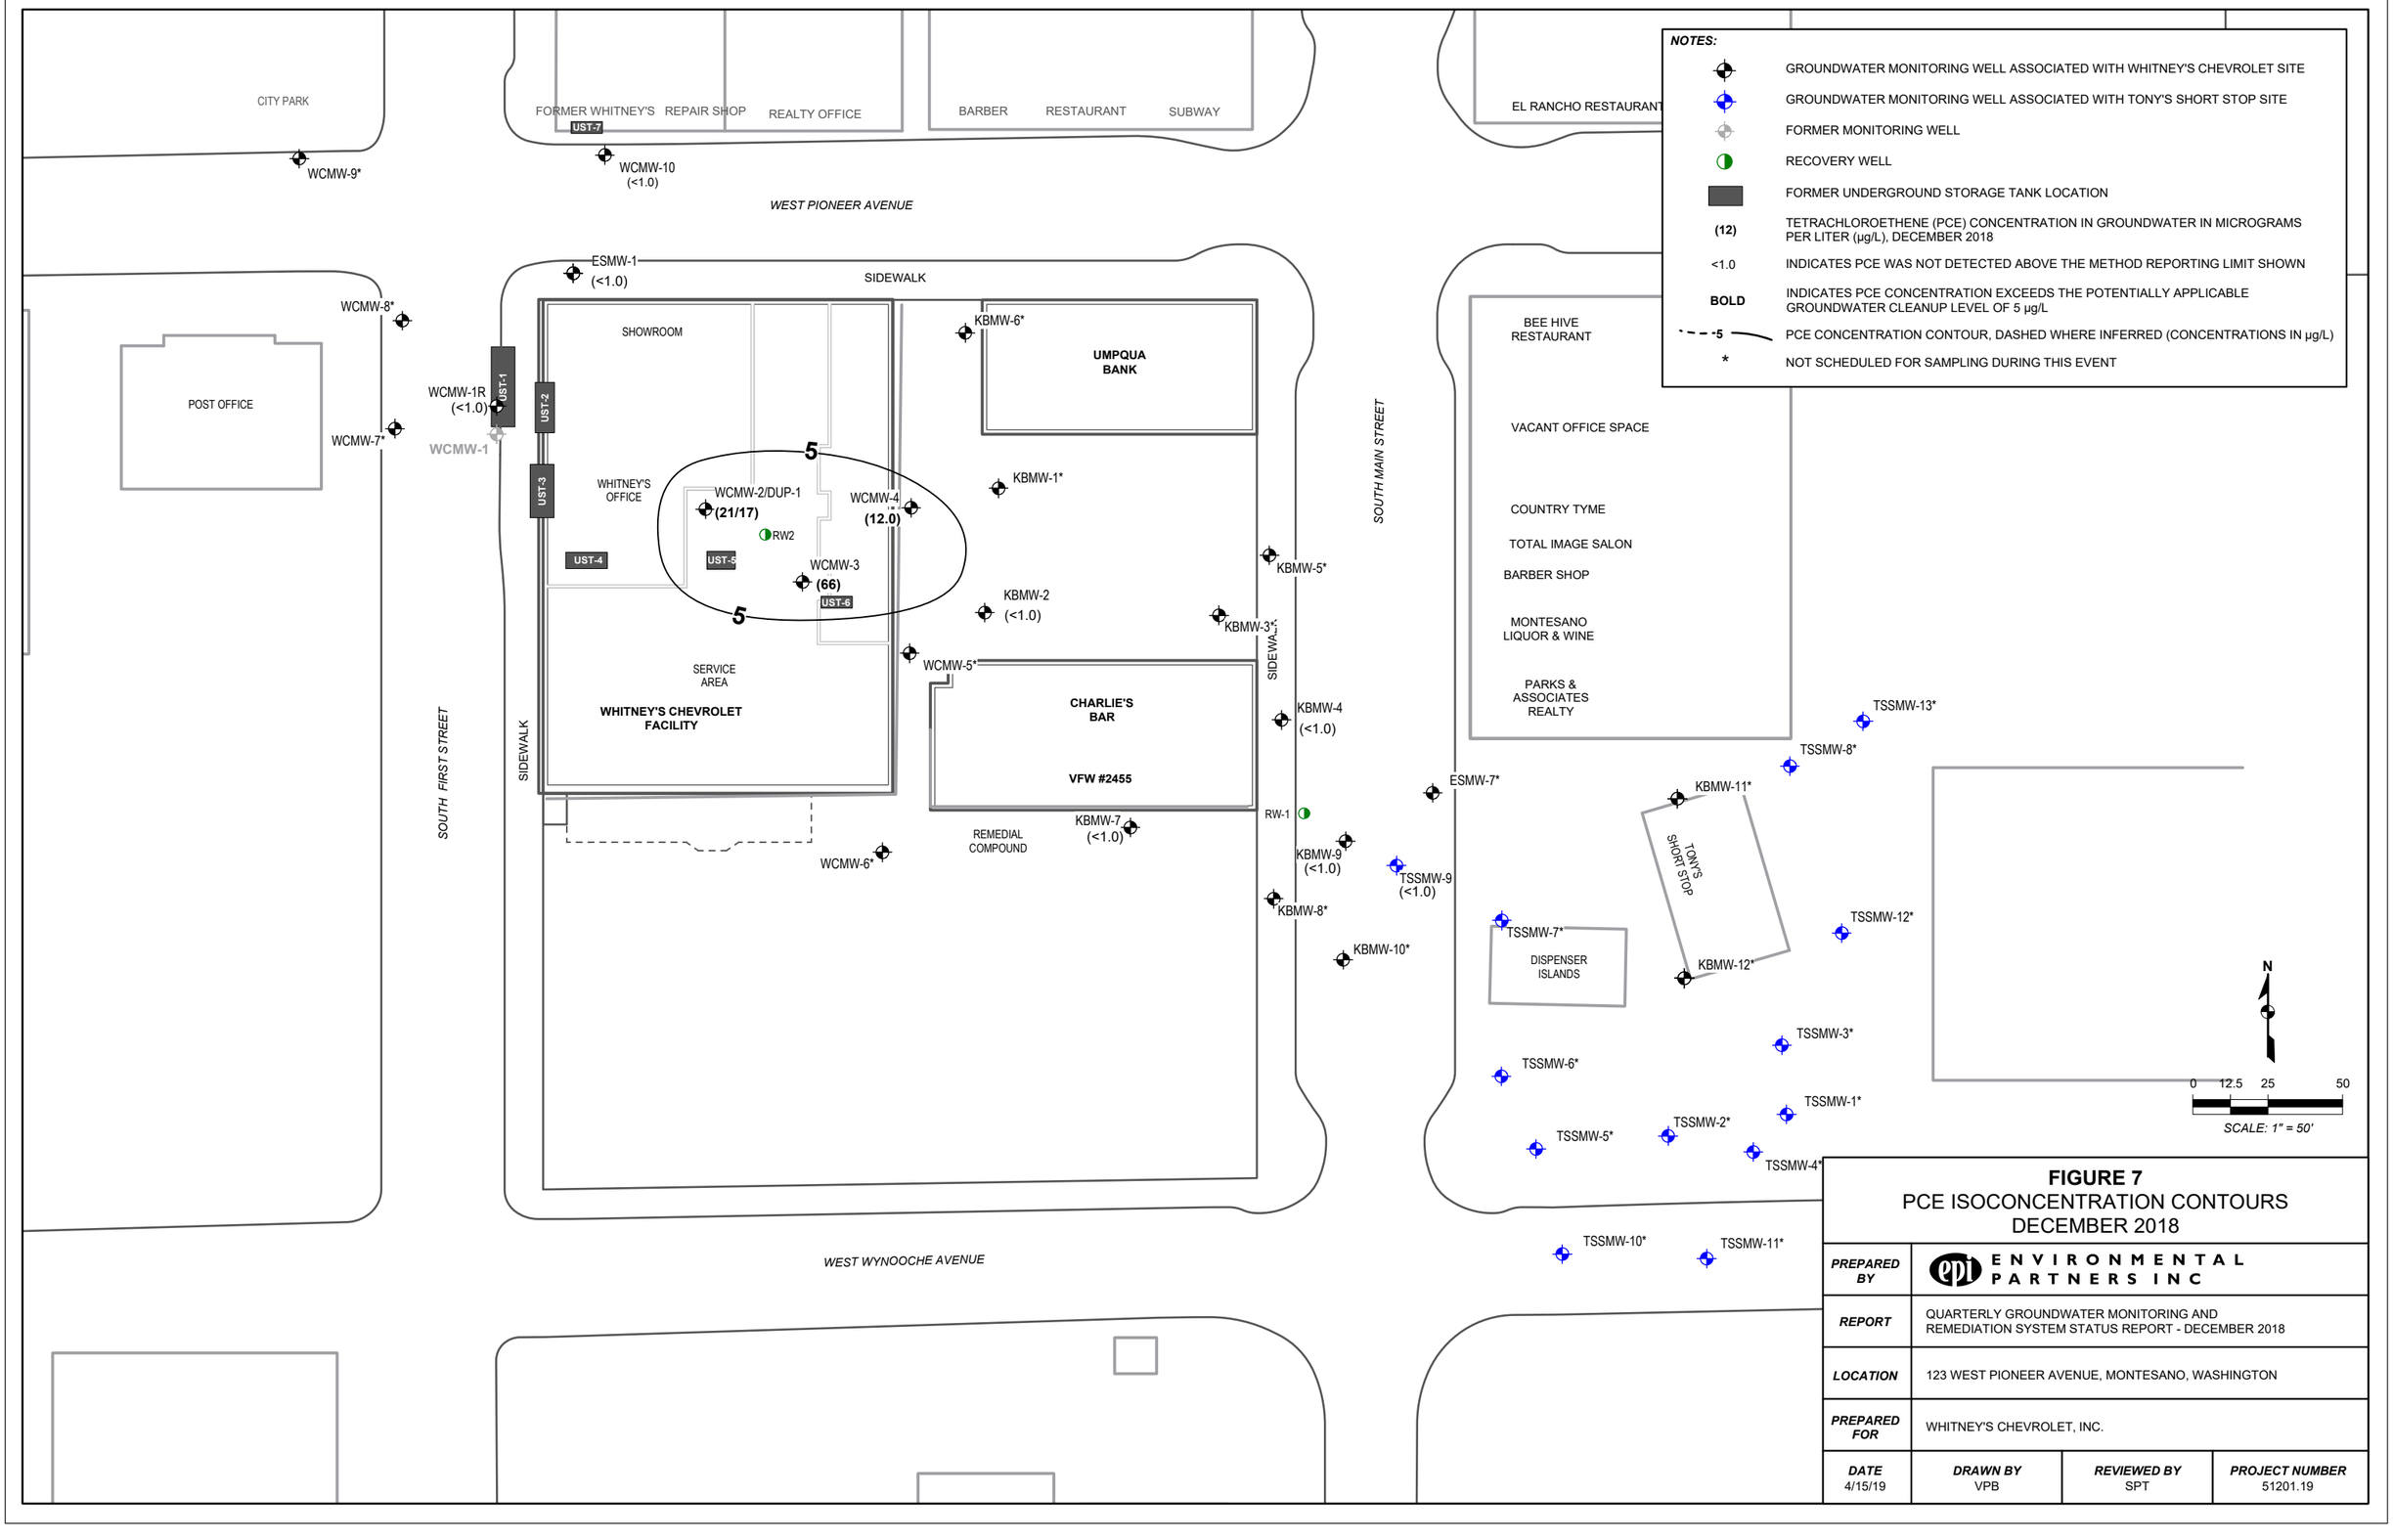
FIGURE 7
PCE ISOCONCENTRATION CONTOURS DECEMBER 2018

PCE was identified in samples collected from 3 of the 11 monitoring wells sampled during this event. Reported concentrations of PCE ranged from 12 µg/L in the groundwater sample collected from monitoring well WCMW-4 to 66 µg/L in the sample collected from monitoring well WCMW-3. PCE isoconcentration contours for the December 2018 sampling event are presented on Figure 7.
