STATE OF WASHINGTON
DEPARTMENT OF ECOLOGY
7272 Cleanwater Lane, LU-11 • Olympia, Washington 98504-6811 • (206) 753-2353

M E M O R A N D U M
November 6, 1985

Subject: Effects of Three Small Sewage Treatment Plants on Budd Inlet Receiving Waters

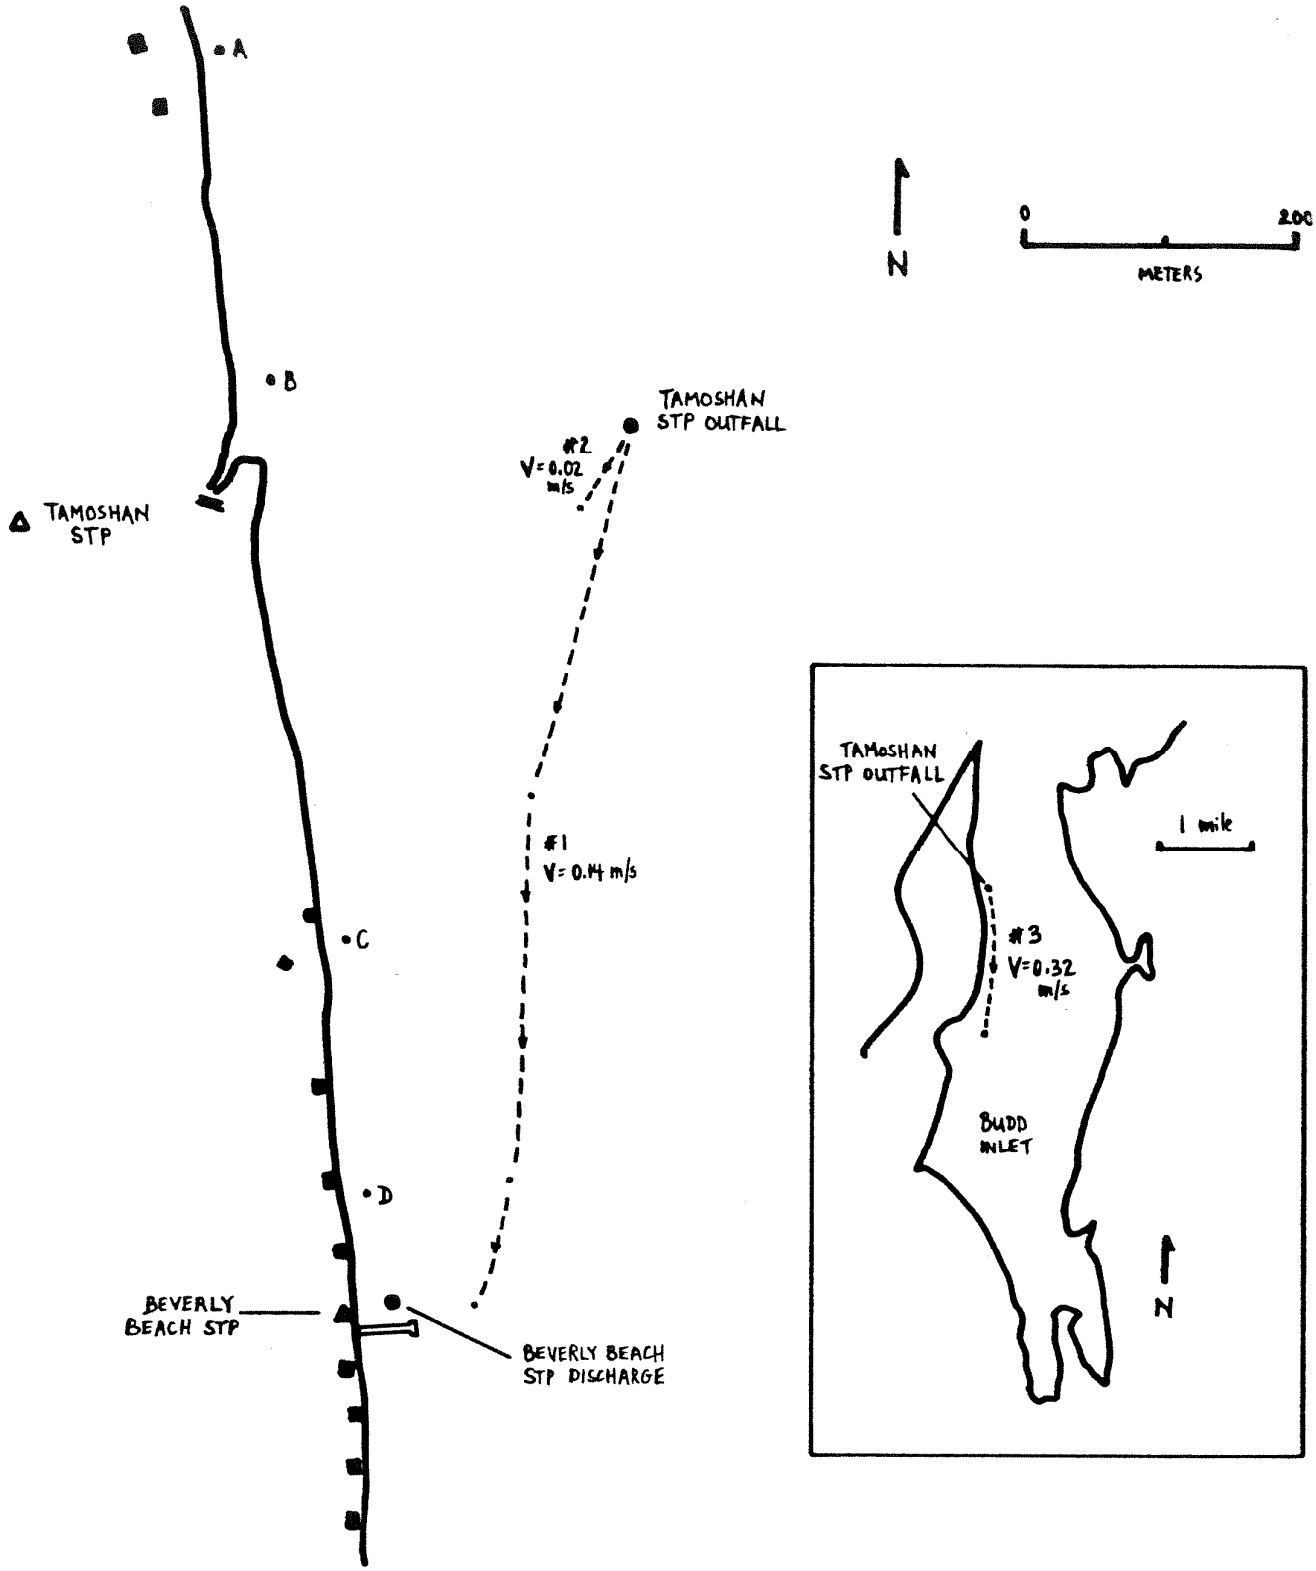
On June 17, 1985, 250 mL of dye were poured into the Tamoshan STP outfall line. Emergence of a dye cloud from a single point about 200 m offshore (Figure 4) confirmed the outfall location reported by Determan (1981).

Drogue studies conducted at Tamoshan, in conjunction with field observations, indicated that currents were variable and eddy-like as slack tide approached, but clearly oriented to the south as the tide began to rise (Figure 4). The same pattern was reported by Determan (1981). Drogue release dates and times, as well as drift durations, were as follows: #1 - June 17, 1115, 79 minutes; #2 - June 18, 1020, 60 minutes; and #3 - June 18, 1150, 135 minutes. Low tide on the 17th and 18th occurred at 1156 and 1231, respectively. Mean current velocity ranged from 0.02 to 0.32 m/s.

Fecal contamination at Tamoshan nearshore sites has been a recurrent problem which does not appear to be related to discharges from Tamoshan STP. Three previous surveys of Tamoshan nearshore waters also showed violations of the state water quality standard for fecal coliforms (Table 4). Inadequate disposal of domestic wastes by shoreside residences may account for the high bacterial levels (these homes are not connected to the Tamoshan sewer system). Other suspected sources include an exposed PVC line which drains sewage from the southeast part of the development. However, inspection of the line by both Determan (1981) and the present authors revealed no breakage. The intermittent stream described earlier was not a potential source of contamination as it was dry at the time of the survey.

Figure 4. Map of Tamoshan and Beverly Beach STPs showing location of discharges and nearshore sampling sites (A - D) as well as drift paths of a drogue released at the Tamoshan STP outfall on three separate occasions (V = drogue velocity). Shaded rectangles denote shoreside residences.

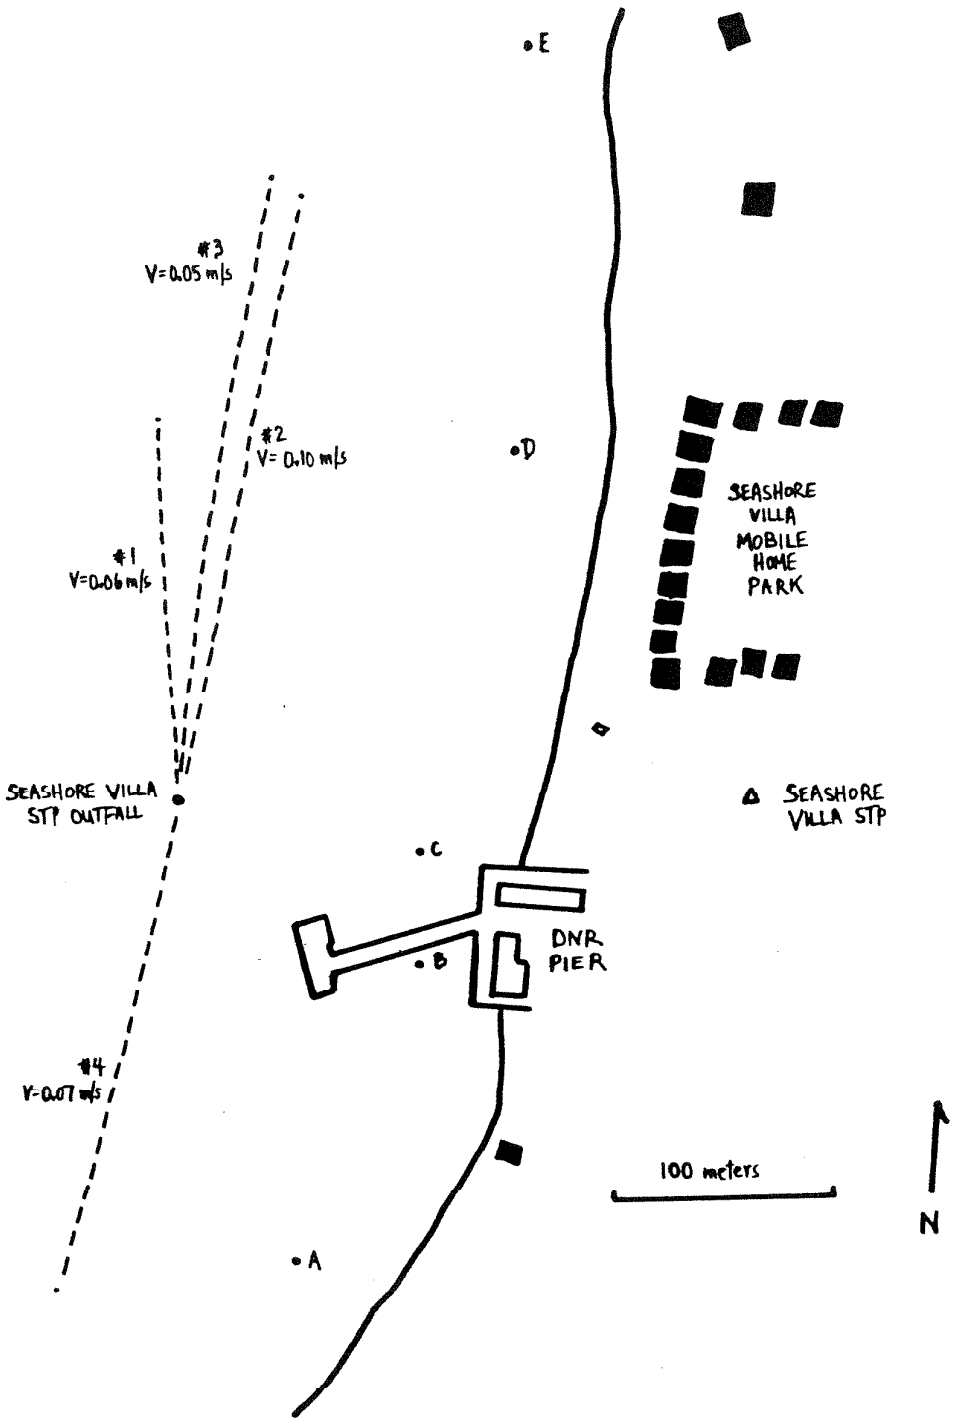
Drogue studies showed that currents were northerly on the ebb tide, but reversed to a southerly direction after slack low tide (Figure 5). Drogue release times and drift durations were as follows: #1 - 0920, 50 minutes; #2 - 1015, 50 minutes; #3 - 1110, 95 minutes; and #4 - 1250, 55 minutes. Low tide occurred at 1216. Mean current velocity ranged from 0.05 to 0.10 m/s.

Figure 5. Location of Seashore Villa STP and outfall as well as nearshore sampling sites (A - E). Drift paths of a drogue released at the STP outfall on four different occasions are traced (V = drogue velocity). Shaded rectangles denote shoreside residences.
