Second Periodic Review

Elliott Tire Center 1 E Lincoln Avenue Yakima, Washington 98902

Facility/Site ID #: 547 Cleanup Site ID #: 1940

December 2013

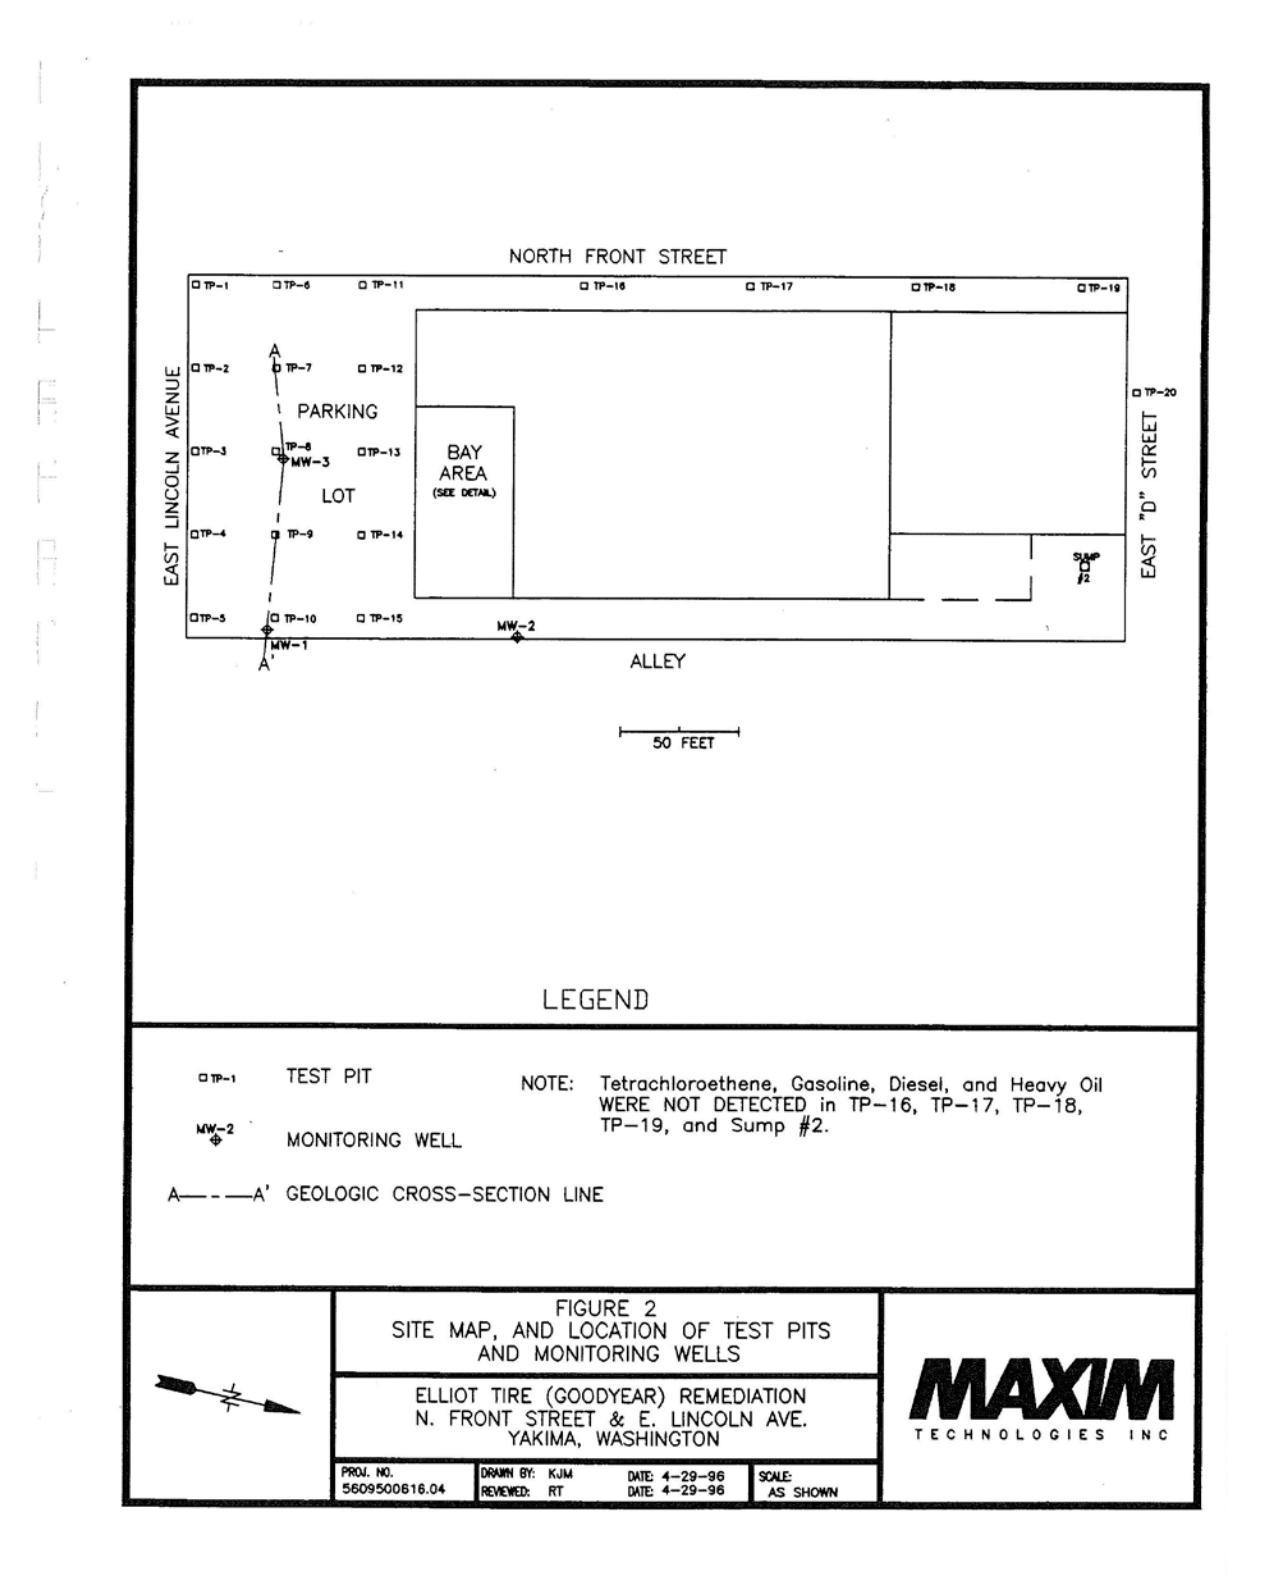
6.2 Site Plan

Elliott Tire is an operating retail tire center and automotive repair shop (Site Plan – Appendix 6.2). Historical maps indicate that the Site was occupied by service stations and residences between 1921 and 1961. In 1961, the property was acquired by the current owners. A tire service center was constructed at the Site by 1968.
