PERIODIC REVIEW

Weyerhaeuser Everett Mill E Facility Site ID#: 12

515 East Marine View Drive, Everett, Washington

June 2016

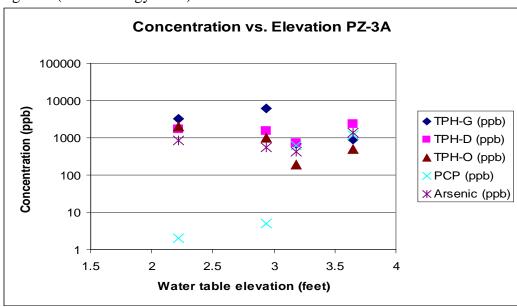
Figure 1 – 3 below depict the water table and contaminant concentration trends in well PZ-3A. Figure 1 shows concentration vs. elevation. Figure 2 shows the change in concentration with time since barrier wall and cap installation, and Figure 3 shows elevation vs. time. Except for PCP, there does not appear to be large variations in contaminant concentration with water table elevation (Figure 1). Figure 2 shows that there was a significant reduction in PCP with time. However, the time series plot of the hydrocarbon contaminant concentrations seem to show increases but with a leveling off with time since the cap installation. This can imply a constant petroleum hydrocarbon source term loading and thus vertical contaminant loading to the lower sand aquifer continues to occur. Although it has been characterized as below the cleanup standard, it is unknown if this is a standard which is protective of water quality and aquatic organism in the river receptor. Arsenic remains above cleanup levels. Finally, the water table beneath the cap still shows fluctuation, although as expected it is much lower than the water table in the upper sand outside of the wall. Note that the other piezometer information is not plotted in this graph, but the total results may be found in the monitoring reports. Parts per billion (ppb) are equivalent to ug/L.
