RE: 2209 East Lake Washington Boulevard – Indoor Air Testing

Shannon & Wilson performed indoor air testing at the 2209 East Lake Washington Boulevard property in Seattle, Washington (property) on behalf of the Washington State Department of Transportation (WSDOT).

SR 520 Montlake to Lake Washington  
I/C and Bridge Replacement  
Seattle, Washington

EXHIBIT 1

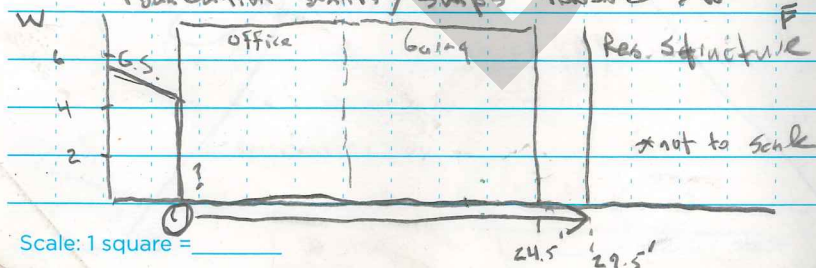
- ° Stains on garage floor

- ° Numerous paints, finishes, stain removers, chemicals + cracks, holes

- ° Foundation slants / sumps toward SW

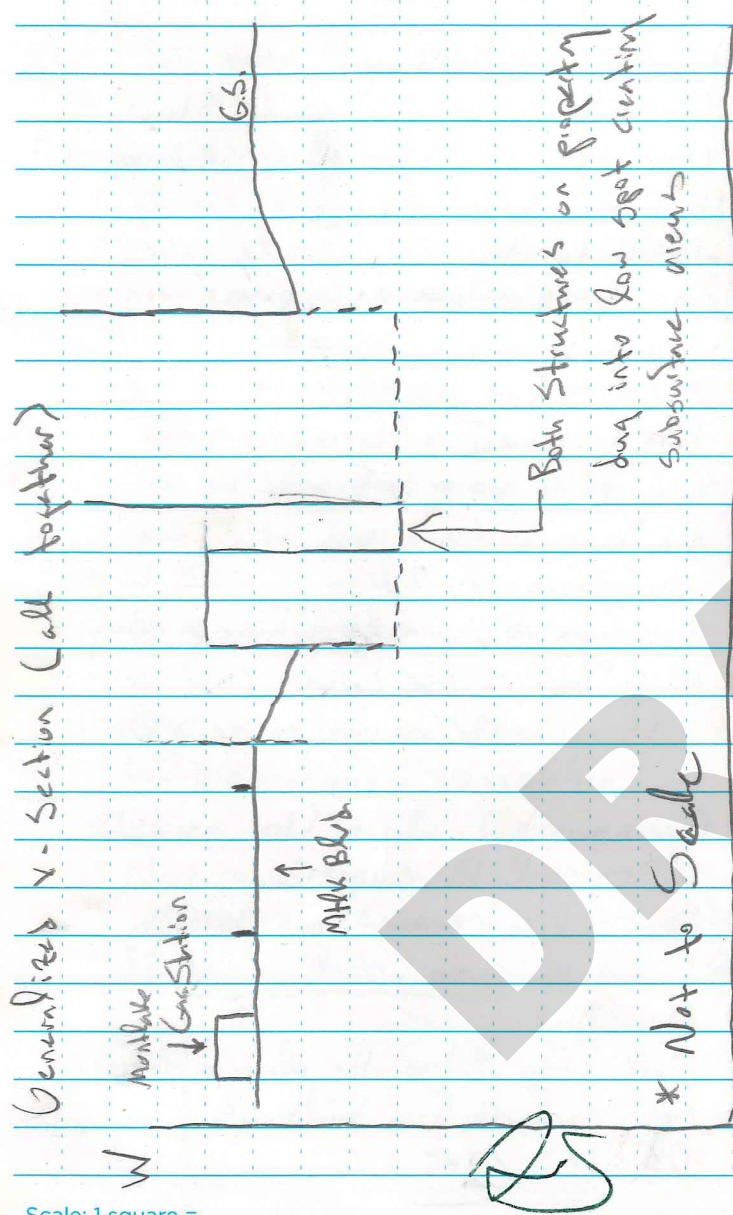
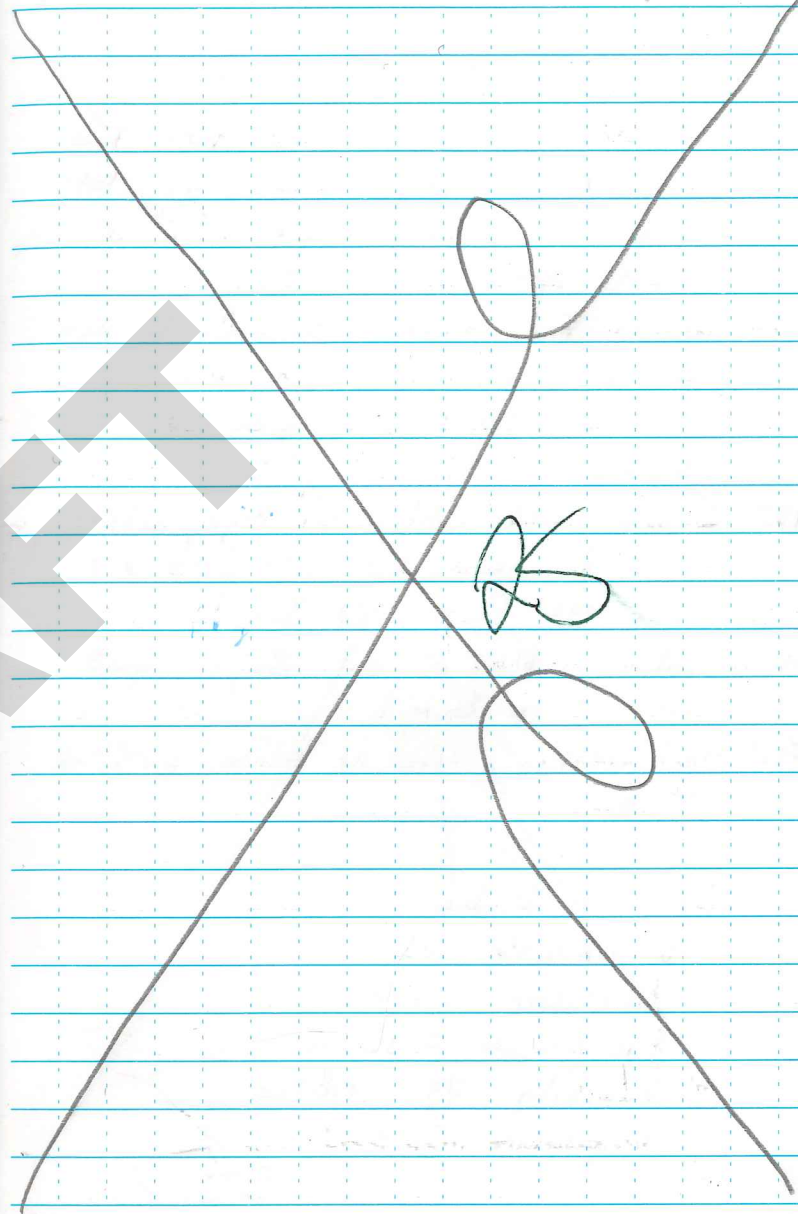
- ° No chemical storage - paint found in entry

- ° Water leak in NW corner

- ° Steve thinks faucet (outdoor) leaking and caused water leak

- ° Cracks not visible on floor as most basement is carpeted
