# Supplemental Focused Subsurface Investigation Report

March 3, 2019

**23418 Pacific Highway South  
Kent, Washington**

ECI Project No.: 0673-01-03

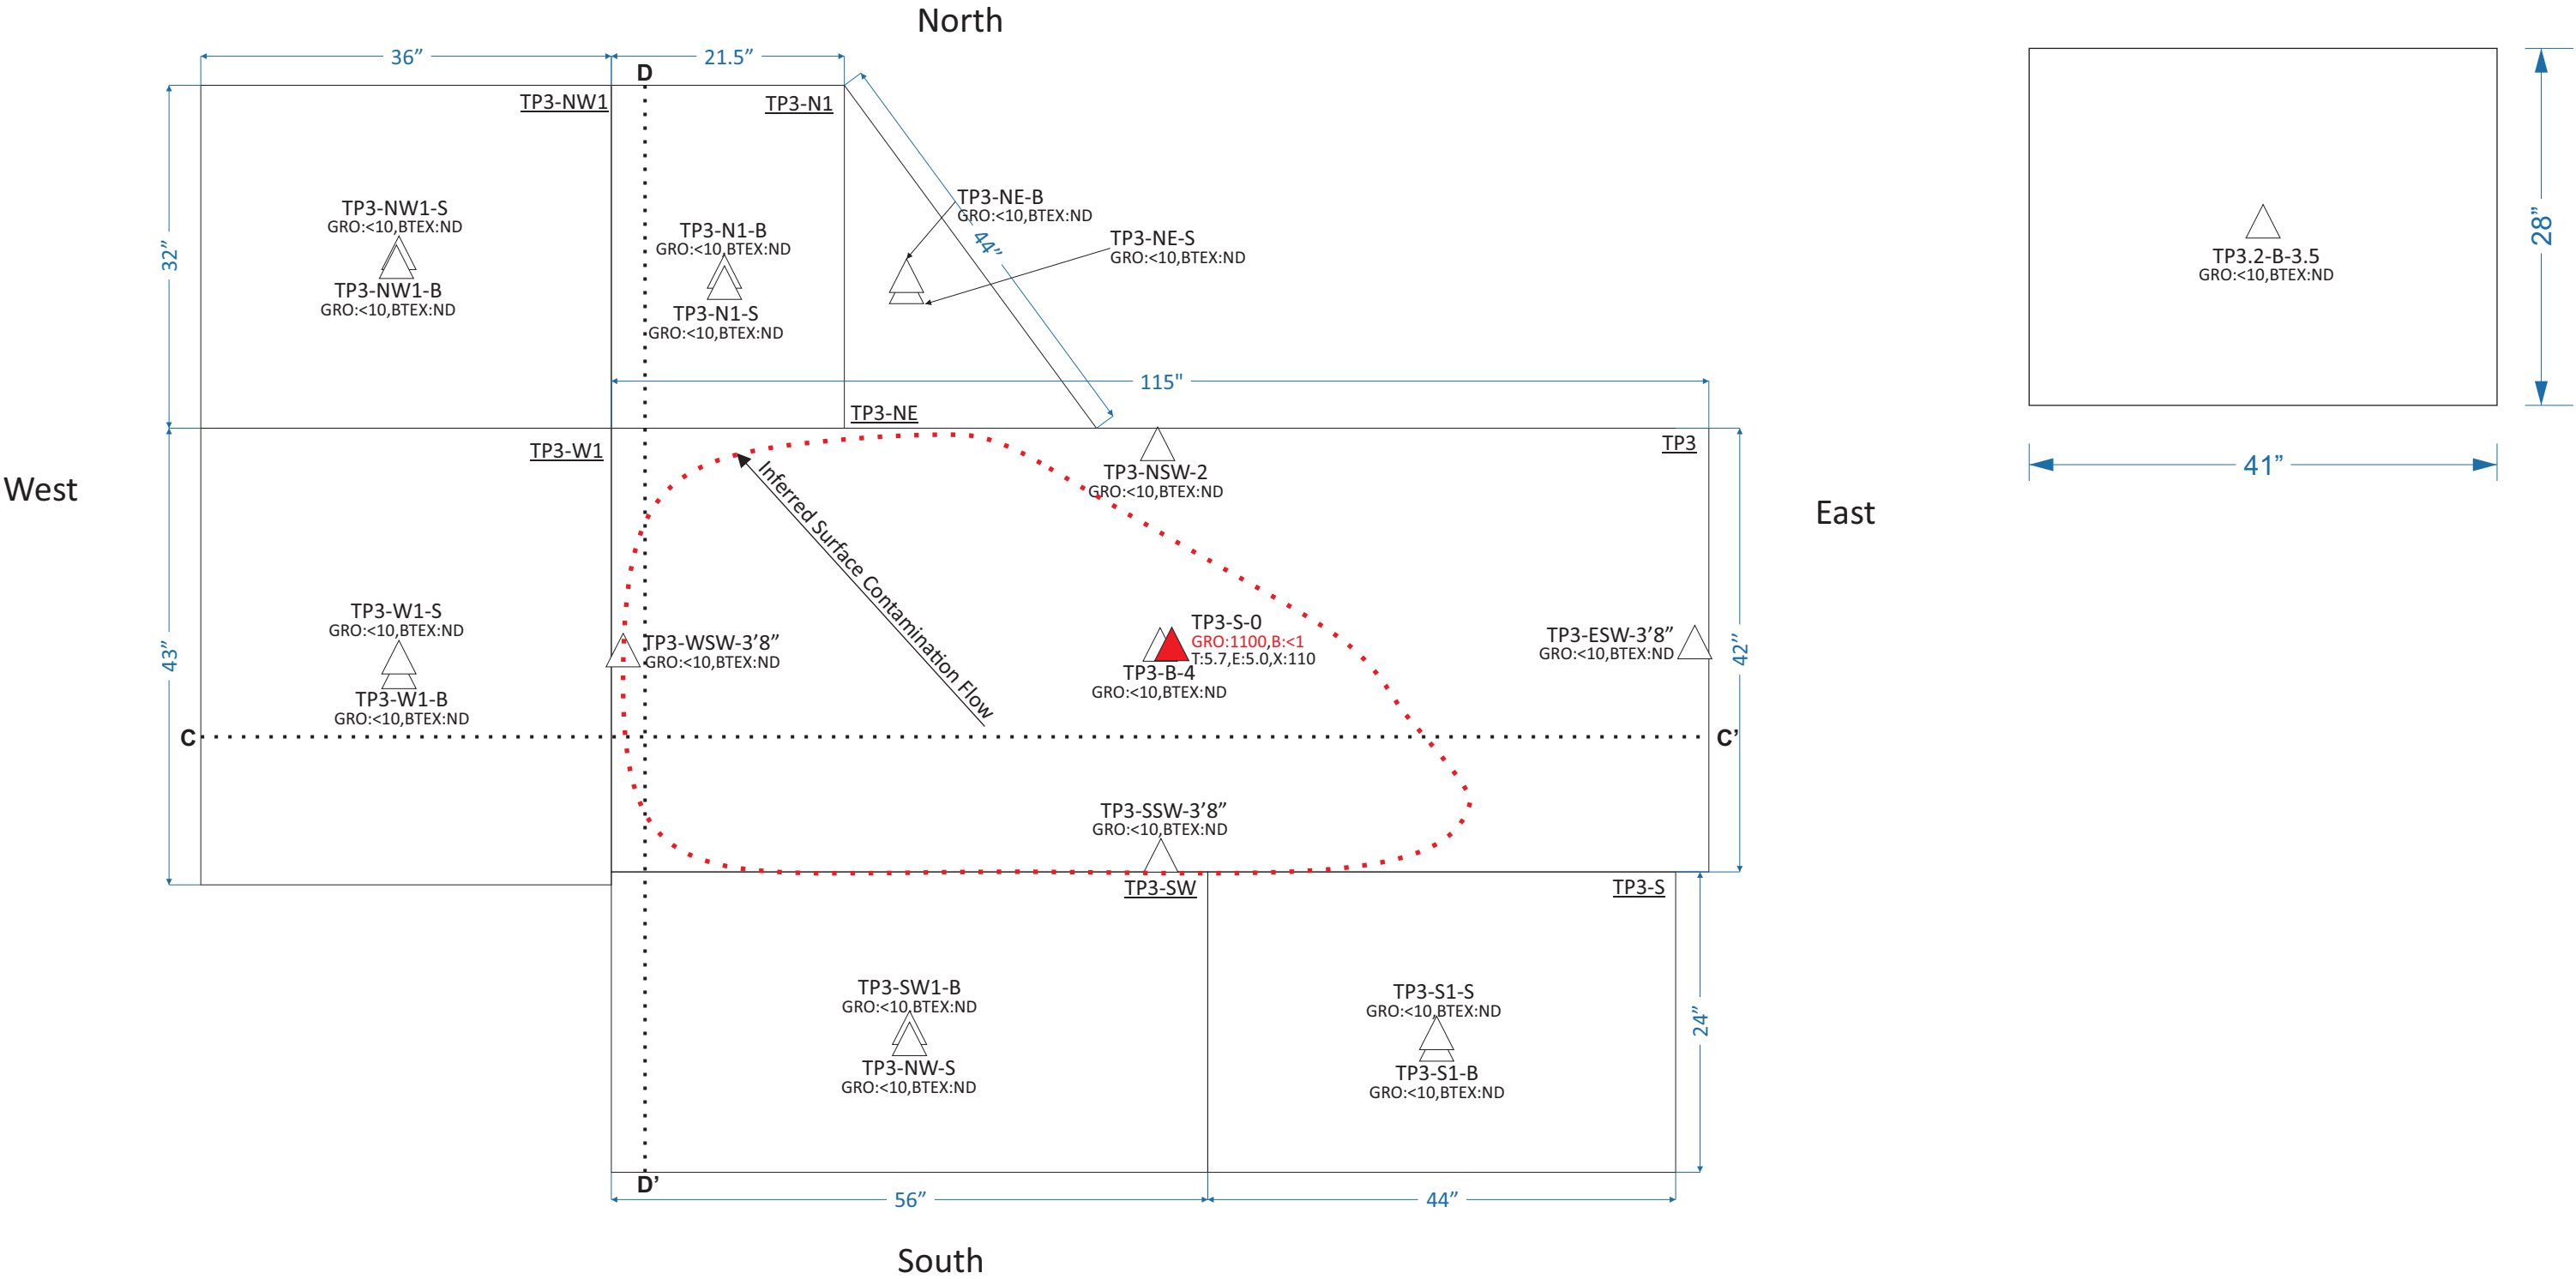
# Test Pit 3 Cross-Section

To further delineate the extent of the contamination observed, the test pit was extended to a depth of 4 feet bgs. Four sidewall samples were collected at depths of 3.66 feet on the east, south, and west sidewalls, and at a depth of 2 feet bgs on the north sidewall. A bottom sample was collected from the middle of the test pit at a depth of 4 feet bgs. A map of the Test Pit showing the sample locations is presented on Figure 8 in Appendix A. A cross-section of the test pit is presented on Figure 9 in Appendix A.
