**PHASE I ENVIRONMENTAL SITE ASSESSMENT  
UNITED STATES POSTAL SERVICE**

**FORMER GENERAL MAIL FACILITY  
2445 3RD AVENUE SOUTH  
SEATTLE, WASHINGTON 98134**

**October 15, 1997**

RE: Final Phase I Environmental Site Assessment  
Former General Mail Facility  
Seattle, Washington

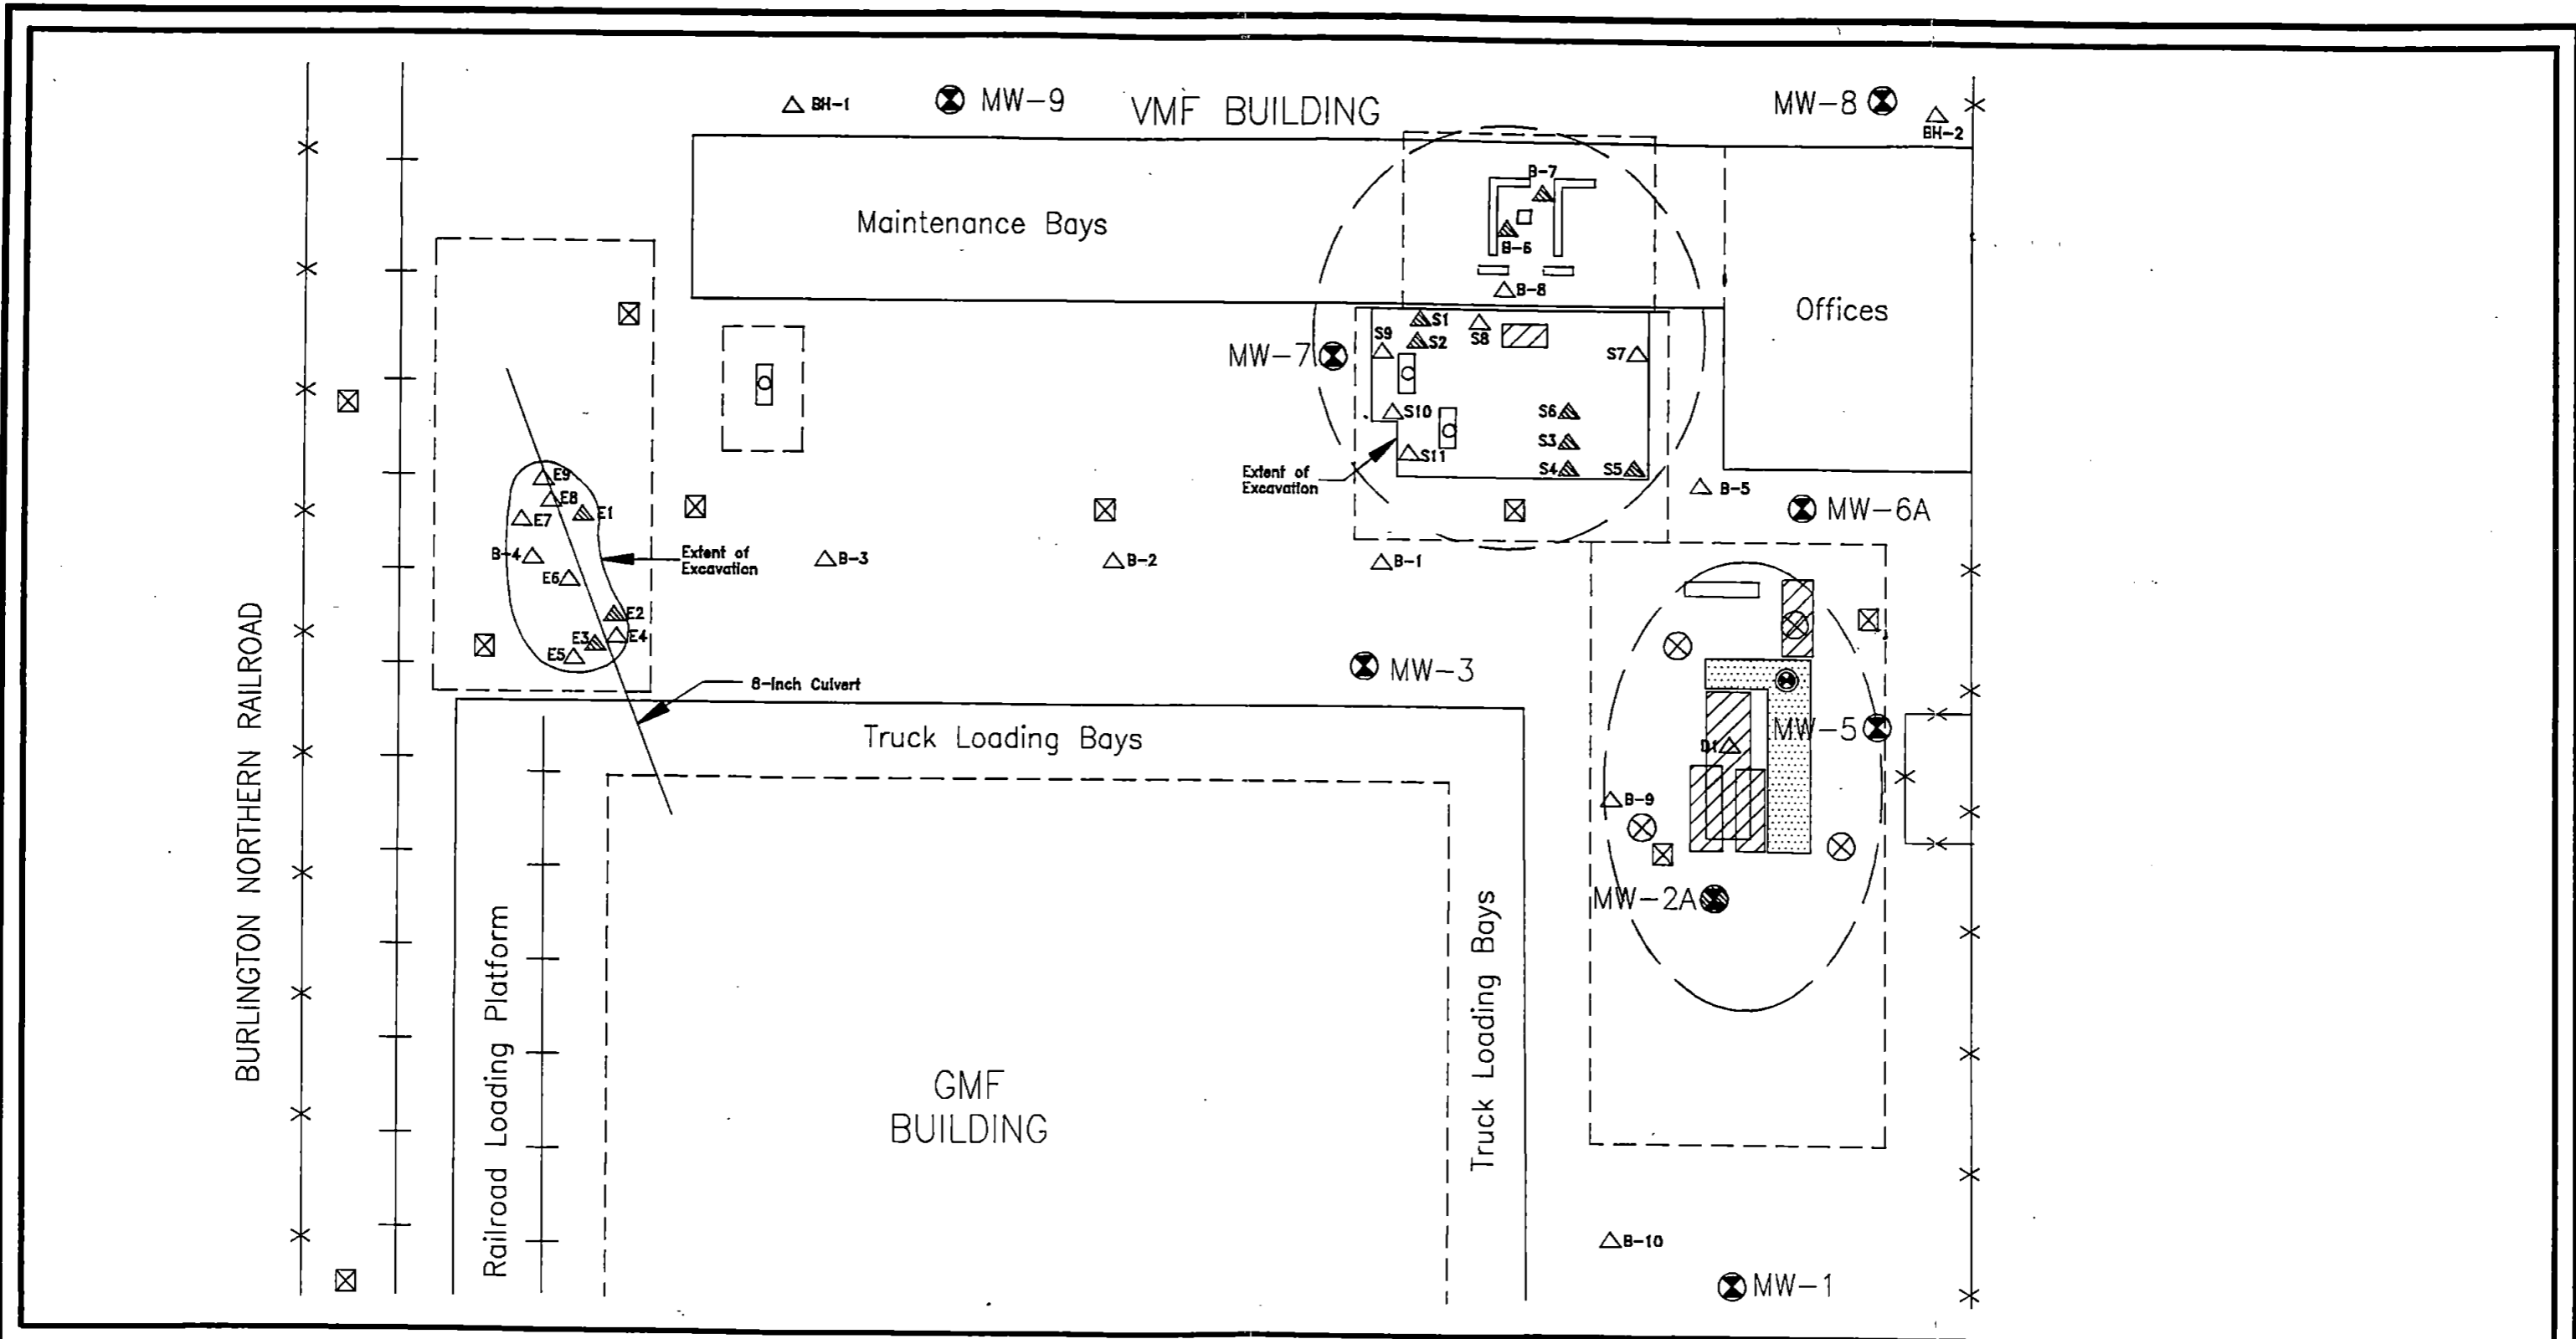
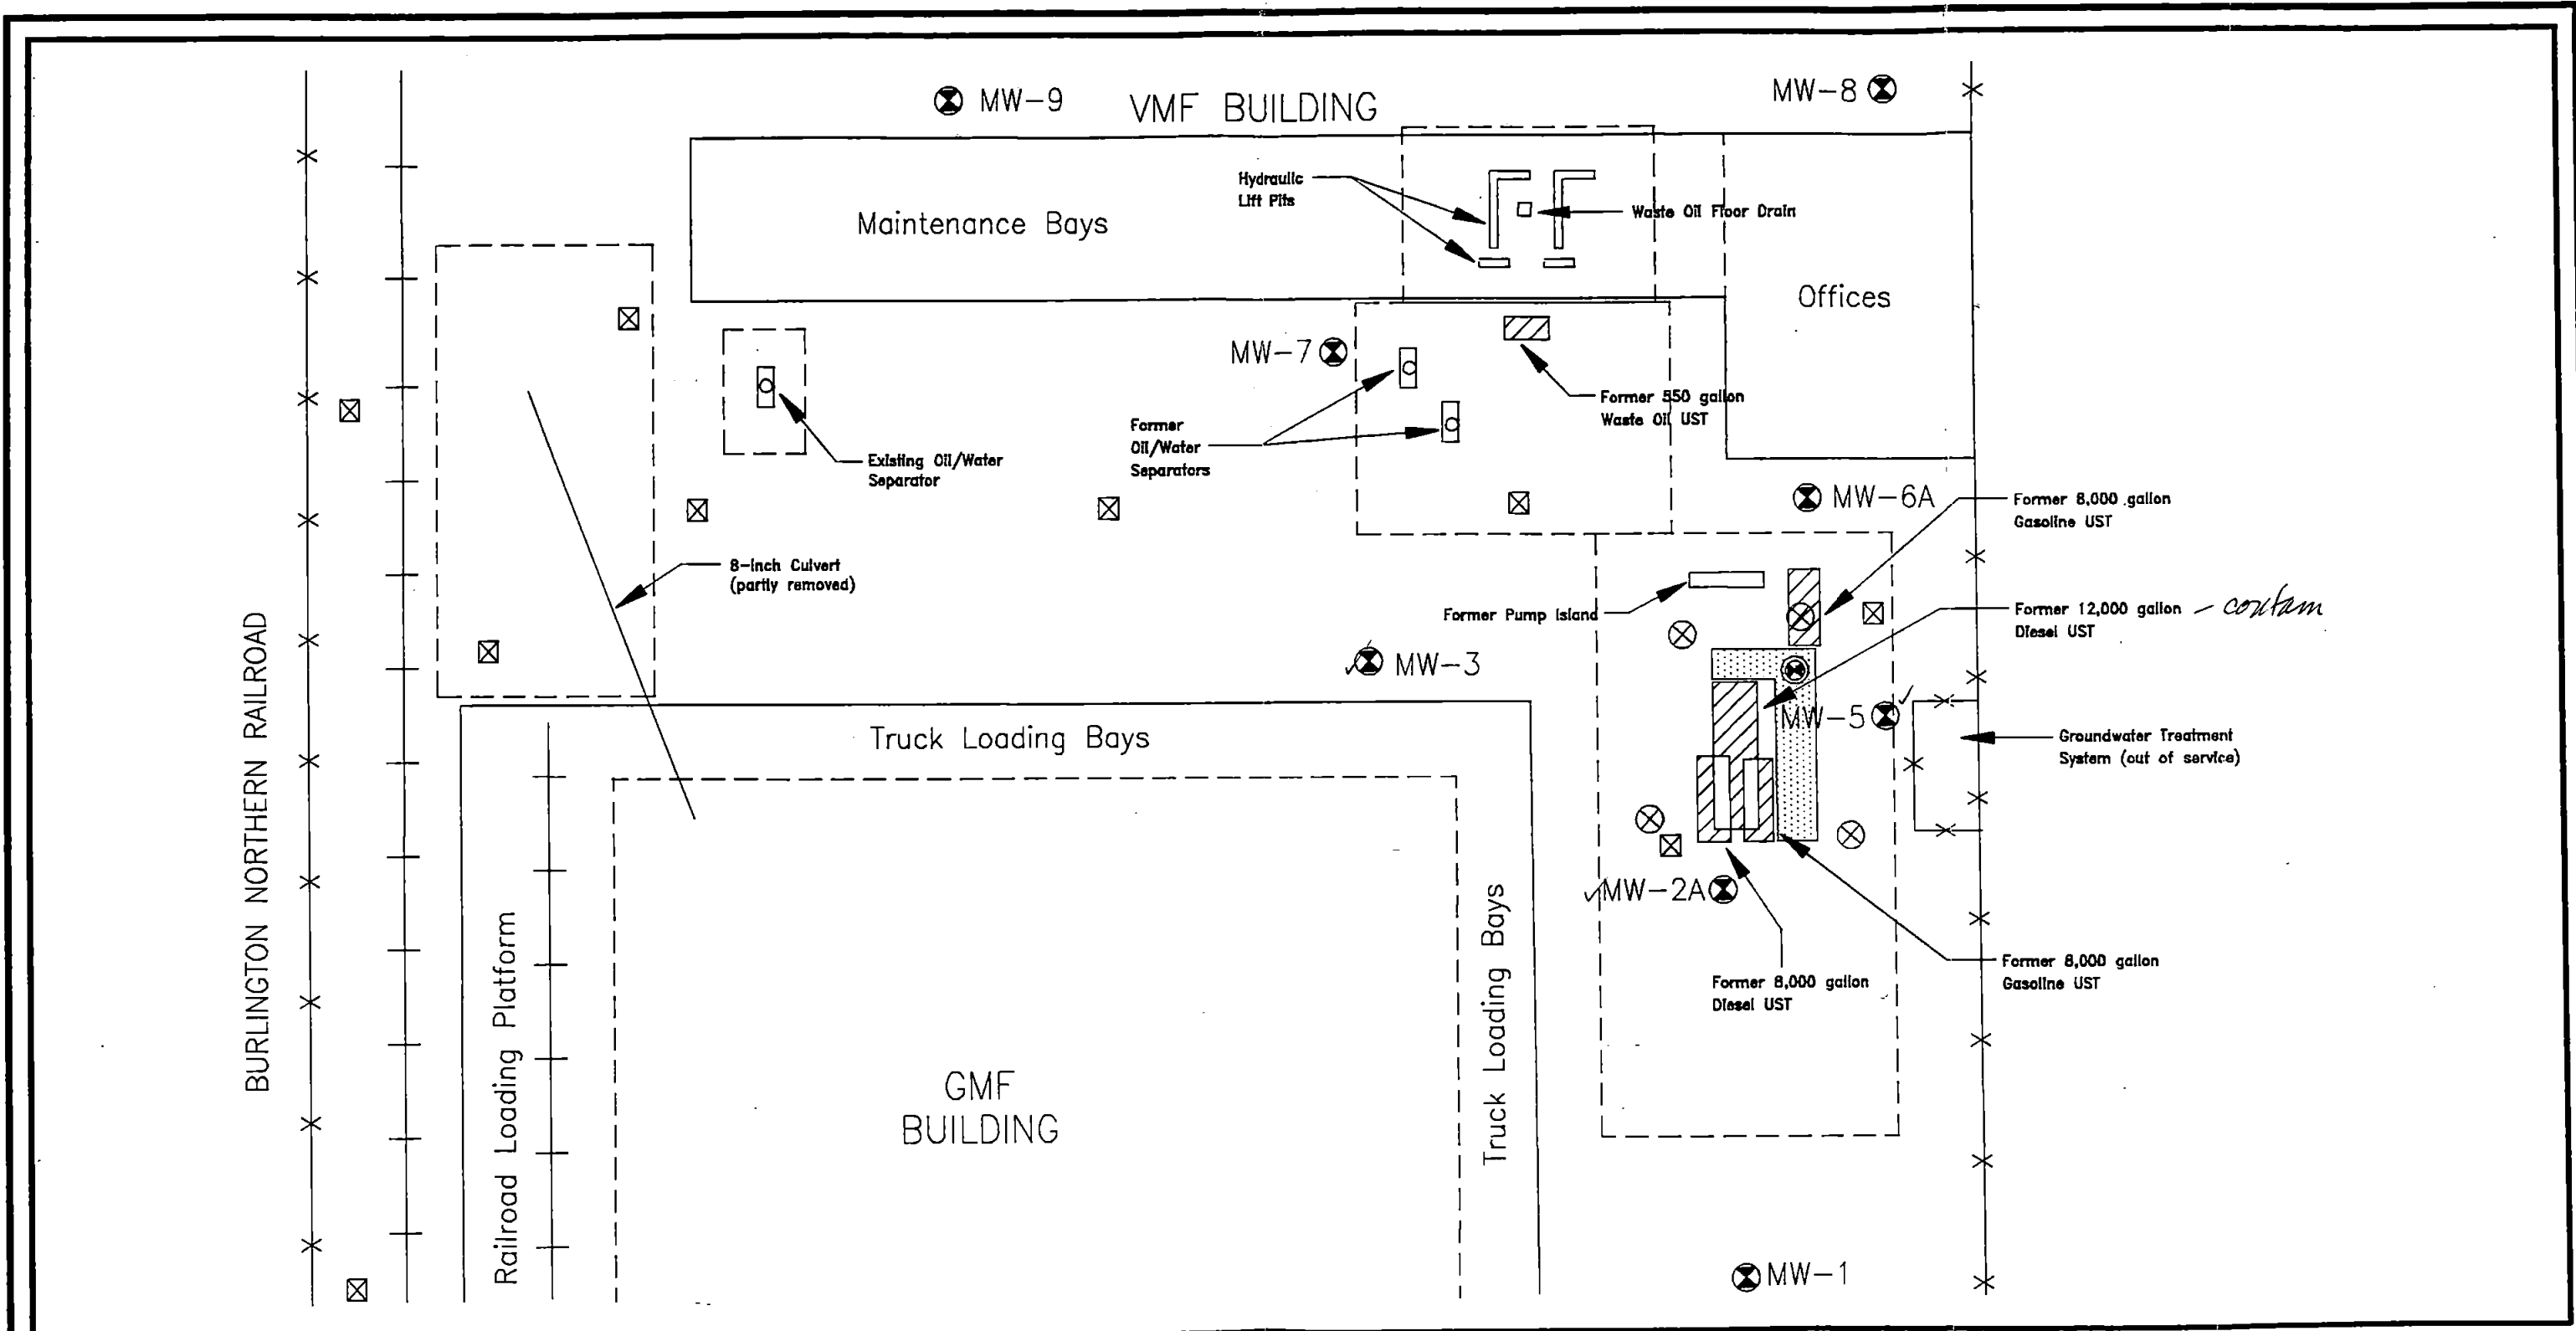
**Figure 4: Site Plan**

A southwestern 8,000-gallon diesel UST was located south of the fuel pump island, adjacent to the southeastern 8,000-gallon gasoline tank discussed above (see Figure 4). This tank was installed at an unknown date and was constructed of single-walled steel. The tank was discovered to be leaking by USPS personnel based on fuel inventory measurements in January 1984 (PEMCO 1995). The tank capacity was measured at a reduced 6,000 gallons and was determined to have been leaking fuel at an average rate of 100 gallons per month. In April 1987, USPS personnel determined that the tank was leaking at a rate of 200 gallons per month. WDOE was notified of the diesel releases at this time. The tank was removed in 1988 along with the two 8,000-gallon gasoline USTs by Crowley Environmental (PEMCO 1995). No closure report for the tank removals was located.

There are two below-grade hydraulic lift pits located in adjacent maintenance bays 2 and 3. Each pit consists of two separate vaults, an east-west rear piston vault, and a north-south, L-shaped front piston vault (see Figure 4). The vaults are approximately 8 feet deep. During the site visit, ICF KE inspected the vaults. They are constructed of concrete that appears to be in good condition. The rear piston vaults have metal siding over the concrete on the sides of the vault. The pistons and other operable hardware have been removed from all four vaults. Less than a foot of water/oil/sludge was observed in the bottoms of the vaults.

There is an existing oil/water separator located south of the western end of the VMF building (see Figure 4). It consists of the area surrounding an existing oil/water separator. It is not known when this separator was installed. The unit looks fairly new and ICF KE observed newer asphalt installed around the separator and over what is assumed to be incoming and outgoing piping. The separator may have been installed in 1994 to replace the two oil/water separators removed at that time. The location of the new asphalt suggests that the long floor drain in the vehicle washing bay, as well as the storm water drain near the southwest corner of the VMF building, drain to the oil/water separator which then discharges water southward presumably to the stormwater or sanitary sewer system that runs along the north side of the GMF building. It is unlikely that there is contaminated soil or ground water near the existing oil/water separator.

During railroad spur rebuilding work in 1993, an abandoned 8-inch steel culvert containing black sludge was uncovered in an excavation. Laboratory analysis of a sample of the sludge gave results of 2,100 ppm TPH-D but non-detect for PCBs. Laboratory analysis of two samples of soil removed from the excavation showed levels of TPH at 340 ppm, above MTCA cleanup levels, and PCBs at a maximum of 634 ppb, below the MTCA residential soil cleanup level. Above-ground tracing of the culvert indicated that it ran north/northwest-south/southeast approximately 40 feet to the south and 20 feet to the north (Figure 4). At that time, the excavation was backfilled.
