Department of Ecology

Injection Pilot Test Results and Effects

June 2, 2021

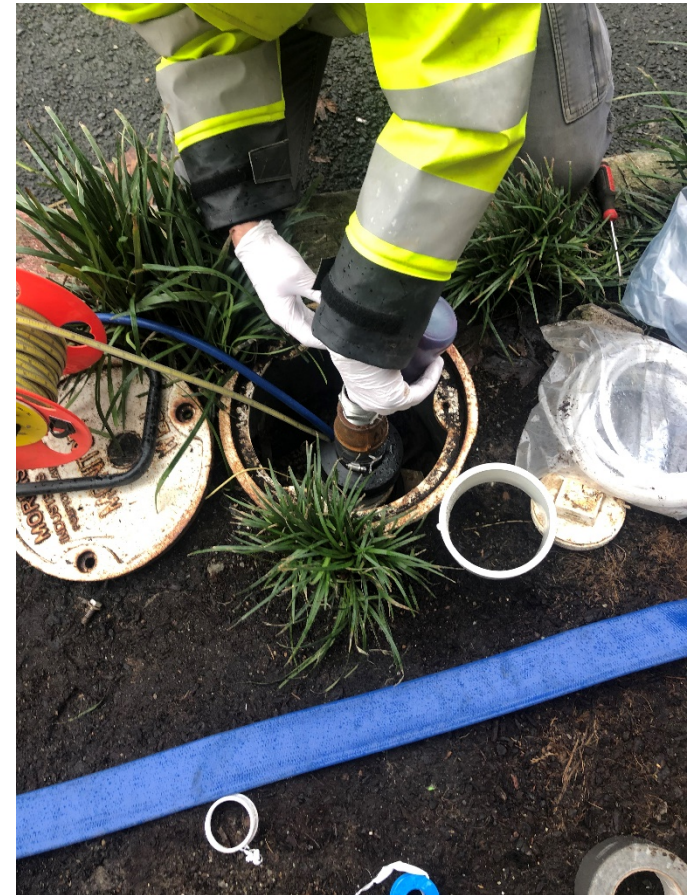
- January 5-12, 2021 active injections
- Dec. 29, 2020 to Feb. 9, 2021: sump monitoring
- Scope:
 - Approx. 1100 gal. of clean water was gravity fed to each well: RW03, RW04, RW05
 - Unique, conservative, fluorescent, nonreactive tracer dye applied as a slug ahead of water in each well
 - Packer placed in the well to concentrate injection in the upper 5 feet of saturated screen
 - Whittaker building stormwater sump monitored for fluorescence
 - Injected at 2-3 gpm

- Tracer dye from RW05 detected in the sump approx. 48 hours after completing the injection
- Tracer dye from RW05 still present in the sump 28 days after completing the injection

Conclusion: Short circuiting pathway exists between the well network and the Whittaker storm drainage system, which could introduce oxidant to the stormwater system during an ISCO injection program.

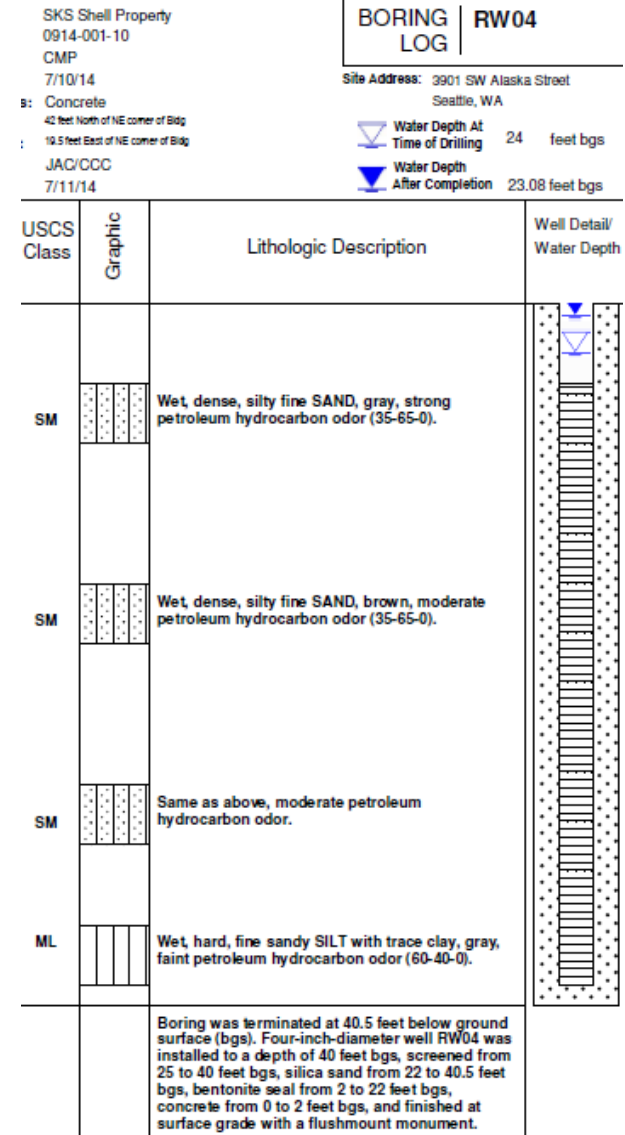
- Groundwater dewatering/extraction was intended as part of the remediation approach
- RW01 through RW09 originally installed as extraction wells
- Target extraction rate from each wells was 0.5 gpm for a total system dewatering of 4.5 gpm (SES, Cleanup Action Plan, 2014)
- Dewatering of the Site was completed 3/2015 through 6/2017 (SES, Cleanup Action Report, 2017)
- Based on calculations made in the Cleanup Action Report, 4 gallons of dissolved phase gasoline and 0.18 gallons of benzene was removed in a total of over 135,000 gallons of water removed

- 2014: RW03 through RW09 installed
- 2015: Groundwater extraction occurs during Site redevelopment; RW06 through RW09 altered during construction
- 2016: Compliance groundwater monitoring begins using RW03
- 2017: Compliance groundwater monitoring begins using RW04 and RW05. Ecology deems RW06 through RW09 out of compliance
- Jan. 2021: Injection pilot test completed on wells RW03, RW04, and RW05
- Mar 2021: Q1 compliance groundwater monitoring occurs

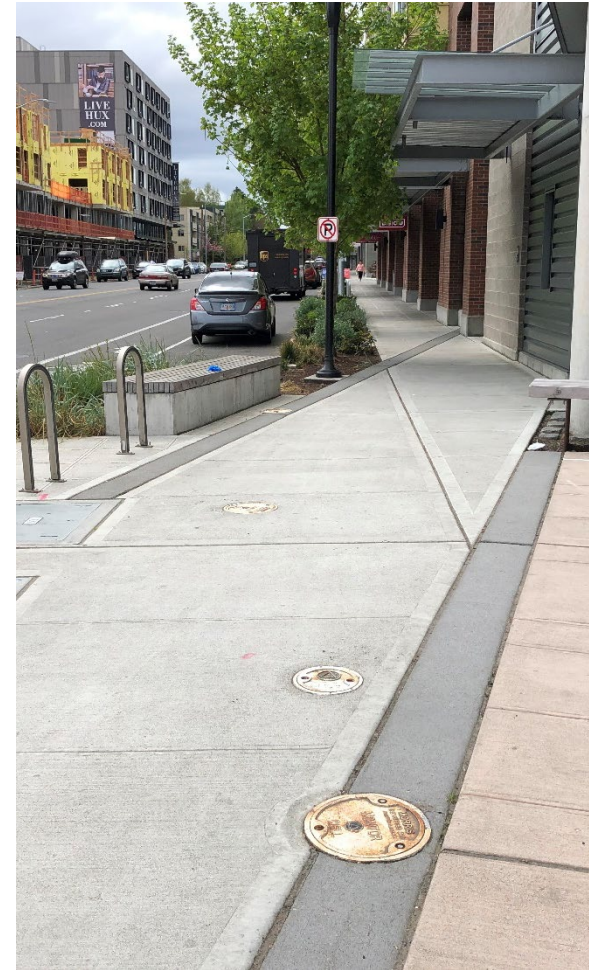
- Pilot test was useful in establishing that the well network is not suitable for ISCO injections without short-circuiting to storm system beneath the building
- Q1 2021 hydrocarbon detections in RW wells are abnormal - likely due to interference possibly from historic rind in RW wells, or a substance washed into the wells from the casing, or interaction of dye in the subsurface.
- RW wells are not constructed for use as groundwater monitoring wells and should be discontinued as such. These wells were used to remove large volumes of contaminated groundwater from the excavation and may contain residual degraded organics and hydrocarbons – not representative of surrounding groundwater.

- Decommission remaining RW extraction wells
- Install proper compliance well in Fauntleroy Way
- Evaluate results after two quarters:
 - Targeted injections via probes?
 - Adjust monitoring frequency?
