STATE OF WASHINGTON
DEPARTMENT OF ECOLOGY

Re: Opinion pursuant to WAC 173-340-515(5) on Remedial Action for a Property associated with a Site:

- **Property Address:** 23418 Pacific Highway South, Kent, Washington 98032
- **Site Name:** Southgate Oil – Muscatel Midway
- **Facility/Site No.:** 84946863
- **Cleanup Site ID:** 6762
- **VCP Project No.:** NW3309

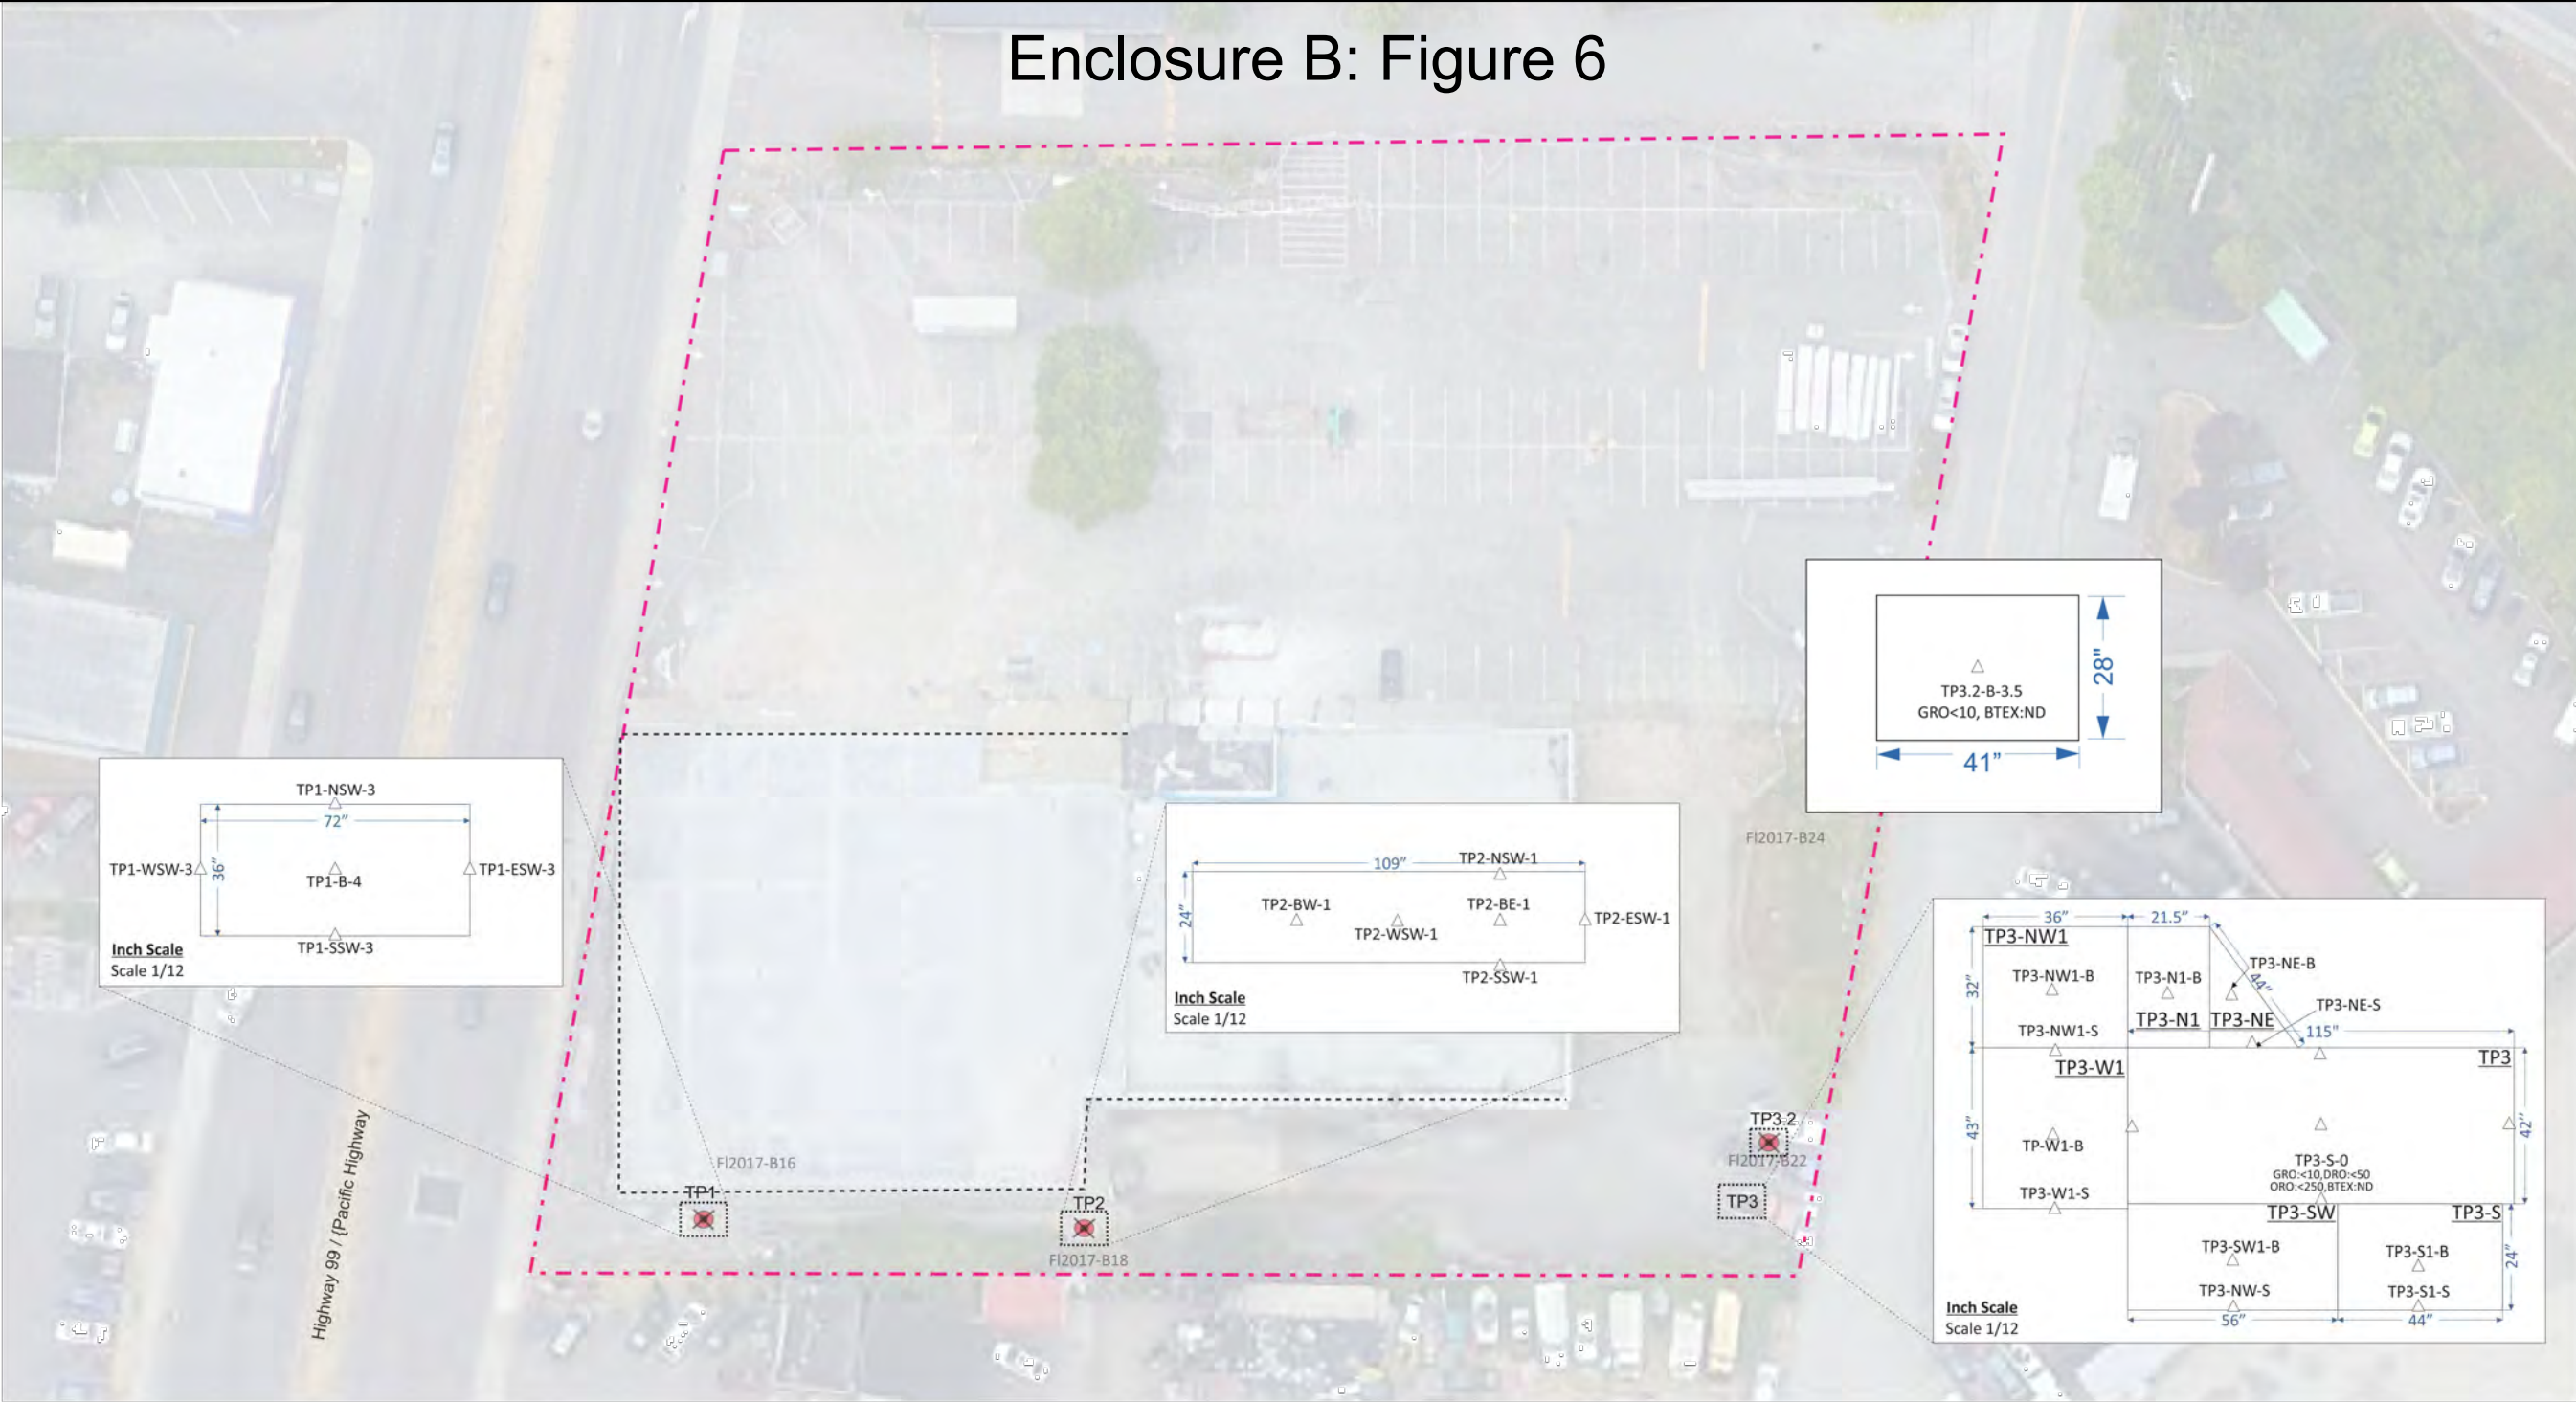
Enclosure B: Figure 6

- In February 2019, four test pits were excavated along the southern and eastern Property boundary. Test Pit 1 was excavated at the soil boring FL207-B16 location, measuring approximately 6 feet by 3 feet, and 4 feet deep. Test Pit 2 was excavated at soil boring FL207-B18 location, measuring approximately 9 feet by 2 feet, and 1.5 feet deep. Test Pit 3 and 3.2 were excavated at or near soil boring FL207-B22. Test pit 3 was measured approximately 12.6 feet by 8.3 feet, and 4 feet deep; Test Pit 3.2 was measured approximately 3.4 feet by 2.3 feet, and 3.5 feet deep. The test pit limits and sampling locations are depicted on **Figure 6**.

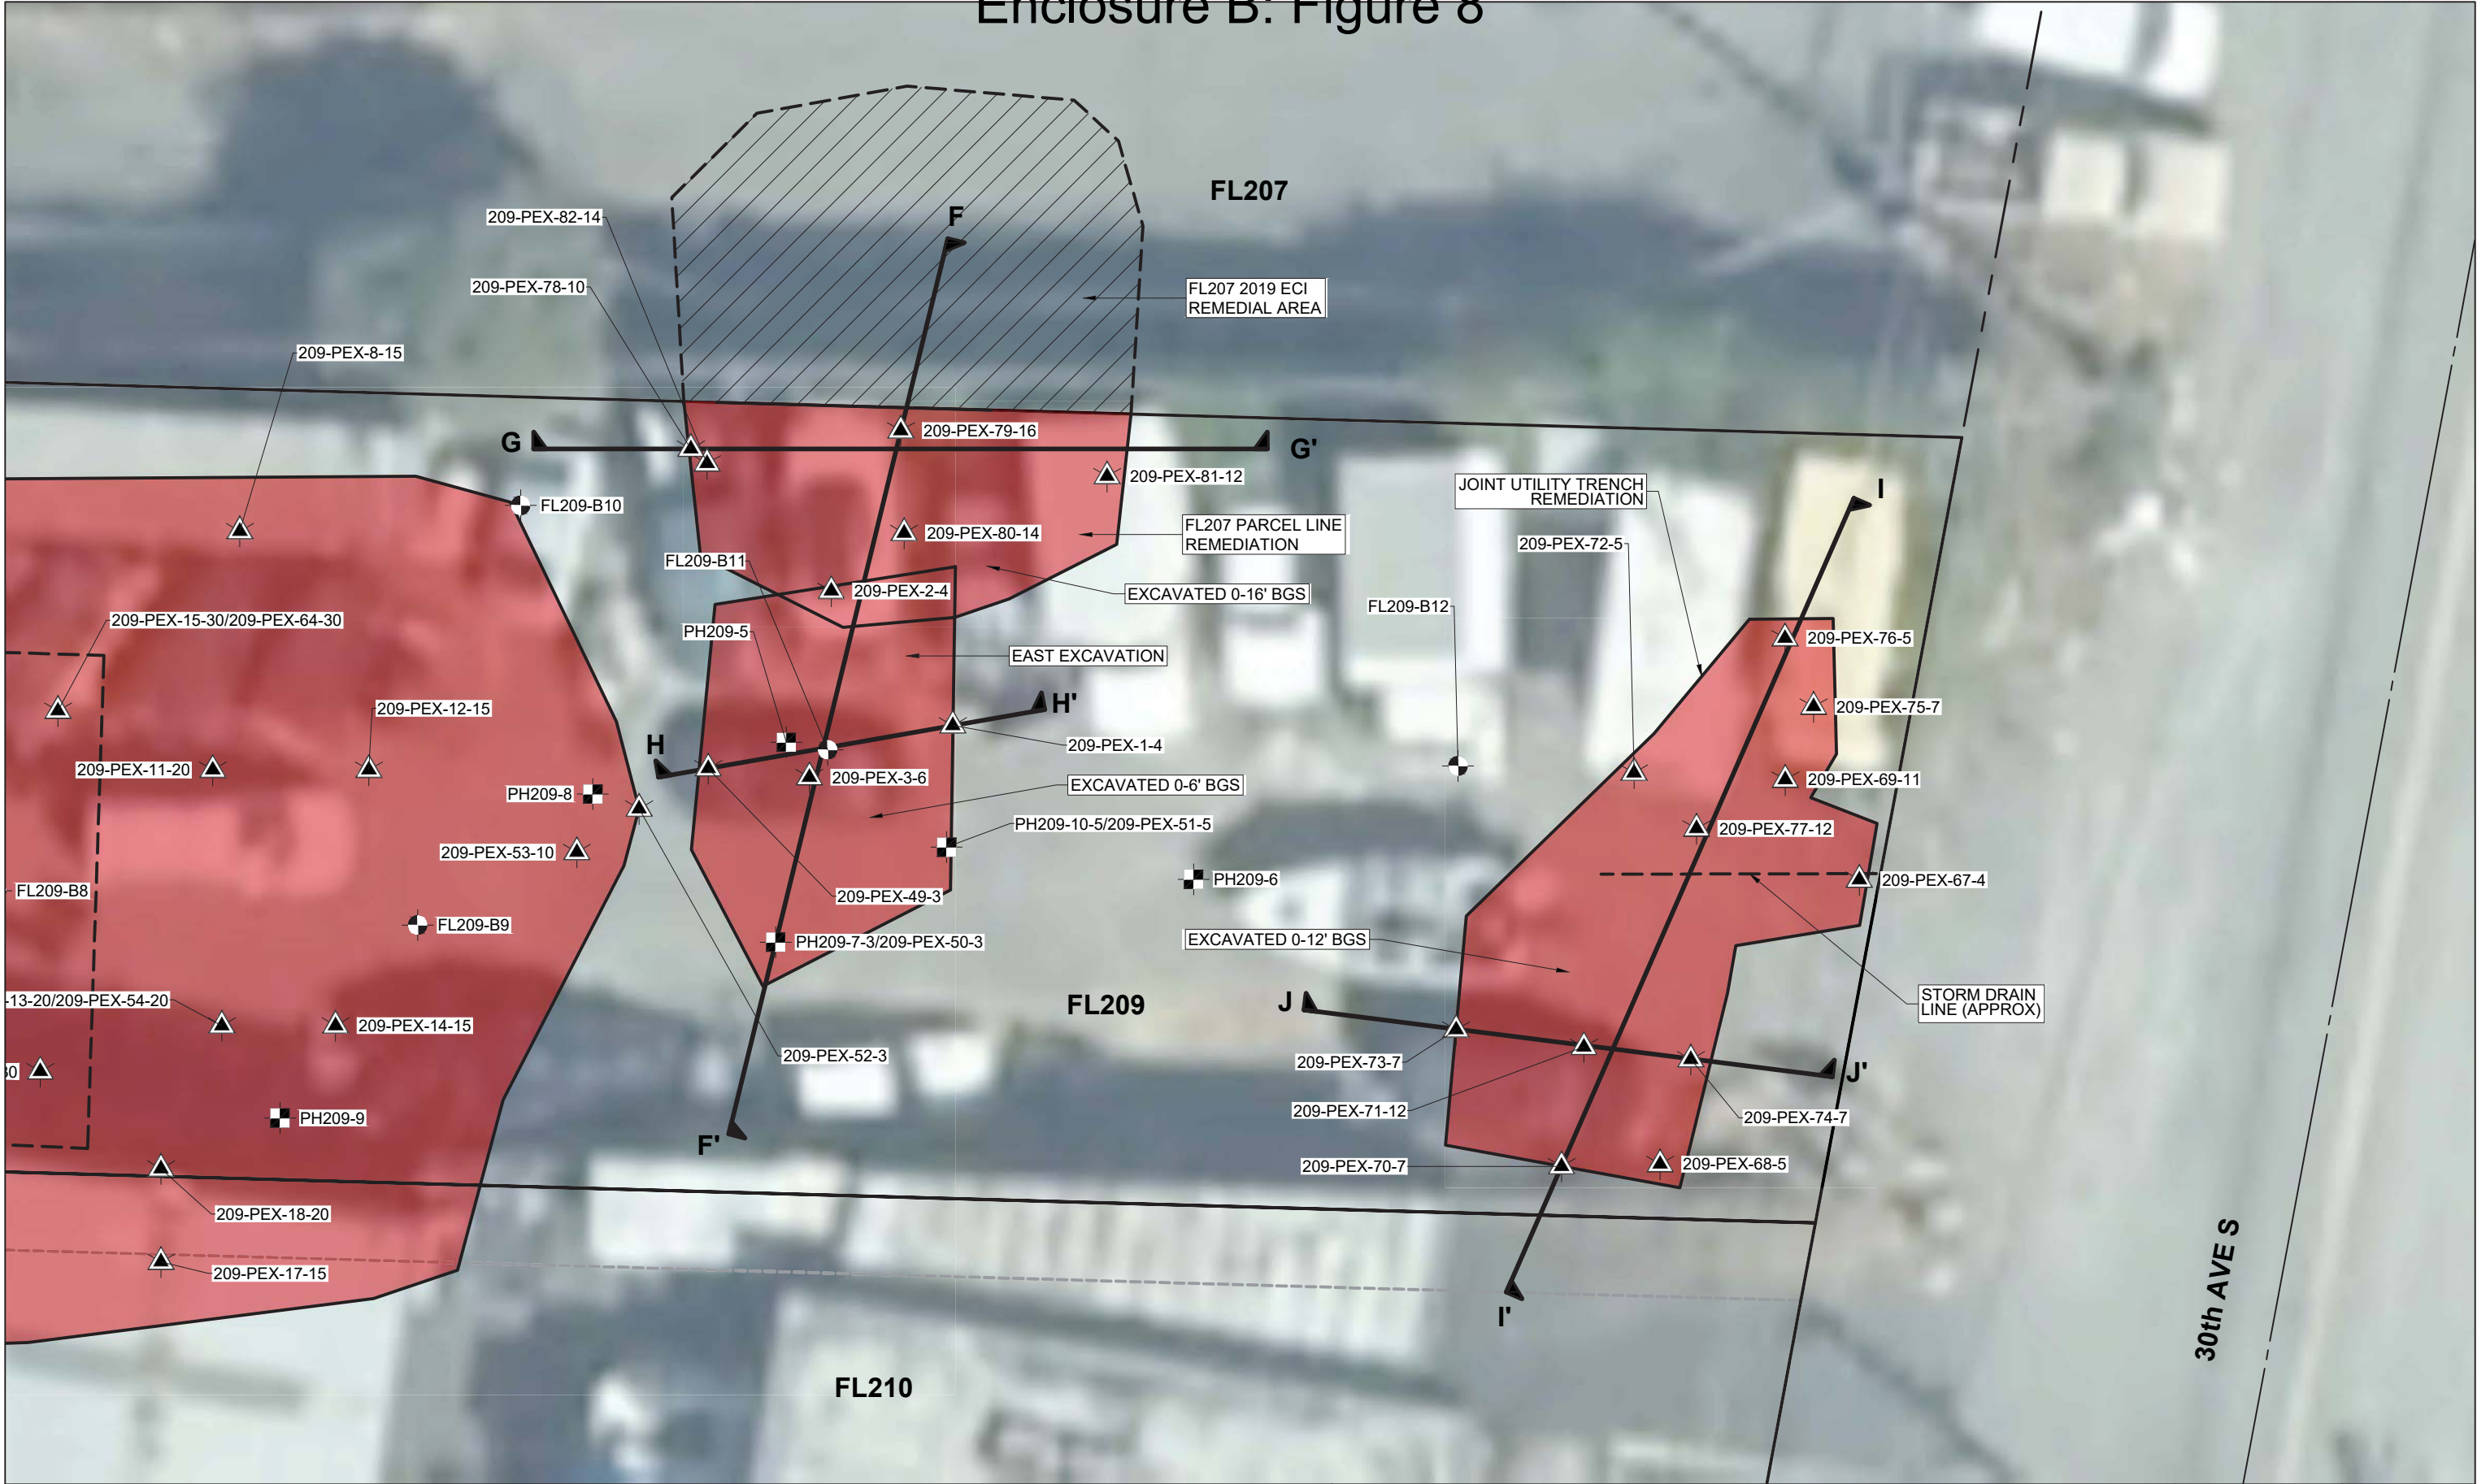
Enclosure B: Figure 8

Five soil samples (209-PEX-78-10, 209-PEX-80-14, 209-PEX-81-12, 209-PEX-82-14, and 209-PEX-79-16) were collected between 10 and 16 feet bgs (relative to the ground surface of south property) from the final excavation limits. All soil samples contained TPHg, TPHd, TPHo, and BTEX concentrations below the MTCA Method A soil cleanup levels. The excavation limits and the soil sampling locations are depicted on **Figure 8 and 9**.
