## Outfall Verification Report

**Location:** East, West, and Upper Duwamish Waterway  
**Report Date:** 9/12/2007  
**Inspection Date:** 6/13/2007 & 6/14/2007  
**Present:** Matt Eyer, Phoinix Corporation  
Edwin Wong, Phoinix Corporation  
Tim Fitzgerald, Port of Seattle Contractor

**Purpose:** To locate and verify outfall locations from the Port of Seattle properties into the Duwamish, focusing on the East, West, and Upper Duwamish waterway. Also to confirm and obtain outfall pipe sizes, material, photos, and location.

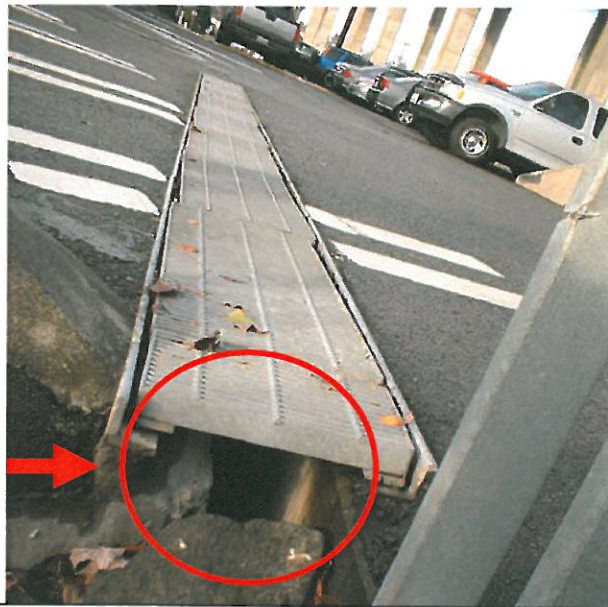
November 10, 2006 - Photo 100-0002  
 Looking west at trench drain and outfall # T102\_Outfall\_01.

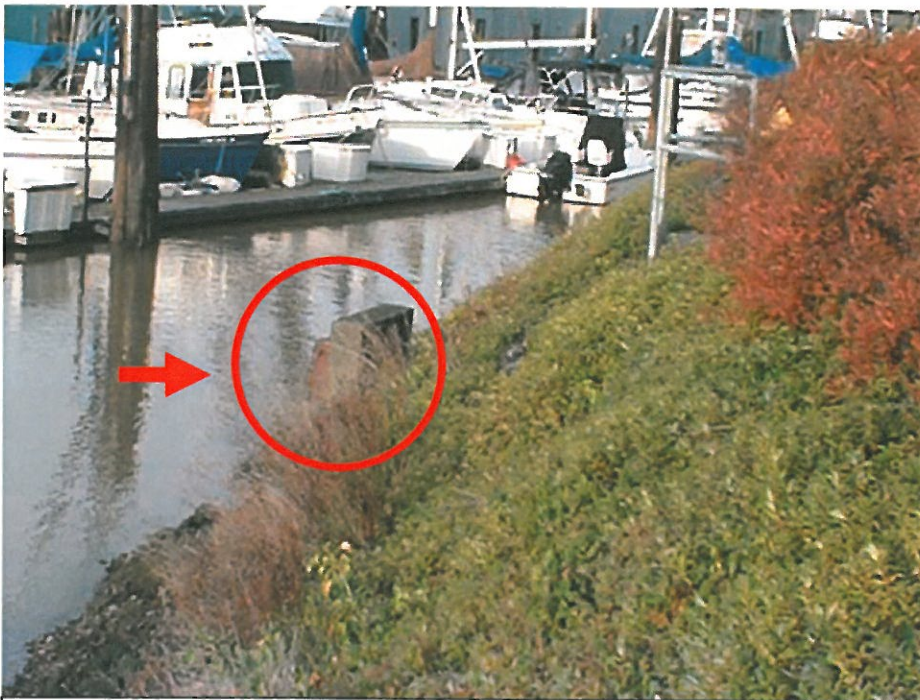
November 10, 2006 - Photo 100-0005  
Looking west at outfall # T102\_Outfall\_04.

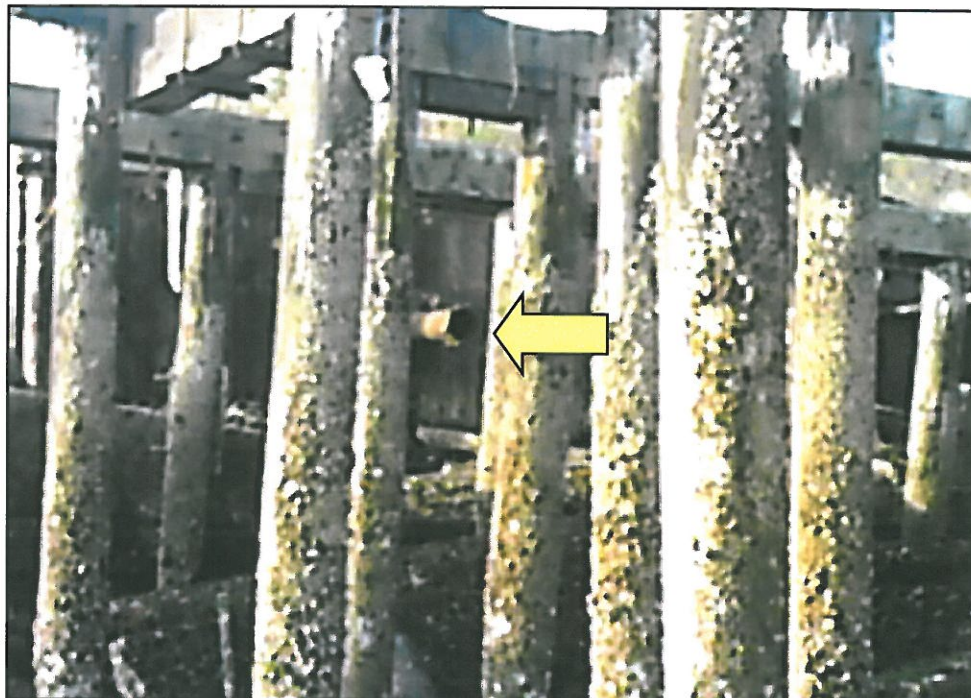
October 4, 2006 – Photo 100-0023  
Looking south at outfall # T5\_Outfall\_02.

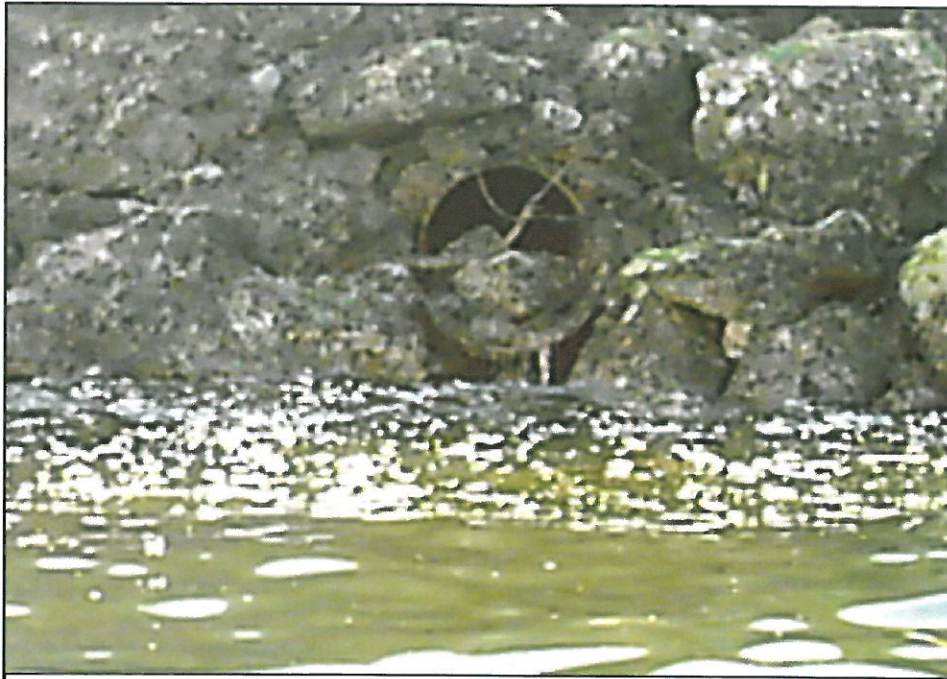
October 4, 2006 – Photo 100-0020  
Looking south at outfall # T5\_Outfall\_03.

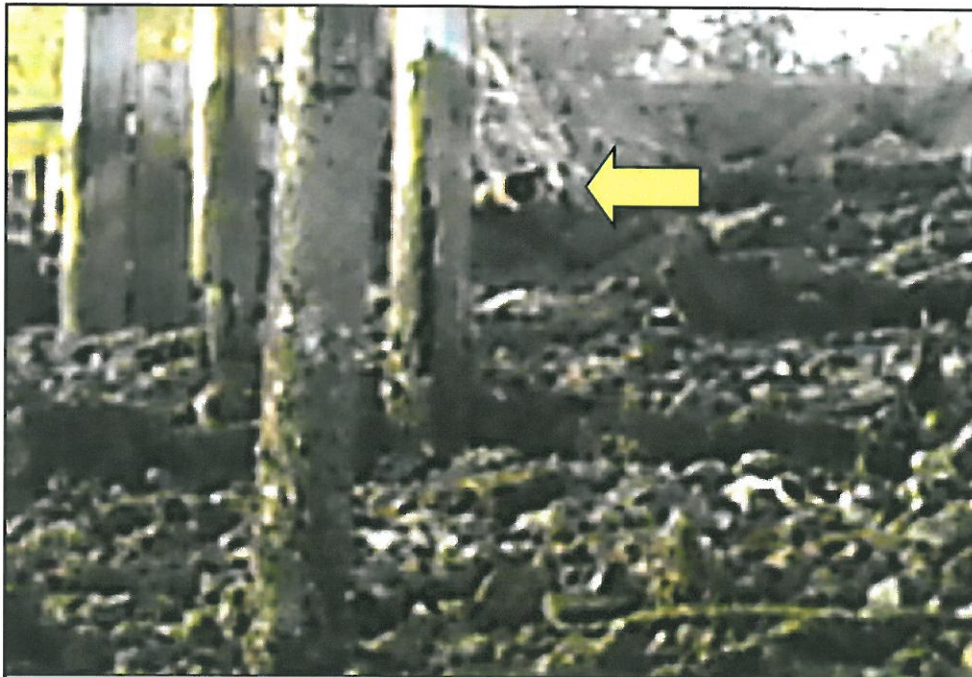
October 4, 2006 – Photo 100-0027  
Looking southwest at outfall # T5\_Outfall\_05.

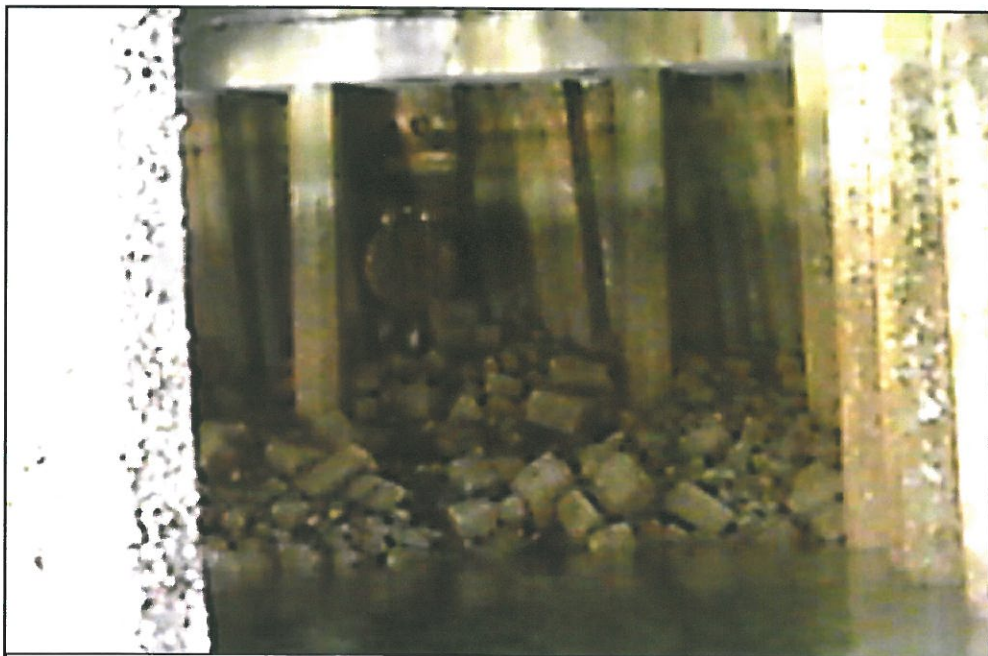
October 4, 2006 – Photo 100-0044  
Looking west at outfall # T5\_Outfall\_13.

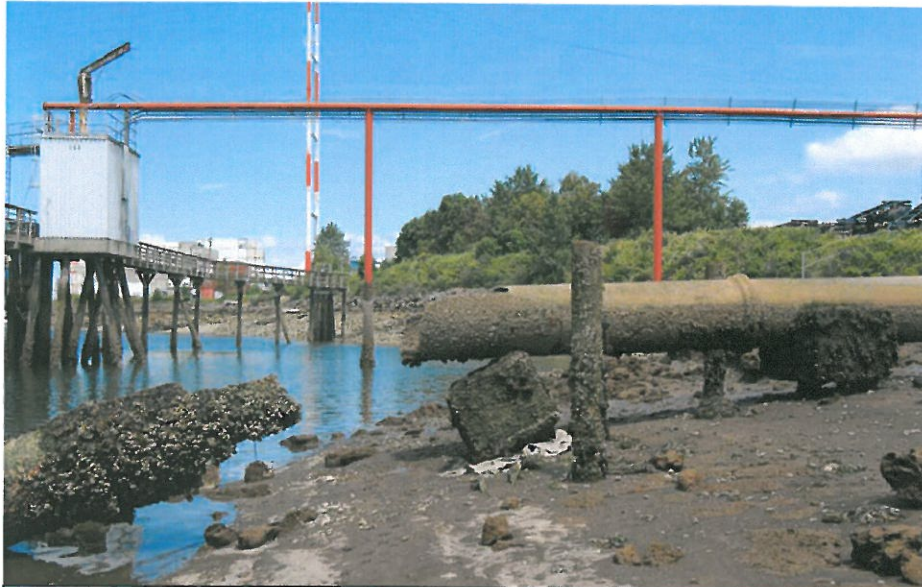
June 14, 2007 - Photo DSC-0060  
Looking northeast at outfall # T108\_Outfall\_01.

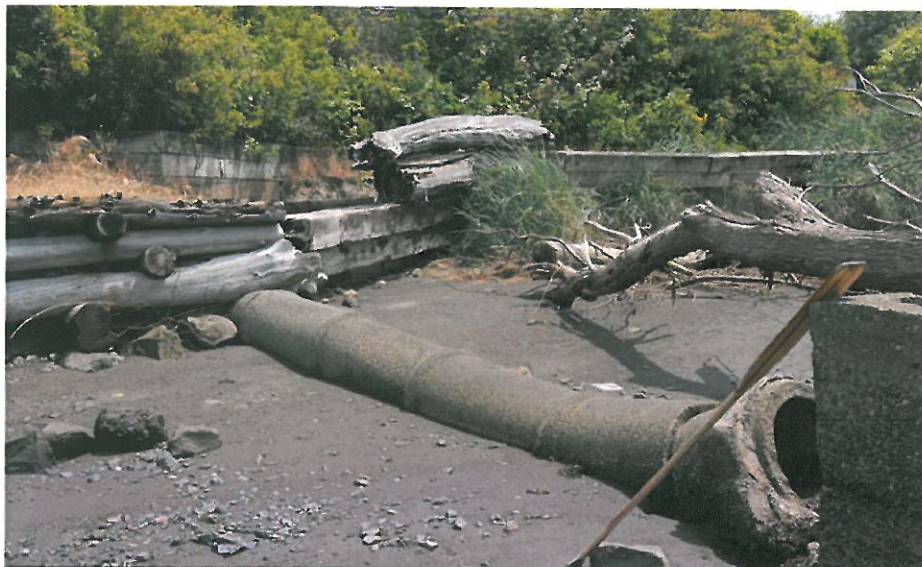
June 14, 2007 - Photo DSC-0058  
Looking east at outfall # T108\_Outfall\_02.

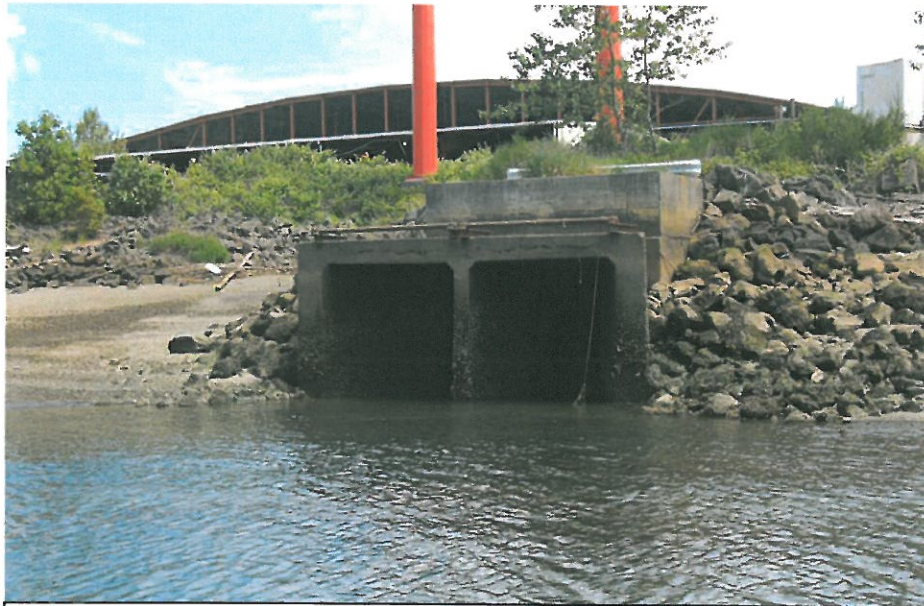
June 14, 2007 - Photo DSC-0063  
Looking east at outfall # T108\_Outfall\_03.

T108\_Outfall\_03:  
12 ft^2 x2 Concrete Open Box

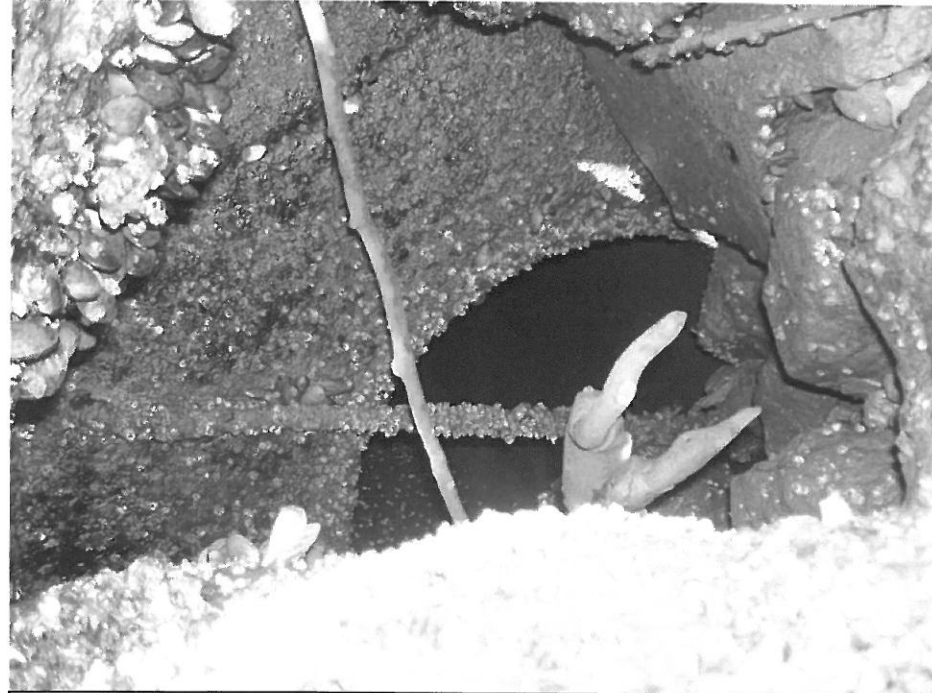
June 20, 2007 - Photo DSCF-0653  
Looking east at outfall # T106\_Outfall\_01.

T106\_Outfall\_01:  
12" Concrete Open  
Outfall is covered by rocks

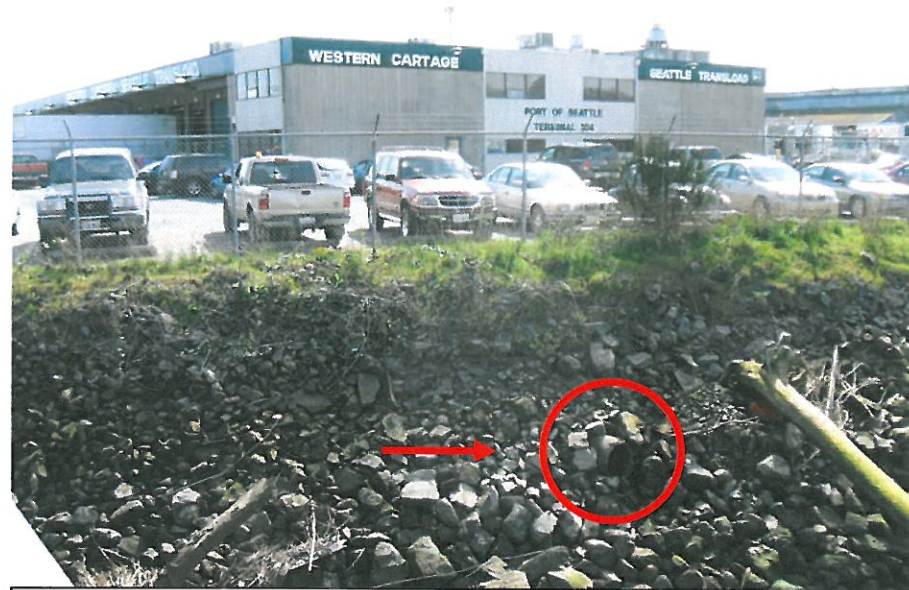
April 3, 2007 - Photo 100-0292  
 Looking east at outfall # T104\_Outfall\_01.

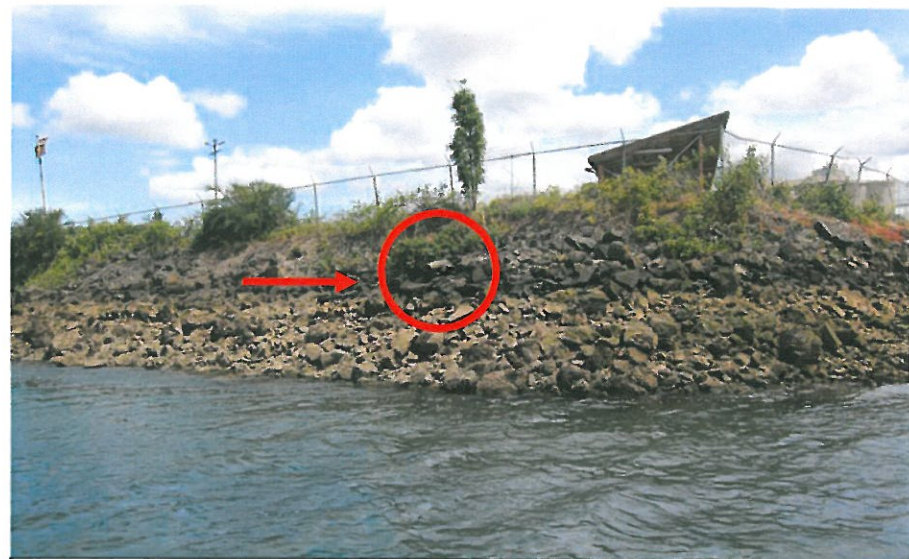
June 13, 2007 - Photo DSC-0105  
 Looking east at outfall # T104\_Outfall\_02.
