***Preliminary Environmental Site Evaluation and
Focused Pentachlorophenol Explorations
Merrill and Ring, Inc.
Port Angeles, Washington***

***Prepared for
Merrill and Ring, Inc.
and
Davis Wright & Jones***

June 28, 1988

J-2159-03

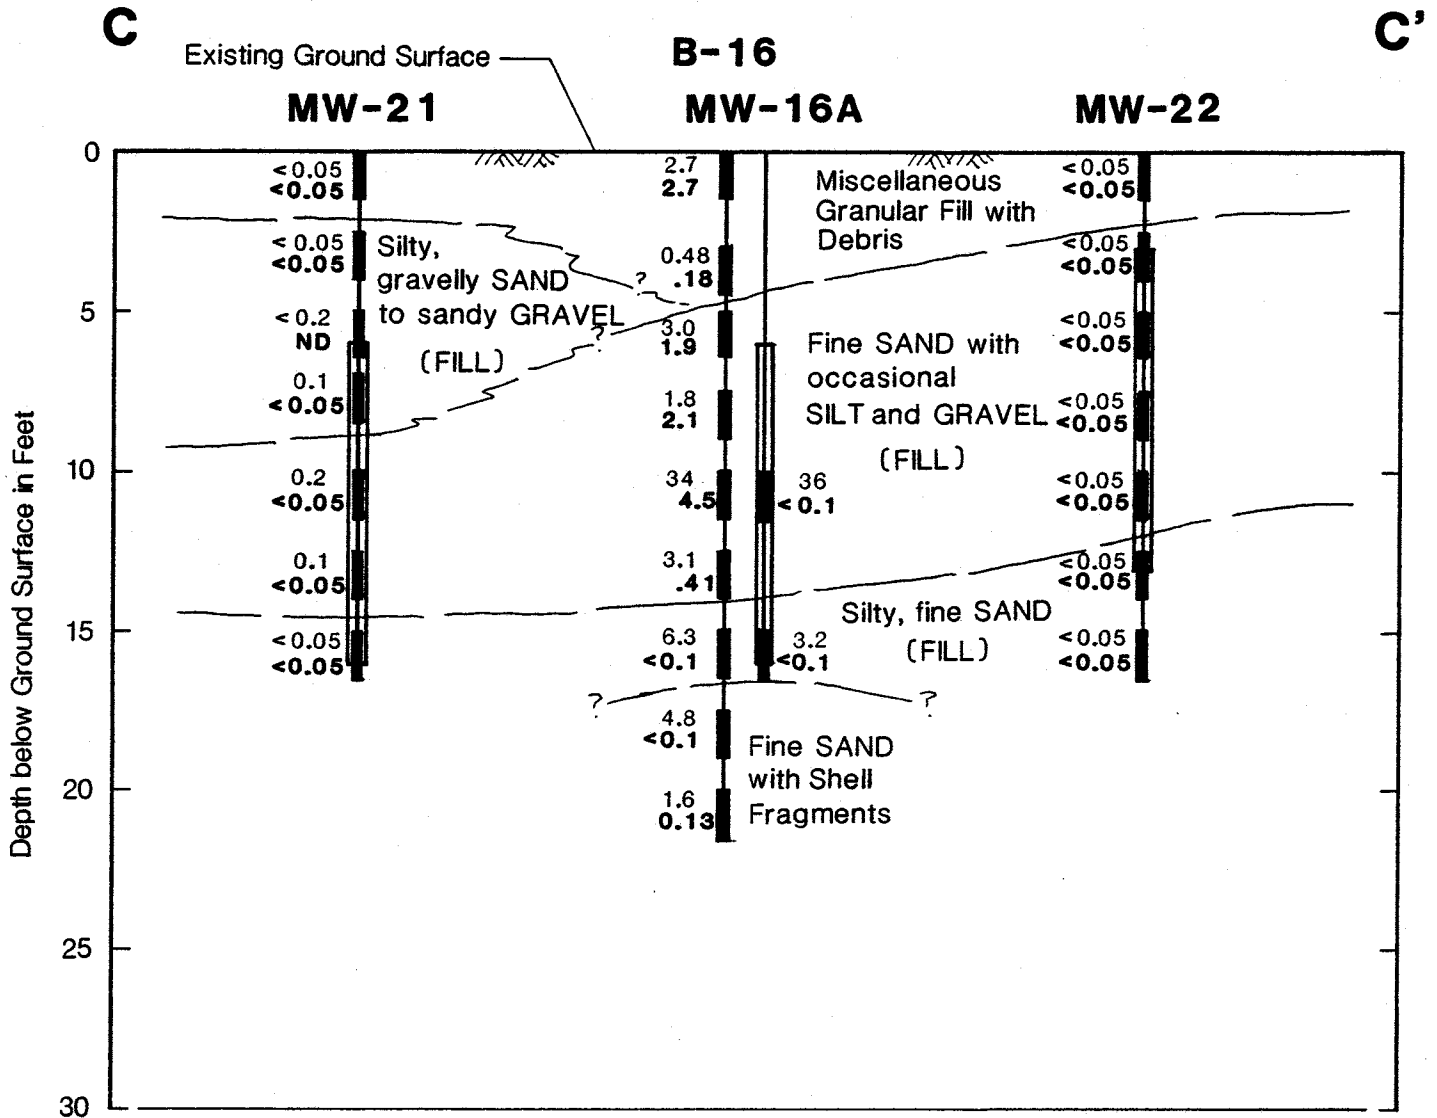
Generalized Subsurface Cross Section C-C'

Vertical extent of the soil contamination is at least to 25 feet as shown on Figures 11, 12, and 13. Note that soil in B-16 contained 1.6 mg/kg at its base. We therefore do not know the maximum vertical extent of soil contamination.

The highest values of pentachlorophenol were found in B-6 and B-16. These locations are directly downgradient of the suspected surface source. The maximum value of pentachlorophenol was found in a wood zone in B-16 between 10 and 15 feet below surface. Excess PCP is probably adsorbed to the wood in this zone.
