**Assessment of
PCB Contamination**

**Snoqualmie Falls
Plywood Plant
Fire Site**

**Weyerhaeuser
Cascade
Division**

MARCH 1989

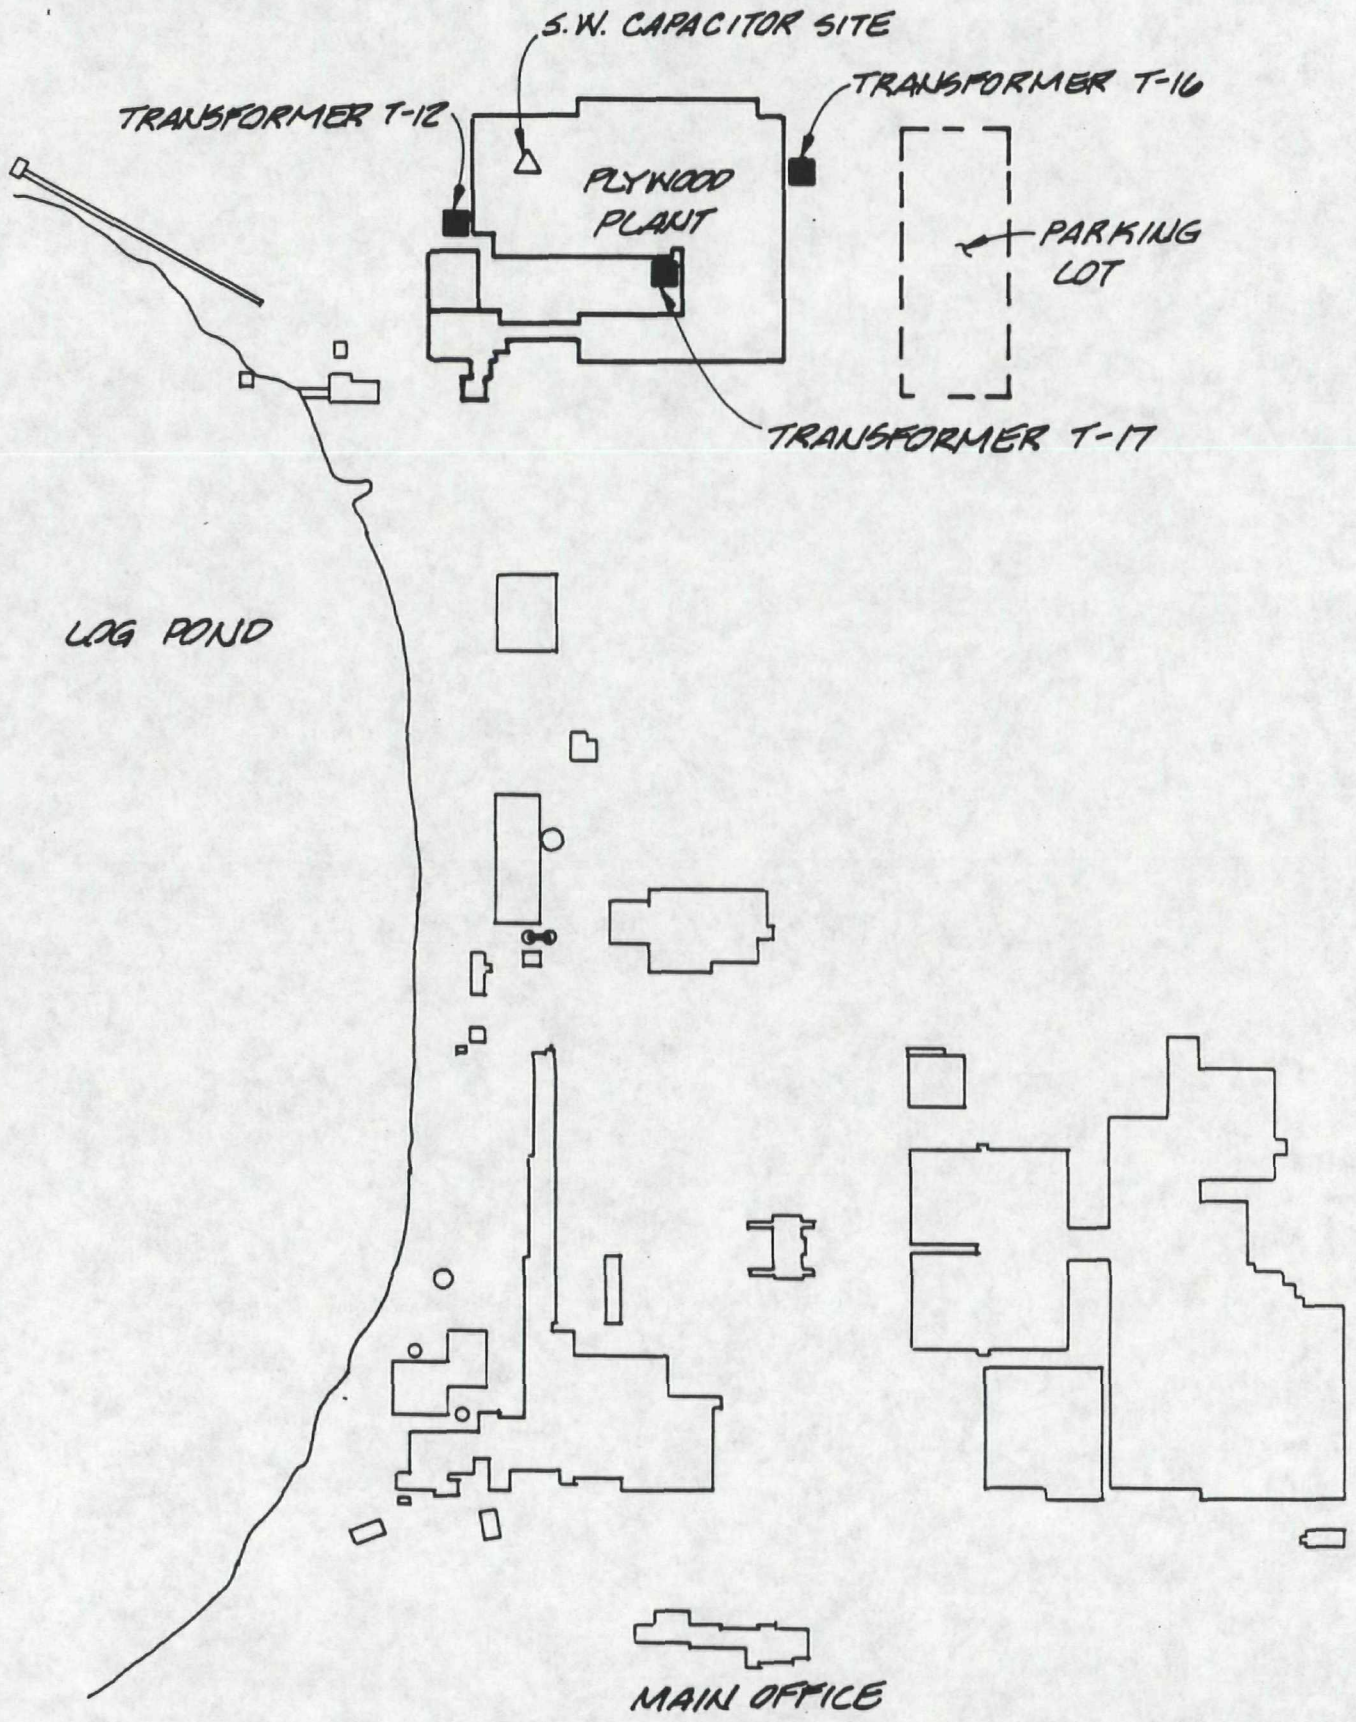
FIGURE 1.2

Figure 1.2 shows the locations of these units. Transformer T-16 did not release any dielectric fluids and was removed as a PCB inventory reduction measure. Wipe sampling was conducted on the concrete pad at T-16 to verify the absence of PCBs.

SITE MAP
