Summary Report – Environmental Construction Activities

**Sam's Club Store No. 4835
Renton, King County, Washington**

J-1470-10

Subject: Summary Report – Environmental Construction Activities
Sam's Club Store No. 4835
901 South Grady Way
Renton, King County, Washington

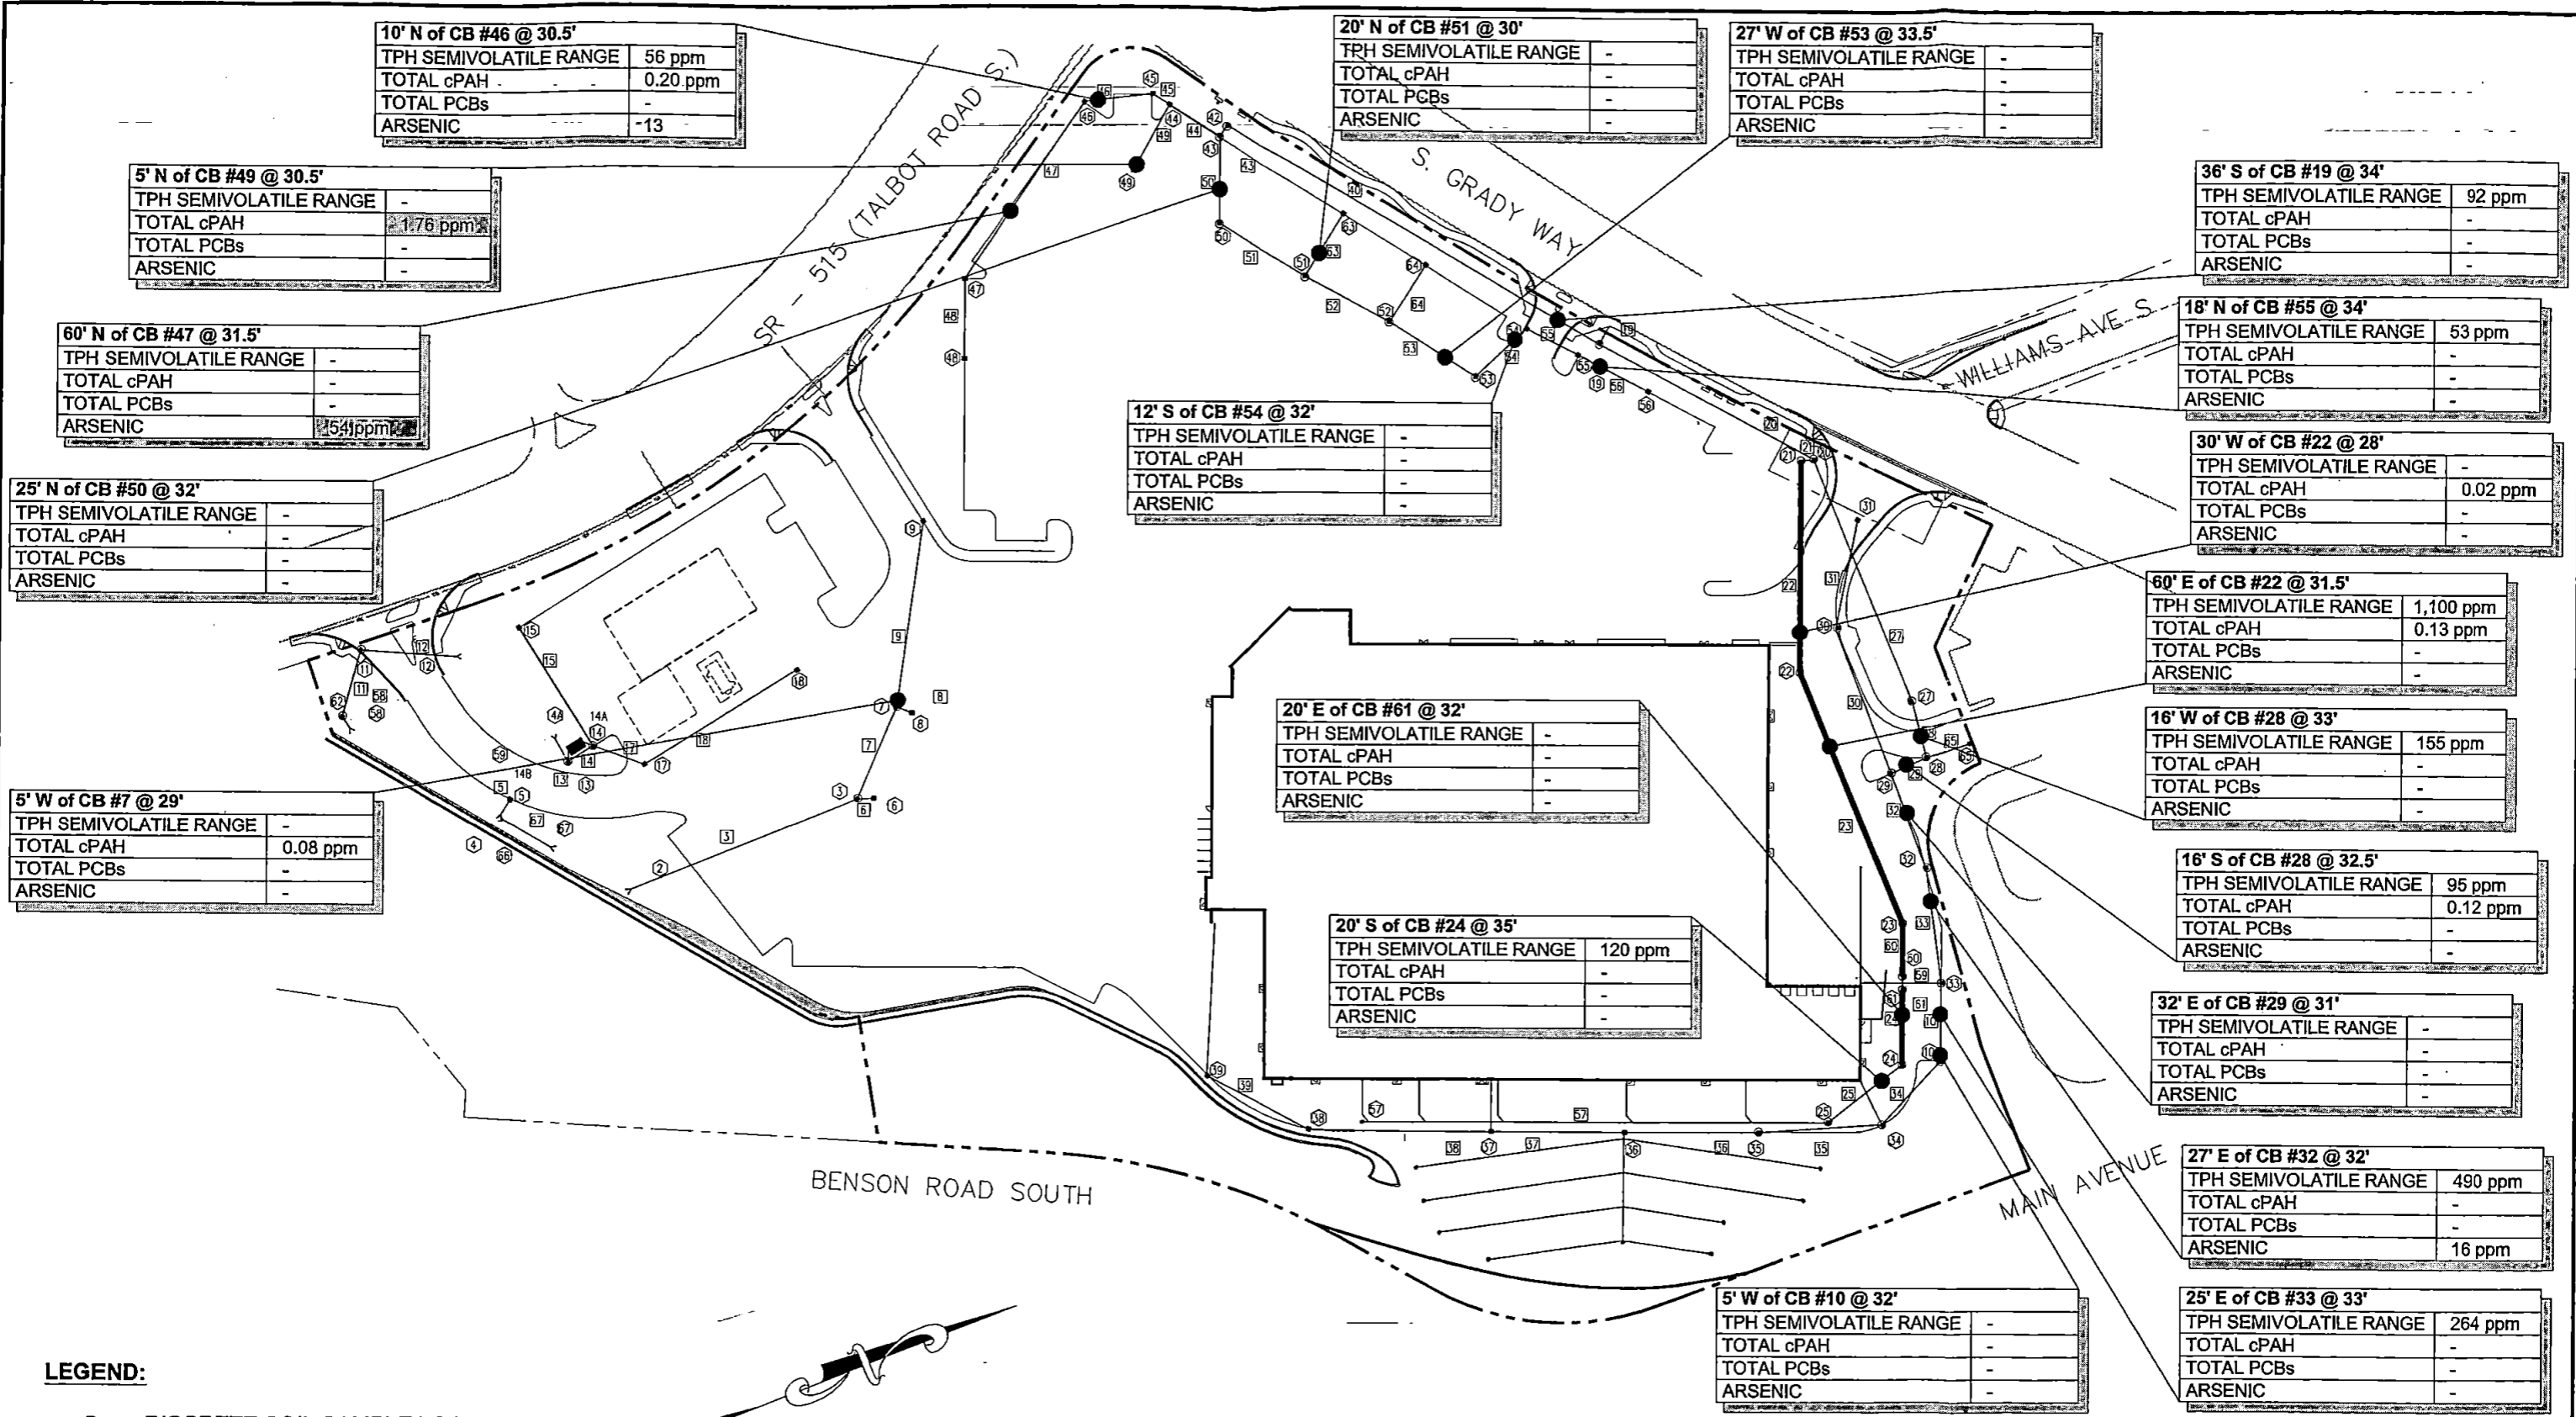
During the excavation of stormwater Pipe No. 49, located south of the intersection of Talbot Road and South Grady Way, a sample obtained from the sidewall of the trench (5' N of CB #49 @ 30.5') was reported with 1.76 ppm cumulative cPAH, exceeding the site specific cleanup standard of 1.7015 ppm. (See Figure 4 for a graphical representation of the location of this sample, Table I for the tabulated data set, and Appendix A for the analytical laboratory test certificates). The material from which the sample was collected consisted of fine fragments of coal, coal cinders, ash, and occasional pockets of weathered sandstone.

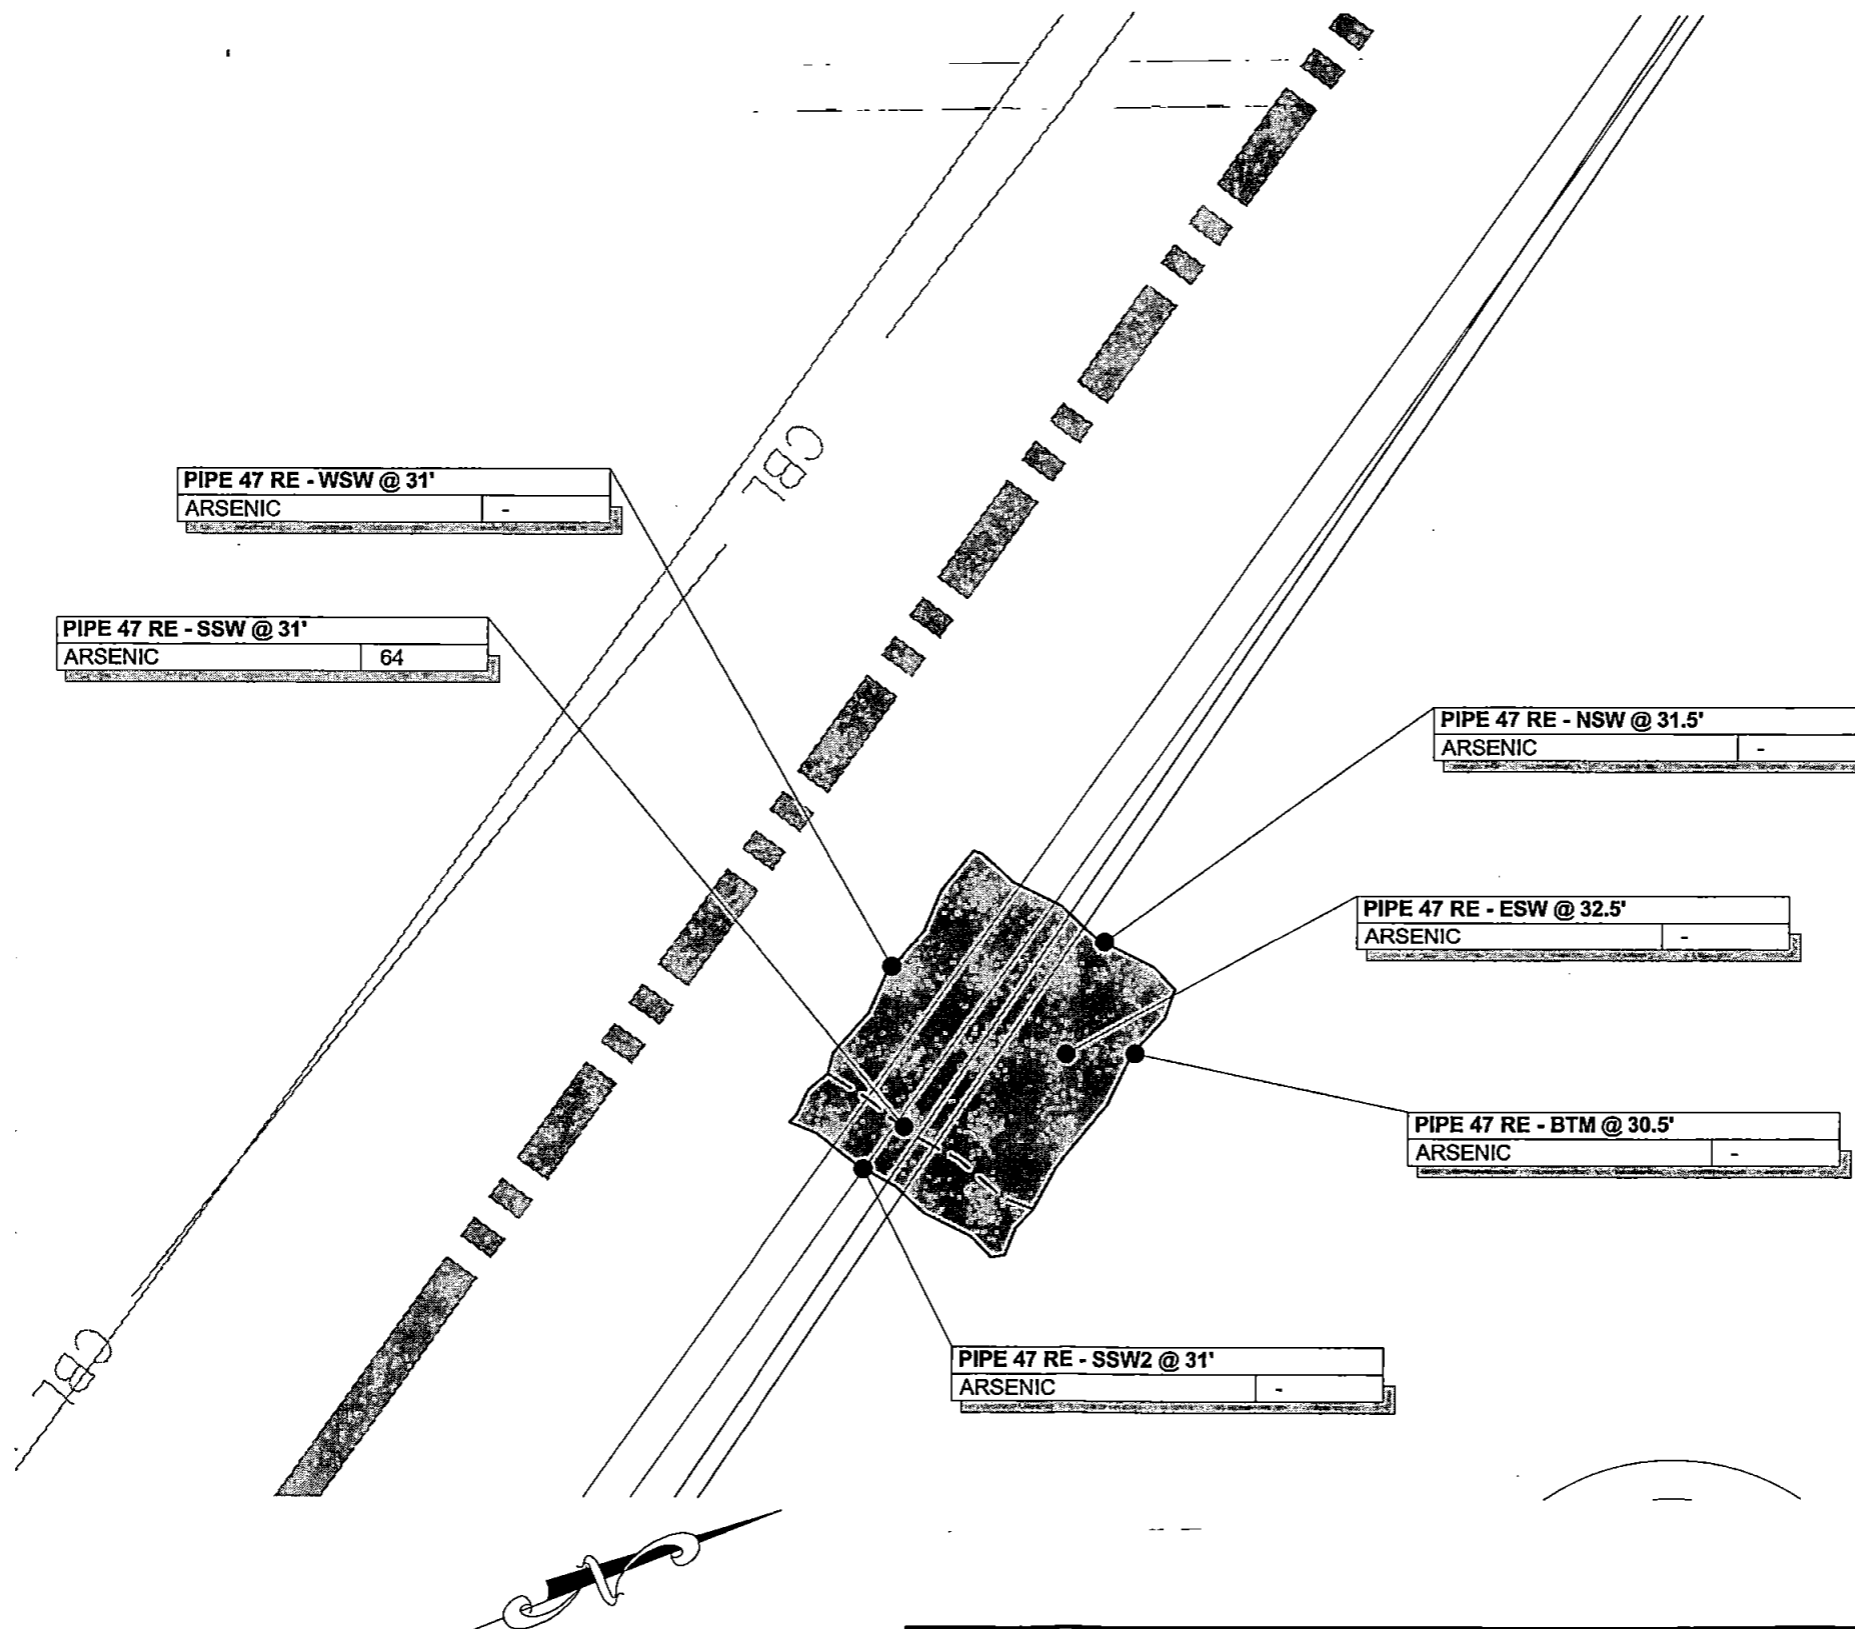
FIGURE 10a - PIPE 47 REMEDIAL EXCAVATION

During the excavation of the utility trench in order to install Pipe No. 47, located along the western property line, south of the intersection of Talbot Road and South Grady Way, arsenic was detected in a sample obtained from the sidewall of the trench (*60' N of CB #47 @ 31.5'*) at 54 ppm, which exceeded the cleanup level of 20 ppm. See Figure 4 for the location of the sample, Appendix A for laboratory documentation, and Table I for tabulated analytical data.

The material from which the sample was collected consisted of fine fragments of coal, coal cinders, ash, and occasional pockets of weathered sandstone. In response, ZZA recommended to the earthwork contractor to cover the excavation spoils from the trench between catchbasins CB #47 and CB#46 (area was still paved with asphalt) and indicated that a remedial excavation would need to be advanced.

A graphical representation of this remedial excavation is provided with this report as Figure 10a. Soil sample results as reported by the laboratory are presented in this report on Table I with original lab documentation provided in Appendix A.
