RE: TECHNICAL MEMORANDUM – Vapor Mitigation System Installation
Franciscan Medical Clinic
4550 Fauntleroy Way SW
Seattle, Washington 98126-3471
AEG Project No. 18-172

Associated Environmental Group, LLC (AEG) has prepared this Technical Memorandum for the purpose of presenting a summary of the vapor mitigation system installation activities performed at the Franciscan Medical Clinic, located at the above-referenced address in Seattle, Washington (Site). The Site work was completed over a weekend to allow access to all areas within the lower level of the building and parking areas. The objective of work was to address health concerns and reduce the petroleum vapors detected within the building. This system is intended to operate until such time that BP West Coast Products, LLC (BP) finishes their investigation of the petroleum impact to Site subsurface associated with the adjacent Shell site to the west.

Sub-Slab Depressurization System Installation Activities

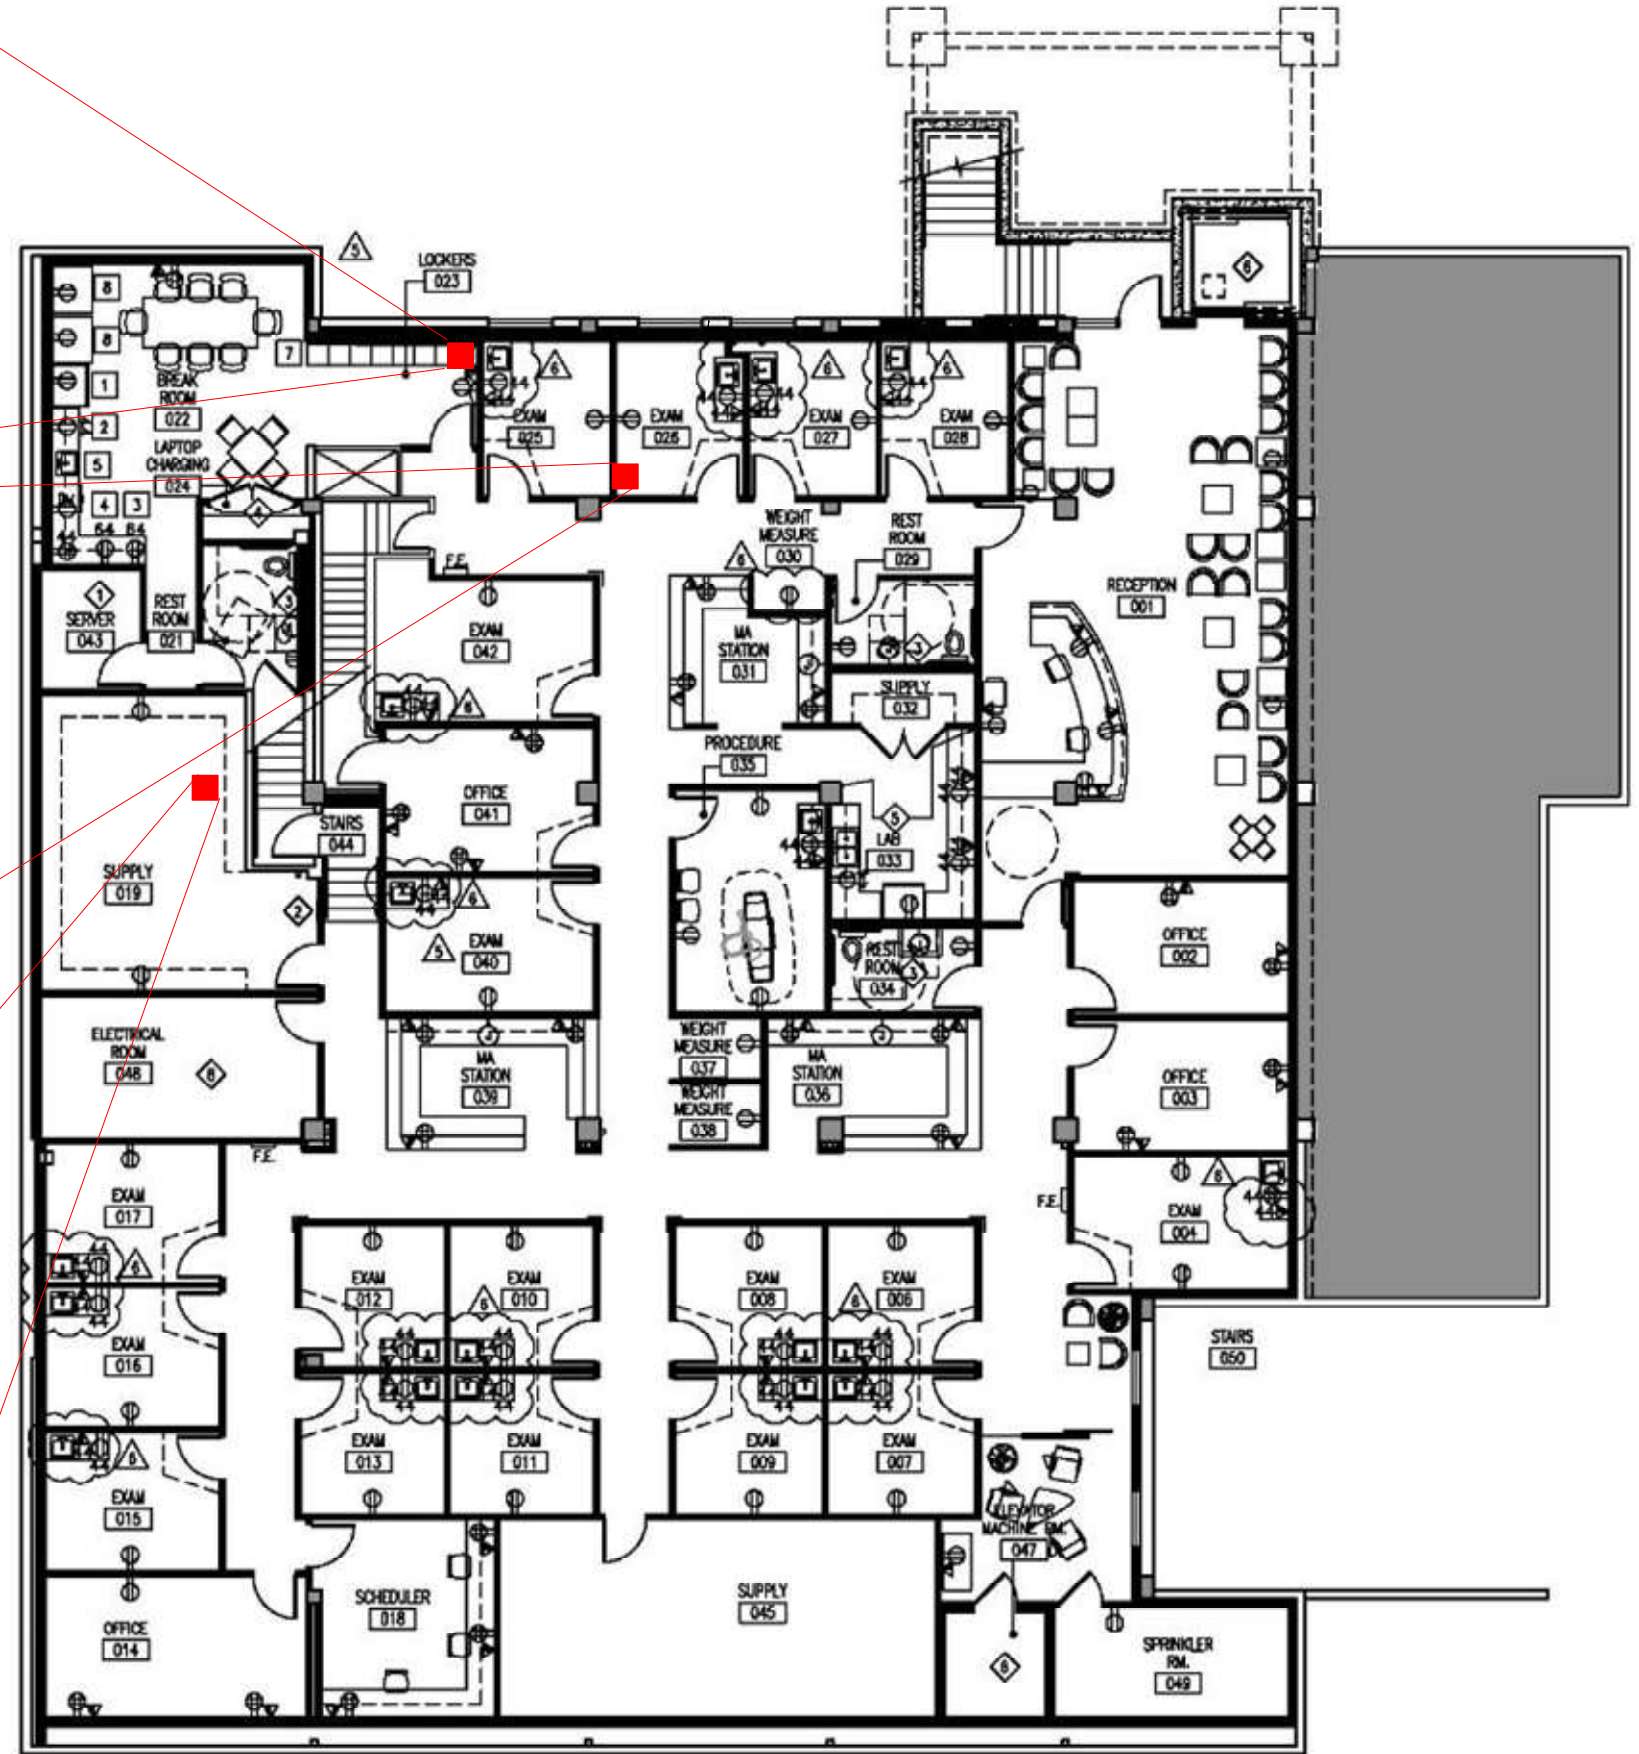
Associated Environmental Group, LLC	FIGURE 3			
	SUB-SLAB DEPRESSURIZATION POINT LOCATIONS FRANCISCAN WEST SEATTLE, WASHINGTON			
PROJECT: 18-172	SIZE	FSCM NO	DWG NO	REV
	SCALE	1 : 1	SHEET	1 OF 3

On November 3, and 4, 2018, AEG personnel along with a Washington licensed contractor and electrician installed three SSD points located in the Exam Room 3, employee break room, and the storage room, respectively, in the basement of the clinic building. The SSD points provide a pressure differential (vacuum) using vertical vapor collection points installed through the concrete floor, while connecting the points to air conveyance piping to a central point above the acoustic drop ceiling. The Site's current layout and SSD locations are illustrated in Figure 3, *Sub-Slab Depressurization Point Locations*, and photographs of the installation are included in Appendix A, *Site Photographs*.
