## **PHASE I ENVIRONMENTAL SITE ASSESSMENT**

Poulsbo RV Property  
Parcels 1522049027, 7260200060  
23051 & 22951 Military Road South  
Kent, Washington 98032

**MILITARY ROAD INVESTMENTS LLC &  
POULSBO RV, INC.**

October 14, 2015

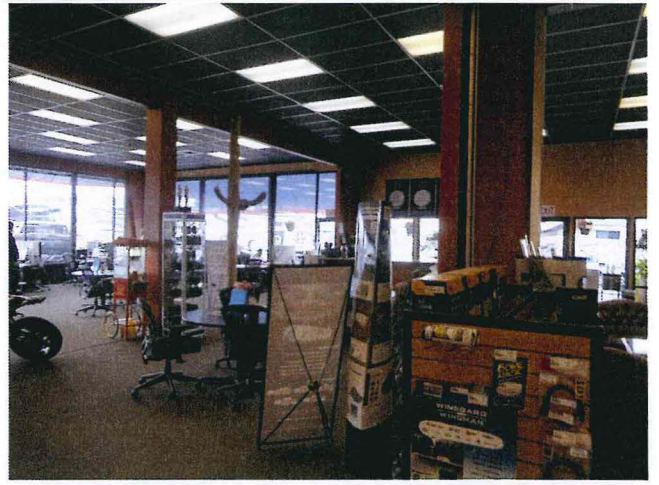
Typical interior office area of 23051 building

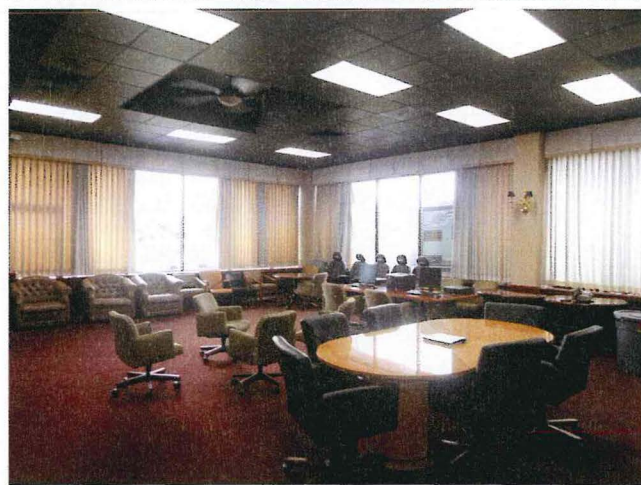
Typical interior office area of 22951 building

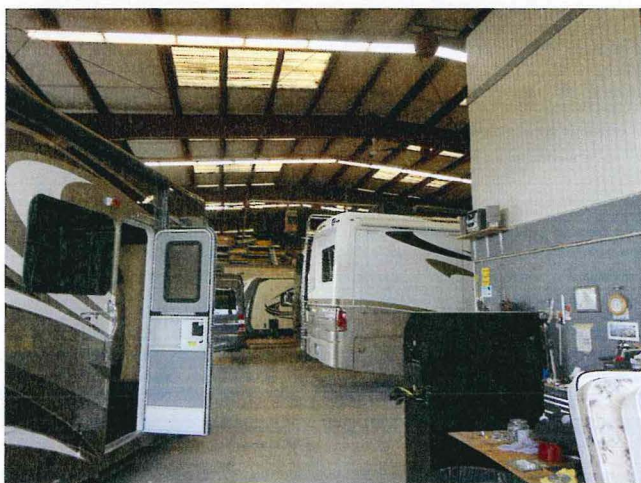
Shop area in 22951 building

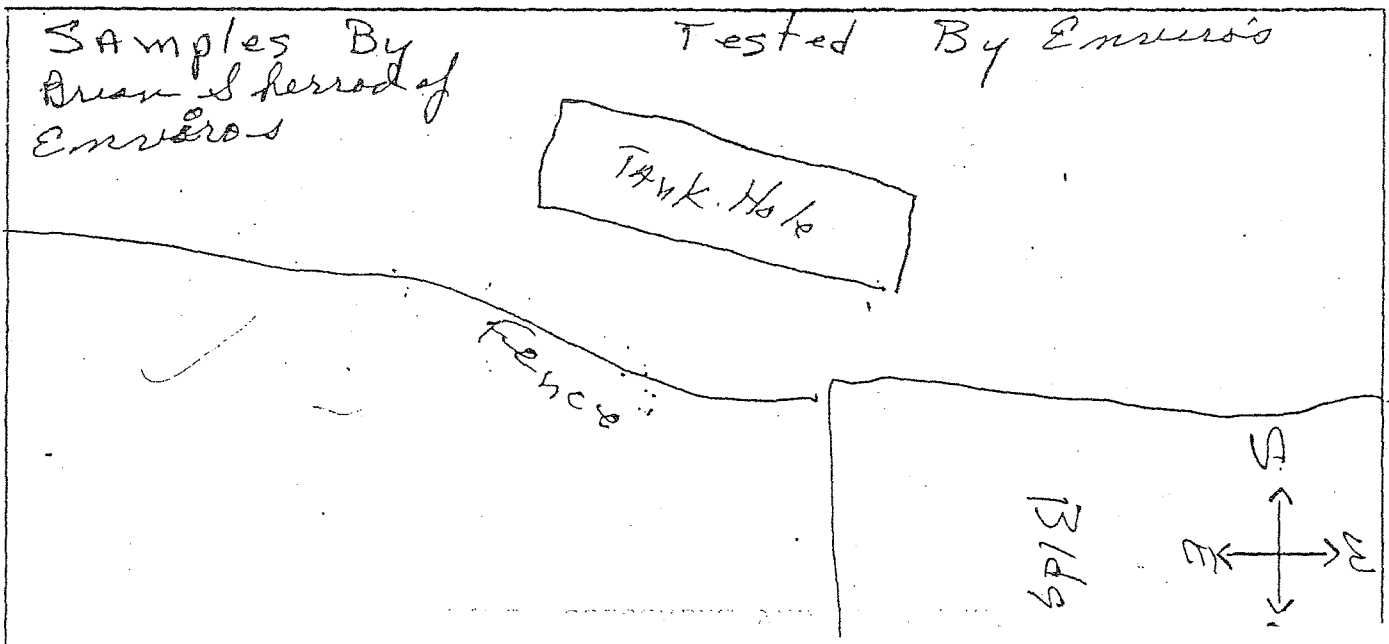
## Sketch of Excavation

Physical condition of tank(s): Good

Physical condition of piping: Good

Comments: Looks like no leaks soil around tank, looks good and probably can be used as backfill pending test results

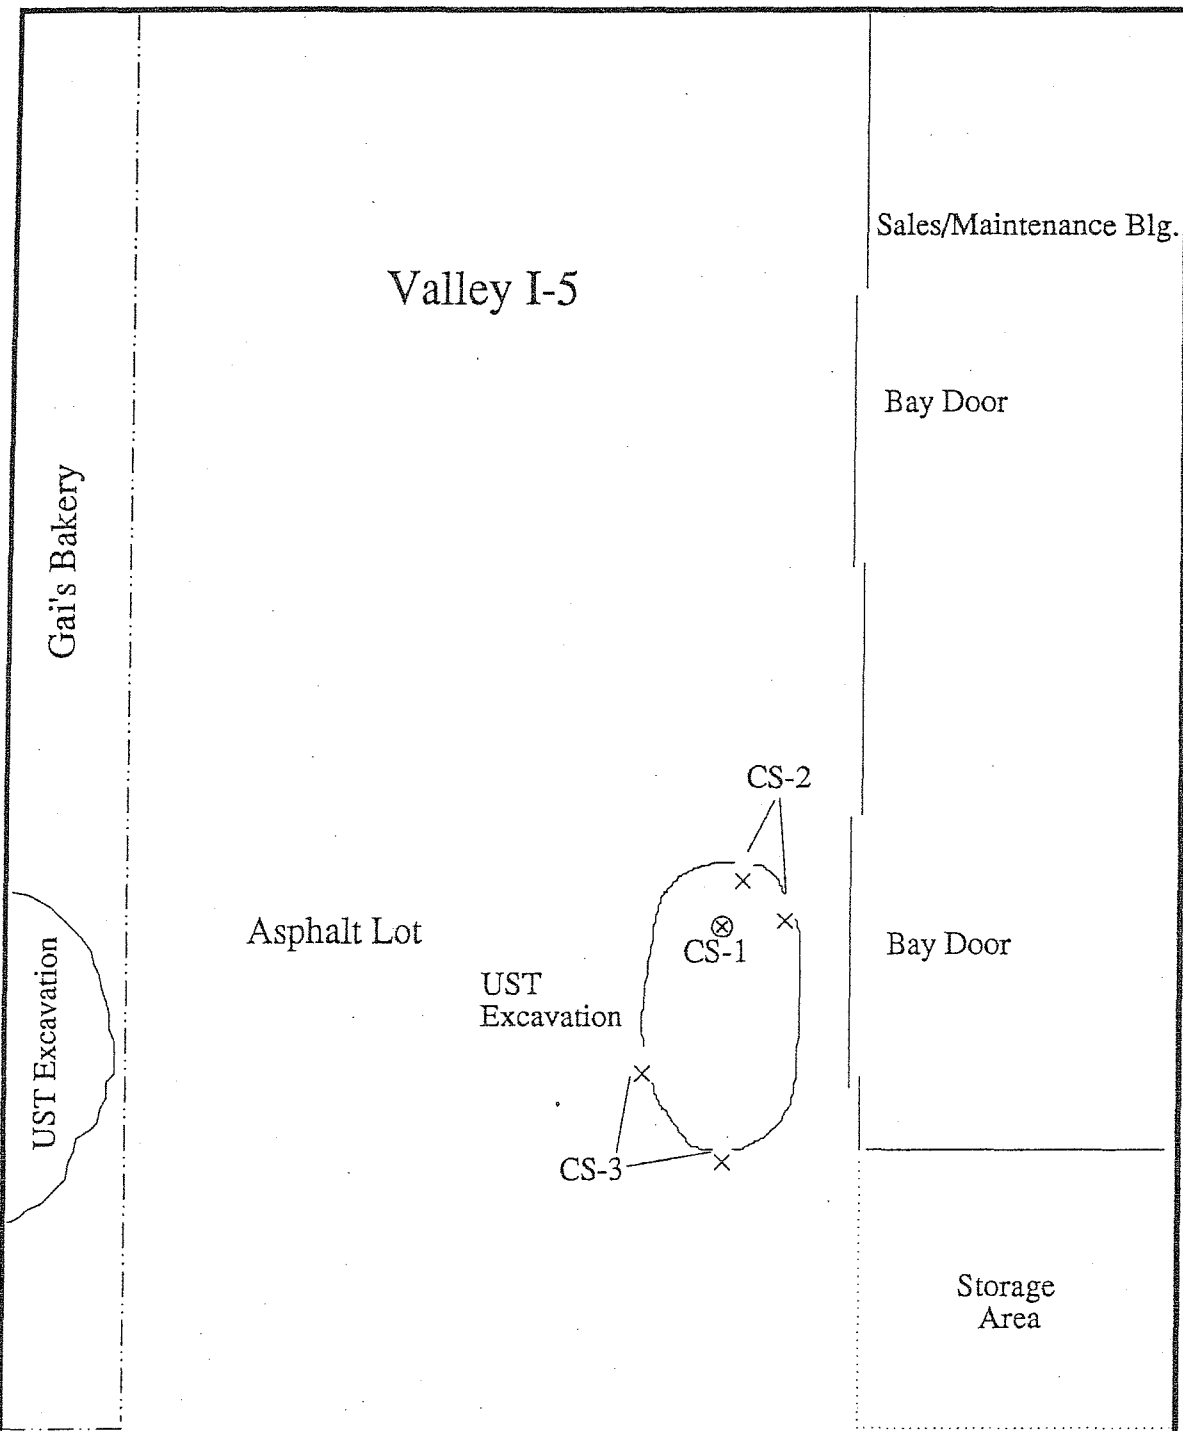
Following removal, the tank was visually inspected and was found to be in good condition. The soil samples collected during this investigation indicate that subsurface contamination was not present at levels exceeding the Method A Model Toxics Control Act Standards for soils (WAC 173-340-740). These data, combined with the data from the previous investigation, indicate that no releases of petroleum hydrocarbons to the environment had occurred that resulted in the accumulation of subsurface contamination.

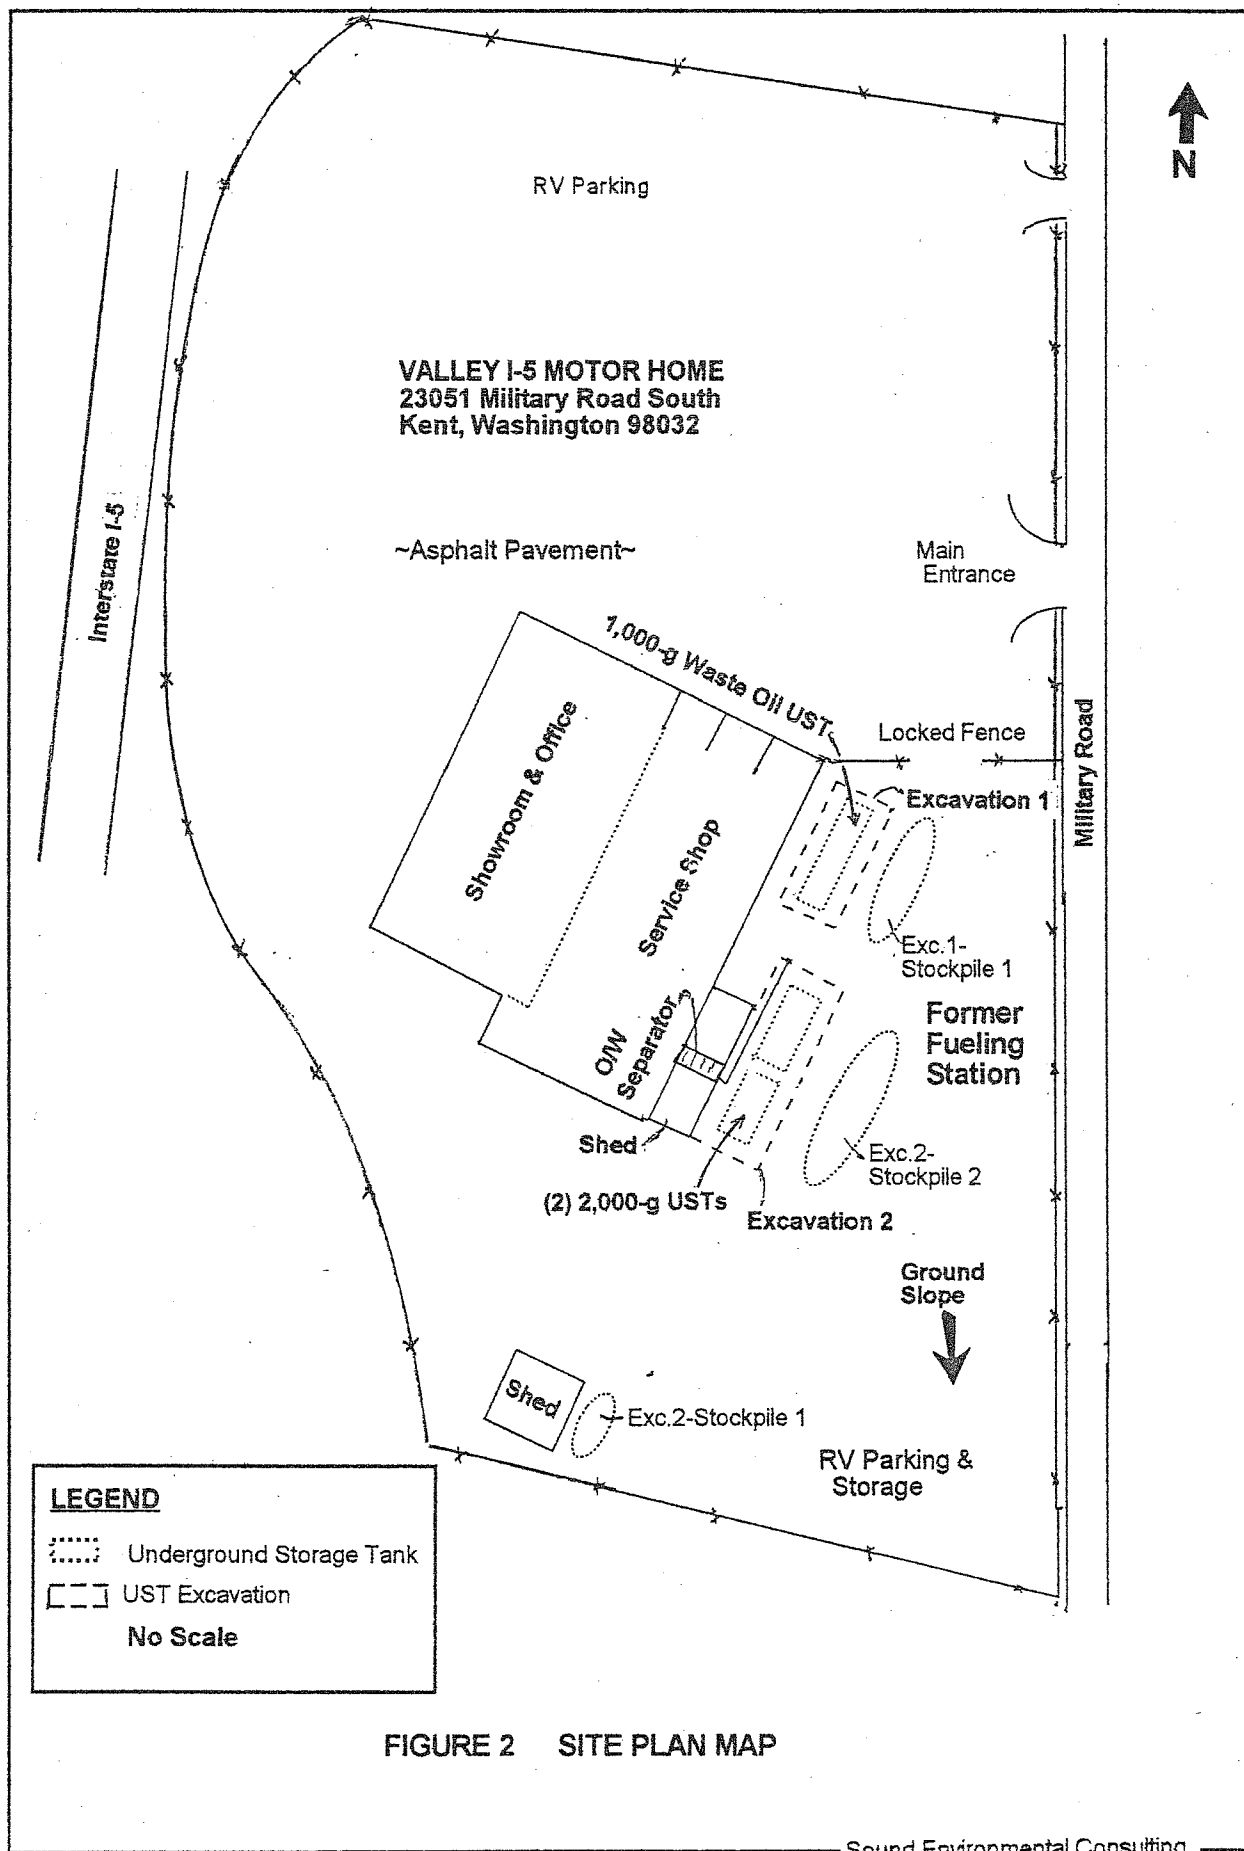
Figure 2 is a Site Plan Map illustrating the facility building features, approximate location of the former two 2,000-gallon gasoline and one 1,000-gallon waste oil USTs, soil sampling locations.

The former fueling system, was constructed in about 1978 and consisted of one waste oil tank and two unleaded gasoline tanks, a fuel dispenser, fuel lines, and vent lines. The location of the former fueling station and UST excavation is illustrated in Figure 2.
