SITE HAZARD ASSESSMENT

SITE NAME: Block 79 East

Completed on 2/7/2022 for inclusion

on the February 2022 Hazardous Sites List.

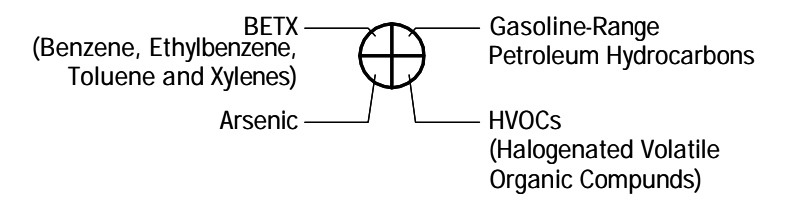
Chemical Analytical Results of Discrete Soil Samples

- Contaminants of concern detected at concentrations greater than the MTCA Method A cleanup levels.
- Contaminants of concern detected at concentrations less than the MTCA Method A cleanup levels.
- Contaminants of concern were not detected; metal concentrations were detected below natural background concentrations.

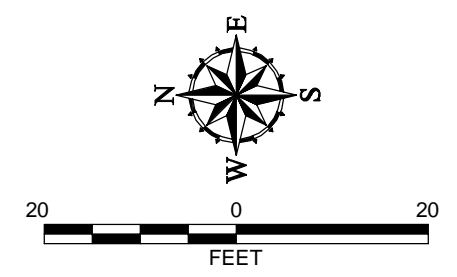
Soil Vapor Chemical Analytical Results	
South Lake Union Marriott AC Seattle, Washington	
GEOENGINEERS	Figure 5

Benzene exceeds its Method B screening level in soil vapor probes (SV) 3 through 6, PCE in SV 5 and 6, naphthalene in SV 3 and 4, and xylenes in SV 3 (Figure 5). The air source was assumed to be the eastern half of the property, which is approximately 65 x 190 feet, which corresponds to approximately 12,300 square feet.

SV-5			
TPH (low fraction)	Benzene	1,4-Dioxane	Tetrachloroethylene
µg/m ³	µg/m ³	µg/m ³	µg/m ³
3,600	15	40	2,400

SV-6	
Benzene	Tetrachloroethylene
µg/m ³	µg/m ³
4.2	120
