CLEANUP ACTION PLAN

Texaco February 22, 1991 Oil Spill
Anacortes, Washington

Washington Department of Ecology

May 25, 1993

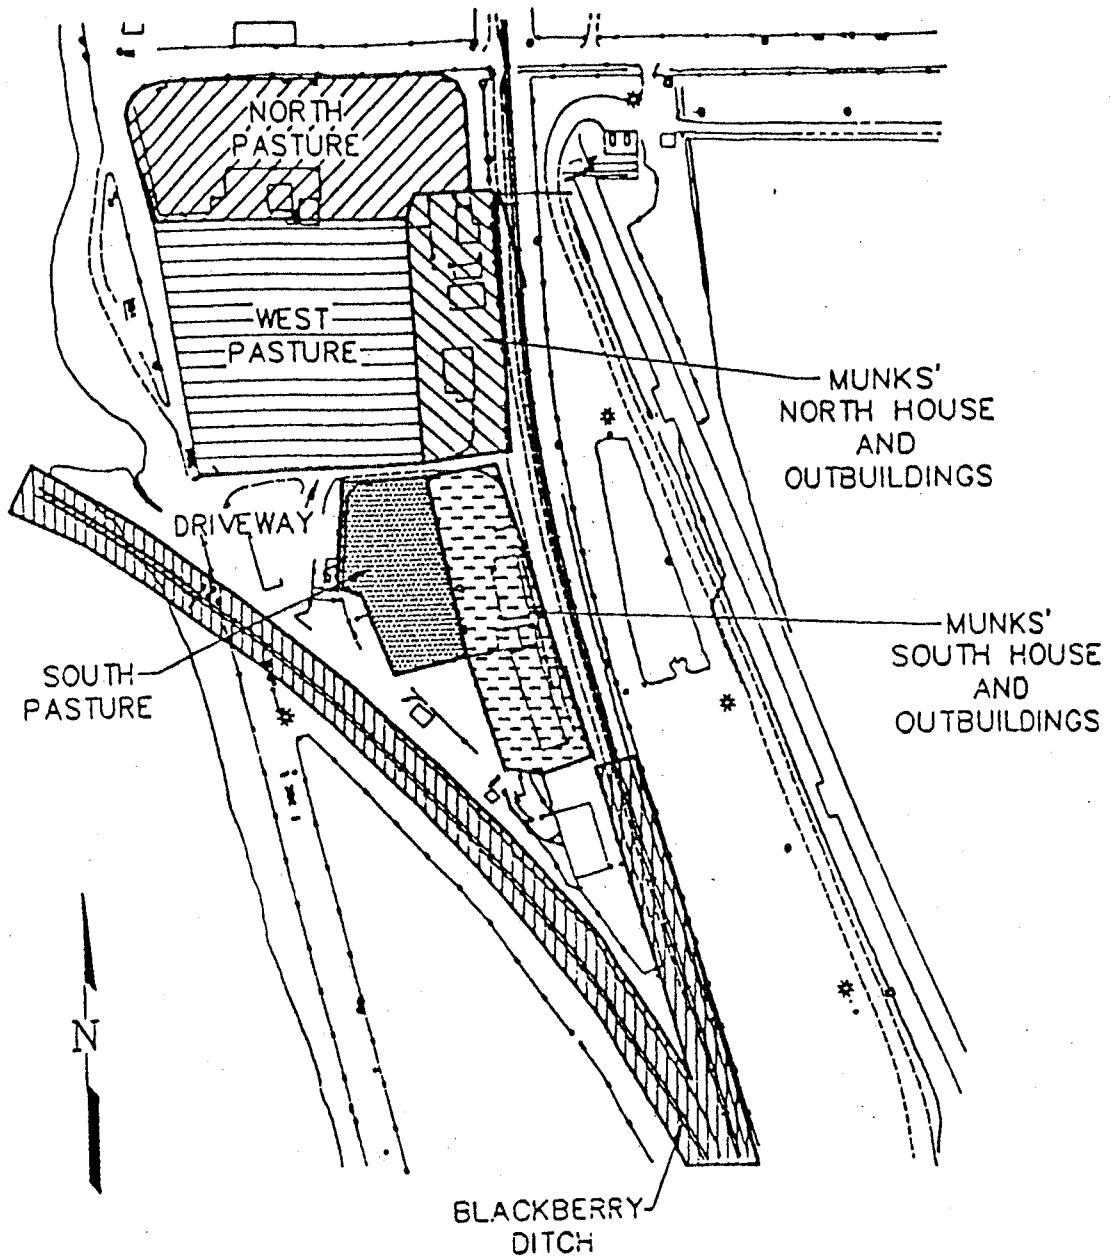
PROJECT:	701091008-237 (PSPSAMP)
LOCATION:	ANACORTES, WASHINGTON
APPR:	DATE: 01/16/92
DRAWN BY:	RMO SCALE: AS SHOWN
DATE:	05/21/91 FIGURE: 4

The oil spill site is located on the western flank of March Point approximately 3 miles from Anacortes, Washington. The site is bounded on the north by North Texas Road, a north-south trending Texaco pipeway to the east, West March Point Road to the west, and a railroad spur running northwest-southeast that crosses Fidalgo Bay to the south (Figure 3). For the purpose of cleanup activities, the site was divided into three areas (sectors): Munks property (sector 3), Shell railroad right of way (sector 2), and Texaco property (sector 1). During the interim action the Munks property (sector 3), was divided into six principal areas (Figure 4).

- o North Pasture
- o South Pasture
- o West Pasture
- o Area adjacent to Munks north residence
- o South house area
- o The blackberry ditch - a drainage ditch that parallels the railroad spur

Primary areas within Munks' property.

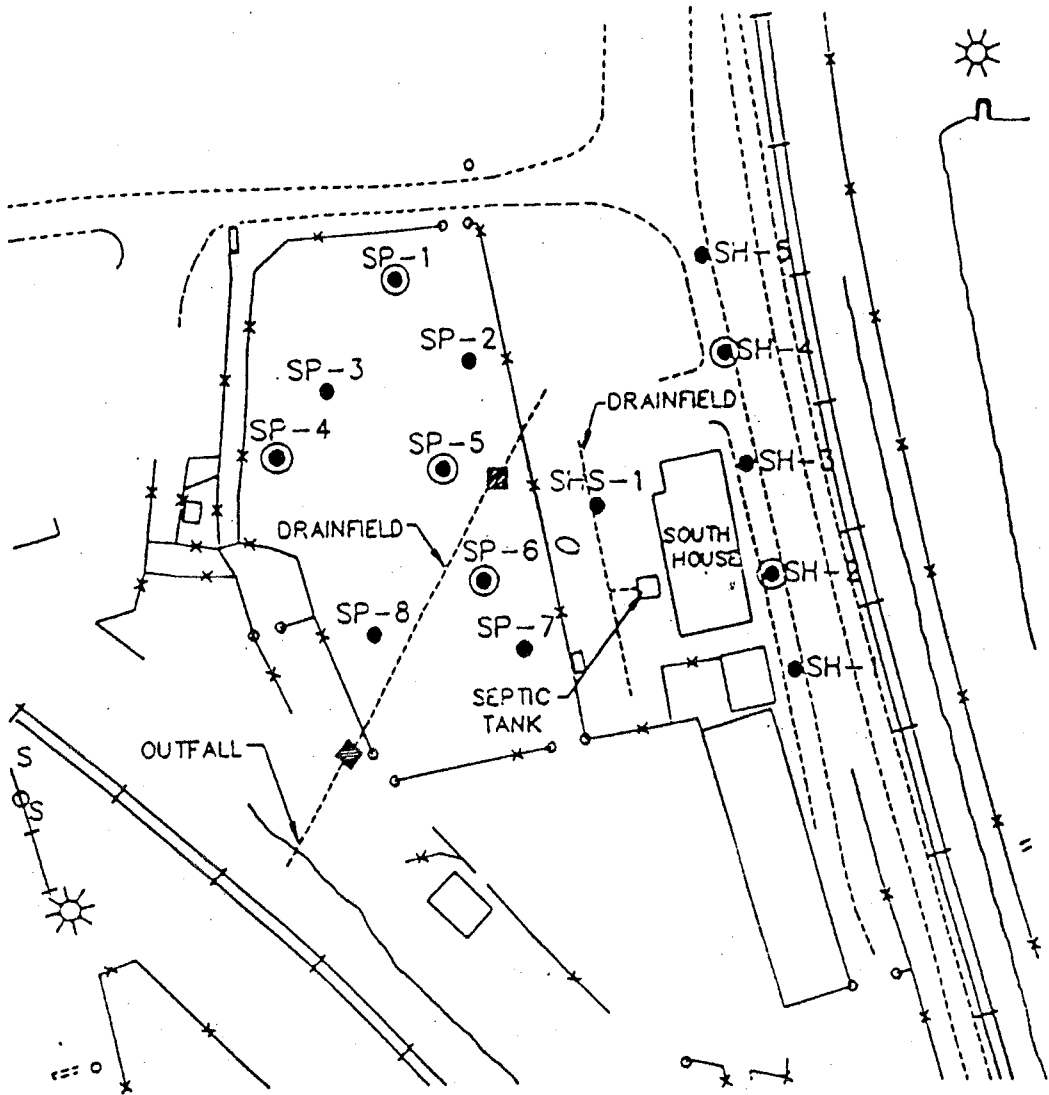
DATE: 01/21/92 FIGURE: 10

Approximately 11,000 cubic yards of contaminated soil was removed from the area and landfarmed in the Texaco flare landfarms. The deepest contamination was observed beneath the Munks barn where crude oil had pooled under the flooring. This resulted in hydrocarbon contamination to depths of 15 feet in the fractured clay. Soil analysis was completed in the bottom of the pit after removal of contaminated soils. None of the samples from the North house area yielded results above the 200 mg/kg cleanup standard (Figure 10).

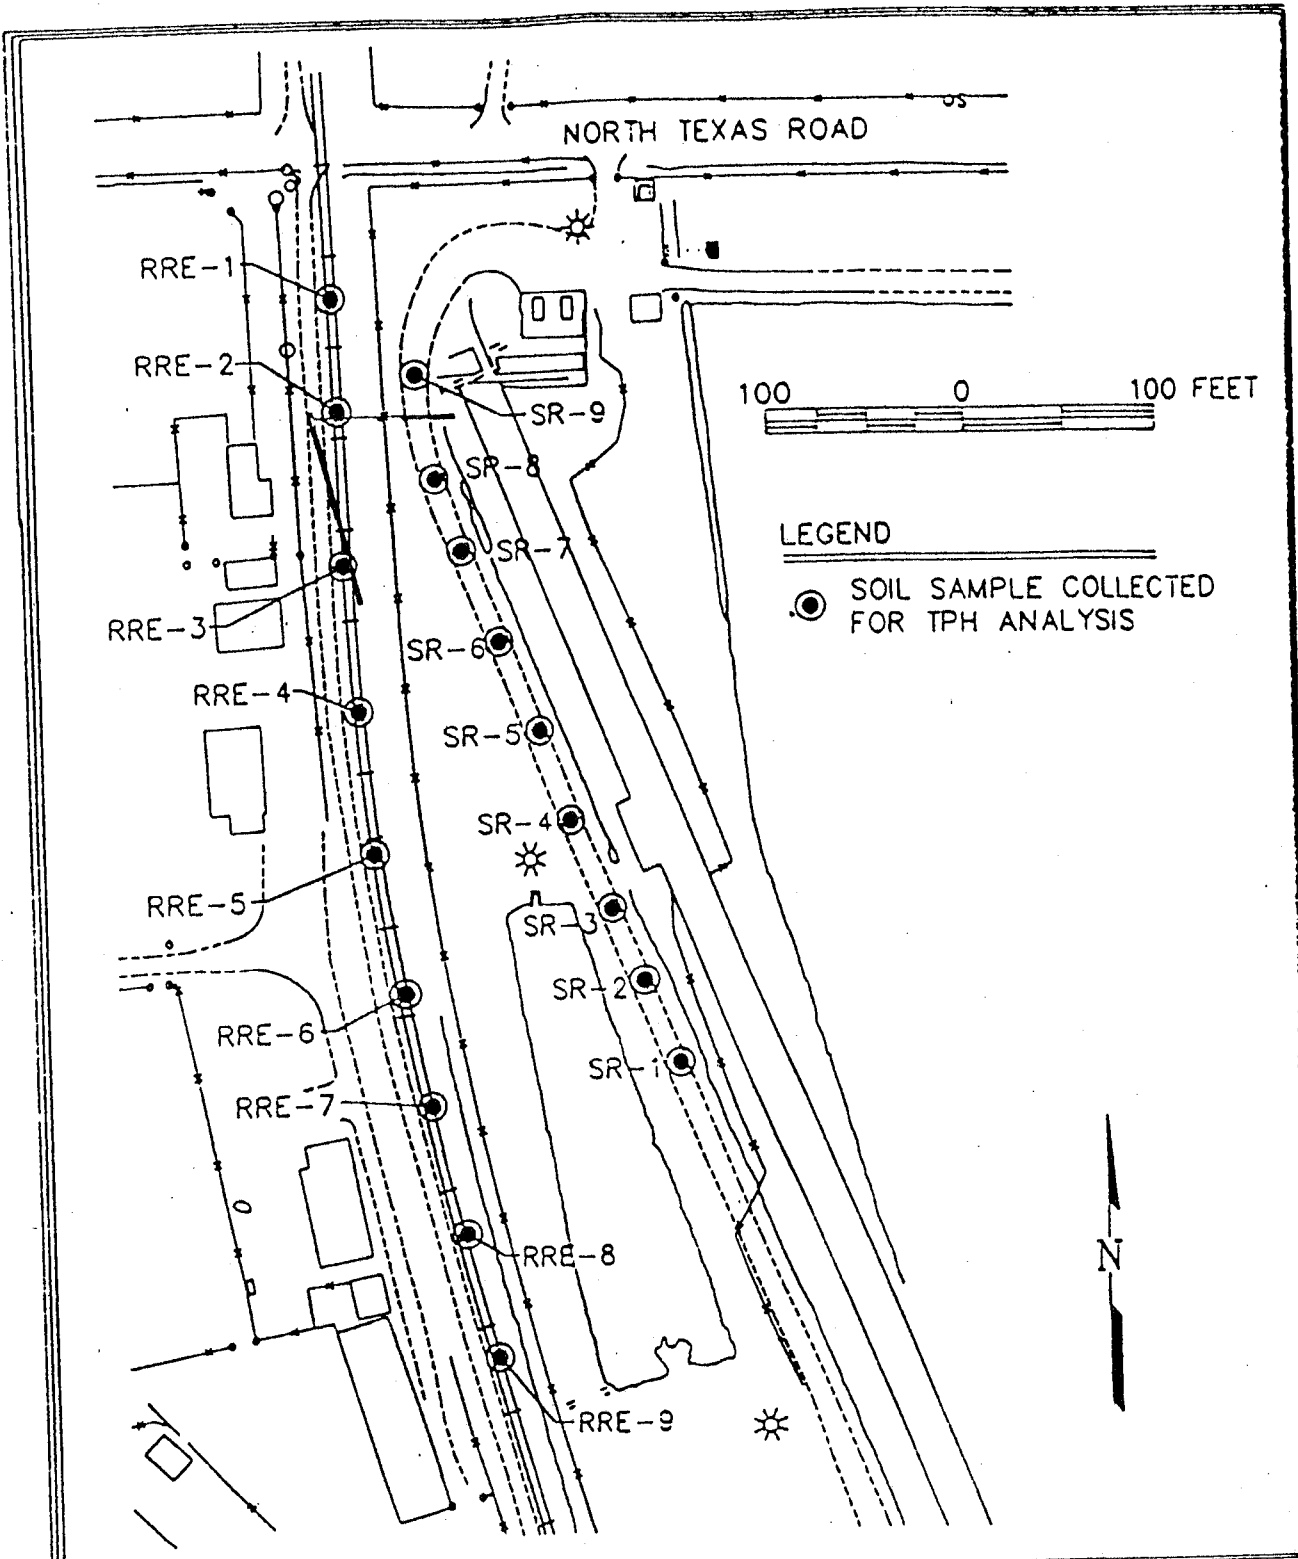
PROJECT:	701091008-237 (PSPSAMP4)
LOCATION:	ANACORTES, WASHINGTON
APPR:	DATE: 10/23/91
DRAWN BY:	RMM SCALE: AS SHOWN
DATE:	10/23/91 ; FIGURE: 13

The July 1991 Agreed Order was amended to include the investigation and cleanup of the railroad spur easement in September 1991 (Figure 12,13). The initial agreed order directed Texaco to conduct the cleanup of the spur under the cleanup consent decree. The agreed order was amended to include the spur cleanup because of the potential of contaminating the clean fill that had been placed down gradient on the Munks property. The railroad spur roadbed contained free crude oil from the spill.
