## **Remedial Investigation Report**

**DeBock's Main Street Texaco (aka Debock's Auto Repair)  
100 W., 101 W., and 101 E. Wine Country Road  
Grandview, WA  
Facility Site No. 94369212  
Cleanup Site ID No. 6910**

**Prepared by AECOM for:  
Resource Environmental, LLC**

**February 15, 2022**

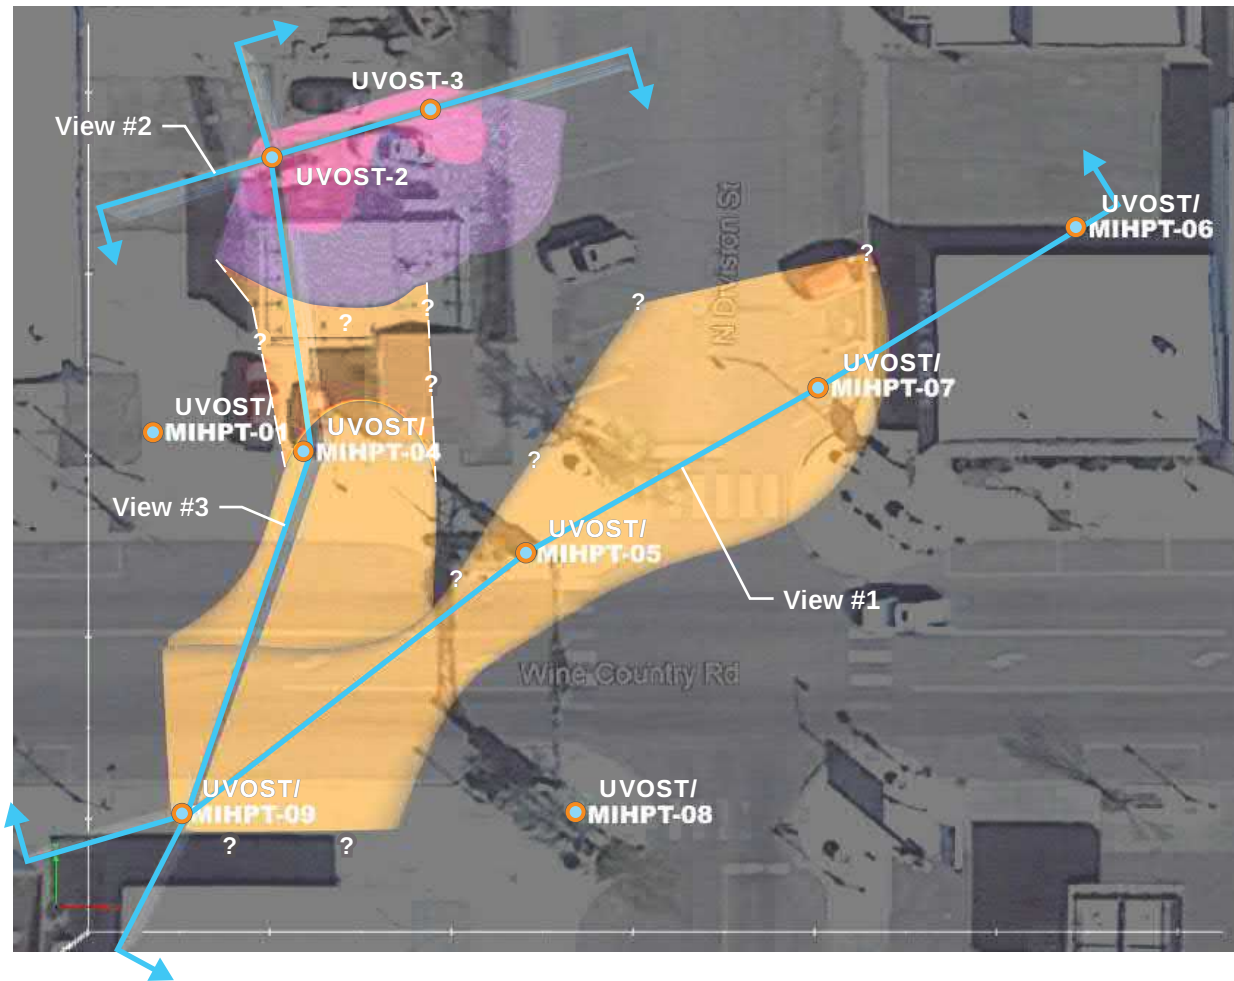
Figure 8  
LIF and PID Responses – Plan View

The UVOST® and MIHPT investigation results are discussed in the following sections. LIF responses, generated and measured by UVOST®, were generally at background levels<sup>1</sup> at most depths. LIF and PID data and the extrapolated extent of petroleum hydrocarbons are depicted on **Figure 8**. **Figure 9** shows this data for a southwest to northeast cross section and **Figure 10** shows the data for a north to south cross section. LIF and PID data are depicted on geologic fence diagrams presented on **Figures 11** and **12**, respectively. The full UVOST® and MIHPT investigation results are included in **Appendix C**

- In the UVOST and MIHPT borings advanced on the 101 W. Wine Country Road property, evidence of LNAPL was identified in the vicinity of the former fueling rack area, which is located in the northern portion of the property (**Figure 8**). In borings UVOST/MIHPT-2 and -3, LNAPL was identified within the vadose zone and extending into the saturated zone (**Figure 10**). The presence of LNAPL in this area is likely associated with releases from the former USTs and/or piping or from spills at the loading rack area. LNAPL was not identified in borings UVOST/MIHPT-1 and -4, which were advanced to the south of borings UVOST/MIHPT-2 and -3. The extent of LNAPL to the north, west and east of this area is presently unknown. LNAPL in this area appears to range from approximately 13 to 20 feet bgs (**Figures 10 and 12**). Evidence of dissolved phase petroleum hydrocarbons was identified in borings UVOST/MIHPT-4 and -5, located south of the LNAPL occurrence (**Figure 6**). In boring UVOST/MIHPT-1, located southwest of the former fueling rack, evidence of elevated dissolved phase petroleum hydrocarbons was not detected, which may suggest that there is a more southerly groundwater flow direction beneath this property. Evidence of dissolved-phase petroleum hydrocarbons was identified from approximately 14 to 24 feet bgs in boring UVOST/MIHPT-5, located in the city ROW. Evidence of dissolved phase petroleum hydrocarbons in the same depth interval was also detected in boring UVOST/MIHPT-7, which was completed across Division Street east of boring UVOST/MIHPT-5. Therefore, it is not conclusive that the impacts noted in boring UVOST/MIHPT-5 are solely associated with sources of contamination on the 101 W. Wine Country Road property.

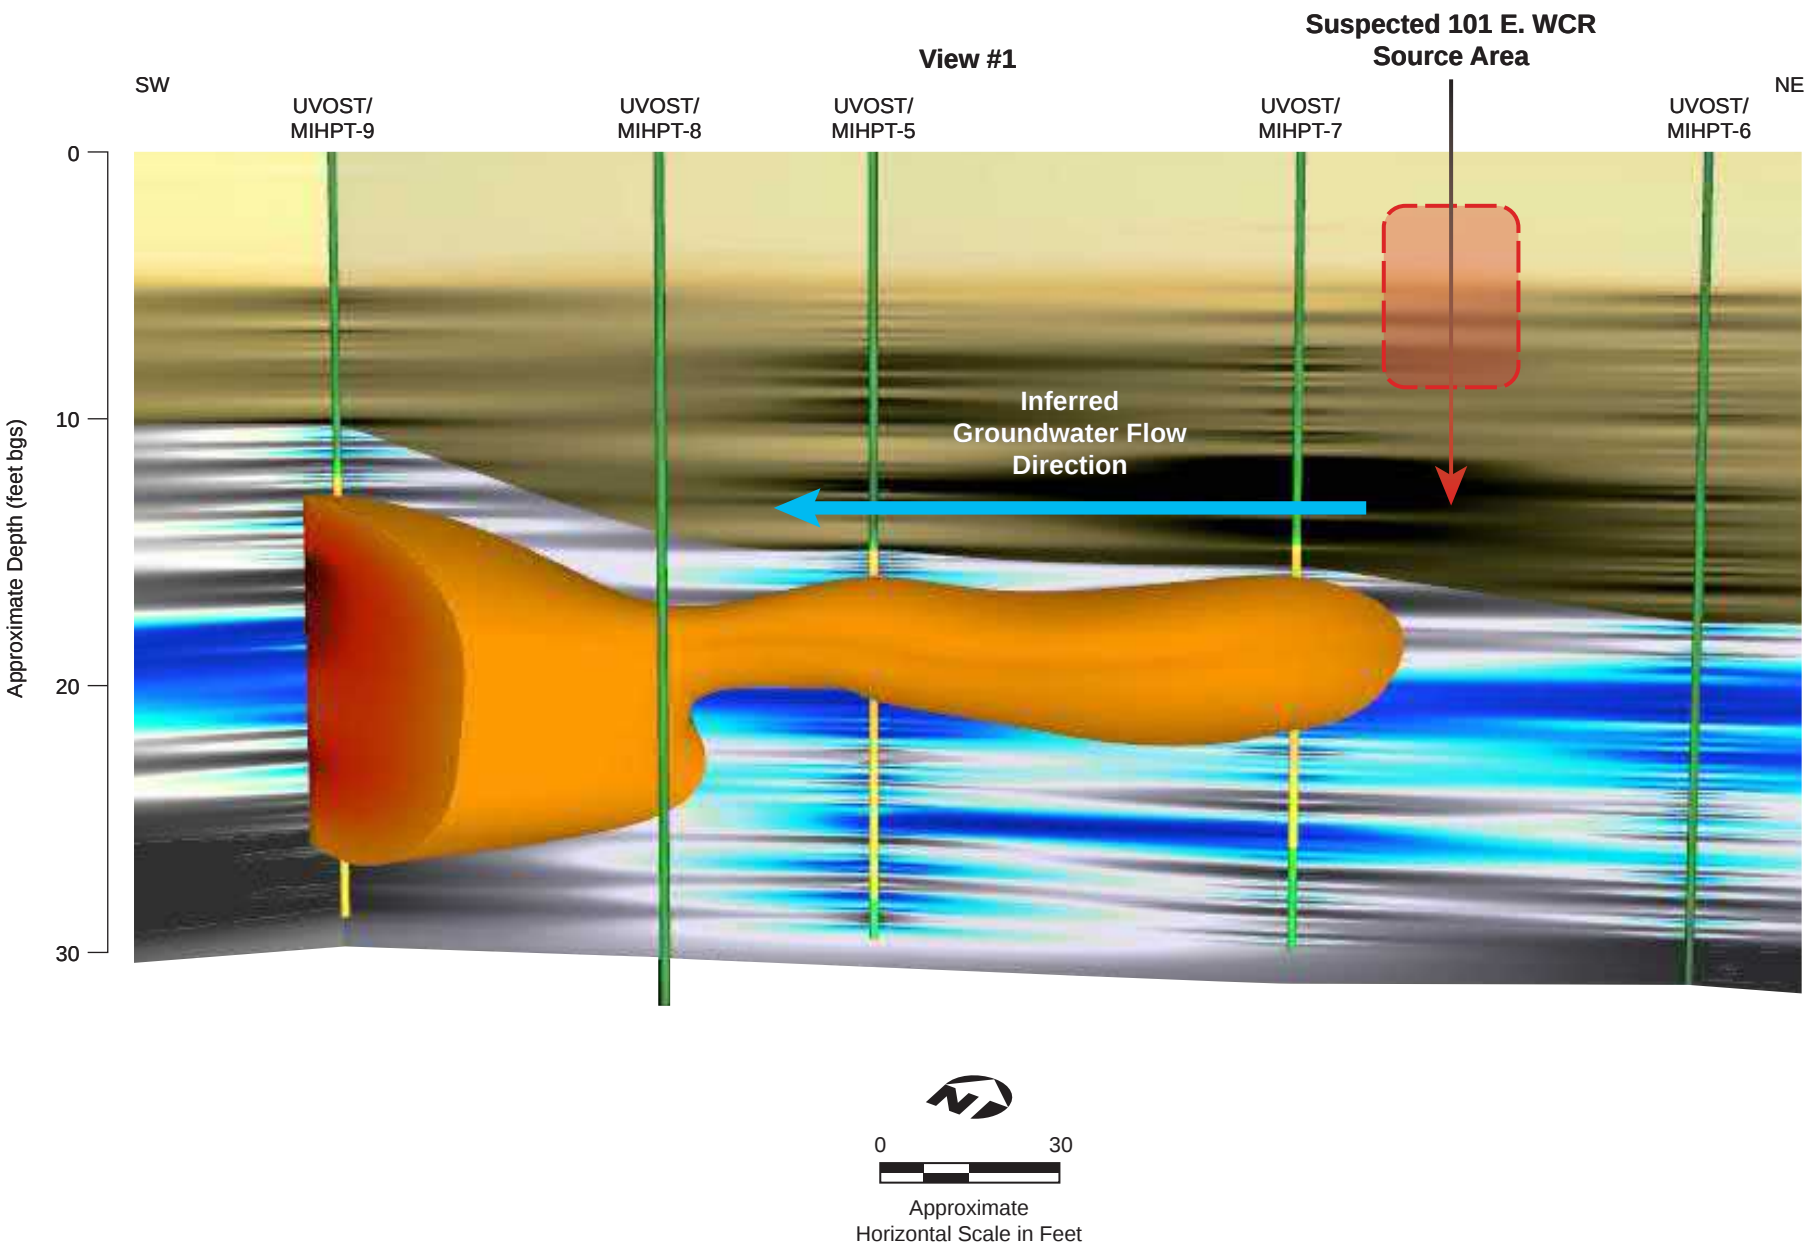
Figure 9  
**PID Responses – Cross Section View #1**

- Boring UVOST/MIHPT-5 was advanced within the city ROW southeast of the former service station. LIF responses were not present in these borings. Low PID responses were present between 15 and 21 feet bgs (**Figure 9**).

Borings UVOST/MIHPT-6 and -7 were advanced to the north and west, respectively, of the former service station (**Figure 3**). No LIF or PID responses were present above background levels in boring UVOST/MIHPT-6, located north of the former service station (**Figure 9**). In boring UVOST/MIHPT-7, advanced west of the former service station, LIF responses were not present,

but PID responses were present between 14 and 23 feet bgs, indicating the presence of dissolved-phase petroleum hydrocarbons at this location (*Figures 9 and 11*).

Borings UVOST/MIHPT-8 and -9 were advanced in the city ROW to the north of the 100 W. Wine Country Road property (*Figure 3*). For boring UVOST/MIHPT-8, LIF and PID responses were not present above background levels. For boring UVOST/MIHPT-9, which was located adjacent to known petroleum-impacted groundwater at the DeBock's Texaco, PID responses between 12.5 and 23 feet bgs indicated dissolved-phase petroleum hydrocarbons were present within the smear zone (*Figure 9 and 11*).

MIHPT dissipation testing indicated that the groundwater surface in the borings ranged from approximately 14 to 16.5 feet bgs. Hydraulic conductivity (K) measurements via MIHPT generally confirmed the presence of interbedded higher hydraulic conductivity sands (i.e., floodwater sands) and lower hydraulic conductivity silts (i.e., slackwater silt). Dissolved-phase hydrocarbons appear to be concentrated within shallow, high hydraulic conductivity sands, while LNAPL identified at the 101 W. Wine Country Road property primarily resided within the water table/capillary fringe above the shallowest high hydraulic conductivity unit. Hydraulic conductivity data are provided in *Figures 9 and 10*.

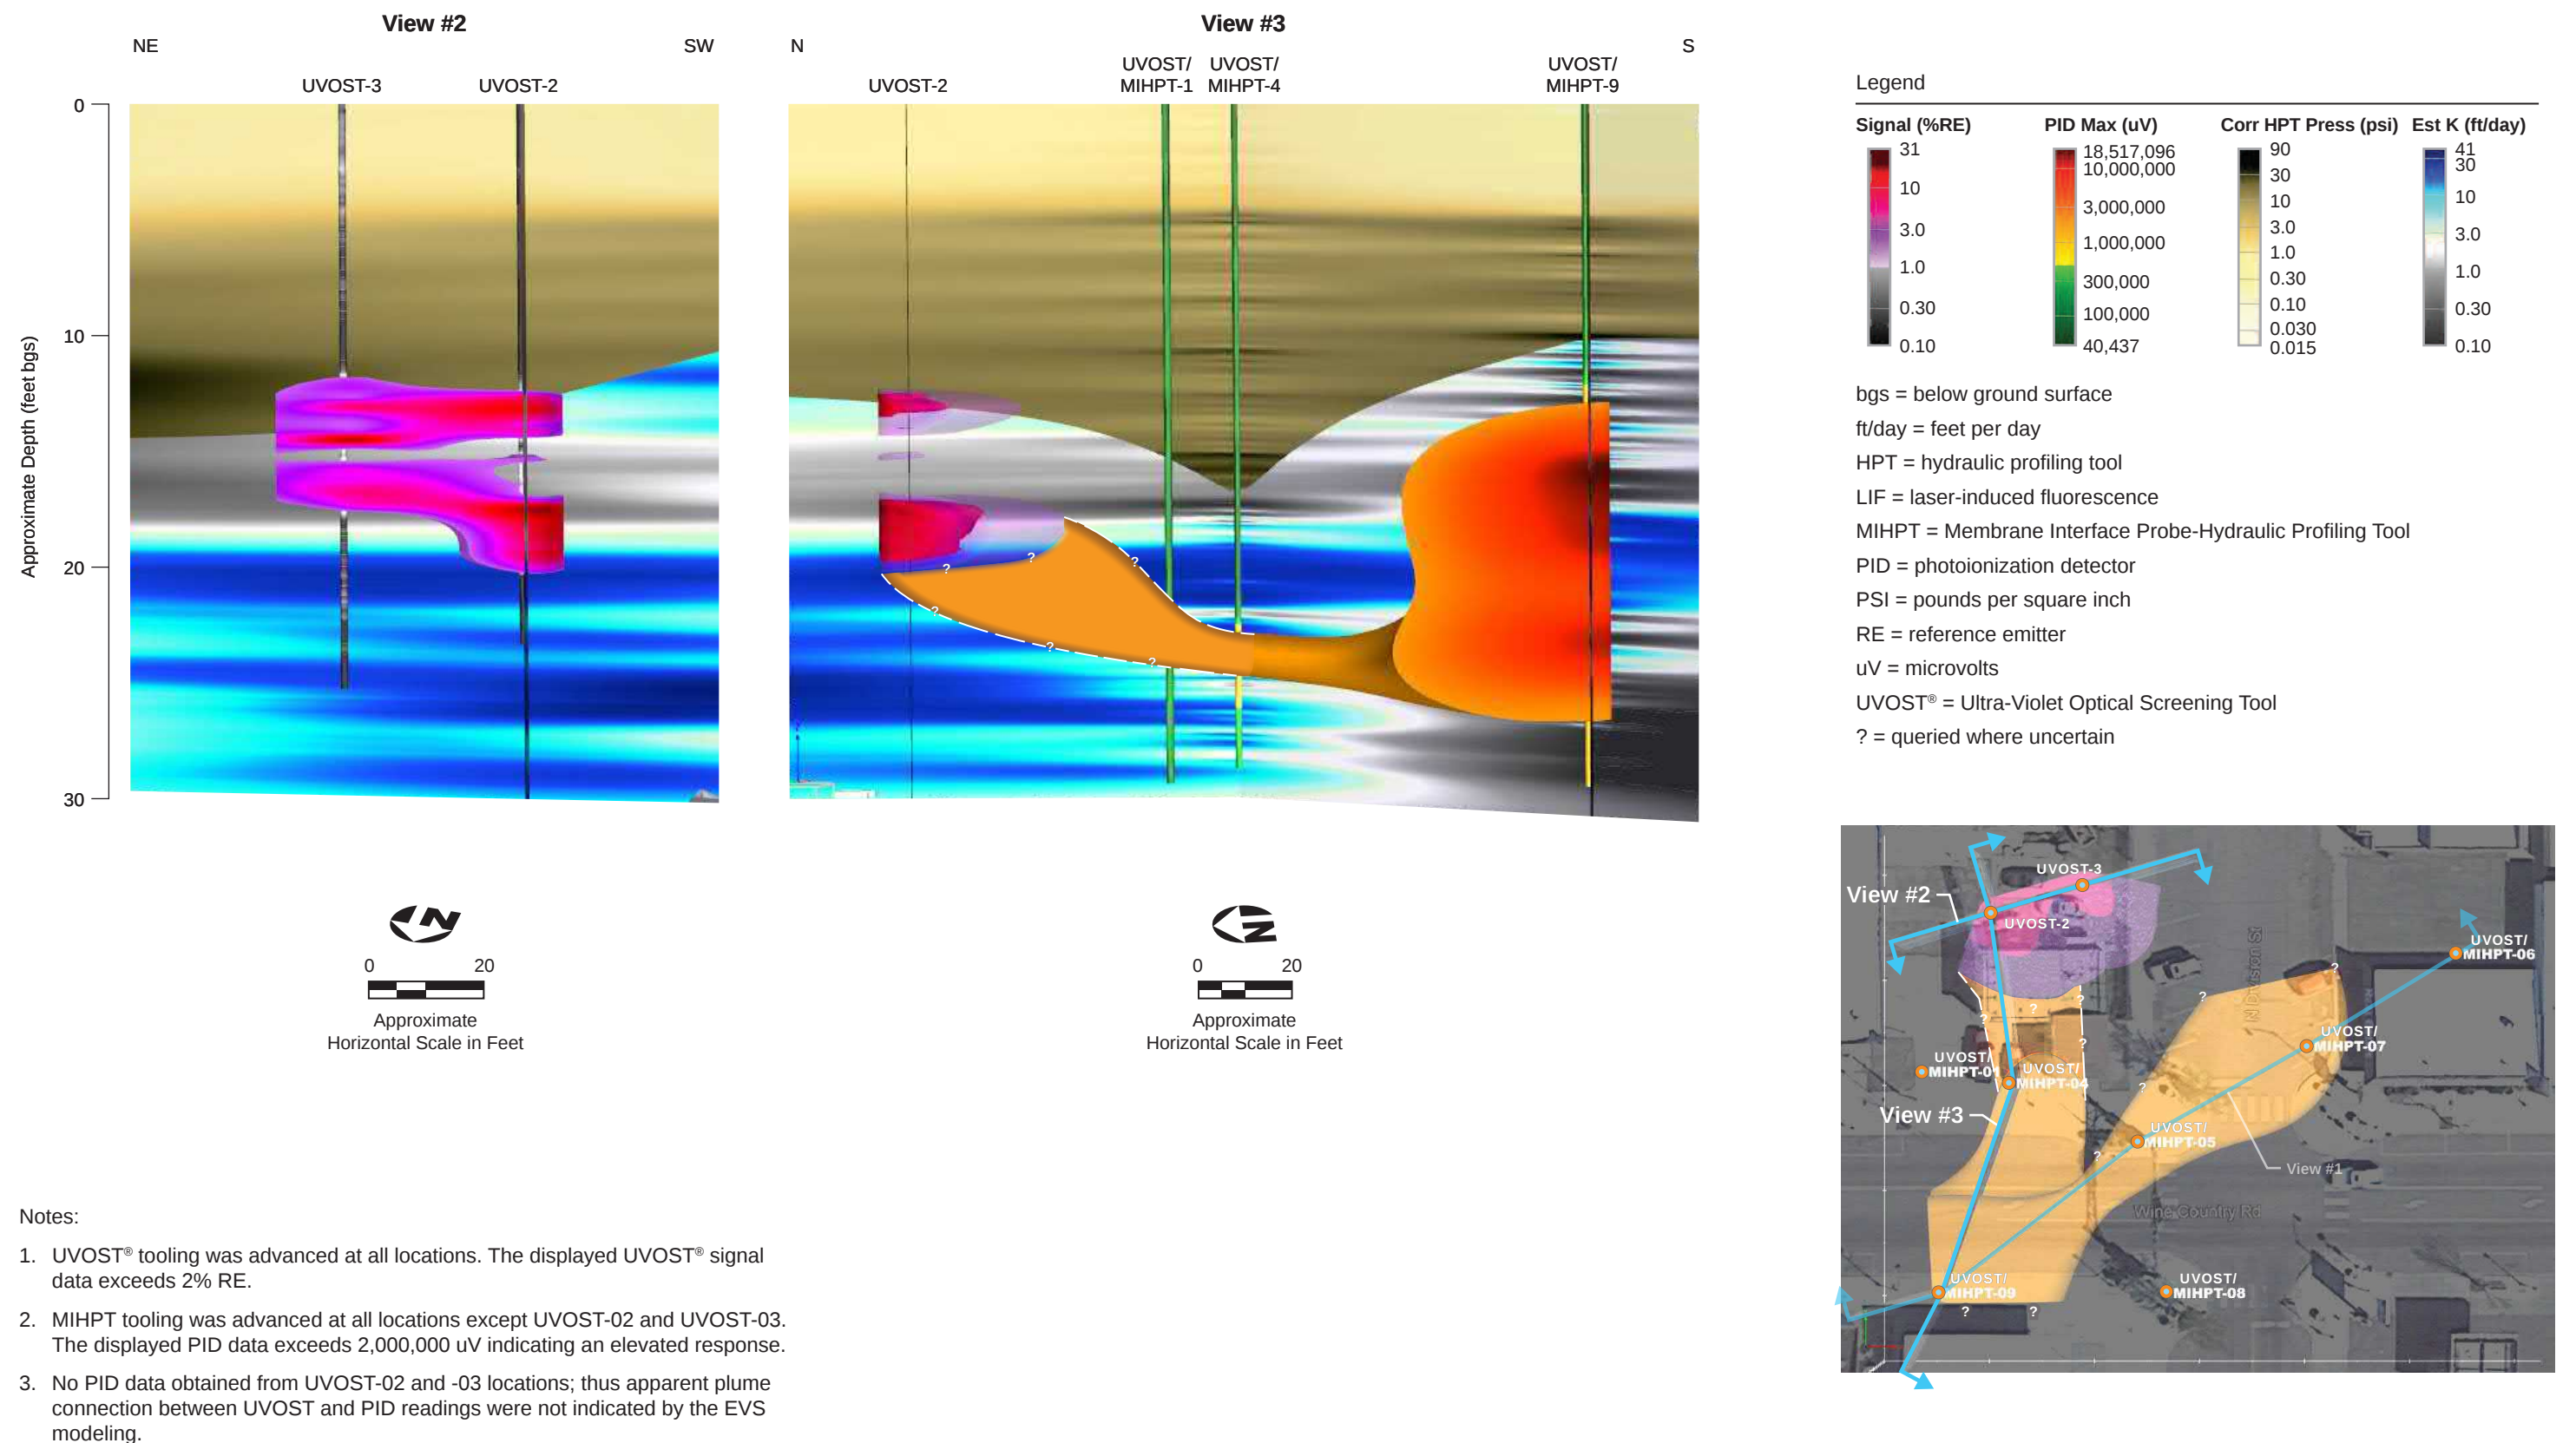
- The EC and hydraulic conductivity data generally confirmed that the site is underlain by interbedded sands and silt to silty sand. Higher hydraulic conductivity values were evident in the sandier material and contaminant migration rates are suspected to be greater in the sand layers (*Figures 9 and 10*). LNAPL identified beneath the 101 W. Wine Country Road property appears to be located within lower hydraulic conductivity siltier material (*Figure 10*).
