October 27, 2016

Subject: Engineering and Institutional Controls Monitoring Report – Year 2
Cap Sante Marine Site
Anacortes, Washington
Ecology Consent Decree No. 9917
GEI File No. 5147-005-10

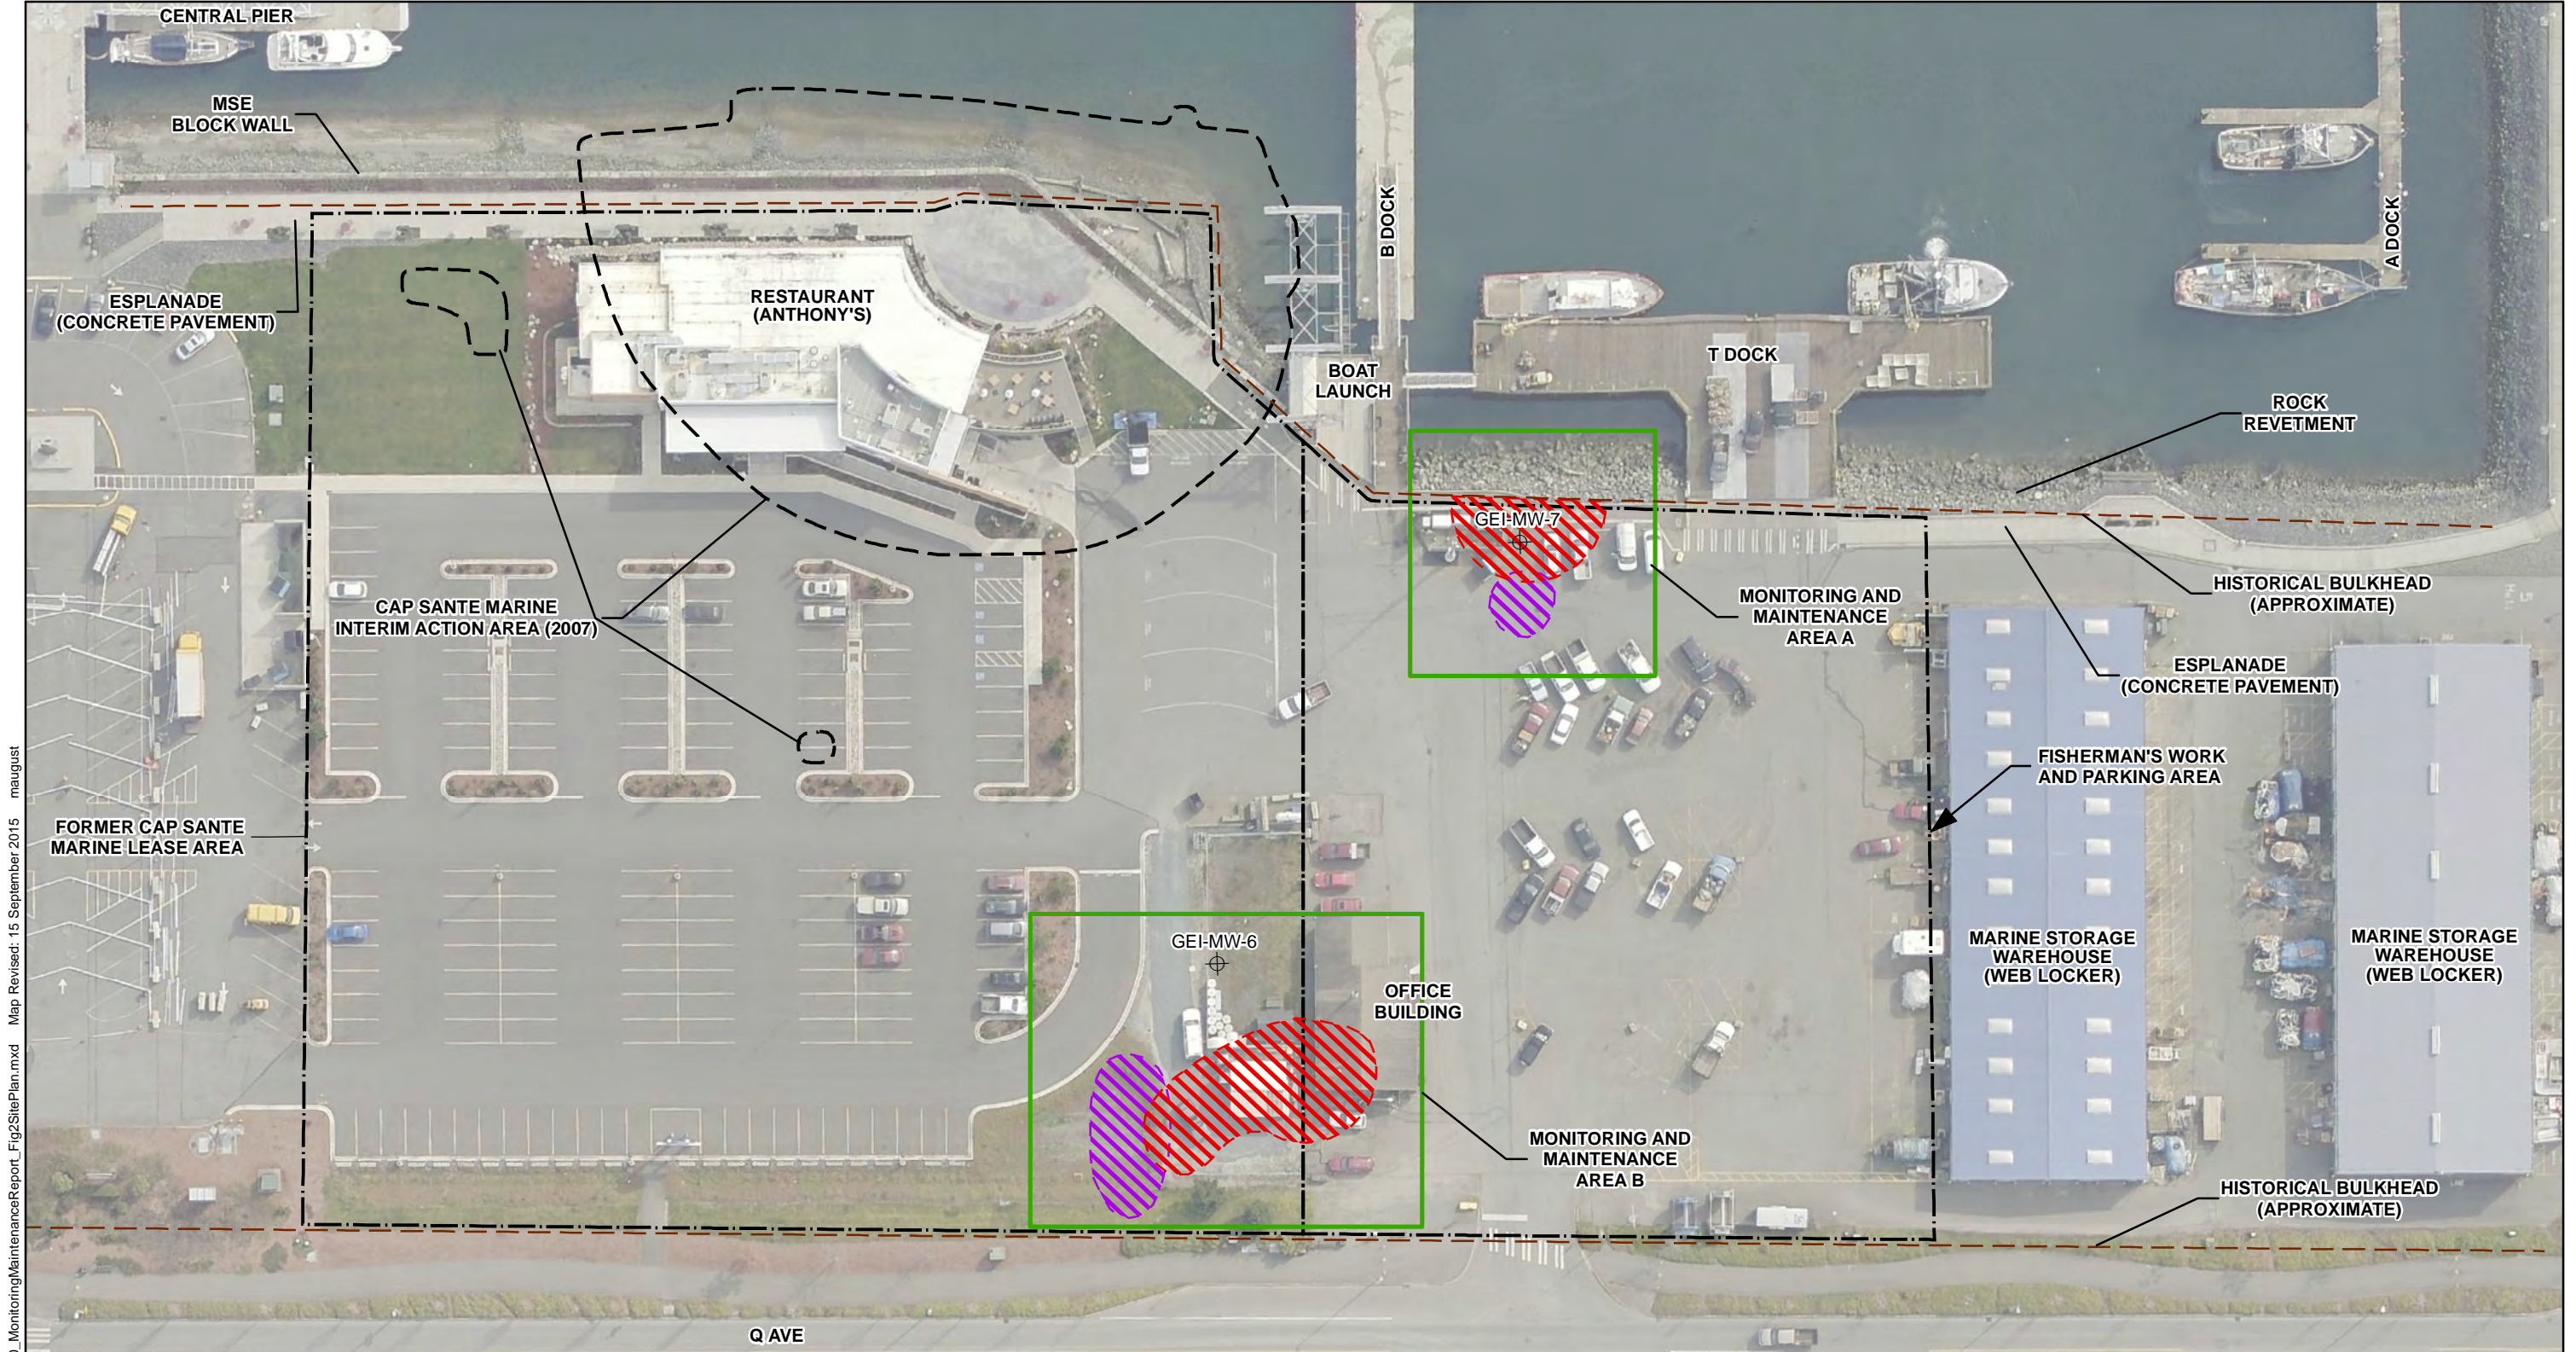
Site Plan	
Cap Sante Marine Site Anacortes, Washington	
	Figure 2

The location of the Site relative to surrounding physical features is shown on Figure 1. Current Site conditions and the locations of Monitoring and Maintenance Area A and B are shown on Figure 2. Site history including previous use, area redevelopment and cleanup actions implemented as well as, engineering and institutional controls established to prevent human/terrestrial wildlife exposure is summarized in the EICMP. Monitoring activities are summarized below.
