FOCUSED SITE ASSESSMENT REPORT

COLLEGE AVENUE STEAM PLANT
PULLMAN, WASHINGTON

Prepared for
PORT OF WHITMAN COUNTY
March 30, 2022
Project No. M0457.02.003

Prepared by
Maul Foster & Alongi, Inc.
601 East Front Ave., Suite 202, Coeur d'Alene, ID 83814

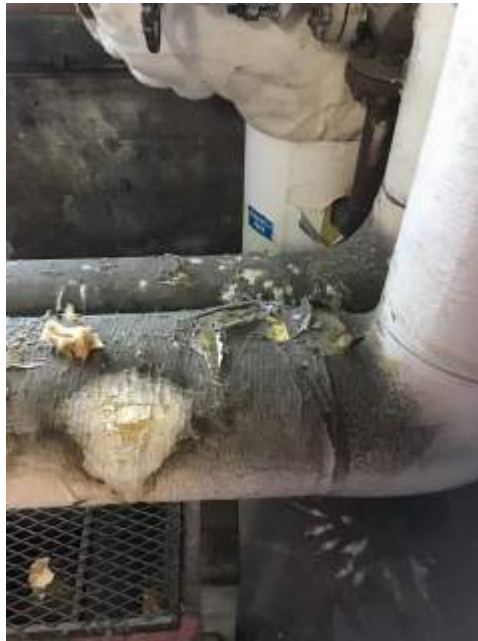
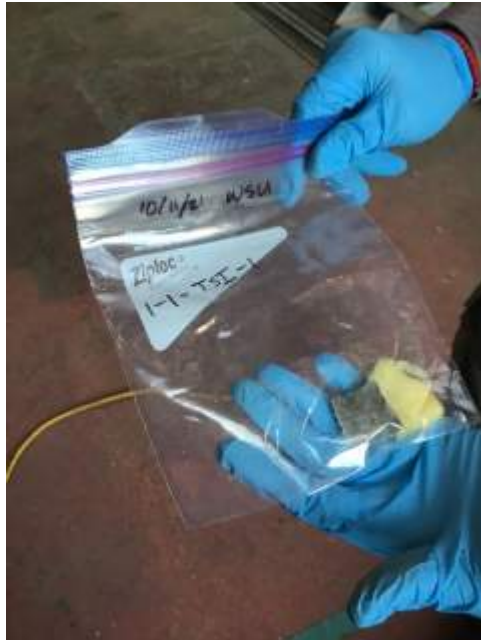
Sample ID:	Sample Type:	
1-1-TSI-1	TSI	
Sample Location:	Detailed Sample Location:	
Room 101	Condensate pipe in northwest corner of room.	
Sample Quantity:	38 linear feet.	
Sample Color:	XRF:	
Misc Sample Material:	Sample Condition:	Sample Friable?:
	Damaged or significantly damaged	Yes

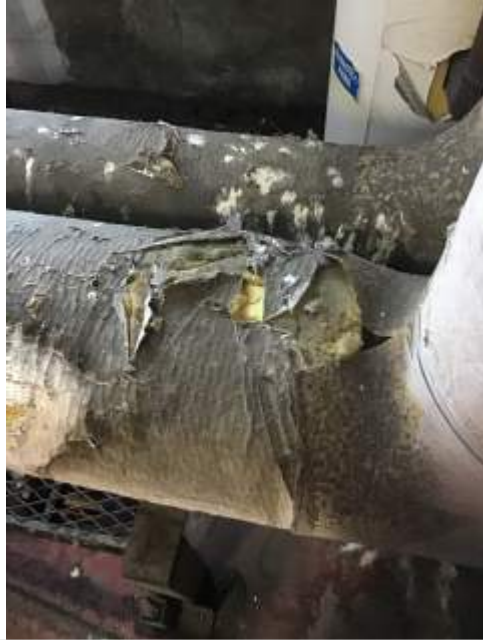
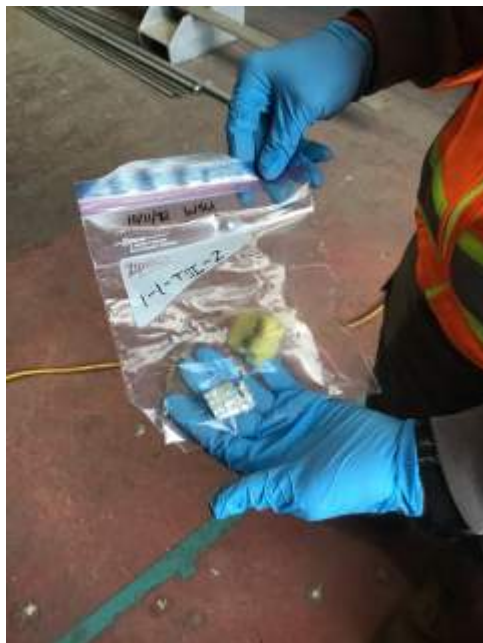
Additional Sample Notes:	White pipe wrapping with yellow insulation.	
Sample ID:	Sample Type:	
1-1-TSI-2	TSI	
Sample Location:	Detailed Sample Location:	
Room 101	Condensate pipe in northwest corner of room.	
Sample Quantity:	38 linear feet.	
Sample Color:	XRF:	
Misc Sample Material:	Sample Condition:	Sample Friable?:
	Damaged or significantly damaged	Yes

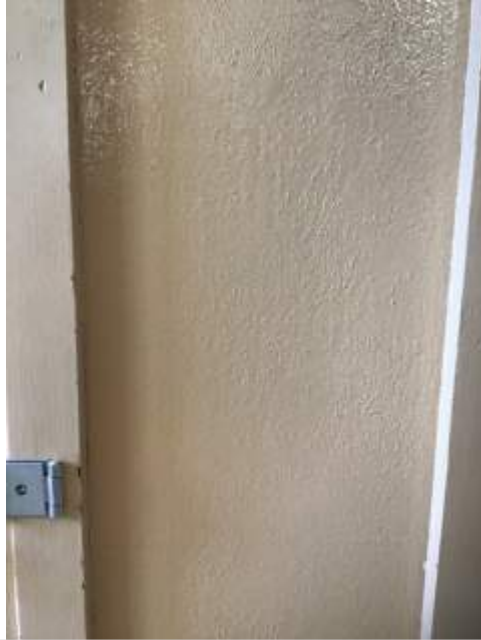
Additional Sample Notes:	White pipe wrapping with yellow insulation.
Sample ID:	Sample Type:
1-1-PB-1	PB
Sample Location:	Detailed Sample Location:
Room 102	West wall between room 106 doorway and stairway.
Sample Quantity:	N/A
Sample Color:	XRF:
Tan	0.108
Sample Photo:

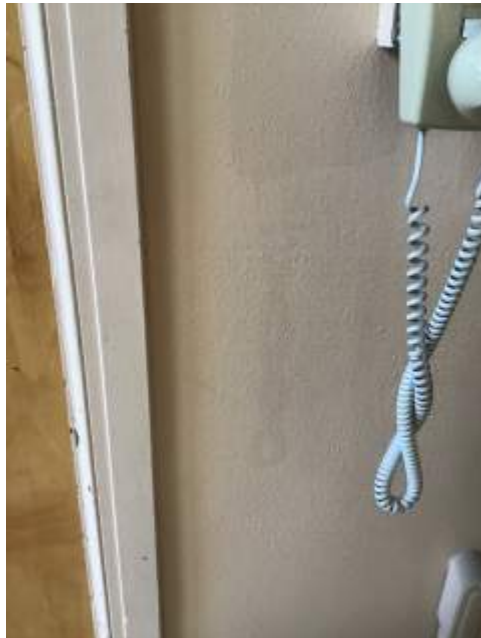
Sample ID:	Sample Type:
1-1-PB-2	PB
Sample Location:	Detailed Sample Location:
Room 102	West wall north of room 105 doorway.
Sample Quantity:	N/A
Sample Color:	XRF:
Tan	0.071

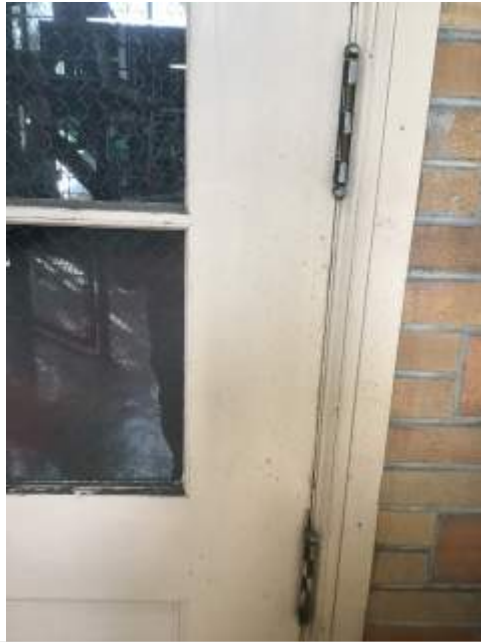
Sample ID:	Sample Type:
1-1-PB-3	PB
Sample Location:	Detailed Sample Location:
Room 102	North double doors between room 102 and 101.
Sample Quantity:	N/A
Sample Color:	XRF:
Tan	0.177

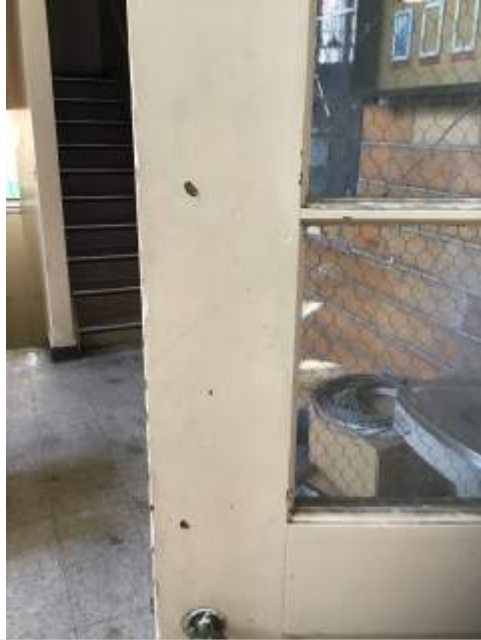
Sample ID:	Sample Type:
1-1-PB-4	PB
Sample Location:	Detailed Sample Location:
Room 102	North double door between room 102 and 101.
Sample Quantity:	N/A
Sample Color:	XRF:
Tan	0.224

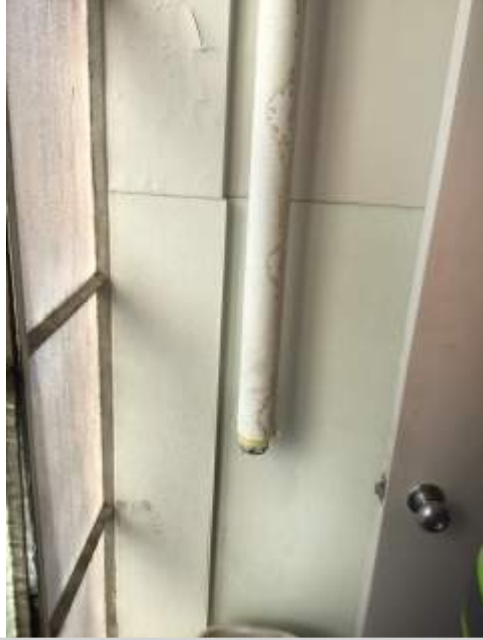
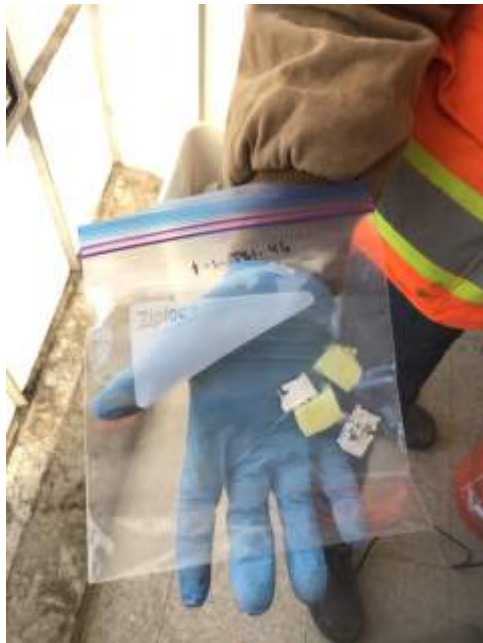
Additional Sample Notes:		
Sample ID:	Sample Type:	
1-1-TSI-46	TSI	
Sample Location:	Detailed Sample Location:	
Room 107	Pipe in northwest corner of room 107.	
Sample Quantity:	38 linear feet.	
Sample Color:	XRF:	
Misc Sample Material:	Sample Condition:	Sample Friable?:
	Damaged or significantly damaged; Potential ACBM with potential for significant damage	Yes

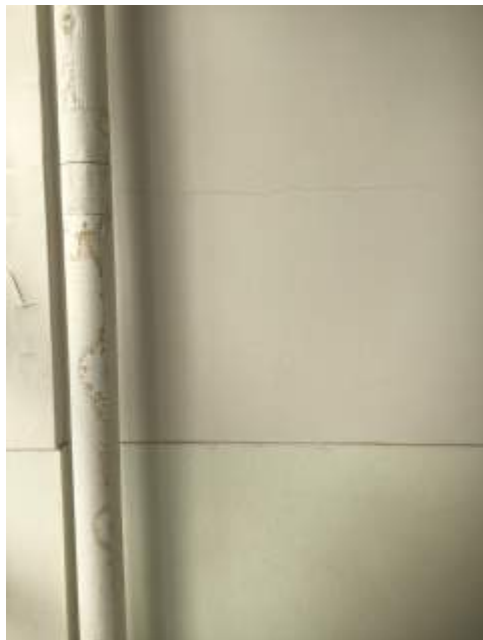
Sample ID:	Sample Type:
1-2-PB-6	PB
Sample Location:	Detailed Sample Location:
Room 107	North wall of room 107.
Sample Quantity:	120 square feet.
Sample Color:	XRF:
White	1.63

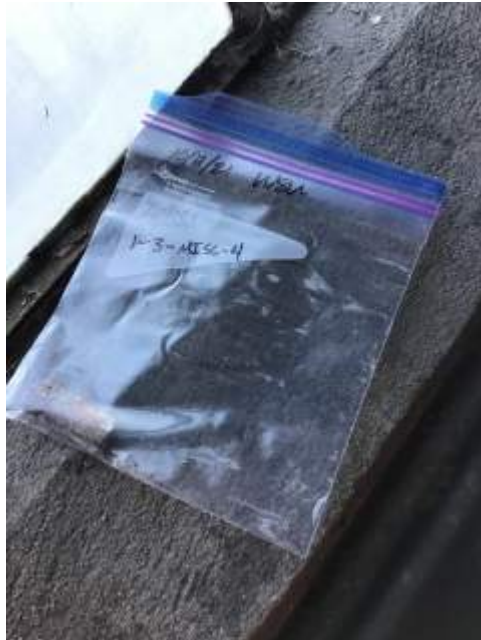
Additional Sample Notes:		White pipe covering with yellow insulation.
Sample ID:	Sample Type:	
1-3-MISC-4	MISC	
Sample Location:	Detailed Sample Location:	
Room 101	Window at northwest corner of room.	
Sample Quantity:	4,030 linear feet.	
Misc Sample Material:	Sample Condition:	Sample Friable?:
Window glazing.	Potential ACBM with potential for damage	Yes

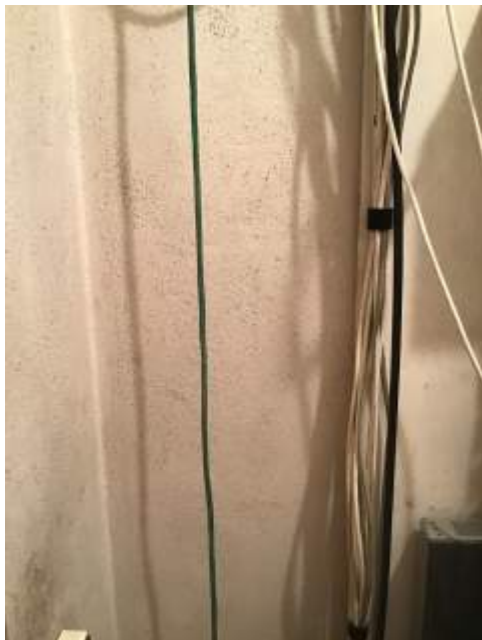
Sample ID:	Sample Type:
1-3-PB-7	PB
Sample Location:	Detailed Sample Location:
Room 106T	East wall in room 106T.
Sample Quantity:	N/A
Sample Color:	XRF:
Off-white	ND

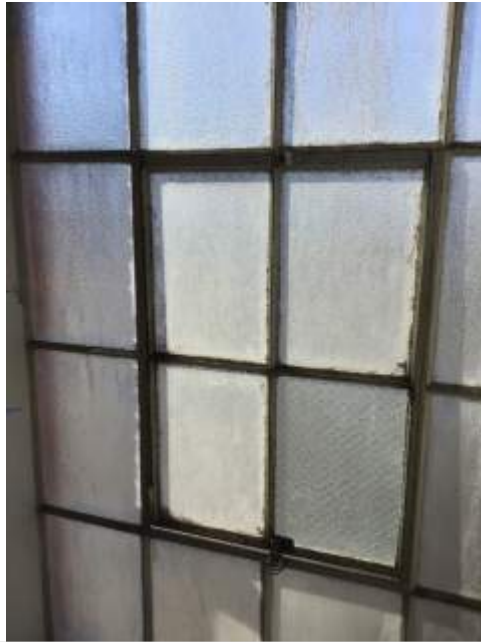
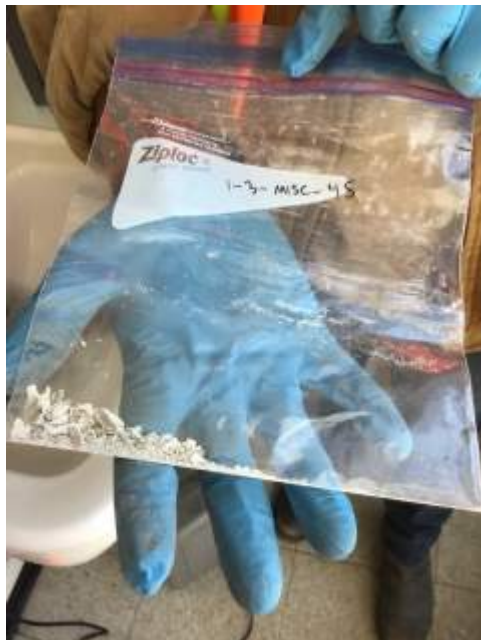
Sample ID:	Sample Type:	
1-3-MISC-45	MISC	
Sample Location:	Detailed Sample Location:	
Room 107	West wall window frame in room 107.	
Sample Quantity:	4,030 linear feet.	
Misc Sample Material:	Sample Condition:	Sample Friable?:
Window glazing.	Potential ACBM with potential for damage	No

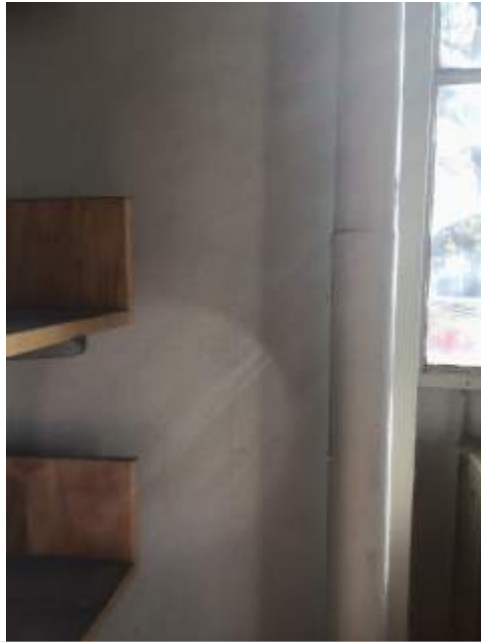
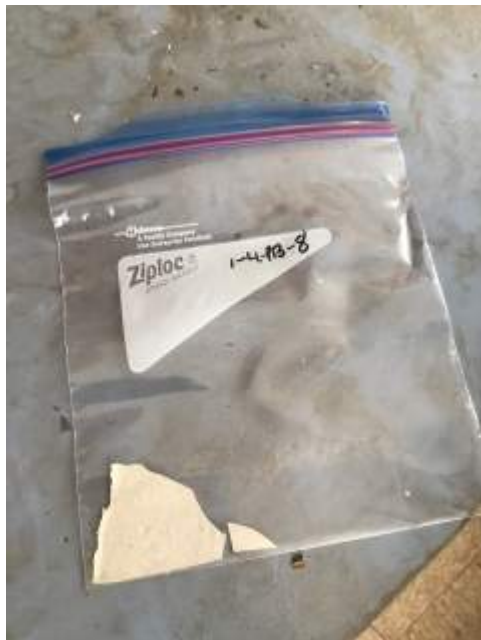
Sample ID:	Sample Type:
1-4-PB-8	PB
Sample Location:	Detailed Sample Location:
Room 104	South wall east of window in room 104.
Sample Quantity:	N/A
Sample Color:	XRF:
White	0.181

Additional Sample Notes:	Submitted paint chip sample to laboratory for analysis.
---------------------------------	---

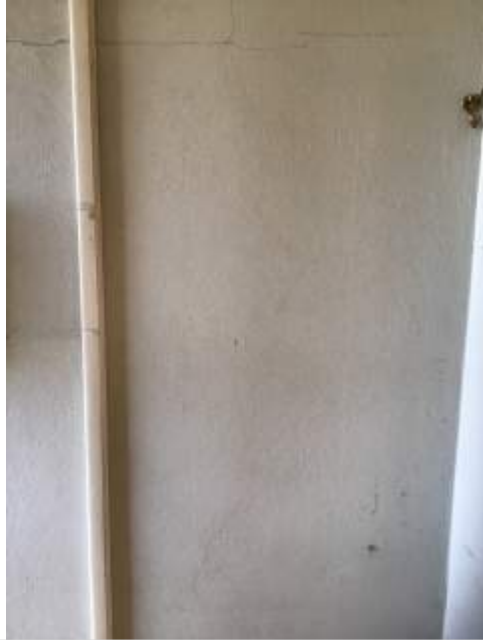
Sample ID:	Sample Type:
1-4-PB-10	PB
Sample Location:	Detailed Sample Location:
Room 105	East side of north wall.
Sample Quantity:	N/A
Sample Color:	XRF:
White	0.211

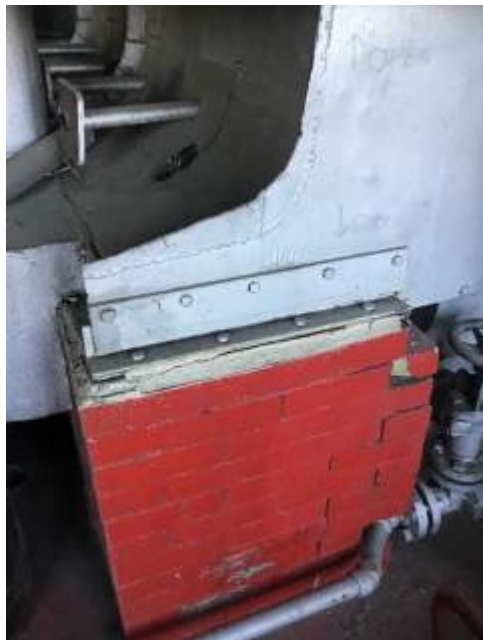
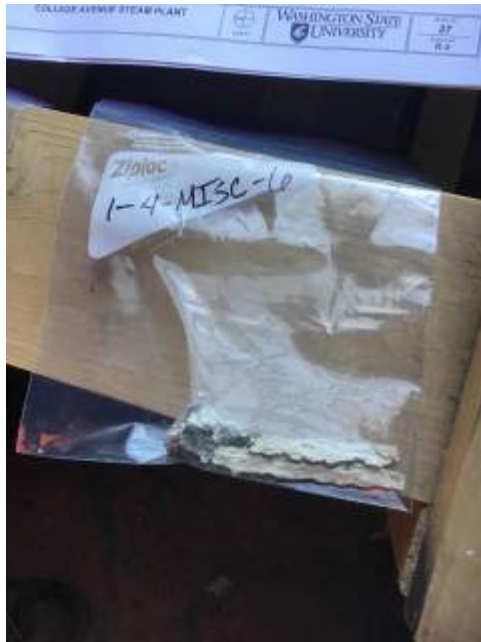
Sample ID:	Sample Type:	
1-4-MISC-6	MISC	
Sample Location:	Detailed Sample Location:	
Room 101	Above red brick on northwest corner of northwest boiler.	
Sample Quantity:	3.5 linear feet.	
Misc Sample Material:	Sample Condition:	Sample Friable?:
Tan cementitious material.	Potential ACBM with potential for damage	Yes

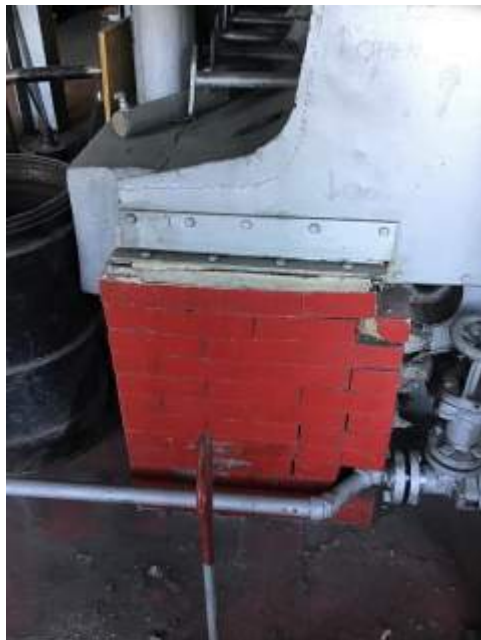
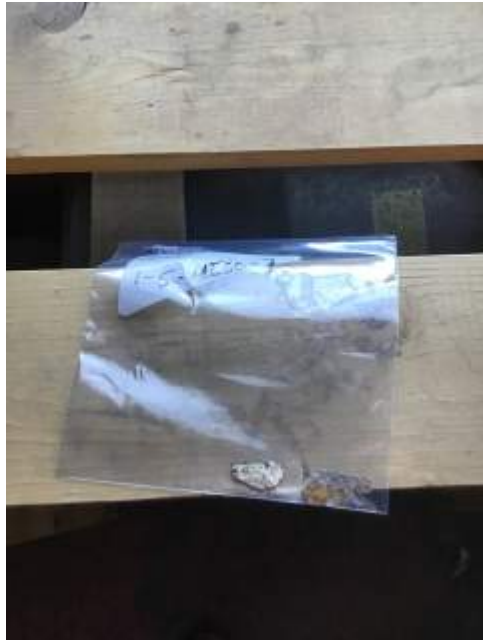
Sample ID:	Sample Type:	
1-5-MISC-7	MISC	
Sample Location:	Detailed Sample Location:	
Room 101	Red brick on northwest corner of northwest boiler.	
Sample Quantity:	8 square feet.	
Misc Sample Material:	Sample Condition:	Sample Friable?:
Red brick.	Potential ACBM with potential for damage	Yes

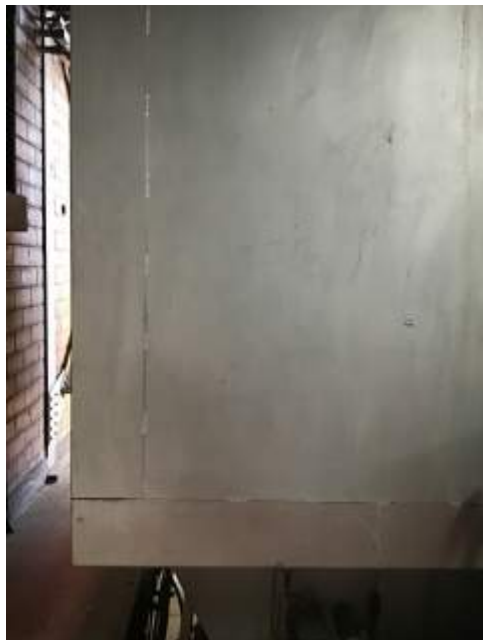
Sample ID:	Sample Type:
1-5-PB-11	PB
Sample Location:	Detailed Sample Location:
Room 101	South side of east wall on south boiler.
Sample Quantity:	N/A
Sample Color:	XRF:
Silver	ND

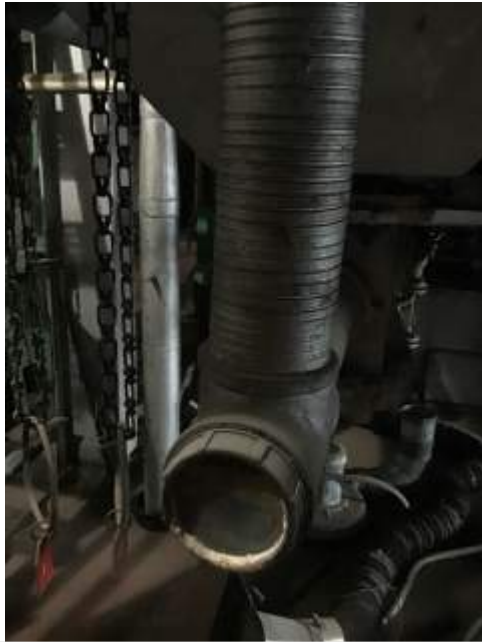
Sample ID:	Sample Type:
1-5-PB-34	PB
Sample Location:	Detailed Sample Location:
Room 101	North side of northeast boiler.
Sample Quantity:	N/A
Sample Color:	XRF:
Silver	ND

Additional Sample Notes:	Silver paint on various steam equipment in room 101.
---------------------------------	--

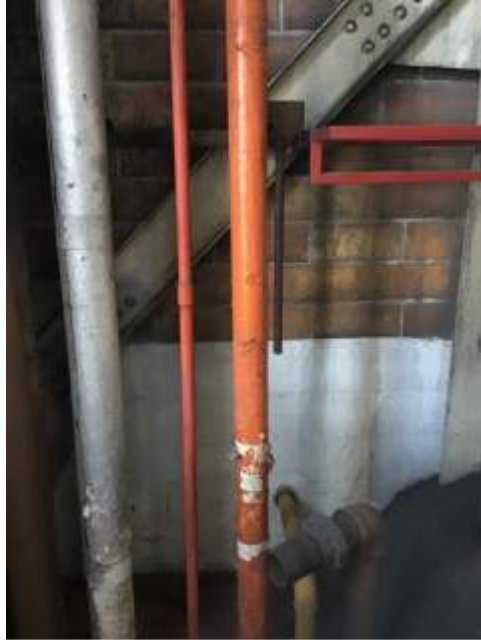
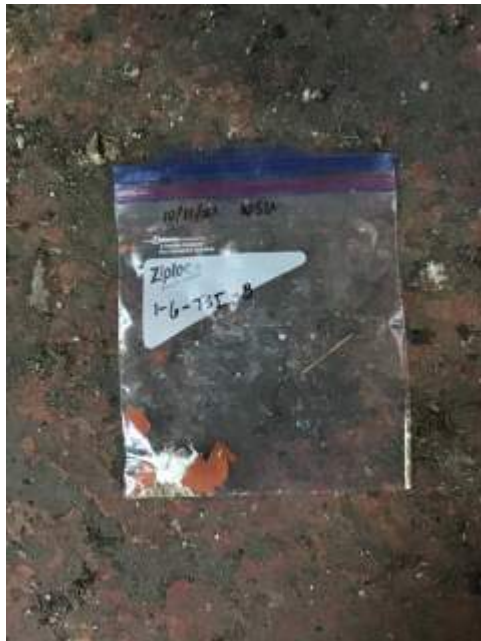
Additional Sample Notes:		
Sample ID:	Sample Type:	
1-6-TSI-8	TSI	
Sample Location:	Detailed Sample Location:	
Room 101	Red pipe by double doors on west side of room.	
Sample Quantity:	20 linear feet.	
Sample Color:	XRF:	
Misc Sample Material:	Sample Condition:	Sample Friable?:
Tan cementitious material	Damaged or significantly damaged	Yes

Additional Sample Notes:	Red pipe wrap with fibrous white insulation.
Sample ID:	Sample Type:
1-6-PB-38	PB
Sample Location:	Detailed Sample Location:
Room 101	Green pipe on south end of south middle boiler.
Sample Quantity:	N/A
Sample Color:	XRF:
Green	0.375

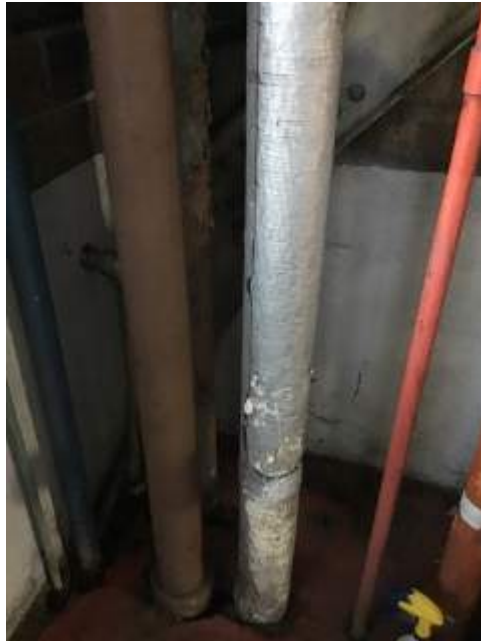
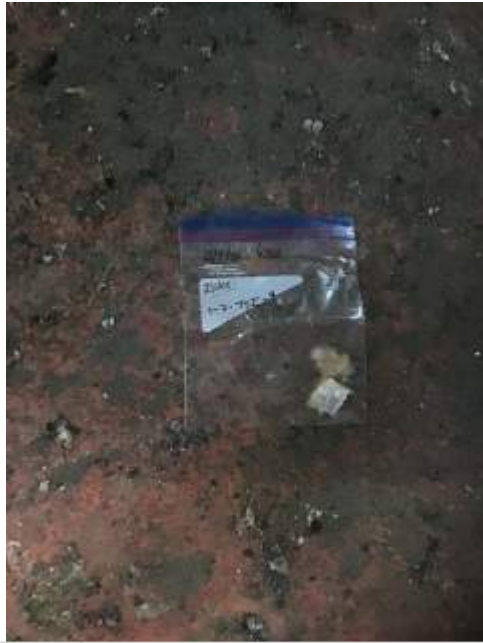
Additional Sample Notes:	Green paint on various steam equipment in 101.	
Sample ID:	Sample Type:	
1-7-TSI-9	TSI	
Sample Location:	Detailed Sample Location:	
Room 101	Silver pipe by double doors on west side of room.	
Sample Quantity:	30 linear feet.	
Sample Color:	XRF:	
Misc Sample Material:	Sample Condition:	Sample Friable?:
Tan cementitious material	Damaged or significantly damaged	Yes

Additional Sample Notes:	Silver pipe wrap with yellow fibrous insulation
Sample ID:	Sample Type:
1-7-PB-13	PB
Sample Location:	Detailed Sample Location:
Room 101	Floor on south side of room in front of double door between room 102 and 101.
Sample Quantity:	N/A
Sample Color:	XRF:
Red	0.188

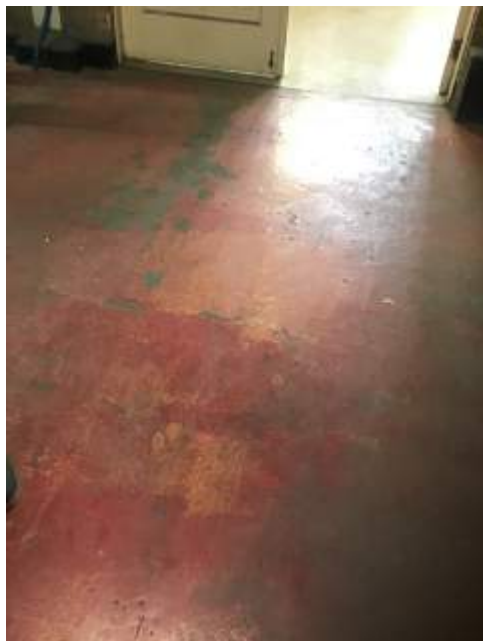
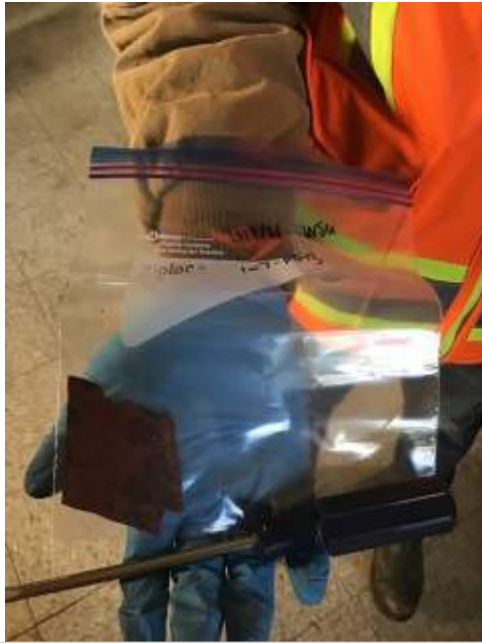
1-7-PB-13

Additional Sample Notes:	Submitted paint chip sample to laboratory for analysis.
Sample ID:	Sample Type:
1-8-PB-14	PB
Sample Location:	Detailed Sample Location:
Room 101	West metal support beam next to fire extinguisher.
Sample Quantity:	15 square feet
Sample Color:	XRF:
Red	5.00

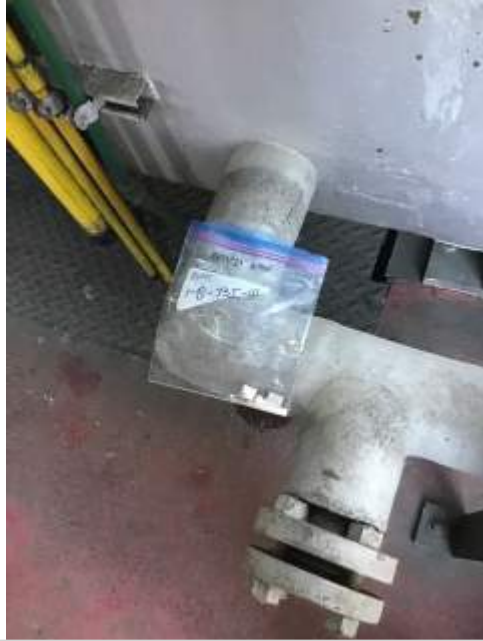
1-8-TSI-10

Misc Sample Material: Tan cementitious material **Sample Condition:** Damaged or significantly damaged **Sample Friable?:** Yes

White fibrous insulation with various colors of pipe wrap covers (e.g., also includes red pipe in southwest corner of room that runs to north section of room). Difficult to quantify due to distribution and various wrap colors.

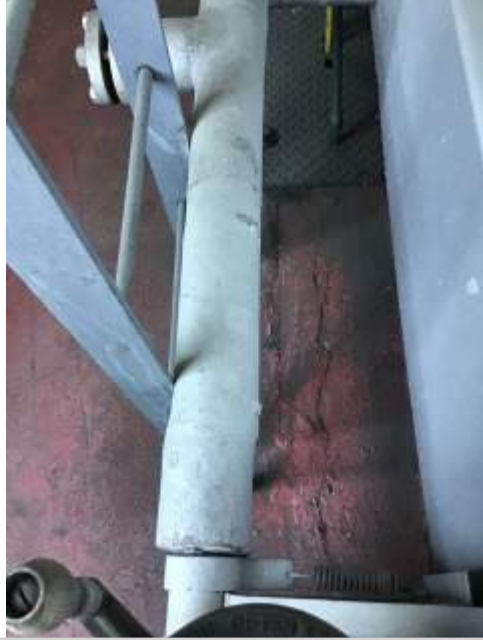
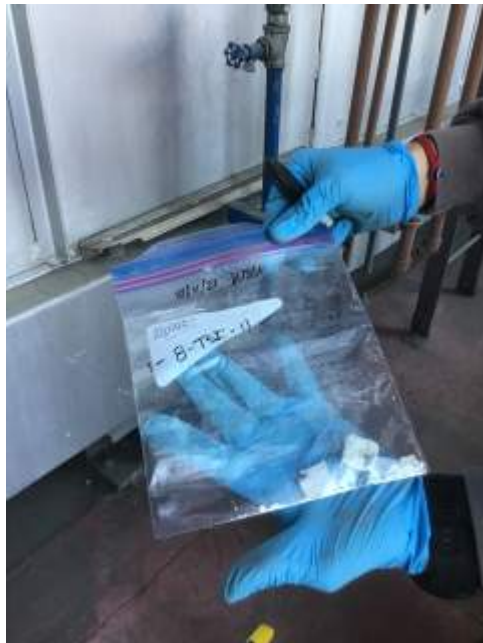
Sample ID:	Sample Type:	
1-8-TSI-11	TSI	
Sample Location:	Detailed Sample Location:	
Room 101	Silver pipe on boiler by staircase to lower floor on west side of room.	
Sample Quantity:	3,000 linear feet.	
Sample Color:	XRF:	
Misc Sample Material:	Sample Condition:	Sample Friable?:
Tan cementitious material	Damaged or significantly damaged	Yes

White fibrous insulation with various colors of pipe wrap covers (e.g., also includes red pipe in southwest corner of room that runs to north section of room). Difficult to quantify due to distribution and various wrap colors.

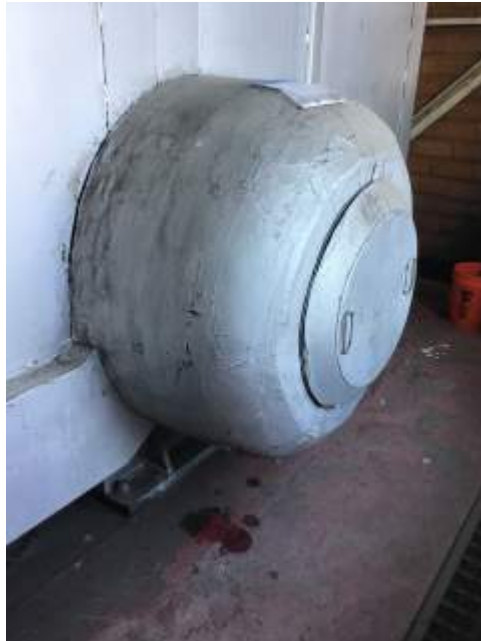
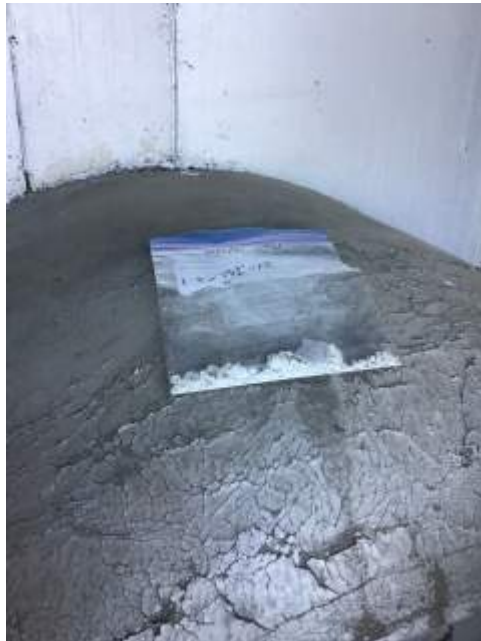
1-8-TSI-12

Misc Sample Material:	Sample Condition:	Sample Friable?:
Tan cementitious material	Damaged or significantly damaged	Yes

Additional Sample Notes:	White fibrous insulation with various colors of pipe wrap covers (e.g., also includes red pipe in southwest corner of room that runs to north section of room). Difficult to quantify due to distribution and various wrap colors.
---------------------------------	--

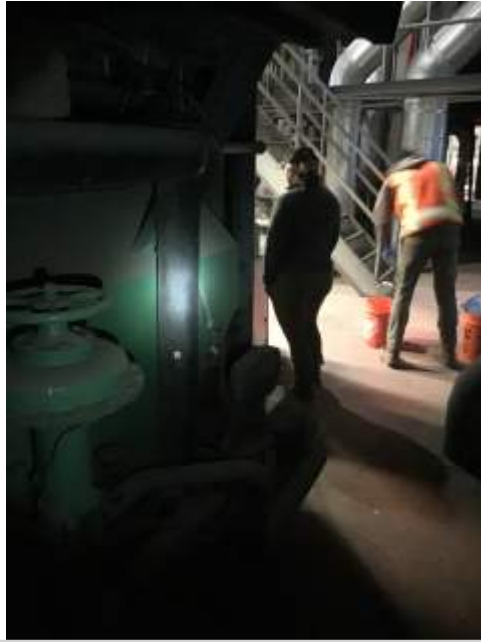
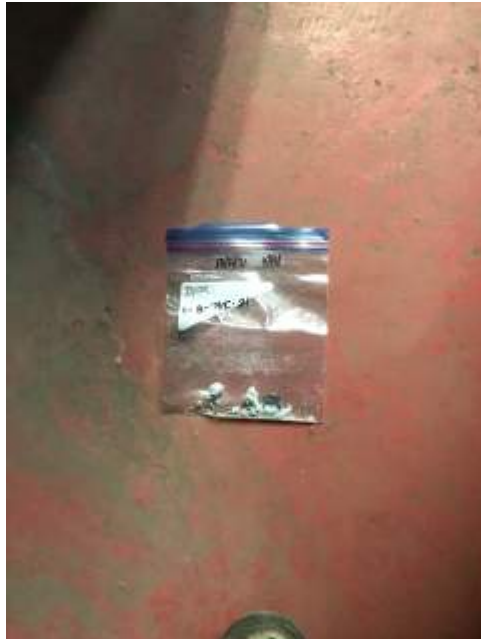
1-8-TSI-21

Room 101	Dark gray pipe between boilers 4 and 5.	
Sample Quantity:	3,000 linear feet.	
Sample Color:	XRF:	
Misc Sample Material:	Sample Condition:	Sample Friable?:
Tan cementitious material	Damaged or significantly damaged	Yes

Additional Sample Notes:	Dark gray pipe wrap with white fibrous insulation. Insulation appears to be consistent with Homogenous Area 8. Difficult to quantify due to distribution and various wrap colors.
---------------------------------	---

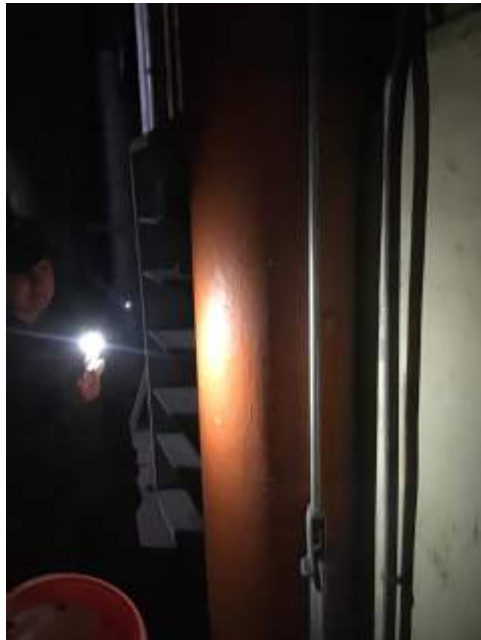
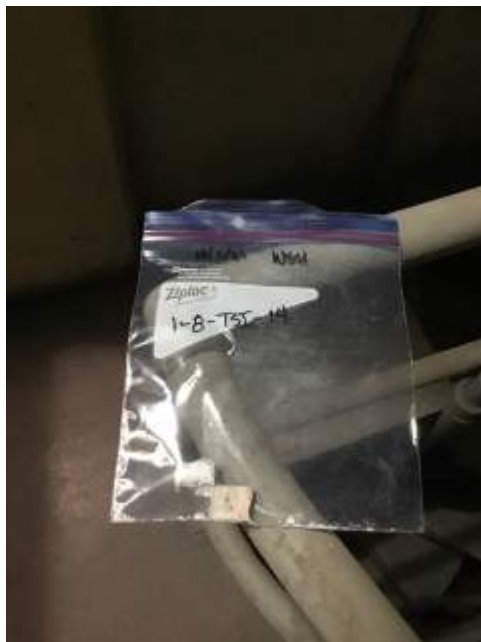
Sample ID:	Sample Type:	
1-8-TSI-14	TSI	
Sample Location:	Detailed Sample Location:	
Room 101	Orange pipe in southeast corner of room.	
Sample Quantity:	3,000 linear feet.	
Sample Color:	XRF:	
Misc Sample Material:	Sample Condition:	Sample Friable?:
Tan cementitious material	Damaged or significantly damaged	Yes

Additional Sample Notes:	White fibrous insulation with various colors of pipe wrap covers (e.g., also includes red pipe in southwest corner of room that runs to north section of room). Difficult to quantify due to distribution and various wrap colors.
---------------------------------	--

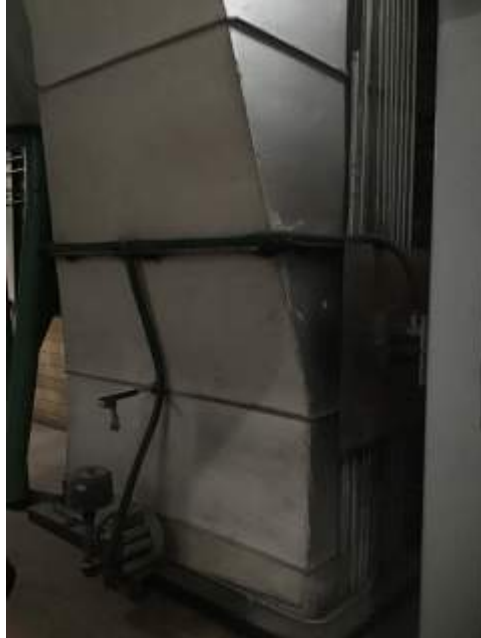
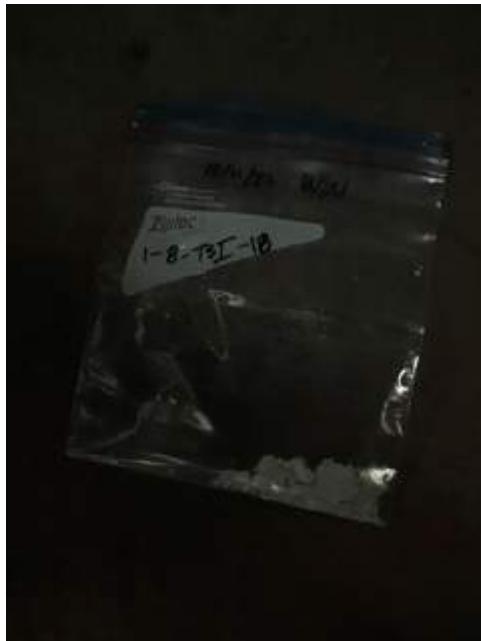
Sample ID:	Sample Type:	
1-8-TSI-18	TSI	
Sample Location:	Detailed Sample Location:	
Room 101	East side of room.	
Sample Quantity:	3,000 linear feet.	
Sample Color:	XRF:	
Misc Sample Material:	Sample Condition:	Sample Friable?:
Tan cementitious material	Damaged or significantly damaged	Yes

Gray duct cover with white fibrous insulation. Insulation appears to be consistent with Homogenous Area 8. Difficult to quantify due to distribution and various wrap colors.

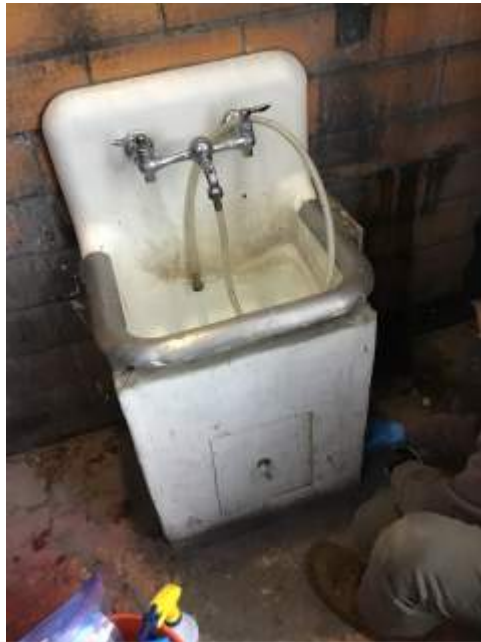
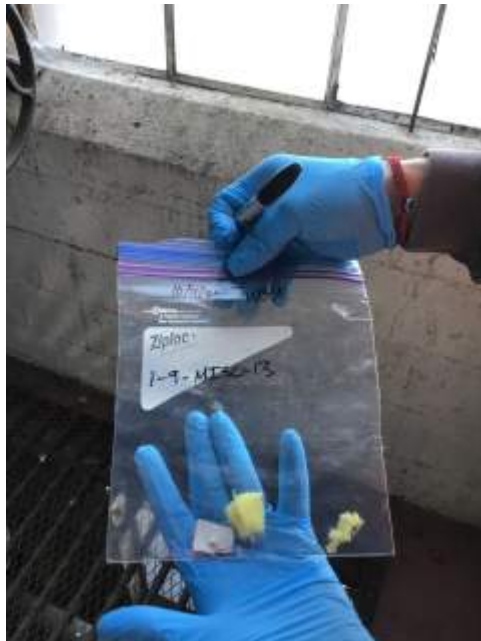
1-9-MISC-13

Potential ACBM with potential for damage

Additional Sample Notes:	Yellow fibrous insulation.
---------------------------------	----------------------------

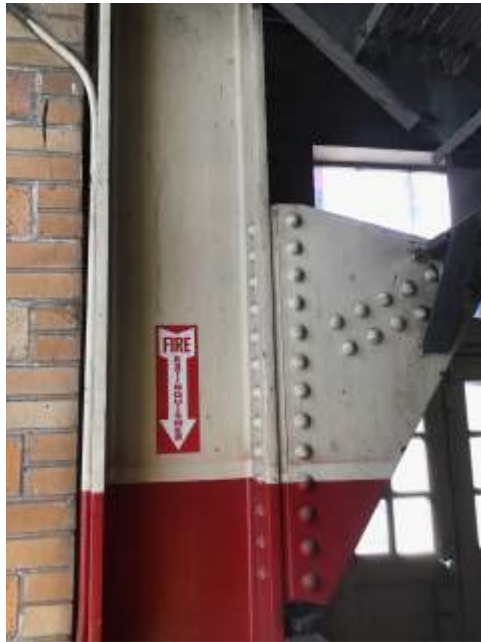
Sample ID:	Sample Type:
1-9-PB-15	PB
Sample Location:	Detailed Sample Location:
Room 101	West metal support beam above fire extinguisher.
Sample Quantity:	3,000 square feet.
Sample Color:	XRF:
White	5.00

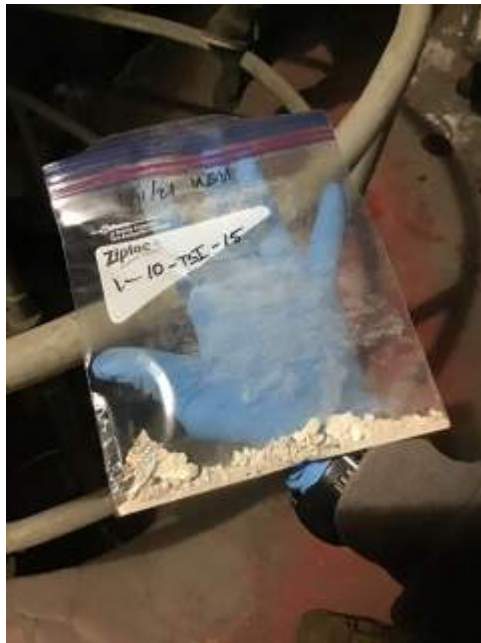
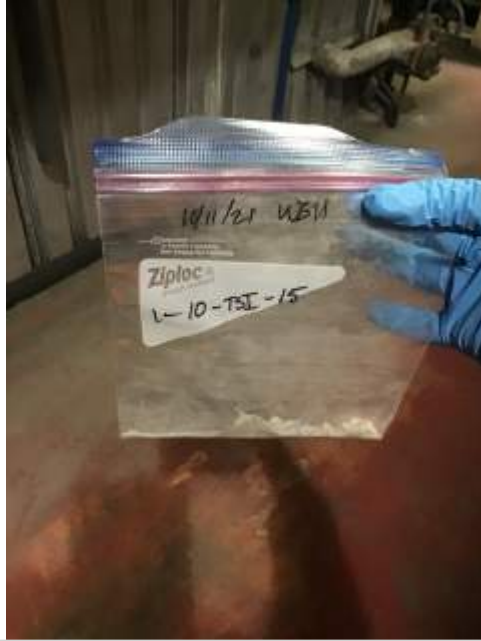
Additional Sample Notes:		
Sample ID:	Sample Type:	
1-10-TSI-15	TSI	
Sample Location:	Detailed Sample Location:	
Room 101	Southeast corner of room on corrugated boiler.	
Sample Quantity:	2 linear feet.	
Sample Color:	XRF:	
Misc Sample Material:	Sample Condition:	Sample Friable?:
Tan cementitious material	Damaged or significantly damaged	Yes

Additional Sample Notes:	Gray insulation and fabric.	
Sample ID:	Sample Type:	
1-11-MISC-16	MISC	
Sample Location:	Detailed Sample Location:	
Room 101	Southeast corner of room on corrugated boiler wall.	
Sample Quantity:	2 linear feet.	
Misc Sample Material:	Sample Condition:	Sample Friable?:
Tan soundproofing material.	Potential ACBM with potential for damage	Yes

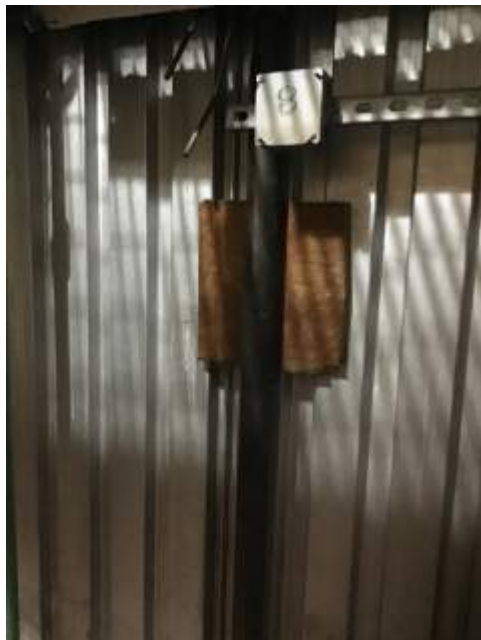
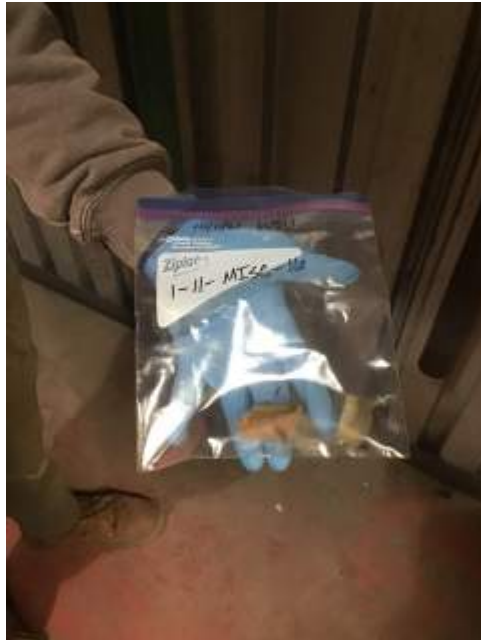
1-11-MISC-16

Additional Sample Notes:	Soundproofing material.
Sample ID:	Sample Type:
1-11-PB-17	PB
Sample Location:	Detailed Sample Location:
Room 101	Mirror above sink in southwest corner of room 101.
Sample Quantity:	N/A
Sample Color:	XRF:
Green	0.472

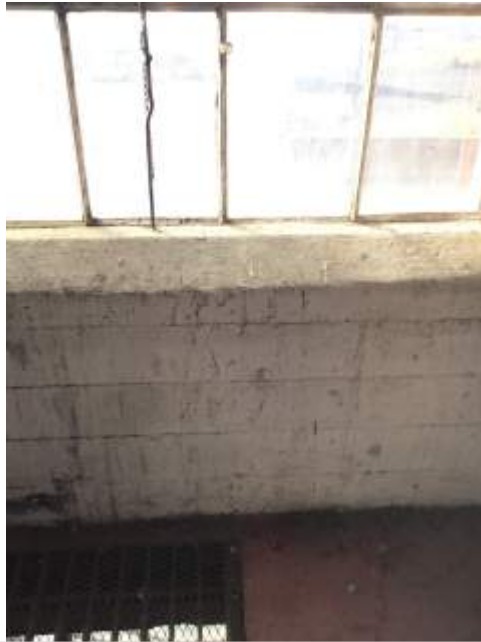
Sample ID:	Sample Type:
1-12-PB-18	PB
Sample Location:	Detailed Sample Location:
Room 101	Southwest corner of room 101.
Sample Quantity:	N/A
Sample Color:	XRF:
White	0.013

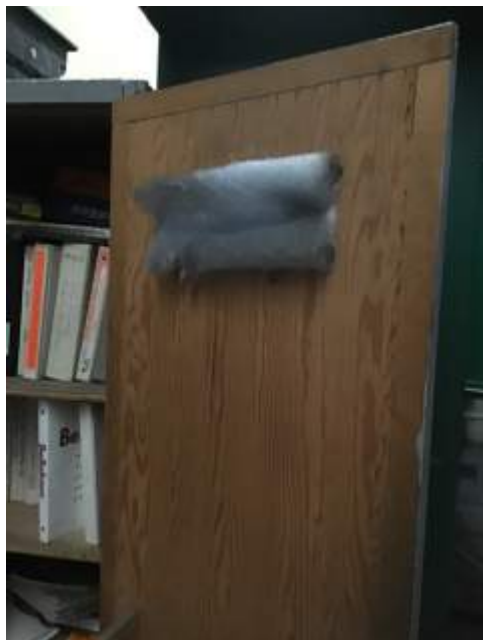
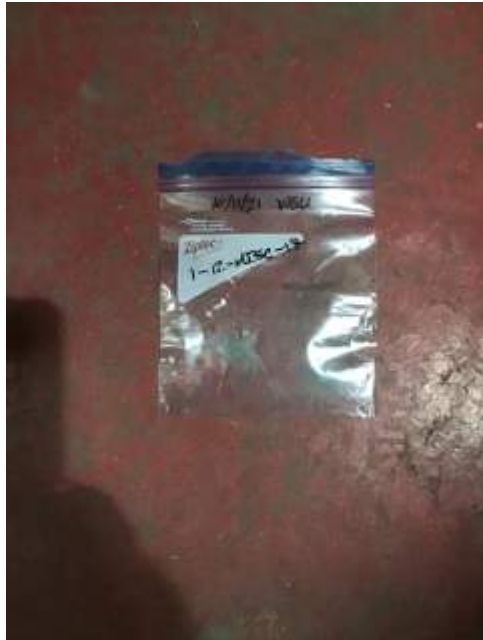
Sample ID:	Sample Type:	
1-12-MISC-17	MISC	
Sample Location:	Detailed Sample Location:	
Room 101	Green cabinet in southeast corner of room.	
Sample Quantity:	Less than 5 square feet.	
Misc Sample Material:	Sample Condition:	Sample Friable?:
Gray fibrous material.	Damaged or significantly damaged friable miscellaneous ACM	Yes

Additional Sample Notes:	Gray fibrous material.
Sample ID:	Sample Type:
1-12-PB-39	PB
Sample Location:	Detailed Sample Location:
Room 101	Southeast corner of room 101.
Sample Quantity:	N/A
Sample Color:	XRF:
White	0.068

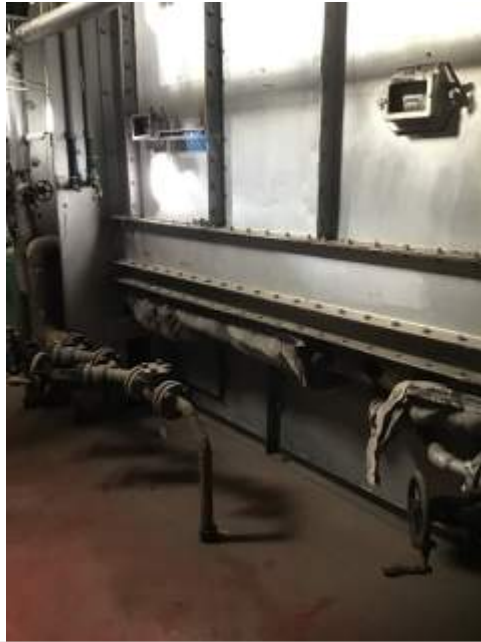
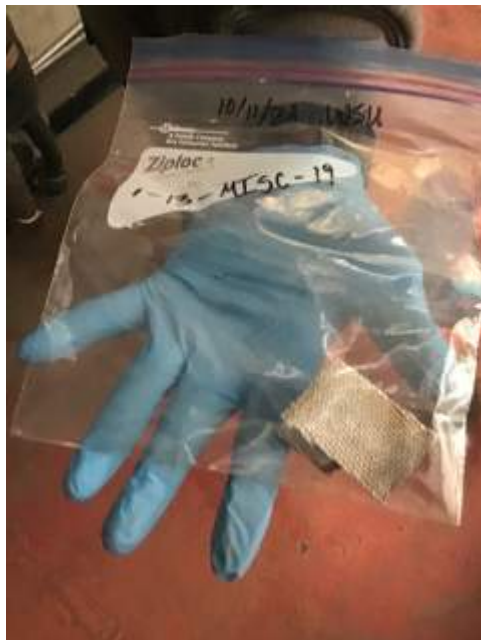
Additional Sample Notes:		
Sample ID:	Sample Type:	
1-13-MISC-19	MISC	
Sample Location:	Detailed Sample Location:	
Room 101	Soundproofing material on boiler in northeast corner of room.	
Sample Quantity:	15 square feet.	
Misc Sample Material:	Sample Condition:	Sample Friable?:
Gray and tan soundproofing material wrap.	Potential ACBM with potential for damage	Yes

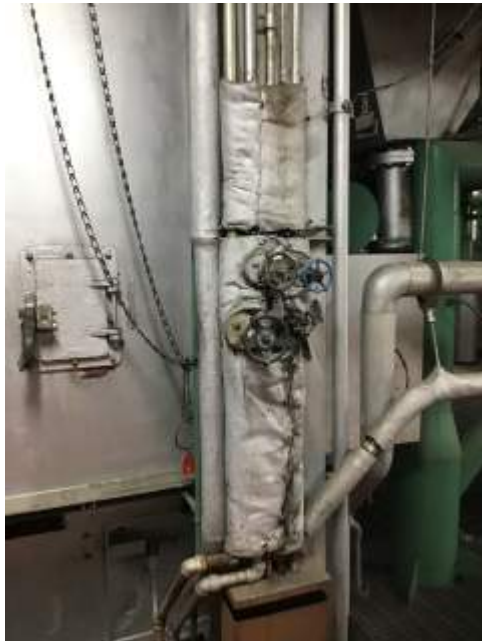
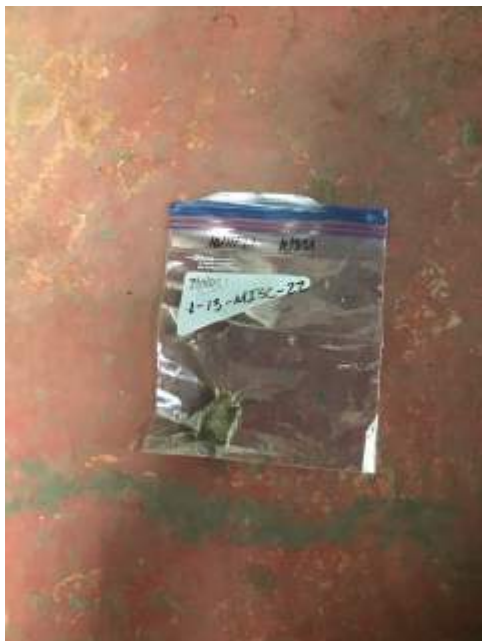
Additional Sample Notes:		
Sample ID:	Sample Type:	
1-13-MISC-22	MISC	
Sample Location:	Detailed Sample Location:	
Room 101	Fabric material on southeast boiler by double doors on south end of room.	
Sample Quantity:	15 square feet.	
Misc Sample Material:	Sample Condition:	Sample Friable?:
Gray fabric material.	Potential ACBM with potential for damage	Yes

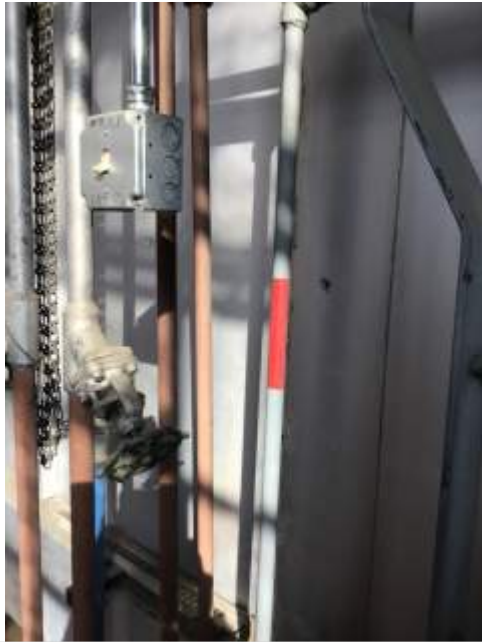
Sample ID:	Sample Type:
1-13-PB-19	PB
Sample Location:	Detailed Sample Location:
Room 101	Pipe on west side of southwest boiler.
Sample Quantity:	N/A
Sample Color:	XRF:
Red	0.092

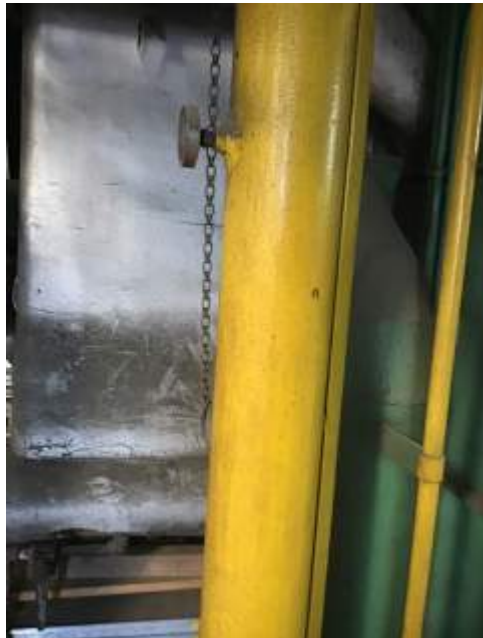
Sample ID:	Sample Type:
1-14-PB-29	PB
Sample Location:	Detailed Sample Location:
Room 101	North pipe on the northwest corner of north middle boiler.
Sample Quantity:	600 linear feet.
Sample Color:	XRF:
Yellow	5.00

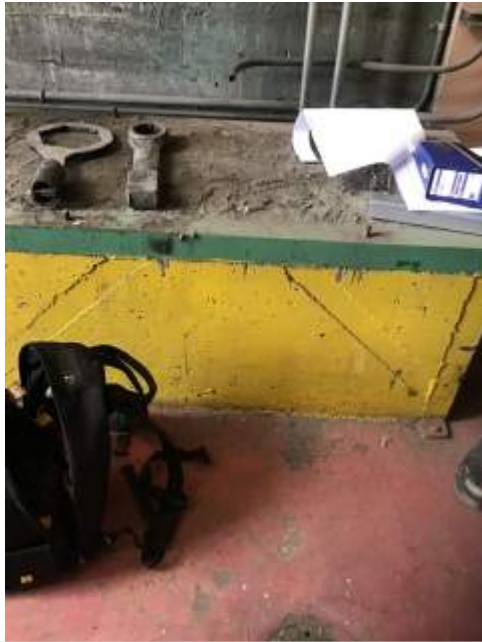
Sample ID:	Sample Type:
1-14-PB-30	PB
Sample Location:	Detailed Sample Location:
Room 101	North concrete bench west of north door.
Sample Quantity:	600 linear feet.
Sample Color:	XRF:
Yellow	2.83

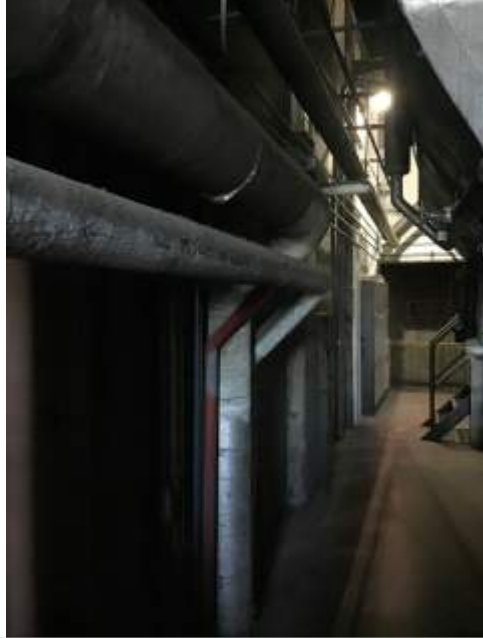
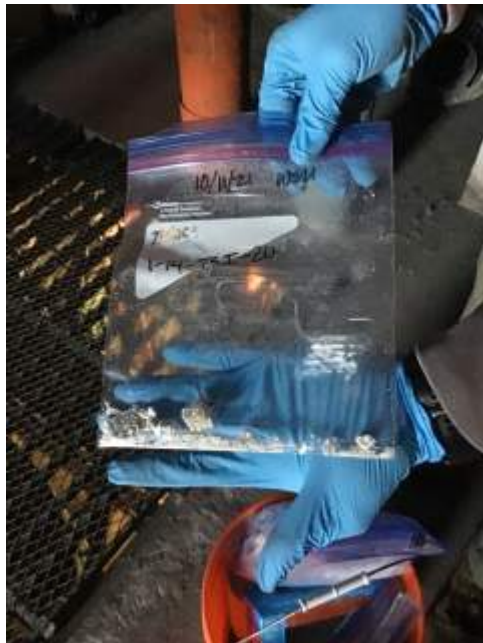
1-14-TSI-20

Misc Sample Material:	Sample Condition:	Sample Friable?:
	Damaged or significantly damaged	Yes

Additional Sample Notes:	White patch on silver pipe with white fibrous insulation.
---------------------------------	---

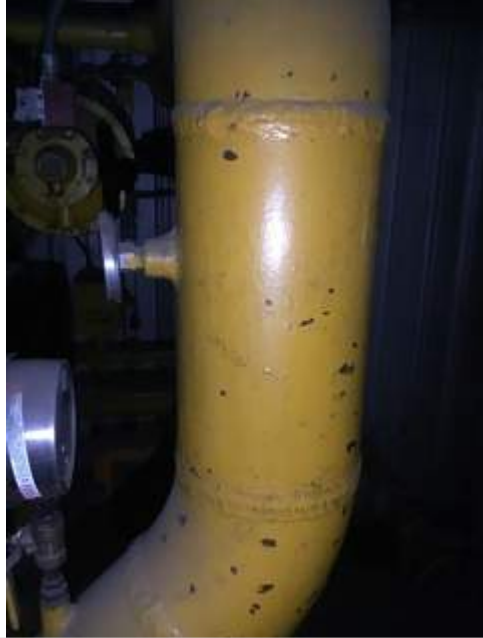
1-14-PB-37

Yellow	5.00
--------	------
