FOCUSED SITE ASSESSMENT REPORT

COLLEGE AVENUE STEAM PLANT
PULLMAN, WASHINGTON

Prepared for
PORT OF WHITMAN COUNTY
March 30, 2022
Project No. M0457.02.003

Prepared by
Maul Foster & Alongi, Inc.
601 East Front Ave., Suite 202, Coeur d'Alene, ID 83814

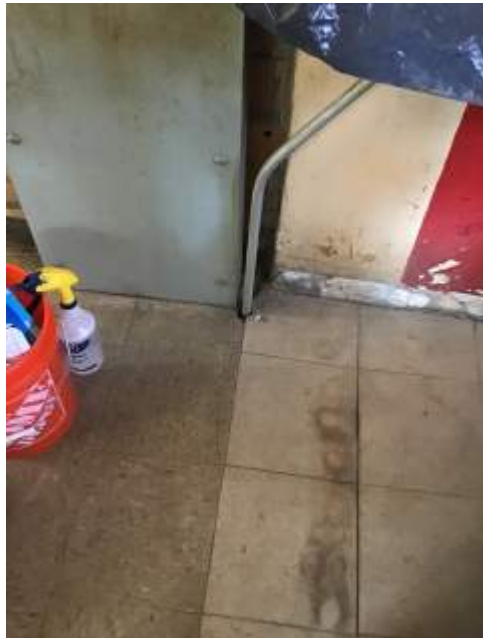
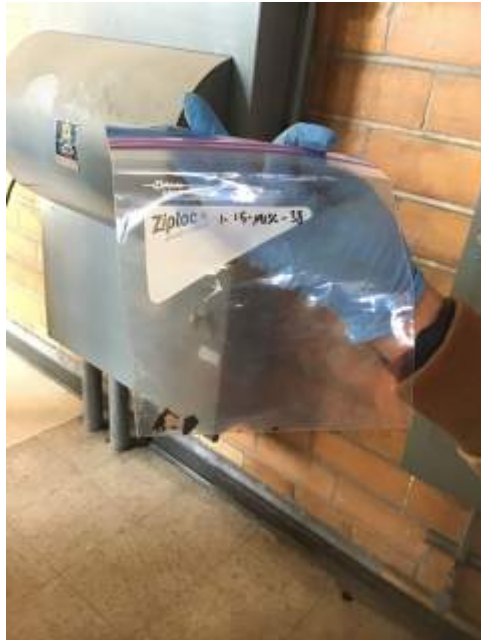
Sample ID:	Sample Type:	
1-15-MISC-38	MISC	
Sample Location:	Detailed Sample Location:	
Room 102	North wall west of single doorway in room 102.	
Sample Quantity:	3,000 square feet.	
Misc Sample Material:	Sample Condition:	Sample Friable?:
Tan 12" x 12" vinyl floor tile with black mastic.	Potential ACBM with potential for damage	No

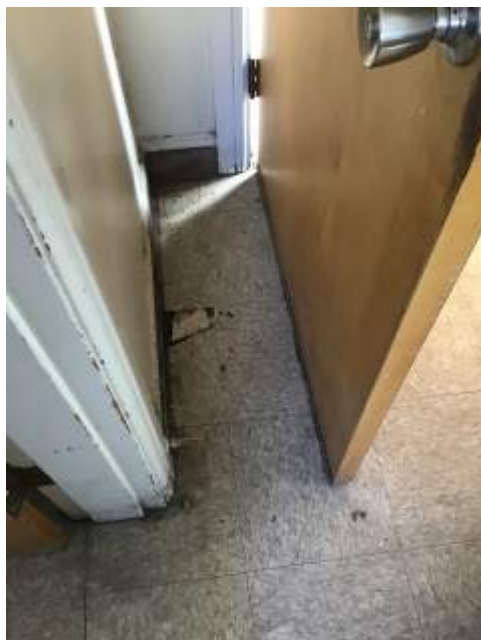
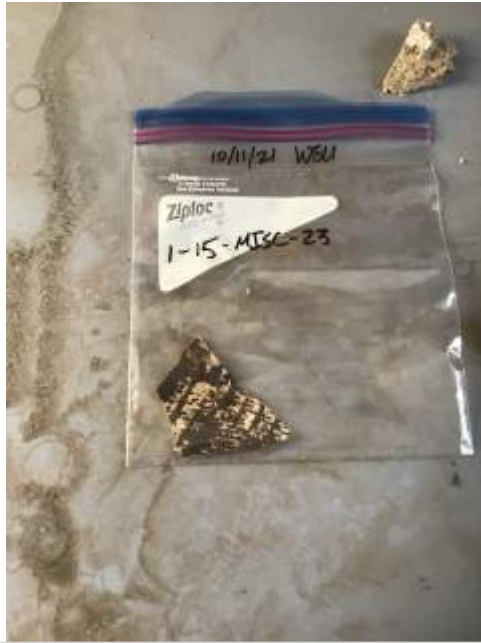
1-15-MISC-23

Potential ACBM with potential for damage

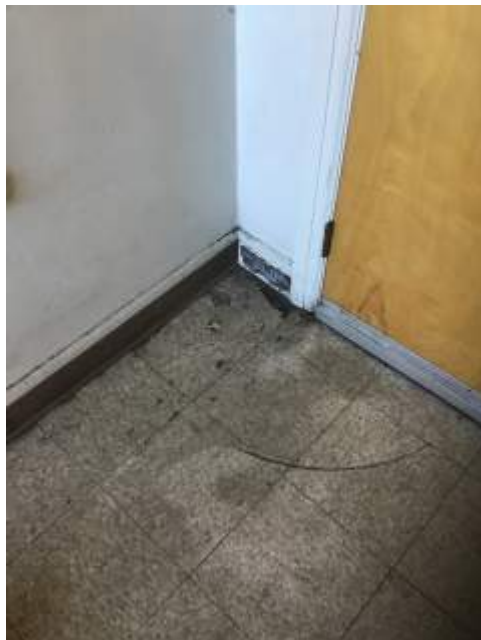
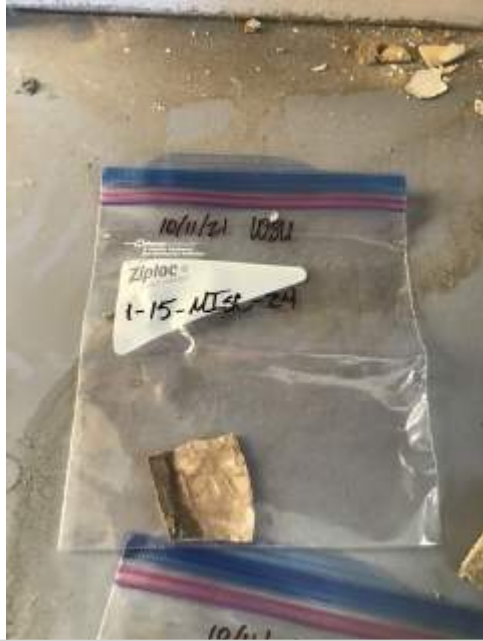
Sample ID:	Sample Type:	
1-15-MISC-24	MISC	
Sample Location:	Detailed Sample Location:	
Room 105	Northeast corner of room.	
Sample Quantity:	3,000 square feet.	
Misc Sample Material:	Sample Condition:	Sample Friable?:
Tan 12" x 12" vinyl floor tile with black mastic.	Potential ACBM with potential for damage	No

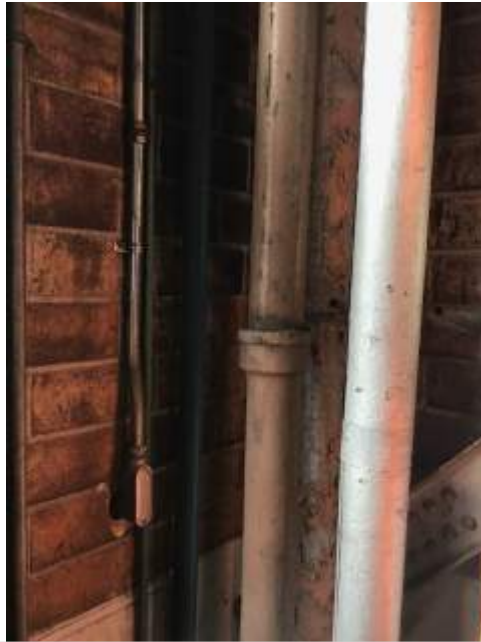
Sample ID:	Sample Type:
1-16-PB-22	PB
Sample Location:	Detailed Sample Location:
Room 101	West wall north of double door.
Sample Quantity:	N/A
Sample Color:	XRF:
Brown	0.015

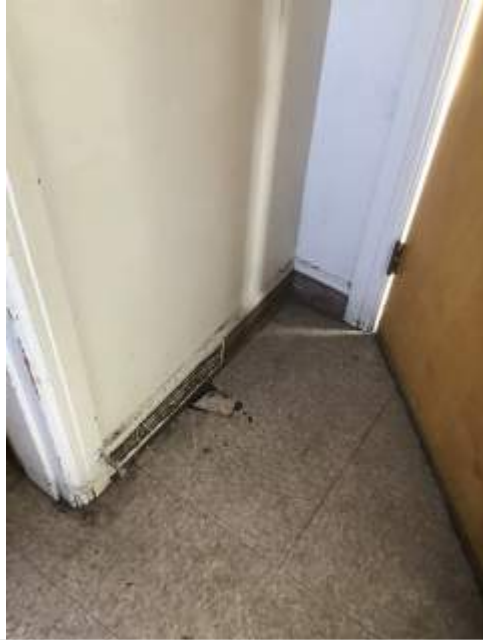
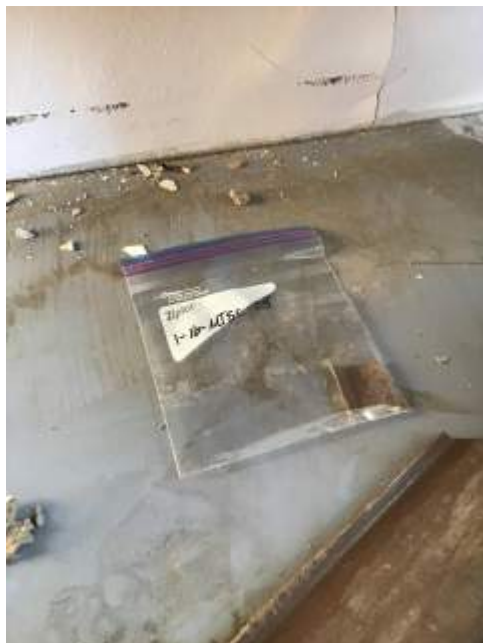
Sample ID:	Sample Type:	
1-16-MISC-25	MISC	
Sample Location:	Detailed Sample Location:	
Room 104	East wall of room.	
Sample Quantity:	80 linear feet.	
Misc Sample Material:	Sample Condition:	Sample Friable?:
Brown cove base with brown mastic.	Potential ACBM with potential for damage	No

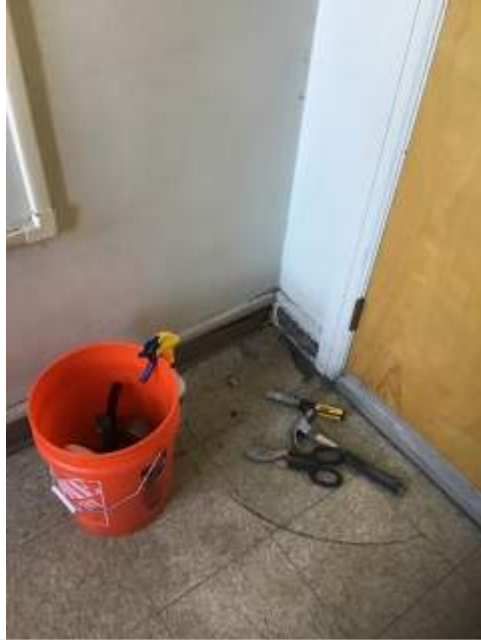
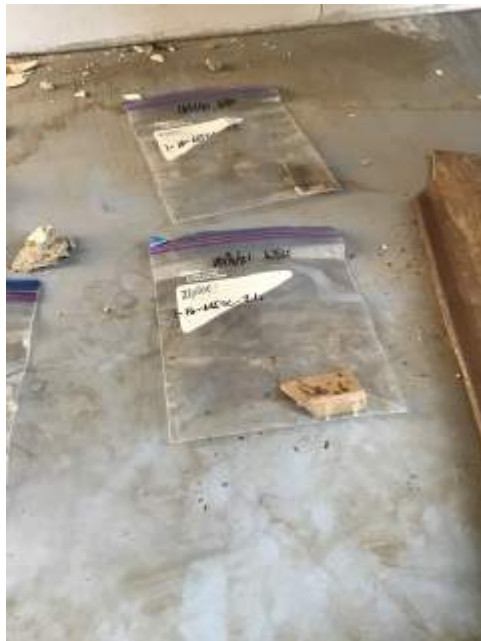
1-16-MISC-26

Potential ACBM with potential for damage

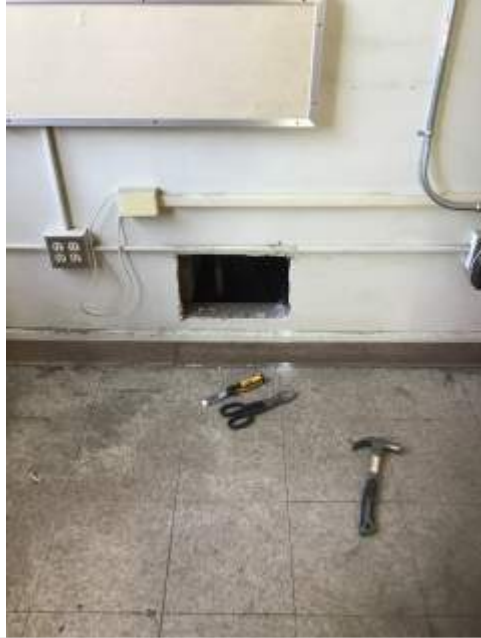
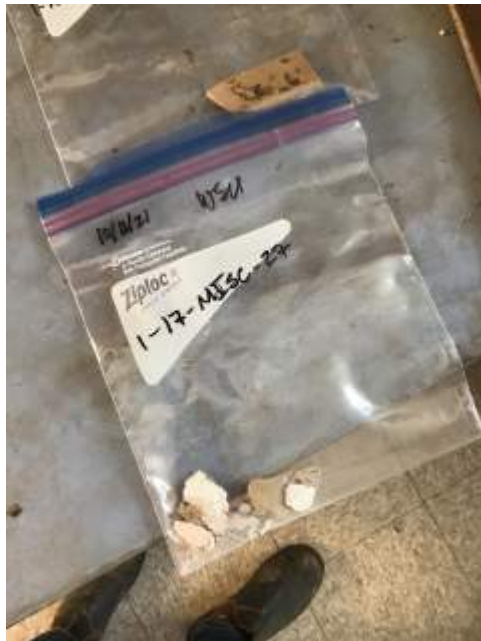
1-17-MISC-27

Potential ACBM with potential for damage

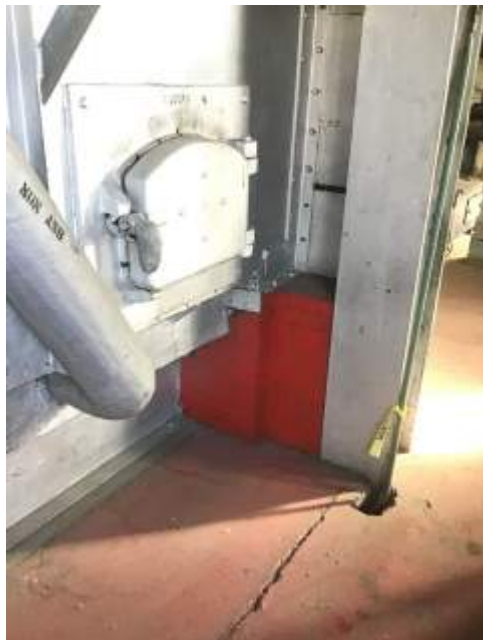
Sample ID:	Sample Type:
1-18-PB-25	PB
Sample Location:	Detailed Sample Location:
Room 101	Brick on southwest corner of northwest boiler.
Sample Quantity:	N/A
Sample Color:	XRF:
Red	ND

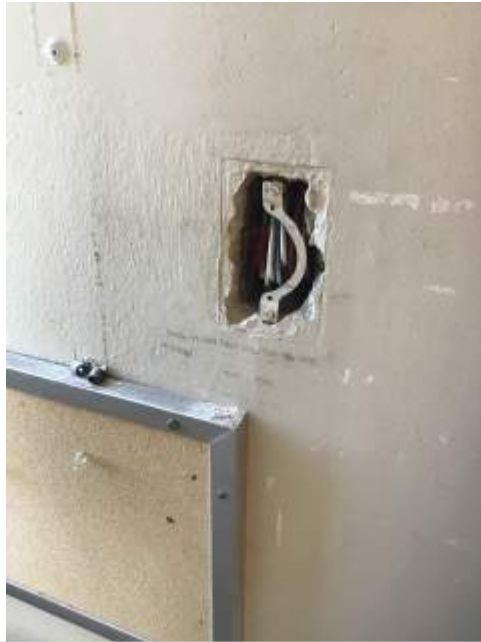
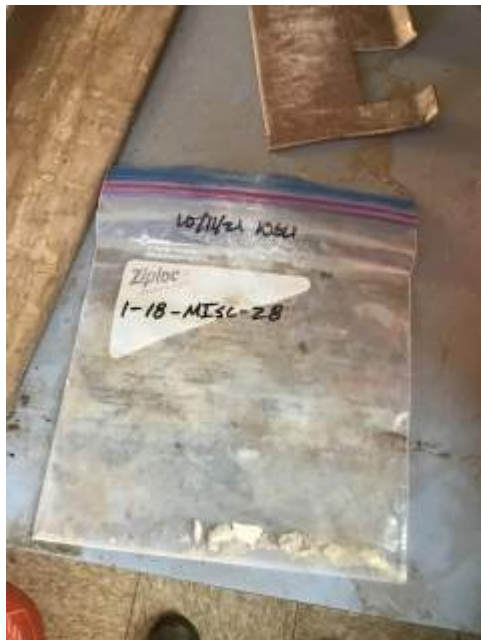
Additional Sample Notes:		
Sample ID:	Sample Type:	
1-18-MISC-28	MISC	
Sample Location:	Detailed Sample Location:	
Room 104	North wall of room in light switch casing.	
Sample Quantity:	785 square feet.	
Misc Sample Material:	Sample Condition:	Sample Friable?:
Light gray cementitious wallboard.	Potential ACBM with potential for damage	Yes

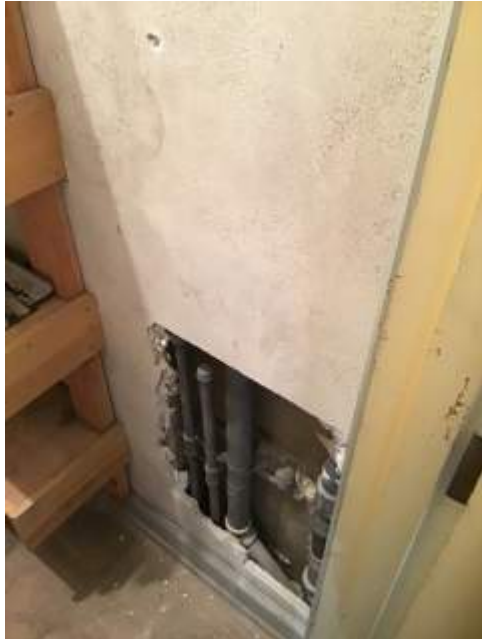
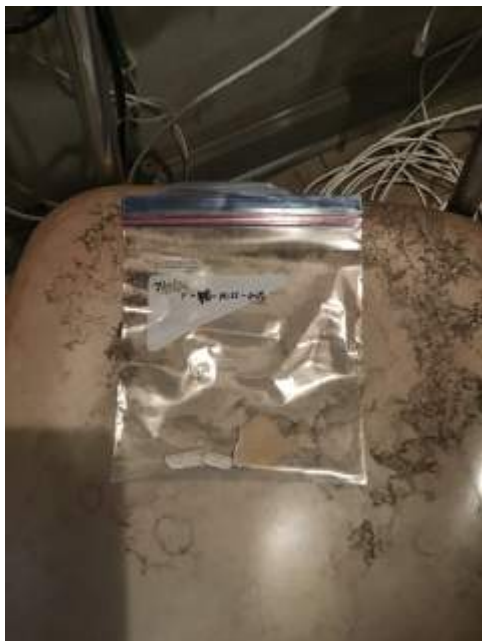
Additional Sample Notes:		
Sample ID:	Sample Type:	
1-18-MISC-43	MISC	
Sample Location:	Detailed Sample Location:	
Room 106T	West wall by door in room 106T.	
Sample Quantity:	785 square feet.	
Misc Sample Material:	Sample Condition:	Sample Friable?:
White drywall with cementitious wallboard.	Damaged or significantly damaged friable miscellaneous ACM	Yes

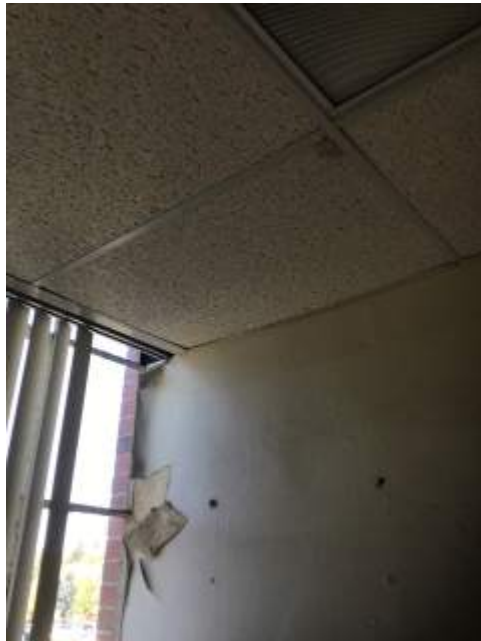
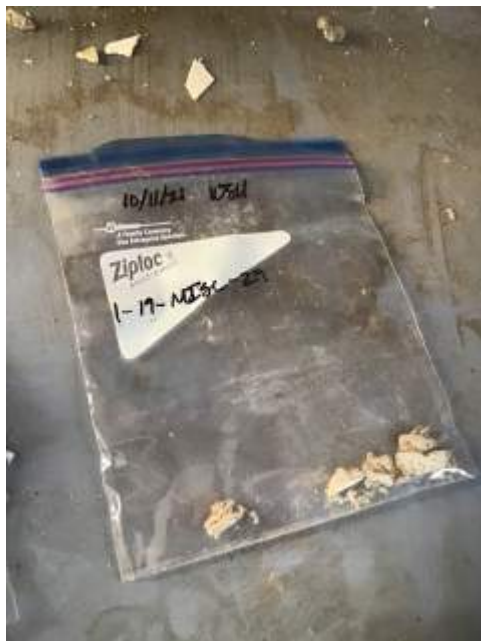
Additional Sample Notes:		
Sample ID:	Sample Type:	
1-19-MISC-29	MISC	
Sample Location:	Detailed Sample Location:	
Room 104	Northwest corner of room above light switch.	
Sample Quantity:	180 square feet.	
Misc Sample Material:	Sample Condition:	Sample Friable?:
White 18" x 36" ceiling tile with randomized stipple pattern.	Potential ACBM with potential for damage	Yes

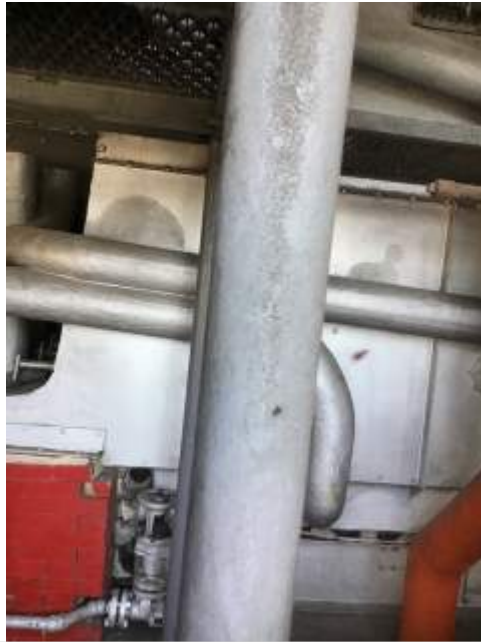
Sample ID:	Sample Type:
1-19-PB-26	PB
Sample Location:	Detailed Sample Location:
Room 101	Support pole in northwest corner of room 101.
Sample Quantity:	N/A
Sample Color:	XRF:
Gray	0.111

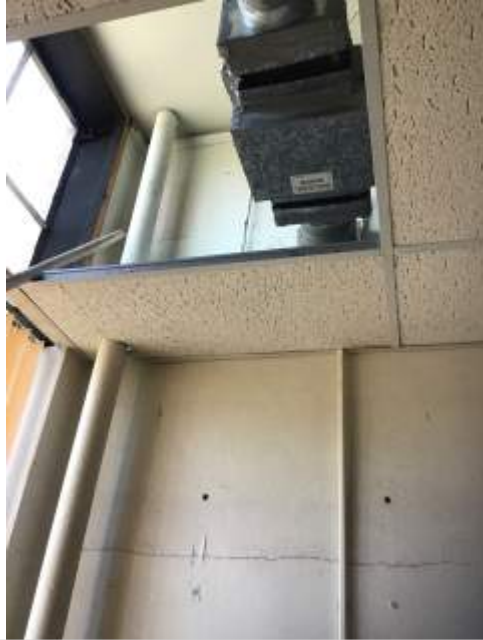
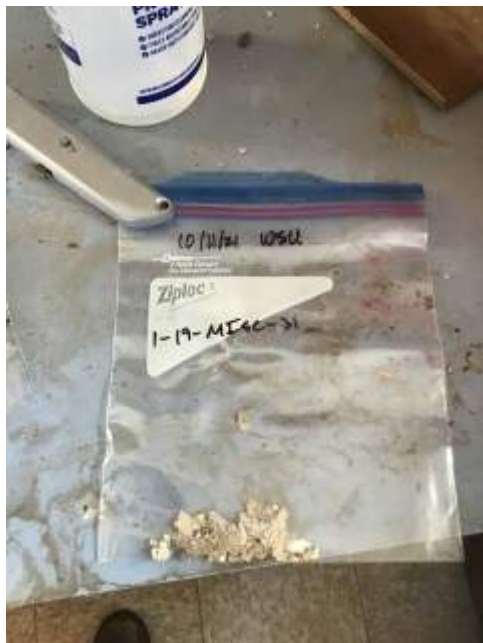
Sample ID:	Sample Type:	
1-19-MISC-31	MISC	
Sample Location:	Detailed Sample Location:	
Room 105	Northwest corner of room.	
Sample Quantity:	180 square feet.	
Misc Sample Material:	Sample Condition:	Sample Friable?:
White 18" x 36" ceiling tile with randomized stipple pattern.	Potential ACBM with potential for damage	Yes

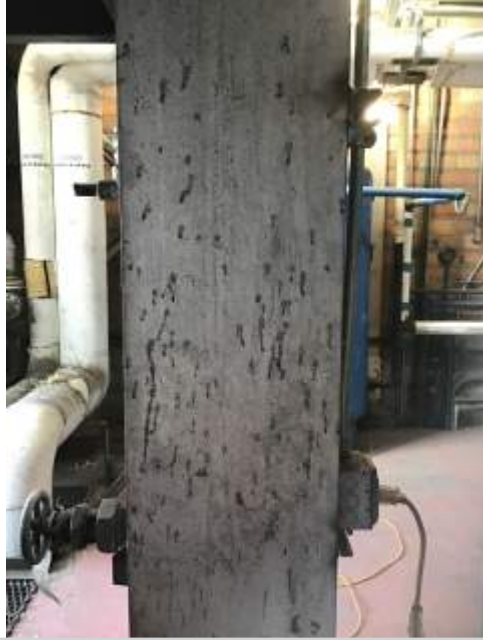
Sample ID:	Sample Type:
1-20-PB-27	PB
Sample Location:	Detailed Sample Location:
Room 101	Northwest support beam of northwest boiler.
Sample Quantity:	3,000 linear feet.
Sample Color:	XRF:
Silver	2.47

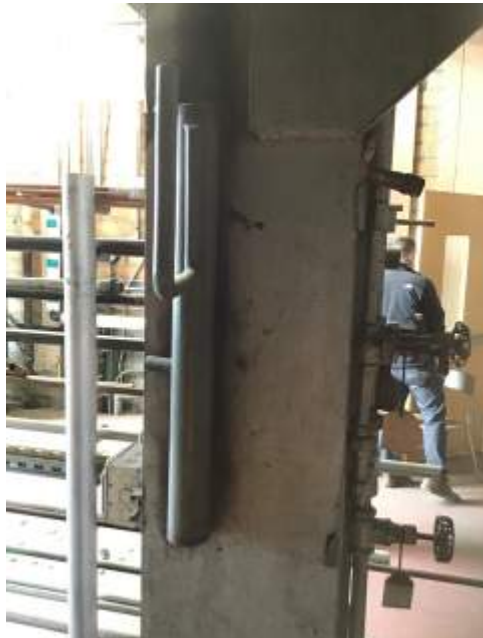
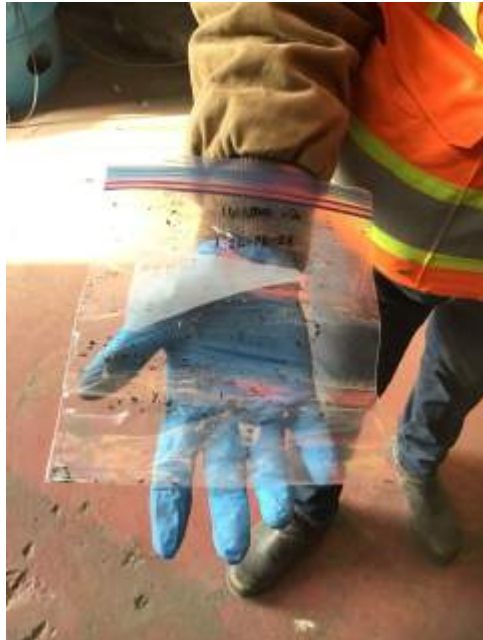
Additional Sample Notes:	Quantity difficult to estimate.
Sample ID:	Sample Type:
1-20-PB-28	PB
Sample Location:	Detailed Sample Location:
Room 101	Northeast support beam of northwest boiler.
Sample Quantity:	3,000 linear feet.
Sample Color:	XRF:
Silver	1.66

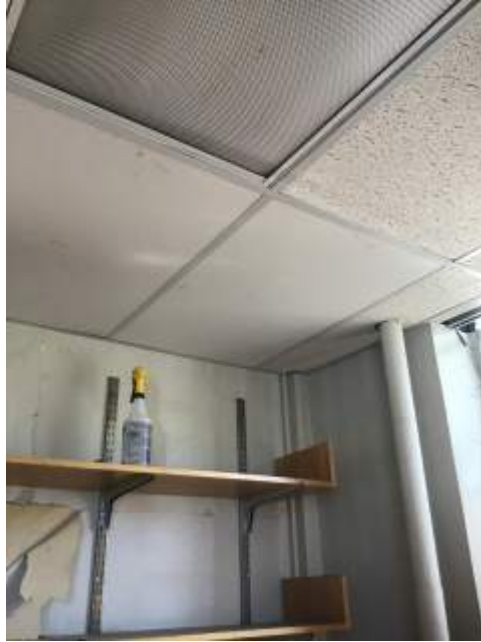
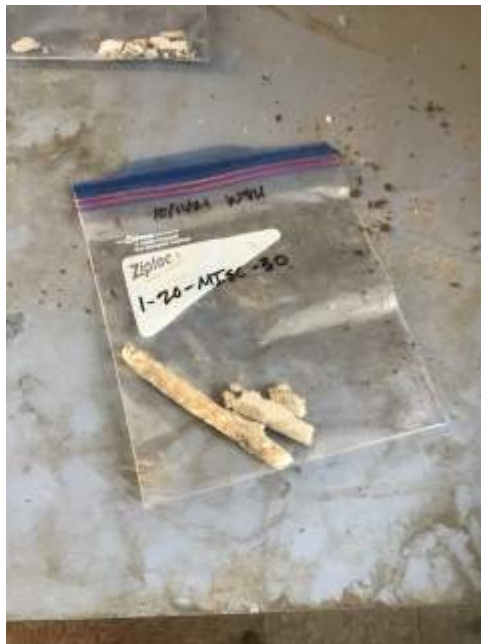
1-20-MISC-30

White 18" x 36" ceiling tile with uniform stipple pattern.	Potential ACBM with potential for damage	Yes
--	--	-----

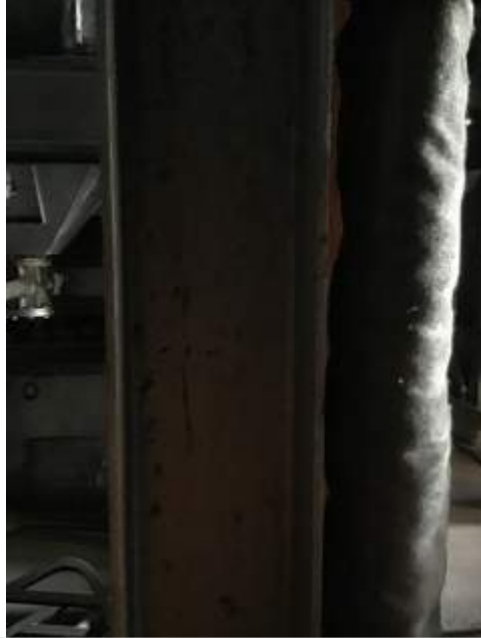
Sample ID:	Sample Type:
1-20-PB-33	PB
Sample Location:	Detailed Sample Location:
Room 101	Support beam on northwest corner of northeast boiler.
Sample Quantity:	3,000 linear feet.
Sample Color:	XRF:
Silver	0.040

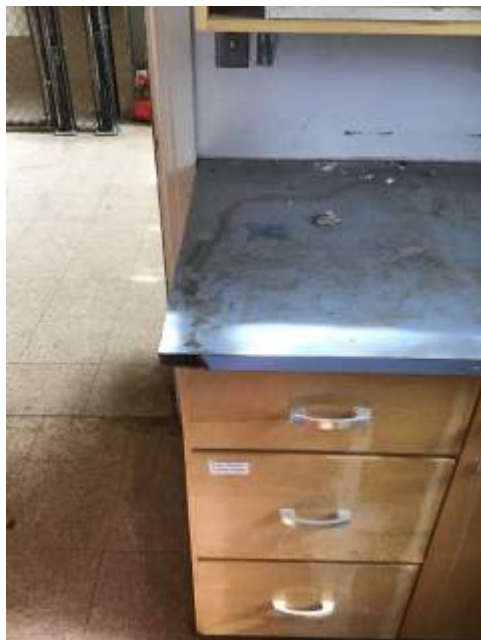
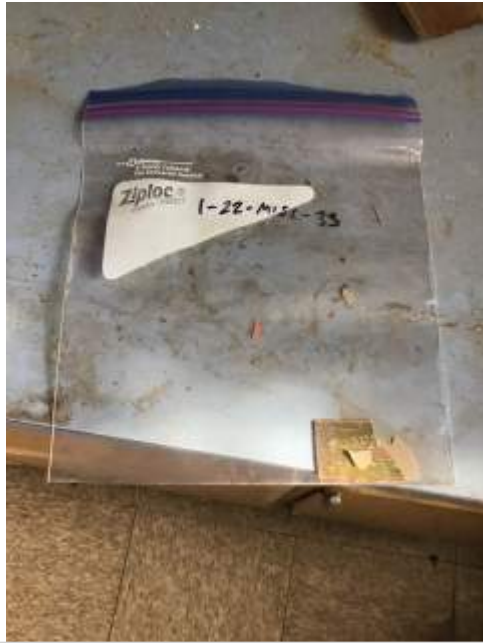
Sample ID:	Sample Type:	
1-21-MISC-33	MISC	
Sample Location:	Detailed Sample Location:	
104	Gray blue counter top on east side of room.	
Sample Quantity:	12 square feet.	
Misc Sample Material:	Sample Condition:	Sample Friable?:
Gray blue laminate countertop with black and green mastic.	Potential ACBM with potential for damage	No

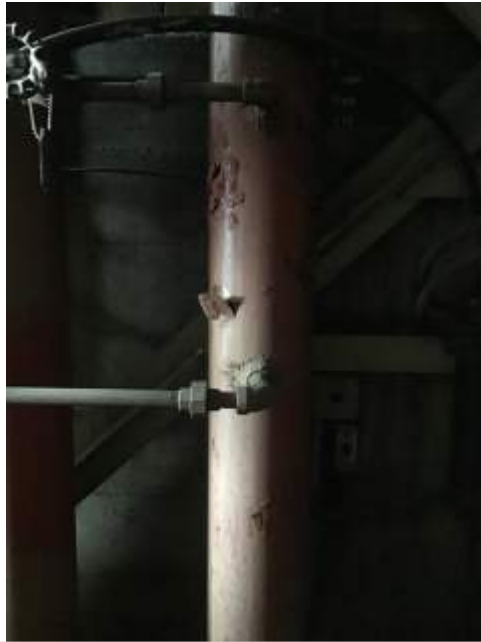
Sample ID:	Sample Type:
1-21-PB-32	PB
Sample Location:	Detailed Sample Location:
Room 101	Pipe north of north middle boiler.
Sample Quantity:	70 linear feet.
Sample Color:	XRF:
Brown	1.208

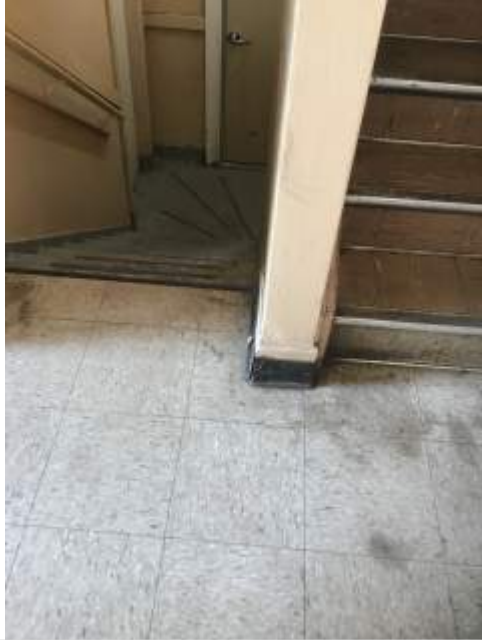
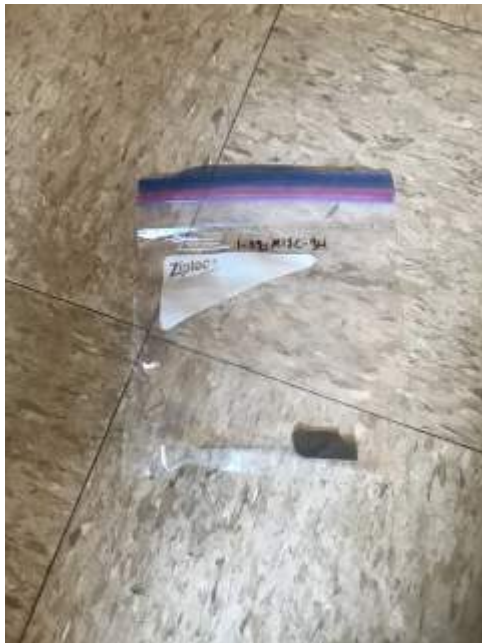
Sample ID:	Sample Type:	
1-22-MISC-34	MISC	
Sample Location:	Detailed Sample Location:	
Room 102	Northwest corner of room by stairs.	
Sample Quantity:	240 linear feet.	
Misc Sample Material:	Sample Condition:	Sample Friable?:
Dark brown cove base with brown mastic.	Potential ACBM with potential for damage	No

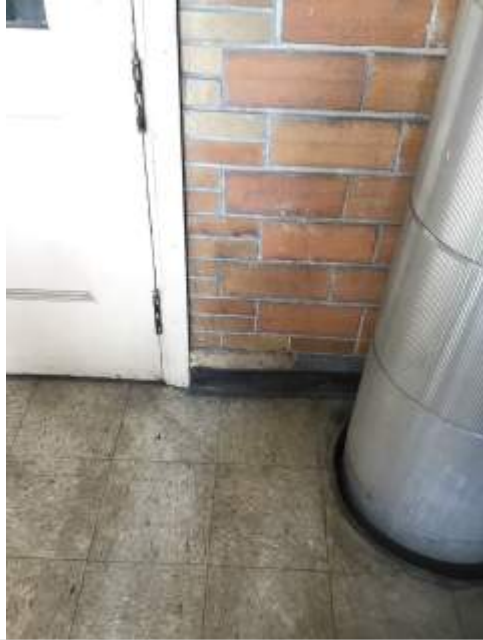
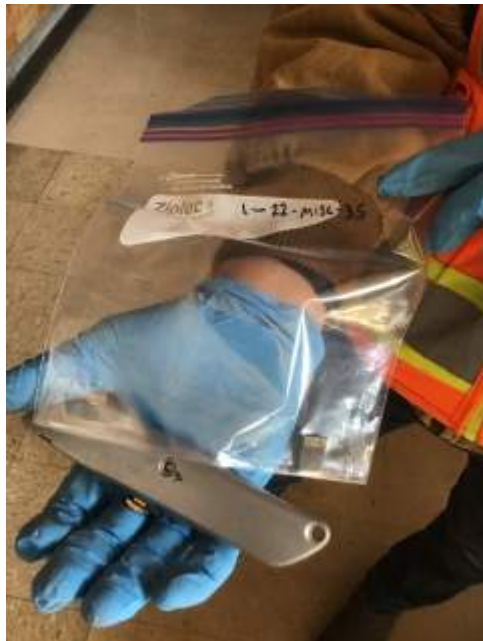
Sample ID:	Sample Type:	
1-22-MISC-35	MISC	
Sample Location:	Detailed Sample Location:	
Room 102	North wall east of double door.	
Sample Quantity:	240 linear feet.	
Misc Sample Material:	Sample Condition:	Sample Friable?:
Dark brown cove base with brown mastic.	Potential ACBM with potential for damage	No

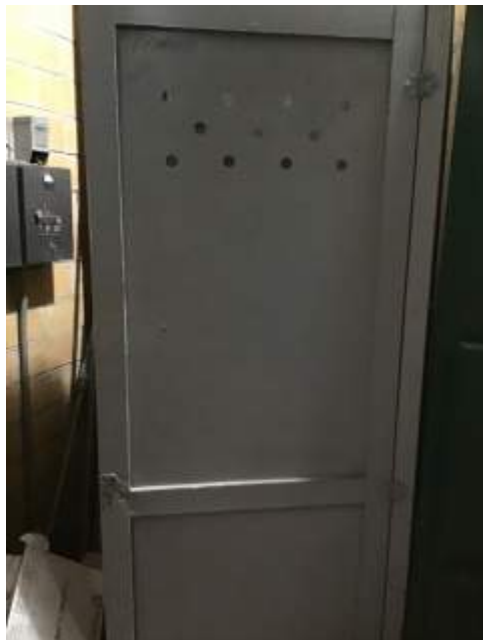
Sample ID:	Sample Type:
1-23-PB-41	PB
Sample Location:	Detailed Sample Location:
Room 101	Light gray cabinet in southeast corner of room 101.
Sample Quantity:	N/A
Sample Color:	XRF:
Light gray	0.048

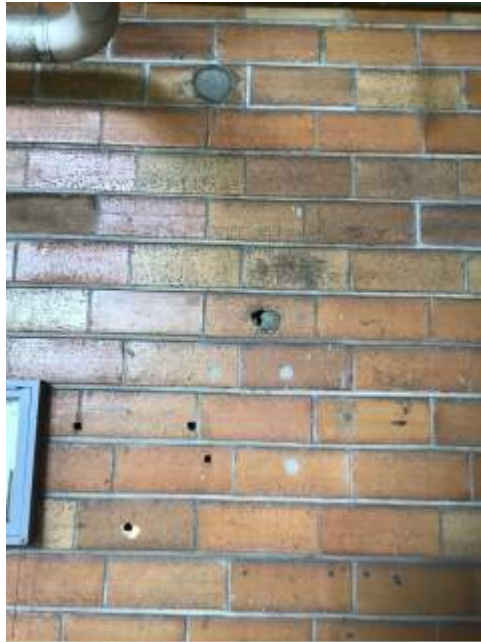
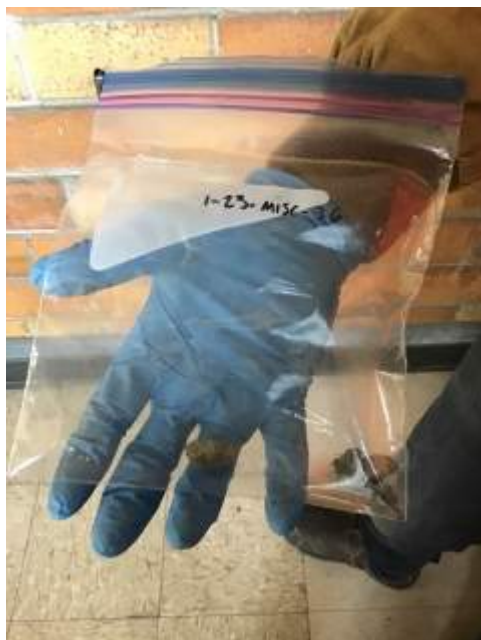
Additional Sample Notes:		
Sample ID:	Sample Type:	
1-23-MISC-36	MISC	
Sample Location:	Detailed Sample Location:	
Room 102	North wall, west of transformer box and east of the double doors.	
Sample Quantity:	Less than 5 square feet.	
Misc Sample Material:	Sample Condition:	Sample Friable?:
Gray cementitious patching material.	Potential ACBM with potential for damage	No

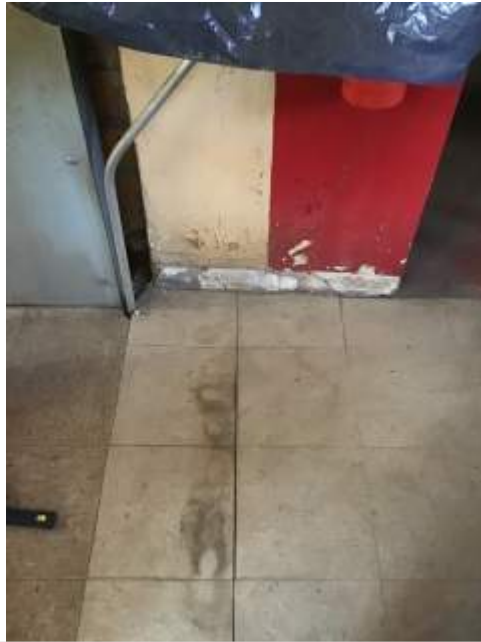
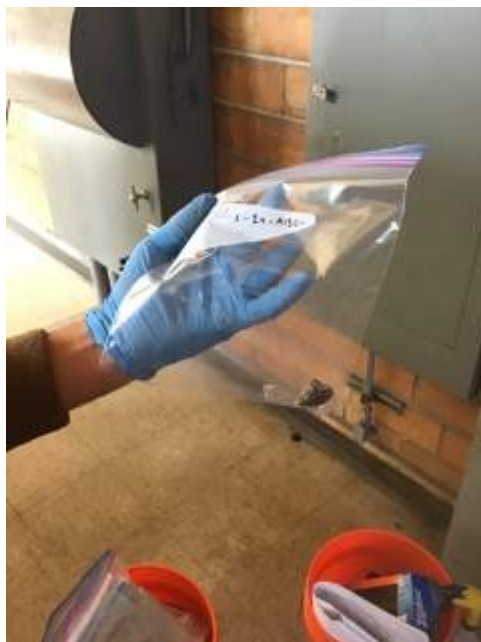
Additional Sample Notes:		
Sample ID:	Sample Type:	
1-24-MISC-37	MISC	
Sample Location:	Detailed Sample Location:	
Room 102	North wall west of single doorway.	
Sample Quantity:	77.5 square feet.	
Misc Sample Material:	Sample Condition:	Sample Friable?:
Light gray 12" x 12" vinyl floor tile with gray mastic.	Potential ACBM with potential for damage	No

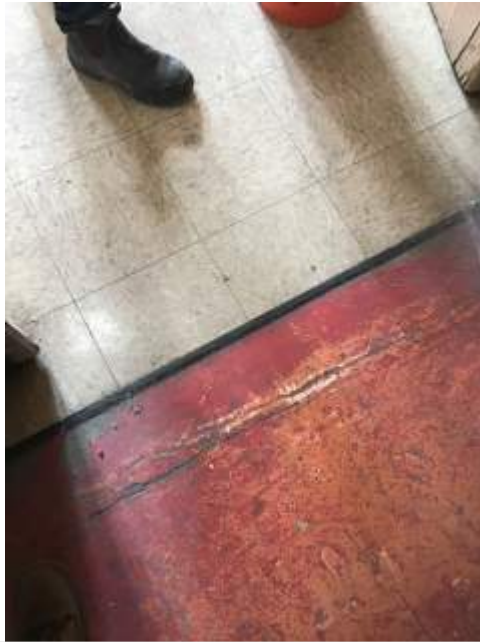
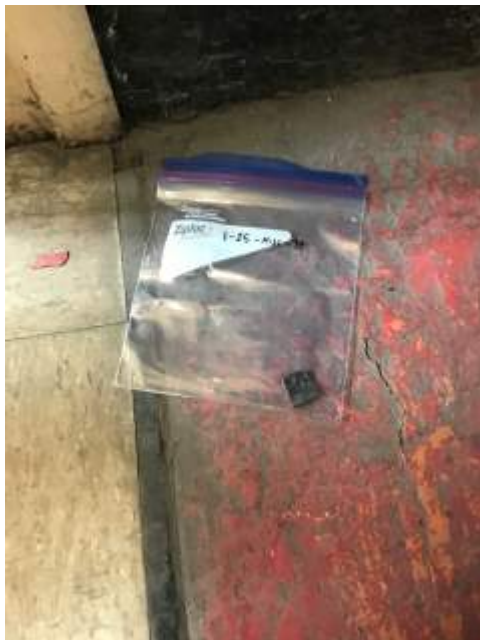
Additional Sample Notes:		
Sample ID:	Sample Type:	
1-25-MISC-39	MISC	
Sample Location:	Detailed Sample Location:	
Rooms 102 and 101.	Double doorway between room 102 and 101.	
Sample Quantity:	11 linear feet.	
Misc Sample Material:	Sample Condition:	Sample Friable?:
Black transition strip with brown mastic.	Potential ACBM with potential for damage	No

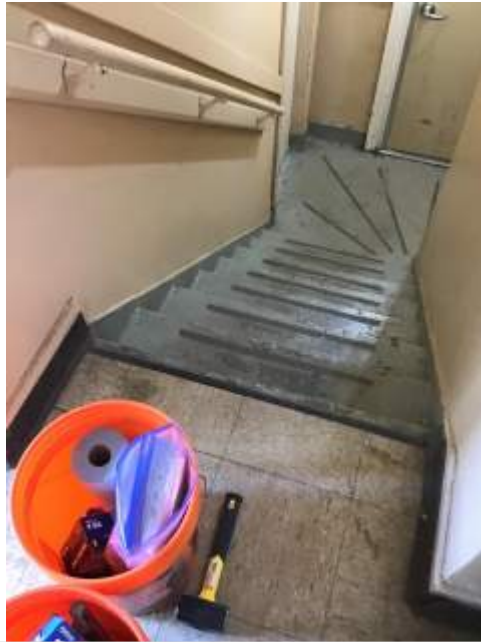
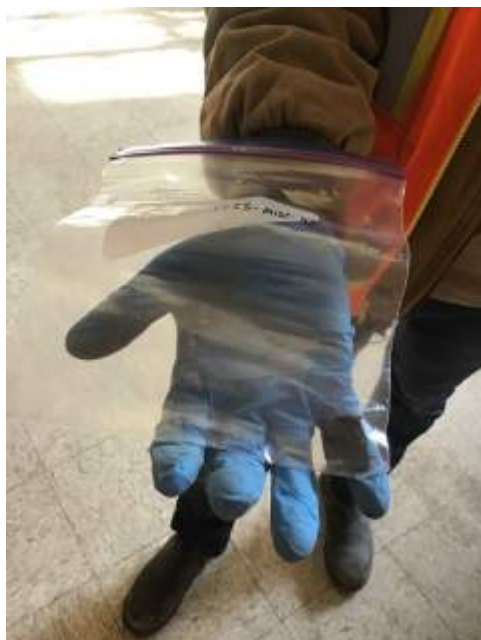
Additional Sample Notes:		
Sample ID:	Sample Type:	
1-25-MISC-47	MISC	
Sample Location:	Detailed Sample Location:	
Room 102	West stairway moving down in room 102.	
Sample Quantity:	11 linear feet.	
Misc Sample Material:	Sample Condition:	Sample Friable?:
Black transition strip with brown mastic.	Potential ACBM with potential for damage	No

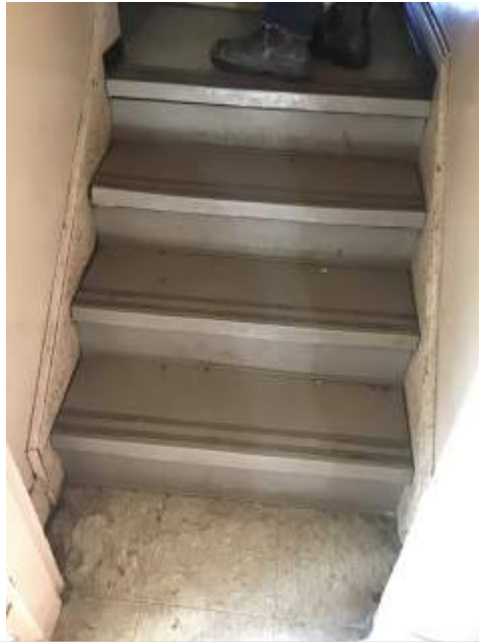
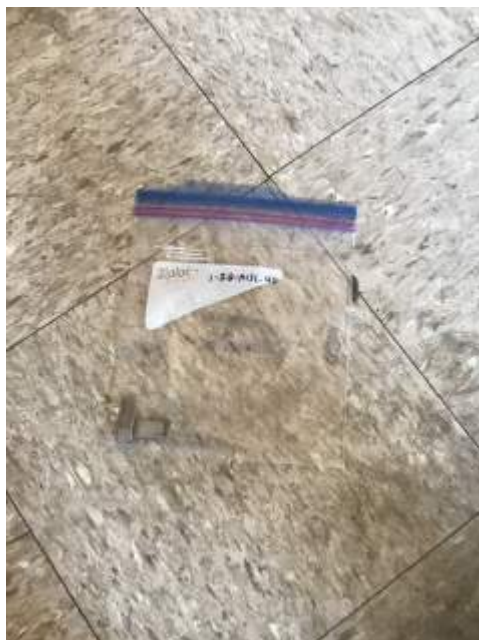
1-26-MISC-40

Rubber stair tread with clear mastic.	Potential ACBM with potential for damage	No
---------------------------------------	--	----

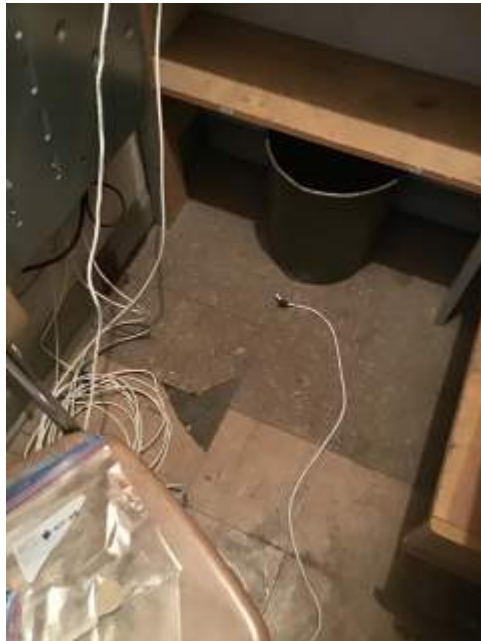
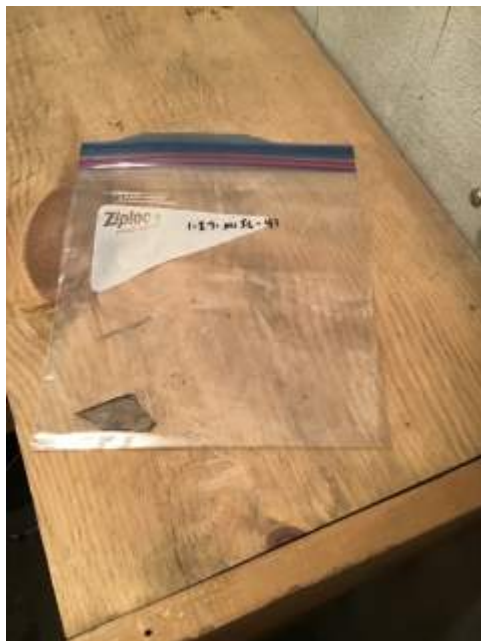
Additional Sample Notes:		
Sample ID:	Sample Type:	
1-27-MISC-41	MISC	
Sample Location:	Detailed Sample Location:	
Room 106T	Center floor of room 106T.	
Sample Quantity:	16 square feet.	
Misc Sample Material:	Sample Condition:	Sample Friable?:
Dark brown patterned 9 x 9 vinyl floor tiles with black mastic.	Potential ACBM with potential for damage	No

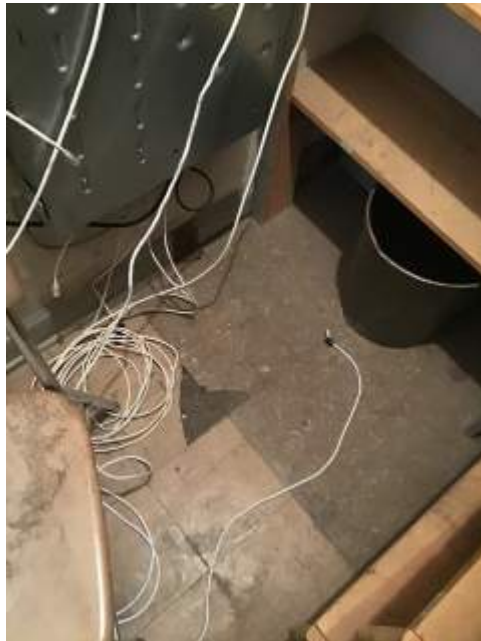
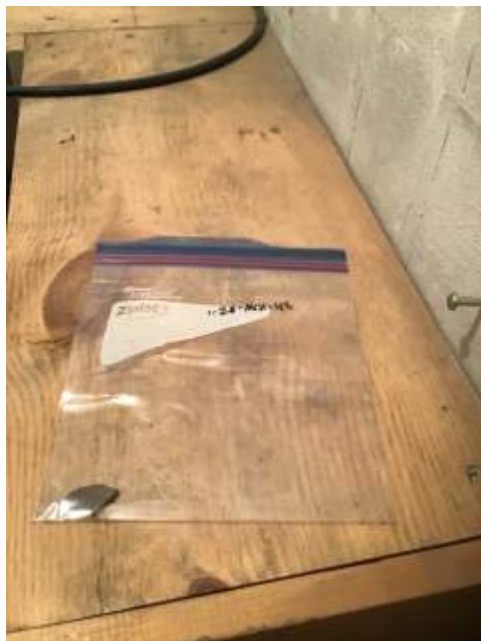
Additional Sample Notes:		
Sample ID:	Sample Type:	
1-28-MISC-42	MISC	
Sample Location:	Detailed Sample Location:	
Room 106T	Center floor of room 106T.	
Sample Quantity:	76 square feet.	
Misc Sample Material:	Sample Condition:	Sample Friable?:
Light tan patterned 9" x 9" vinyl floor tile with black mastic.	Damaged or significantly damaged; Potential ACBM with potential for damage	No

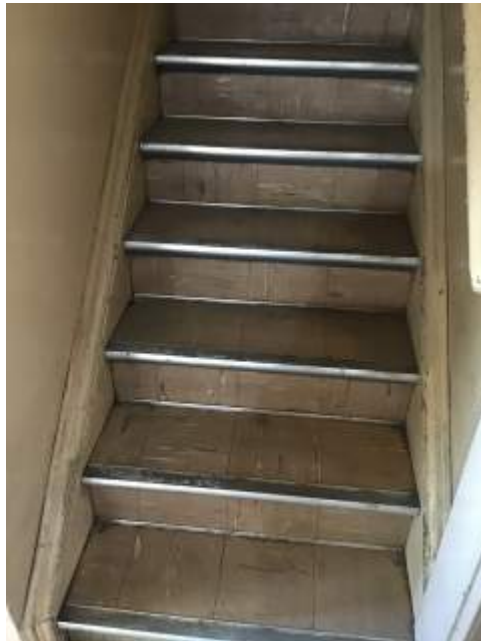
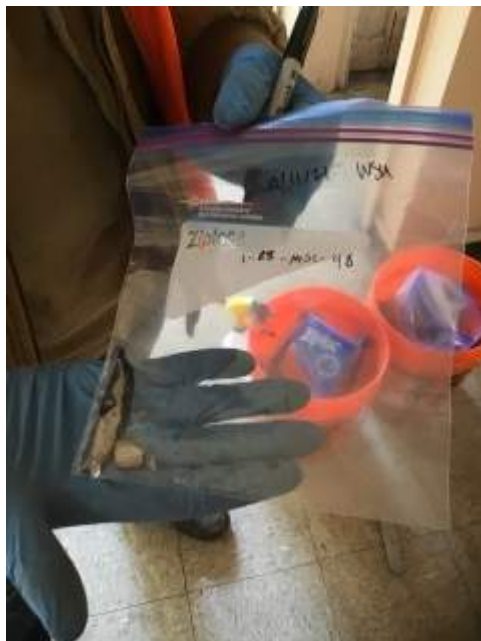
Additional Sample Notes:		
Sample ID:	Sample Type:	
1-28-MISC-48	MISC	
Sample Location:	Detailed Sample Location:	
Room 102	West stairway moving up in room 102.	
Sample Quantity:	76 square feet.	
Misc Sample Material:	Sample Condition:	Sample Friable?:
Light tan patterned 9" x 9" vinyl floor tile with black mastic.	Potential ACBM with potential for damage	No

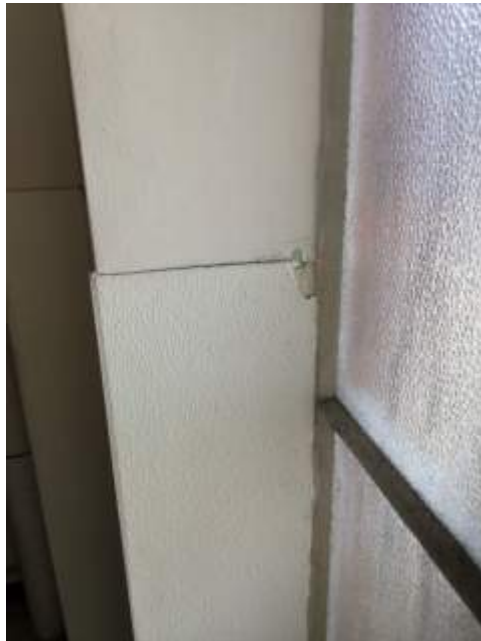
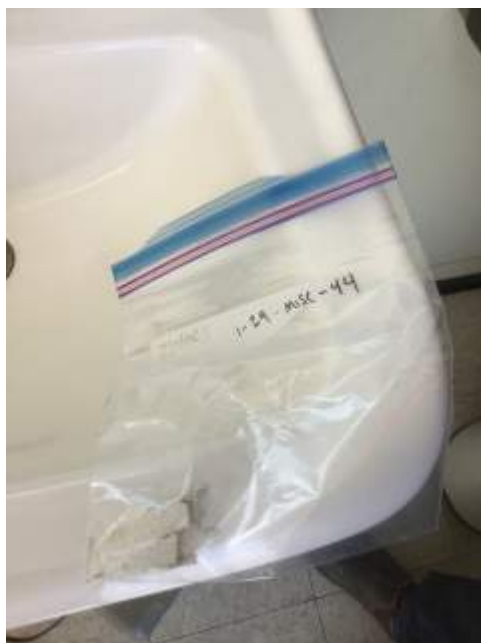
Additional Sample Notes:		
Sample ID:	Sample Type:	
1-29-MISC-44	MISC	
Sample Location:	Detailed Sample Location:	
Room 107	West wall next to window in room 107.	
Sample Quantity:	60 square feet.	
Misc Sample Material:	Sample Condition:	Sample Friable?:
White plastic waterproofing material with pale yellow adhesive.	Potential ACBM with potential for damage	No

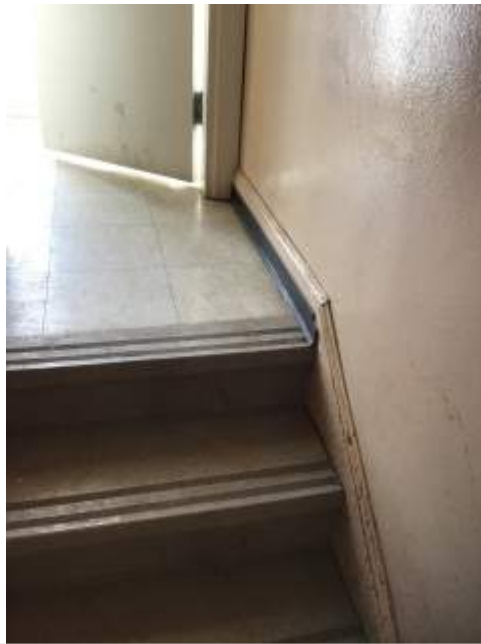
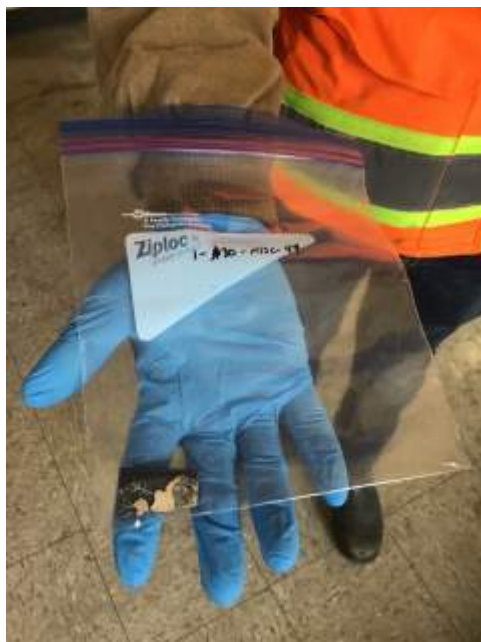
Additional Sample Notes:		
Sample ID:	Sample Type:	
1-30-MISC-49	MISC	
Sample Location:	Detailed Sample Location:	
Top of stairway from room 102 to 107.	North wall at the top of stairs.	
Sample Quantity:	20 linear feet.	
Misc Sample Material:	Sample Condition:	Sample Friable?:
Black cove base with tan mastic	Potential ACBM with potential for damage	No

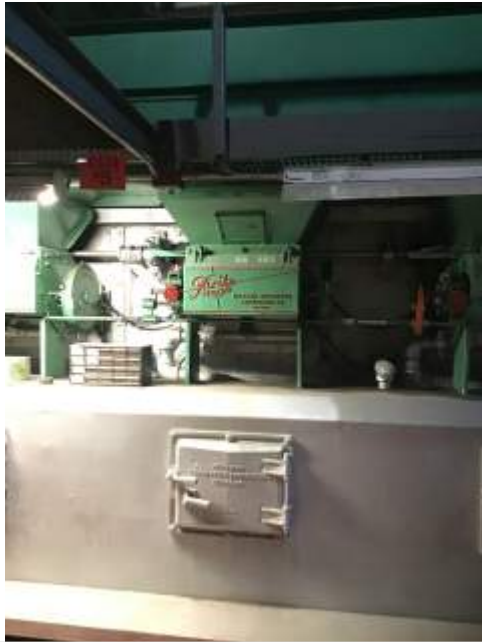
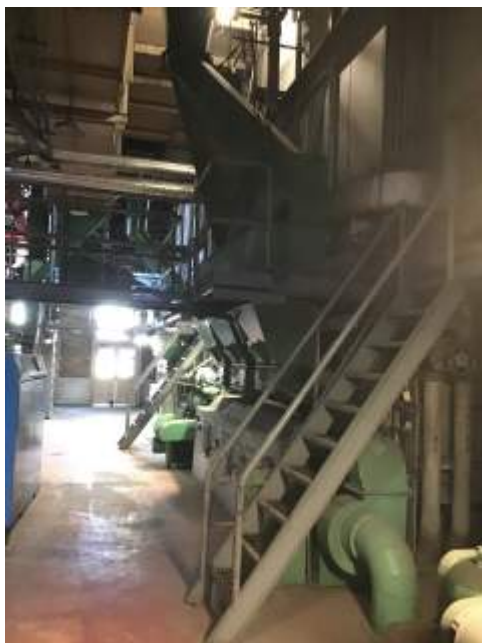
General Fixture Location:	Detailed Fixture Location:
Room 101	Throughout the room.
Type of Fixture:	Quantity:
Boilers and steam equipment.	6
Condition:	Additional Fixture Notes:
Good	Associated motors, residual mechanical fluids and coal dust.

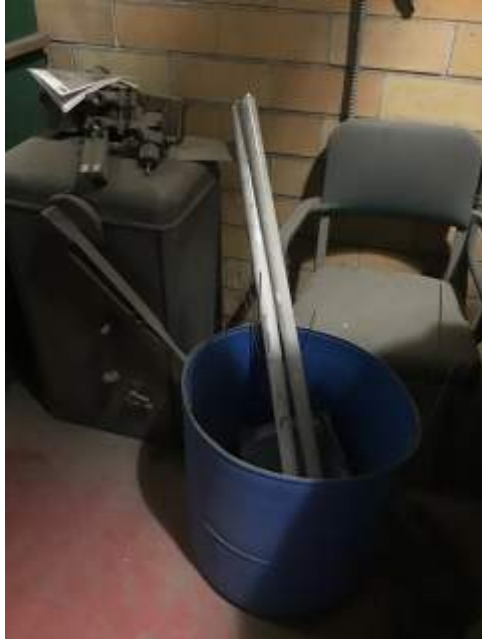
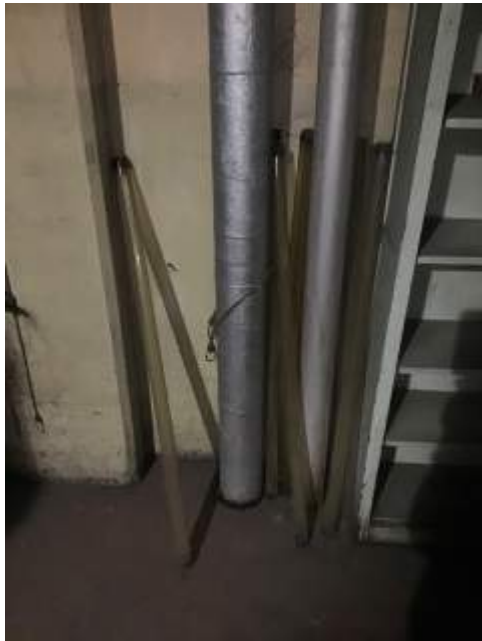
General Fixture Location:	Detailed Fixture Location:
Room 101	Southeast corner of room 101.
Type of Fixture:	Quantity:
Fluorescent light bulbs.	13
Condition:	Additional Fixture Notes:
Good

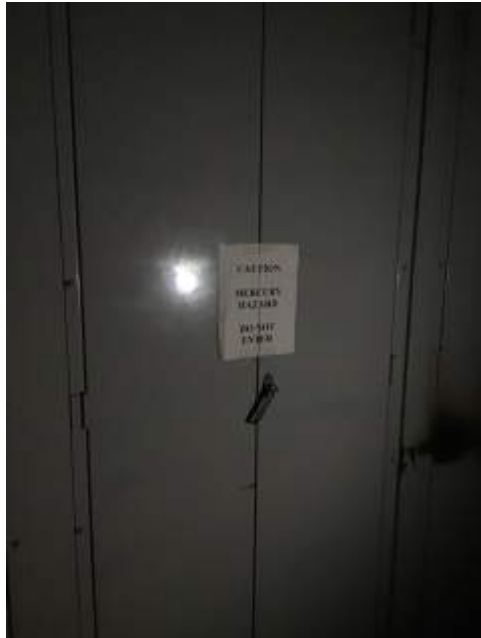
General Fixture Location:	Detailed Fixture Location:
Room 101	East wall behind control panels.
Type of Fixture:	Quantity:
	1
Condition:	Additional Fixture Notes:
Good	Boiler and equipment control panels containing mercury.

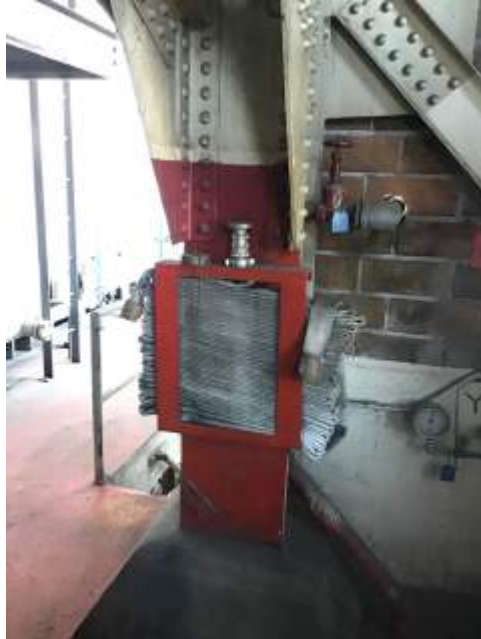
General Fixture Location:	Detailed Fixture Location:
Room 101	West wall south of double doors.
Type of Fixture:	Quantity:
Fire hose.	1
Condition:	Additional Fixture Notes:
Good	Assumed asbestos containing material in fire hose.

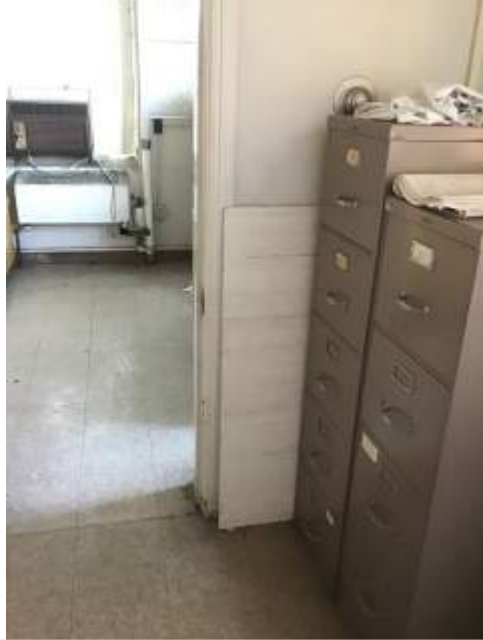
General Fixture Location:	Detailed Fixture Location:
Room 105	West of south door.
Type of Fixture:	Quantity:
Fire-resistant board.	1
Condition:	Additional Fixture Notes:
Good

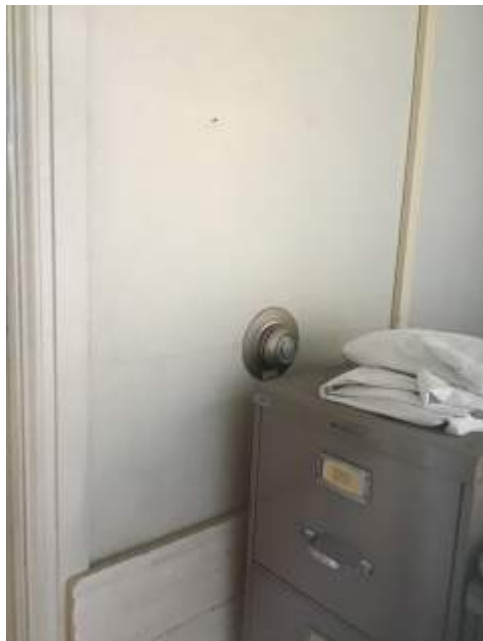
General Fixture Location:	Detailed Fixture Location:
Room 105 and 104	West of door between room 105 and 104.
Type of Fixture:	Quantity:
	2
Condition:	Additional Fixture Notes:
Good	Assumed mercury containing thermostats.
