FOCUSED SITE ASSESSMENT REPORT

COLLEGE AVENUE STEAM PLANT
PULLMAN, WASHINGTON

Prepared for
PORT OF WHITMAN COUNTY
March 30, 2022
Project No. M0457.02.003

Prepared by
Maul Foster & Alongi, Inc.
601 East Front Ave., Suite 202, Coeur d'Alene, ID 83814

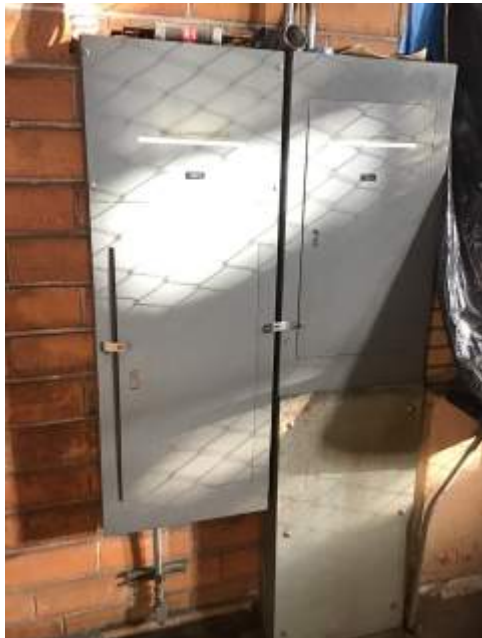
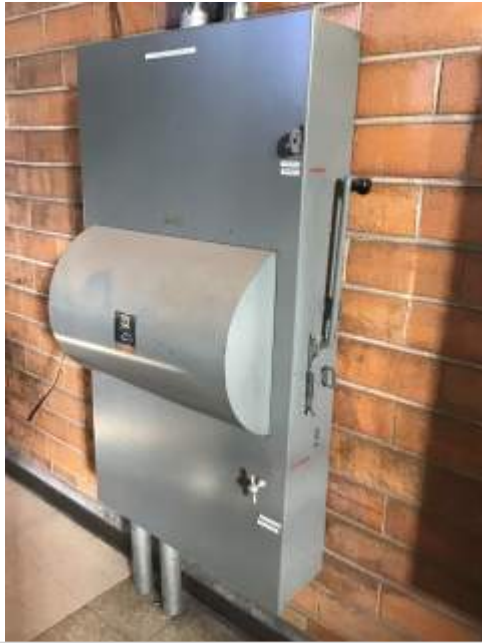
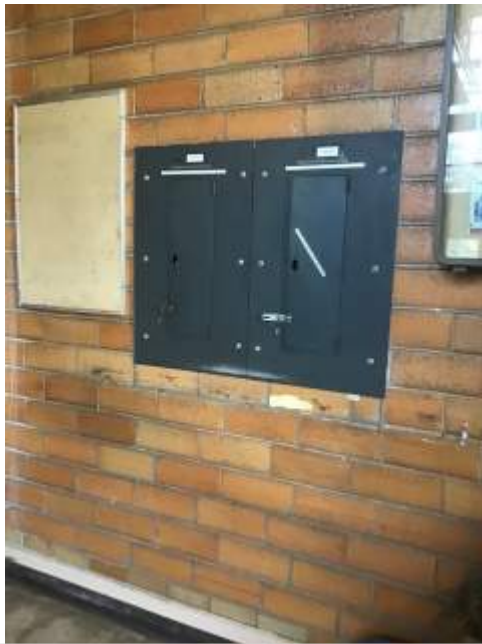
General Fixture Location:	Detailed Fixture Location:
Throughout first floor.	
Type of Fixture:	Quantity:
Electrical equip	Several.
Condition:	Additional Fixture Notes:
Good	Electrical equipment: 13 breaker/electrical panels, 2 motor control center.

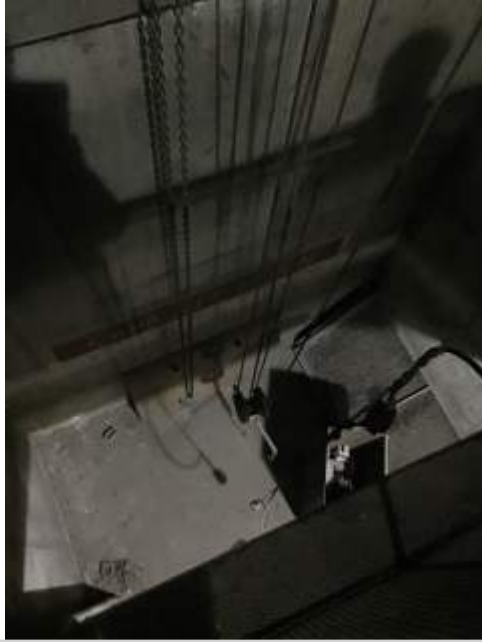
General Fixture Location:	Detailed Fixture Location:
Room 101	Northwest corner of room 101.
Type of Fixture:	Quantity:
Equipment lift system.	1
Condition:	Additional Fixture Notes:
Good	Mechanical hazard with motor.

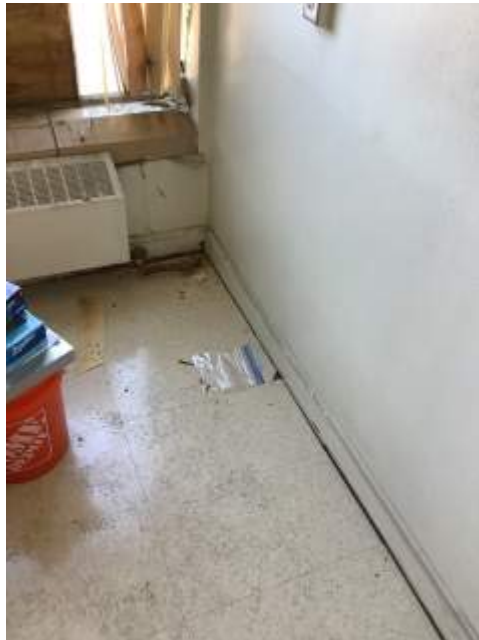
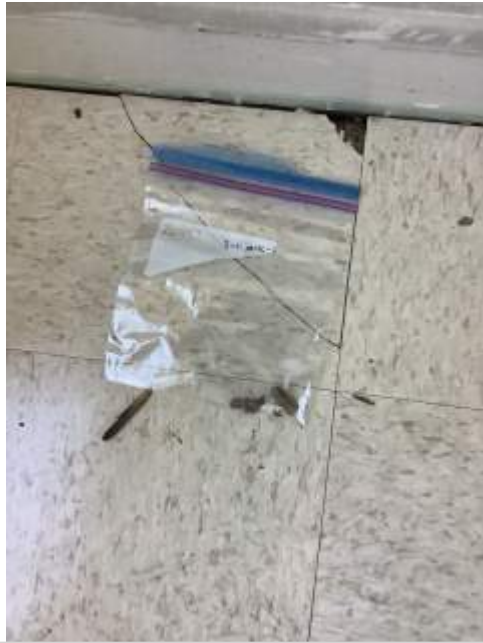
Sample ID:	Sample Type:	
2-1-MISC-1	MISC	
Sample Location:	Detailed Sample Location:	
Room 202	Northwest corner floor.	
Sample Quantity:	66 square feet.	
Misc Sample Material:	Sample Condition:	Sample Friable?:
White stipple pattern 12" x 12" vinyl floor tile with black mastic.	Potential ACBM with potential for damage	No

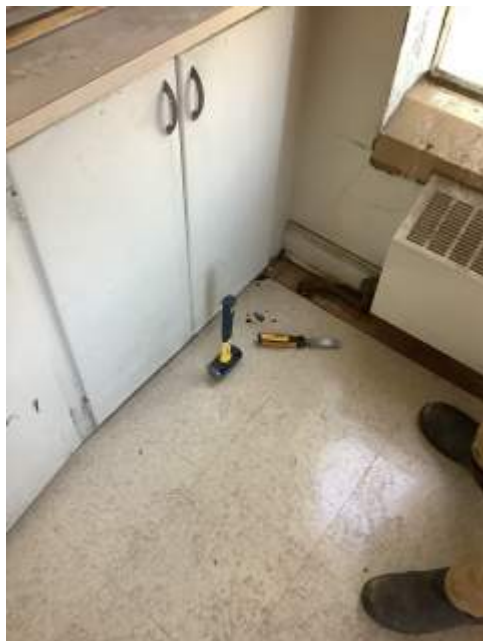
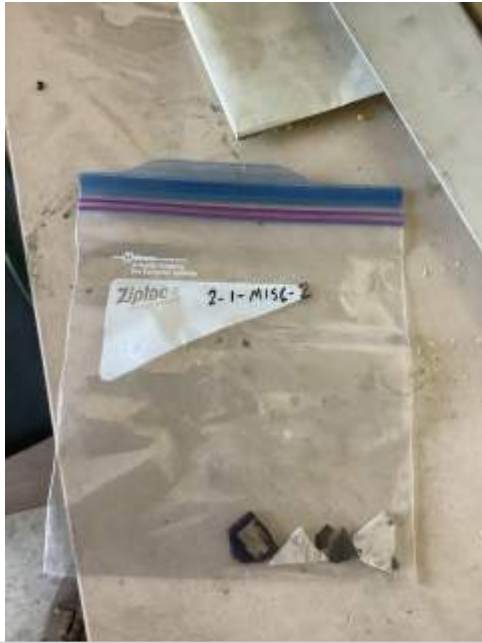
Sample ID:	Sample Type:	
2-1-MISC-2	MISC	
Sample Location:	Detailed Sample Location:	
Room 203	Southeast corner floor.	
Sample Quantity:	66 square feet.	
Misc Sample Material:	Sample Condition:	Sample Friable?:
White stipple pattern 12" x 12" vinyl floor tile with black mastic.	Potential ACBM with potential for damage	No

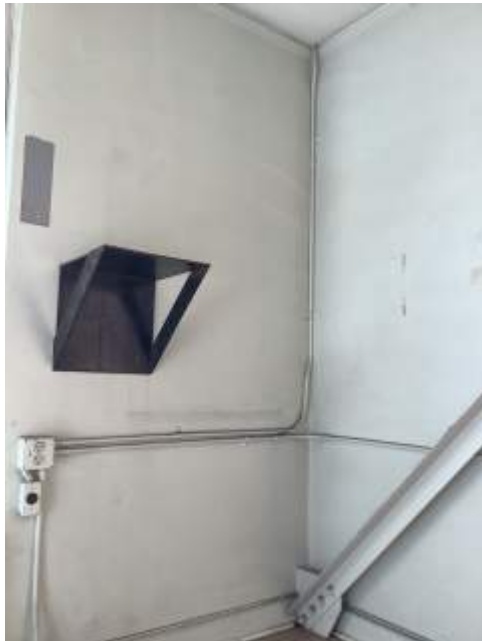
Sample ID:	Sample Type:
2-1-PB-1	PB
Sample Location:	Detailed Sample Location:
Room 203	Southeast corner of room.
Sample Quantity:	NA
Sample Color:	XRF:
White	0.180

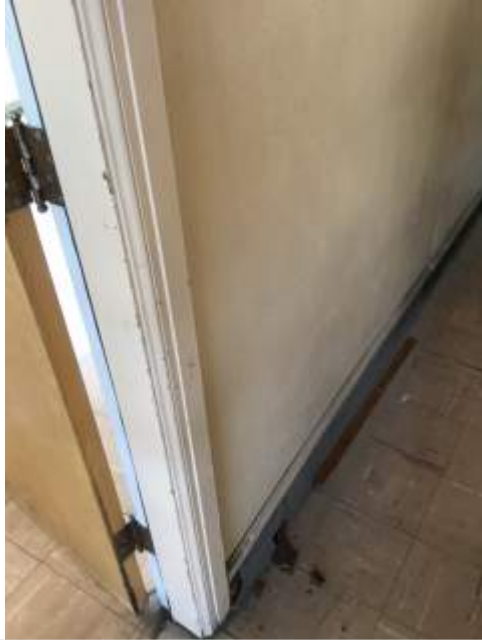
Sample ID:	Sample Type:
2-2-PB-3	PB
Sample Location:	Detailed Sample Location:
Room 200S	Catwalk outside of room 204.
Sample Quantity:	NA
Sample Color:	XRF:
Tan	0.085

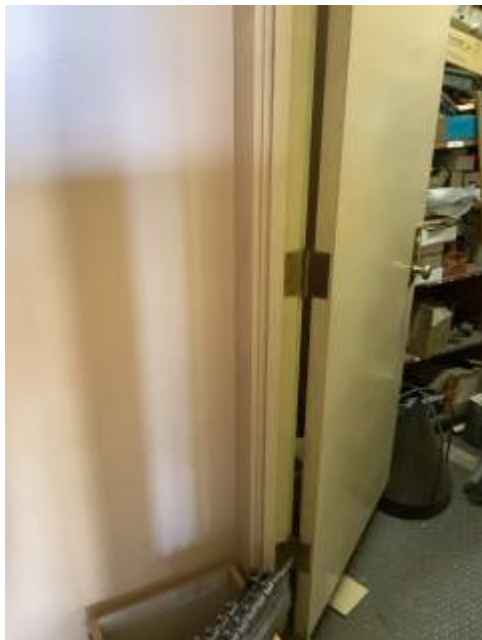
Sample ID:	Sample Type:
2-2-PB-4	PB
Sample Location:	Detailed Sample Location:
Room 200S	Catwalk outside of room 201.
Sample Quantity:	NA
Sample Color:	XRF:
Tan	0.219

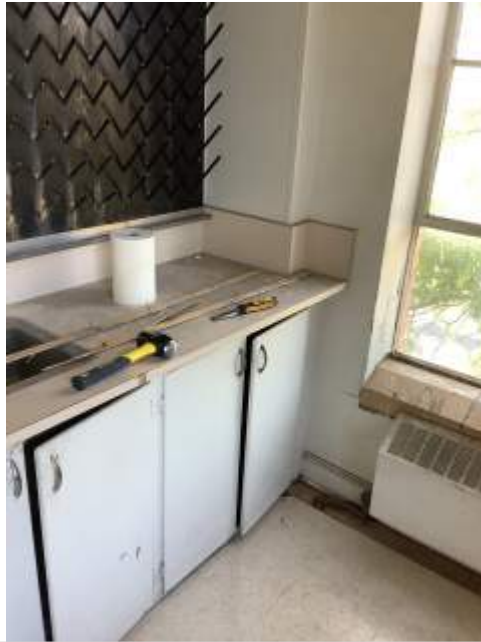
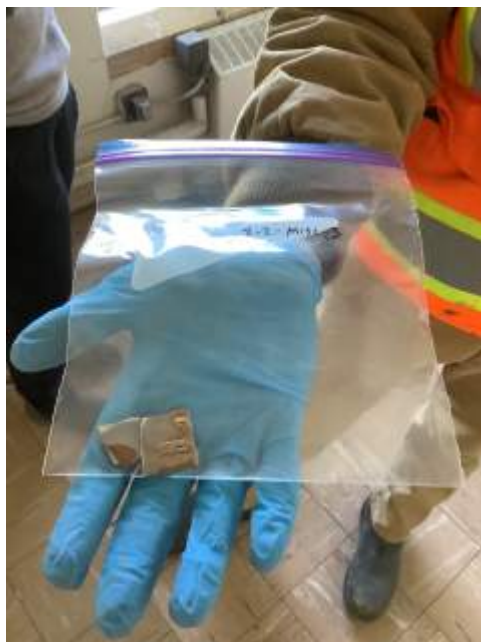
Additional Sample Notes:		
Sample ID:	Sample Type:	
2-2-MISC-3	MISC	
Sample Location:	Detailed Sample Location:	
Room 203	Southeast corner of counter.	
Sample Quantity:	22 square feet.	
Misc Sample Material:	Sample Condition:	Sample Friable?:
Tan laminate countertop with clear mastic.	Potential ACBM with potential for damage	No

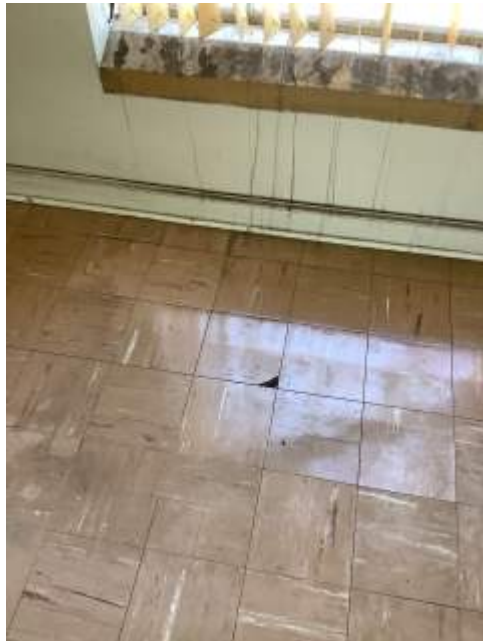
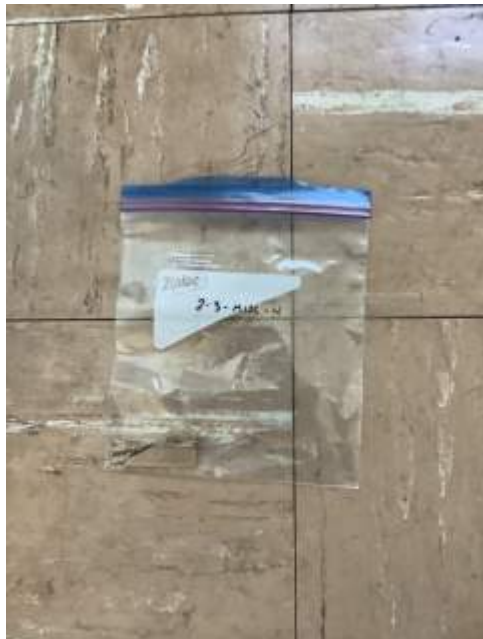
Additional Sample Notes:		
Sample ID:	Sample Type:	
2-3-MISC-4	MISC	
Sample Location:	Detailed Sample Location:	
Room 202	West side of floor.	
Sample Quantity:	175 square feet.	
Misc Sample Material:	Sample Condition:	Sample Friable?:
Light brown patterned 9" x 9" vinyl floor tile with black mastic.	Potential ACBM with potential for damage	No

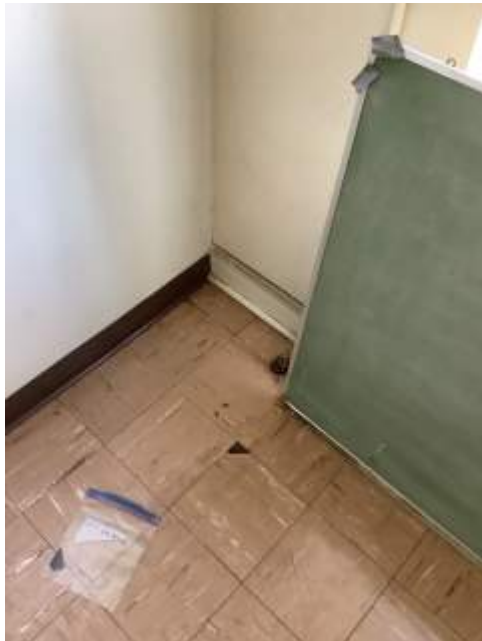
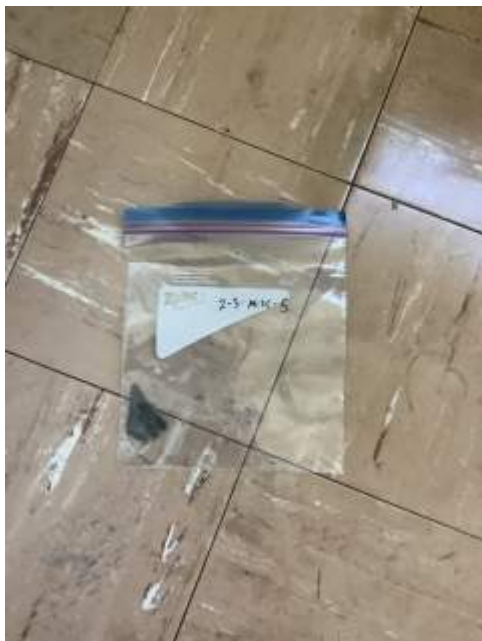
Additional Sample Notes:		
Sample ID:	Sample Type:	
2-3-MISC-5	MISC	
Sample Location:	Detailed Sample Location:	
Room 203	Southwest corner of floor.	
Sample Quantity:	175 square feet.	
Misc Sample Material:	Sample Condition:	Sample Friable?:
Light brown patterned 9" x 9" vinyl floor tile with black mastic.	Potential ACBM with potential for damage	No

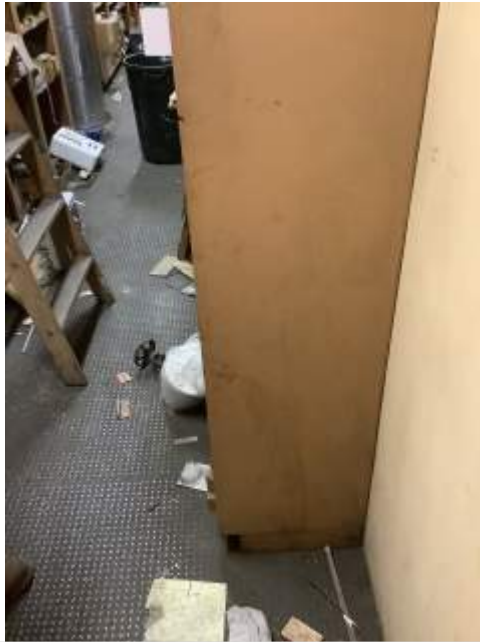
Sample ID:	Sample Type:
2-3-PB-5	PB
Sample Location:	Detailed Sample Location:
Room 201	Cabinet inside doorway.
Sample Quantity:	NA
Sample Color:	XRF:
Dark tan	0.330

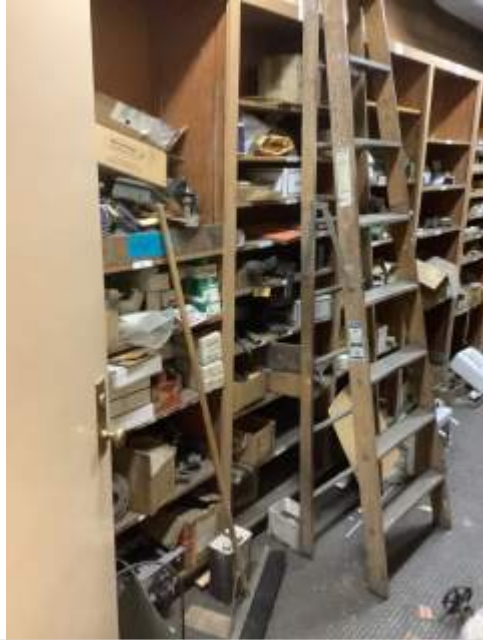
Sample ID:	Sample Type:
2-3-PB-6	PB
Sample Location:	Detailed Sample Location:
Room 201	Cabinet on north wall.
Sample Quantity:	NA
Sample Color:	XRF:
Dark tan	0.268

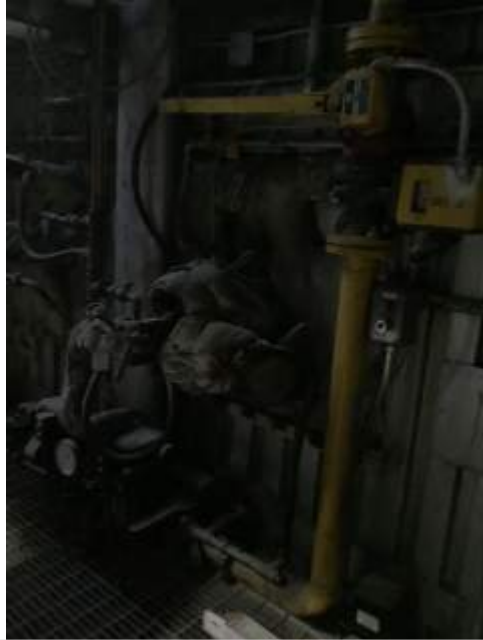
Sample ID:	Sample Type:
2-4-PB-12	PB
Sample Location:	Detailed Sample Location:
Room 101	Yellow pipe on first catwalk, east side of room.
Sample Quantity:	600 linear feet.
Sample Color:	XRF:
Yellow	3.28

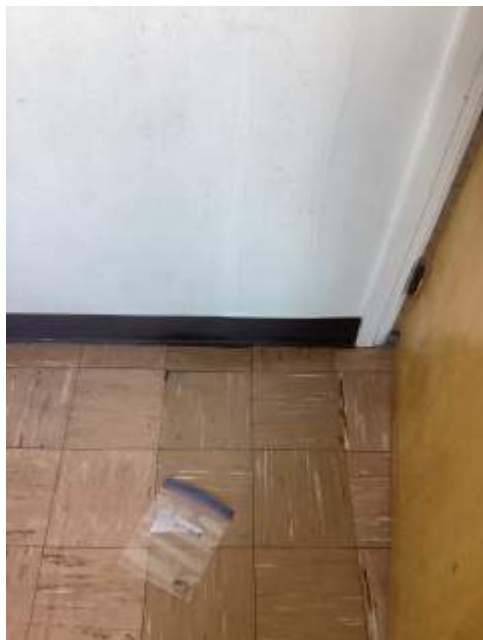
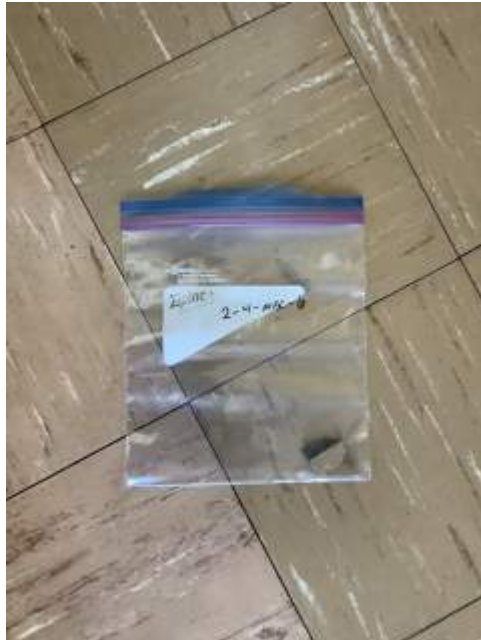
Sample ID:	Sample Type:	
2-4-MISC-6	MISC	
Sample Location:	Detailed Sample Location:	
Room 202	East side of floor north of door.	
Sample Quantity:	20 square feet.	
Misc Sample Material:	Sample Condition:	Sample Friable?:
Brown stripped patterned 9" x 9" vinyl floor tile with black mastic.	Potential ACBM with potential for damage	No

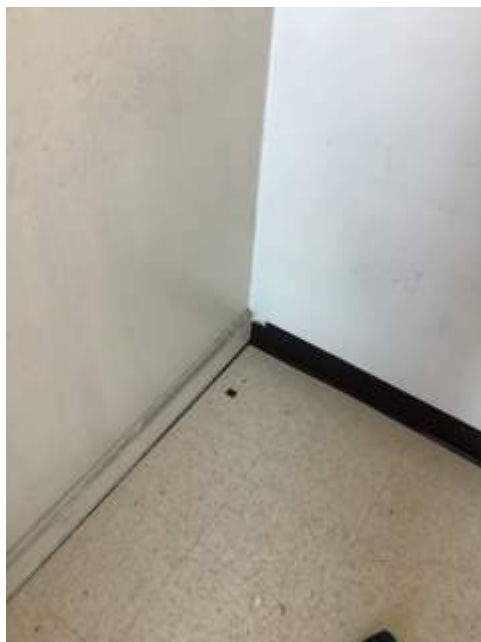
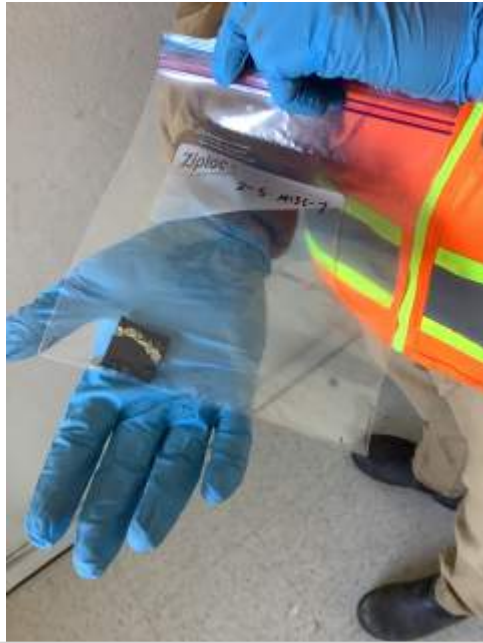
Sample ID:	Sample Type:	
2-5-MISC-7	MISC	
Sample Location:	Detailed Sample Location:	
Room 202	Northeast corner of room.	
Sample Quantity:	30 linear feet.	
Misc Sample Material:	Sample Condition:	Sample Friable?:
Black cove base with tan mastic.	Potential ACBM with potential for damage	No

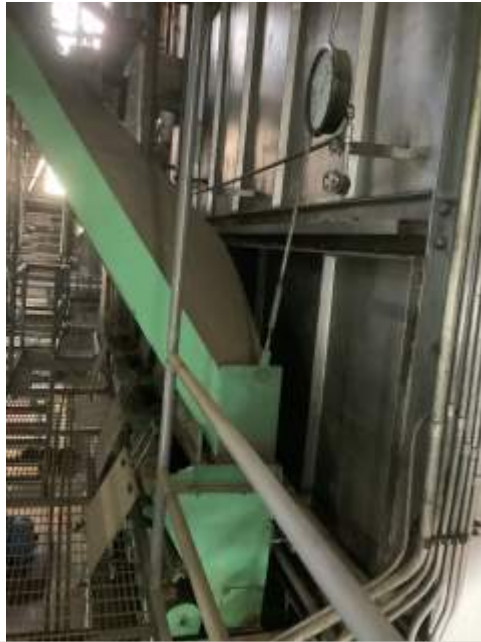
Sample ID:	Sample Type:
2-5-PB-9	PB
Sample Location:	Detailed Sample Location:
Room 101	Light green pipe on first catwalk in center of room.
Sample Quantity:	NA
Sample Color:	XRF:
Light green	0.242

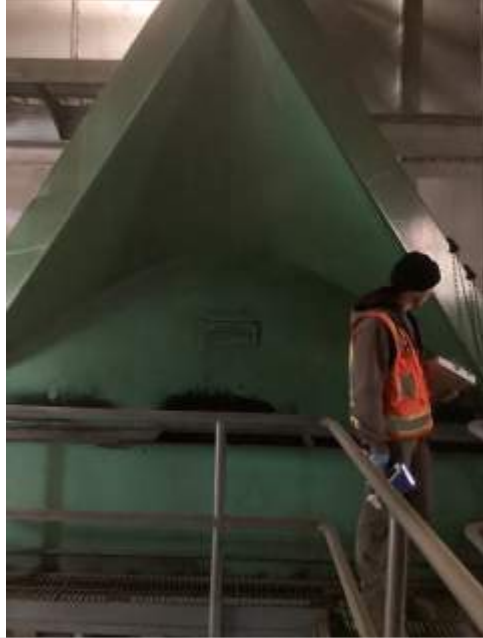
Sample ID:	Sample Type:
2-5-PB-10	PB
Sample Location:	Detailed Sample Location:
Room 101	Light green pipe on first catwalk in center of room.
Sample Quantity:	NA
Sample Color:	XRF:
Light green	0.108

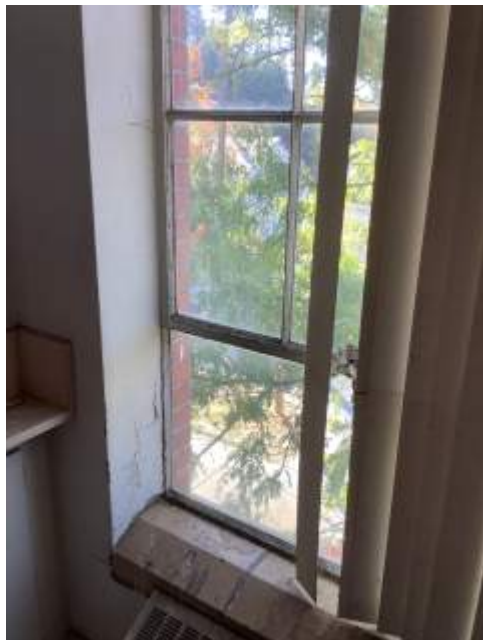
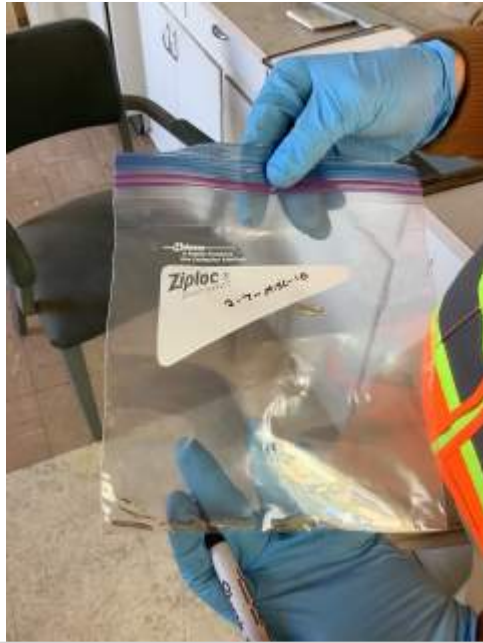
Sample ID:	Sample Type:	
2-7-MISC-10	MISC	
Sample Location:	Detailed Sample Location:	
Room 203	Southeast window.	
Sample Quantity:	4,030 linear feet.	
Misc Sample Material:	Sample Condition:	Sample Friable?:
Window glazing.	Potential ACBM with potential for damage	No

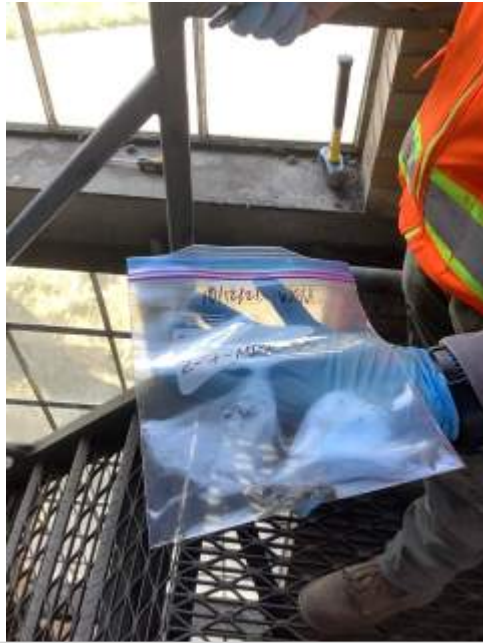
Sample ID:	Sample Type:	
2-7-MISC-33	MISC	
Sample Location:	Detailed Sample Location:	
Room 101	Northwest corner; highest catwalk.	
Sample Quantity:	4,030 linear feet.	
Misc Sample Material:	Sample Condition:	Sample Friable?:
Window glazing.	Damaged or significantly damaged friable miscellaneous ACM	Yes

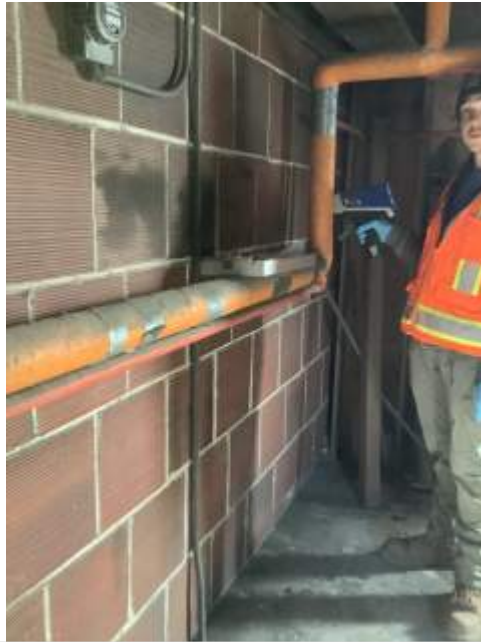
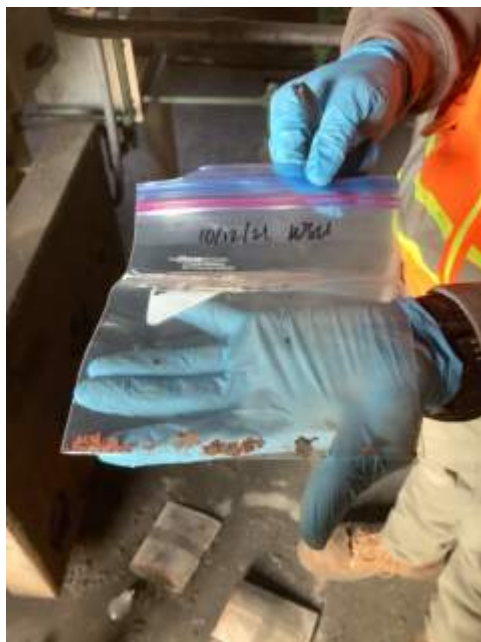
2-7-PB-24

Sample Color: Red **XRF:** 1.164

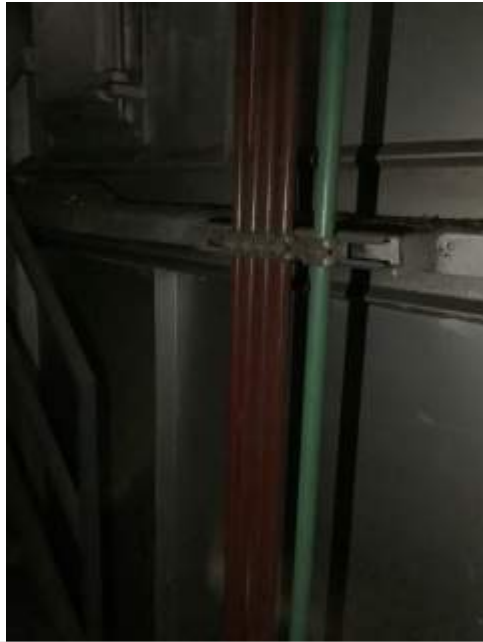
Sample ID:	Sample Type:
2-8-PB-25	PB
Sample Location:	Detailed Sample Location:
Room 101	Red pipe on first catwalk, east side of room.
Sample Quantity:	NA
Sample Color:	XRF:
Red	ND

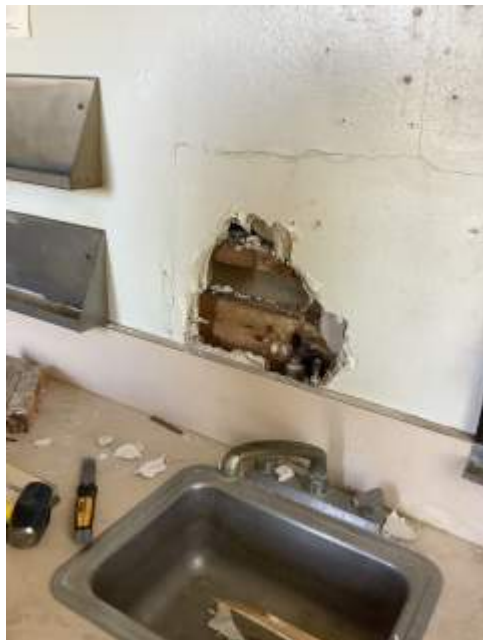
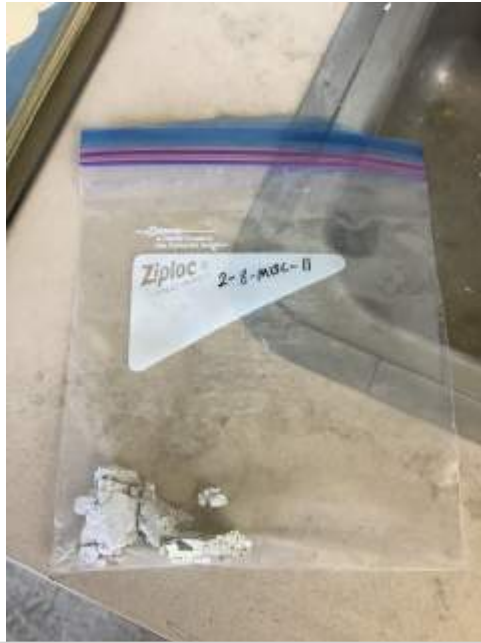
Sample ID:	Sample Type:	
2-8-MISC-11	MISC	
Sample Location:	Detailed Sample Location:	
Room 203	East wall above sink.	
Sample Quantity:	1,000 square feet.	
Misc Sample Material:	Sample Condition:	Sample Friable?:
White drywall with cementitious wallboard.	Potential ACBM with potential for damage	No;Yes

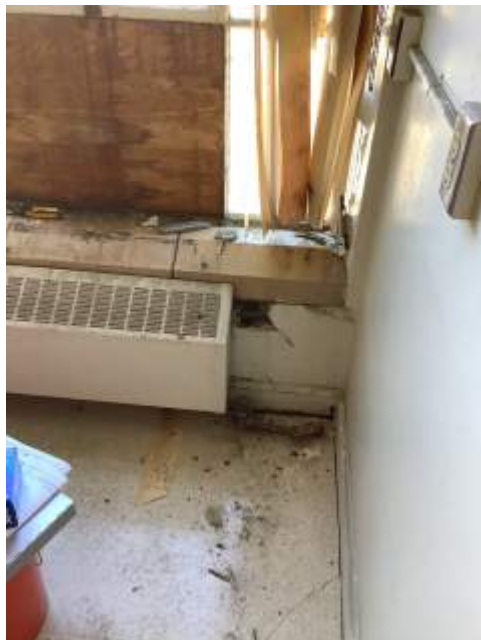
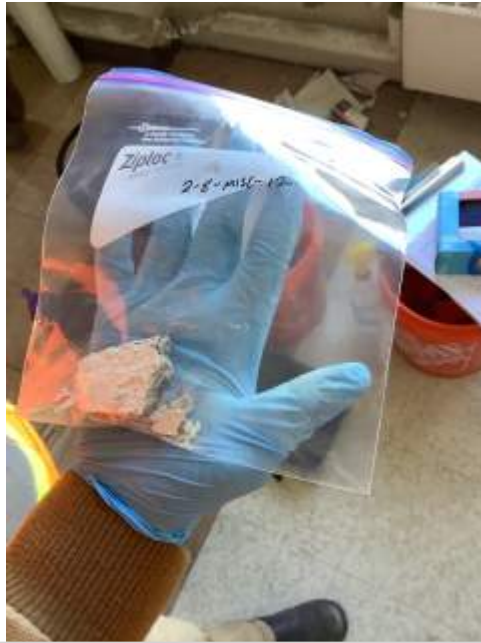
Sample ID:	Sample Type:	
2-8-MISC-12	MISC	
Sample Location:	Detailed Sample Location:	
Room 202	Northwest corner wall under window.	
Sample Quantity:	1,000 square feet.	
Misc Sample Material:	Sample Condition:	Sample Friable?:
White drywall with cementitious wallboard.	Potential ACBM with potential for damage	No

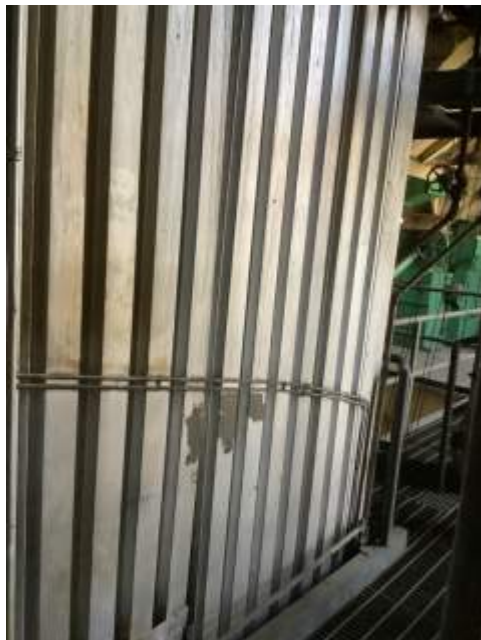
Sample ID: 2-9-PB-15 **Sample Type:** PB

Sample Color: Gray **XRF:** ND

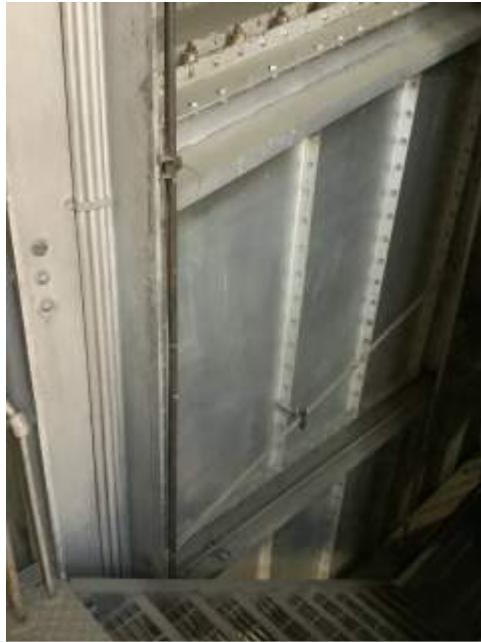
Sample ID:	Sample Type:
2-9-PB-19	PB
Sample Location:	Detailed Sample Location:
Room 101	Gray boiler siding on second catwalk, east side of room.
Sample Quantity:	NA
Sample Color:	XRF:
Gray	0.035

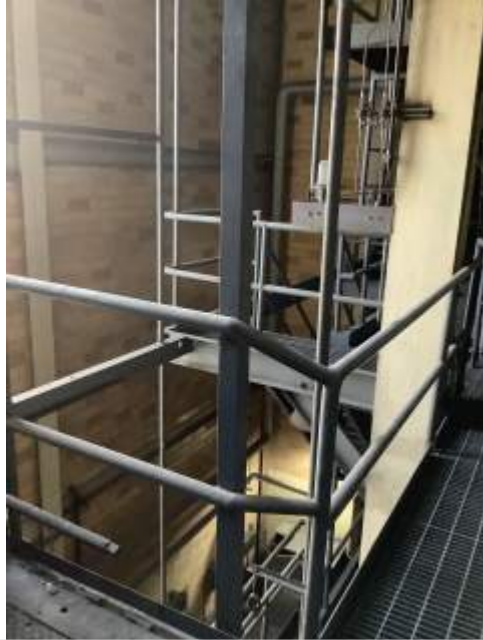
Sample ID:	Sample Type:
2-10-PB-17	PB
Sample Location:	Detailed Sample Location:
Room 101	Gray railing on second catwalk on east side of room.
Sample Quantity:	NA
Sample Color:	XRF:
Gray	0.007

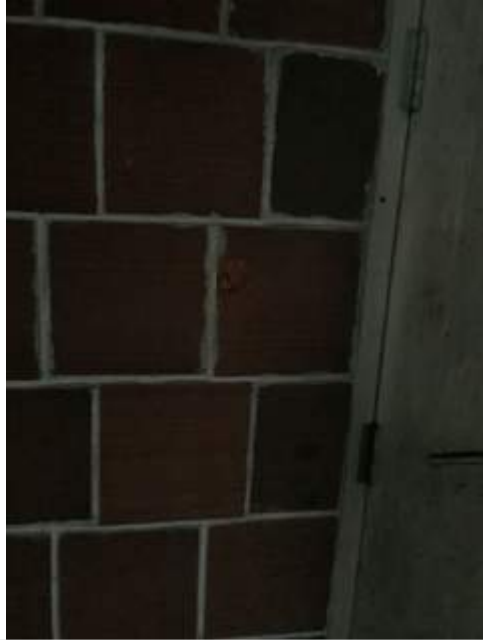
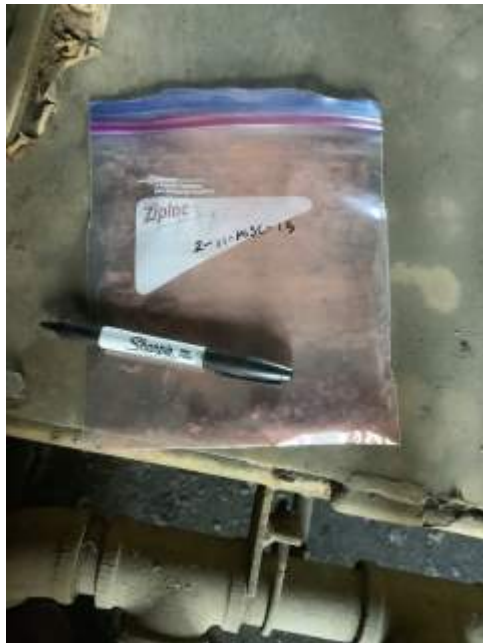
Sample ID:	Sample Type:	
2-11-MISC-15	MISC	
Sample Location:	Detailed Sample Location:	
Room 204	West wall south of double door.	
Sample Quantity:	615 square feet.	
Misc Sample Material:	Sample Condition:	Sample Friable?:
Red 12" x 12" brick.	Potential ACBM with potential for damage	No

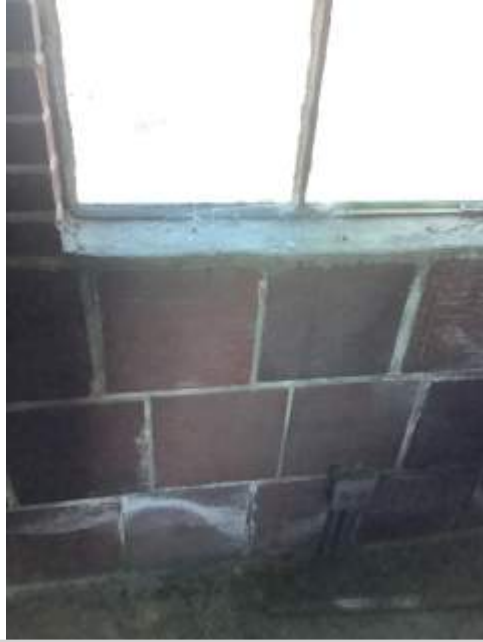
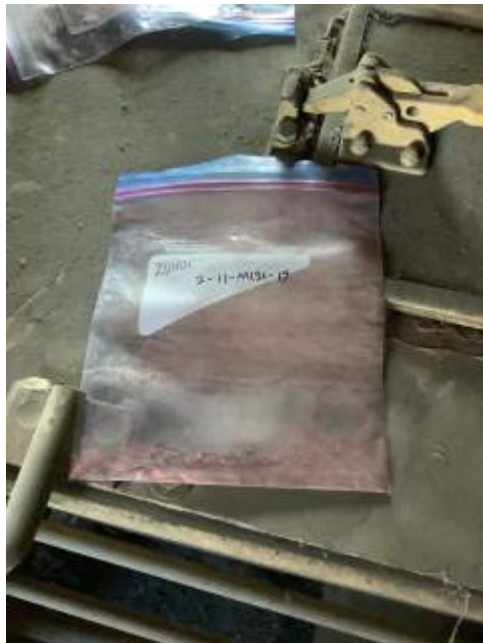
Sample ID:	Sample Type:	
2-11-MISC-17	MISC	
Sample Location:	Detailed Sample Location:	
Room 204	North wall below window.	
Sample Quantity:	615 square feet.	
Misc Sample Material:	Sample Condition:	Sample Friable?:
Red 12" x 12" brick.	Potential ACBM with potential for damage	No

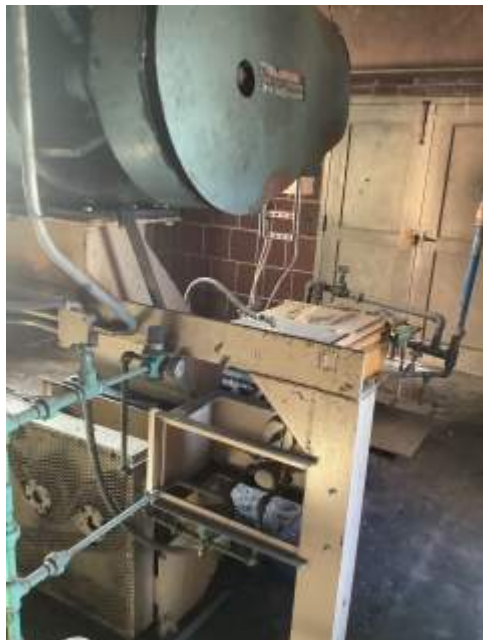
Sample ID:	Sample Type:
2-11-PB-22	PB
Sample Location:	Detailed Sample Location:
Room 101	Tan mechanical part in room 204.
Sample Quantity:	NA
Sample Color:	XRF:
Tan	ND

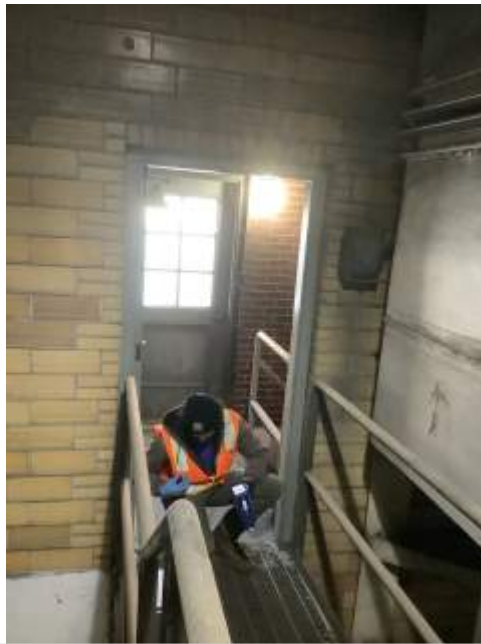
Sample ID:	Sample Type:
2-12-PB-20	PB
Sample Location:	Detailed Sample Location:
Room 101	Gray door frame on second catwalk, east side of room.
Sample Quantity:	NA
Sample Color:	XRF:
Gray	0.517

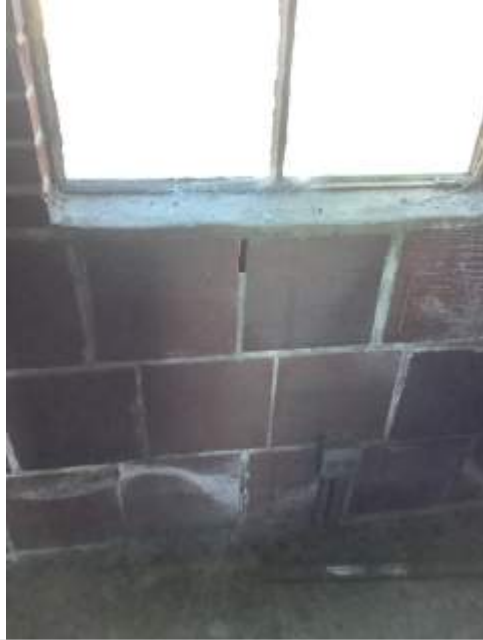
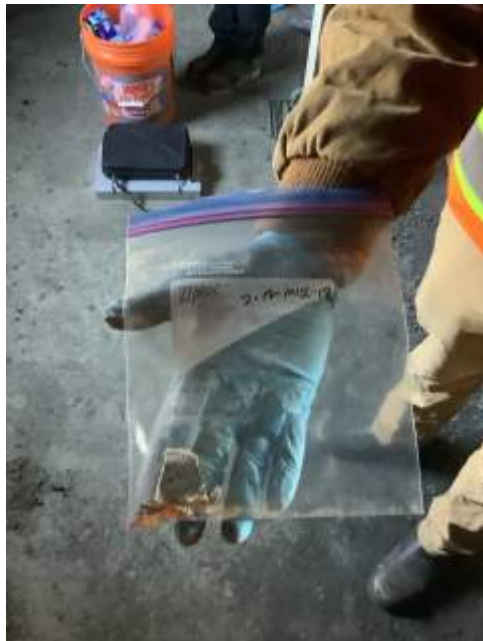
Sample ID:	Sample Type:	
2-12-MISC-18	MISC	
Sample Location:	Detailed Sample Location:	
Room 204	North wall below window.	
Sample Quantity:	550 linear feet.	
Misc Sample Material:	Sample Condition:	Sample Friable?:
Gray brick mortar.	Potential ACBM with potential for damage	No

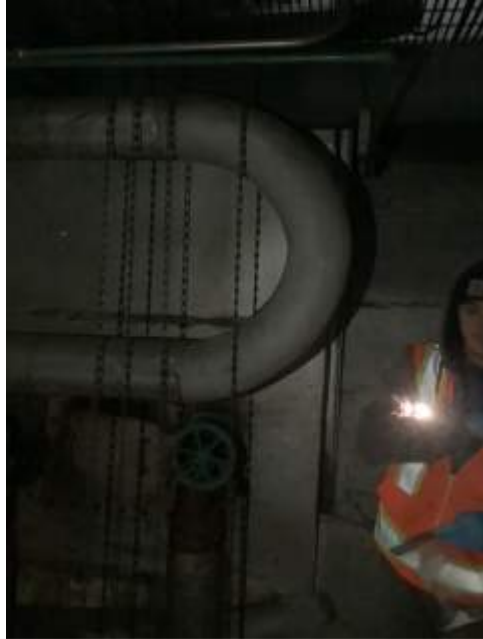
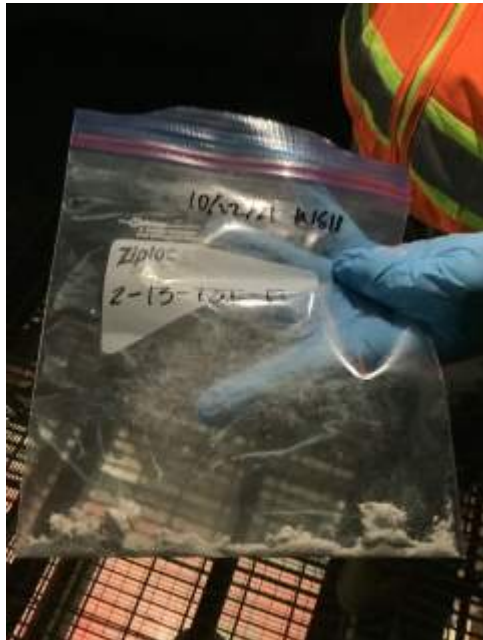
Additional Sample Notes:		
Sample ID:	Sample Type:	
2-13-TSI-19	TSI	
Sample Location:	Detailed Sample Location:	
Room 101	Second catwalk on southwest side of Boiler 6.	
Sample Quantity:	3,000 linear feet.	
Sample Color:	XRF:	
Misc Sample Material:	Sample Condition:	Sample Friable?:
	Damaged or significantly damaged	Yes

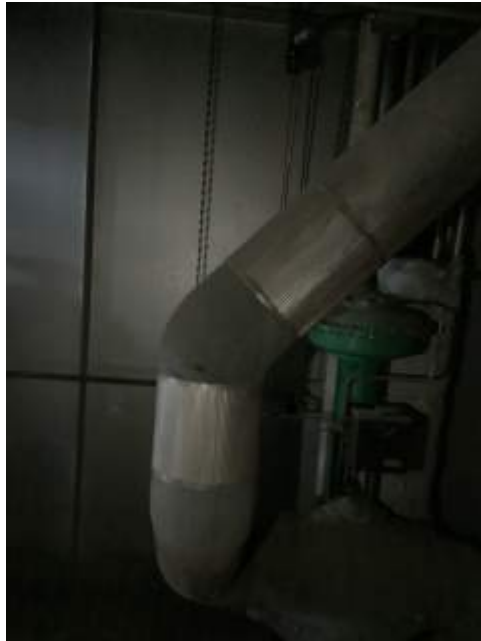
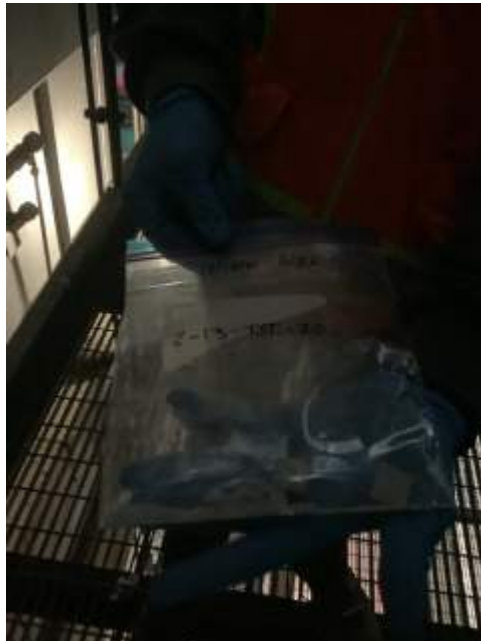
Additional Sample Notes:	Silver pipe with white insulation.
Sample ID:	Sample Type:
2-13-TSI-20	TSI
Sample Location:	Detailed Sample Location:
Room 101	Second catwalk on southwest side of Boiler 6.
Sample Quantity:	3,000 linear feet.
Sample Color:	XRF:

Misc Sample Material:	Sample Condition:	Sample Friable?:
	Damaged or significantly damaged	Yes

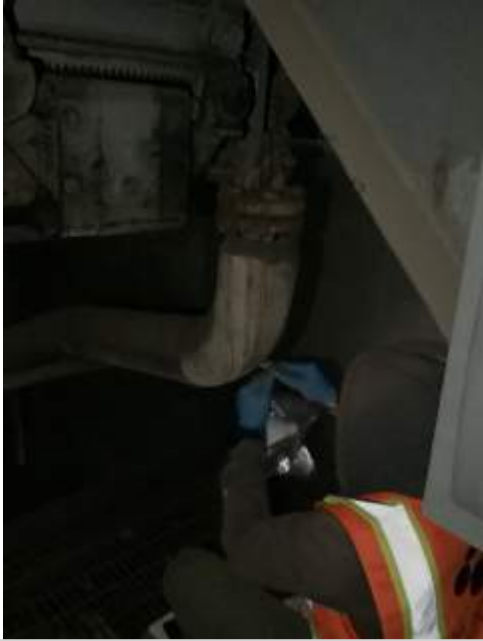
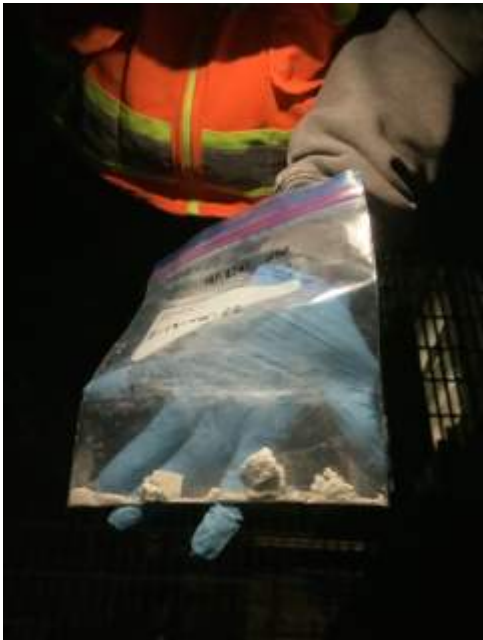
Sample ID:	Sample Type:
2-13-TSI-22	TSI
Sample Location:	Detailed Sample Location:
Room 101	Second catwalk on southwest side of Boiler 6.
Sample Quantity:	3,000 linear feet.

Sample Color:	XRF:	
Misc Sample Material:	Sample Condition:	Sample Friable?:
	Damaged or significantly damaged	Yes

Additional Sample Notes:	Elbow on silver pipe.
---------------------------------	-----------------------

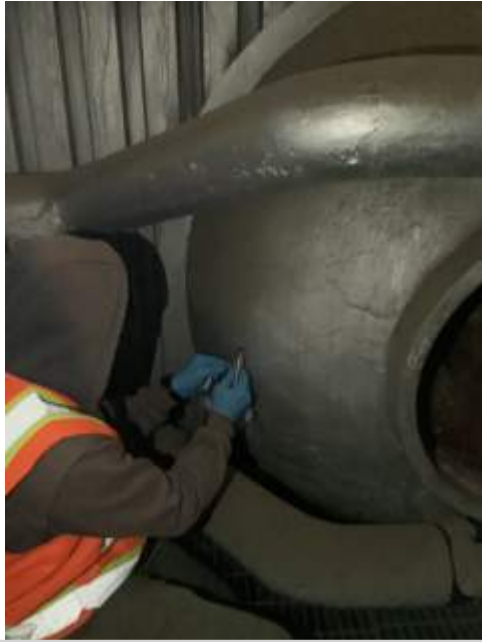
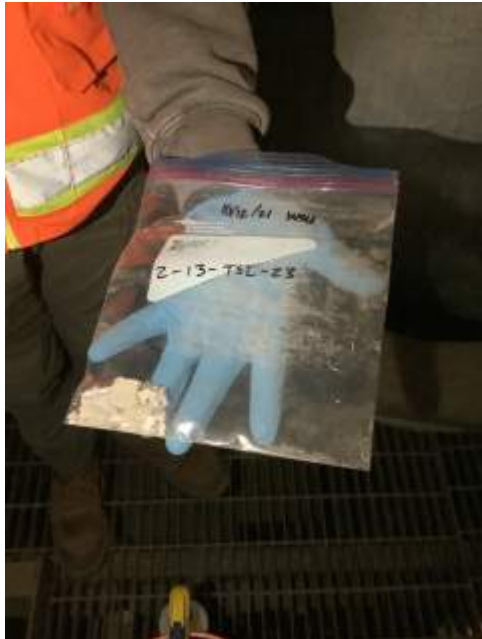
2-13-TSI-23

Room 101	Second catwalk on southeast side of Boiler 6.	
Sample Quantity:	3,000 linear feet.	
Sample Color:	XRF:	
Misc Sample Material:	Sample Condition:	Sample Friable?:
	Damaged or significantly damaged	Yes

Additional Sample Notes:	Silver pipe with white insulation.
---------------------------------	------------------------------------

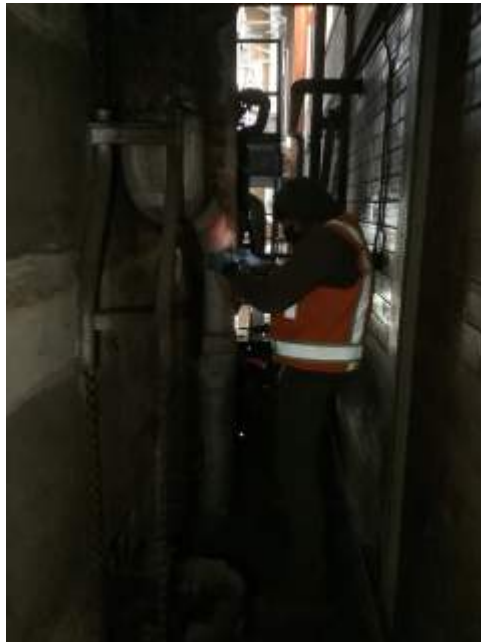
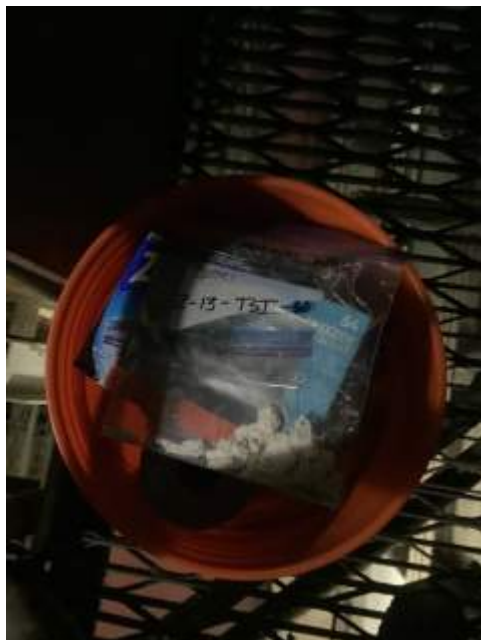
2-13-TSI-30	TSI	
Sample Location:	Detailed Sample Location:	
Room 101	Located throughout northeast side of room on and around Boiler 2 by staircase entrance.	
Sample Quantity:	3,000 linear feet.	
Sample Color:	XRF:	
Misc Sample Material:	Sample Condition:	Sample Friable?:
	Damaged or significantly damaged	No

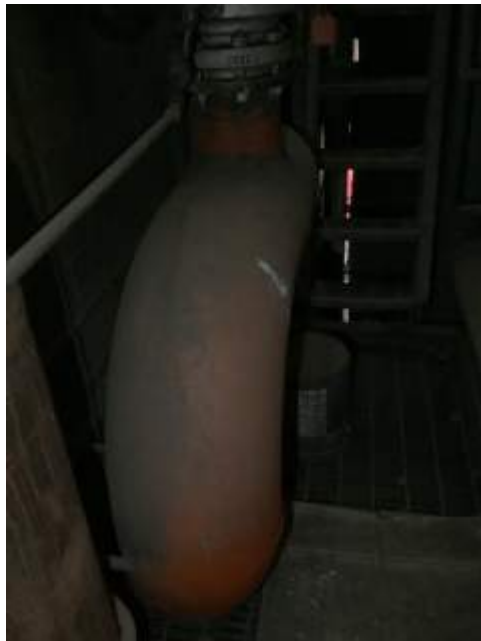
Additional Sample Notes:	Orange pipe wrap with white insulation.	
Sample ID:	Sample Type:	
2-13-TSI-25	TSI	
Sample Location:	Detailed Sample Location:	
Room 101	Second catwalk on south side of Boiler 6.	
Sample Quantity:	3,000 linear feet.	
Sample Color:	XRF:	
Misc Sample Material:	Sample Condition:	Sample Friable?:
	Damaged or significantly damaged	Yes

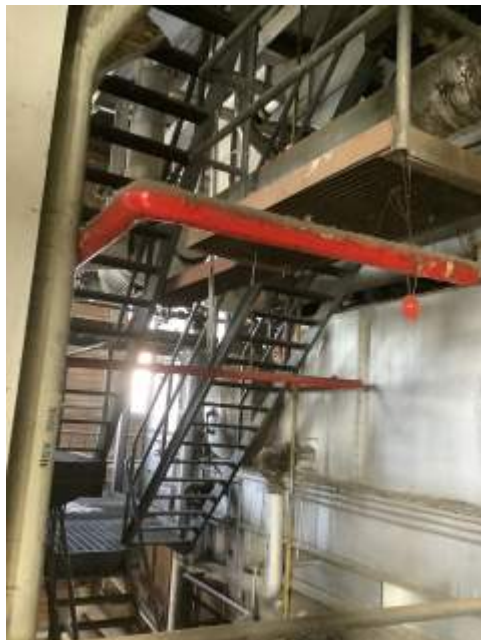
Additional Sample Notes:	Orange pipe with white insulation.
Sample ID:	Sample Type:
2-13-PB-21	PB
Sample Location:	Detailed Sample Location:
Room 101	Red pipe on west side of Boiler 4.
Sample Quantity:	NA
Sample Color:	XRF:
Red	ND

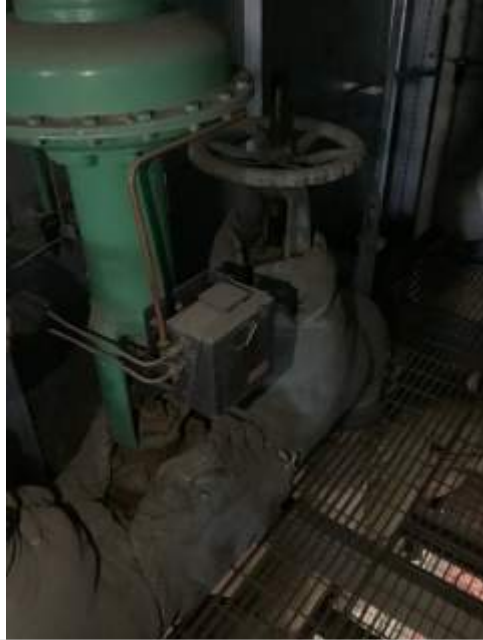
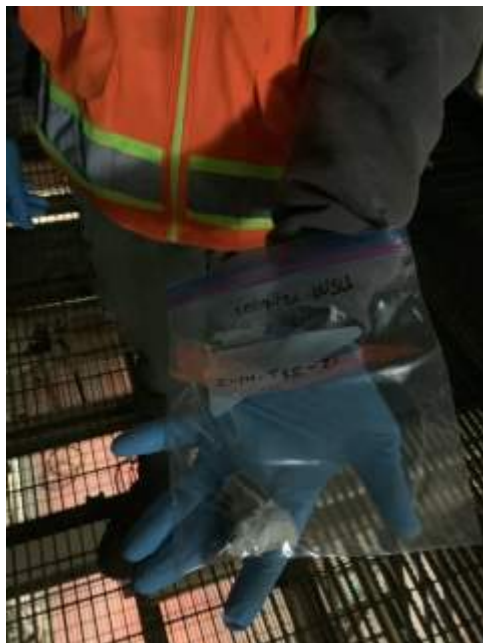
Additional Sample Notes:		Silver pipe with white insulation.	
Sample ID:		Sample Type:	
2-14-TSI-21		TSI	
Sample Location:		Detailed Sample Location:	
Room 101		Second catwalk on southwest side of Boiler 6.	
Sample Quantity:		500 linear feet.	
Sample Color:		XRF:	
Misc Sample Material:		Sample Condition:	Sample Friable?:
		Damaged or significantly damaged	Yes

Silver pipe with white insulation.

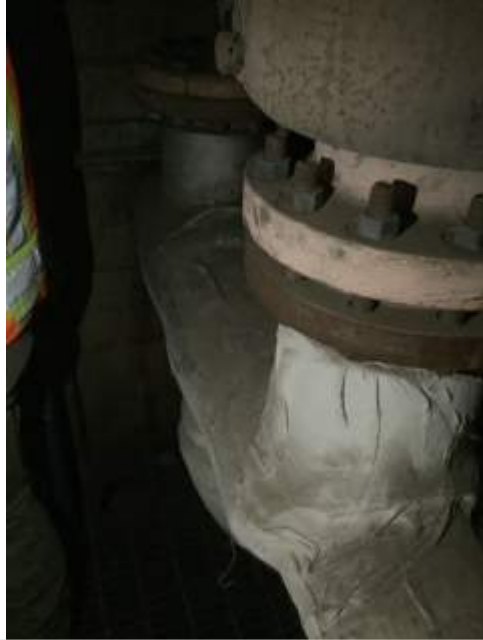
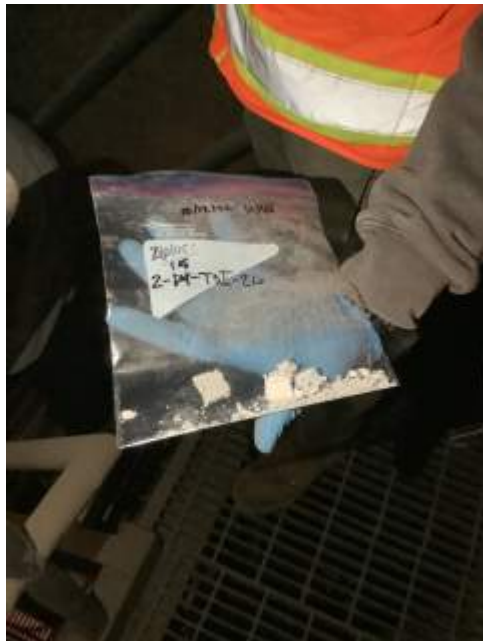
Additional Sample Notes:		
Sample ID:	Sample Type:	
2-15-TSI-26	TSI	
Sample Location:	Detailed Sample Location:	
Room 101	Southeast corner of room.	
Sample Quantity:	35 linear feet.	
Sample Color:	XRF:	
Misc Sample Material:	Sample Condition:	Sample Friable?:
	Damaged or significantly damaged	No
