FOCUSED SITE ASSESSMENT REPORT

COLLEGE AVENUE STEAM PLANT
PULLMAN, WASHINGTON

Prepared for
PORT OF WHITMAN COUNTY
March 30, 2022
Project No. M0457.02.003

Prepared by
Maul Foster & Alongi, Inc.
601 East Front Ave., Suite 202, Coeur d'Alene, ID 83814

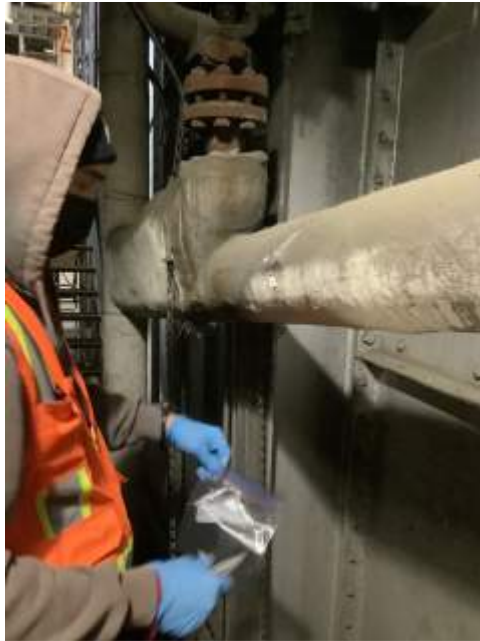
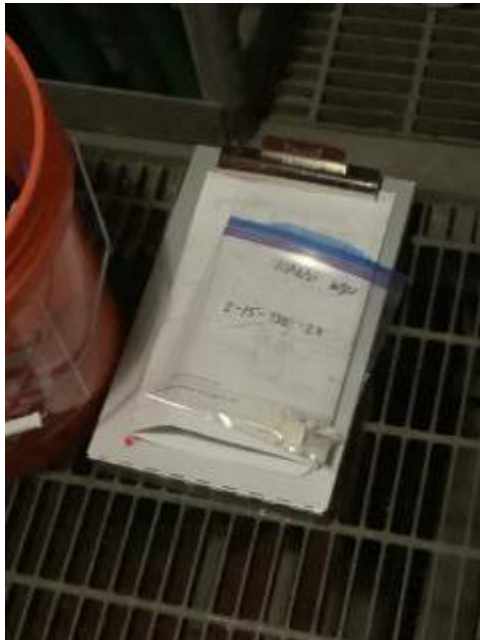
Additional Sample Notes:	Tan / white pipe wrap with white insulation.	
Sample ID:	Sample Type:	
2-15-TSI-27	TSI	
Sample Location:	Detailed Sample Location:	
Room 101	East side of room by staircase entrance.	
Sample Quantity:	35 linear feet.	
Sample Color:	XRF:	
Misc Sample Material:	Sample Condition:	Sample Friable?:
	Damaged or significantly damaged	No

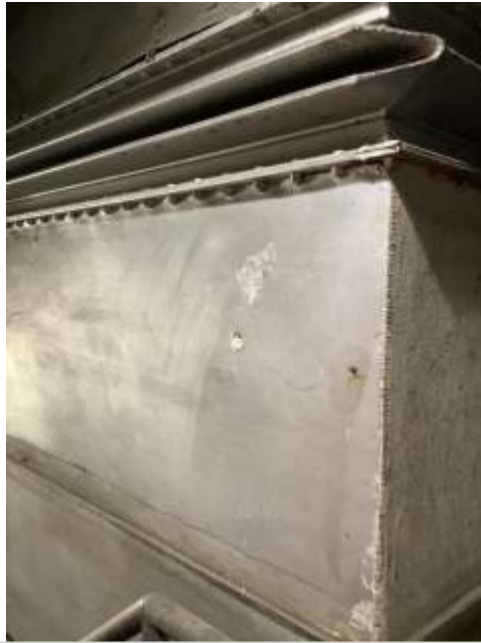
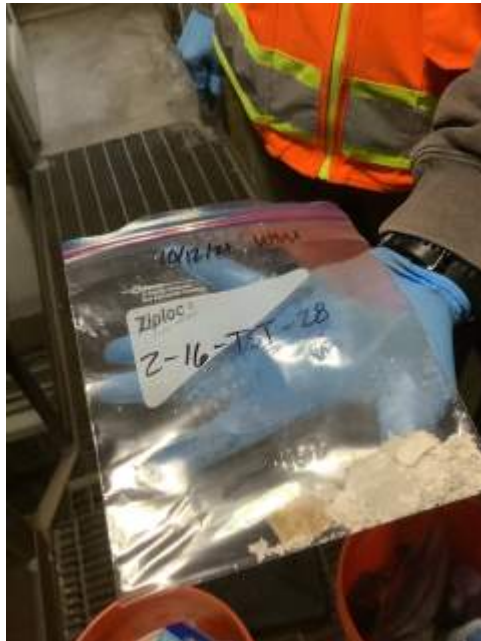
Additional Sample Notes:	White pipe wrap with white insulation.
Sample ID:	Sample Type:
2-16-TSI-28	TSI
Sample Location:	Detailed Sample Location:
Room 101	Located throughout northeast side of room on and around Boiler 2 by staircase entrance.
Sample Quantity:	Difficult to quantify.
Sample Color:	XRF:

Misc Sample Material:	Sample Condition:	Sample Friable?:
	Damaged or significantly damaged	No

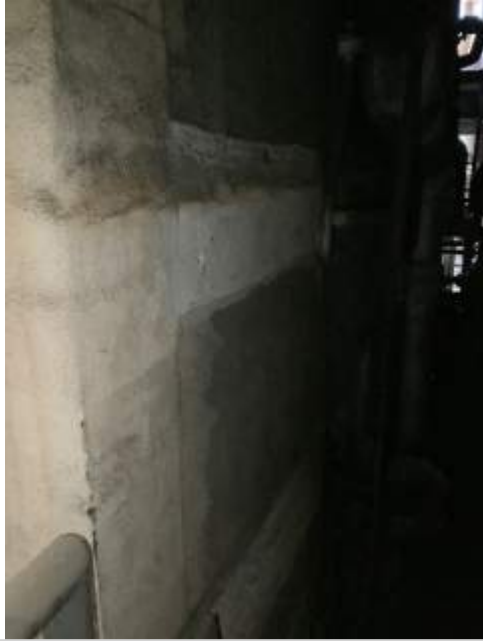
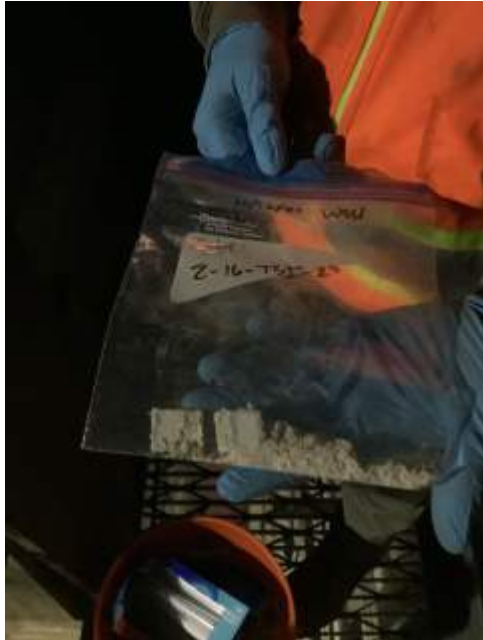
Sample ID:	Sample Type:
2-16-TSI-29	TSI
Sample Location:	Detailed Sample Location:
Room 101	Located throughout northeast side of room on and around Boiler 2 by staircase entrance.
Sample Quantity:	Difficult to quantify.

Sample Color:	XRF:	
Misc Sample Material:	Sample Condition:	Sample Friable?:
	Damaged or significantly damaged	No

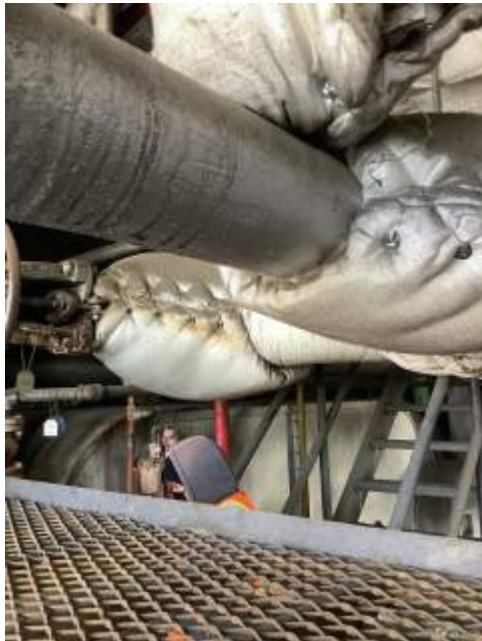
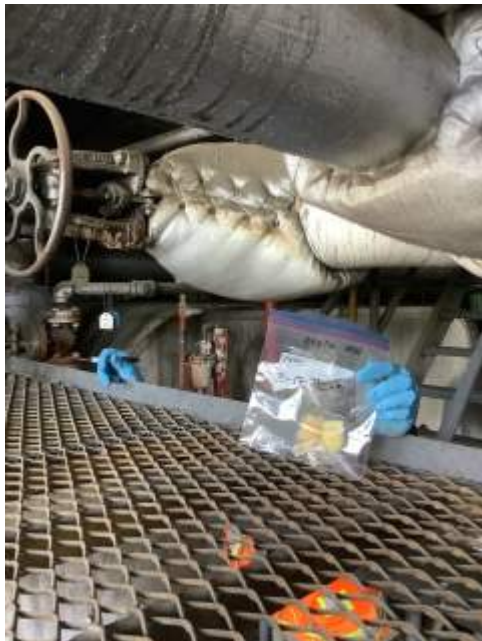
Sample ID:	Sample Type:
2-17-TSI-31	TSI
Sample Location:	Detailed Sample Location:

Room 101	North side of room, highest catwalk by Boiler 4.	
Sample Quantity:	20 linear feet.	
Sample Color:	XRF:	
Misc Sample Material:	Sample Condition:	Sample Friable?:
	Damaged or significantly damaged	Yes

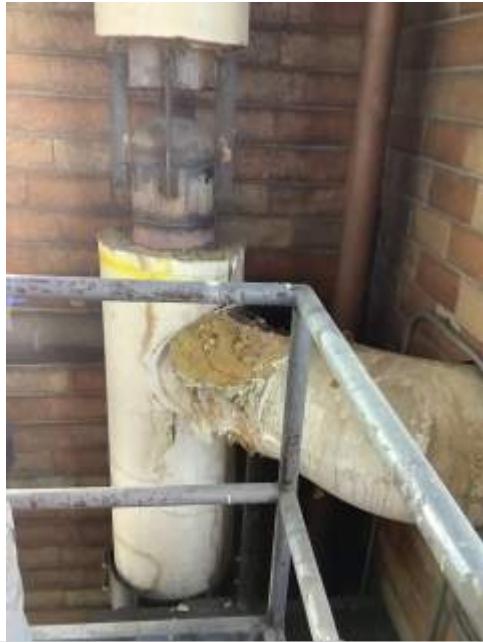
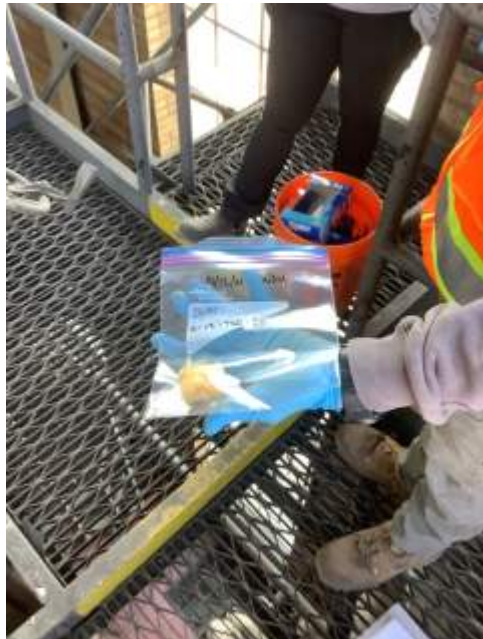
2-17-TSI-32	TSI	
Sample Location:	Detailed Sample Location:	
Room 101	Northwest corner of room, highest catwalk by Boiler 3.	
Sample Quantity:	20 linear feet.	
Sample Color:	XRF:	
Misc Sample Material:	Sample Condition:	Sample Friable?:
	Damaged or significantly damaged	Yes

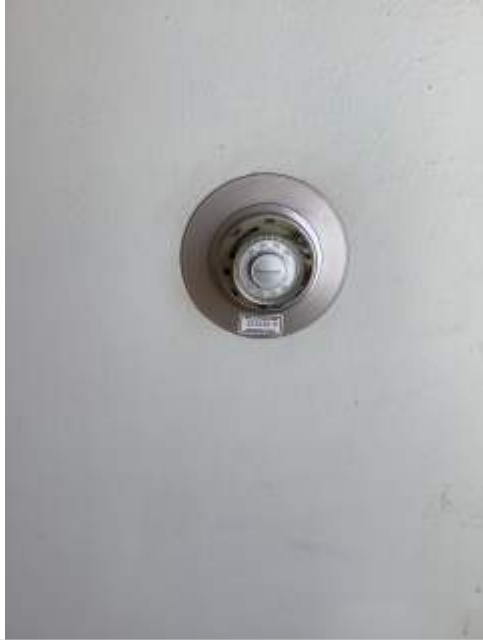
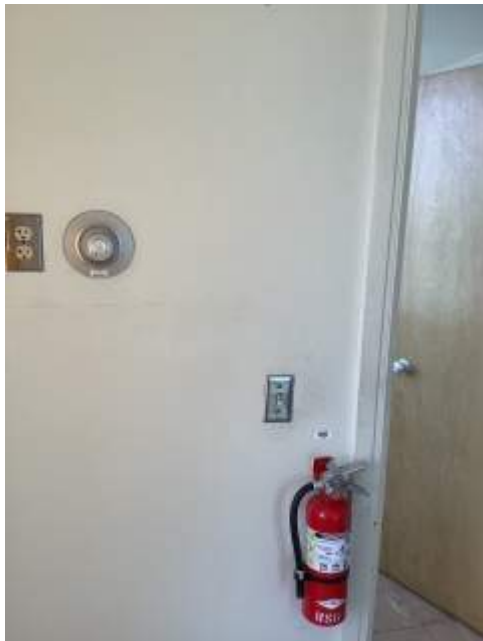
General Fixture Location:	Detailed Fixture Location:
Interior walls of rooms 202 and 203	
Type of Fixture:	Quantity:
	2
Condition:	Additional Fixture Notes:
Poor

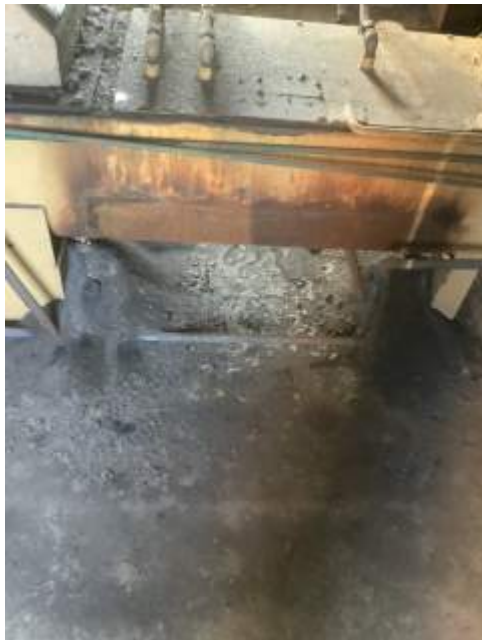
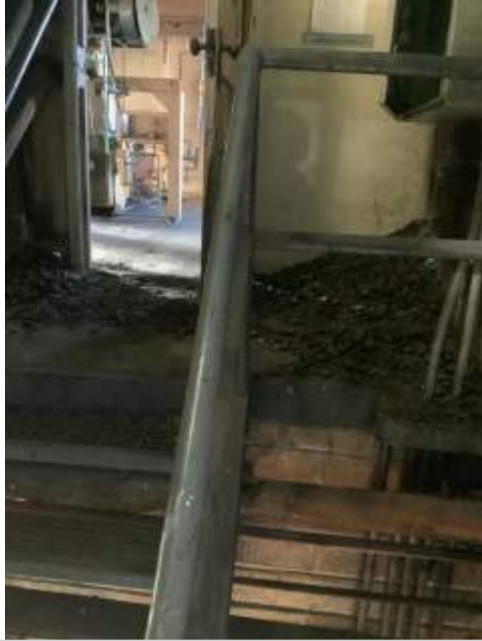
General Fixture Location:	Detailed Fixture Location:
Room 204	Throughout room 204
Type of Fixture:	Quantity:
Coal dust	Throughout room
Condition:	Additional Fixture Notes:
Other	Coal dust exposure.

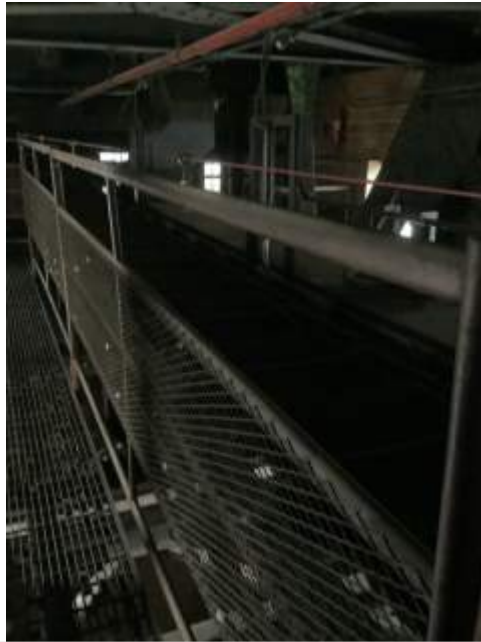
Sample ID:	Sample Type:
3-1-PB-1	PB
Sample Location:	Detailed Sample Location:
Catwalk above coal hopper.	By staircase.
Sample Quantity:	NA
Sample Color:	XRF:
Red	0.136

Additional Sample Notes:	Red water line.
---------------------------------	-----------------

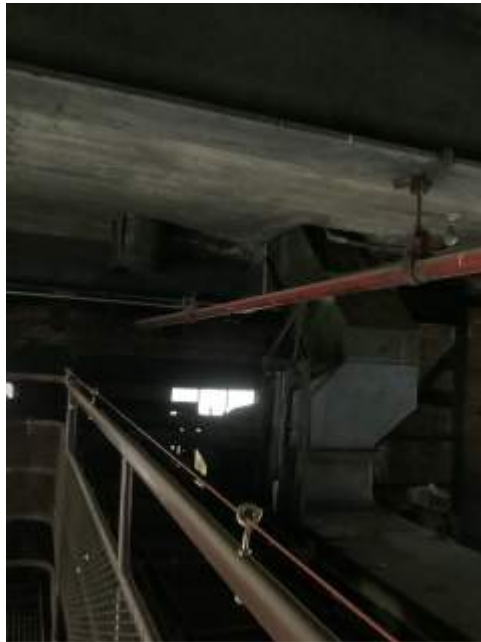
Sample ID:	Sample Type:
3-1-PB-2	PB
Sample Location:	Detailed Sample Location:
Catwalk above coal hopper.	By staircase.
Sample Quantity:	NA
Sample Color:	XRF:
Red	0.160

Additional Sample Notes:	Red water line.
---------------------------------	-----------------

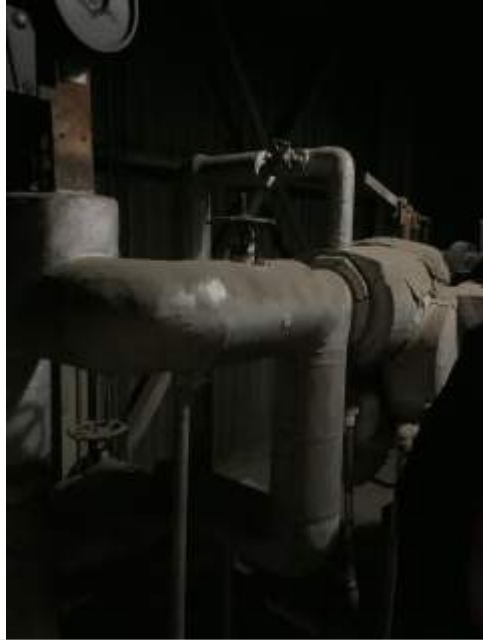
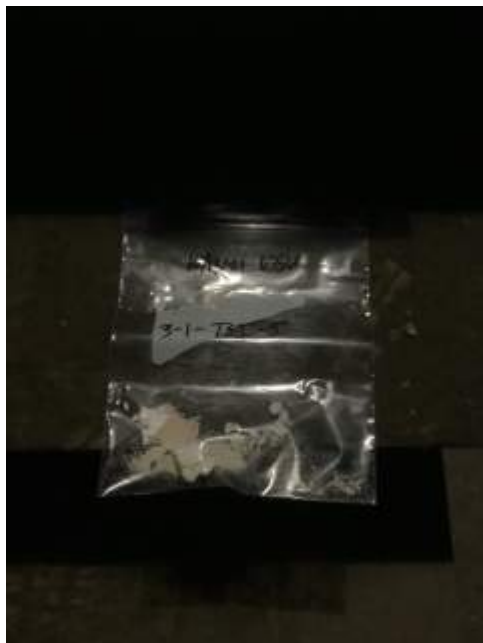
3-1-TSI-5

Misc Sample Material:	Sample Condition:	Sample Friable?:
------------------------------	--------------------------	-------------------------

Damaged or significantly damaged	Yes
--	----------------------------------	-----

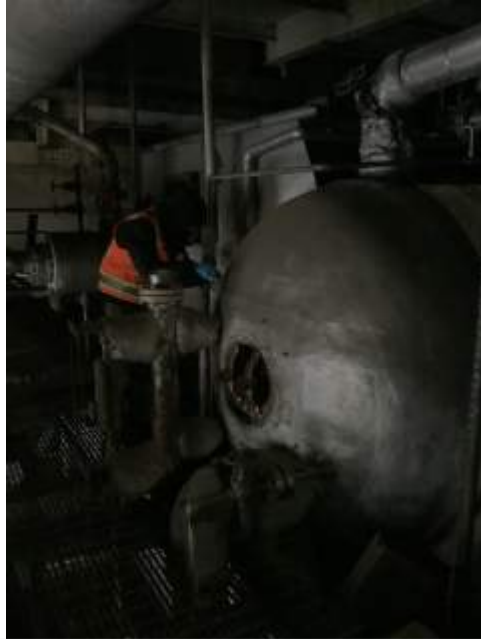
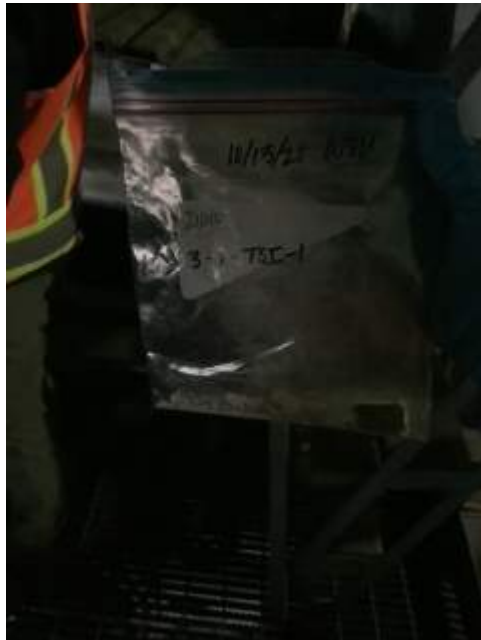
Additional Sample Notes:	White pipe insulation with white wrapping.	
Sample ID:	Sample Type:	
3-1-TSI-1	TSI	
Sample Location:	Detailed Sample Location:	
Room 101	Highest catwalk.	
Sample Quantity:	3,000 linear feet.	
Sample Color:	XRF:	
Misc Sample Material:	Sample Condition:	Sample Friable?:
	Damaged or significantly damaged	Yes

White insulation with silver wrapping on boiler. Area of sampling not included on schematic of upper mezzanine.

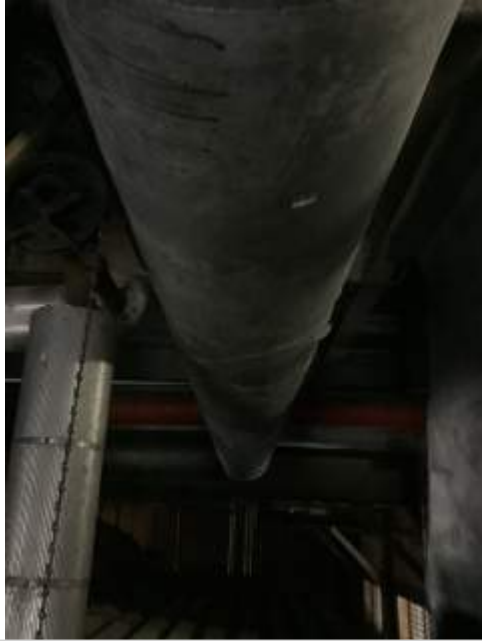
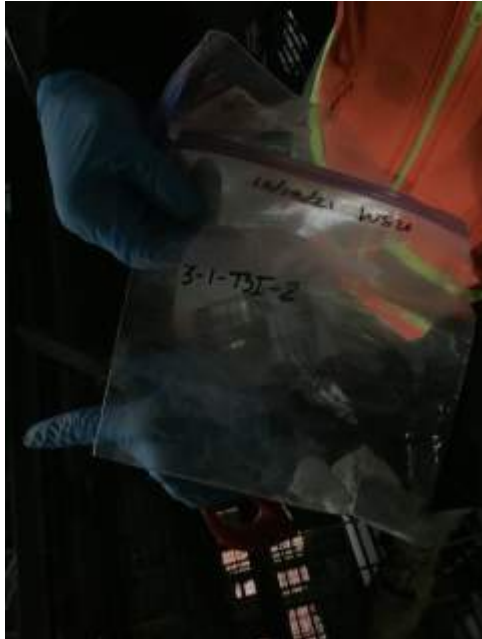
3-1-TSI-2

Misc Sample Material:	Sample Condition:	Sample Friable?:
	Damaged or significantly damaged	Yes

Additional Sample Notes:	White pipe insulation with white wrapping. Area of sampling not included on schematic of upper mezzanine.
---------------------------------	---

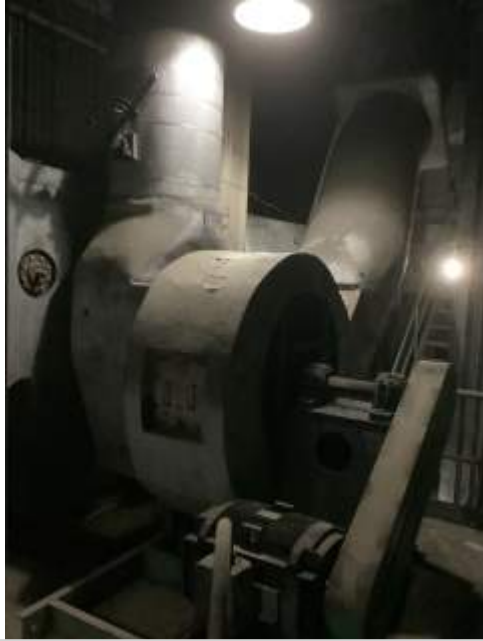
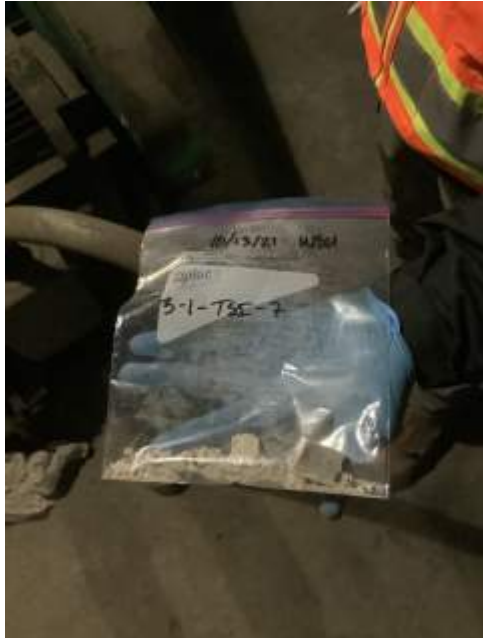
3-1-TSI-7

Sample Color:	XRF:	
Misc Sample Material:	Sample Condition:	Sample Friable?:
	Damaged or significantly damaged	Yes

Additional Sample Notes:	White vent insulation with white wrapping.
---------------------------------	--

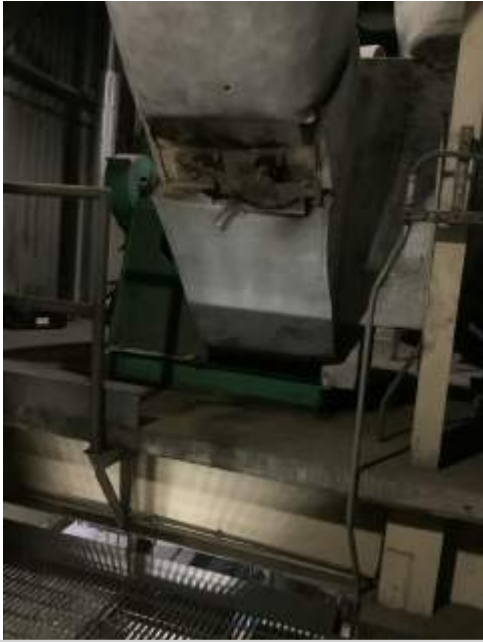
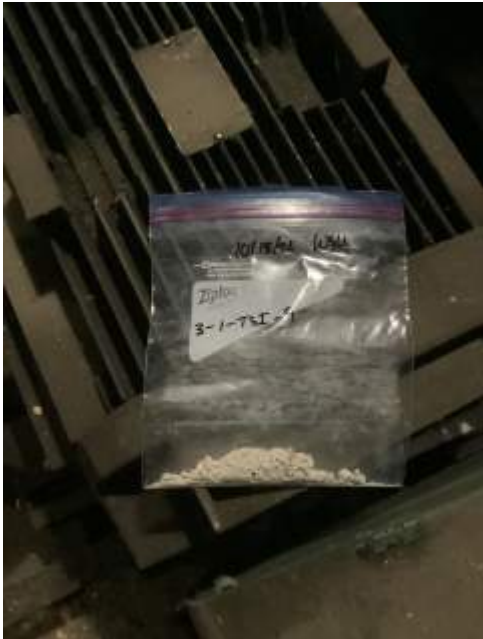
3-1-TSI-9

Room 302	Vent near staircase to lower level.	
Sample Quantity:	3,000 linear feet.	
Sample Color:	XRF:	
Misc Sample Material:	Sample Condition:	Sample Friable?:
	Damaged or significantly damaged	Yes

Additional Sample Notes:	White vent insulation with white wrapping.
---------------------------------	--

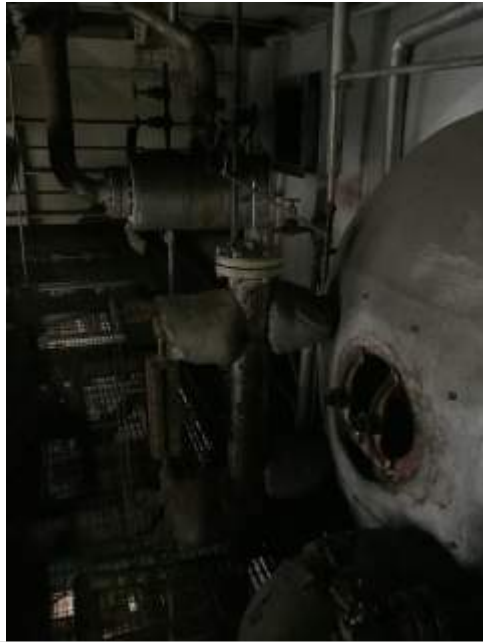
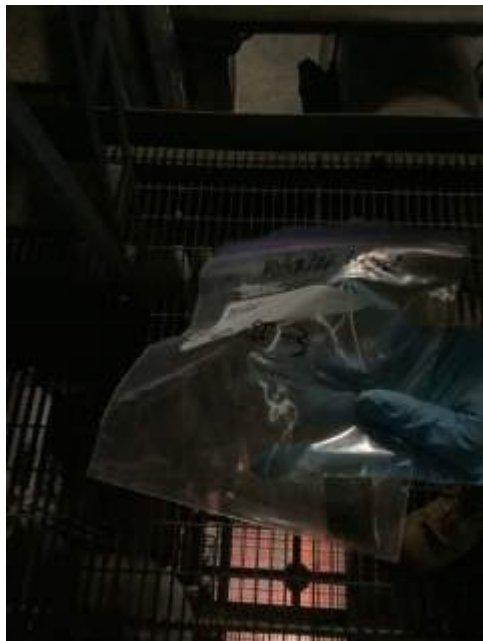
3-2-TSI-3	TSI	
Sample Location:	Detailed Sample Location:	
Room 101	Highest catwalk.	
Sample Quantity:	700 linear feet.	
Sample Color:	XRF:	
Misc Sample Material:	Sample Condition:	Sample Friable?:
	Damaged or significantly damaged	Yes

Additional Sample Notes:	Fabric insulation on pipe coming off of boiler. Area of sampling not included on schematic of upper mezzanine.
---------------------------------	--

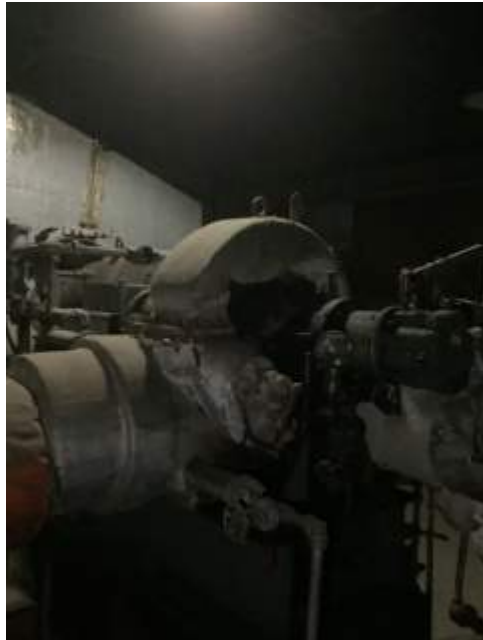
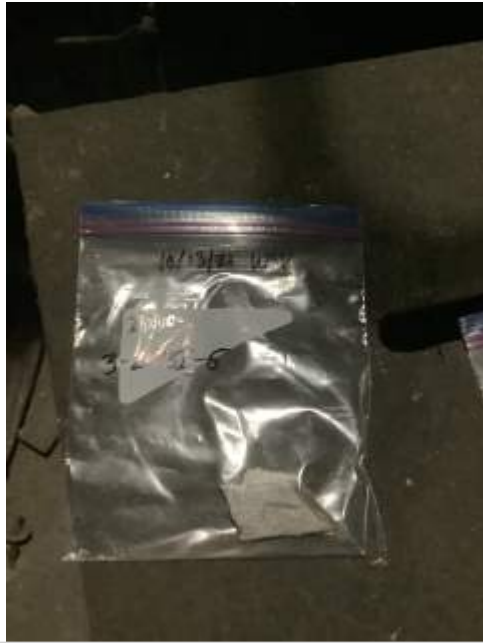
Sample ID:	Sample Type:	
3-2-TSI-6	TSI	
Sample Location:	Detailed Sample Location:	
Room 302	Pipe near west roof access.	
Sample Quantity:	700 linear feet.	
Sample Color:	XRF:	
Misc Sample Material:	Sample Condition:	Sample Friable?:
	Damaged or significantly damaged	Yes

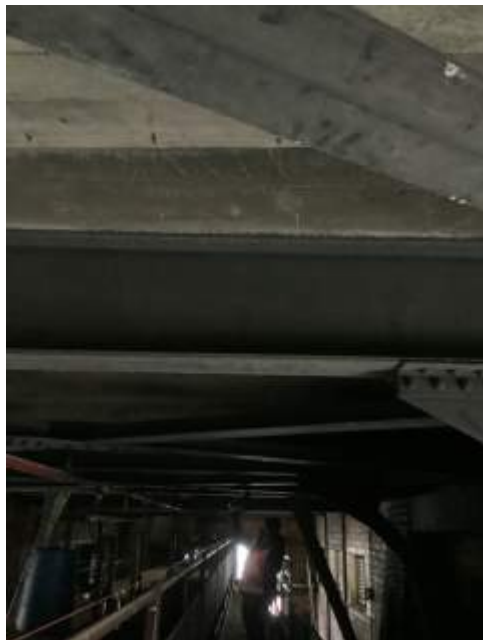
Additional Sample Notes:	White pipe insulation with silver wrapping.
Sample ID:	Sample Type:
3-2-PB-3	PB
Sample Location:	Detailed Sample Location:
Catwalk above coal hopper.	By staircase.
Sample Quantity:	700 linear feet.
Sample Color:	XRF:
Gray	5.00

Additional Sample Notes:	Gray I-beam.
---------------------------------	--------------

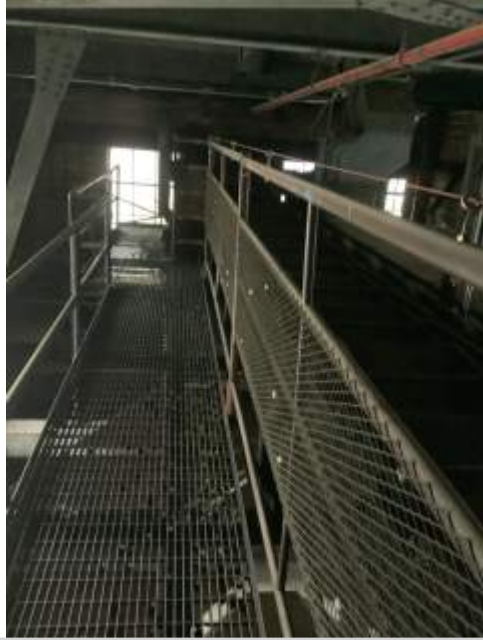
3-3-PB-5

Additional Sample Notes:	Brown catwalk railing.
Sample ID:	Sample Type:
3-3-PB-6	PB
Sample Location:	Detailed Sample Location:
Catwalk above coal hopper.	By staircase.
Sample Quantity:	NA
Sample Color:	XRF:
Brown	ND

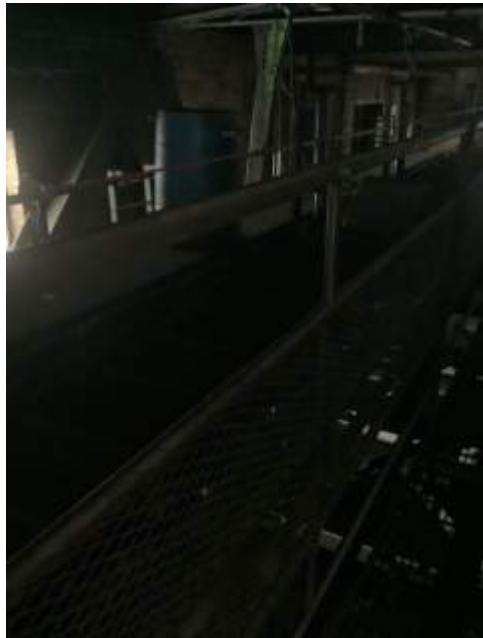
3-3-PB-6

Additional Sample Notes:	Brown catwalk railing.	
Sample ID:	Sample Type:	
3-3-TSI-4	TSI	
Sample Location:	Detailed Sample Location:	
Room 302	Motor part near west roof access.	
Sample Quantity:	40 linear feet.	
Sample Color:	XRF:	
Misc Sample Material:	Sample Condition:	Sample Friable?:
	Damaged or significantly damaged	Yes

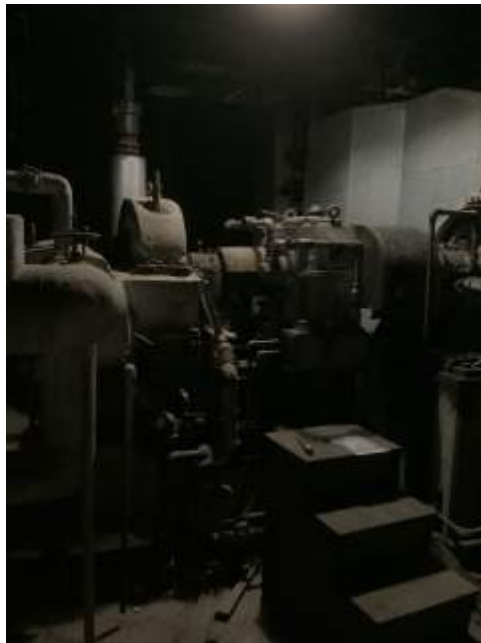
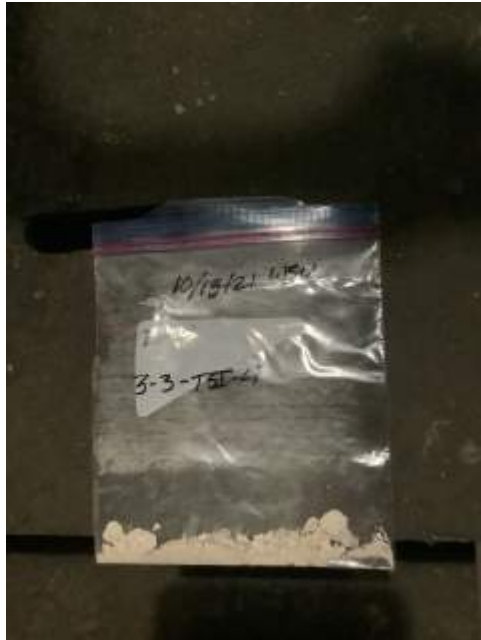
3-3-TSI-4

Additional Sample Notes:		White insulation on mechanical part.	
Sample ID:		Sample Type:	
3-3-TSI-10		TSI	
Sample Location:		Detailed Sample Location:	
Room 302		Motor part near west roof access.	
Sample Quantity:		40 linear feet.	
Sample Color:		XRF:	
Misc Sample Material:		Sample Condition:	Sample Friable?:
		Damaged or significantly damaged	Yes

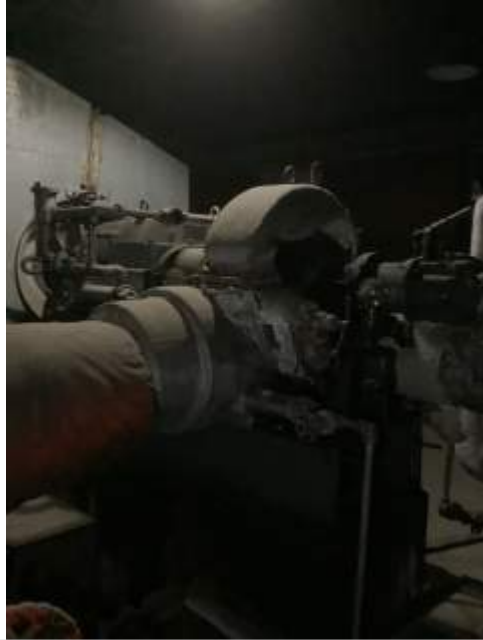
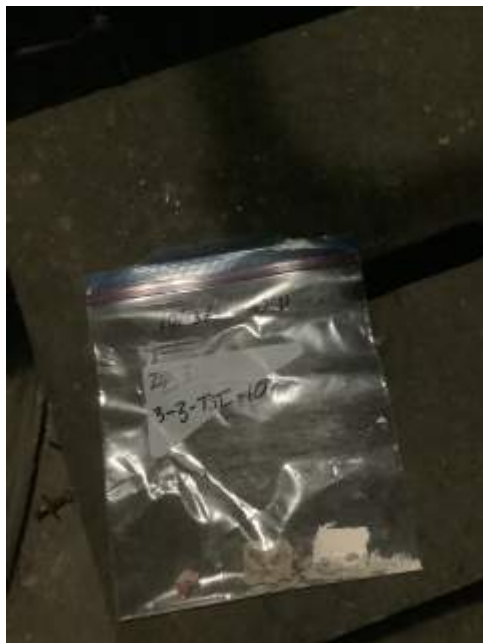
3-3-TSI-10

Additional Sample Notes:	White insulation on mechanical part.	
Sample ID:	Sample Type:	
3-4-TSI-8	TSI	
Sample Location:	Detailed Sample Location:	
Room 302	Pipe near motor.	
Sample Quantity:	6 linear feet.	
Sample Color:	XRF:	
Misc Sample Material:	Sample Condition:	Sample Friable?:
	Damaged or significantly damaged	Yes

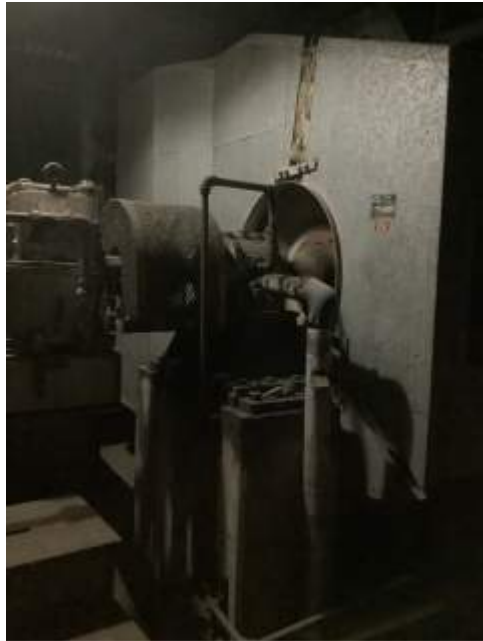
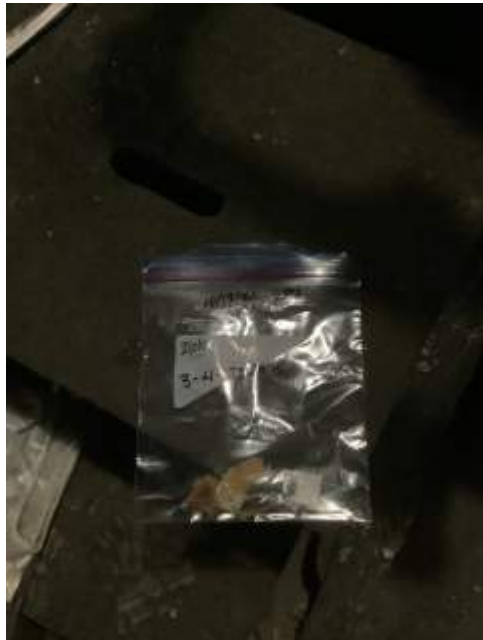
3-4-TSI-8

Additional Sample Notes:	Yellow insulation with white wrapping.
Sample ID:	Sample Type:
3-4-PB-7	PB
Sample Location:	Detailed Sample Location:
Room 302	On equipment by east side door.
Sample Quantity:	NA
Sample Color:	XRF:
Silver	ND

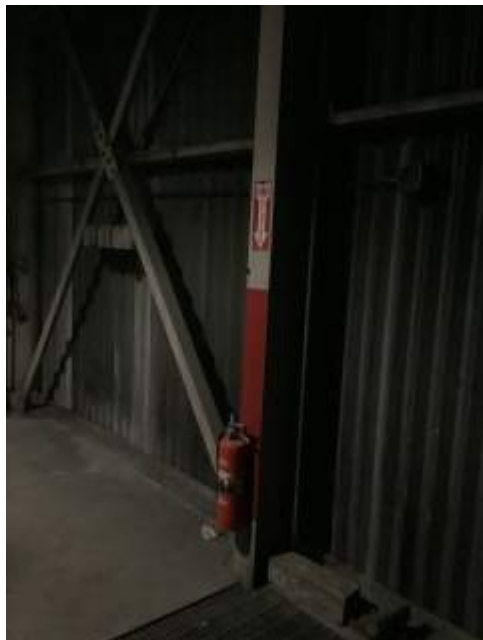
Additional Sample Notes:	Silver piping.
Sample ID:	Sample Type:
3-5-PB-9	PB
Sample Location:	Detailed Sample Location:
Room 302	By west side door.
Sample Quantity:	NA
Sample Color:	XRF:
Red	0.528

Additional Sample Notes:	Red fire extinguisher marking paint.
---------------------------------	--------------------------------------

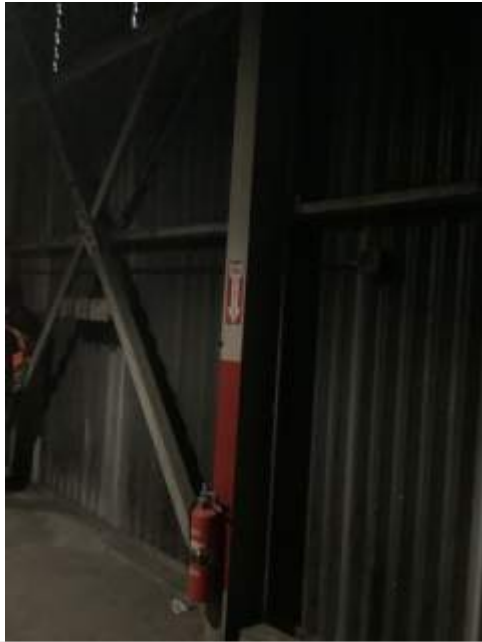
Sample ID:	Sample Type:
3-6-PB-10	PB
Sample Location:	Detailed Sample Location:
Room 302	By west side door.
Sample Quantity:	NA
Sample Color:	XRF:
Tan	0.531

Additional Sample Notes:	Tan paint above fire extinguisher.
---------------------------------	------------------------------------

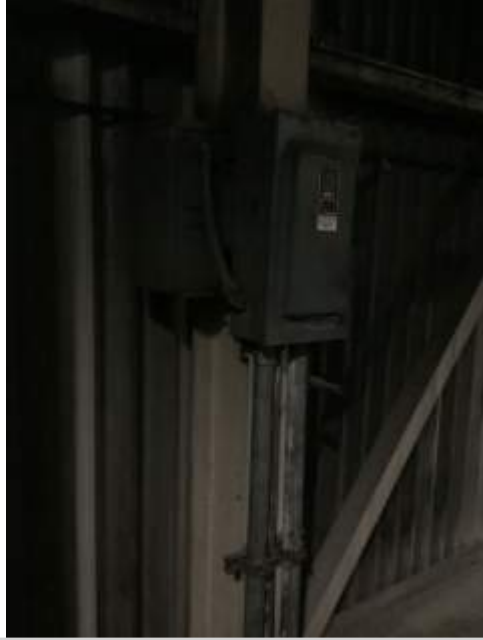
Sample ID:	Sample Type:
3-6-PB-11	PB
Sample Location:	Detailed Sample Location:
Room 302	By west side door.
Sample Quantity:	NA
Sample Color:	XRF:
Tan	0.922

Additional Sample Notes:	Tan paint on I-beam next to safety switch box.
---------------------------------	--

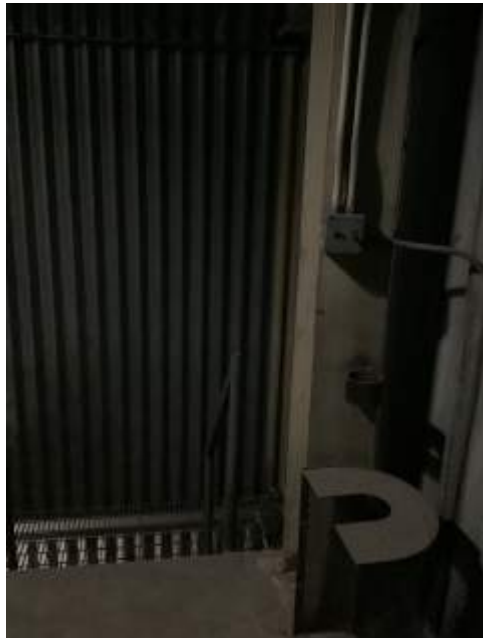
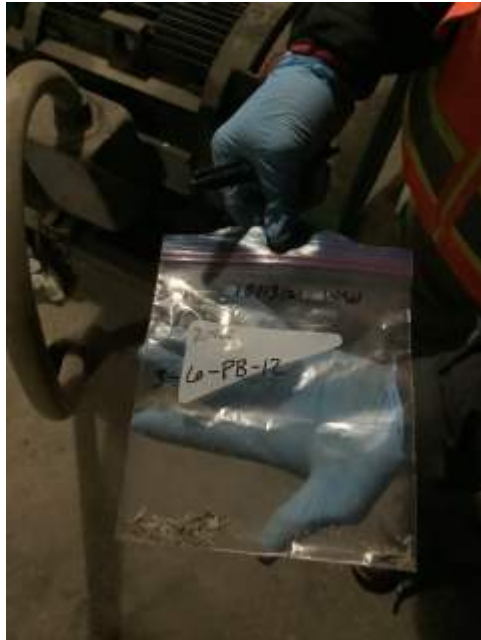
Sample ID:	Sample Type:
3-6-PB-12	PB
Sample Location:	Detailed Sample Location:
Room 302	By staircase.
Sample Quantity:	NA
Sample Color:	XRF:
Tan	0.920

Additional Sample Notes:	Tan paint on I-beam. Sample collected for laboratory analysis.
Sample ID:	Sample Type:
3-7-PB-13	PB
Sample Location:	Detailed Sample Location:
Room 302	East door.
Sample Quantity:	NA
Sample Color:	XRF:
Tan	ND

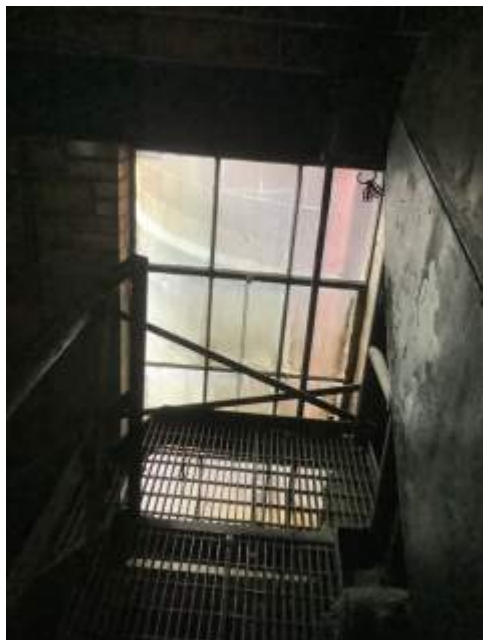
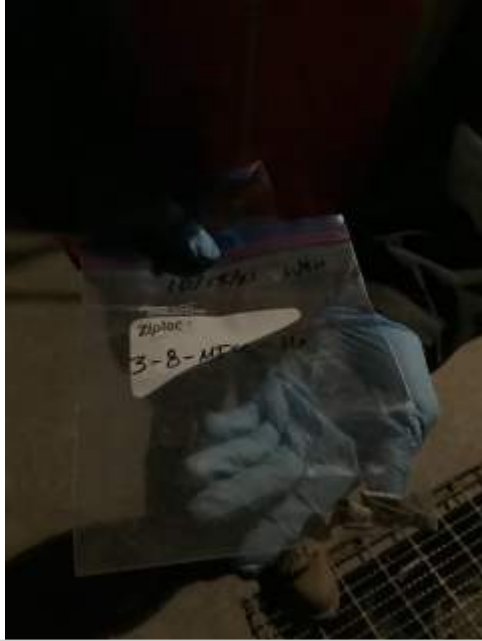
Additional Sample Notes:		Brown paint on pipe to ceiling.
Sample ID:	Sample Type:	
3-8-MISC-11	MISC	
Sample Location:	Detailed Sample Location:	
Room 303	Window on west side of room.	
Sample Quantity:	4,030 linear feet.	
Misc Sample Material:	Sample Condition:	Sample Friable?:
Window glazing	Damaged or significantly damaged friable miscellaneous ACM	No

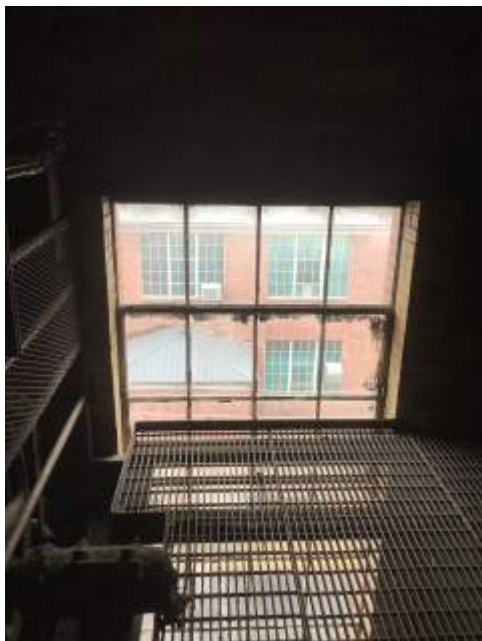
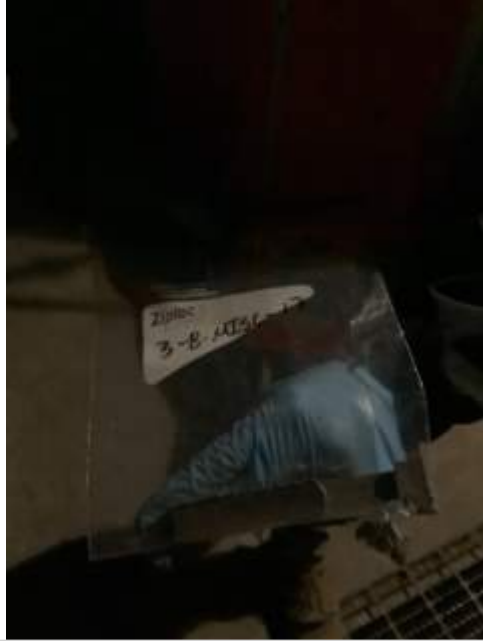
Additional Sample Notes:		
Sample ID:	Sample Type:	
3-8-MISC-12	MISC	
Sample Location:	Detailed Sample Location:	
Room 303	Window on west side of room.	
Sample Quantity:	4,030 linear feet.	
Misc Sample Material:	Sample Condition:	Sample Friable?:
Window glazing.	Damaged or significantly damaged friable miscellaneous ACM	No

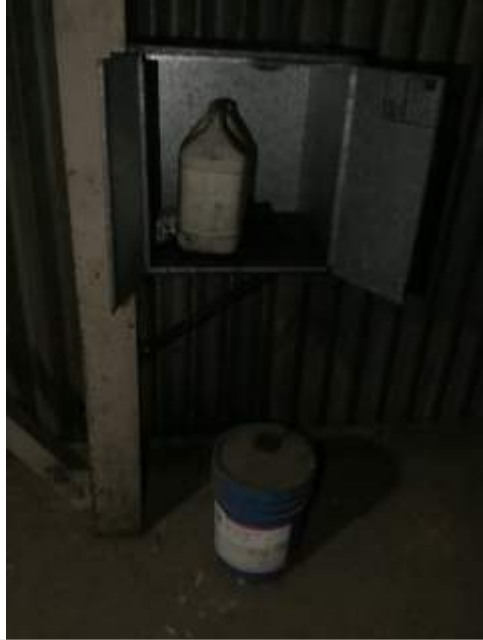
General Fixture Location:	Detailed Fixture Location:
Room 302	East wall.
Type of Fixture:	Quantity:
Unmarked jug and turbine oil container.	2
Condition:	Additional Fixture Notes:
Poor

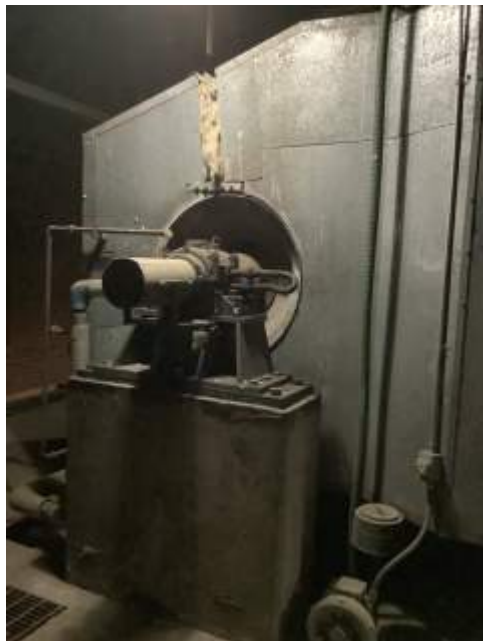
General Fixture Location:	Detailed Fixture Location:
Room 302	
Type of Fixture:	Quantity:
Potential mechanical fluid-containing fixture.	Throughout room
Condition:	Additional Fixture Notes:
Poor

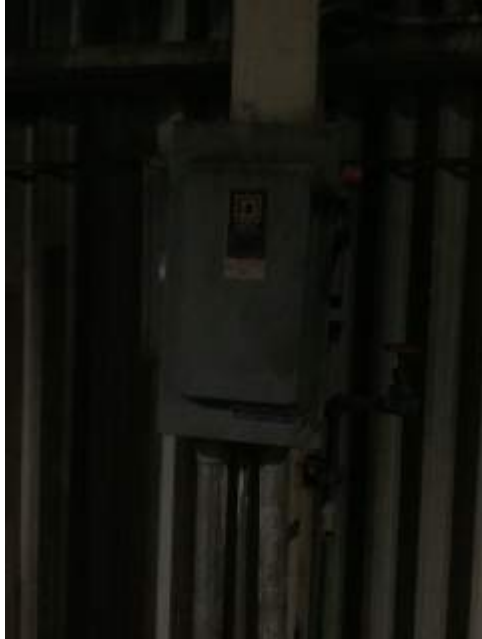
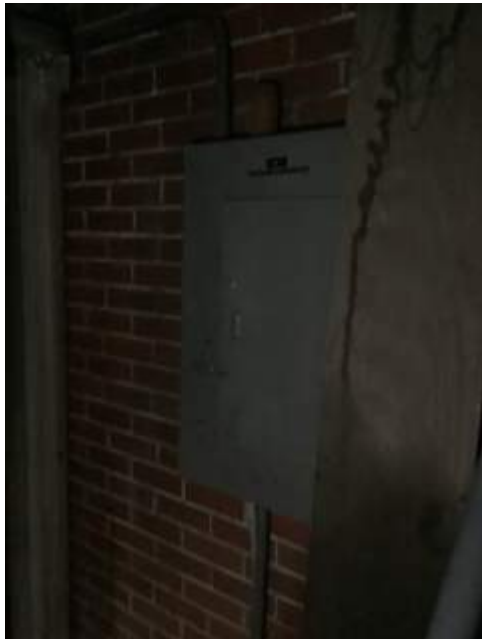
General Fixture Location:	Detailed Fixture Location:
Room 302	West side of room.
Type of Fixture:	Quantity:
Potential electrical hazard.	2
Condition:	Additional Fixture Notes:
Good	1 control panel, 1 safety switch.

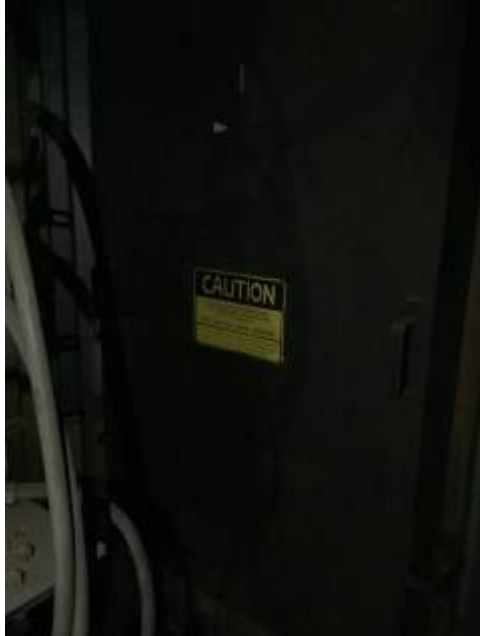
General Fixture Location:	Detailed Fixture Location:
Room 303M	
Type of Fixture:	Quantity:
Potentially pressurized confined spaces.	17
Condition:	Additional Fixture Notes:
Good

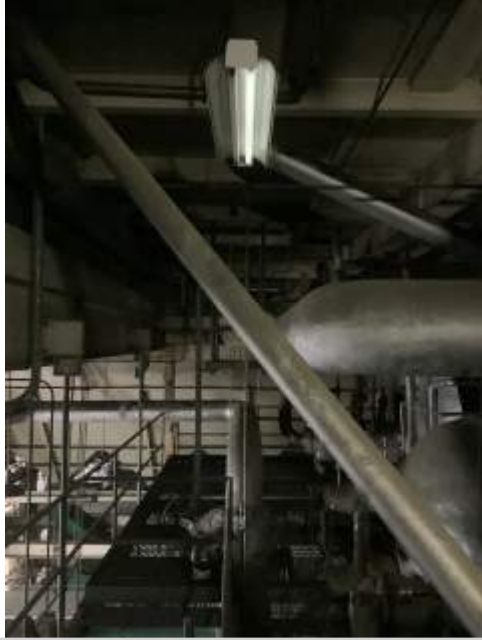
General Fixture Location:	Detailed Fixture Location:
Room 101	Highest catwalk.
Type of Fixture:	Quantity:
	2
Condition:	Additional Fixture Notes:
Good	Fluorescent lightbulbs.

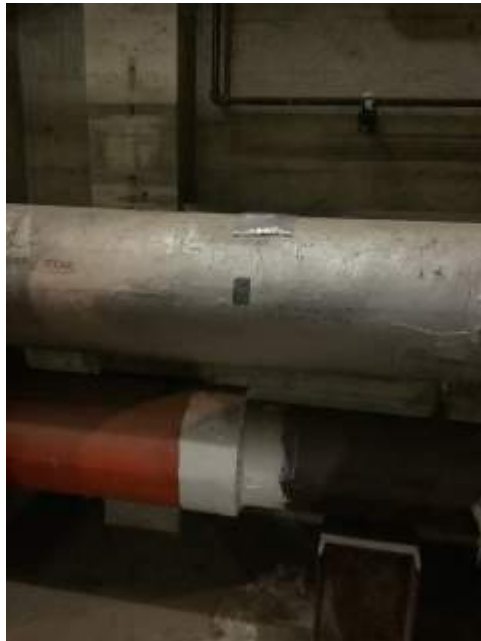
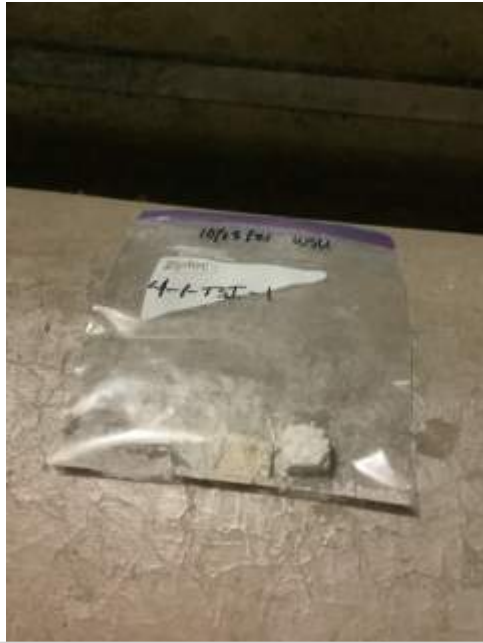
Sample ID:	Sample Type:	
4-1-TSI-1	TSI	
Sample Location:	Detailed Sample Location:	
Room 21	By entrance to room 22.	
Sample Quantity:	600 linear feet.	
Sample Color:	XRF:	
Misc Sample Material:	Sample Condition:	Sample Friable?:
	Damaged or significantly damaged	Yes

Additional Sample Notes:		White insulation with silver fabric patch.	
Sample ID:		Sample Type:	
4-1-TSI-6		TSI	
Sample Location:		Detailed Sample Location:	
Room 23		Northeast corner of room.	
Sample Quantity:		600 linear feet.	
Sample Color:		XRF:	
Misc Sample Material:		Sample Condition:	Sample Friable?:
		Damaged or significantly damaged	Yes

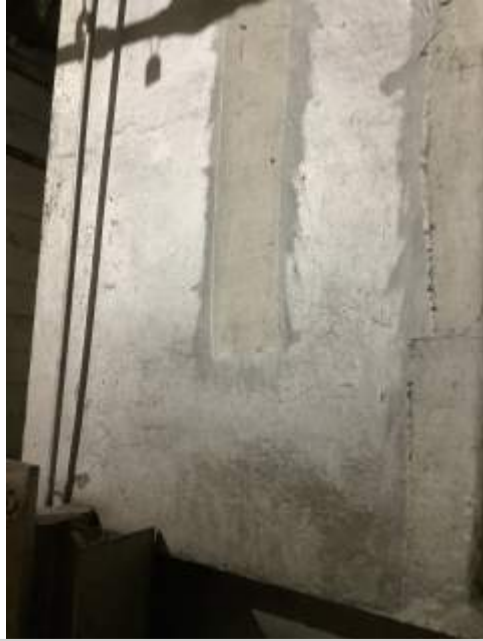
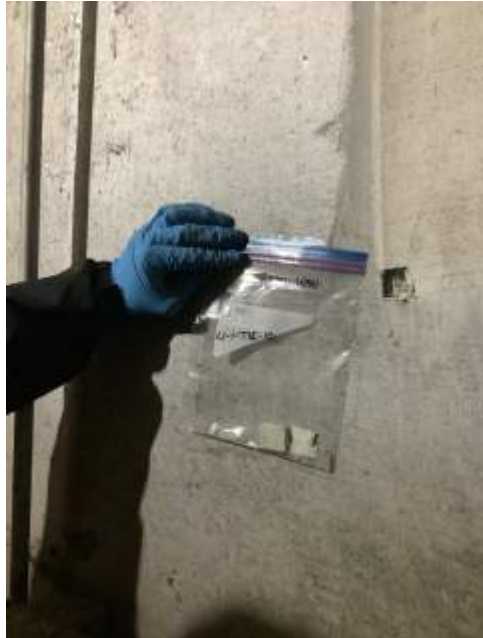
Additional Sample Notes:	White insulation with silver fabric patch.	
Sample ID:	Sample Type:	
4-1-TSI-10	TSI	
Sample Location:	Detailed Sample Location:	
Room 11	Southeast portion of room by entrance to room 23.	
Sample Quantity:	600 linear feet.	
Sample Color:	XRF:	
Misc Sample Material:	Sample Condition:	Sample Friable?:
	Damaged or significantly damaged	Yes

Additional Sample Notes:	White insulation with silver fabric patch on boiler.
Sample ID:	Sample Type:
4-1-TSI-17	TSI
Sample Location:	Detailed Sample Location:
Room 11	Northeast portion of room between northeast staircase and elevator.
Sample Quantity:	600 linear feet.
Sample Color:	XRF:

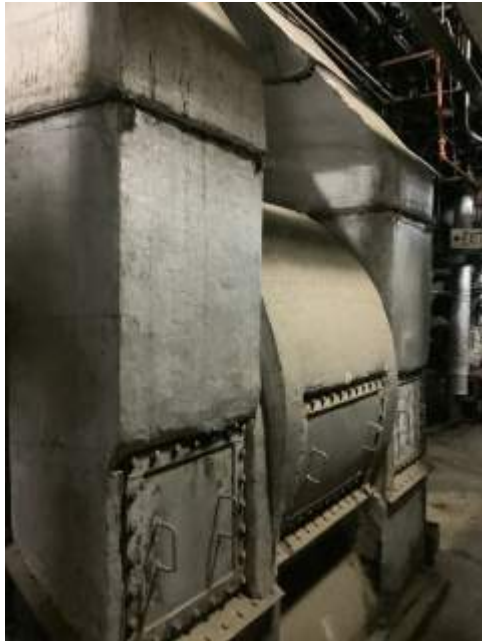
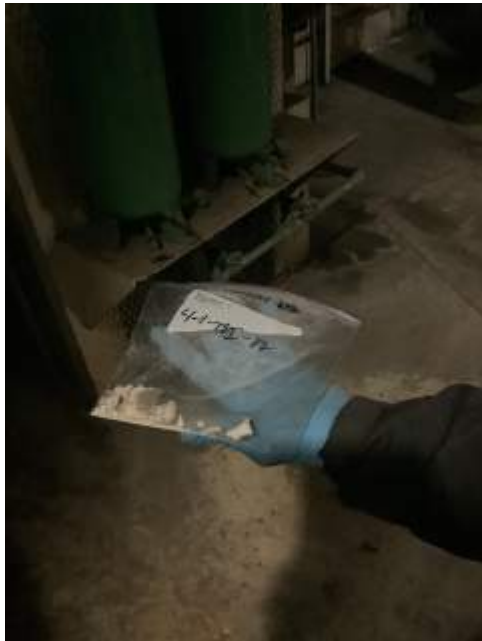
4-1-TSI-17

Misc Sample Material:	Sample Condition:	Sample Friable?:
	Damaged or significantly damaged	Yes

Additional Sample Notes:	White insulation with silver fabric patch on machinery.
---------------------------------	---

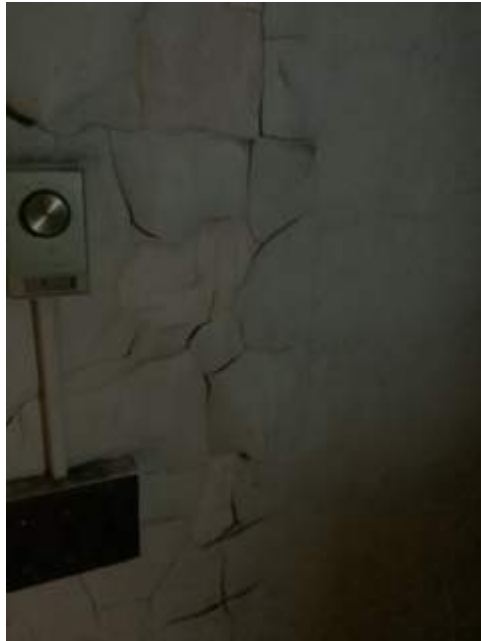
Sample ID:	Sample Type:
4-1-PB-1	PB
Sample Location:	Detailed Sample Location:
Room 17	East wall south of door.
Sample Quantity:	N/A

Sample Color:	XRF:
Light green	0.336

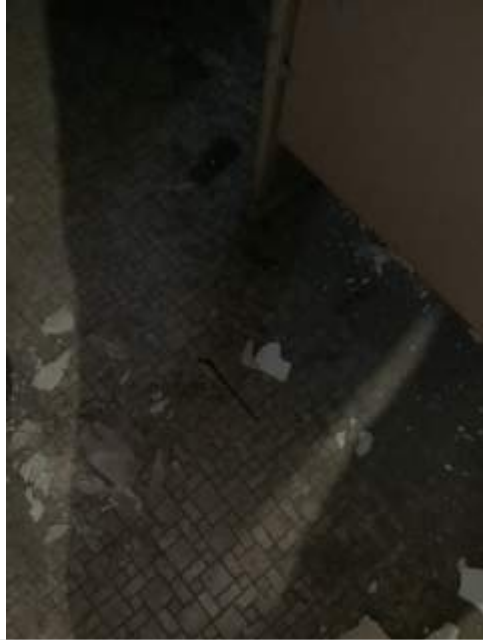
Sample ID:	Sample Type:
4-1-PB-2	PB
Sample Location:	Detailed Sample Location:
Room 17	Paint chip on floor next to bathroom stall.
Sample Quantity:	N/A
Sample Color:	XRF:
Light green	0.237

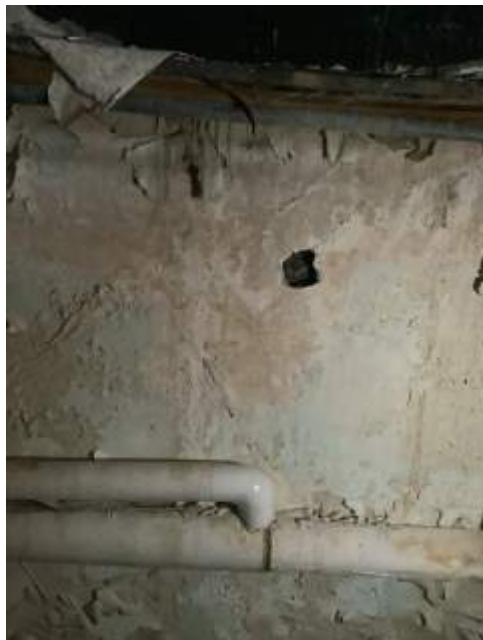
Sample ID:	Sample Type:
4-1-PB-60	PB
Sample Location:	Detailed Sample Location:
Room 15	Paint on south wall of room.
Sample Quantity:	N/A
Sample Color:	XRF:
Light green	0.014
