FOCUSED SITE ASSESSMENT REPORT

COLLEGE AVENUE STEAM PLANT
PULLMAN, WASHINGTON

Prepared for
PORT OF WHITMAN COUNTY
March 30, 2022
Project No. M0457.02.003

Prepared by
Maul Foster & Alongi, Inc.
601 East Front Ave., Suite 202, Coeur d'Alene, ID 83814

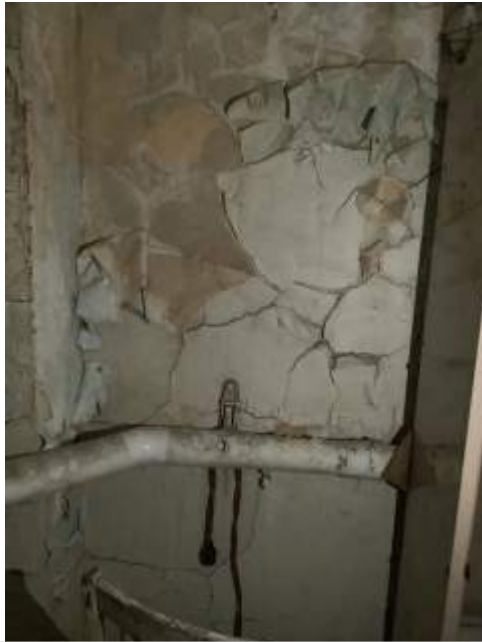
Sample ID:	Sample Type:
4-1-PB-61	PB
Sample Location:	Detailed Sample Location:
Room 15	Southwest corner of room.
Sample Quantity:	N/A
Sample Color:	XRF:
Light green	0.135

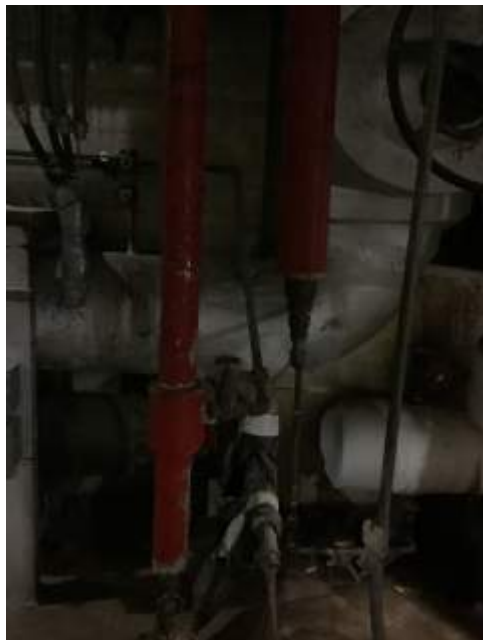
Sample ID:	Sample Type:
4-2-PB-3	PB
Sample Location:	Detailed Sample Location:
Room 21	Pipe in southwest corner of room 21.
Sample Quantity:	N/A
Sample Color:	XRF:
Red	ND

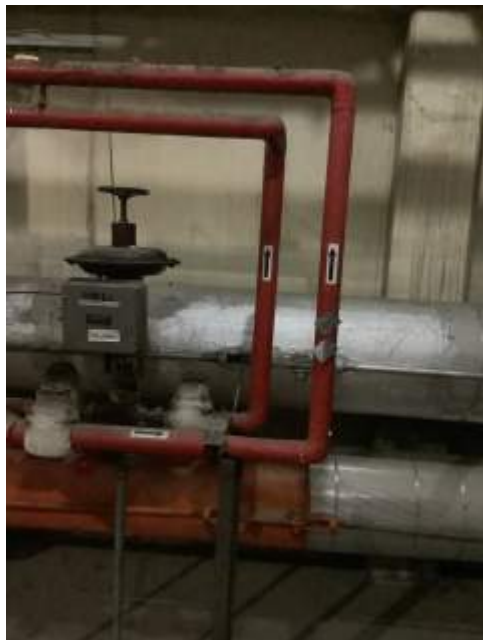
Sample ID:	Sample Type:
4-2-PB-25	PB
Sample Location:	Detailed Sample Location:
Room 23	Red pipe wrap on the south side of room.
Sample Quantity:	N/A
Sample Color:	XRF:
Red	0.919

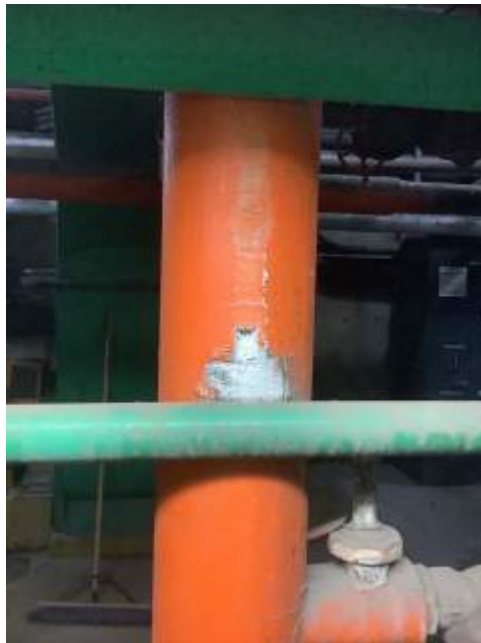
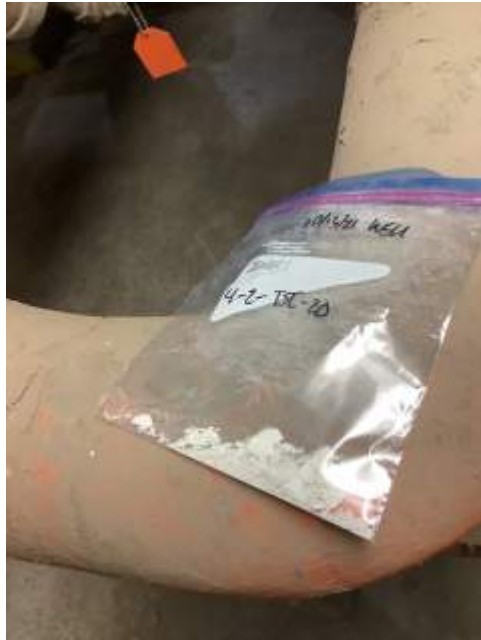
Additional Sample Notes:		
Sample ID:	Sample Type:	
4-2-TSI-20	TSI	
Sample Location:	Detailed Sample Location:	
Room 11	Northeast portion of room near northeast staircase.	
Sample Quantity:	1,200 linear feet.	
Sample Color:	XRF:	
Misc Sample Material:	Sample Condition:	Sample Friable?:
	Damaged or significantly damaged	Yes

Additional Sample Notes:		White insulation with orange painted wrap.	
Sample ID:		Sample Type:	
4-2-TSI-22		TSI	
Sample Location:		Detailed Sample Location:	
Room 11		Northeast portion of room.	
Sample Quantity:		1,200 linear feet.	
Sample Color:		XRF:	
Misc Sample Material:		Sample Condition:	Sample Friable?:
		Damaged or significantly damaged	Yes

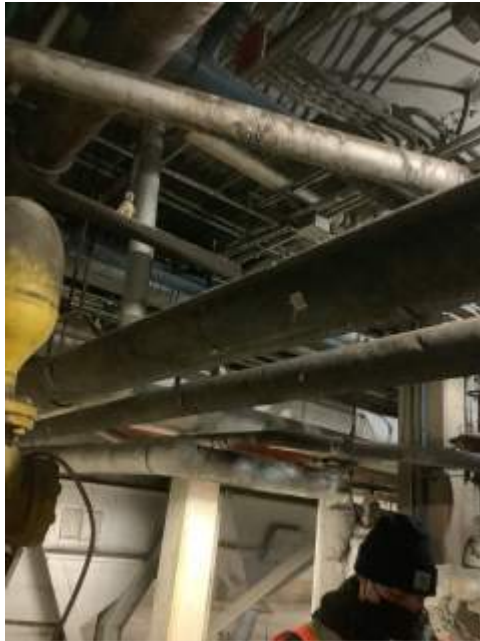
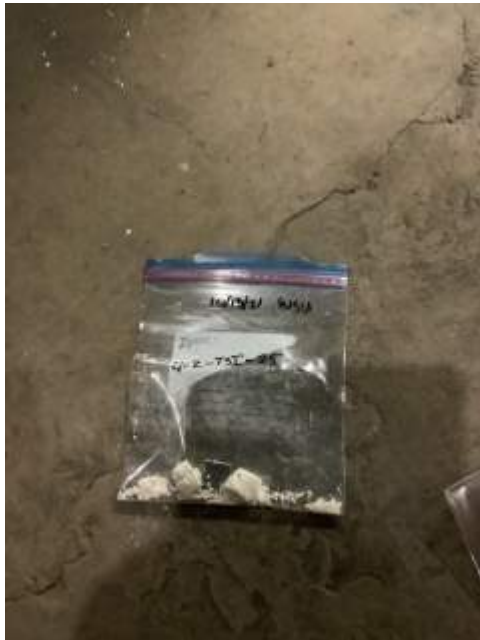
Additional Sample Notes:		White insulation with white painted wrap.
Sample ID:	Sample Type:	
4-2-TSI-25	TSI	
Sample Location:	Detailed Sample Location:	
Room 11	On west side of room by staircase down.	
Sample Quantity:	1,200 linear feet.	
Sample Color:	XRF:	
Misc Sample Material:	Sample Condition:	Sample Friable?:
	Damaged or significantly damaged	Yes

Additional Sample Notes:	White insulation with orange painted wrap.
Sample ID:	Sample Type:
4-2-TSI-7	TSI
Sample Location:	Detailed Sample Location:
Room 23	Northeast corner of room.
Sample Quantity:	1,200 linear feet.
Sample Color:	XRF:

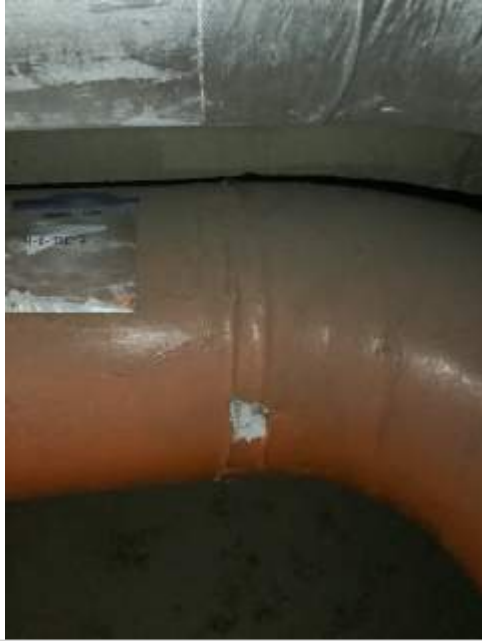
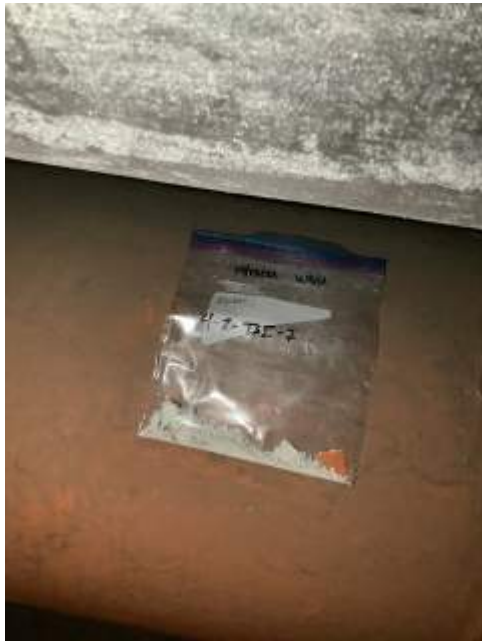
4-2-TSI-7

Misc Sample Material:	Sample Condition:	Sample Friable?:
	Damaged or significantly damaged	Yes

Additional Sample Notes:	White insulation with orange painted wrap.
---------------------------------	--

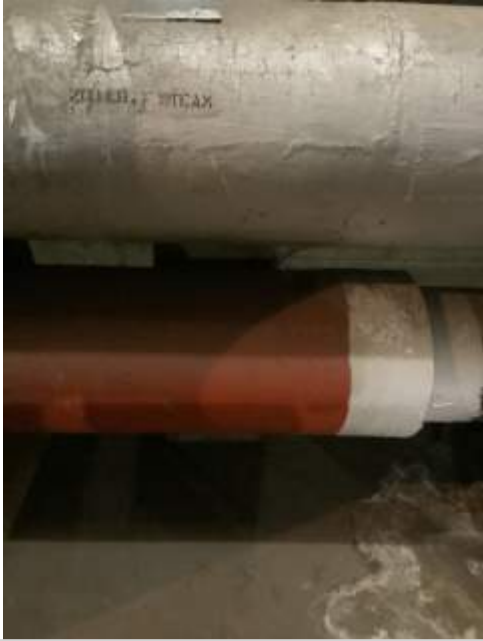
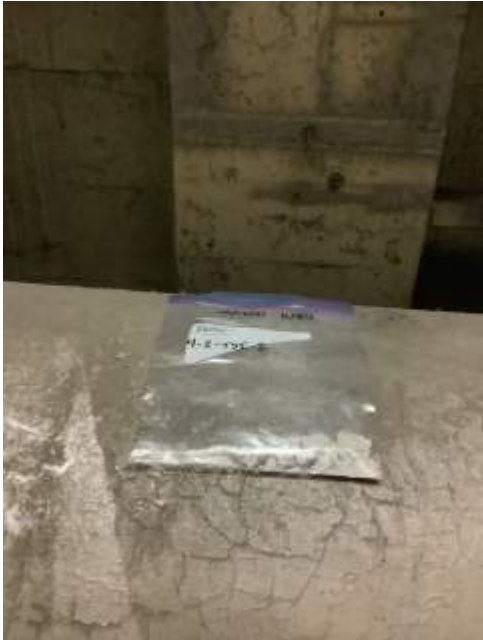
Sample ID:	Sample Type:
4-2-TSI-2	TSI
Sample Location:	Detailed Sample Location:
Room 21	By entrance to room 22.
Sample Quantity:	1,200 linear feet.

Sample Color:	XRF:	
Misc Sample Material:	Sample Condition:	Sample Friable?:
	Damaged or significantly damaged	Yes

Additional Sample Notes:	White insulation with orange painted wrap.
---------------------------------	--

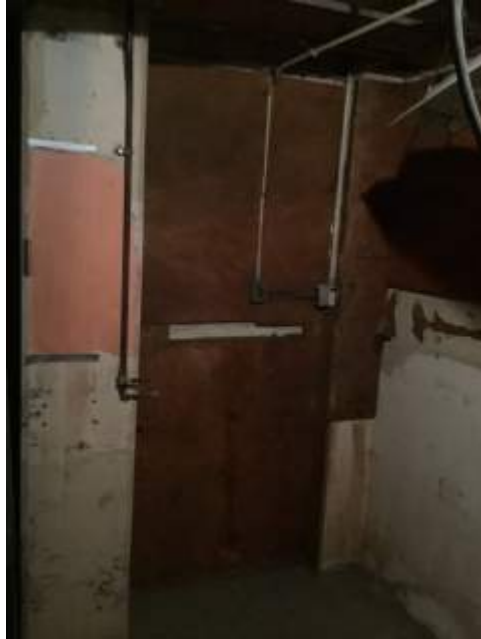
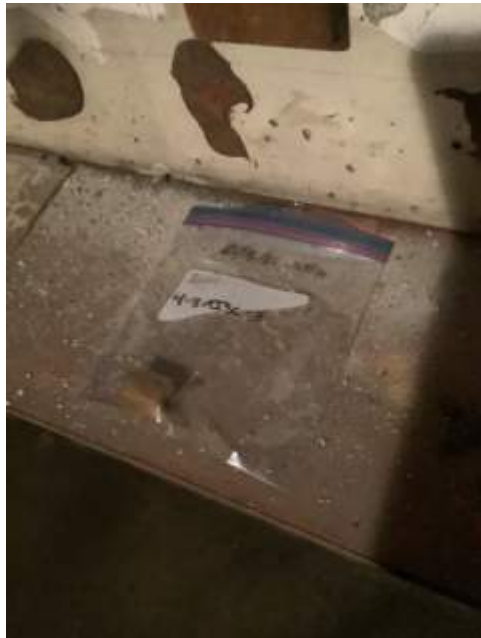
4-3-MISC-3

Room 22	East wall.	
Sample Quantity:	110 square feet.	
Misc Sample Material:	Sample Condition:	Sample Friable?:
Brown soundproofing wall pad.	Potential ACBM with potential for damage	Yes

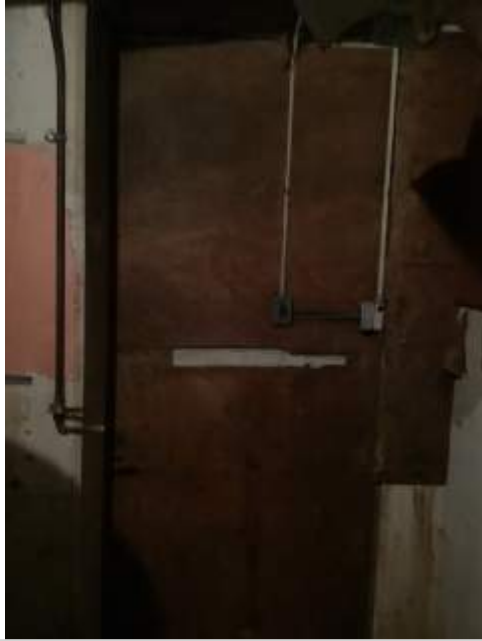
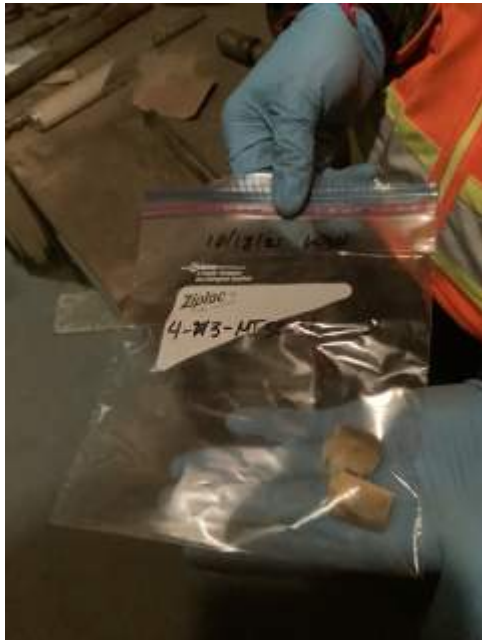
4-3-MISC-4

Room 22	North wall.	
Sample Quantity:	110 square feet.	
Misc Sample Material:	Sample Condition:	Sample Friable?:
Brown soundproofing wall pad.	Potential ACBM with potential for damage	Yes

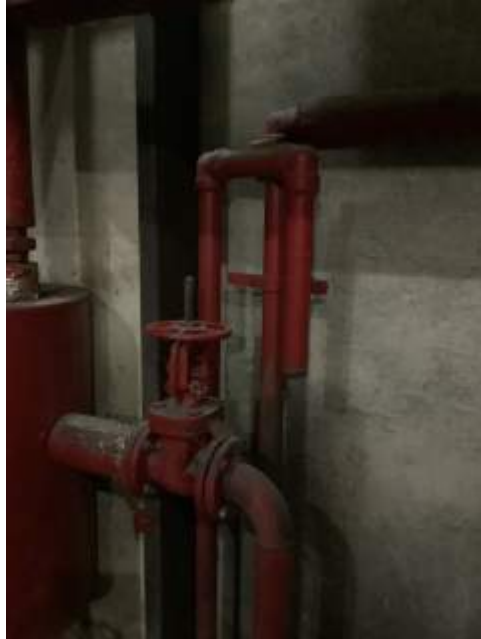
4-3-PB-20

Room 23	Red pipe in southwest corner.
Sample Quantity:	145 linear feet.
Sample Color:	XRF:
Red	ND

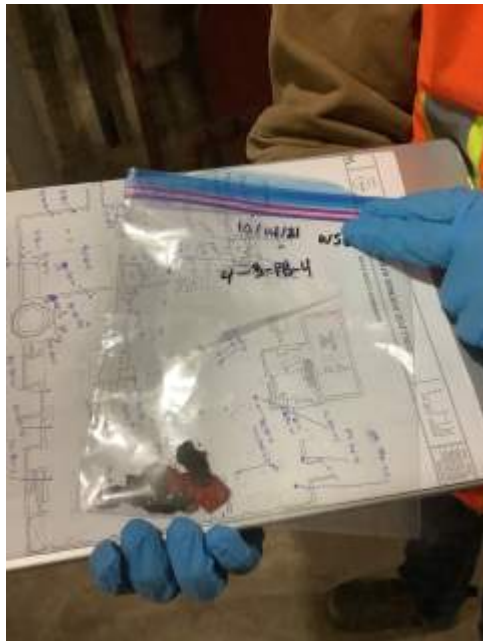
4-3-PB-4

Did not XRF tank due to high heat. Submitted sample to laboratory for analysis.

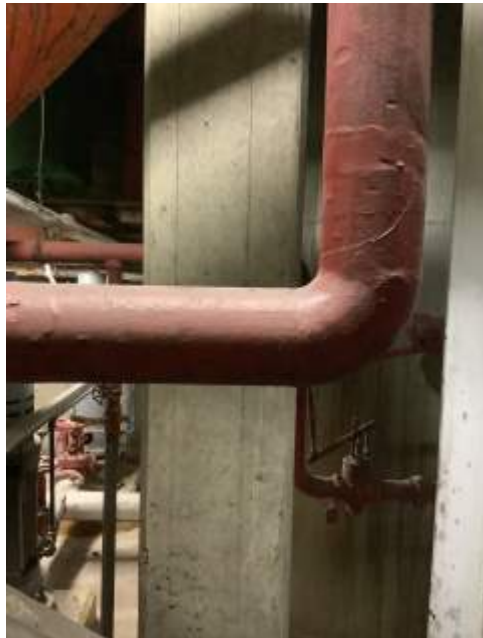
Sample ID:	Sample Type:
4-3-PB-43	PB
Sample Location:	Detailed Sample Location:
Room 11	Red pipe on the north side of room south of active tank.
Sample Quantity:	145 linear feet.
Sample Color:	XRF:
Red	5.0

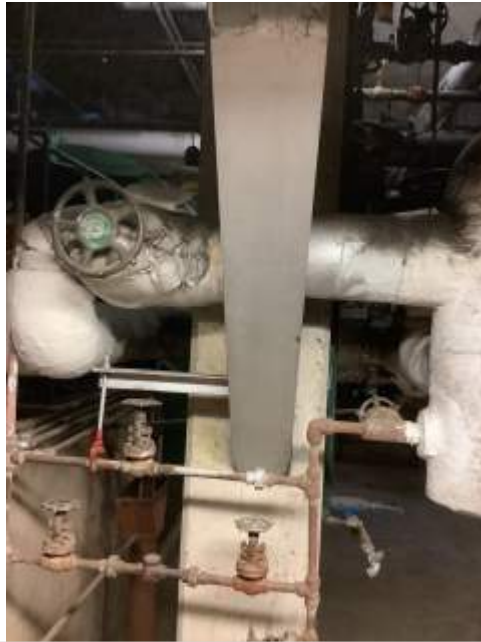
Sample ID:	Sample Type:
4-4-PB-30	PB
Sample Location:	Detailed Sample Location:
Room 11	Silver support on west side of room east of sun basement entrance.
Sample Quantity:	N/A
Sample Color:	XRF:
Silver	ND

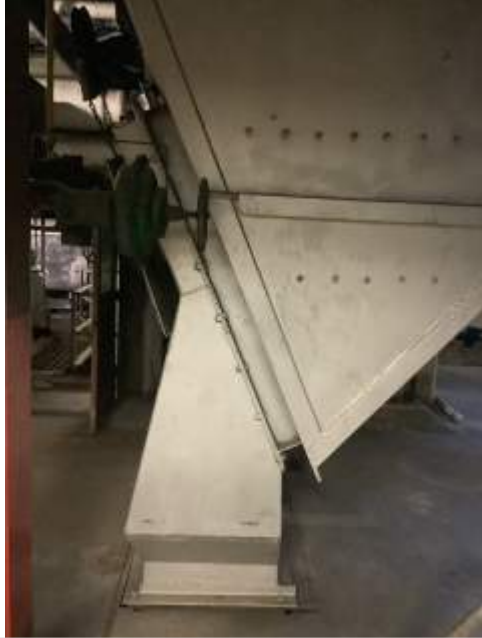
Sample ID:	Sample Type:
4-4-PB-33	PB
Sample Location:	Detailed Sample Location:
Room 11	Silver painted equipment on west side of room north of sub basement door.
Sample Quantity:	N/A
Sample Color:	XRF:
Silver	ND

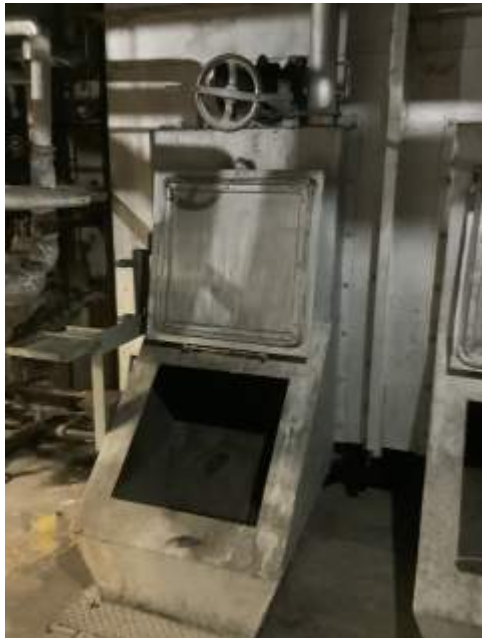
Additional Sample Notes:	
Sample ID:	Sample Type:
4-4-PB-47	PB
Sample Location:	Detailed Sample Location:
Room 11	Underside of lid on southwest face of northeast boiler.
Sample Quantity:	N/A
Sample Color:	XRF:
Silver	0.071

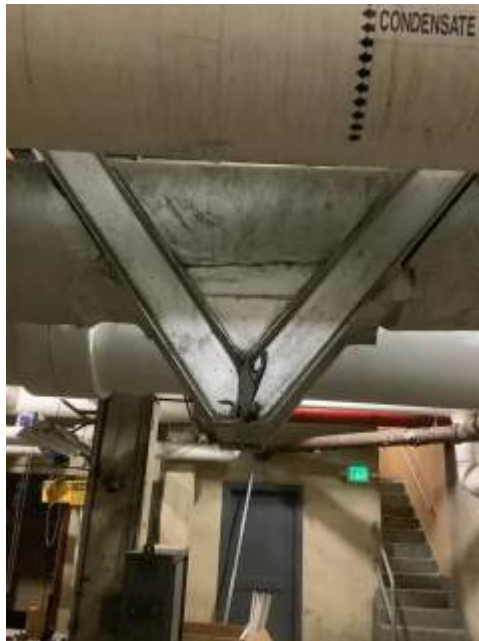
Sample ID:	Sample Type:
4-4-PB-5	PB
Sample Location:	Detailed Sample Location:
Room 21	Silver pipe support on north ceiling.
Sample Quantity:	N/A
Sample Color:	XRF:
Silver	0.024

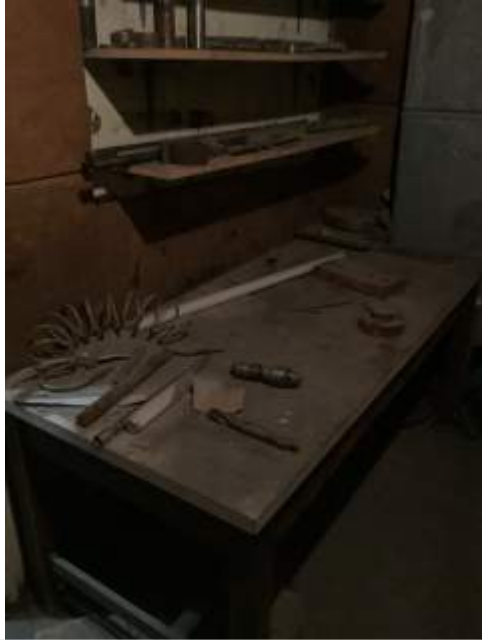
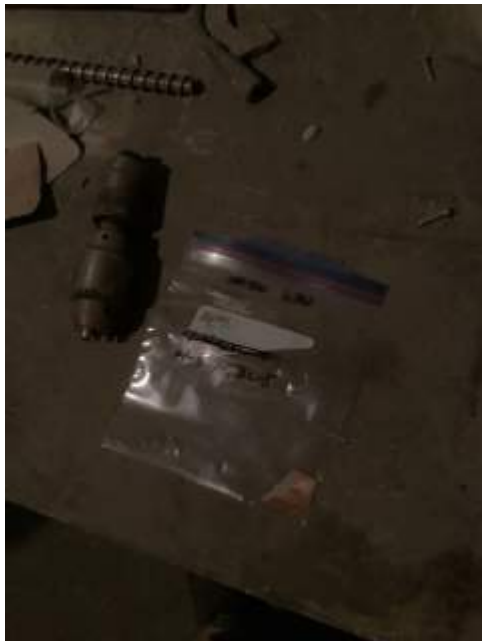
Sample ID:	Sample Type:	
4-4-MISC-5	MISC	
Sample Location:	Detailed Sample Location:	
Room 22	Northwest corner tabletop.	
Sample Quantity:	15 square feet.	
Misc Sample Material:	Sample Condition:	Sample Friable?:
Off-white laminate tabletop with clear adhesive.	Potential ACBM with potential for damage	Yes

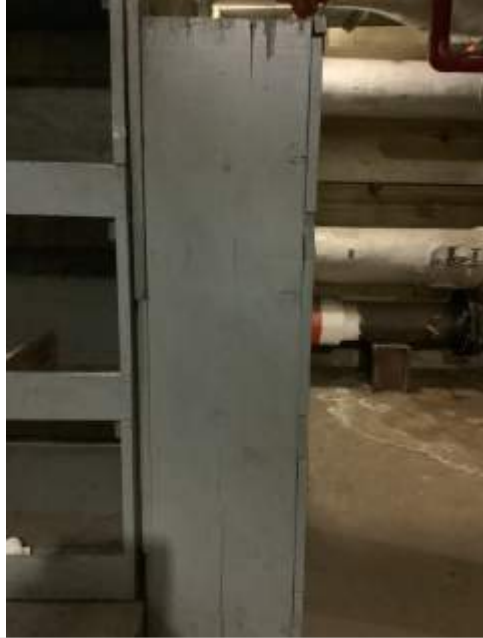
Sample ID:	Sample Type:
4-5-PB-6	PB
Sample Location:	Detailed Sample Location:
Room 21	Cabinet in center of room north of room 22.
Sample Quantity:	N/A
Sample Color:	XRF:
Gray	0.063

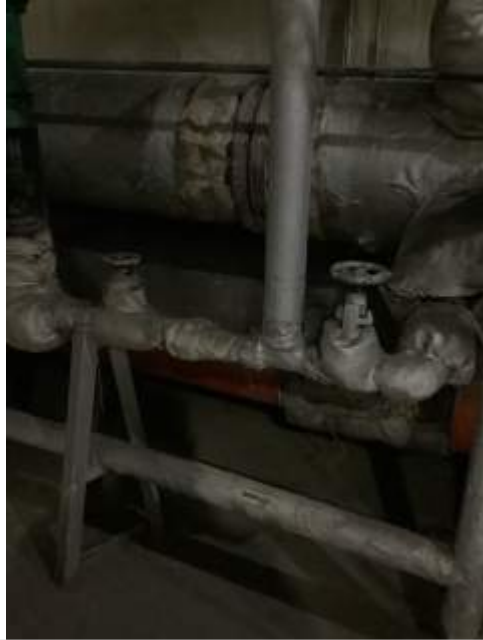
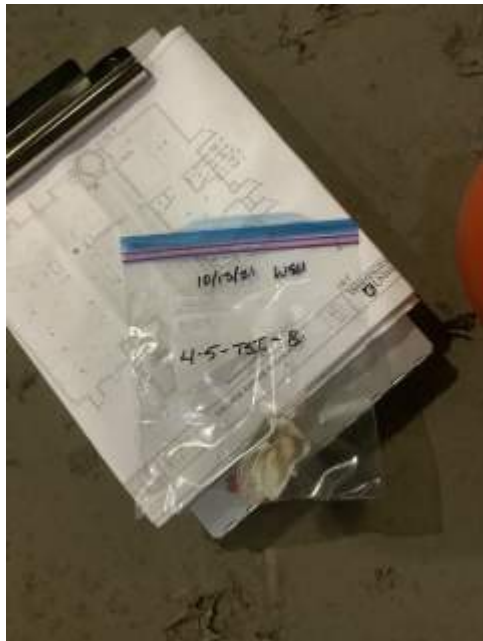
Additional Sample Notes:		
Sample ID:	Sample Type:	
4-5-TSI-8	TSI	
Sample Location:	Detailed Sample Location:	
Room 23	Southeast corner of room.	
Sample Quantity:	200 linear feet.	
Sample Color:	XRF:	
Misc Sample Material:	Sample Condition:	Sample Friable?:
	Damaged or significantly damaged	Yes

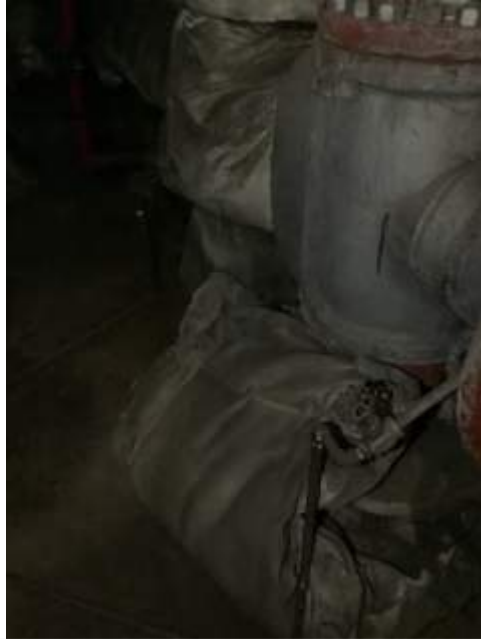
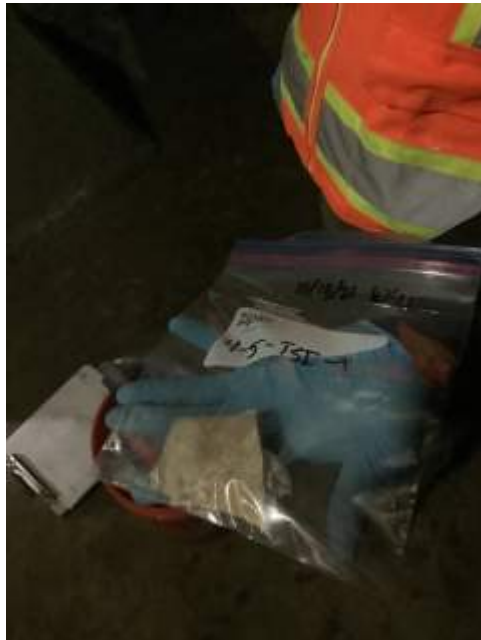
Additional Sample Notes:	Silver steam pipe fabric wrap.	
Sample ID:	Sample Type:	
4-5-TSI-9	TSI	
Sample Location:	Detailed Sample Location:	
Room 11	Southeast corner of room by entrance to room 23.	
Sample Quantity:	200 linear feet.	
Sample Color:	XRF:	
Misc Sample Material:	Sample Condition:	Sample Friable?:
	Damaged or significantly damaged	Yes

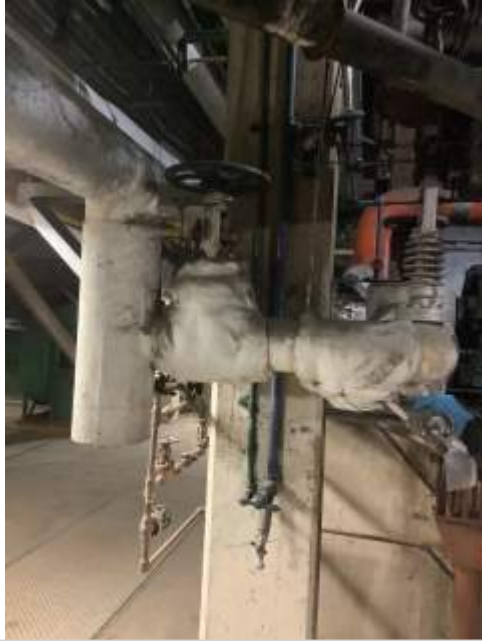
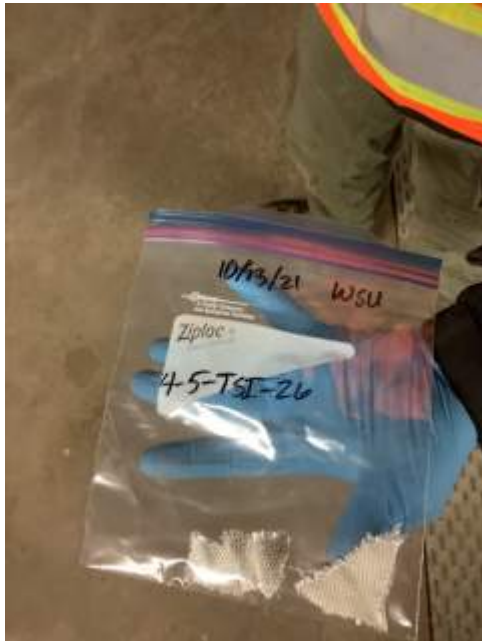
Additional Sample Notes:	Silver steam pipe fabric wrap.
Sample ID:	Sample Type:
4-5-TSI-26	TSI
Sample Location:	Detailed Sample Location:
Room 11	On west side of room by staircase down.
Sample Quantity:	200 linear feet.
Sample Color:	XRF:

Misc Sample Material:	Sample Condition:	Sample Friable?:
	Damaged or significantly damaged	Yes

Additional Sample Notes:	Silver steam pipe fabric wrap.
---------------------------------	--------------------------------

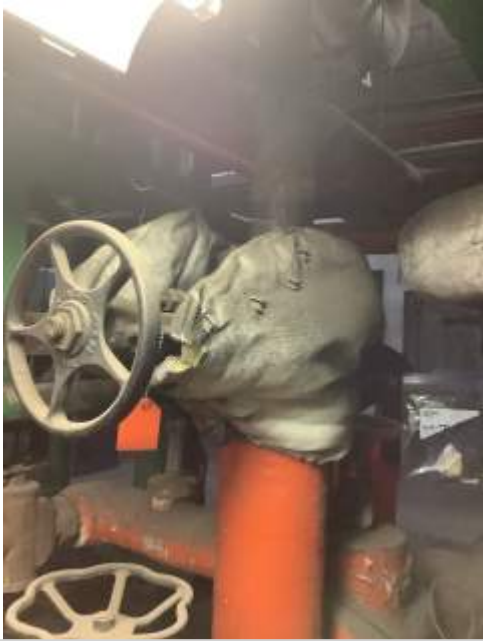
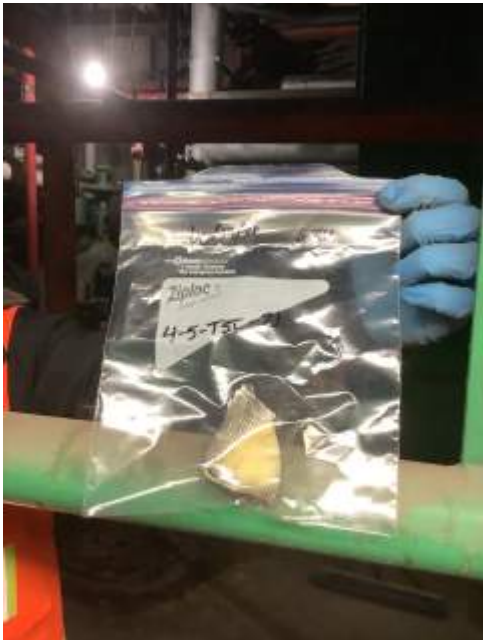
Sample ID:	Sample Type:
4-5-TSI-21	TSI
Sample Location:	Detailed Sample Location:
Room 11	Northeast portion of room near northeast staircase.
Sample Quantity:	200 linear feet.

Sample Color:	XRF:	
Misc Sample Material:	Sample Condition:	Sample Friable?:
	Damaged or significantly damaged	Yes

Additional Sample Notes:	Silver steam pipe fabric wrap.
---------------------------------	--------------------------------

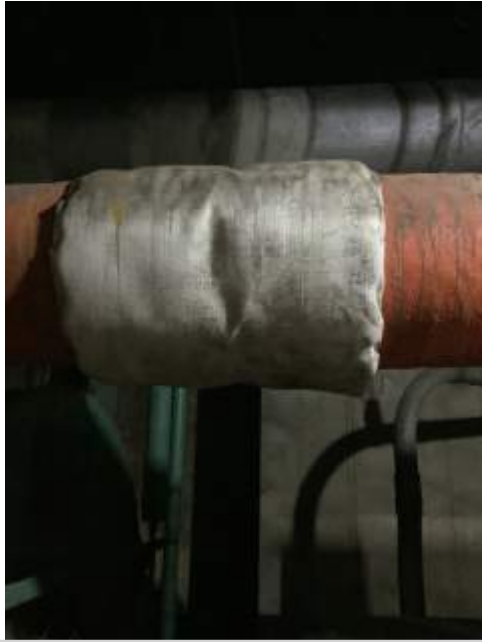
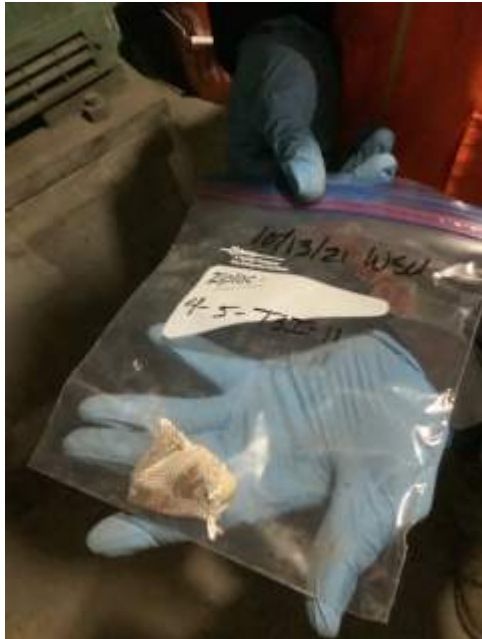
4-5-TSI-11

Room 11	East portion of room by spiral staircase.	
Sample Quantity:	200 linear feet.	
Sample Color:	XRF:	
Misc Sample Material:	Sample Condition:	Sample Friable?:
	Damaged or significantly damaged	Yes

Additional Sample Notes:	Silver steam pipe fabric wrap.
---------------------------------	--------------------------------

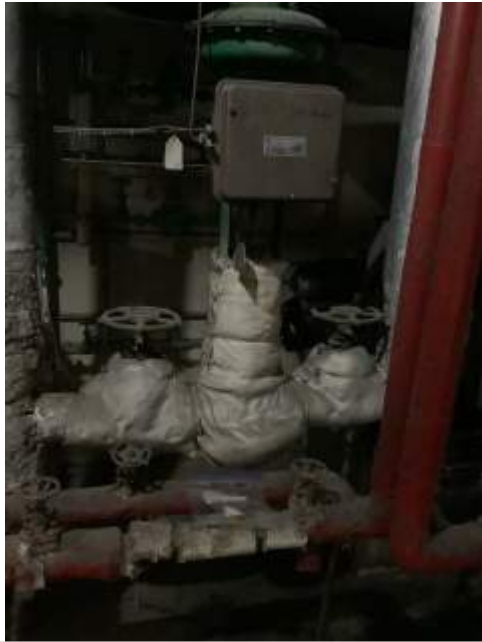
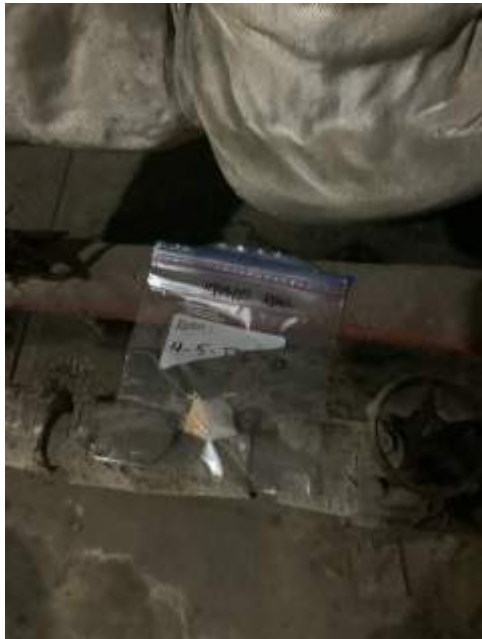
4-5-TSI-13	TSI	
Sample Location:	Detailed Sample Location:	
Room 11	East portion of room north of spiral staircase.	
Sample Quantity:	200 linear feet.	
Sample Color:	XRF:	
Misc Sample Material:	Sample Condition:	Sample Friable?:
	Damaged or significantly damaged	Yes

Additional Sample Notes:	Silver steam pipe fabric wrap.
---------------------------------	--------------------------------

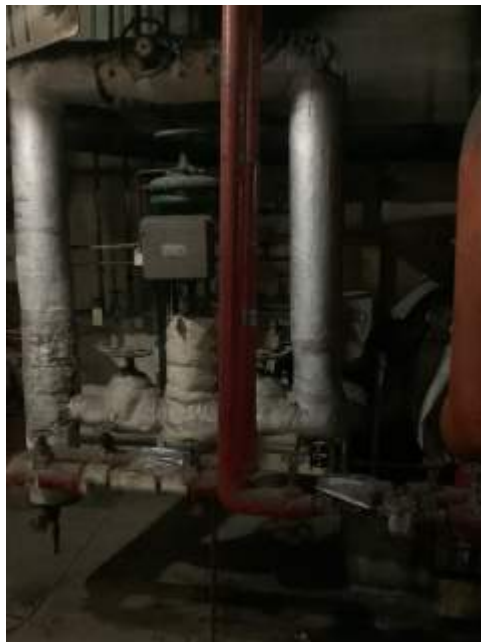
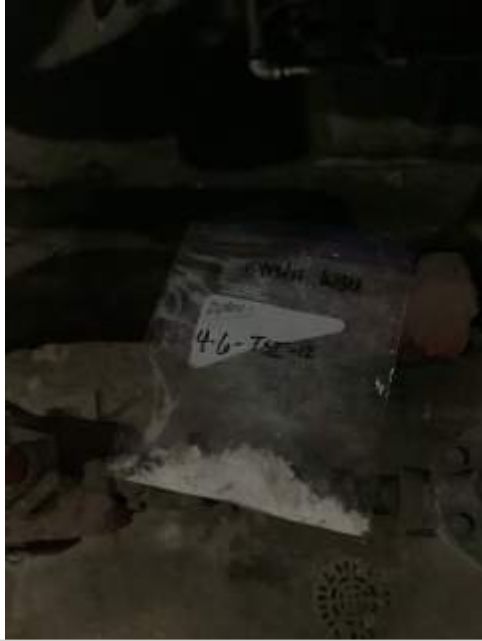
Sample ID:	Sample Type:	
4-6-TSI-12	TSI	
Sample Location:	Detailed Sample Location:	
Room 11	East portion of room north of spiral staircase.	
Sample Quantity:	40 linear feet.	
Sample Color:	XRF:	
Misc Sample Material:	Sample Condition:	Sample Friable?:
	Damaged or significantly damaged	Yes

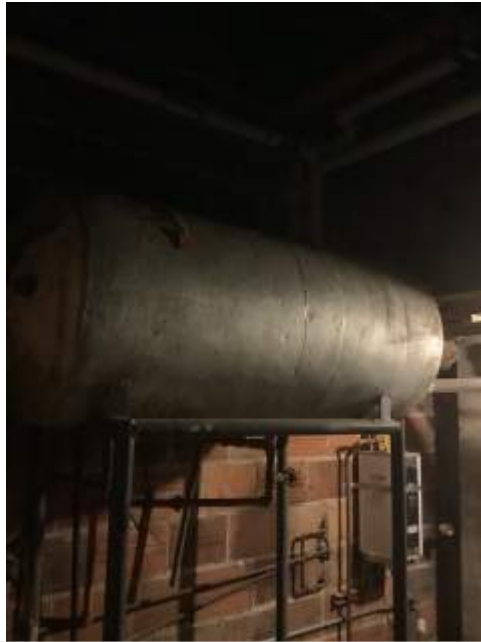
Sample ID:	Sample Type:
4-7-PB-9	PB
Sample Location:	Detailed Sample Location:
Room 18	Tank in southeast corner of room.
Sample Quantity:	5 linear feet.
Sample Color:	XRF:
Silver	5.00

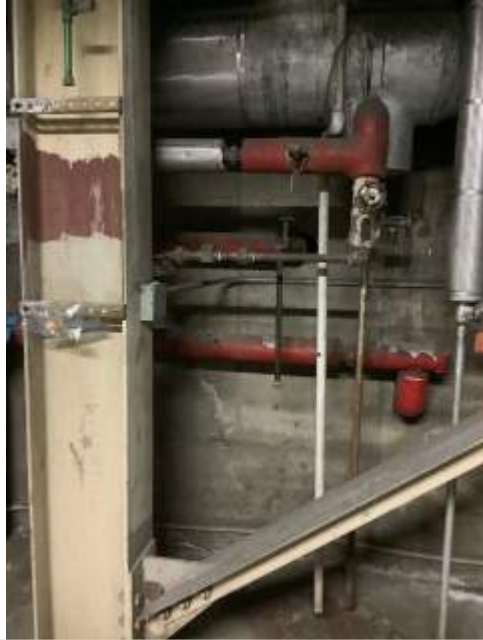
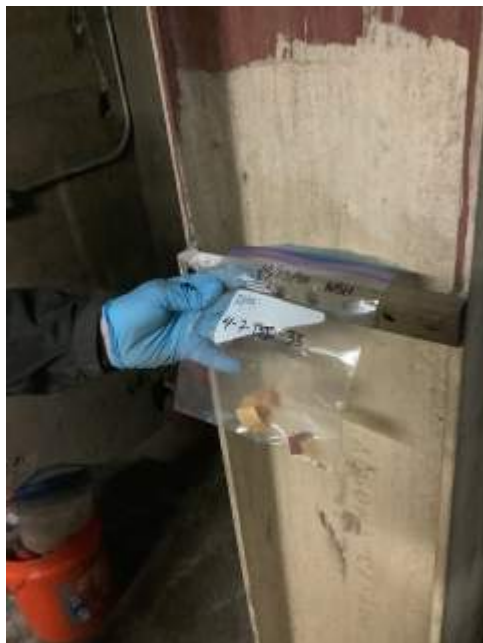
4-7-TSI-33

Misc Sample Material:	Sample Condition:	Sample Friable?:
	Damaged or significantly damaged	Yes

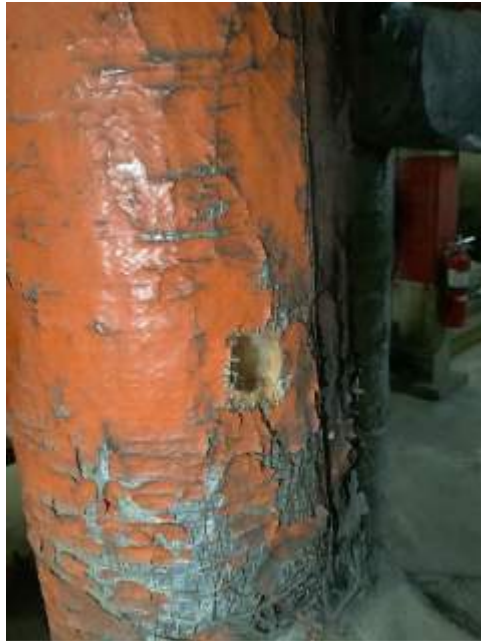
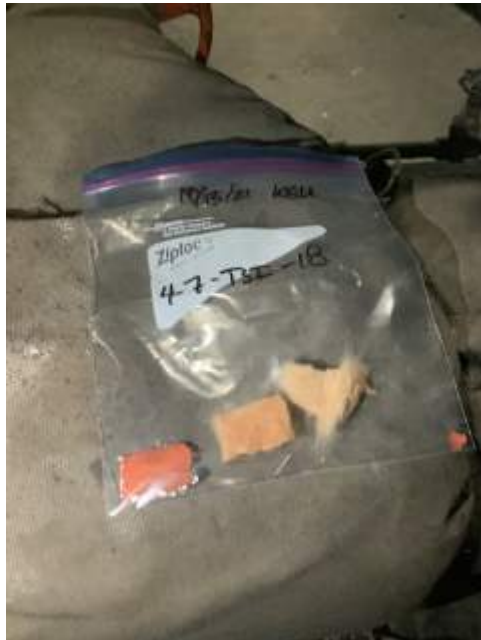
Additional Sample Notes:		Yellow insulation with red painted silver wrap.
Sample ID:	Sample Type:	
4-7-TSI-18	TSI	
Sample Location:	Detailed Sample Location:	
Room 11	Northeast portion of room between northeast staircase and elevator.	
Sample Quantity:	500 linear feet.	
Sample Color:	XRF:	
Misc Sample Material:	Sample Condition:	Sample Friable?:
	Damaged or significantly damaged	Yes

Orange steam pipe fabric wrap with yellow insulation.

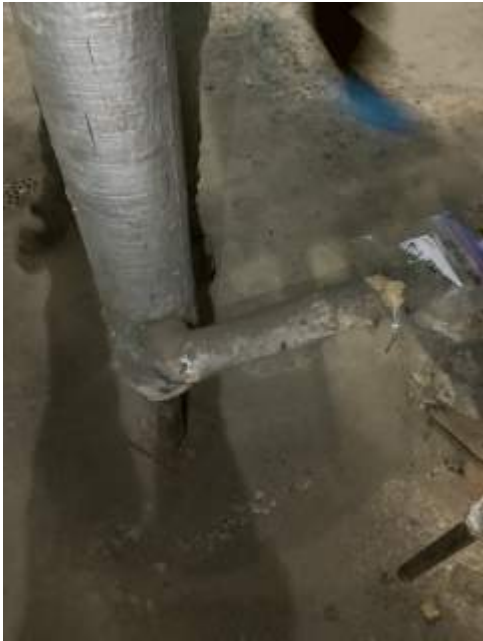
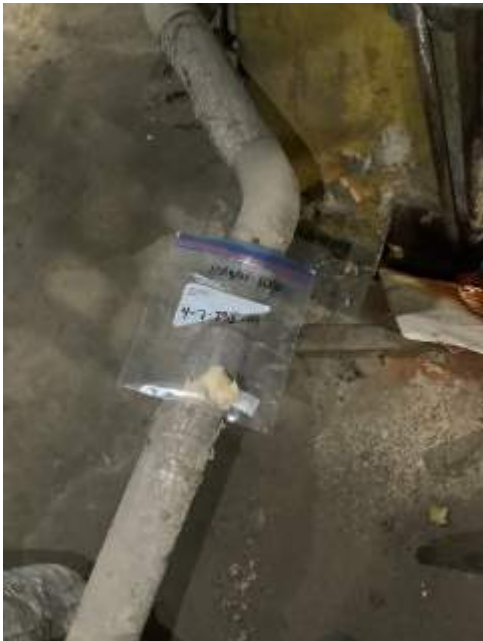
4-7-TSI-19

Misc Sample Material:	Sample Condition:	Sample Friable?:
	Damaged or significantly damaged	Yes

Additional Sample Notes:	Orange steam pipe fabric wrap with yellow insulation.
---------------------------------	---

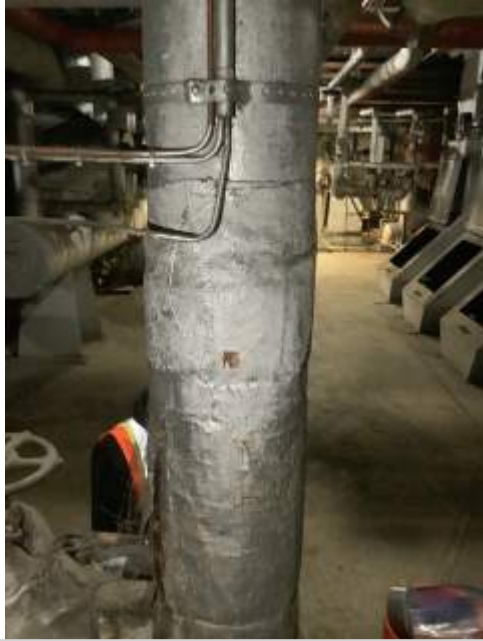
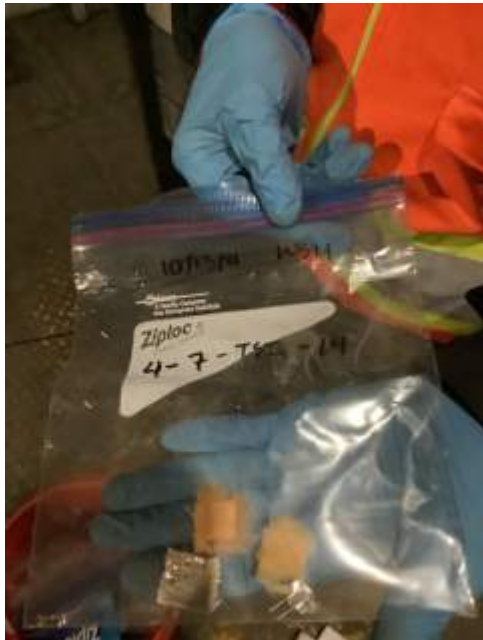
Sample ID:	Sample Type:
4-7-TSI-14	TSI
Sample Location:	Detailed Sample Location:
Room 11	East portion of room north of spiral staircase.
Sample Quantity:	500 linear feet.

Sample Color:	XRF:	
Misc Sample Material:	Sample Condition:	Sample Friable?:
	Damaged or significantly damaged	Yes

Additional Sample Notes:	Silver steam pipe fabric wrap with yellow insulation.
---------------------------------	---

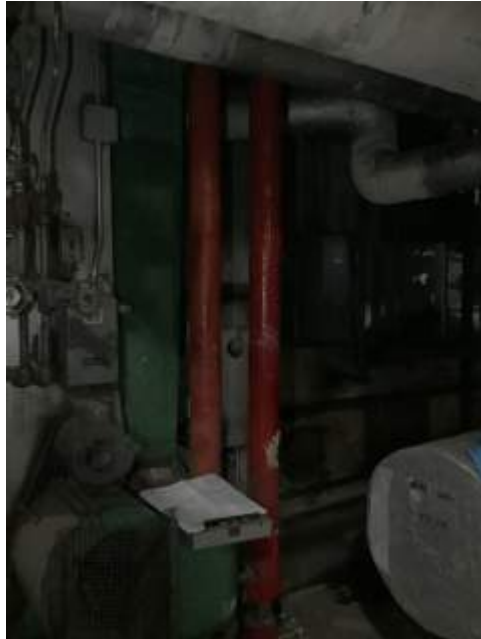
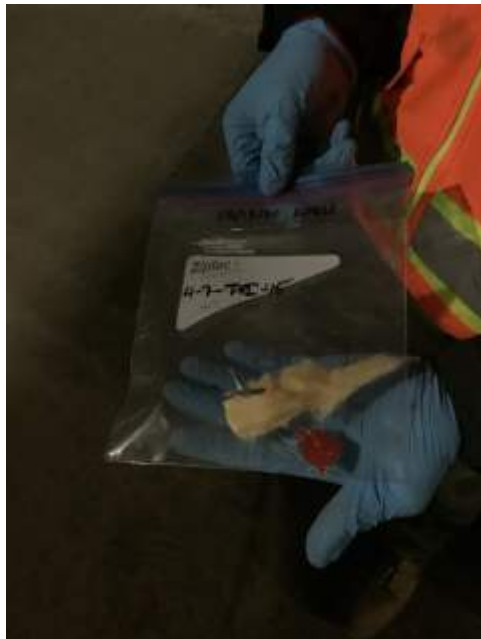
4-7-TSI-15

Room 11	East portion of room north of spiral staircase.	
Sample Quantity:	500 linear feet.	
Sample Color:	XRF:	
Misc Sample Material:	Sample Condition:	Sample Friable?:
	Damaged or significantly damaged	Yes

Additional Sample Notes:	Red steam pipe fabric wrap with yellow insulation.
---------------------------------	--

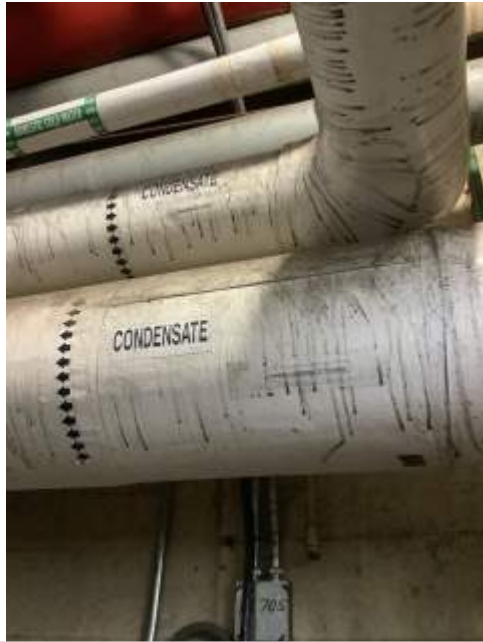
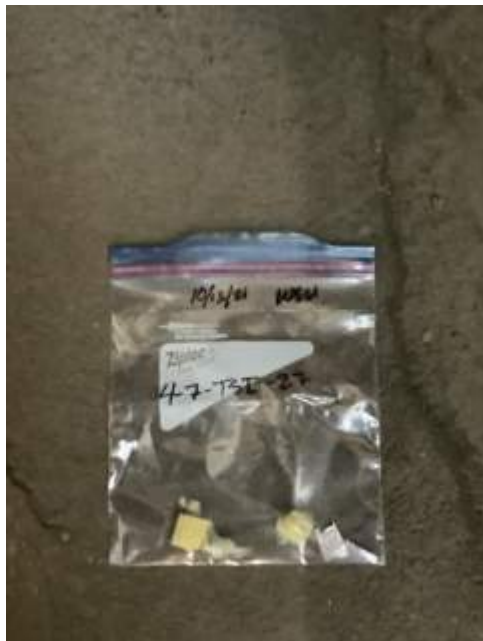
4-7-TSI-27	TSI	
Sample Location:	Detailed Sample Location:	
Room 11	West portion of room by staircase to room 101.	
Sample Quantity:	500 linear feet.	
Sample Color:	XRF:	
Misc Sample Material:	Sample Condition:	Sample Friable?:
	Damaged or significantly damaged	Yes

Additional Sample Notes: White condensate pipe with yellow insulation.

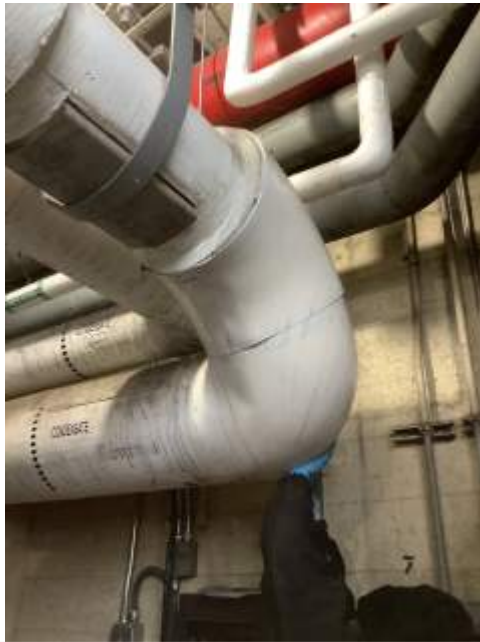
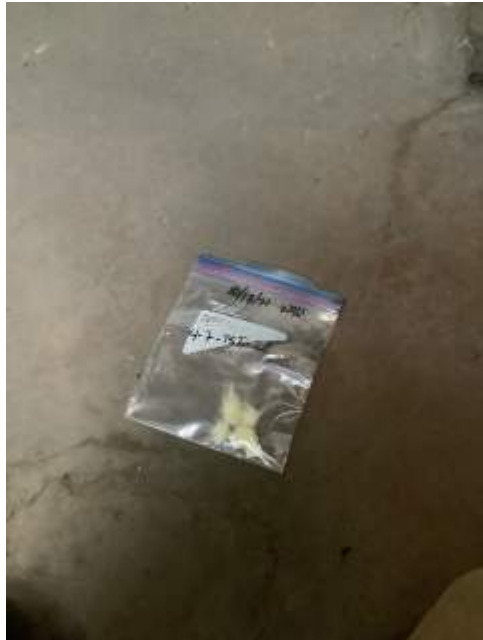
Sample ID:	Sample Type:	
4-7-TSI-28	TSI	
Sample Location:	Detailed Sample Location:	
Room 11	West portion of room by staircase to room 101.	
Sample Quantity:	500 linear feet.	
Sample Color:	XRF:	
Misc Sample Material:	Sample Condition:	Sample Friable?:
	Damaged or significantly damaged	Yes

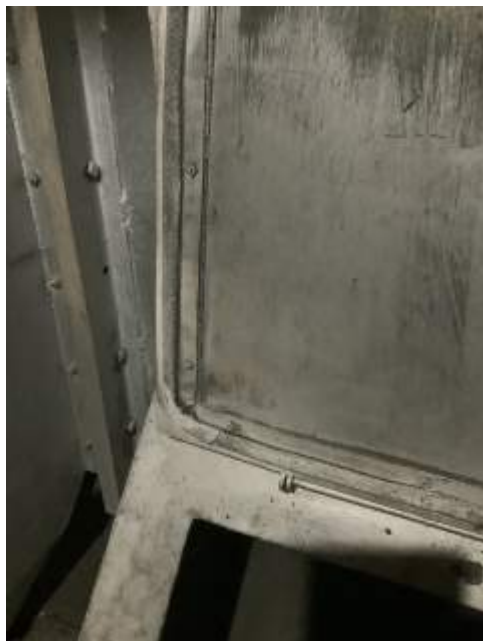
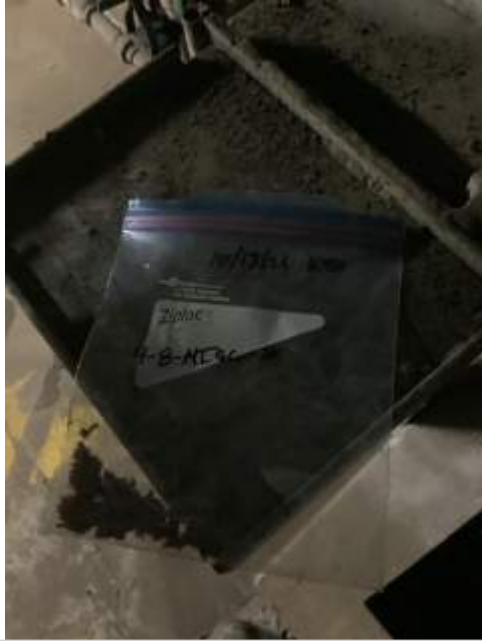
Additional Sample Notes:		White condensate line elbow with yellow insulation.
Sample ID:	Sample Type:	
4-8-MISC-16	MISC	
Sample Location:	Detailed Sample Location:	
Room 11	By control wheels and conveying systems.	
Sample Quantity:	80 linear feet.	
Misc Sample Material:	Sample Condition:	Sample Friable?:
Silver woven heat-resistant seal material on hatch interior.	Potential ACBM with potential for damage	No

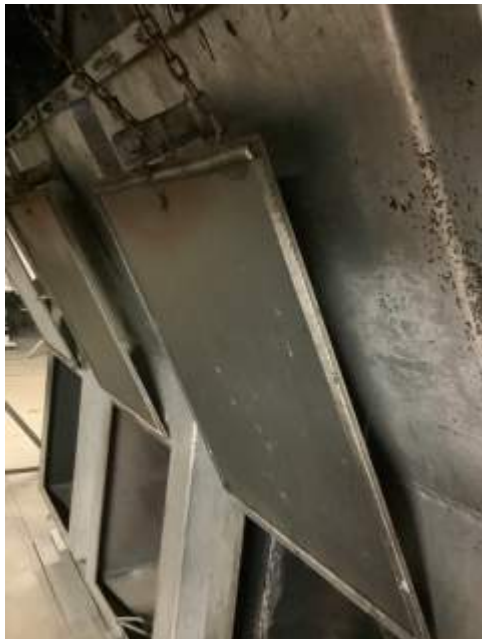
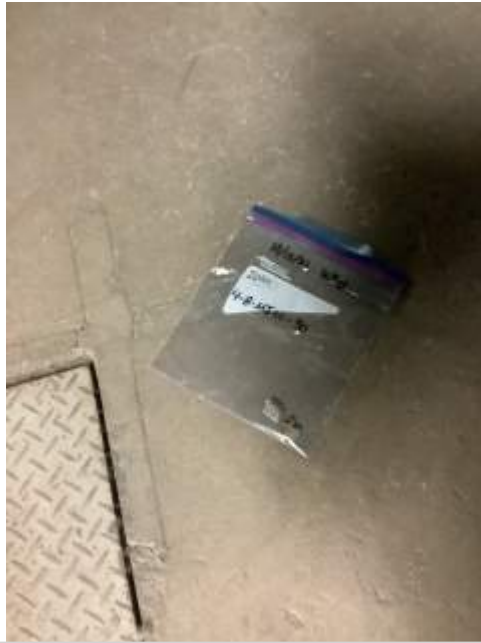
Sample ID:	Sample Type:	
4-8-MISC-30	MISC	
Sample Location:	Detailed Sample Location:	
Room 11	By control wheels and conveying systems.	
Sample Quantity:	80 linear feet.	
Misc Sample Material:	Sample Condition:	Sample Friable?:
Silver woven heat-resistant seal material on hatch interior.	Potential ACBM with potential for damage	No

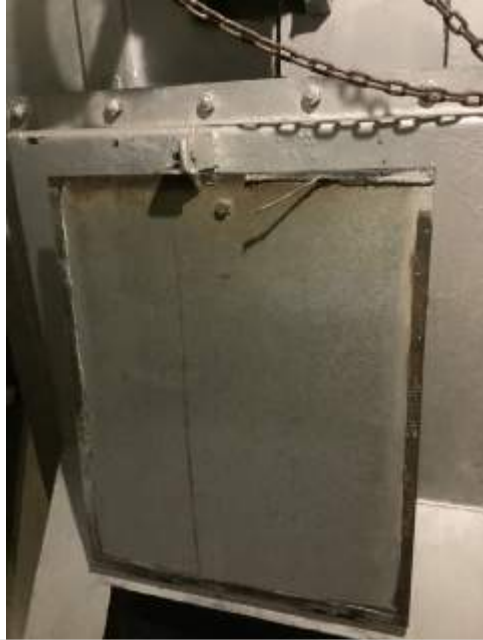
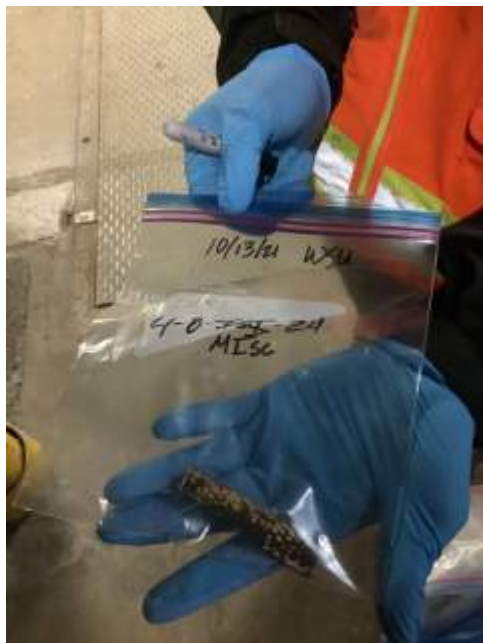
Sample ID:	Sample Type:	
4-8-MISC-24	MISC	
Sample Location:	Detailed Sample Location:	
Room 11	By control wheels and conveying systems.	
Sample Quantity:	80 linear feet.	
Misc Sample Material:	Sample Condition:	Sample Friable?:
Silver woven heat-resistant seal material on hatch interior.	Potential ACBM with potential for damage	No

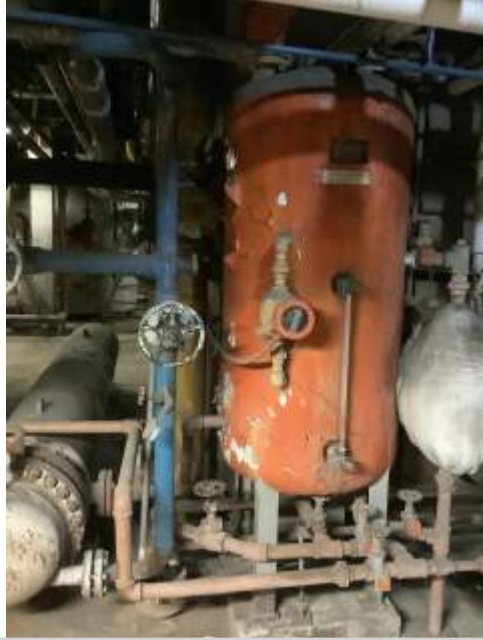
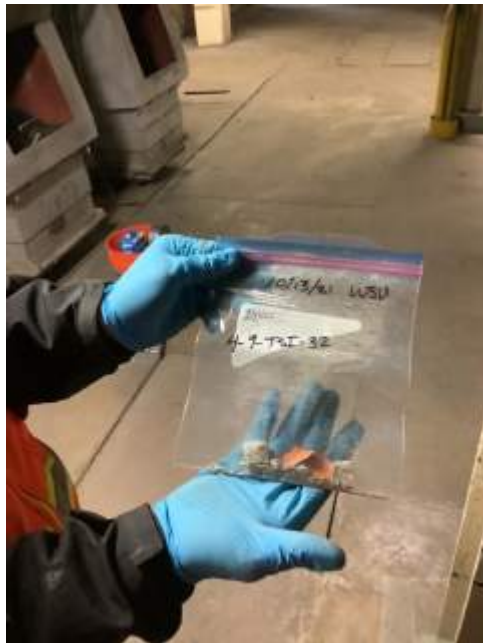
Additional Sample Notes:		
Sample ID:	Sample Type:	
4-9-TSI-32	TSI	
Sample Location:	Detailed Sample Location:	
Room 11	Northeast portion of room.	
Sample Quantity:	20 linear feet.	
Sample Color:	XRF:	
Misc Sample Material:	Sample Condition:	Sample Friable?:
	Damaged or significantly damaged	Yes

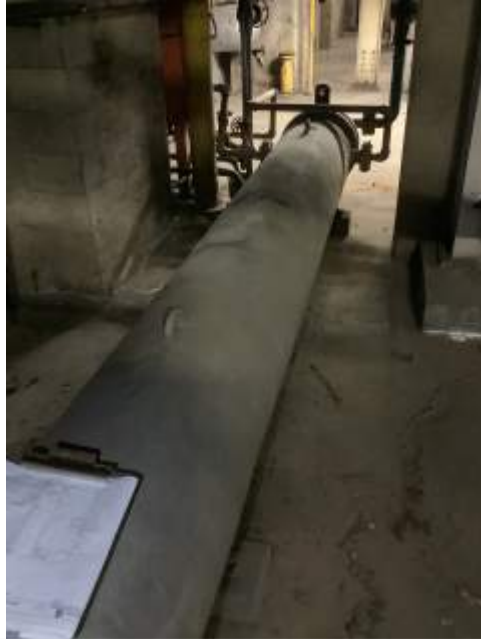
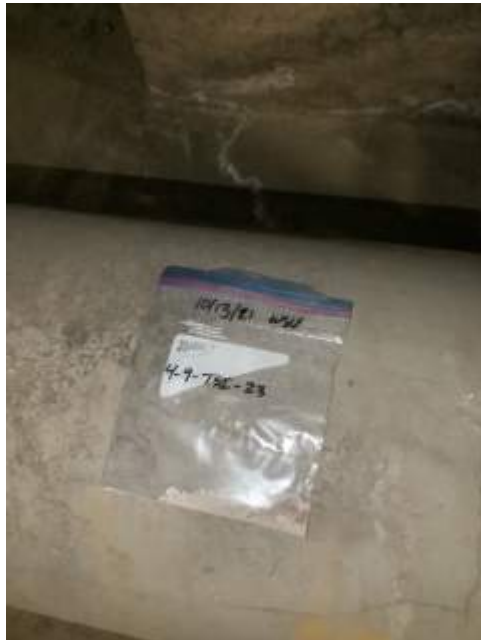
Additional Sample Notes:	White tank insulation with orange wrap.	
Sample ID:	Sample Type:	
4-9-TSI-23	TSI	
Sample Location:	Detailed Sample Location:	
Room 11	Northeast portion of room.	
Sample Quantity:	20 linear feet.	
Sample Color:	XRF:	
Misc Sample Material:	Sample Condition:	Sample Friable?:
	Damaged or significantly damaged	Yes
