FOCUSED SITE ASSESSMENT REPORT

COLLEGE AVENUE STEAM PLANT
PULLMAN, WASHINGTON

Prepared for
PORT OF WHITMAN COUNTY
March 30, 2022
Project No. M0457.02.003

Prepared by
Maul Foster & Alongi, Inc.
601 East Front Ave., Suite 202, Coeur d'Alene, ID 83814

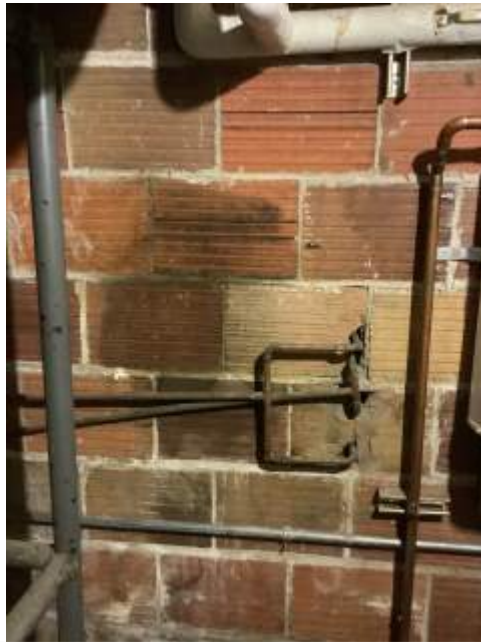
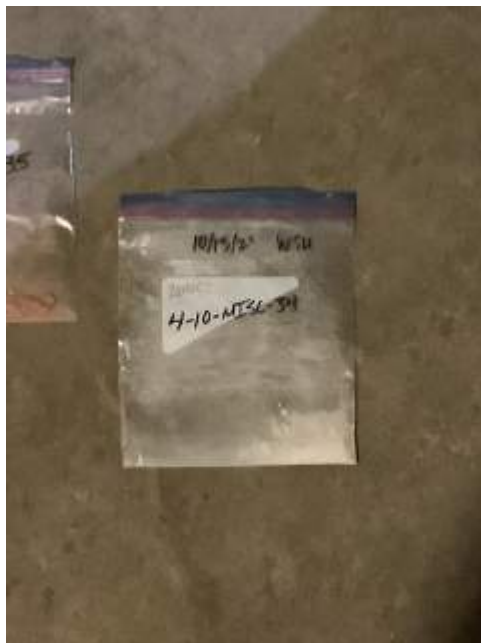
Additional Sample Notes:		White tank insulation with gray painted wrap and fabric patch.
Sample ID:	Sample Type:	
4-10-MISC-34	MISC	
Sample Location:	Detailed Sample Location:	
Room 18	East wall of room.	
Sample Quantity:	350 linear feet.	
Misc Sample Material:	Sample Condition:	Sample Friable?:
Gray brick mortar.	Potential ACBM with potential for damage	No

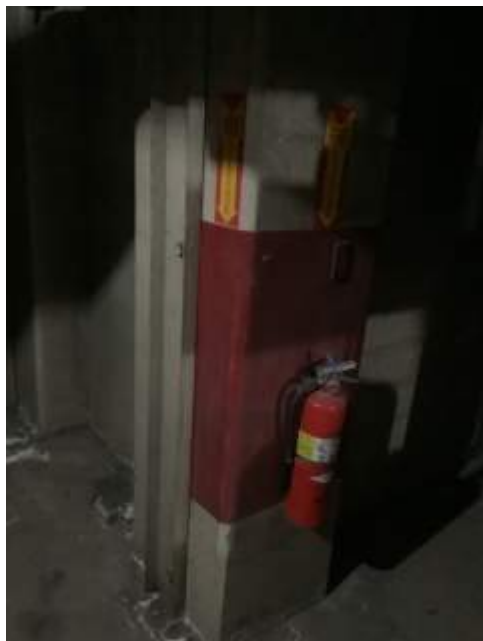
Additional Sample Notes:	
Sample ID:	Sample Type:
4-11-PB-54	PB
Sample Location:	Detailed Sample Location:
Room 11	Red fire extinguisher marking in southeast corner of room north of spiral staircase.
Sample Quantity:	N/A
Sample Color:	XRF:
Red	ND

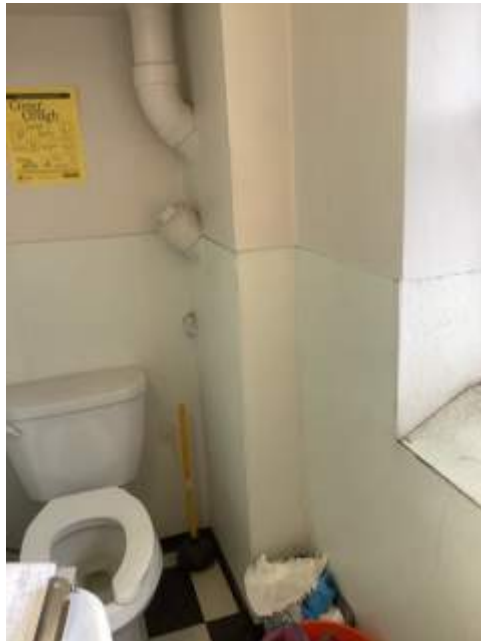
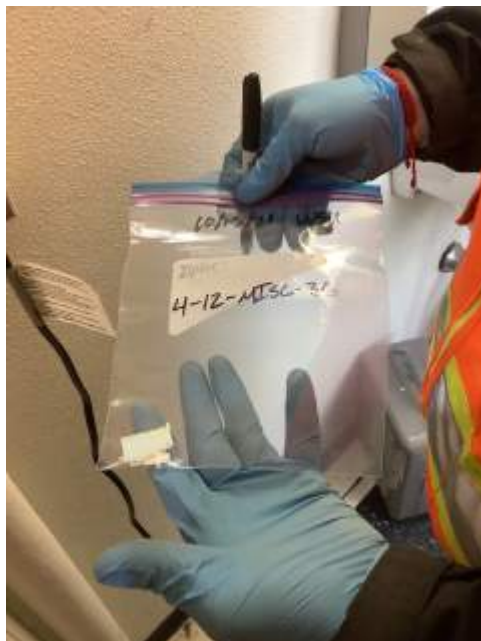
Additional Sample Notes:		
Sample ID:	Sample Type:	
4-12-MISC-36	MISC	
Sample Location:	Detailed Sample Location:	
Bathroom by west exit in stairwell.		
Sample Quantity:	60 square feet.	
Misc Sample Material:	Sample Condition:	Sample Friable?:
White textured waterproofing tile.	Damaged or significantly damaged friable miscellaneous ACM	No

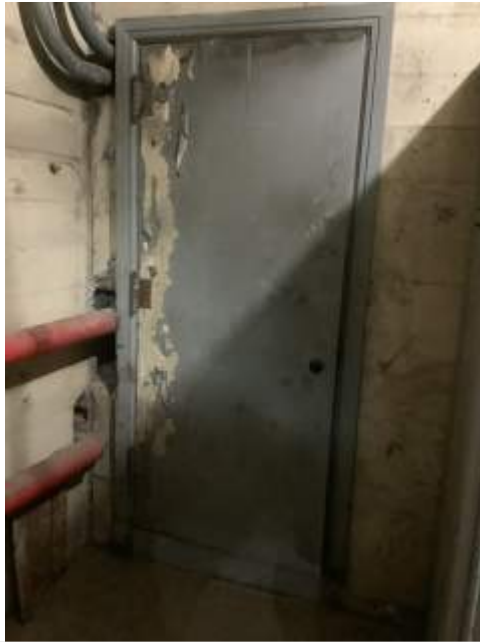
Sample ID:	Sample Type:
4-12-PB-14	PB
Sample Location:	Detailed Sample Location:
Room 21	Door to room 15.
Sample Quantity:	24 square feet.
Sample Color:	XRF:
Gray	4.11

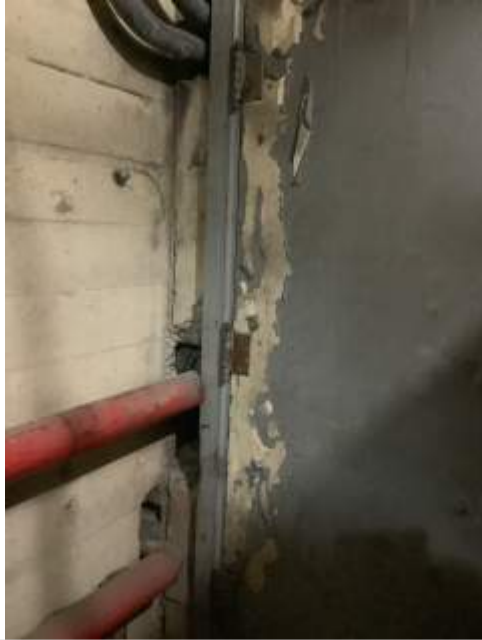
Sample ID:	Sample Type:
4-13-PB-15	PB
Sample Location:	Detailed Sample Location:
Room 21	Paint under new paint on door to room 15.
Sample Quantity:	24 square feet.
Sample Color:	XRF:
Light tan	3.40

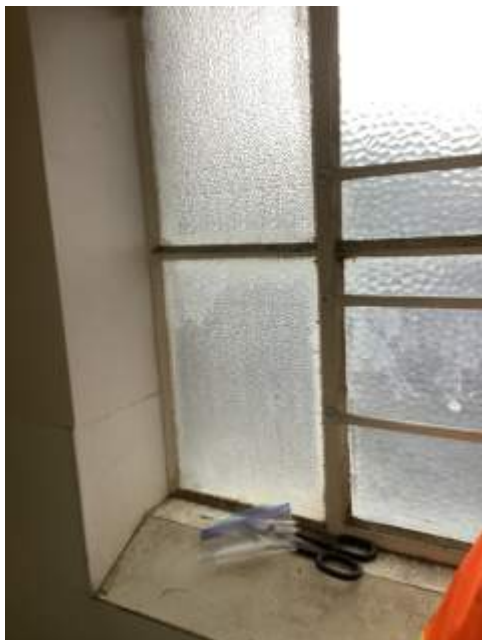
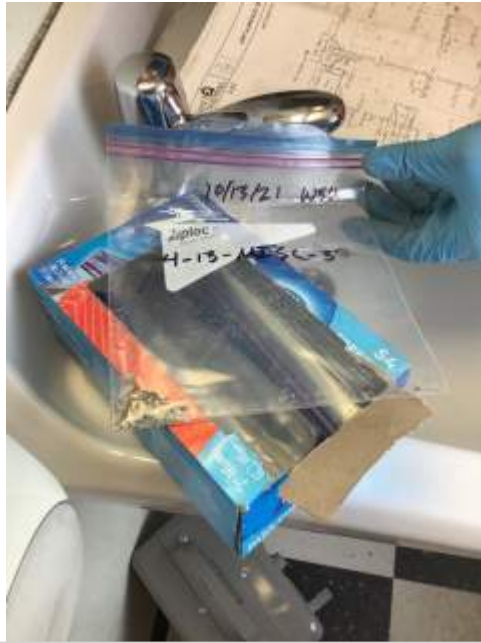
Sample ID:	Sample Type:	
4-13-MISC-37	MISC	
Sample Location:	Detailed Sample Location:	
Bathroom by exit		
Sample Quantity:	30 linear feet.	
Misc Sample Material:	Sample Condition:	Sample Friable?:
Window glazing.	Damaged or significantly damaged friable miscellaneous ACM	No

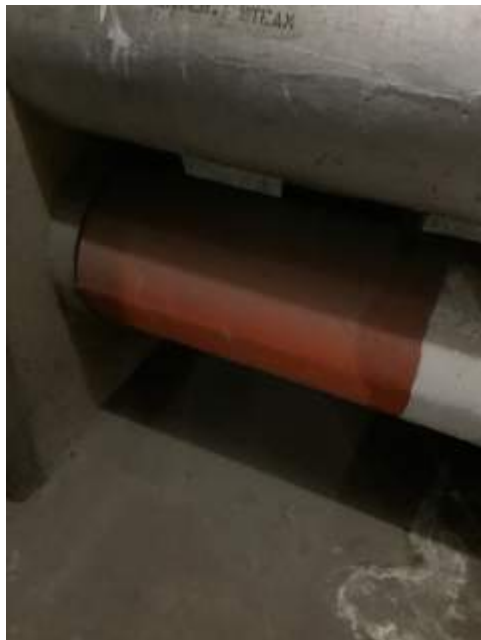
Sample ID:	Sample Type:
4-14-PB-16	PB
Sample Location:	Detailed Sample Location:
Room 21	Orange pipe on south wall west of room 22.
Sample Quantity:	600 linear feet.
Sample Color:	XRF:
Orange	5.00

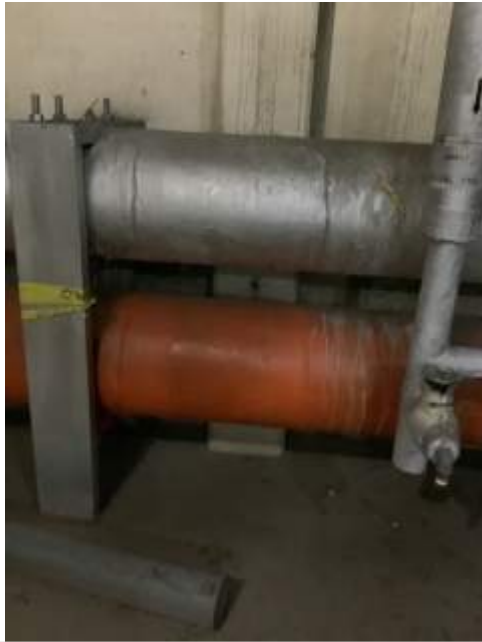
Sample ID:	Sample Type:
4-14-PB-21	PB
Sample Location:	Detailed Sample Location:
Room 23	Orange pipe on east wall.
Sample Quantity:	600 linear feet.
Sample Color:	XRF:
Orange	3.70

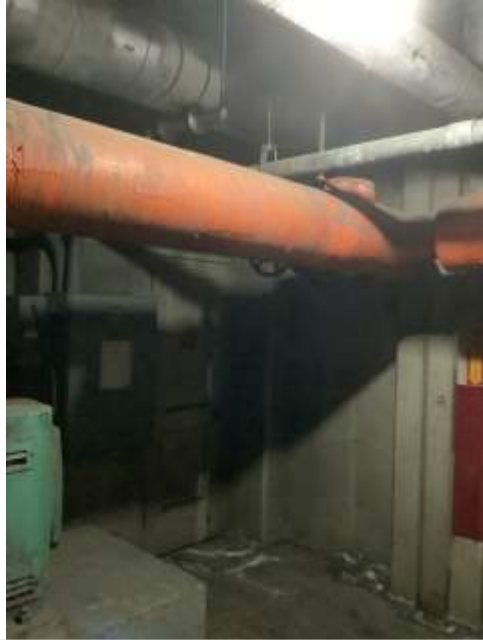
Sample ID:	Sample Type:
4-14-PB-55	PB
Sample Location:	Detailed Sample Location:
Room 11	Orange pipe wrap in southeast corner of room north of spiral staircase.
Sample Quantity:	600 linear feet
Sample Color:	XRF:
Orange	1.275

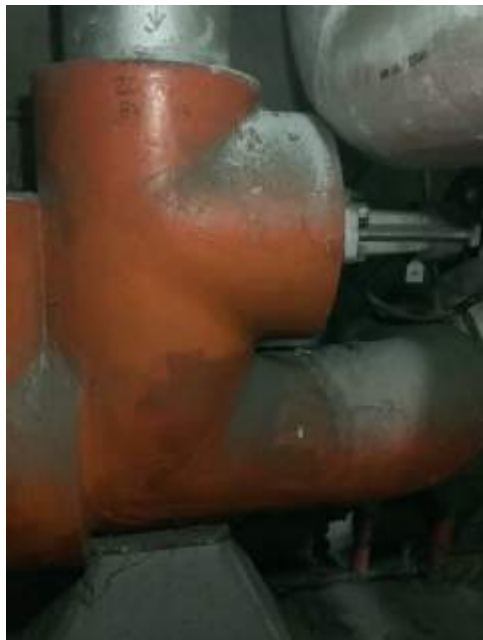
Sample ID:	Sample Type:
4-14-PB-57	PB
Sample Location:	Detailed Sample Location:
Room 11	Southeast corner of room east of doorway.
Sample Quantity:	600 linear feet.
Sample Color:	XRF:
Orange	4.49

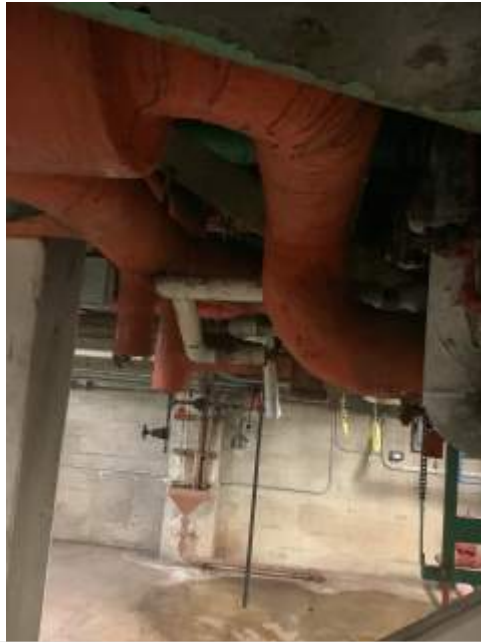
Sample ID:	Sample Type:
4-14-PB-42	PB
Sample Location:	Detailed Sample Location:
Room 11	Orange pipe in northwest corner of room west of active tank.
Sample Quantity:	600 linear feet.
Sample Color:	XRF:
Orange	5.0

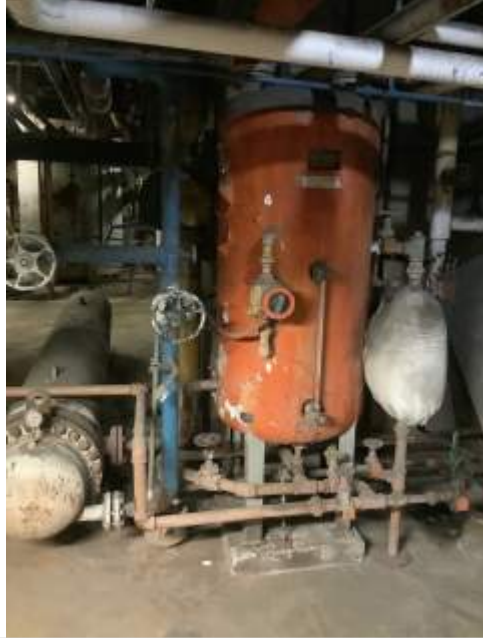
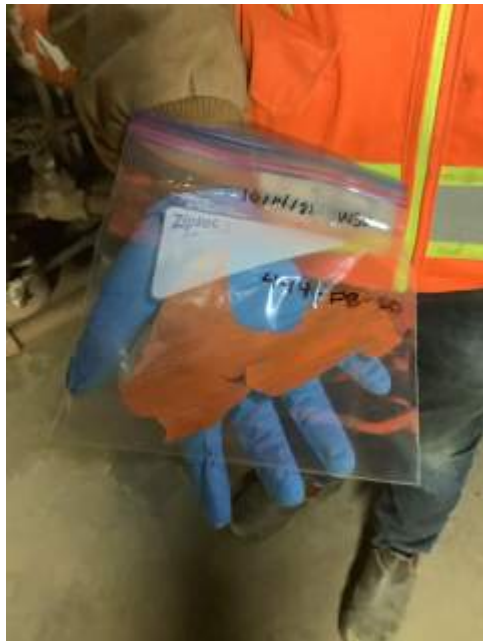
Sample ID:	Sample Type:
4-14-PB-50	PB
Sample Location:	Detailed Sample Location:
Room 11	Orange tank in center of room between the two north boilers.
Sample Quantity:	600 linear feet.
Sample Color:	XRF:
Orange	1.223

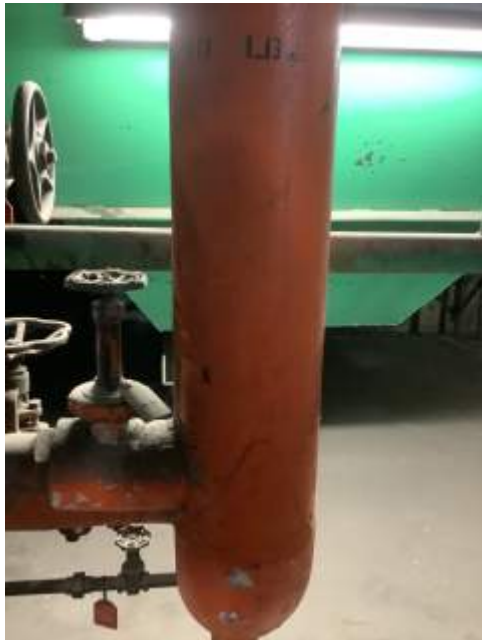
Sample ID:	Sample Type:
4-14-PB-44	PB
Sample Location:	Detailed Sample Location:
Room 11	Northeast corner of room west of exit doorway.
Sample Quantity:	600 linear feet.
Sample Color:	XRF:
Orange	2.43

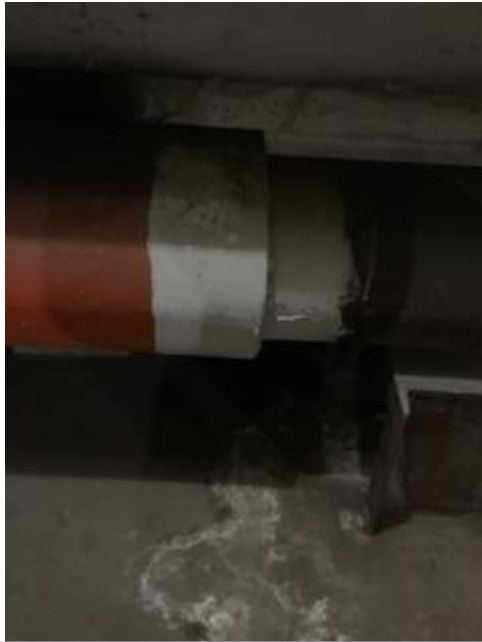
Sample ID:	Sample Type:
4-15-PB-17	PB
Sample Location:	Detailed Sample Location:
Room 21	White paint on orange pipe on south wall west of room 22.
Sample Quantity:	2 linear feet.
Sample Color:	XRF:
White	5.00

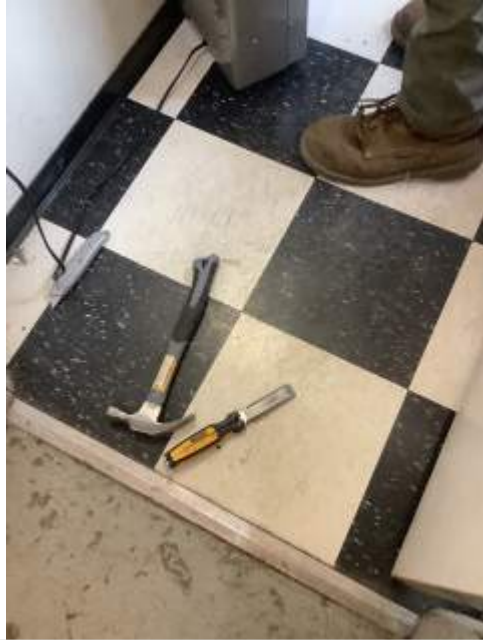
Sample ID:	Sample Type:	
4-15-MISC-39	MISC	
Sample Location:	Detailed Sample Location:	
Bathroom by exit		
Sample Quantity:	20 square feet.	
Misc Sample Material:	Sample Condition:	Sample Friable?:
White 12" x 12" linoleum floor tile with yellow adhesive.	Damaged or significantly damaged friable miscellaneous ACM	No

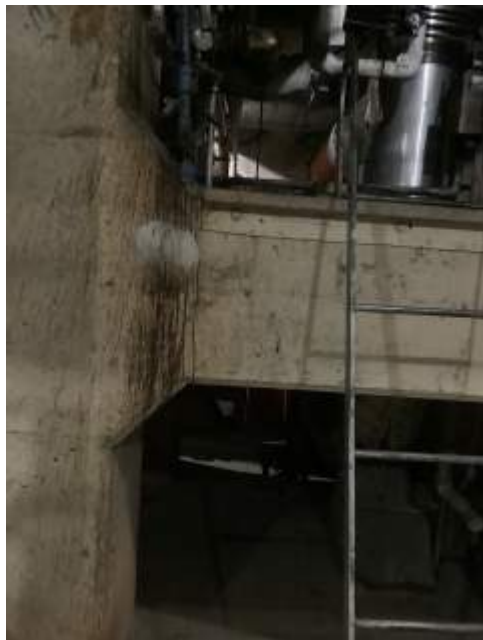
Sample ID:	Sample Type:
4-16-PB-28	PB
Sample Location:	Detailed Sample Location:
Room 11	Support beam in southwest center of room.
Sample Quantity:	N/A
Sample Color:	XRF:
Tan	ND

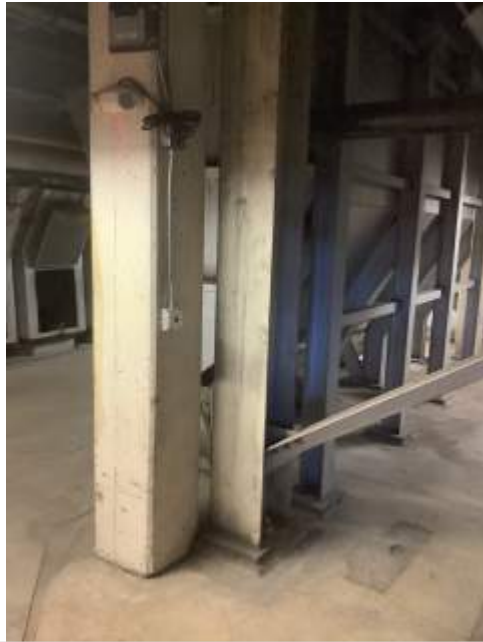
Sample ID:	Sample Type:
4-16-PB-51	PB
Sample Location:	Detailed Sample Location:
Room 11	Support beam on south side of room east of green air equipment.
Sample Quantity:	N/A
Sample Color:	XRF:
White	0.005

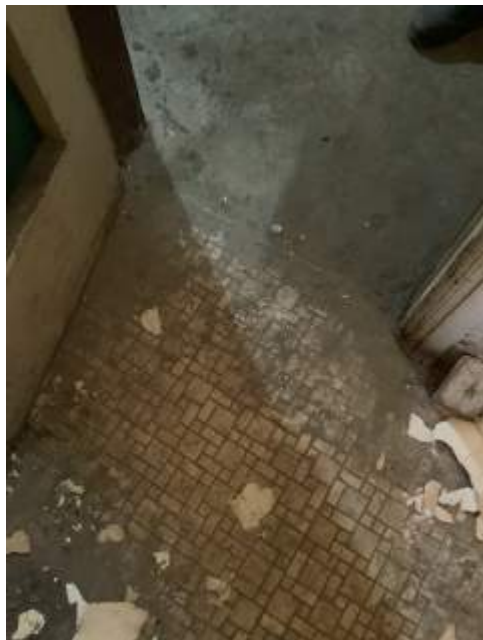
Sample ID:	Sample Type:	
4-17-MISC-41	MISC	
Sample Location:	Detailed Sample Location:	
Room 17	Northeast floor in front of door.	
Sample Quantity:	180 square feet.	
Misc Sample Material:	Sample Condition:	Sample Friable?:
Tan 1"-2" square tile with brown adhesive.	Potential ACBM with potential for damage	No

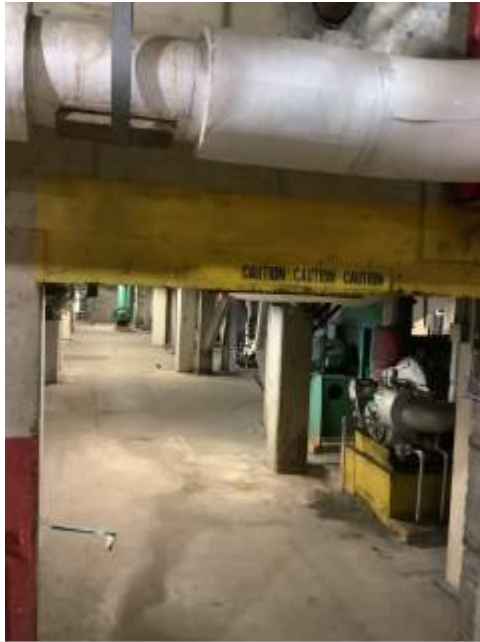
Sample ID:	Sample Type:
4-17-PB-19	PB
Sample Location:	Detailed Sample Location:
Room 21	Yellow caution paint above doorway to room 11.
Sample Quantity:	N/A
Sample Color:	XRF:
Yellow	ND

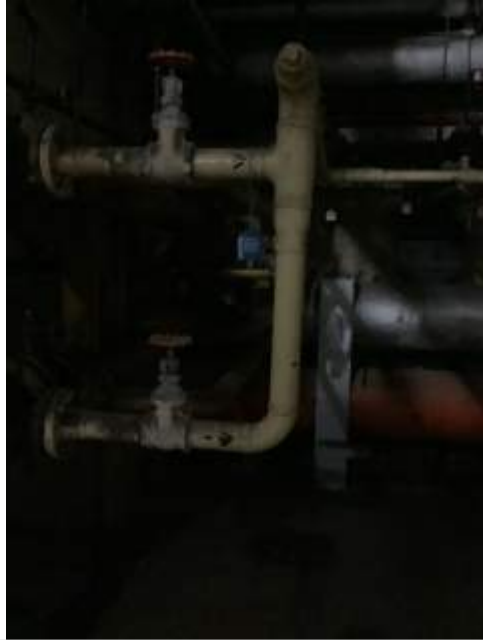
Sample ID:	Sample Type:
4-18-PB-22	PB
Sample Location:	Detailed Sample Location:
Room 23	Yellow pipe in northeast corner.
Sample Quantity:	N/A
Sample Color:	XRF:
Yellow	0.305

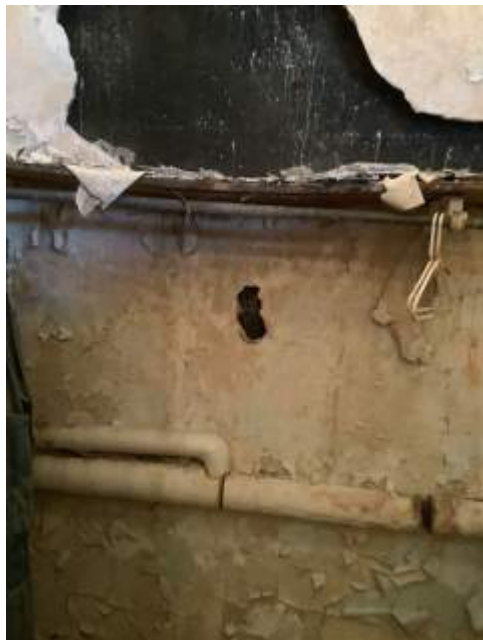
Sample ID:	Sample Type:	
4-18-MISC-43	MISC	
Sample Location:	Detailed Sample Location:	
Room 17	South wall of room.	
Sample Quantity:	920 square feet.	
Misc Sample Material:	Sample Condition:	Sample Friable?:
White drywall with gray cementitious wallboard.	Potential ACBM with potential for damage	No

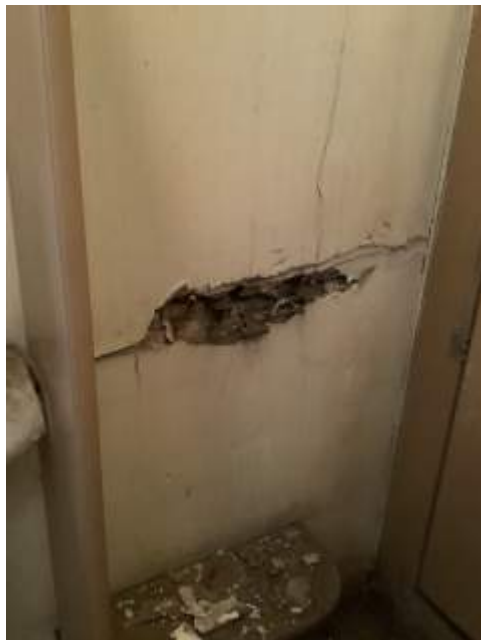
Sample ID:	Sample Type:	
4-18-MISC-45	MISC	
Sample Location:	Detailed Sample Location:	
Room 17	West wall in northwest corner.	
Sample Quantity:	920 square feet.	
Misc Sample Material:	Sample Condition:	Sample Friable?:
White drywall with gray cementitious wallboard.	Potential ACBM with potential for damage	No

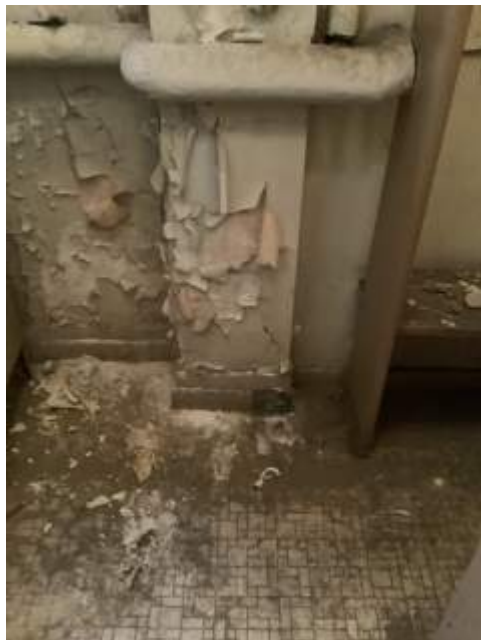
Additional Sample Notes:		
Sample ID:	Sample Type:	
4-19-MISC-44	MISC	
Sample Location:	Detailed Sample Location:	
Room 17	West wall in northwest corner.	
Sample Quantity:	60 linear feet.	
Misc Sample Material:	Sample Condition:	Sample Friable?:
Tan cove base with green adhesive.	Potential ACBM with potential for damage	No

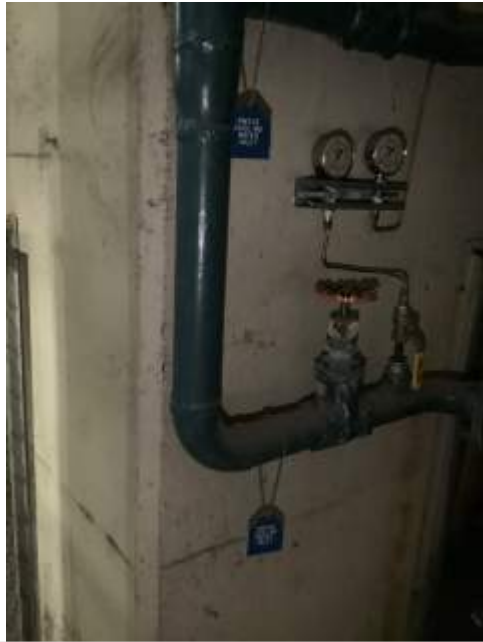
Sample ID:	Sample Type:
4-19-PB-23	PB
Sample Location:	Detailed Sample Location:
Room 23	Blue pipe in northeast corner.
Sample Quantity:	N/A
Sample Color:	XRF:
Blue	0.306

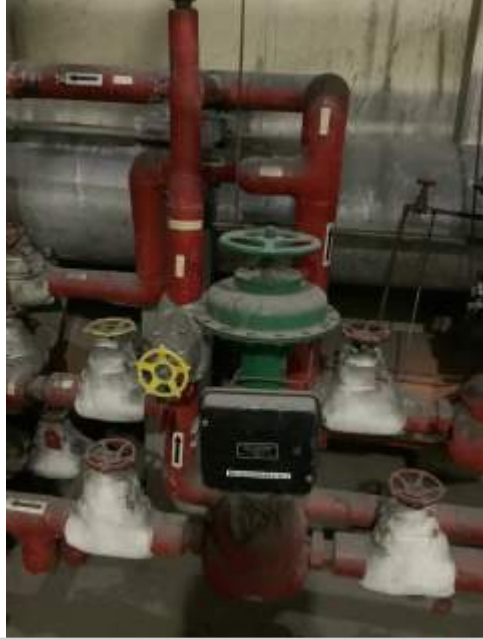
Sample ID:	Sample Type:
4-20-PB-26	PB
Sample Location:	Detailed Sample Location:
Room 23	Green equipment on south side of room.
Sample Quantity:	N/A
Sample Color:	XRF:
Green	0.908

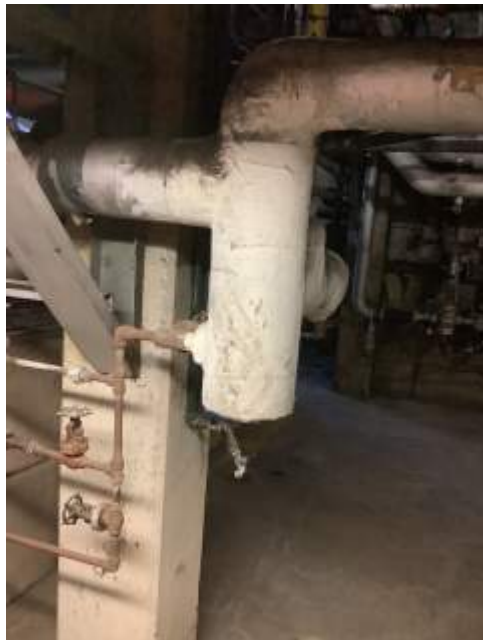
Sample ID:	Sample Type:
4-21-PB-29	PB
Sample Location:	Detailed Sample Location:
Room 11	White pipe wrap on west side of room east of sun basement entrance.
Sample Quantity:	N/A
Sample Color:	XRF:
White	ND

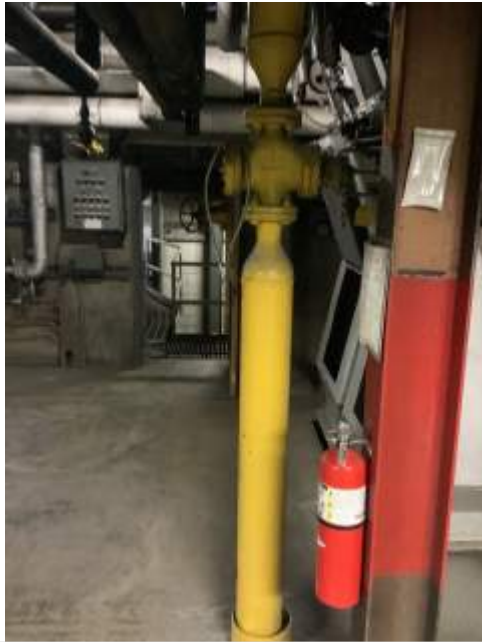
Sample ID:	Sample Type:
4-22-PB-31	PB
Sample Location:	Detailed Sample Location:
Room 11	Yellow pipe on east side of room east of door to sub basement.
Sample Quantity:	140 linear feet.
Sample Color:	XRF:
Yellow	5.00

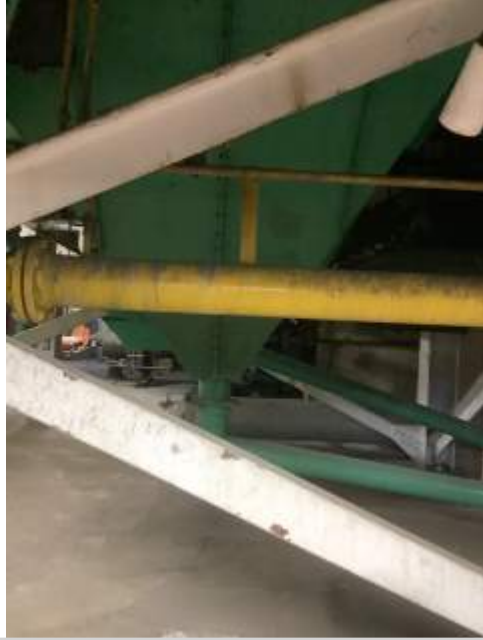
Sample ID:	Sample Type:
4-22-PB-37	PB
Sample Location:	Detailed Sample Location:
Room 11	North side of room north of northwest boiler.
Sample Quantity:	140 linear feet.
Sample Color:	XRF:
Yellow	3.67

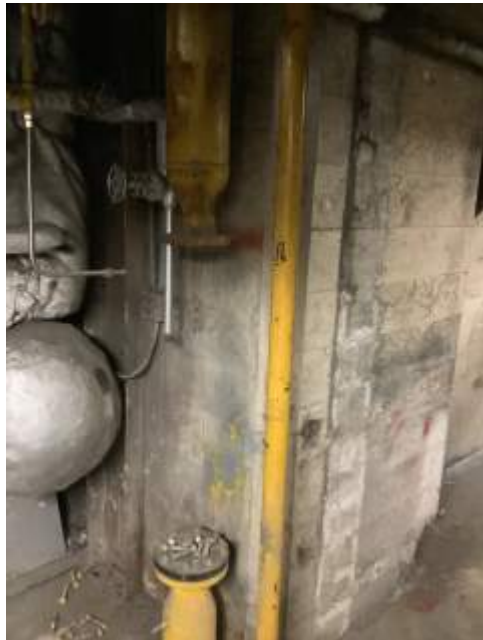
Additional Sample Notes:	
Sample ID:	Sample Type:
4-22-PB-48	PB
Sample Location:	Detailed Sample Location:
Room 11	Center of room east of southwest boiler.
Sample Quantity:	140 linear feet.
Sample Color:	XRF:
Yellow	4.38

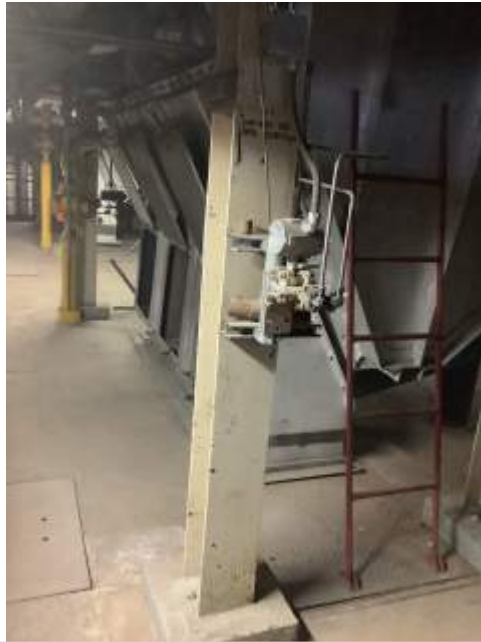
Sample ID:	Sample Type:
4-23-PB-49	PB
Sample Location:	Detailed Sample Location:
Room 11	Support in center of room between the two north boilers.
Sample Quantity:	280 linear feet.
Sample Color:	XRF:
Bright white	5.00

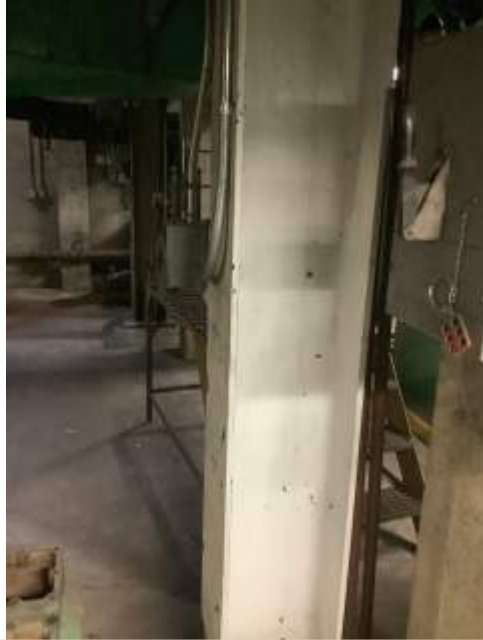
Sample ID:	Sample Type:
4-23-PB-32	PB
Sample Location:	Detailed Sample Location:
Room 11	Support in northwest corner.
Sample Quantity:	264 linear feet.
Sample Color:	XRF:
Bright white	5.00

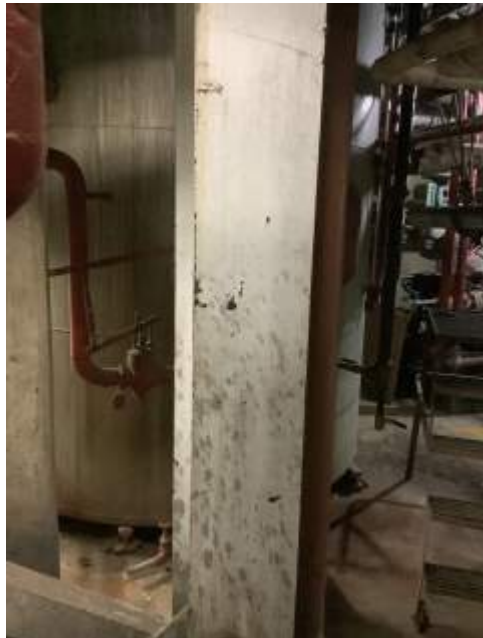
Sample ID:	Sample Type:
4-23-PB-35	PB
Sample Location:	Detailed Sample Location:
Room 11	North side of room south of active tank.
Sample Quantity:	280 linear feet.
Sample Color:	XRF:
White	5.00

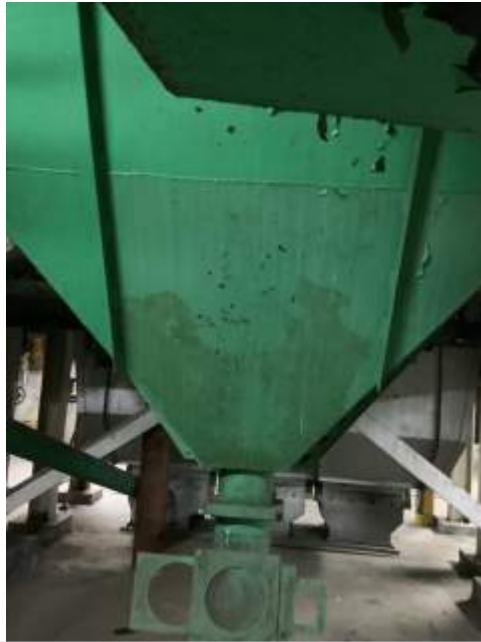
Additional Sample Notes:	
Sample ID:	Sample Type:
4-24-PB-36	PB
Sample Location:	Detailed Sample Location:
Room 11	North side of room north of northwest boiler.
Sample Quantity:	100 linear feet.
Sample Color:	XRF:
Green	0.241

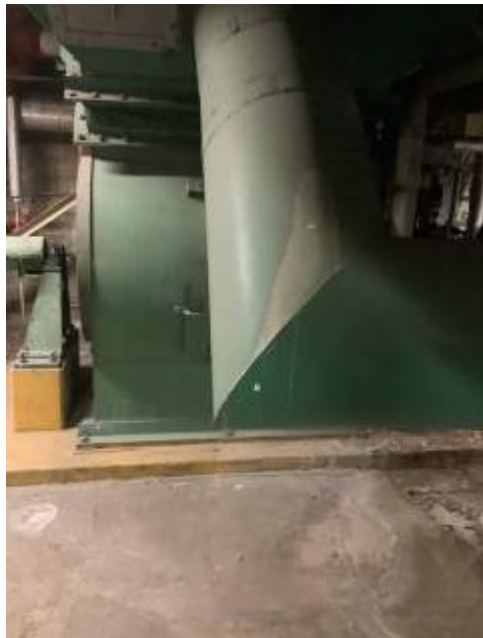
Additional Sample Notes:	Difficult to quantify.
Sample ID:	Sample Type:
4-24-PB-53	PB
Sample Location:	Detailed Sample Location:
Room 11	Green pipe and equipment on south side of room east of entrance to room 21.
Sample Quantity:	100 linear feet.
Sample Color:	XRF:
Green	0.220

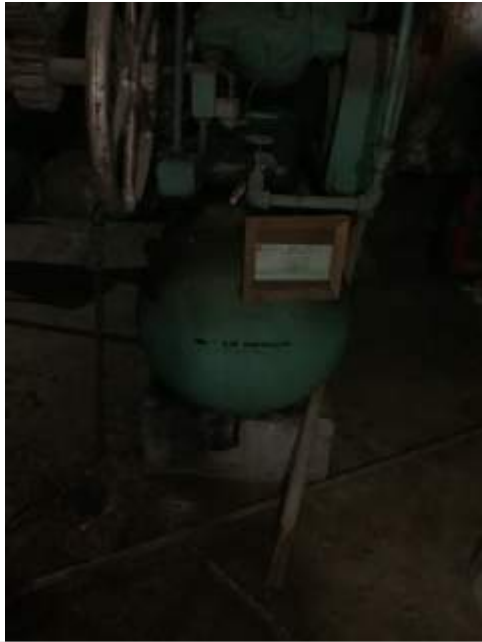
Sample ID:	Sample Type:
4-24-PB-58	PB
Sample Location:	Detailed Sample Location:
Room 11	Southwest corner of room.
Sample Quantity:	100 linear feet.
Sample Color:	XRF:
Green	0.084

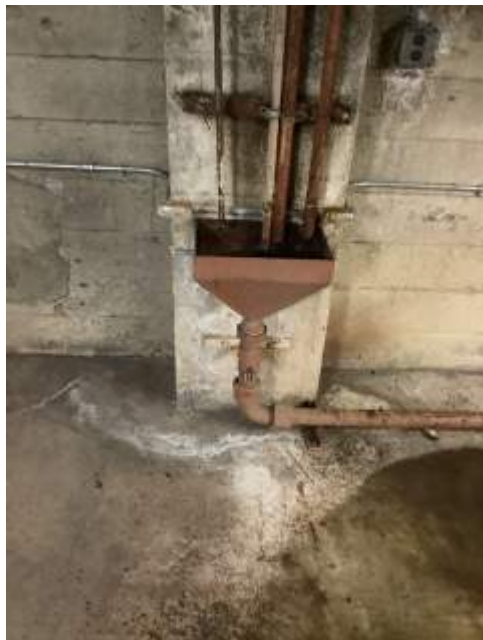
Sample ID:	Sample Type:
4-25-PB-41	PB
Sample Location:	Detailed Sample Location:
Room 11	Drain pipe in northwest corner of room west of active tank.
Sample Quantity:	N/A
Sample Color:	XRF:
Reddish brown	ND

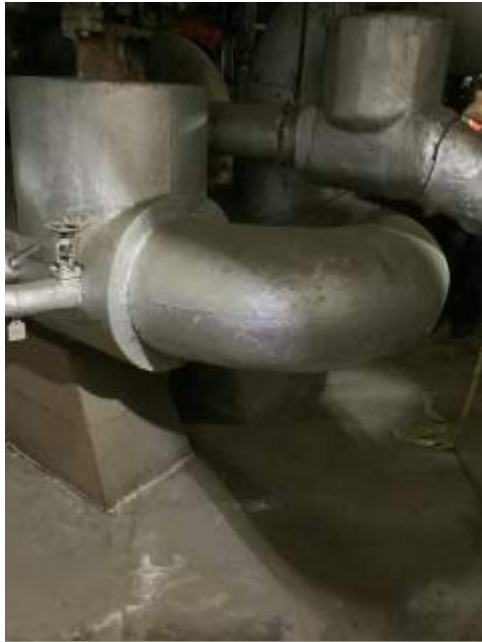
Sample ID:	Sample Type:
4-26-PB-56	PB
Sample Location:	Detailed Sample Location:
Room 11	Silver pipe wrap southeast corner of room.
Sample Quantity:	N/A
Sample Color:	XRF:
Silver	ND

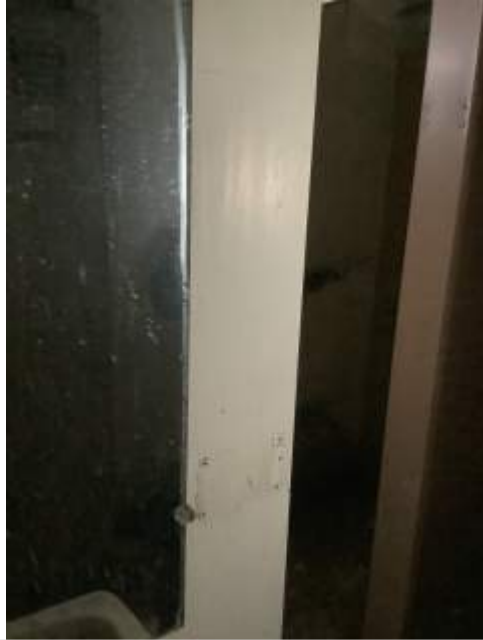
Sample ID:	Sample Type:
4-27-PB-62	PB
Sample Location:	Detailed Sample Location:
Room 15	East side of center wall of room next to mirror.
Sample Quantity:	N/A
Sample Color:	XRF:
Tan	0.008

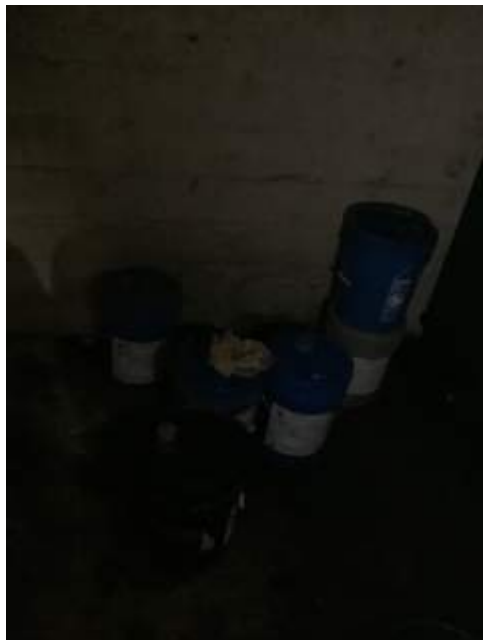
General Fixture Location:	Detailed Fixture Location:
Room 15	Throughout room.
Type of Fixture:	Quantity:
Mechanical fluid hazard.	Throughout room.
Condition:	Additional Fixture Notes:
Good	Mechanical fluid containers throughout room.

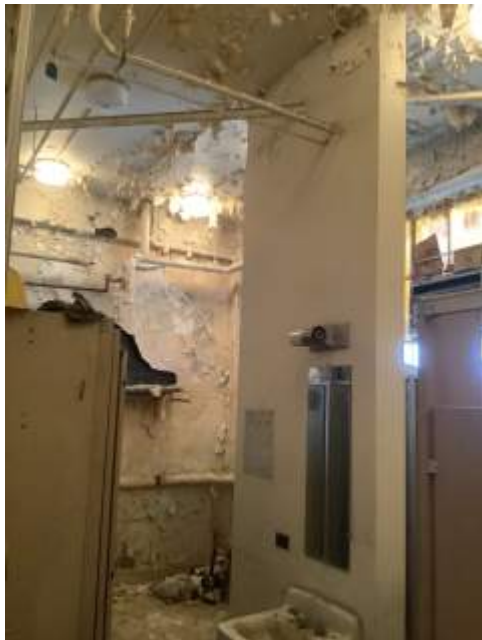
General Fixture Location:	Detailed Fixture Location:
Room 17	Throughout room.
Type of Fixture:	Quantity:
Potential lead paint hazard.	Throughout room.
Condition:	Additional Fixture Notes:
Severely damaged	Paint peeling off walls and ceiling.

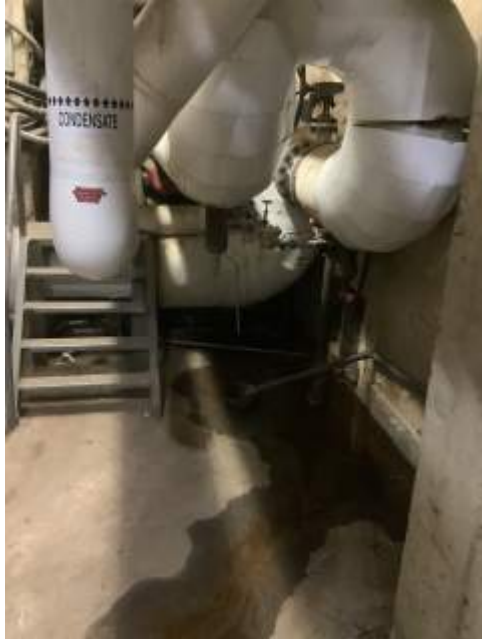
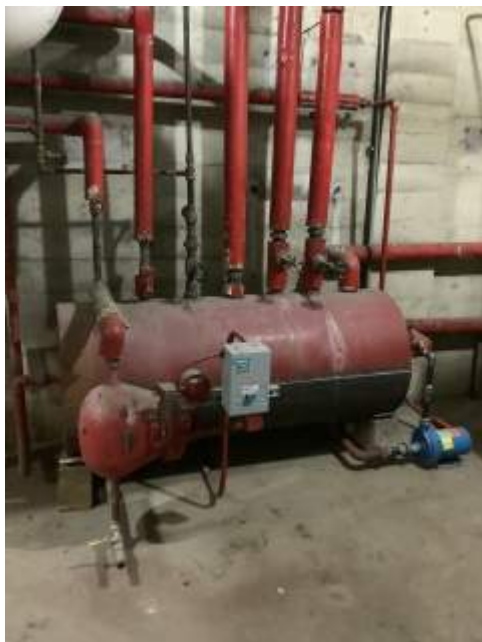
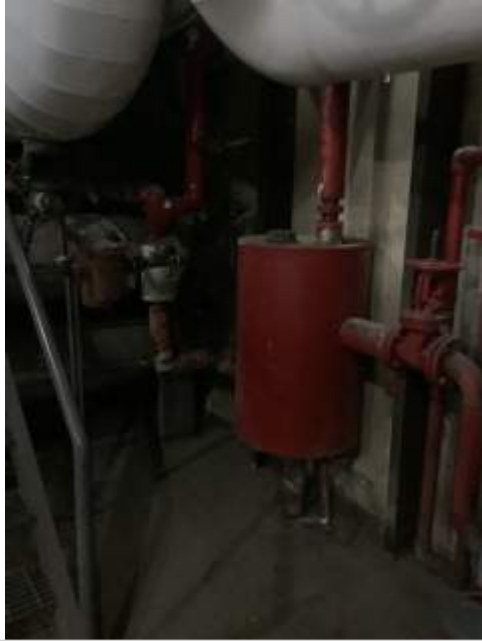
General Fixture Location:	Detailed Fixture Location:
Room 21 and room 23	Throughout rooms.
Type of Fixture:	Quantity:
Hot pipes and tanks.	Several
Condition:	Additional Fixture Notes:
Good	Burn hazard from hot pipes and tanks.

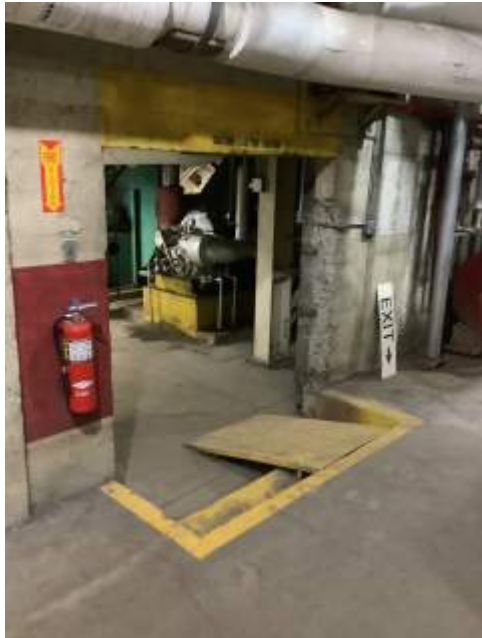
General Fixture Location:	Detailed Fixture Location:
Room 21	North wall.
Type of Fixture:	Quantity:
Low clearance.	1
Condition:	Additional Fixture Notes:
Good	Low ceiling hazard.

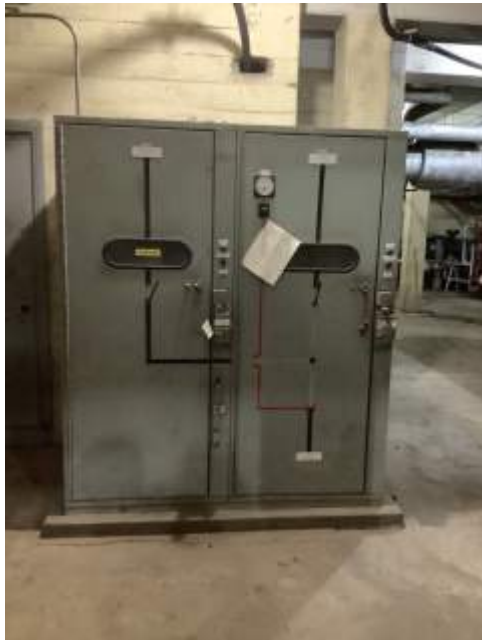
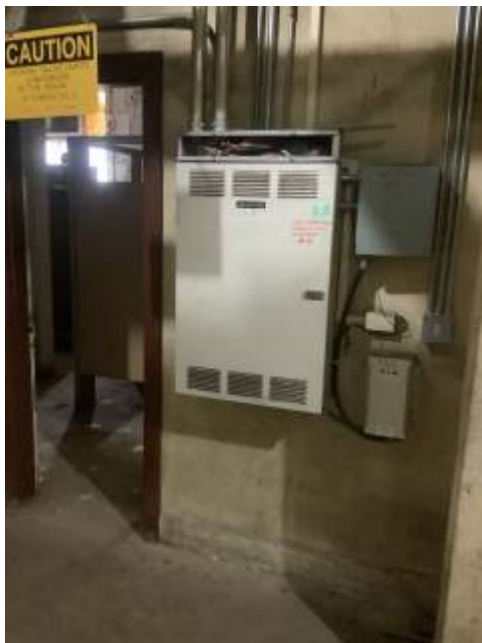
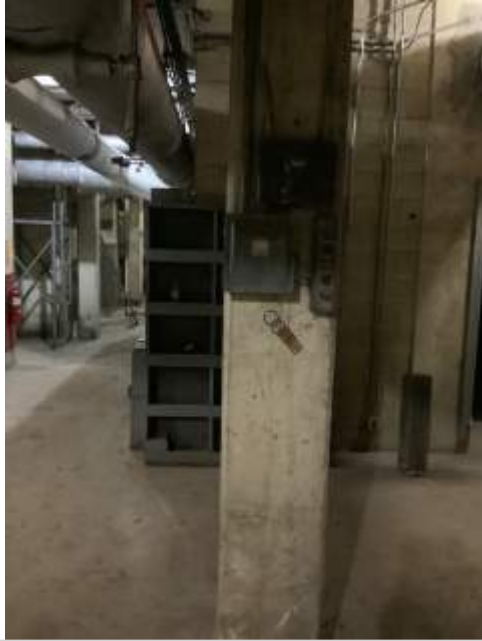
General Fixture Location:	Detailed Fixture Location:
Room 21	Throughout room.
Type of Fixture:	Quantity:
Electrical hazard.	3
Condition:	Additional Fixture Notes:
Good	1 electric source control unit, 1 electrical control panel, 1 electrical switch box.

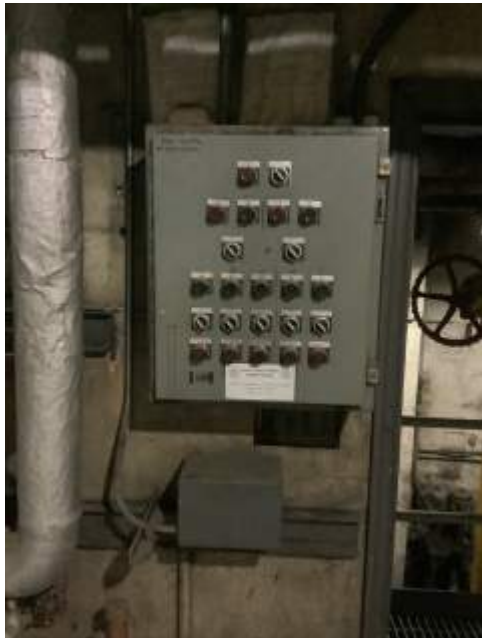
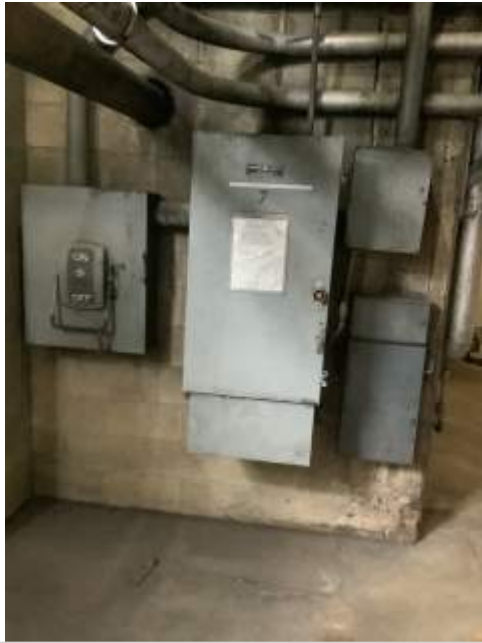
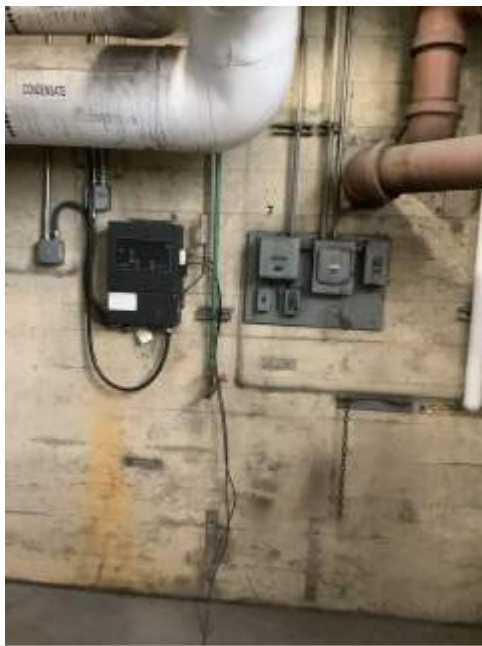
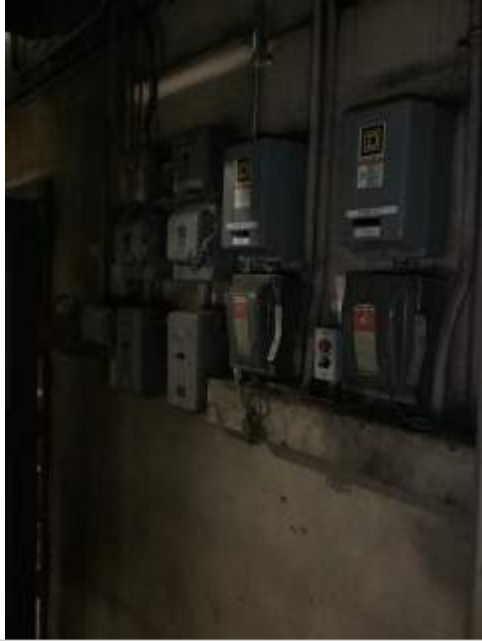
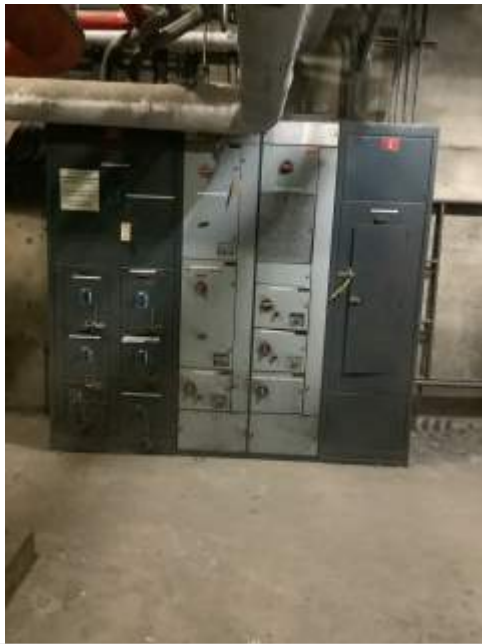
General Fixture Location:	Detailed Fixture Location:
Room 11	Throughout room.
Type of Fixture:	Quantity:
Electrical fixtures.	25
Condition:	Additional Fixture Notes:
Good	1 control box, 20 control switch, 3 electrical boxes, 1 motor control center.

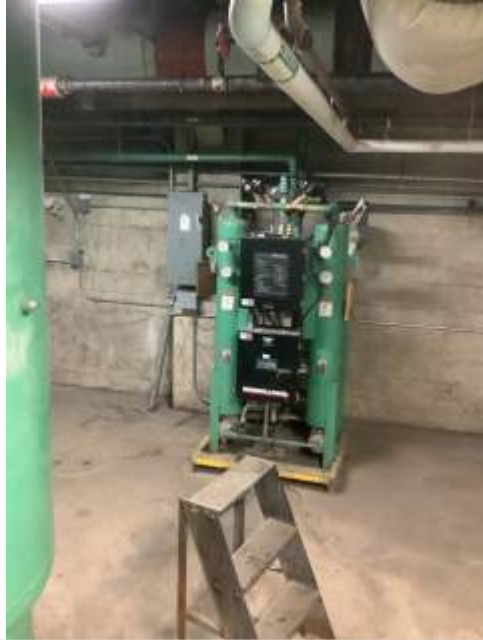
General Fixture Location:	Detailed Fixture Location:
Room 11	North side of room.
Type of Fixture:	Quantity:
Active steam equipment.	Several
Condition:	Additional Fixture Notes:
Good	Active tanks, pumps, and lines.

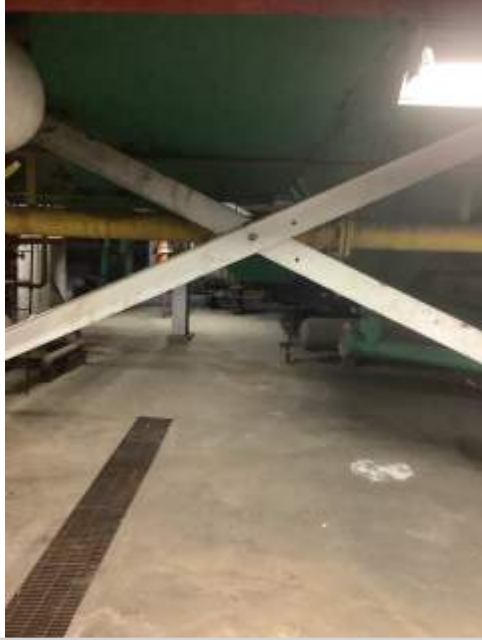
General Fixture Location:	Detailed Fixture Location:
Room 11	Throughout room.
Type of Fixture:	Quantity:
Low clearance.	Several
Condition:	Additional Fixture Notes:
Good	Low pipes and supports.

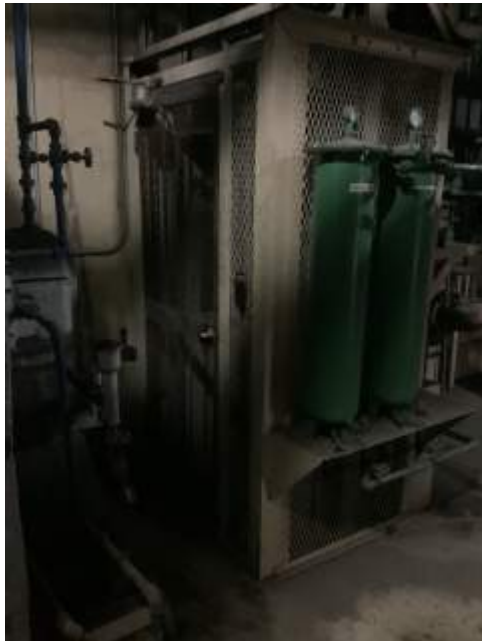
General Fixture Location:	Detailed Fixture Location:
Room 11	East side of room.
Type of Fixture:	Quantity:
Elevator shaft.	1
Condition:	Additional Fixture Notes:
Good	Potential hazard related to mechanical operation.

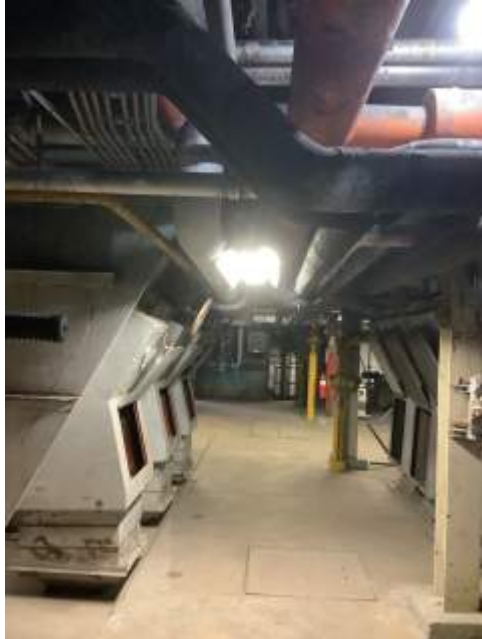
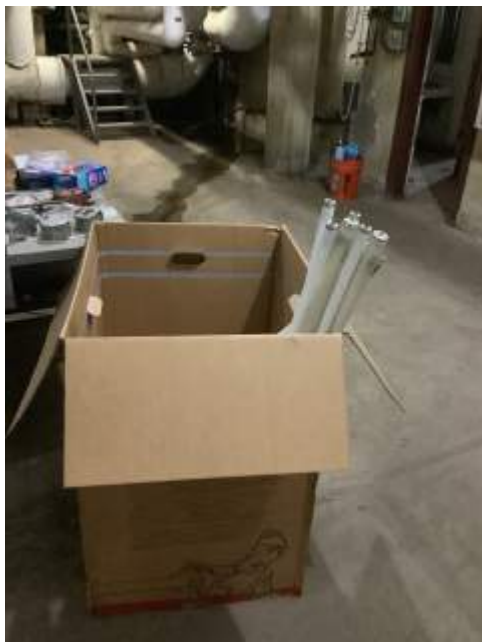
General Fixture Location:	Detailed Fixture Location:
Room 11, 21, 23	Throughout rooms.
Type of Fixture:	Quantity:
Fluorescent light fixtures.	43
Condition:	Additional Fixture Notes:
Good	34 lights in place and active, 9 in box in room 21.

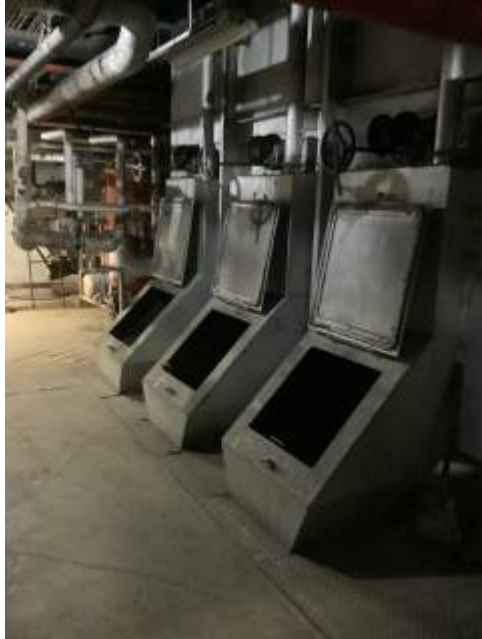
General Fixture Location:	Detailed Fixture Location:
Room 11	Throughout room.
Type of Fixture:	Quantity:
Steam equipment.	Several
Condition:	Additional Fixture Notes:
Good	Mechanical fluid hazard related to inactive and active equipment.

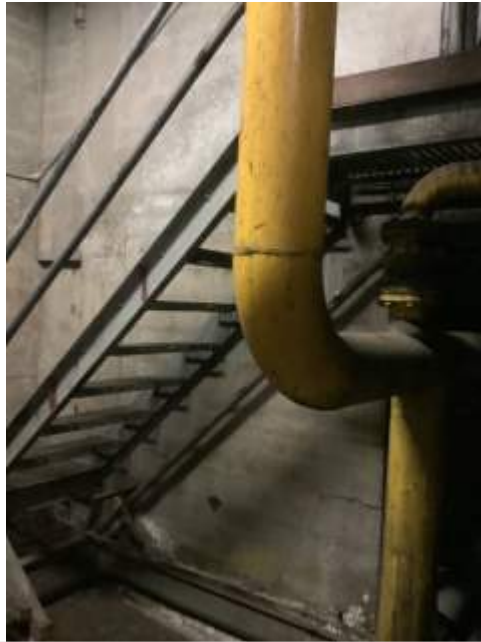
Sample ID:	Sample Type:
5-1-PB-1	PB
Sample Location:	Detailed Sample Location:
Room B1	West hall entrance.
Sample Quantity:	110 linear feet.
Sample Color:	XRF:
Yellow	0.023
