FOCUSED SITE ASSESSMENT REPORT

COLLEGE AVENUE STEAM PLANT
PULLMAN, WASHINGTON

Prepared for
PORT OF WHITMAN COUNTY
March 30, 2022
Project No. M0457.02.003

Prepared by
Maul Foster & Alongi, Inc.
601 East Front Ave., Suite 202, Coeur d'Alene, ID 83814

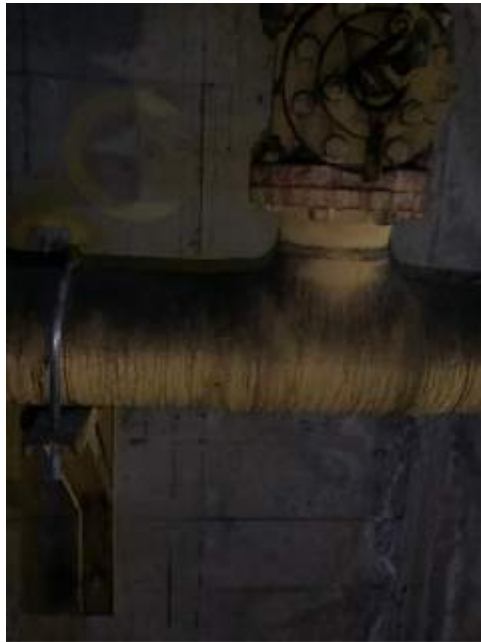
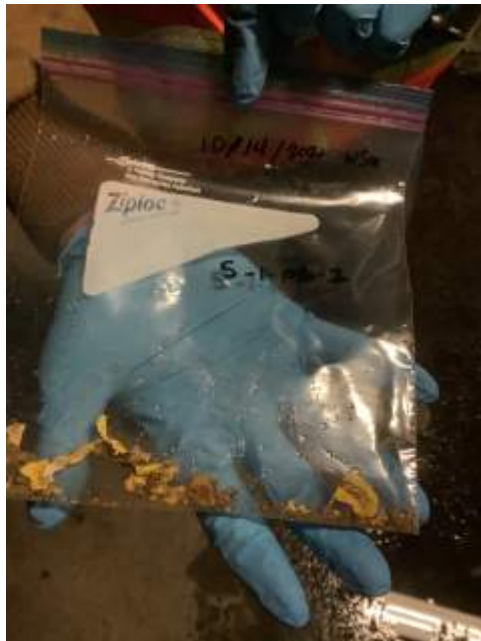
Sample ID:	Sample Type:
5-1-PB-2	PB
Sample Location:	Detailed Sample Location:
Room B1	Center of hallway.
Sample Quantity:	110 linear feet.
Sample Color:	XRF:
Yellow	ND

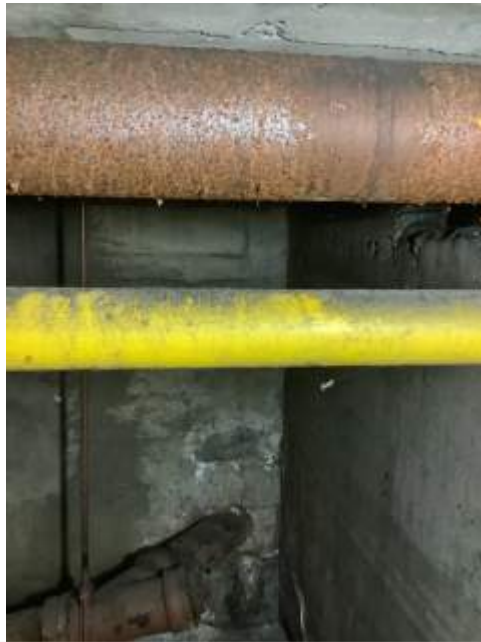
Sample ID:	Sample Type:
5-1-PB-3	PB
Sample Location:	Detailed Sample Location:
Room B1	East end of hallway.
Sample Quantity:	110 linear feet.
Sample Color:	XRF:
Yellow	2.08

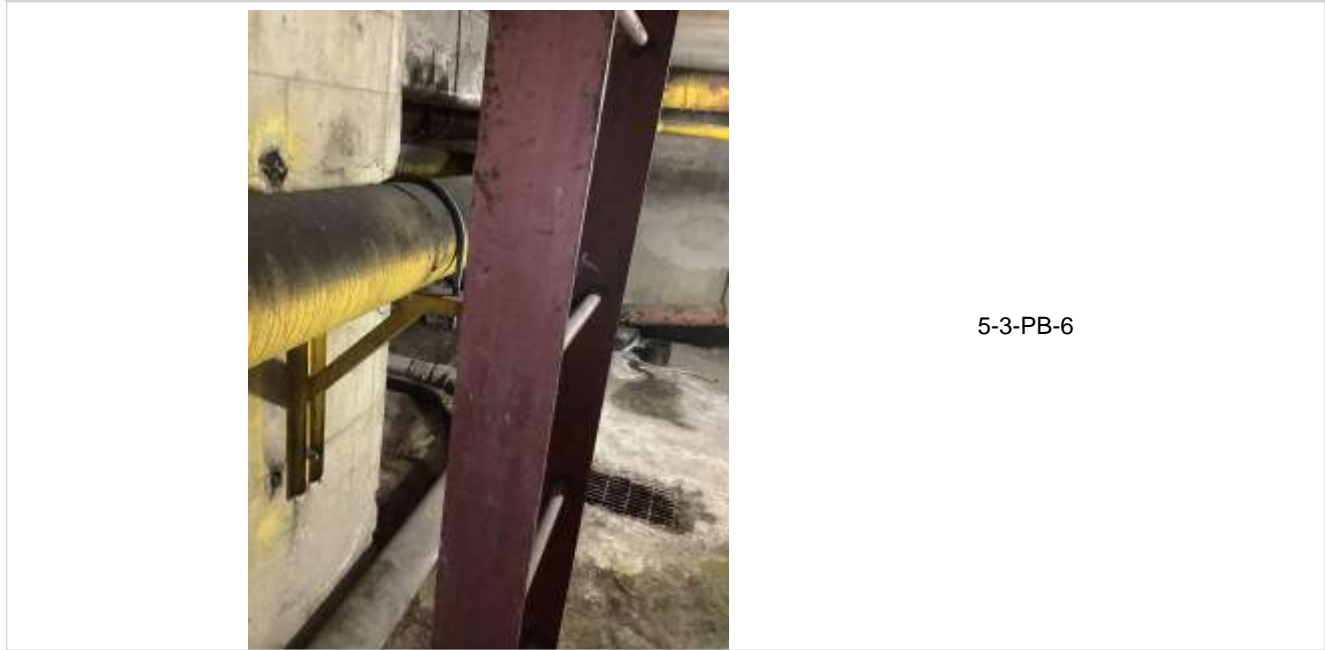
Sample ID:	Sample Type:
5-3-PB-6	PB
Sample Location:	Detailed Sample Location:
Room B1	East end in the center of hall.
Sample Quantity:	N/A
Sample Color:	XRF:
Brown	ND

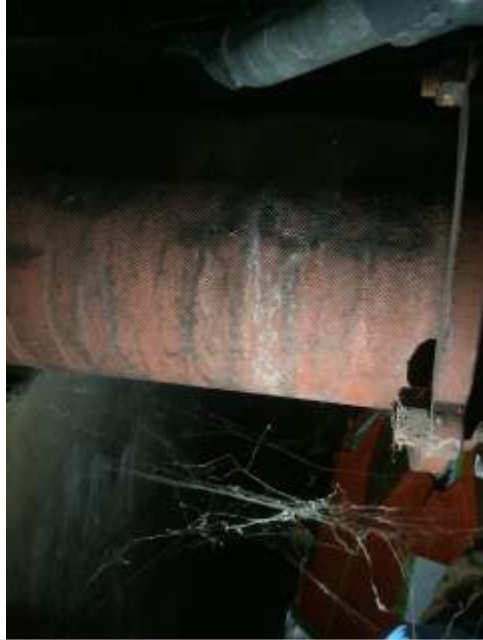
Sample ID:	Sample Type:
5-4-PB-7	PB
Sample Location:	Detailed Sample Location:
Room B1	Center of hallway.
Sample Quantity:	N/A
Sample Color:	XRF:
Reddish brown	ND

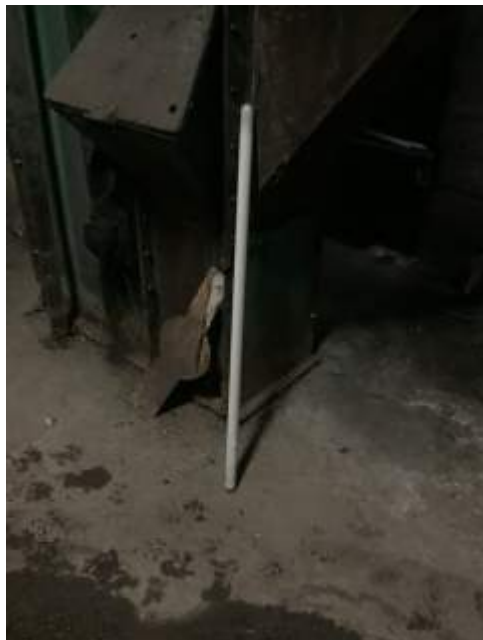
General Fixture Location:	Detailed Fixture Location:
Room B1	Southeast corner of room.
Type of Fixture:	Quantity:
Fluorescent bulbs.	3
Condition:	Additional Fixture Notes:
Good

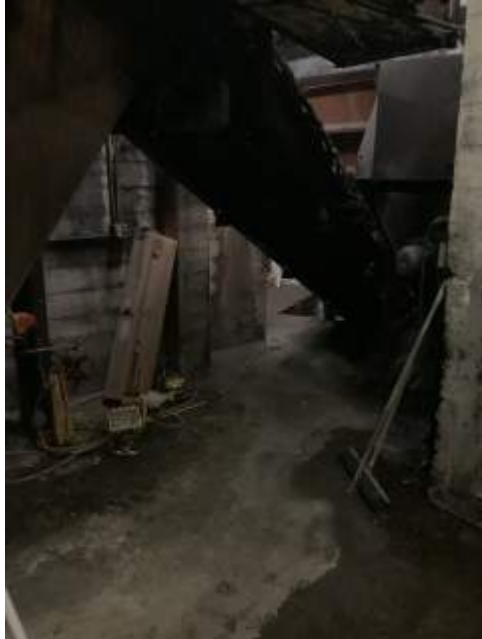
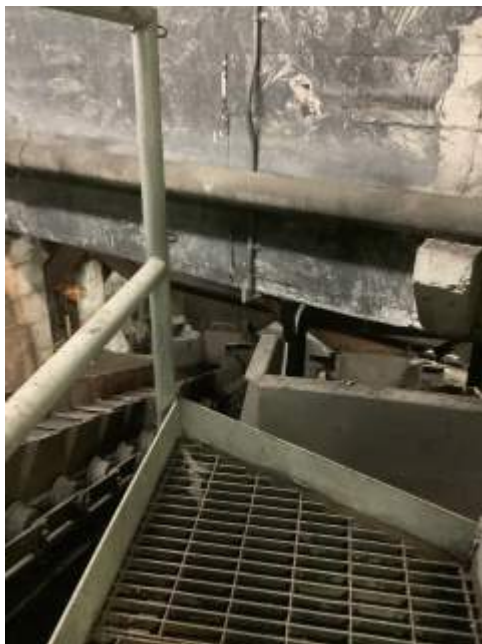
General Fixture Location:	Detailed Fixture Location:
Room B2	Whole room.
Type of Fixture:	Quantity:
Confined space.	1
Condition:	Additional Fixture Notes:
Good	Confined space hazard in room B2.

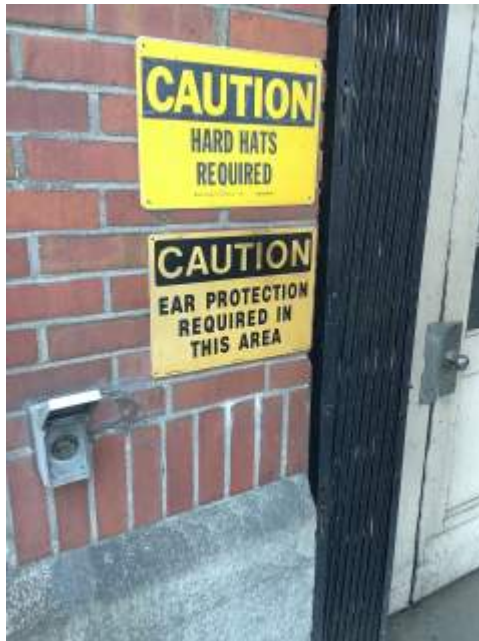
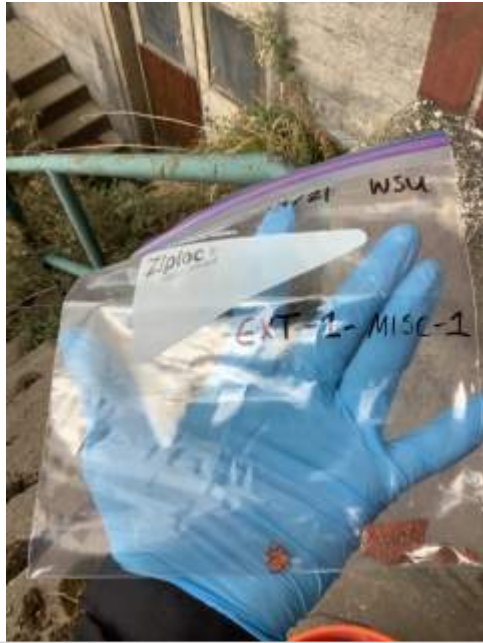
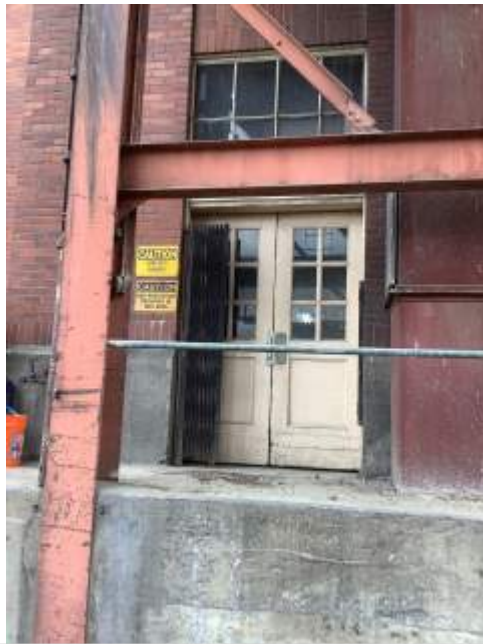
Sample ID:	Sample Type:	
EXT-1-MISC-1	MISC	
Sample Location:	Detailed Sample Location:	
West exterior side of structure.	West exterior side of room 101 north of double doors next to ash pit tower.	
Sample Quantity:	15,000 square feet.	
Misc Sample Material:	Sample Condition:	Sample Friable?:
Red brick	Potential ACBM with potential for damage; Remaining friable ACBM or friable suspected ACBM	No

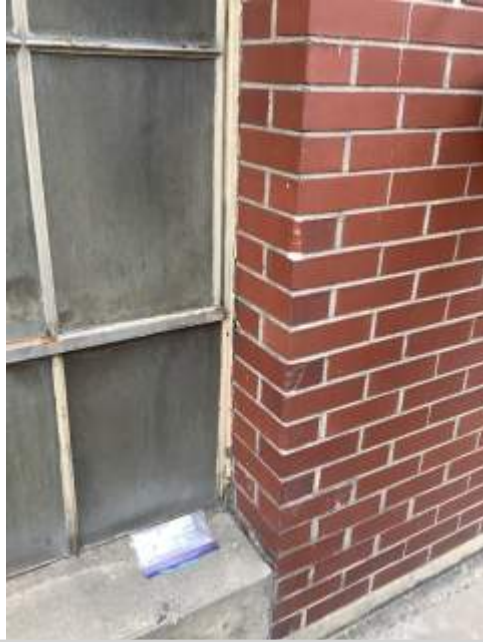
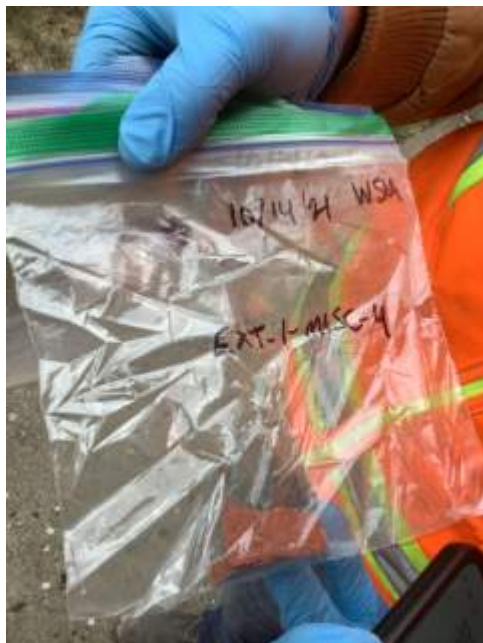
Additional Sample Notes:		Difficult to quantify material.
Sample ID:	Sample Type:	
EXT-1-MISC-4	MISC	
Sample Location:	Detailed Sample Location:	
East exterior side of structure.	East exterior side of room 101 south of stairwell exit door and north of windows.	
Sample Quantity:	15,000 square feet.	
Misc Sample Material:	Sample Condition:	Sample Friable?:
Red brick	Potential ACBM with potential for damage	No
Sample Photo:

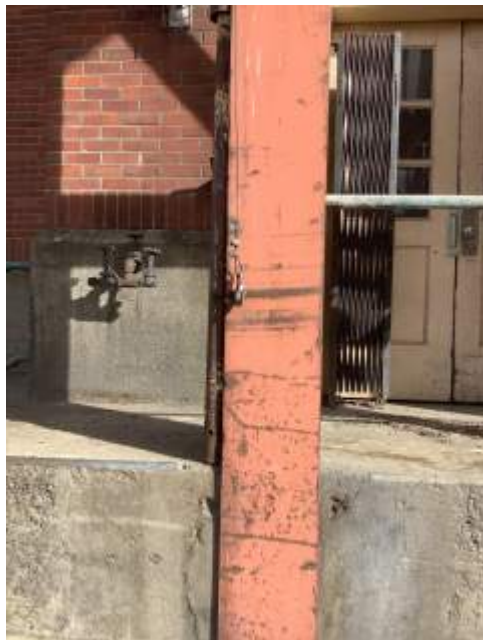
Additional Sample Notes:	Submitted sample to laboratory for analysis.
Sample ID:	Sample Type:
EXT-1-PB-2	PB
Sample Location:	Detailed Sample Location:
West exterior support beams.	Northeast support beam of ash pit outside of room 101.
Sample Quantity:	272 linear feet.
Sample Color:	XRF:
Brownish red	1.15

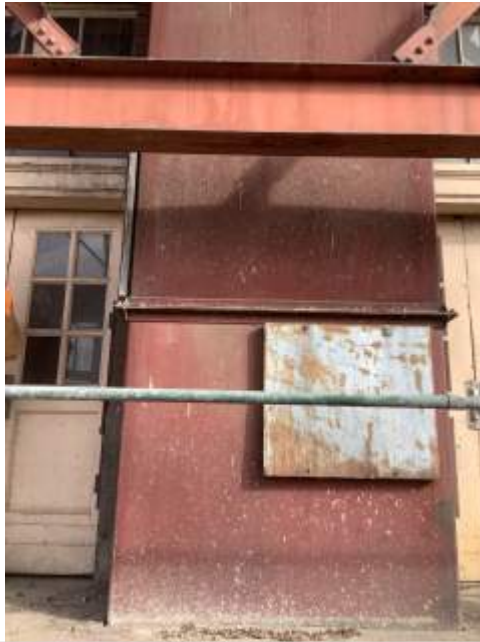
Sample ID:	Sample Type:
EXT-2-PB-3	PB
Sample Location:	Detailed Sample Location:
West exterior side of room 101.	Vent on west exterior side of room 101 in between double doors.
Sample Quantity:	N/A
Sample Color:	XRF:
Dark brown red	0.120

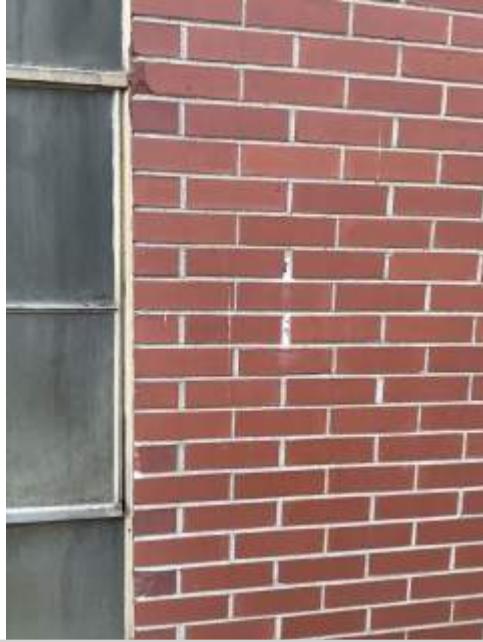
Sample ID:	Sample Type:	
EXT-2-MISC-5	MISC	
Sample Location:	Detailed Sample Location:	
East exterior side of structure.	East exterior side of room 101 south of stairwell exit door and north of windows.	
Sample Quantity:	75,000 linear feet.	
Misc Sample Material:	Sample Condition:	Sample Friable?:
Gray brick mortar	Potential ACBM with potential for damage	No

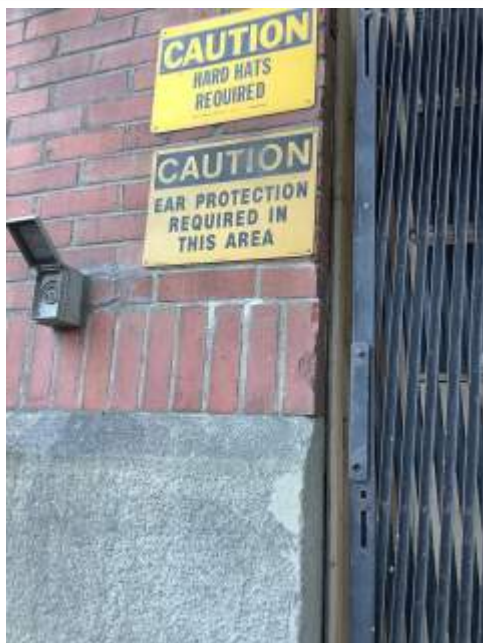
Additional Sample Notes:		Difficult to quantify material.
Sample ID:		Sample Type:
EXT-2-MISC-2		MISC
Sample Location:		Detailed Sample Location:
West exterior side of structure.		West exterior side of room 101 north of double doors next to ash pit tower.
Sample Quantity:		75,000 linear feet.
Misc Sample Material:		Sample Condition:
Gray brick mortar		Potential ACBM with potential for damage
		Sample Friable?:
		No

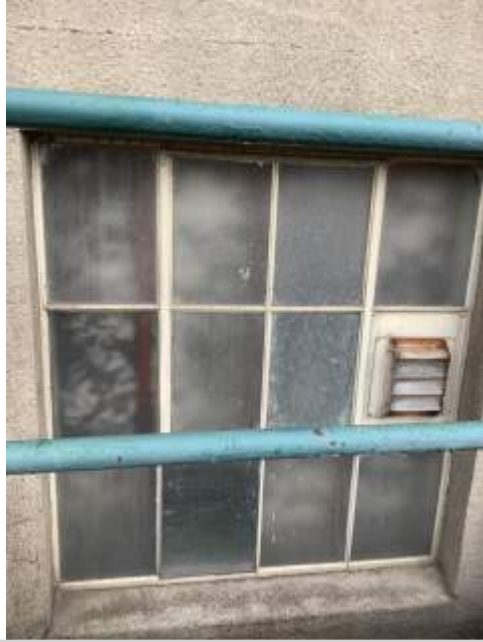
EXT-3-MISC-3

Window glazing.	Potential ACBM with potential for damage	No
-----------------	--	----

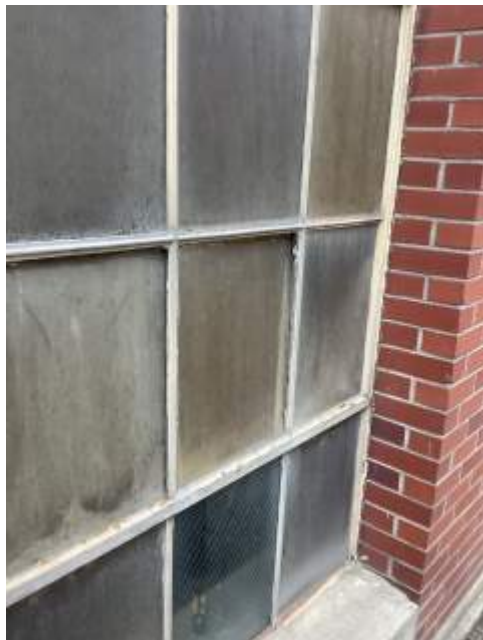
Sample ID:	Sample Type:	
EXT-3-MISC-6	MISC	
Sample Location:	Detailed Sample Location:	
East exterior side of structure.	South window on exterior east wall of room 101.	
Sample Quantity:	4,030 linear feet.	
Misc Sample Material:	Sample Condition:	Sample Friable?:
Window glazing	Potential ACBM with potential for damage	No

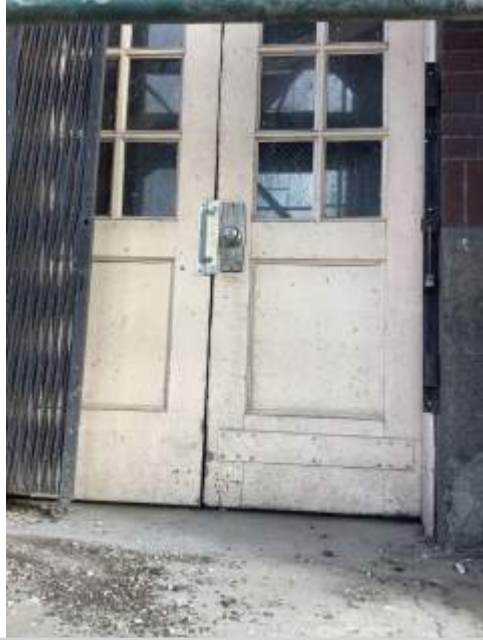
Sample ID:	Sample Type:
EXT-3-PB-4	PB
Sample Location:	Detailed Sample Location:
West exterior side of room 101.	Double doors on west exterior side of room 101.
Sample Quantity:	N/A
Sample Color:	XRF:
Tan	0.058

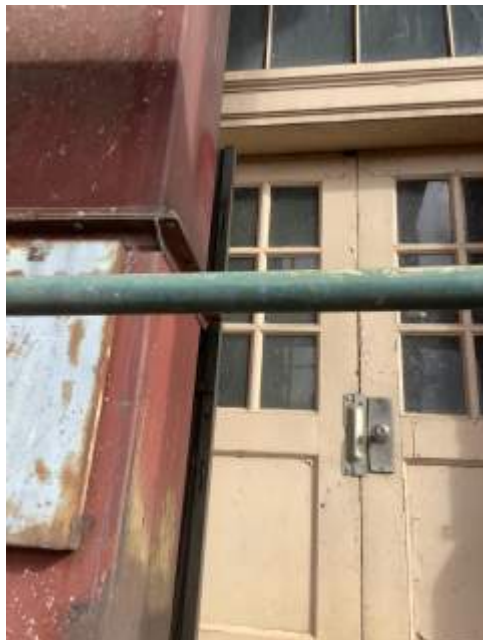
Additional Sample Notes:	
Sample ID:	Sample Type:
EXT-4-PB-5	PB
Sample Location:	Detailed Sample Location:
West exterior side of room 101.	Railing on west exterior side of room 101 in front of double doors.
Sample Quantity:	N/A
Sample Color:	XRF:
Green	0.173

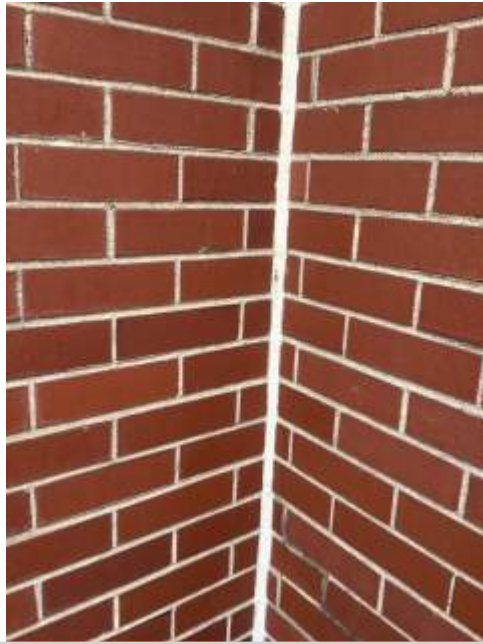
Additional Sample Notes:		
Sample ID:	Sample Type:	
EXT-4-MISC-7	MISC	
Sample Location:	Detailed Sample Location:	
East exterior side of structure.	North corner of east exterior wall of room 101 south of stairwell exit.	
Sample Quantity:	37 linear feet.	
Misc Sample Material:	Sample Condition:	Sample Friable?:
White brick caulking.	Potential ACBM with potential for damage	No

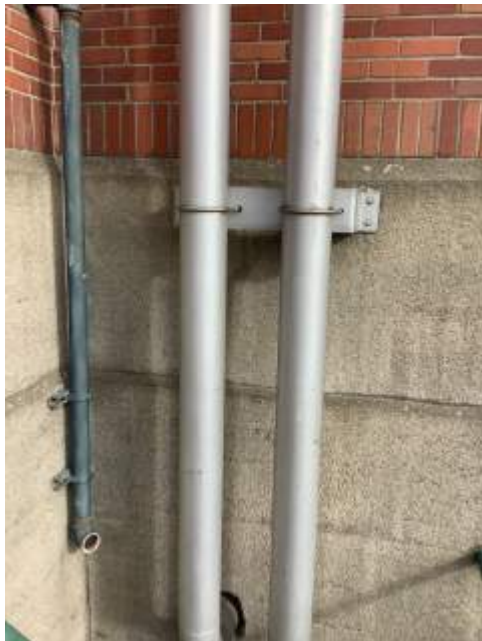
Additional Sample Notes:	
Sample ID:	Sample Type:
EXT-5-PB-6	PB
Sample Location:	Detailed Sample Location:
West exterior side of room 101.	Silver pipe on west exterior side of room 101 and south of double doors.
Sample Quantity:	25 linear feet.
Sample Color:	XRF:
Silver	1.213

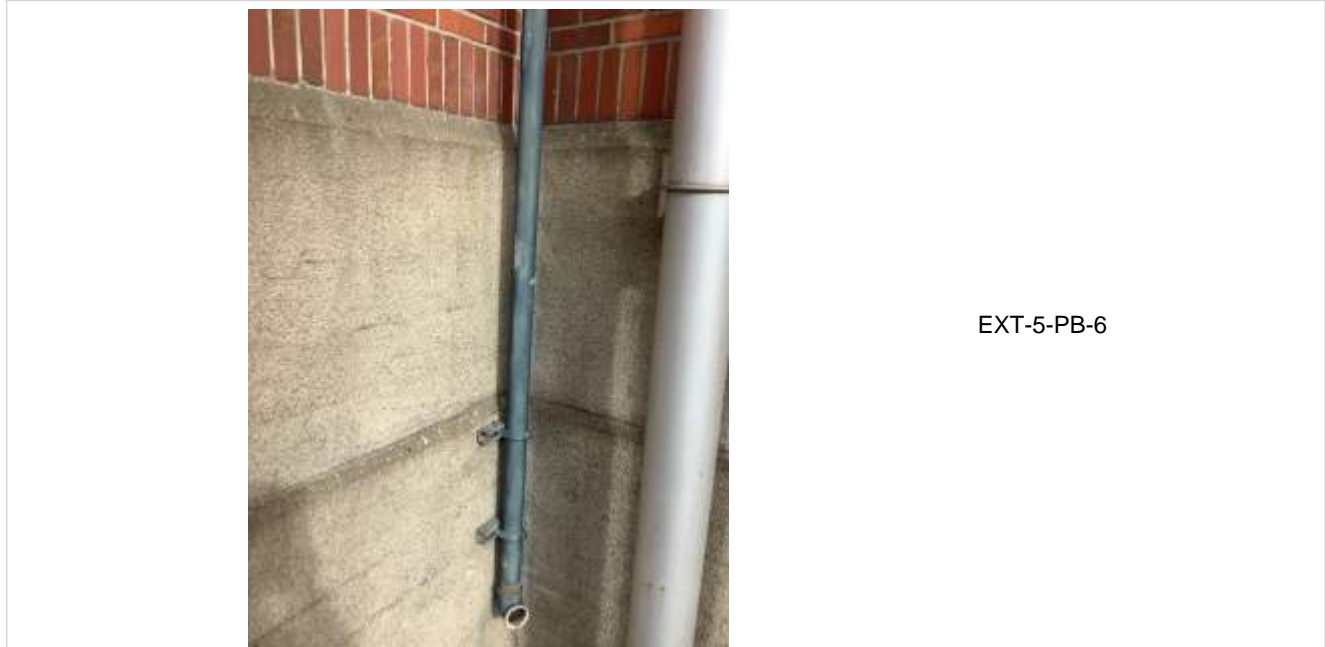
Sample ID:	Sample Type:
EXT-6-PB-7	PB
Sample Location:	Detailed Sample Location:
West exterior side of room 101.	Blue gray pipe in corner of exterior side of room 101 and south of double doors.
Sample Quantity:	25 linear feet.
Sample Color:	XRF:
Blue gray	0.071
