**FINAL REPORT  
INVESTIGATION AND SOIL  
REMEDiation  
DIAMOND TANK TRANSPORT  
PROPERTY  
SEATTLE, WASHINGTON**

**DIAMOND TANK TRANSPORT, INC.  
D&M JOB NO. 38229-001-005  
December 10, 1998**

Final Report  
Subsurface Investigation and Soil Remediation  
Diamond Tank Transport Property  
912 Dexter Avenue North  
Seattle, Washington  
D&M Job No. 38229-001-005

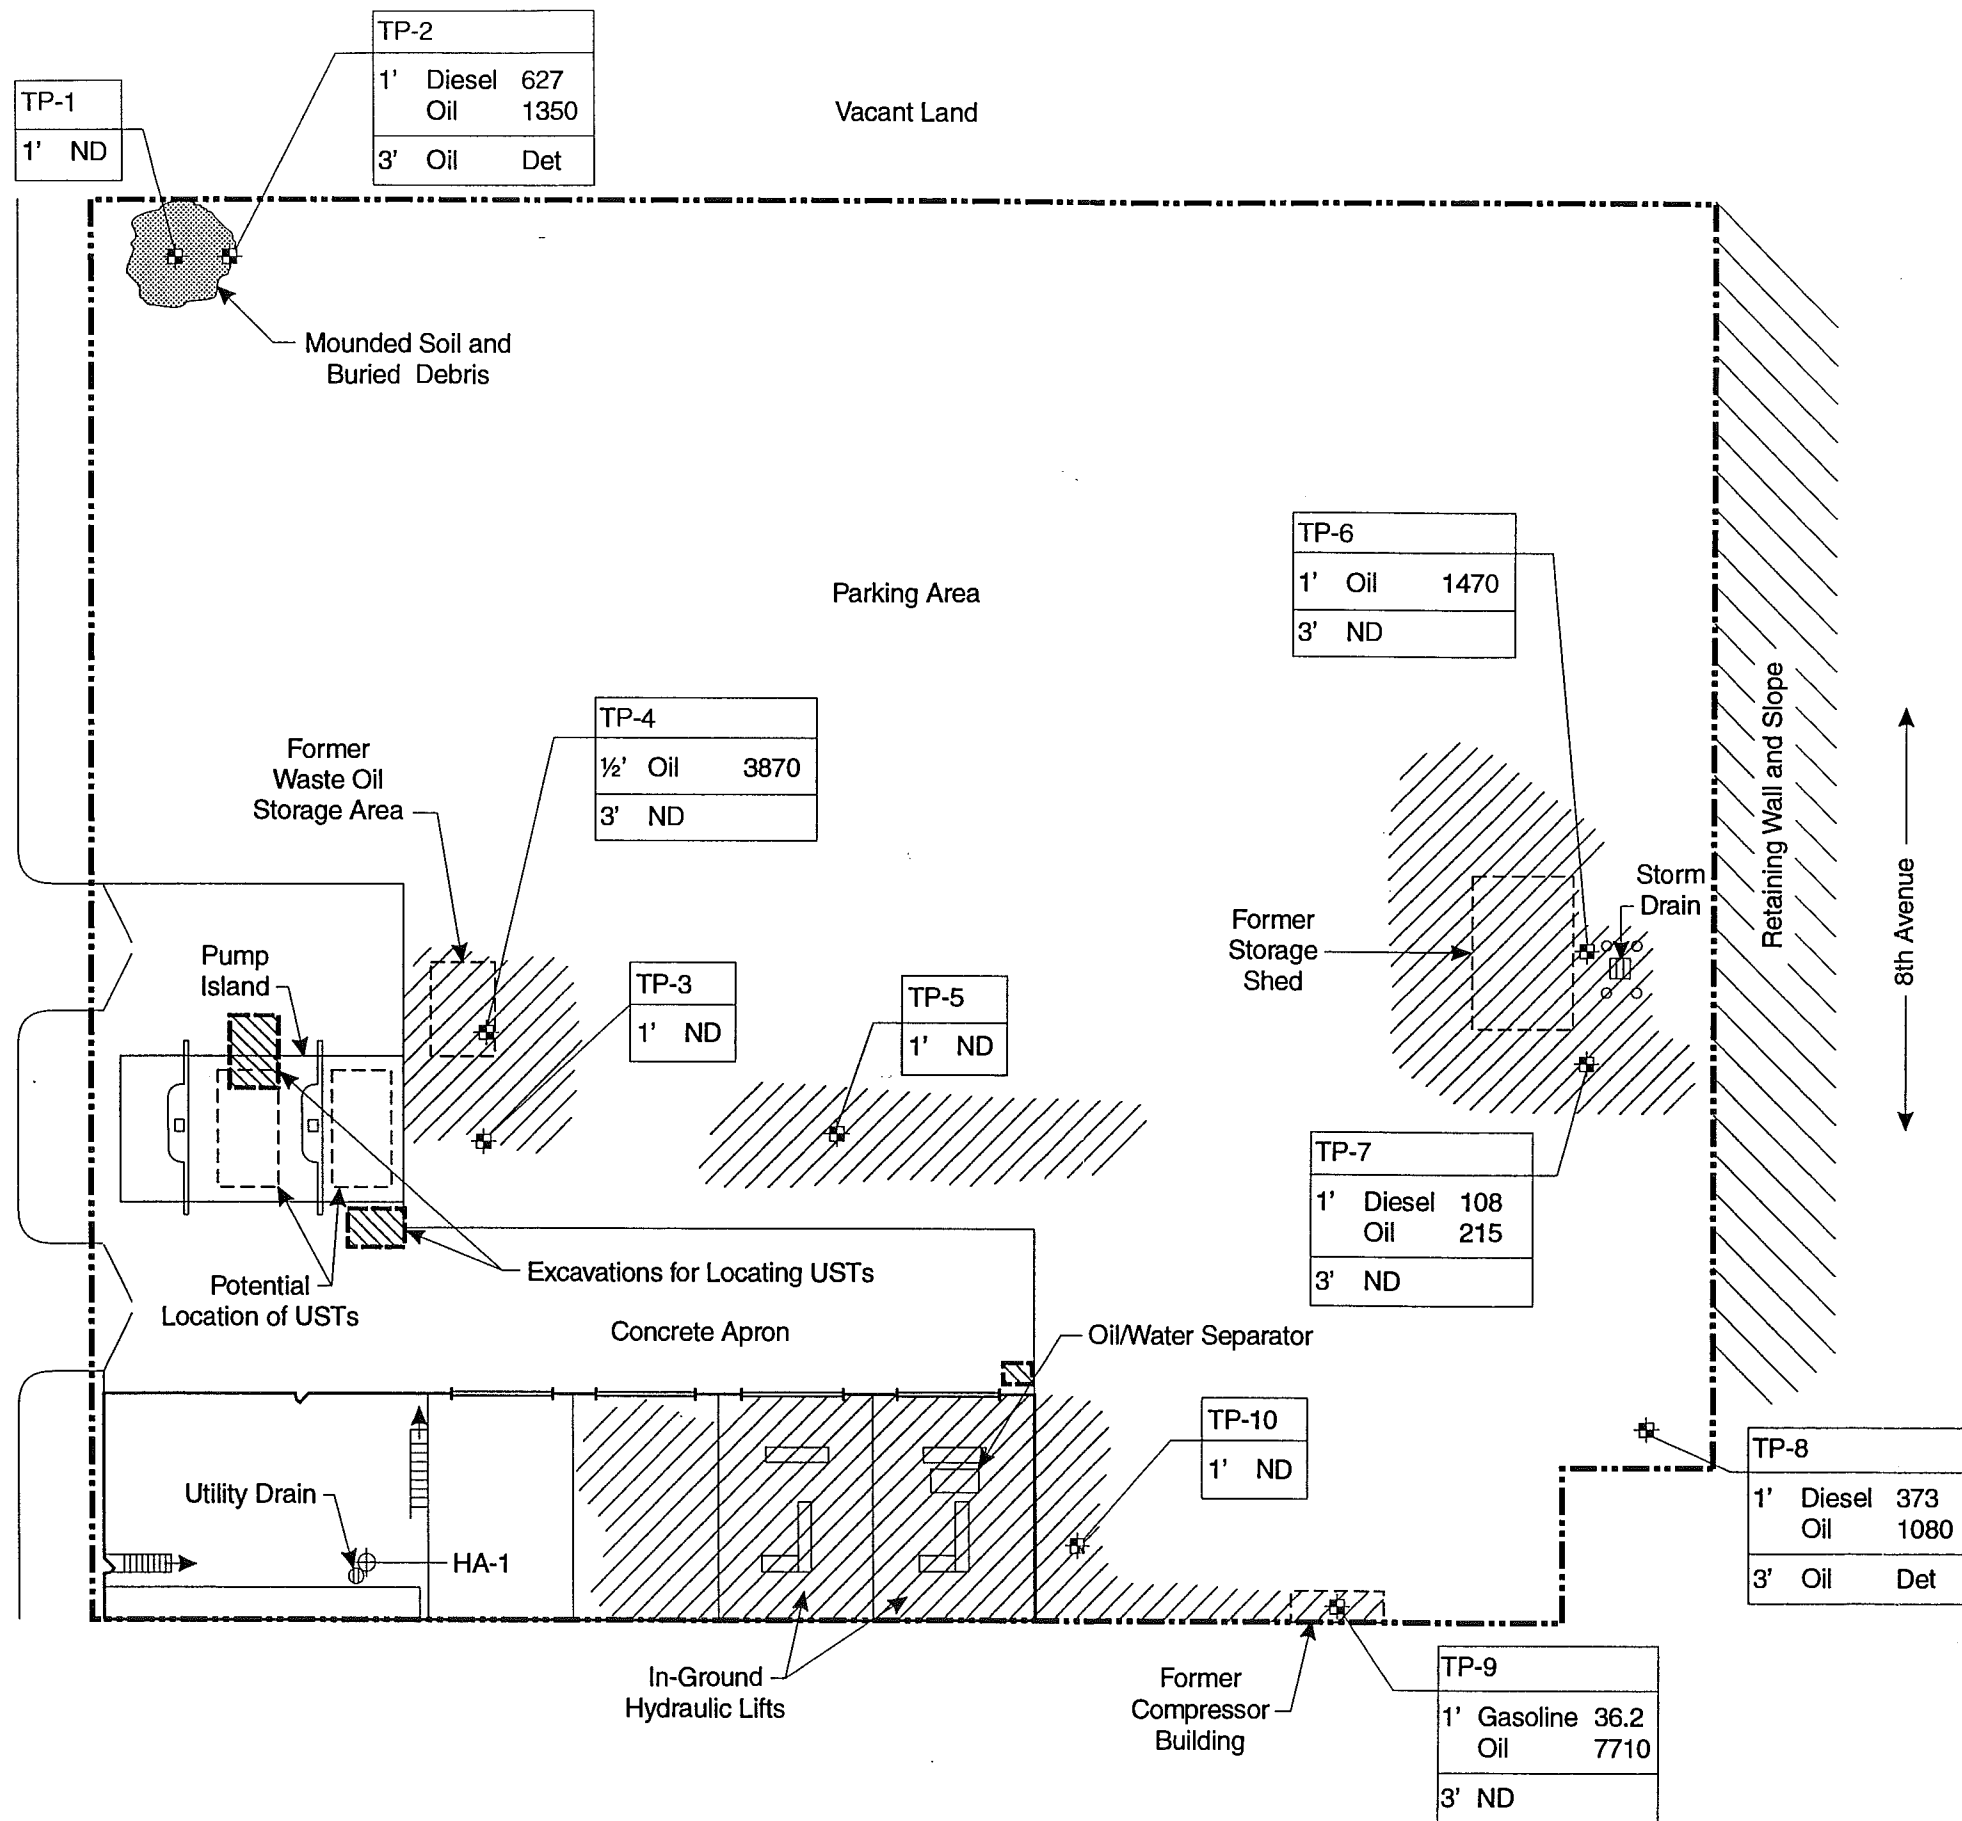
Figure 5  
**SHALLOW SOIL EXCAVATION  
AND SOIL SAMPLE LOCATIONS**

Excavation of the surficial soil was initiated on February 3, 1998 by Ace Contractors. Dames & Moore provided oversight and collected post excavation samples from the base of excavations when it appeared that impacted soil had been removed. The extent of the surficial soil excavations are shown on Figure 5.

Post excavation soil sample locations and analytical results are shown on Figure 5. Results of these samples along with composite samples collected from stockpiled contaminated soil are also summarized in Table 4. Laboratory analytical reports for these samples are provided in Appendix E. Results for four post excavation samples exceeded the Method A soil cleanup levels for petroleum hydrocarbons. Soil in each of these locations was excavated until results of a subsequent post excavation soil sample indicated
