TECHNICAL MEMORANDUM

SUBJECT: 2022 Landfill Cap Inspection

PROJECT NUMBER: 553-1550-067

PROJECT NAME: South Park Landfill Site Coordination

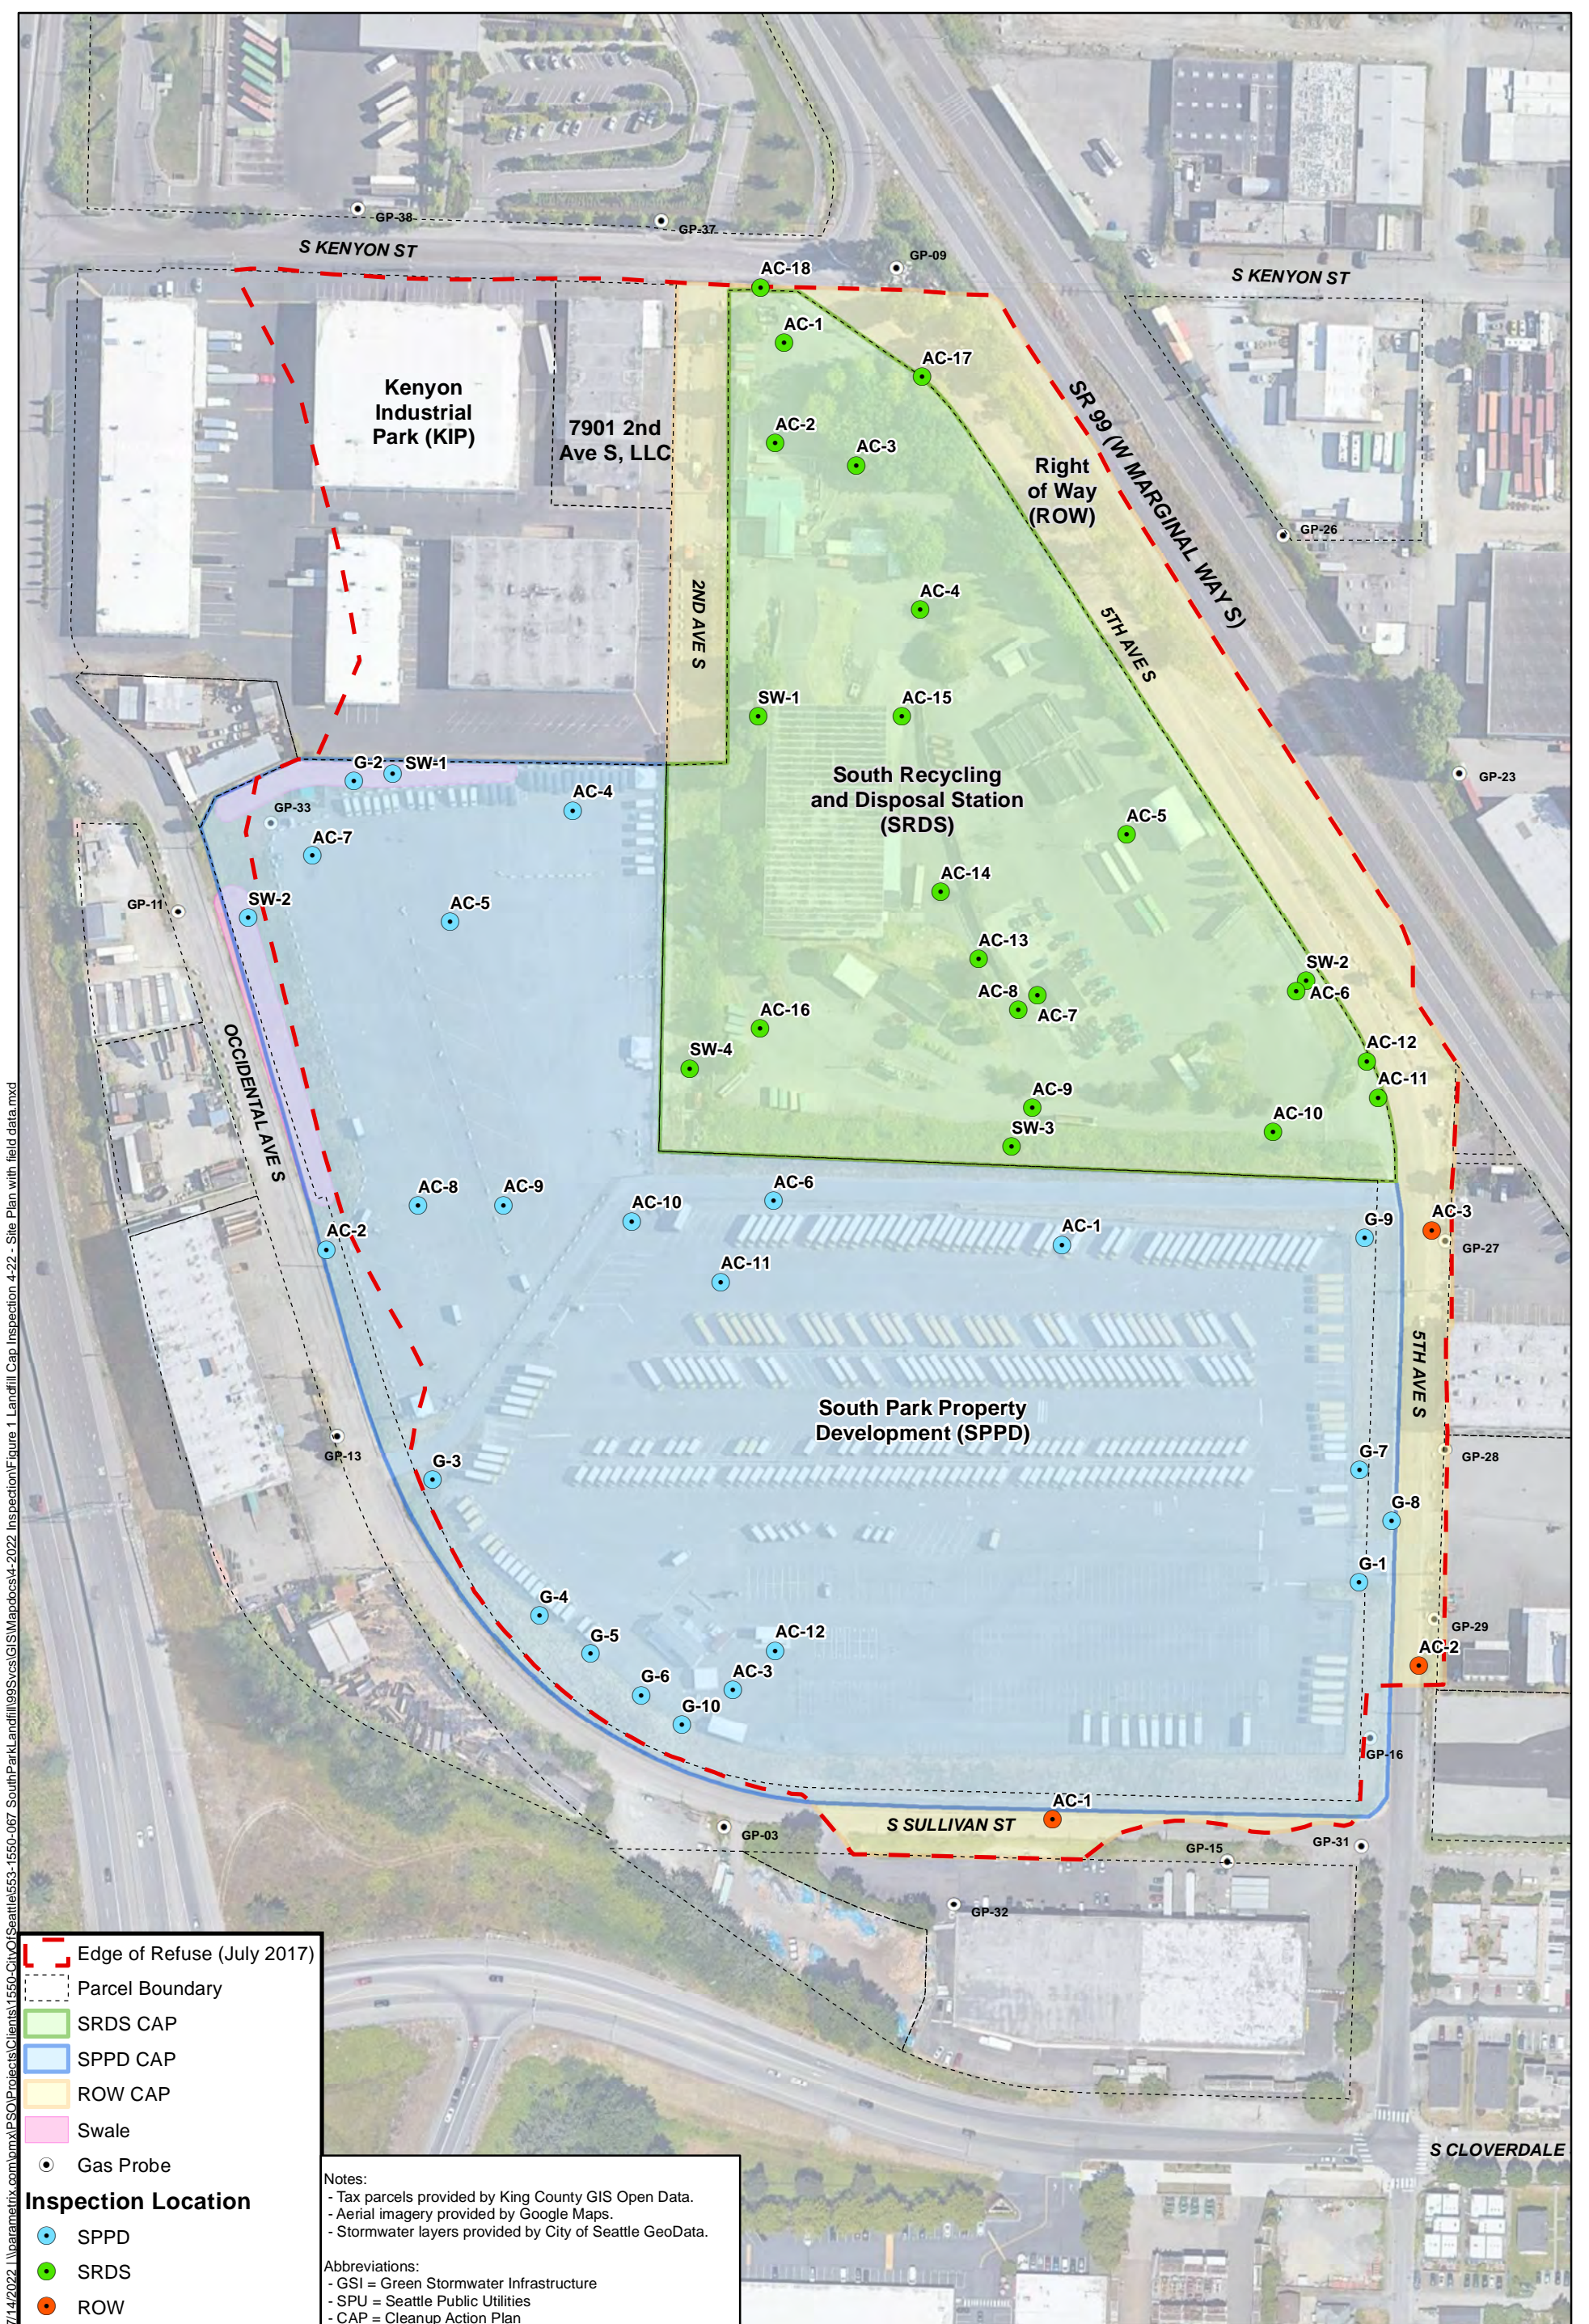
Figure 1
April 20, 2022 Landfill Cap Inspection
Site Plan
 South Park Landfill
 Seattle, WA

Figure 1 shows the SRDS CAP boundary and the locations of concern. The Cap Inspection Checklist Form A was completed for the SRDS property and is included in Attachment A-1.

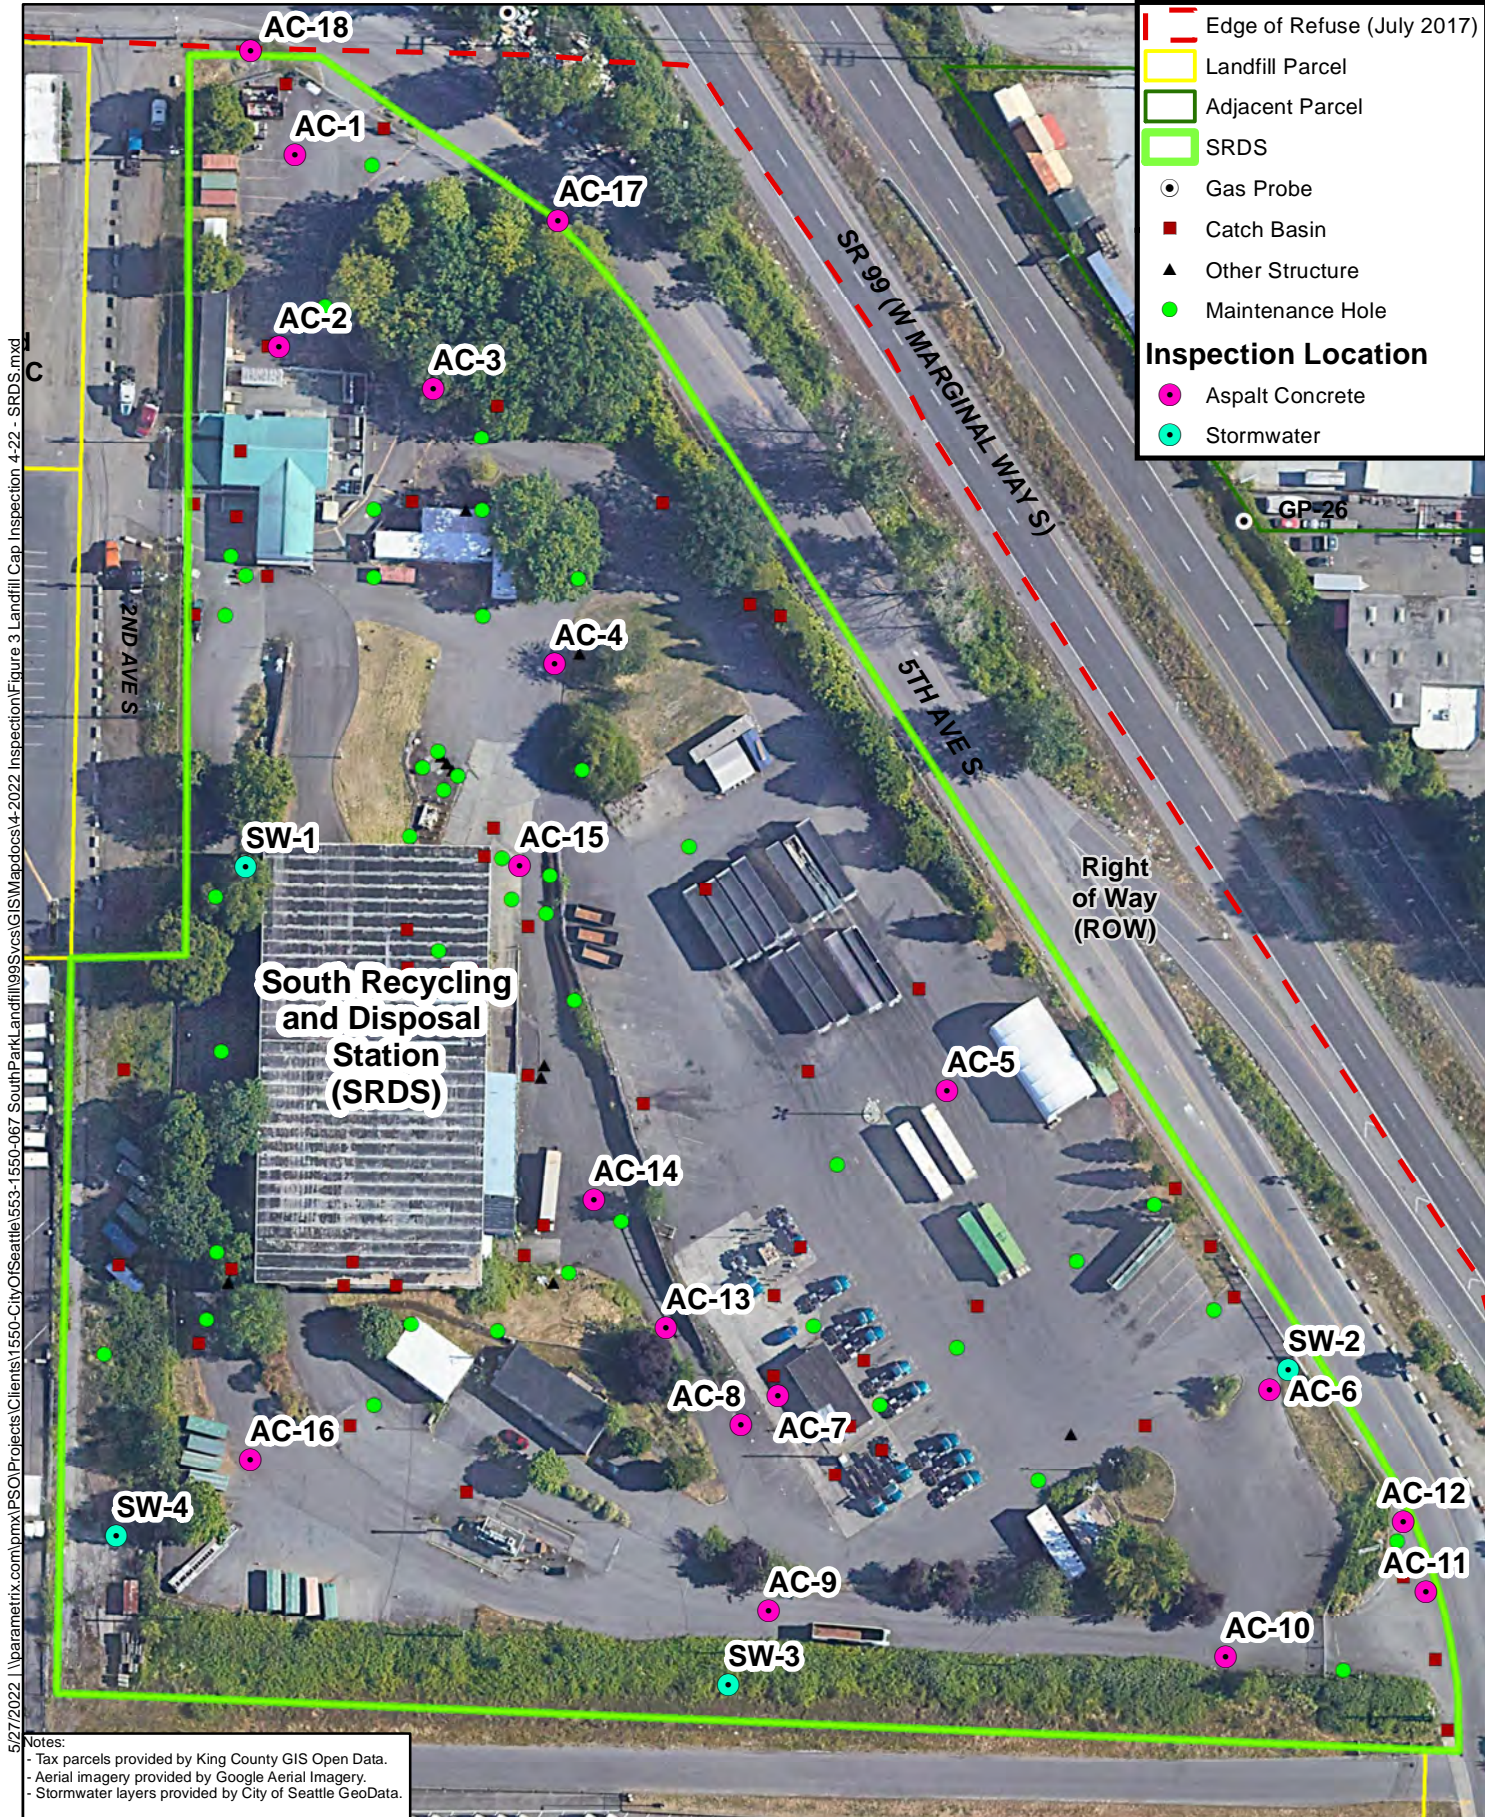
Figure 3
April 20, 2022 Landfill Cap Inspection
SRDS Property
 South Park Landfill
 Seattle, WA

The general property condition was good. Locations on the SRDS property identified in the April 2021 Technical Memorandum were reinspected during this site visit. Pavement cracks and ponding areas remain the primary concerns; however, with the planned redevelopment of the property, temporary pavement restoration is not recommended based on conditions at this time, except at location SRDS AC-2 and SRDS AC-5. Table 2 briefly describes the issue or concern at each location on the SRDS property, status of previous repairs or change of condition if applicable, indicates a recommended action, and proposes a timeline for repairs, maintenance, and/or reinspection. Each location of concern is identified by number in Figures 1, 2, and 5, and corresponding photographs are in Attachment B-1.

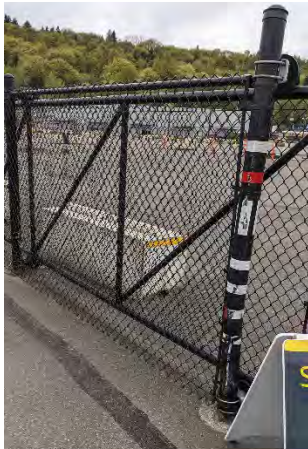
SPPD AC-6: New electric fence

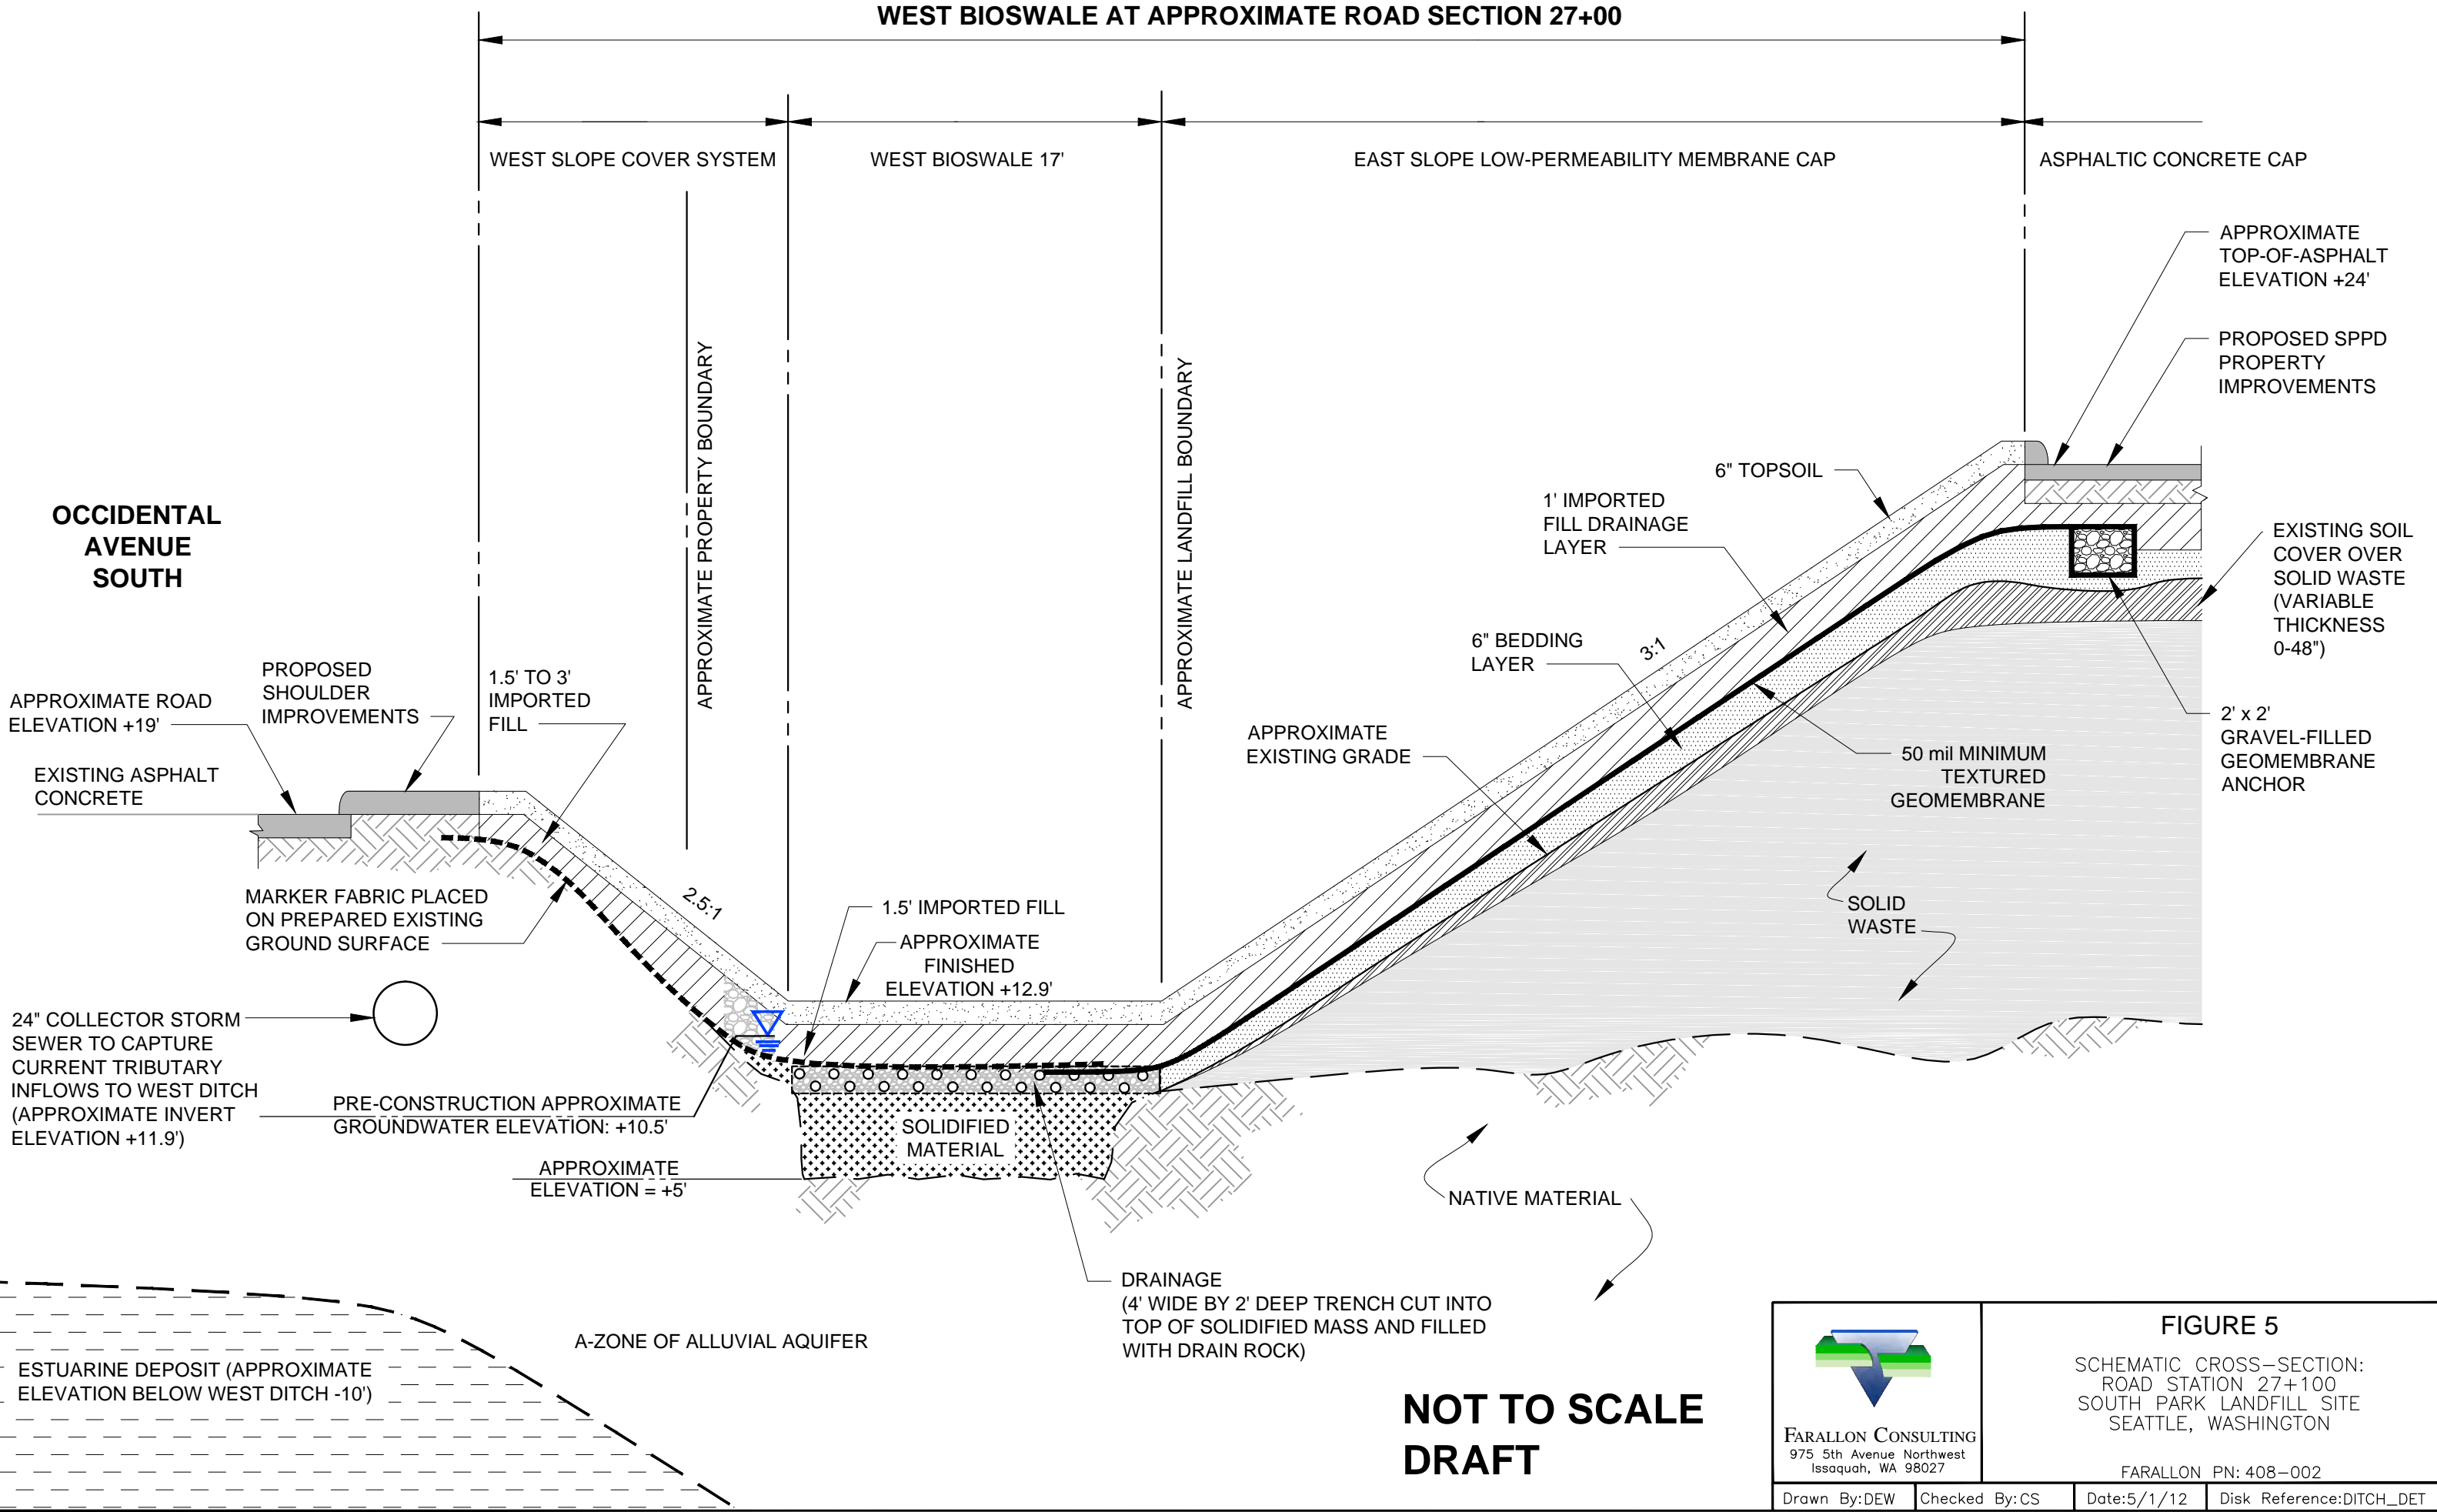
FARALLON CONSULTING 975 5th Avenue Northwest Issaquah, WA 98027	FIGURE 5 SCHEMATIC CROSS-SECTION: ROAD STATION 27+100 SOUTH PARK LANDFILL SITE SEATTLE, WASHINGTON		
	FARALLON PN: 408-002		
Drawn By: DEW	Checked By: CS	Date: 5/1/12	Disk Reference: DITCH_DET

G-4	New grass cover over previously exposed geomembrane	The configuration of the geomembrane and cover at the interface of the parking area does not appear to be in accordance with Figure 5 of the Interim Action Work Plan (IAWP). The geomembrane appears to be directly below the asphalt with no drainage layer or surfacing layer in between. Some locations show evidence of geomembrane damage. Along with Site Coordinator, prepare a plan to reestablish cover over the geomembrane. Most likely, the area should be exposed, and the geomembrane tested for damage before repairs should be made. The crest of slope should then be provided cover to the maximum extent possible considering the existing asphalt and curb configuration.	Exposed geomembrane areas within the work area were covered with 2 to 3 inches of unconsolidated topsoil then heavily seeded. Erosion control measures, which included Jute netting and secured with 6-inch staples, were installed on the steep slopes but not at the top of the hill adjacent to the paved cap. (Maintenance Report 11/2/21)	Improved	Construction documentation should be used to determine how the installation was performed and how to bring the existing location back to design conditions. Currently exposed geomembrane should be cleaned and inspected for cracking or signs of failure. If geomembrane is in good condition, revegetated to the maximum extent practicable and monitored for erosion.	60 days	SPPD will work in coordination with Site Coordinator to establish a solution
