**FINAL SOIL REMEDIATION REPORT  
LYNNWOOD DODGE  
20612 HIGHWAY 99  
LYNNWOOD, WASHINGTON**

**VOLUME I OF II**

**File #11-09664-01**

Subject: Final Soil Remediation Report  
Lynnwood Dodge  
20612 Highway 99  
Lynnwood, Washington

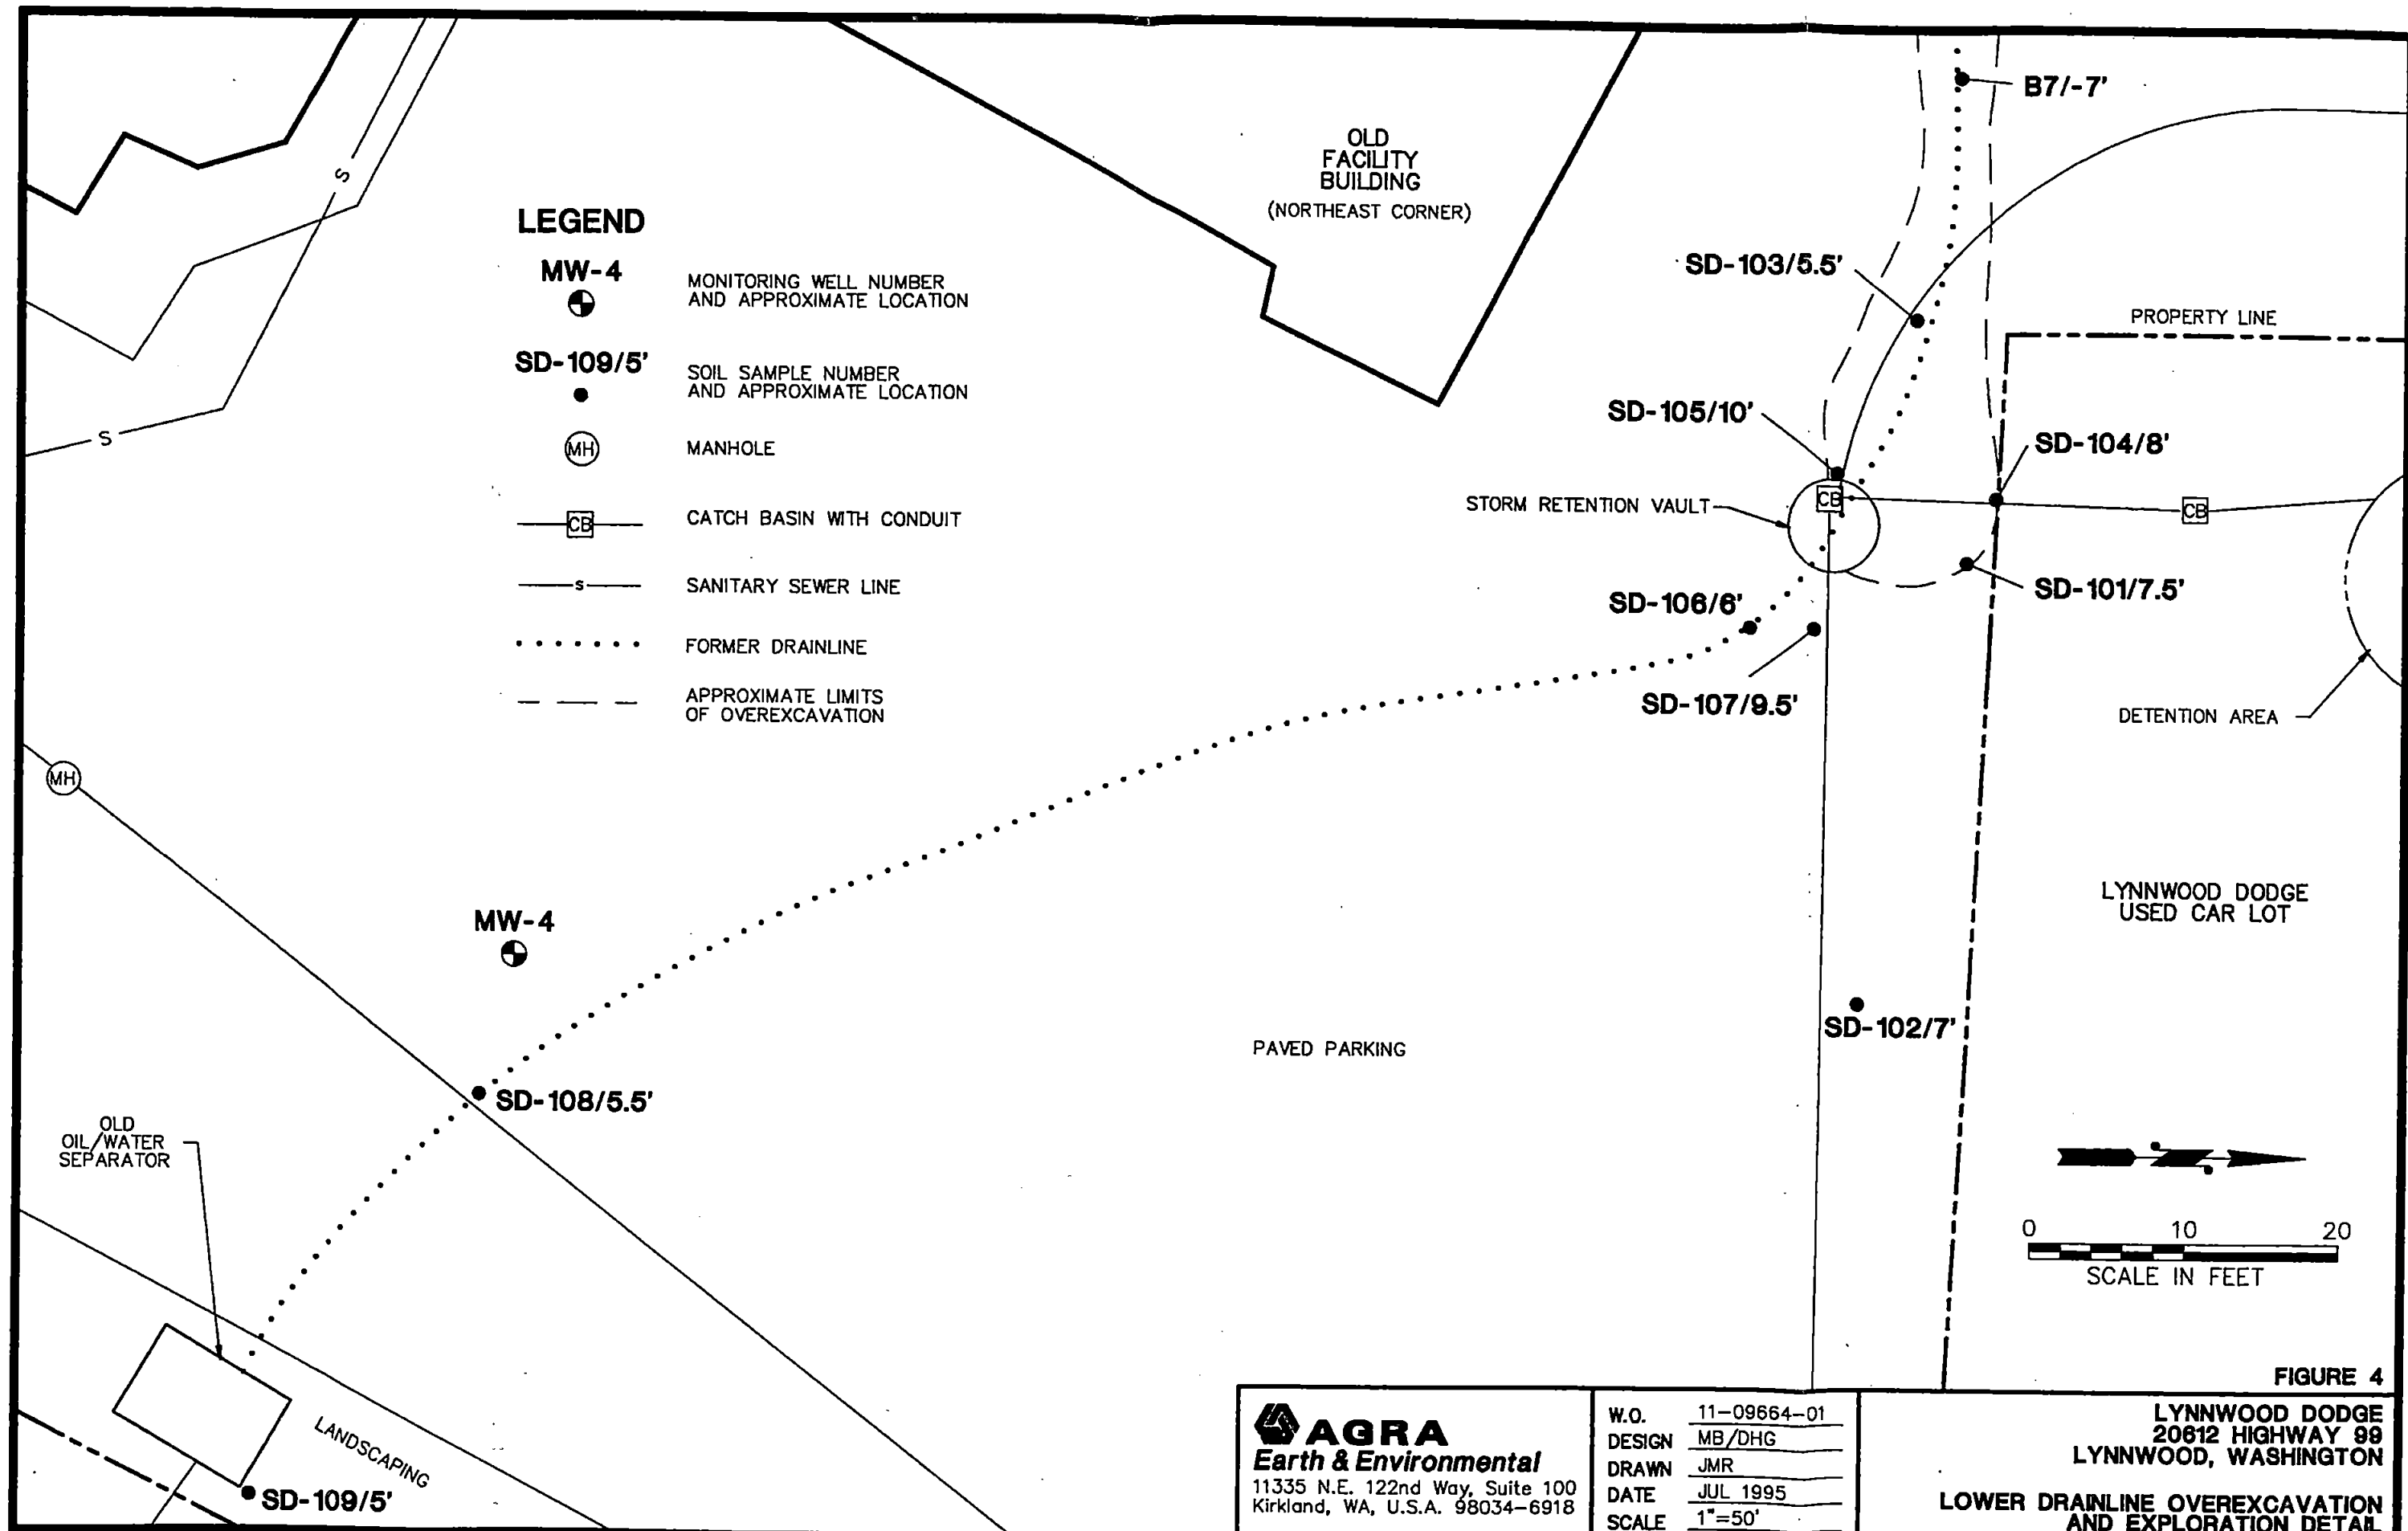
**FIGURE 4**

This trench was shored in order to rout and trace the destination of the drainline. Materials jetted out of the drain were collected by Marine Vacuum Service, and a utility locating contractor traced the jet line as it arced south a distance of approximately 80 feet, in the direction of an old oil/water separator at the edge of the Highway 99 right-of-way. We proceeded to jet out the opposite end of the drainline where it entered the oil/water separator, collecting a mixture of oil and sediment, followed by a muddy mixture of silt, sand and gravel. The jet line was traced northwest for a distance of approximately 25 feet, where it apparently terminated beneath an asphalt patch over a newer storm detention pipe. Another trench was excavated at the end of the trace and on the uphill side of the asphalt patch. At a depth of 5 feet, both the newer storm pipe and the severed drainline were exposed, perpendicular to each other. The location of this intersection is shown on Figure 4.

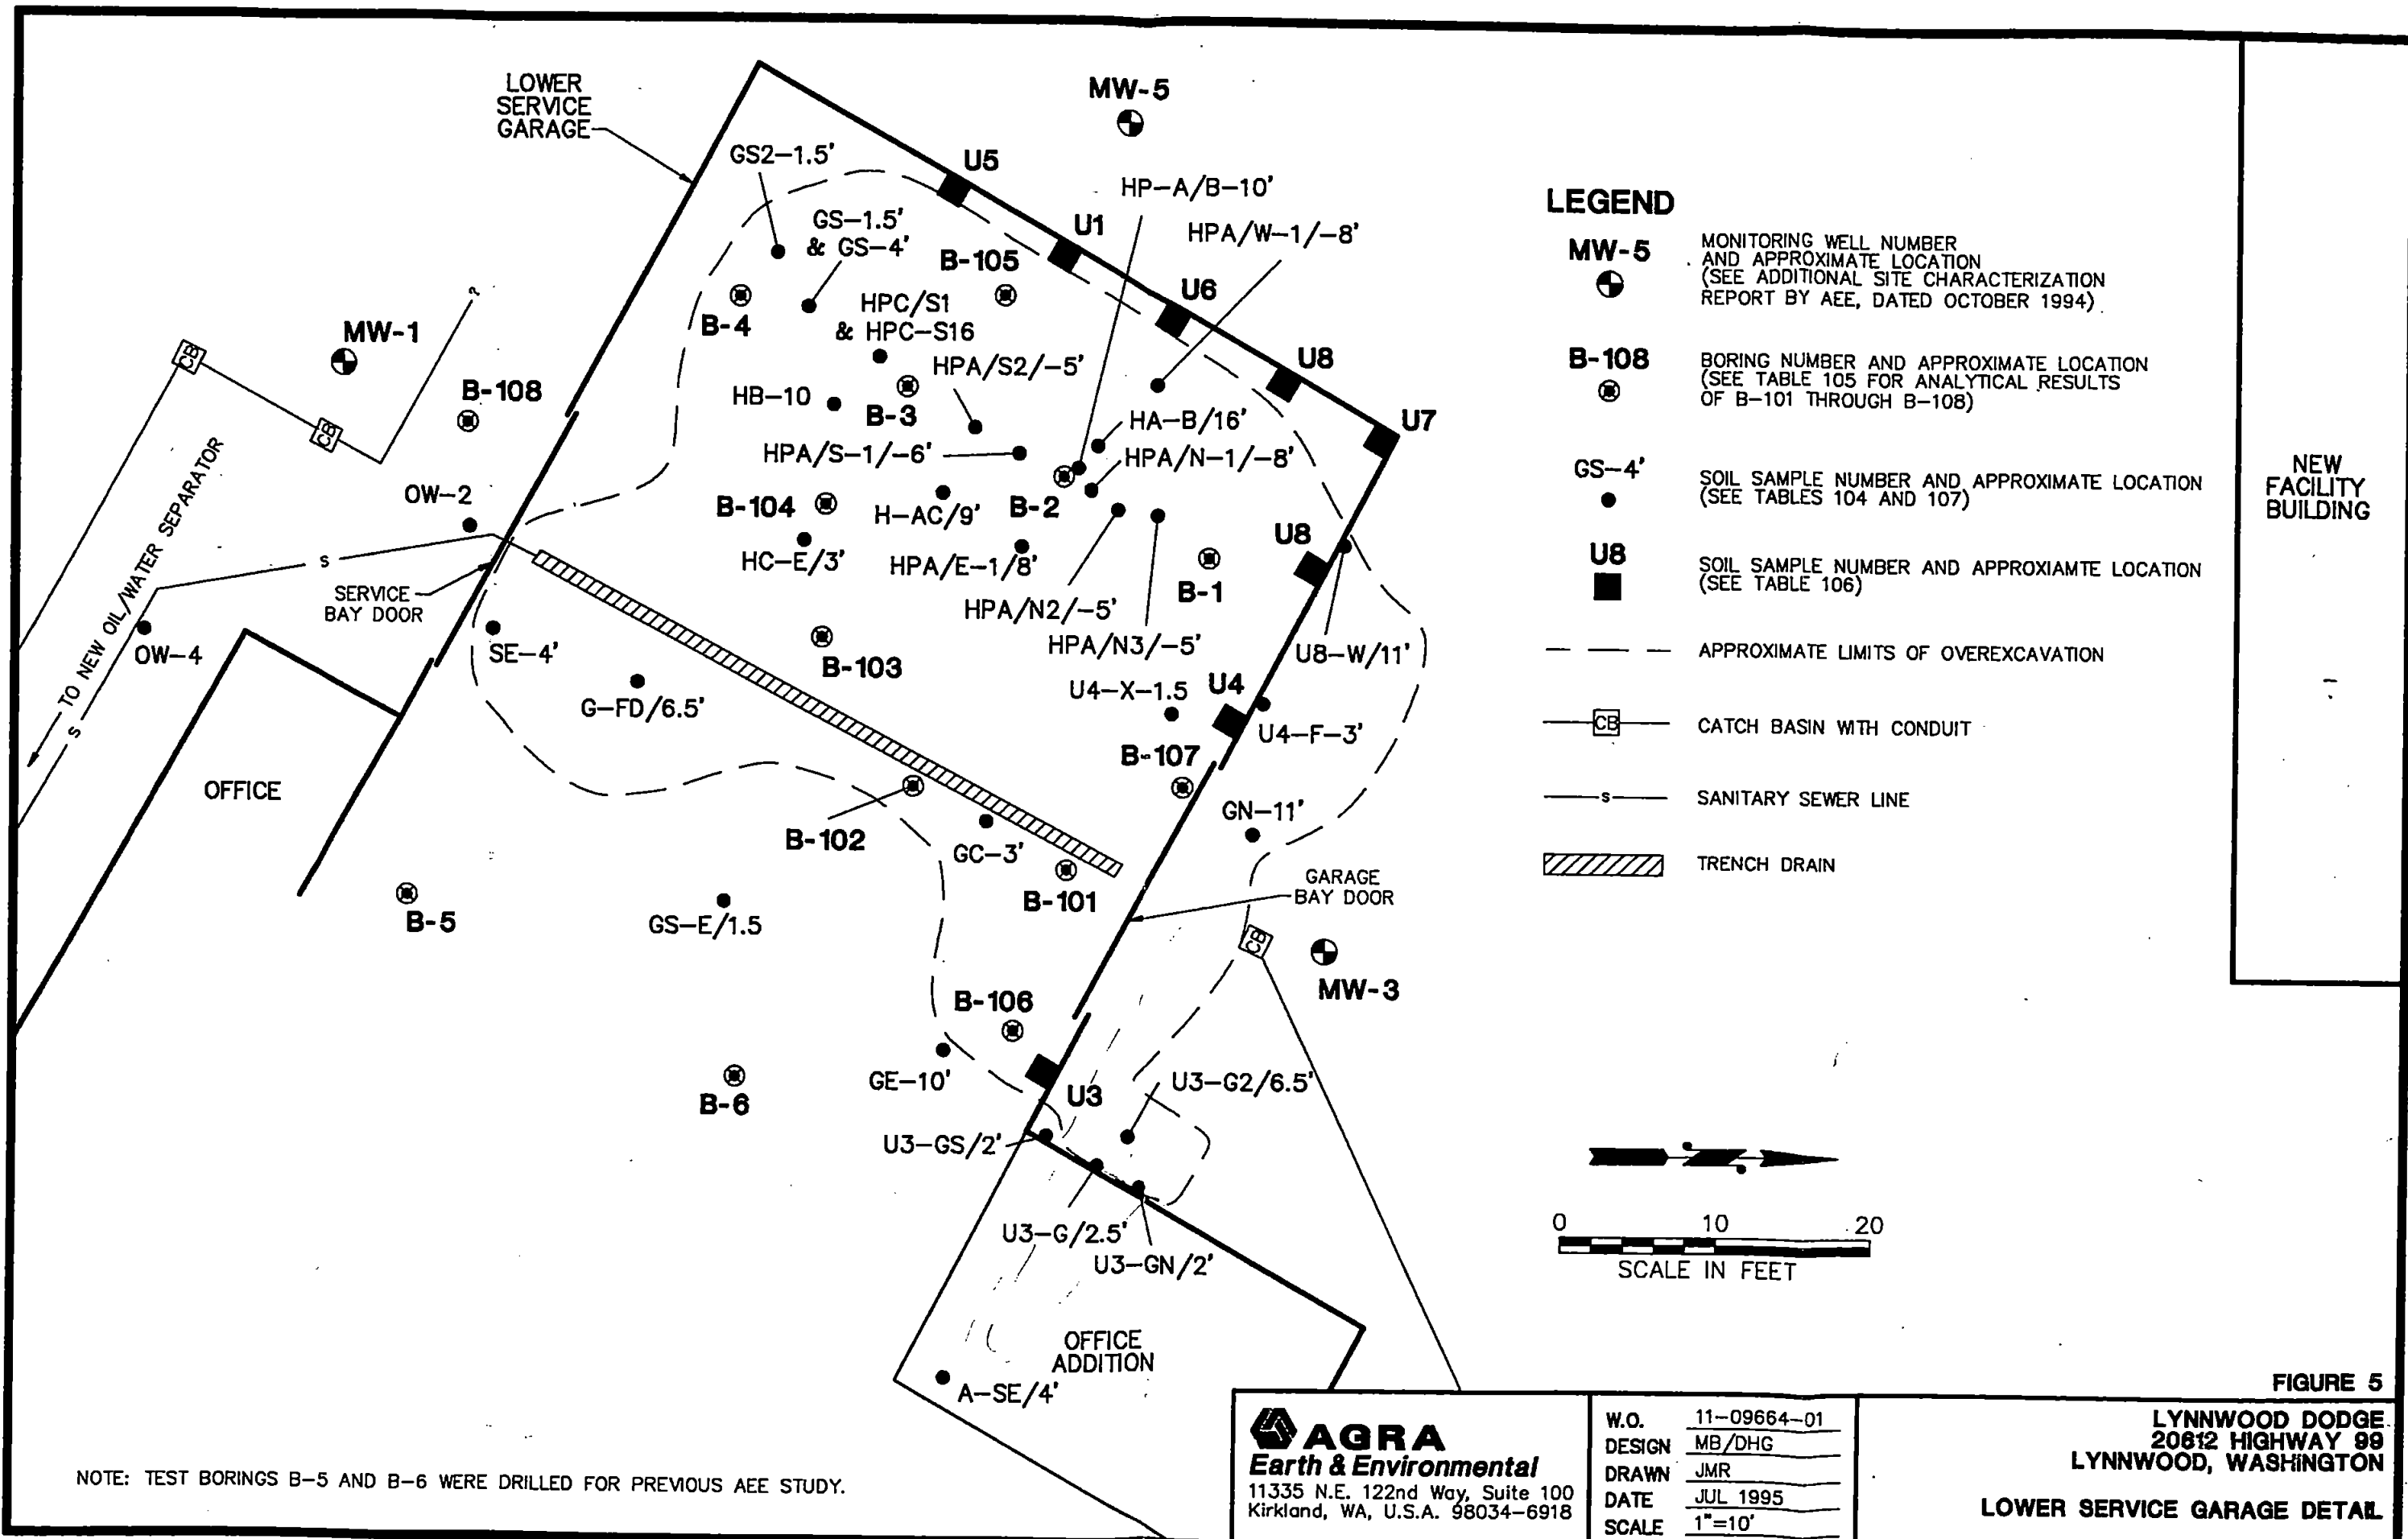
FIGURE 5

Our scope of work included removal of one, single-post hydraulic hoist where a leak to the surrounding soils had been confirmed in our previous work. This hoist was located in the west-central portion of the Lower Service Garage, as indicated by test boring location B-2 on Figure 5 of this report. Hoist removal activities were initiated in December 1994. Upon removal of the one single-post hoist, we encountered an older double-post hoist system which had been deactivated in place and was equipped with a separate, underground reservoir tank. The single-post hoist had been installed in the center of the older double-post system. Both hoist systems were subsequently removed by the subcontractor, APS Services, Inc., along with the one reservoir tank. Approximately 120 tons of TPH impacted soils were removed from the excavation and disposed at the Klickitat County Regional Landfill. Soil disposal receipts are included in Appendix B.

Eight soil samples were collected from this hoist excavation, referred to as HPA, during this phase of work. Analytical results of soil samples collected during hoist removal are summarized on Table 102. The sample locations are shown on Figure 5, Lower Service Garage Detail. The first five samples were collected from the base and each of four sidewalls of the excavation. Sample HP-A/B-10' was collected from the base of the excavation at a depth of 10 feet; the diesel concentration of 30 ppm was below Method A cleanup guidelines, and no heavy oil compounds were detected. North, south and east sidewall samples HPA/N-1/-8', HPA/S-1/-6' and HPA/E-1/-8', as well as resamples HPA/N2/-5' and HPA/S2/-5', all demonstrated diesel and heavy oil concentrations well above Method A cleanup guidelines. Sample HPA/W-1/-8' was collected from the west sidewall next to the former hoist reservoir tank; no TPH was detected. On 5 January 1995, the expanded north sidewall of excavation HPA was resampled; no TPH was detected in sample HPA/N3/-5'.
