2021 Land Use Control Inspections Technical Memorandum

**Sites 302, 303, and 304, and Tank 50
Manchester Fuel Depot, Port Orchard,
Washington**

**United States Department of the Navy
Naval Facilities Engineering Systems Command
Engineering Field Activity, Northwest**

DCN: LBJV-5006-4089-0003

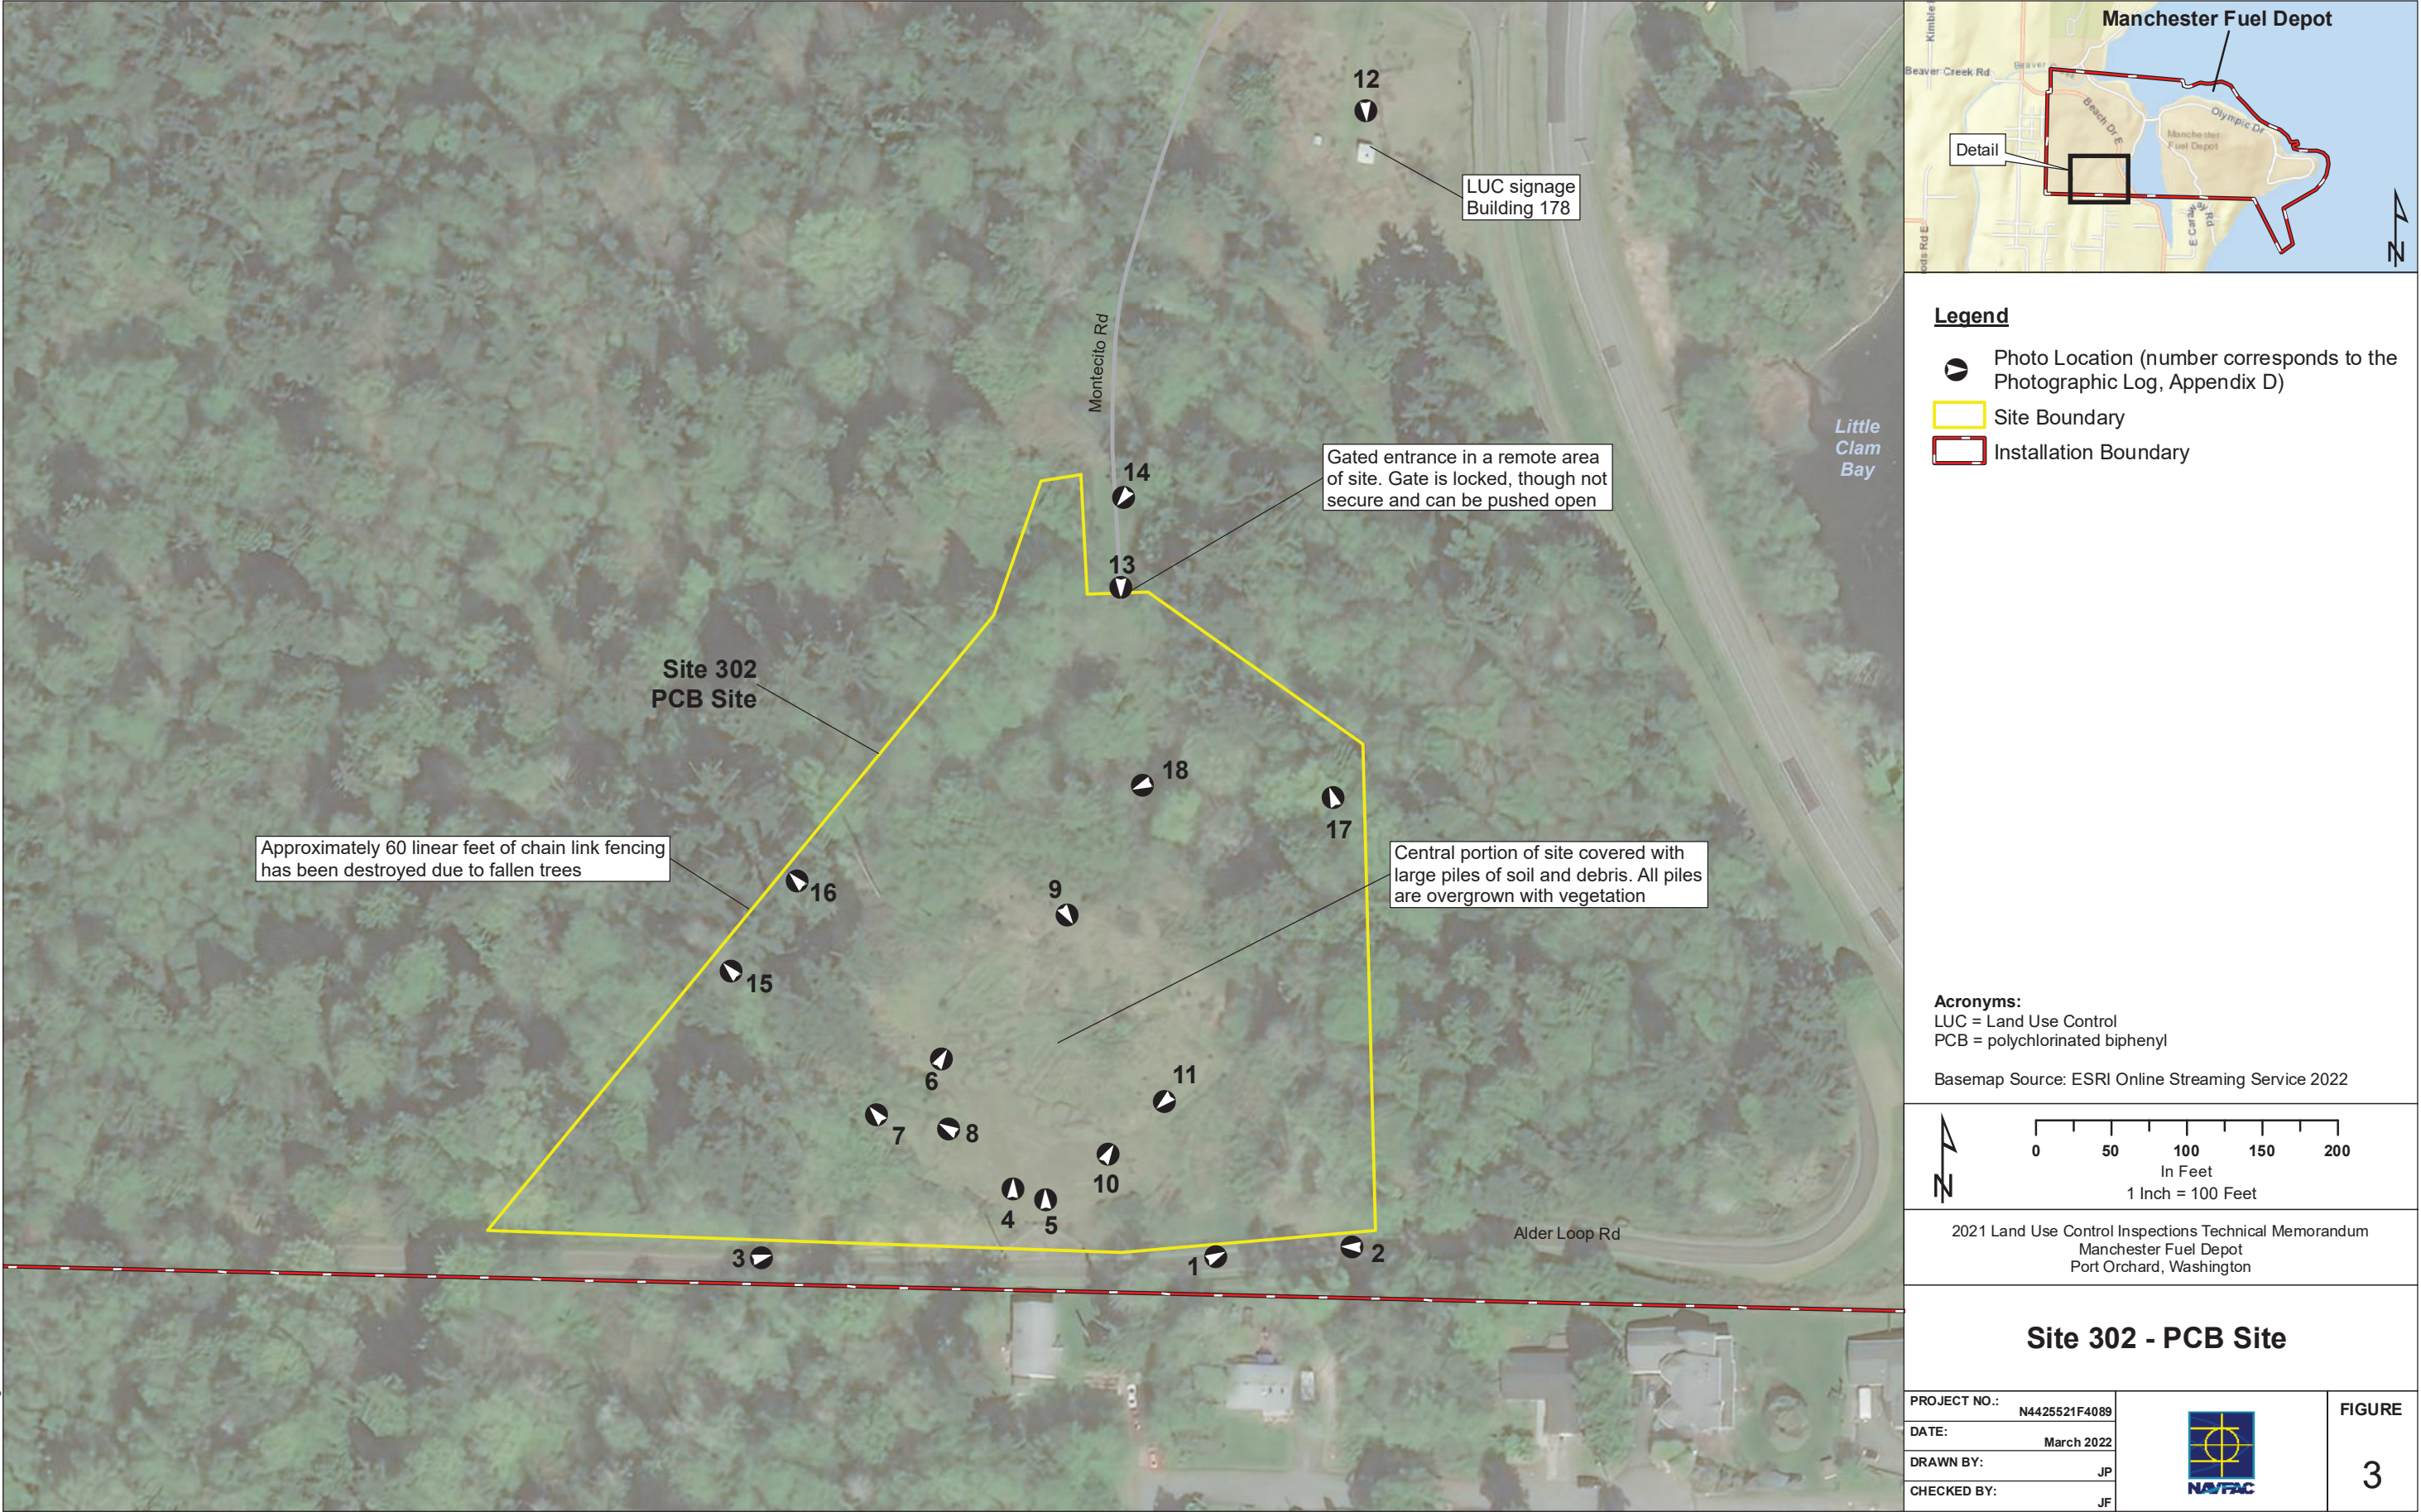
The locations of these findings are depicted on Figure 3. The completed LUC inspection checklist for Site 302 is provided in Appendix A. The field notes and photographs from Site 302 are provided in Appendices C and D, respectively.

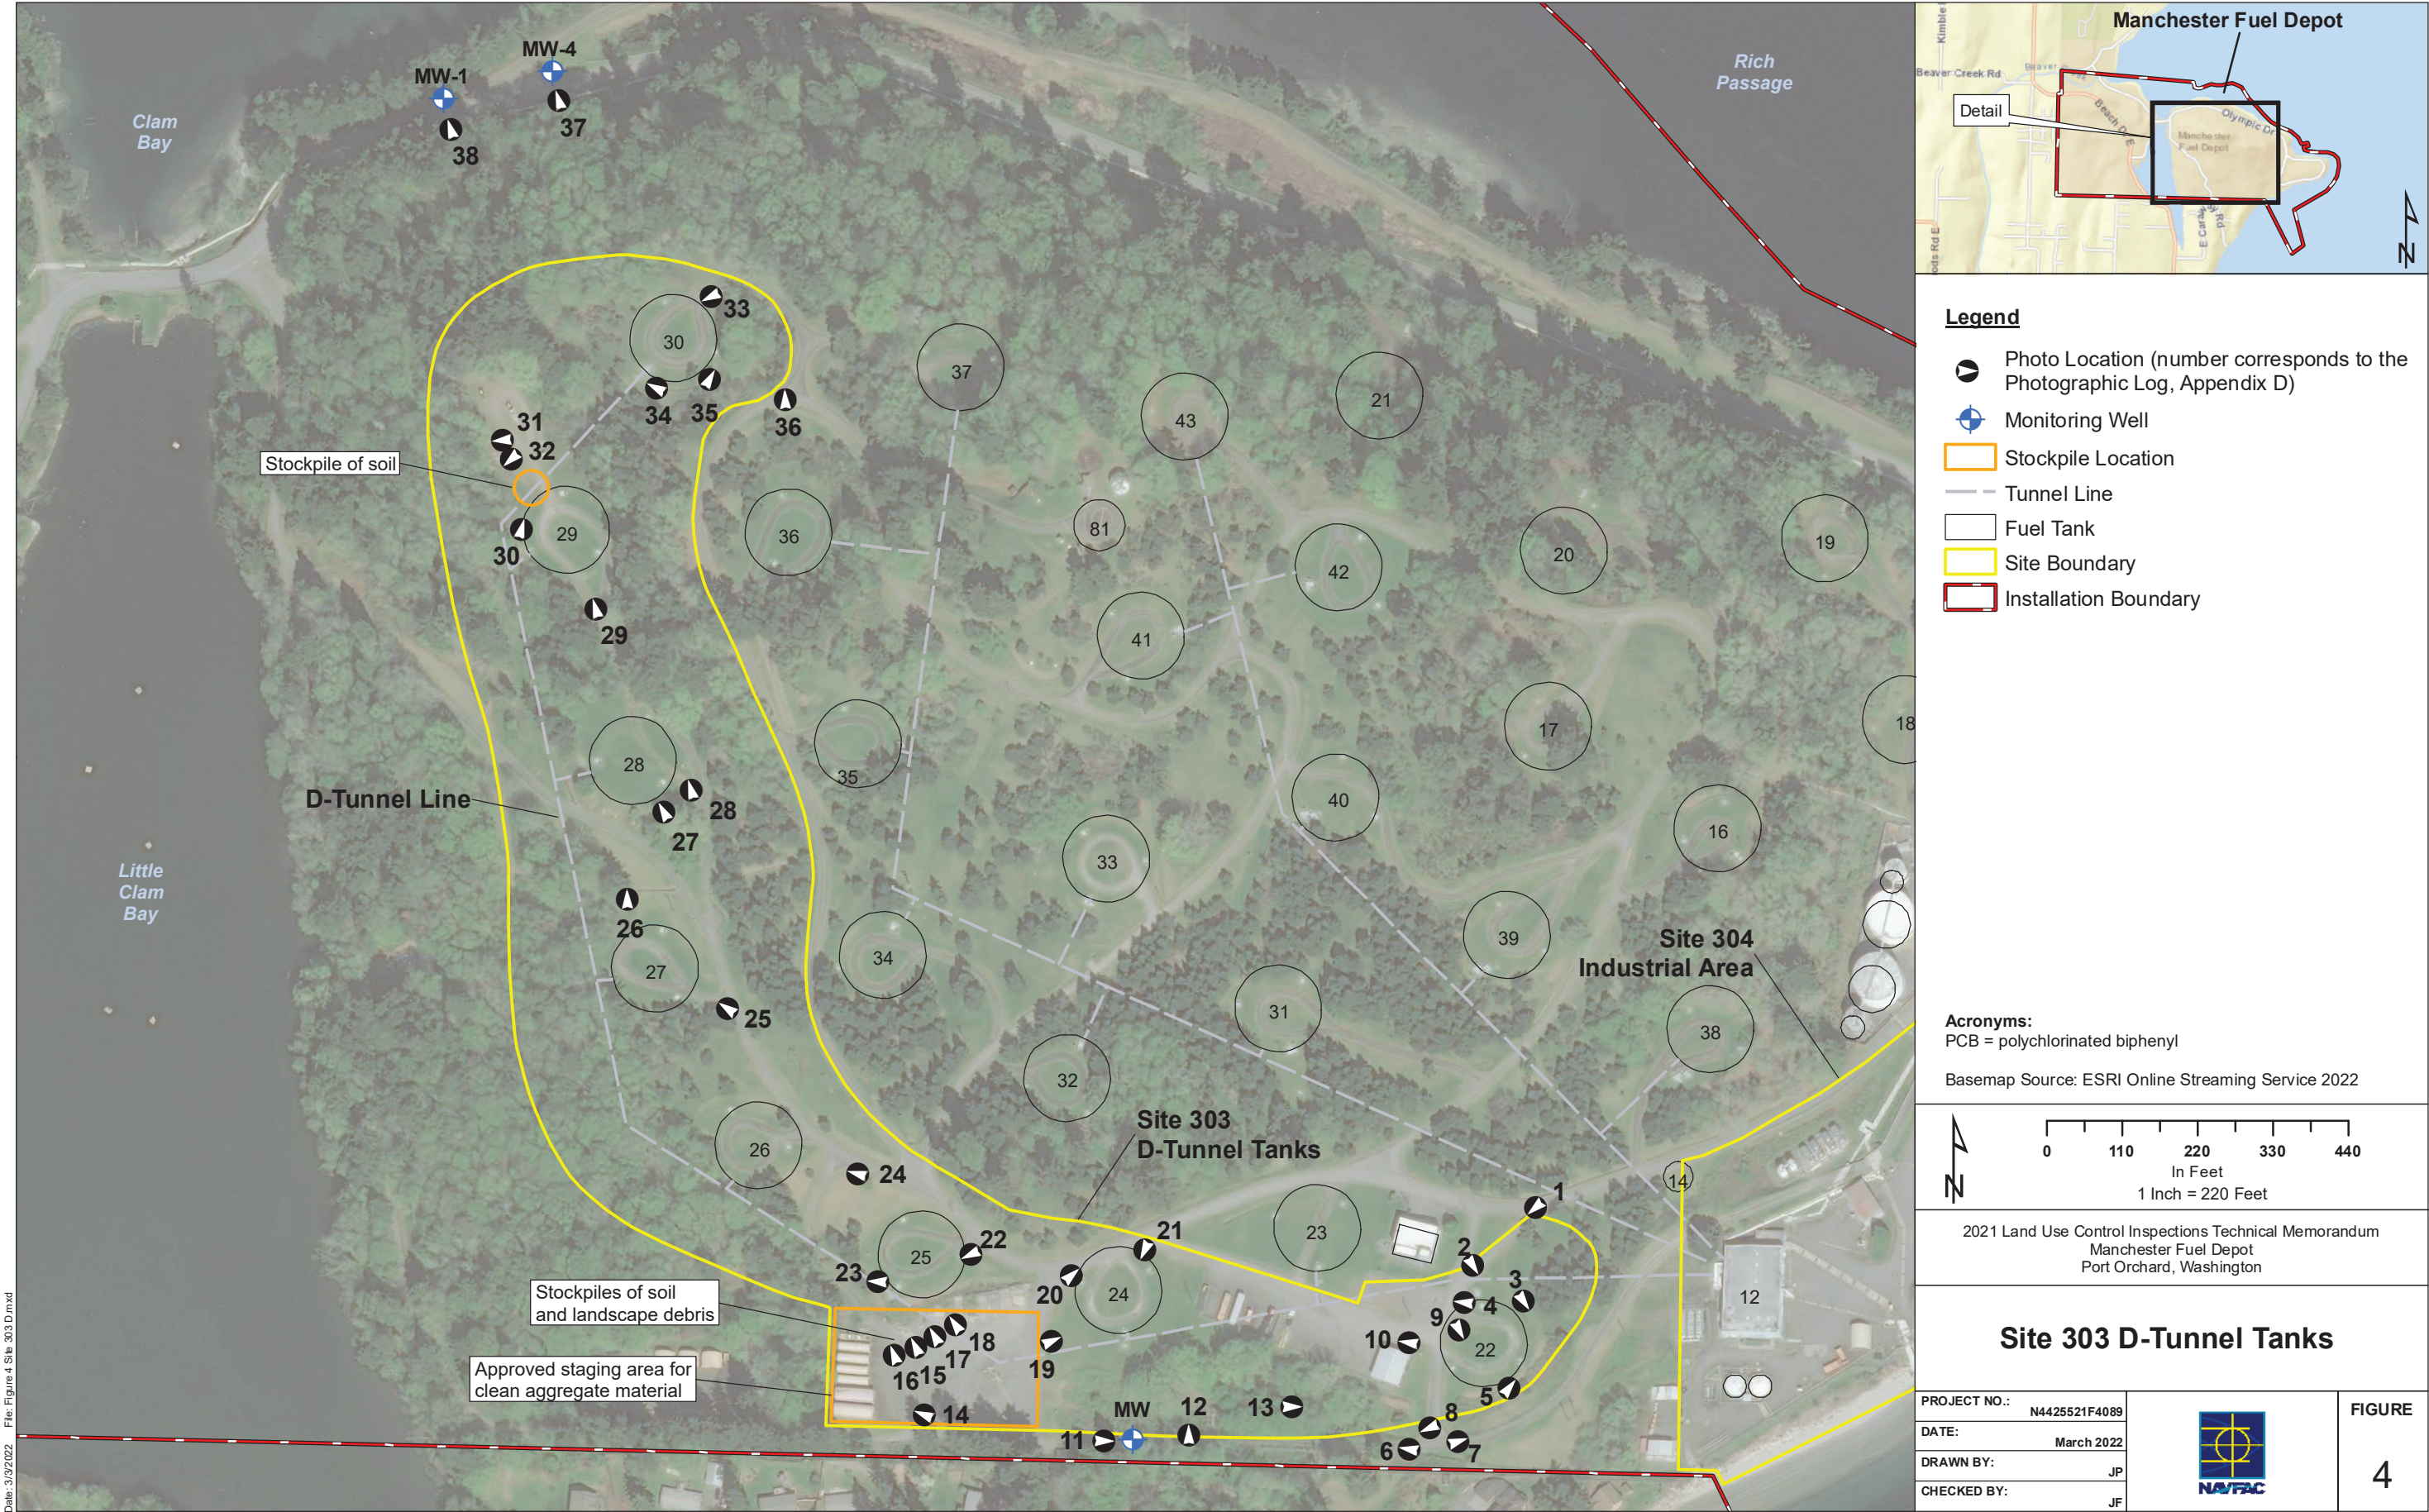
Site 303 consists of eight 20,000- to 50,000-barrel (840,000- to 2,100,000-gallon) concrete USTs used to store marine diesel fuel (see Figures 2 and 4). The Naval fuel currently stored and dispensed at MFD is designated as F-76. The USTs are located adjacent to the D-tunnel line, which extends from Tank 30 to Building 12 in the Industrial Area (Site 304), as shown on Figure 4. Site-specific LUCs (U.S. Navy, 2016a) are as follows:

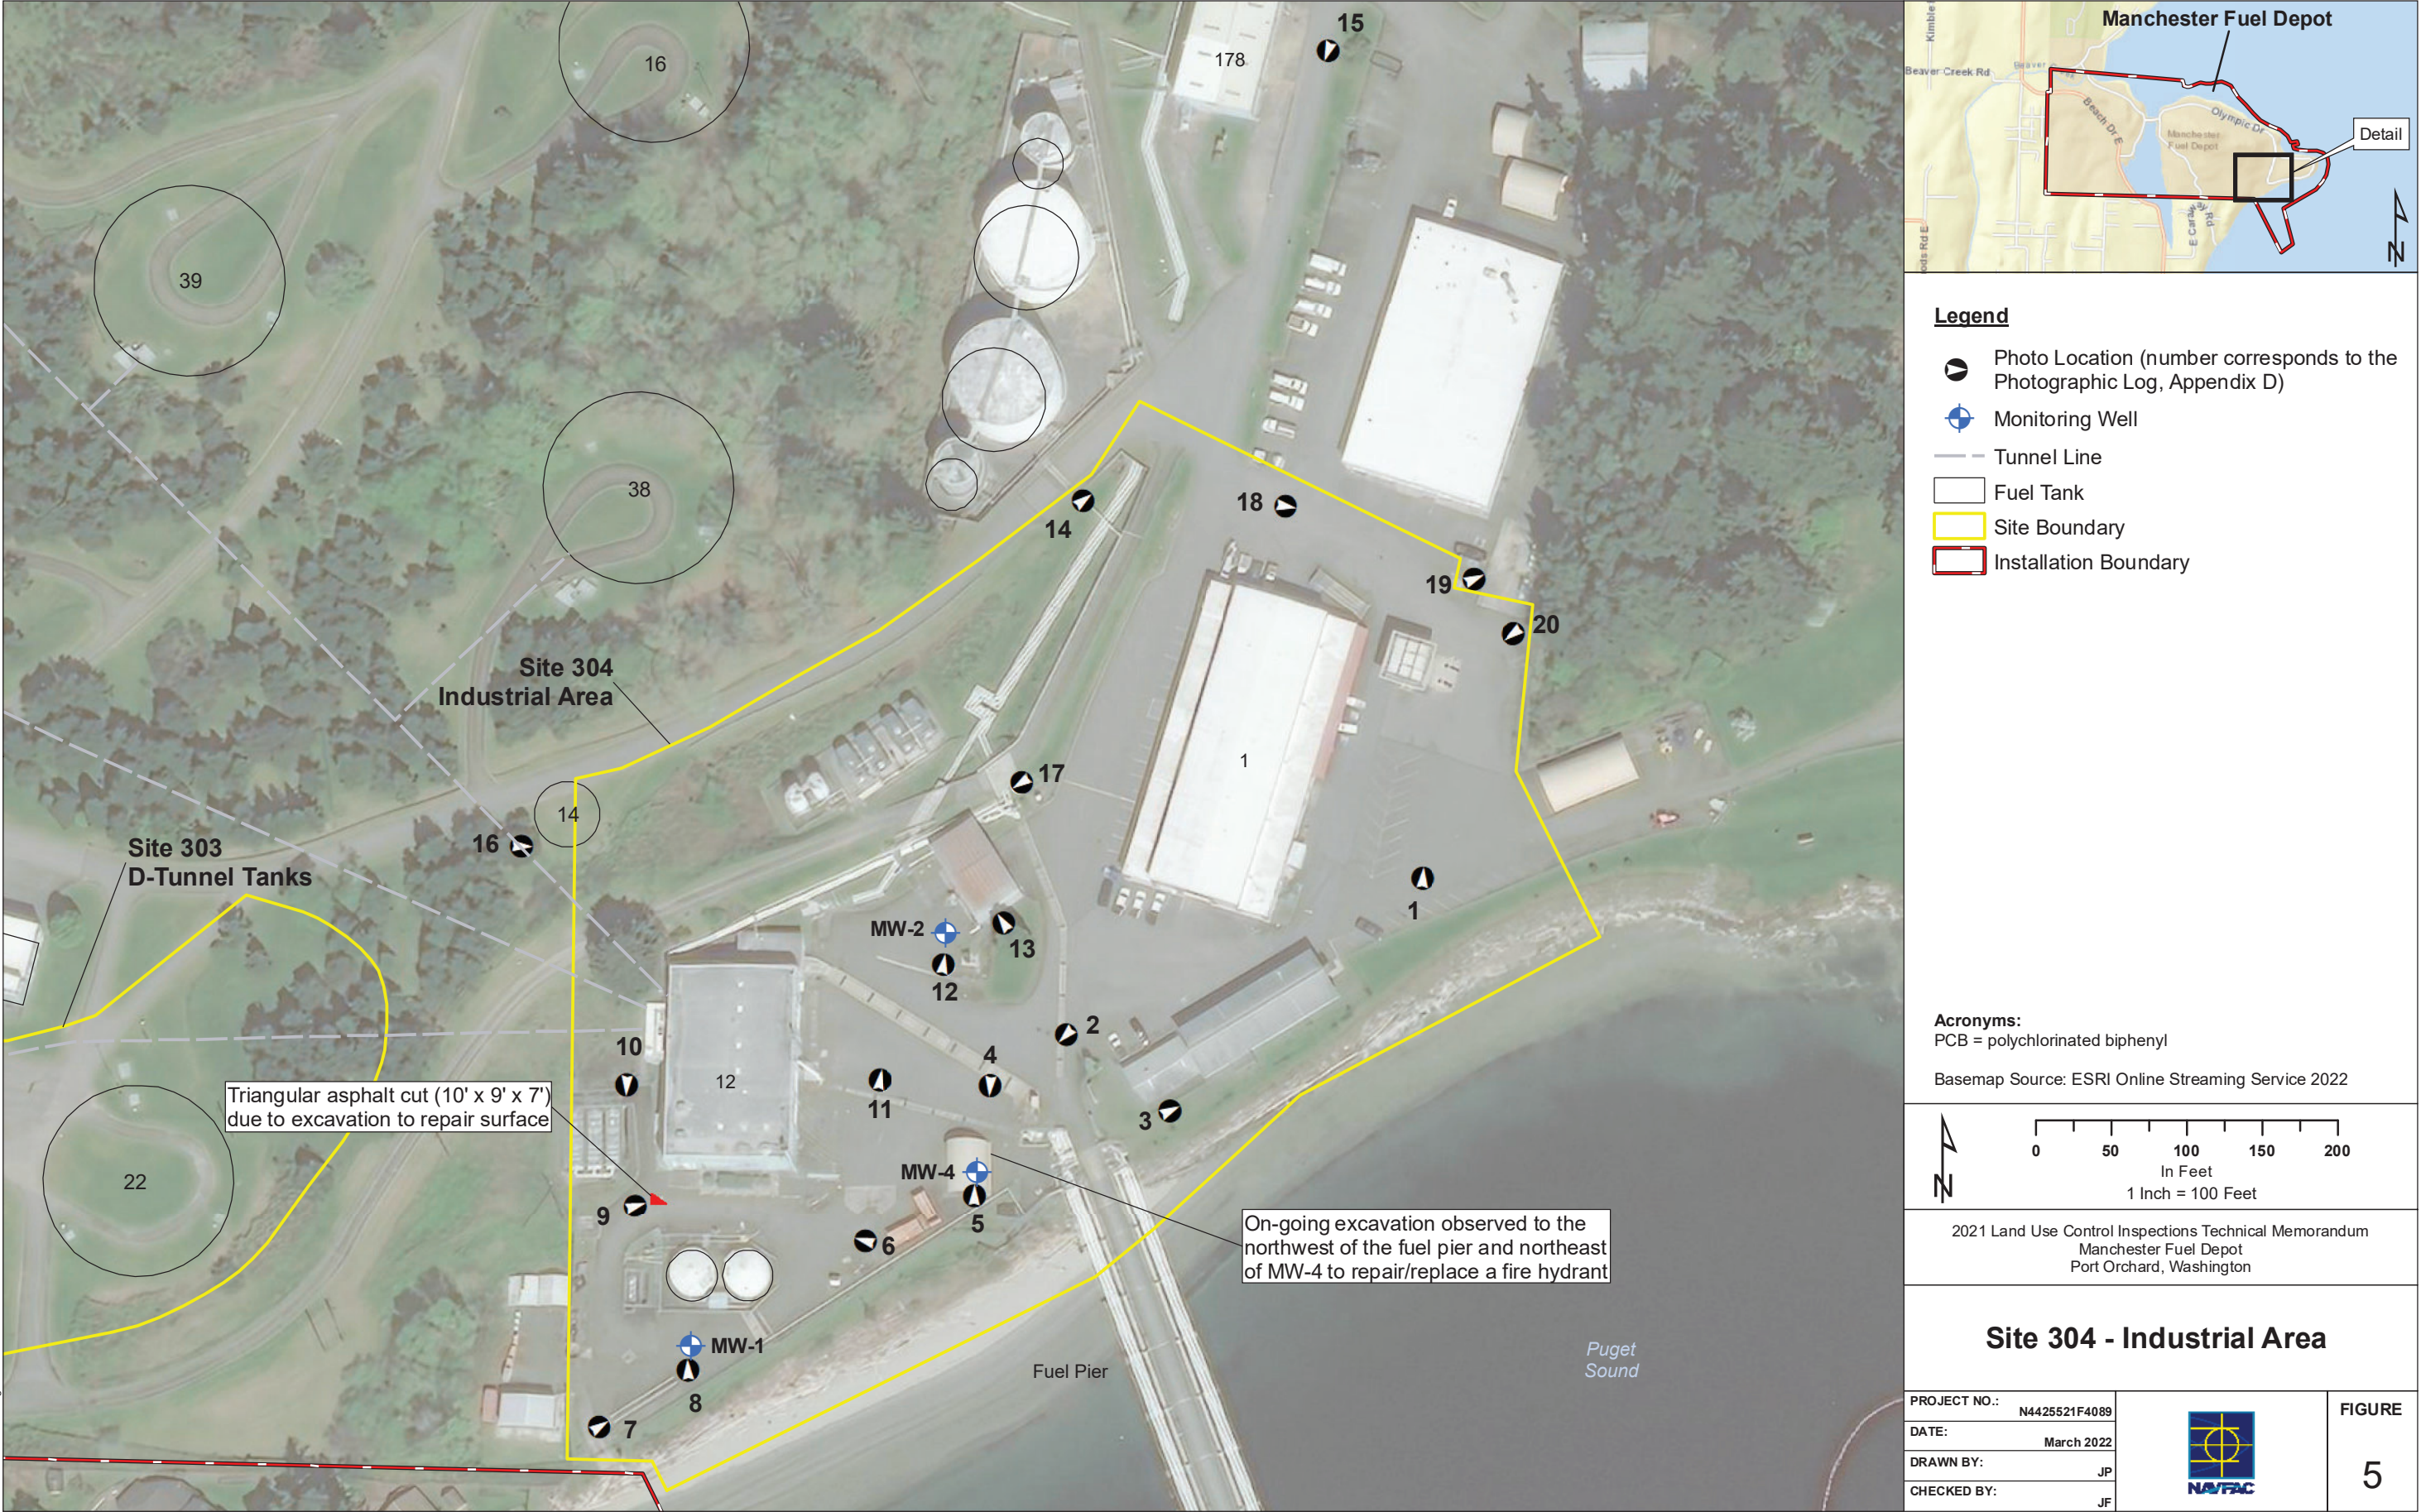
1. The LUC signage for Site 304 is located at the northeastern corner of Building 178, outside and north of the Site 304 LUC boundary (see Figure 5).
2. As noted in the 2020 LUC inspection, a small cut in asphalt was observed off the southwest corner of Building 12, which was due to excavation to repair a small area of subsidence near the building. The asphalt cut was triangular with dimensions of approximately 10 feet by 9 feet by 7 feet, resulting in an opening in the asphalt that had been filled with gravel. At the time of the 2021 LUC inspection, this cut in the asphalt had not been repaired. It is recommended that the cut in the asphalt be repaired.

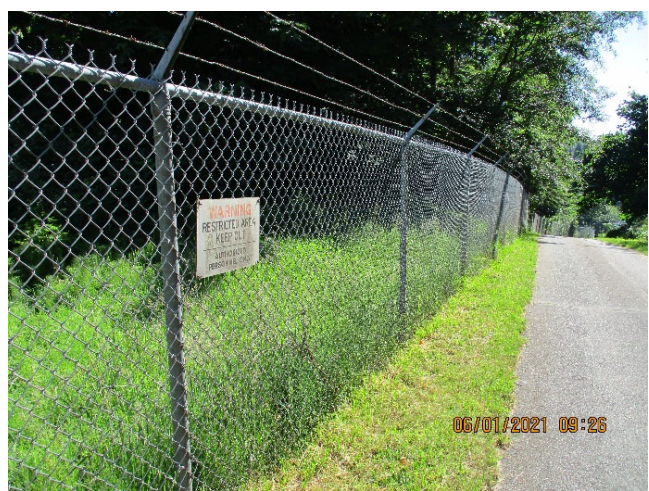
**Photograph 1****File Name:** IMG_0004.JPG**Description:** Land use control (LUC) signage along southeastern road boundary, facing northeast.

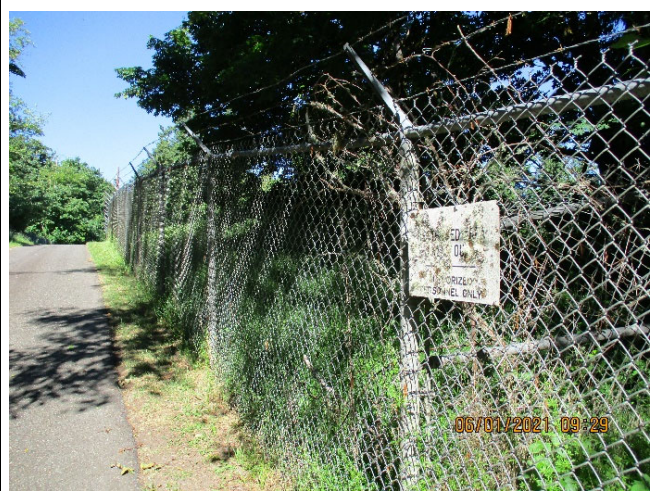
**Photograph 2****File Name:** IMG_0005.JPG**Description:** LUC signage at southeast corner, facing west.

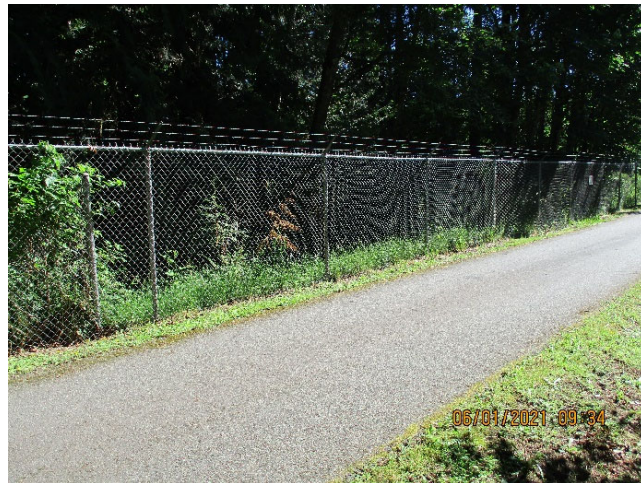
**Photograph 3****File Name:** IMG_0006.JPG**Description:** Fencing along southwestern boundary of site, facing northeast.

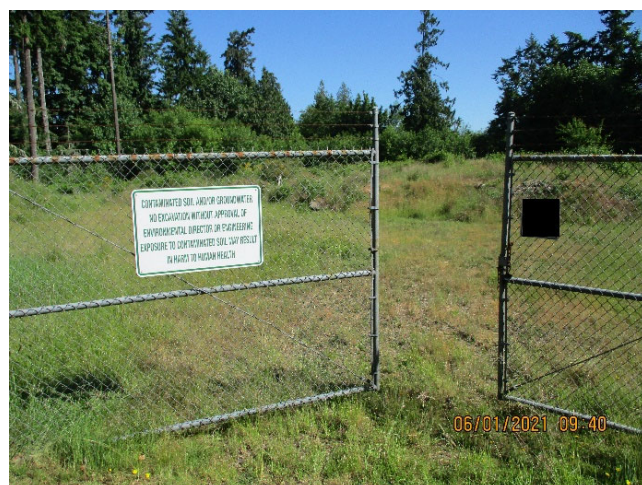
**Photograph 5****File Name:** IMG_0008.JPG**Description:** Locked main access gate and LUC signage located on south side of site, facing north.

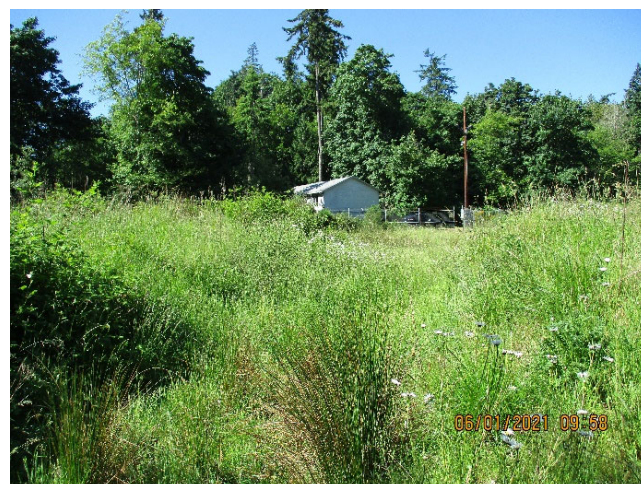
1. Site 302: The central portion of site is covered with large, older (covered with vegetation) stockpiles of soil and armor rock. The excess soil placed in the central portion of the site originated from a culvert replacement project that was located upgradient and outside the four sites with established LUCs, in an area that had not historically been used for industrial activity. The excess soils were sampled and characterized in January 2020 for site contaminants of concern (COCs; PCBs and total petroleum hydrocarbon [TPH]) as a precaution because the MFD operates as a fuel facility. Because there is no knowledge of additional COCs in the area from which the excess soils originated, the samples were not analyzed for other constituents. Analytical results indicated that neither PCBs nor TPH were detected in excess of Washington Model Toxics Control Act (MTCA) Method A Cleanup levels (Kane Environmental, Inc., 2020). The armor rock originated from a shoreline project. A decision on how to handle the stockpiles is being made in consultation with stakeholders and is pending; the Navy anticipates having a plan by summer 2022.

**Photograph 11****File Name:** IMG_0014.JPG**Description:** Stockpiles covered with vegetation, central area of site, facing southwest. Structure in the background is a residential building located off of the installation.

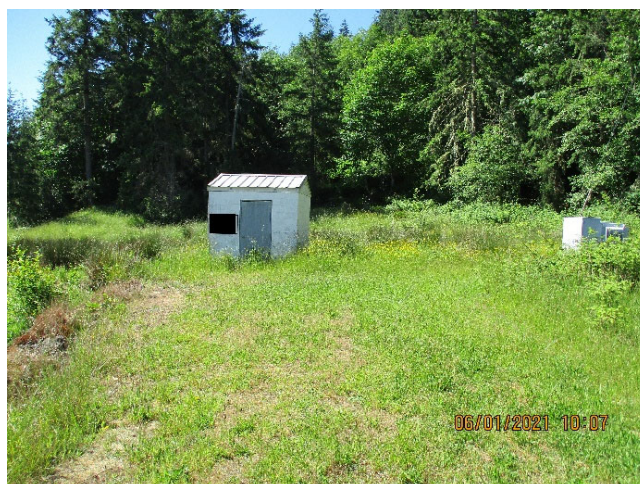
**Photograph 12****File Name:** IMG_0015.JPG**Description:** National Marine Fisheries Service well, northeast of site, facing south.

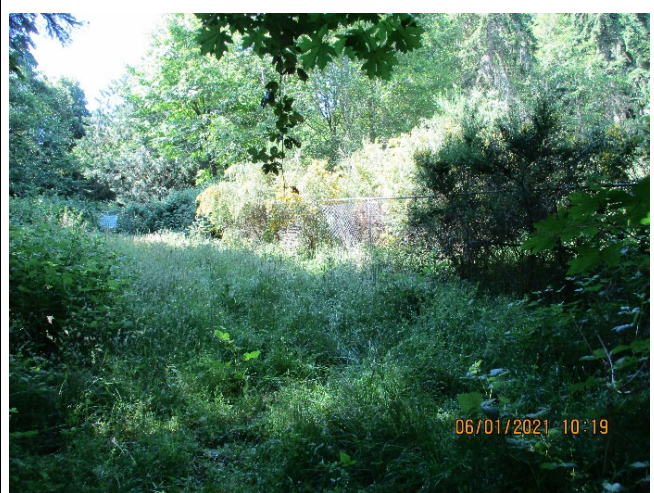
**Photograph 14****File Name:** IMG_0017.JPG**Description:** Northern corner fence line, facing southwest.

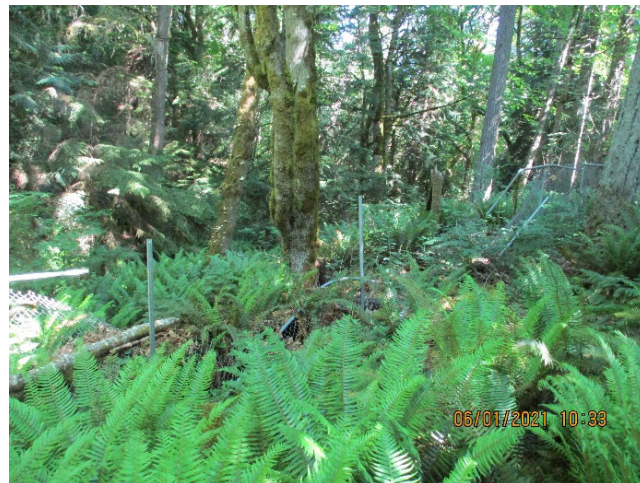
- Site 302: During the 2020 LUC Inspection, approximately 60 linear feet of chain-link fencing was noted to have collapsed on the northwestern side of the site, likely due to incursion of vegetation; however, this area could not be reinspected during the 2021 LUC inspection due to the presence of heavy vegetation. A total of approximately 60 additional linear feet of fencing was noted during the 2021 LUC inspection to have collapsed also on the northwestern boundary of the site, due to fallen trees. It is recommended that the fence be repaired. The Navy will coordinate with the installation on a plan and schedule to fix the damaged fence.

**Photograph 15****File Name:** IMG_0018.JPG**Description:** Section of fence down (approximately 50 feet) due to treefall along southwest perimeter, facing northwest.

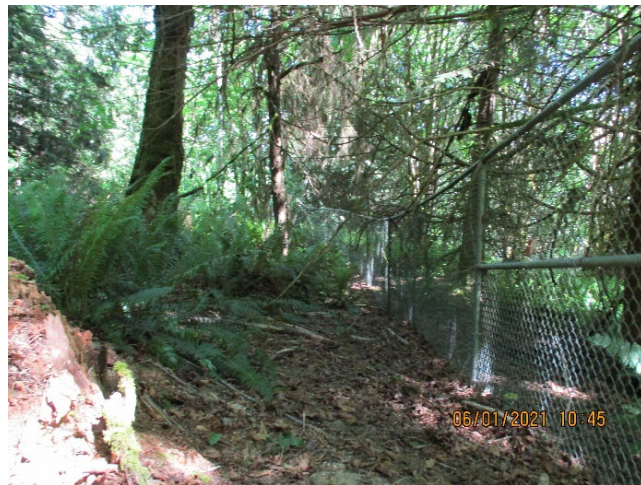
**Photograph 17****File Name:** IMG_0019.JPG**Description:** Northeast perimeter fence line, facing northwest.

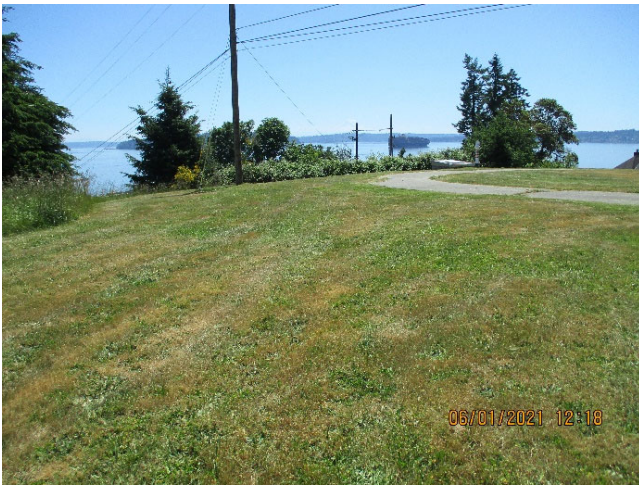
**Photograph 3****File Name:** IMG_0036.JPG**Description:** Abandoned vapor monitoring well locations, facing southeast.

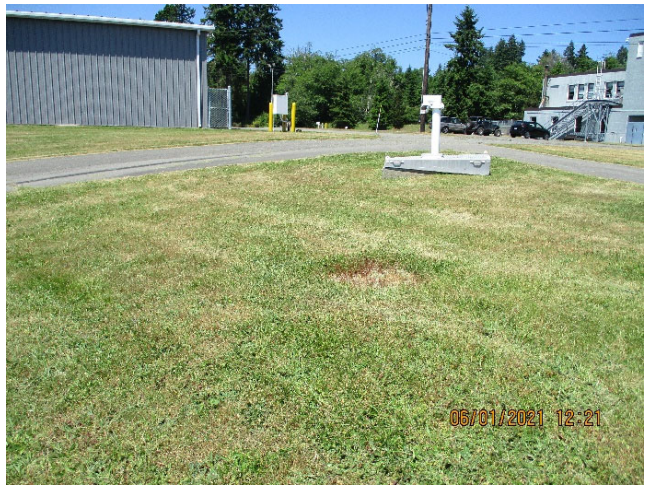
**Photograph 4****File Name:** IMG_0037.JPG**Description:** Abandoned vapor monitoring well locations, facing west.

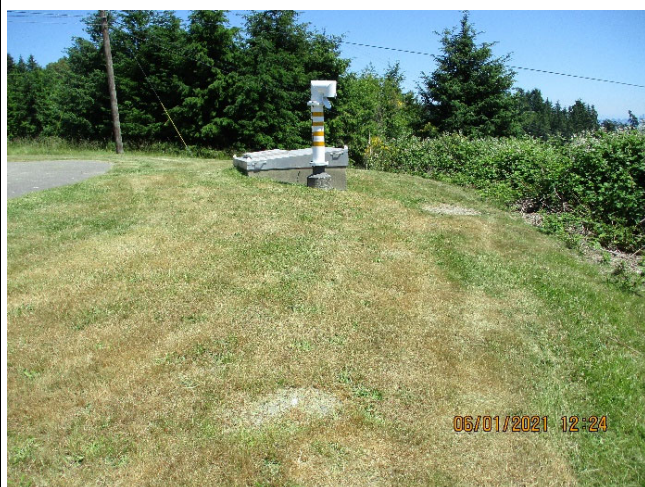
**Photograph 5****File Name:** IMG_0038.JPG**Description:** Abandoned vapor monitoring well location, southeast corner of Tank 22, facing northeast.

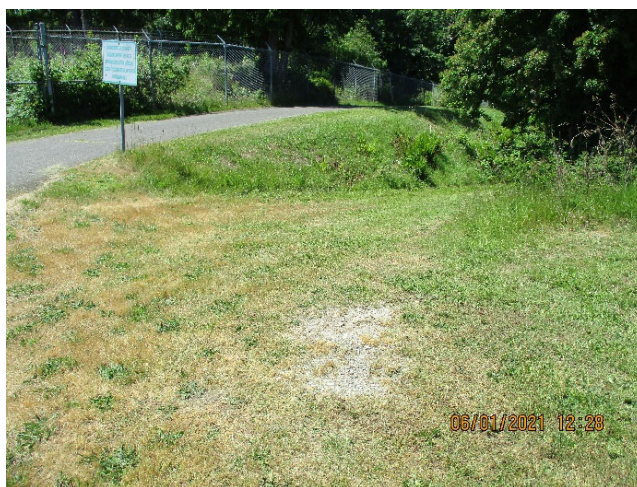
**Photograph 8****File Name:** IMG_0041.JPG**Description:** Location of abandoned groundwater monitoring well MW-3, facing southwest.

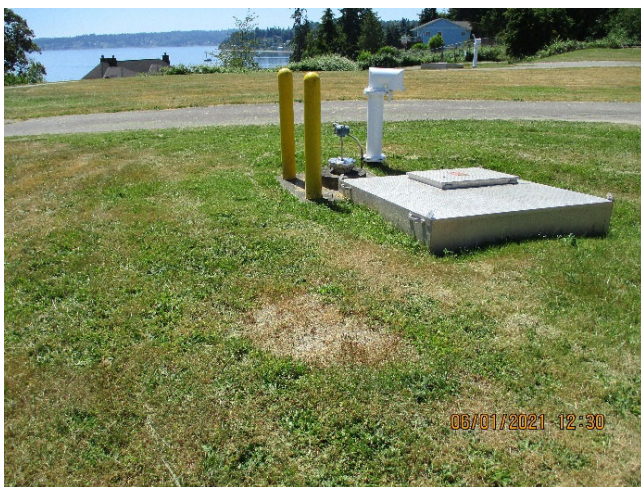
**Photograph 9****File Name:** IMG_0042.JPG**Description:** Location of former vapor monitoring well, facing southeast.

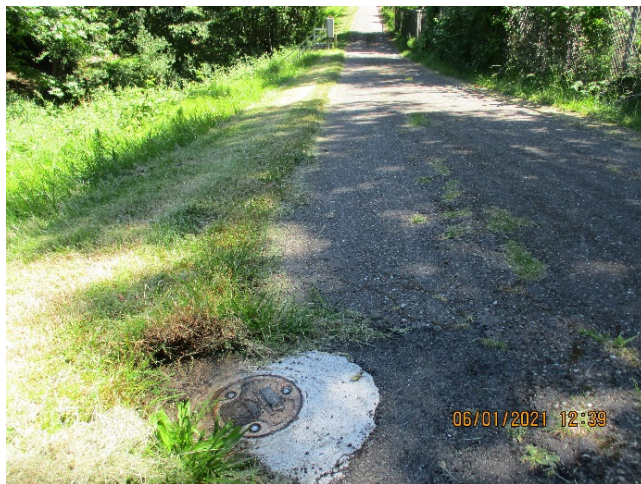
**Photograph 11****File Name:** IMG_0044.JPG**Description:** Groundwater monitoring well MW-1 south of Tank 24, facing east.

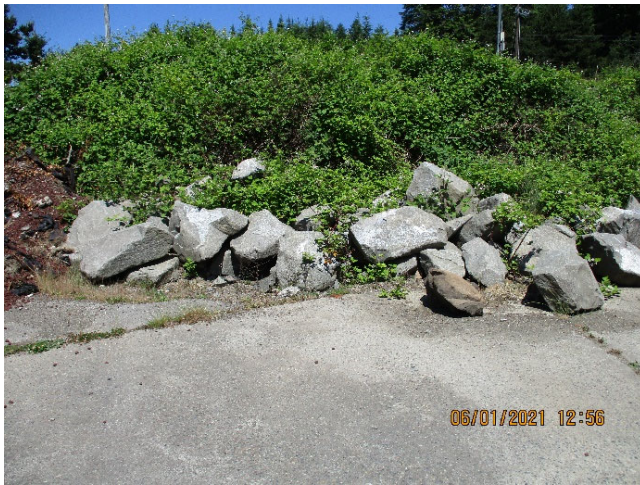
**Photograph 15****File Name:** IMG_0048.JPG**Description:** Boulder stockpile in construction laydown and storage area south of Tank 25, facing northwest.

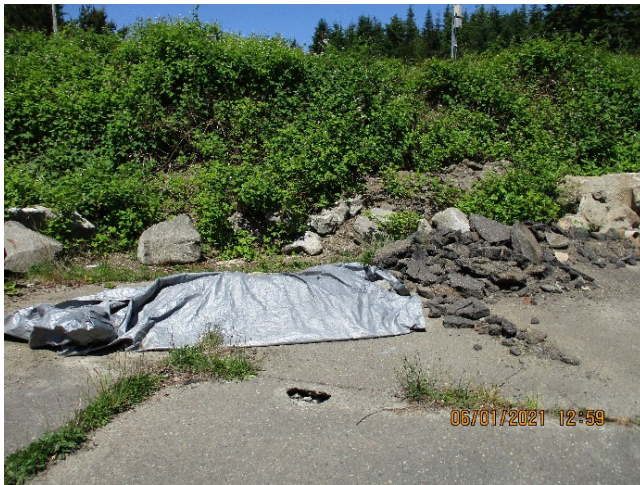
- Site 303: Two new stockpiles of mixed debris (gravel and torn pieces of tarp) were observed in the northwest corner of the construction laydown area south of Tank 25. These stockpiles are authorized reusable material and are in an approved staging area. U.S. Navy personnel are aware of the stockpiles and plan to reuse the material on-site. This finding does not affect the LUC as written.

**Photograph 17****File Name:** IMG_0050.JPG**Description:** Soil stockpile covered with tarp and asphalt debris south of Tank 25, facing northwest.

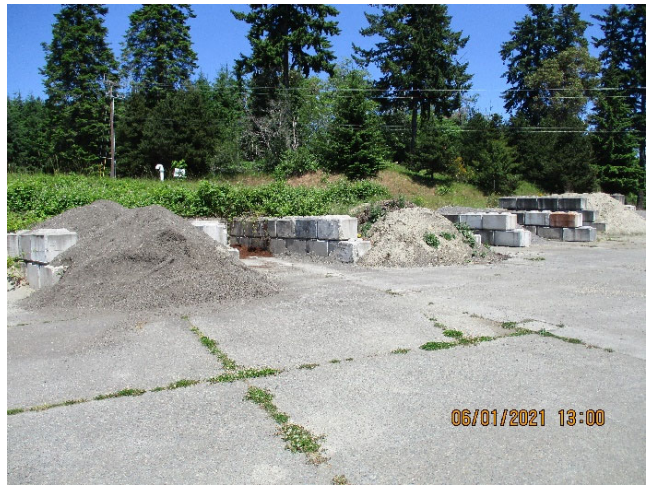
**Photograph 18****File Name:** IMG_0051.JPG**Description:** Clean fill stockpile in construction laydown area south of Tank 25, facing northwest.

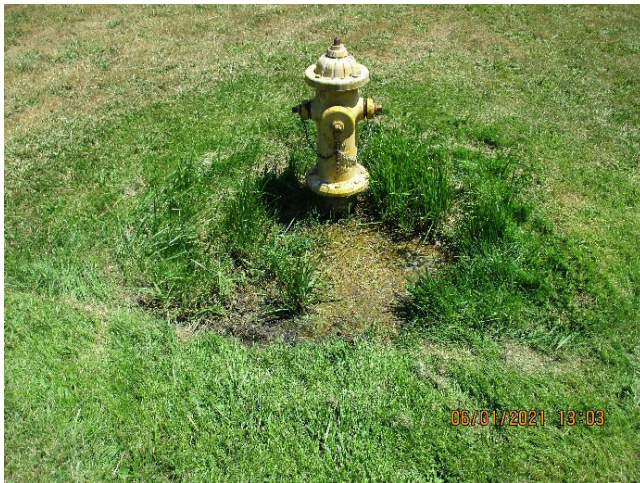
**Photograph 19****File Name:** IMG_0052.JPG**Description:** Ponded water at base of fire hydrant, west of Tank 24, facing east.

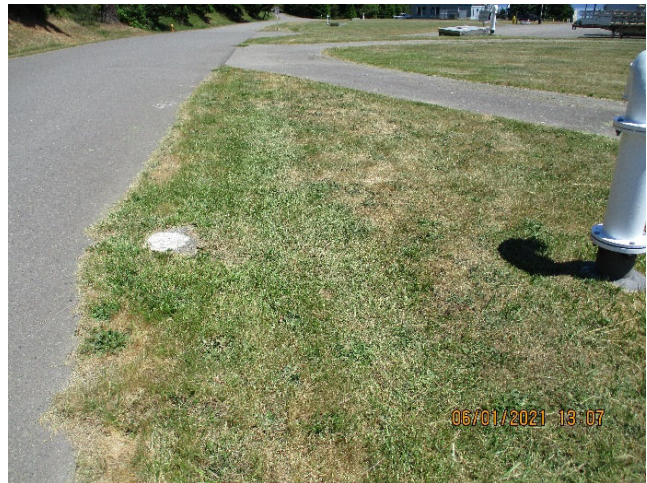
**Photograph 20****File Name:** IMG_0053.JPG**Description:** Abandoned vapor monitoring well near roadway at Tank 24, facing northeast.

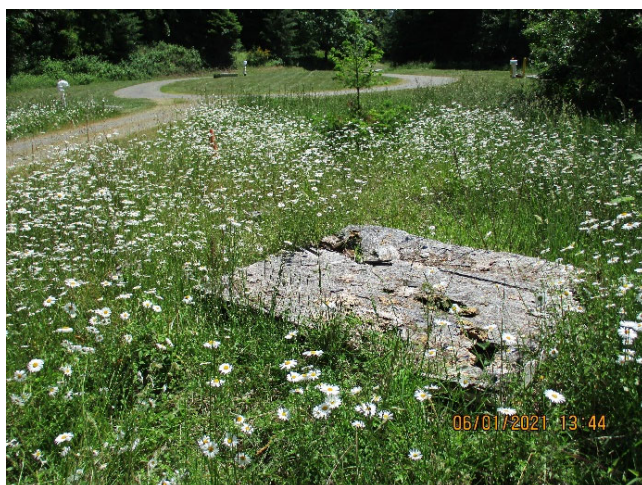
**Photograph 32****File Name:** IMG_0066.JPG**Description:** Wood pallet north of Tank 29, facing southeast.

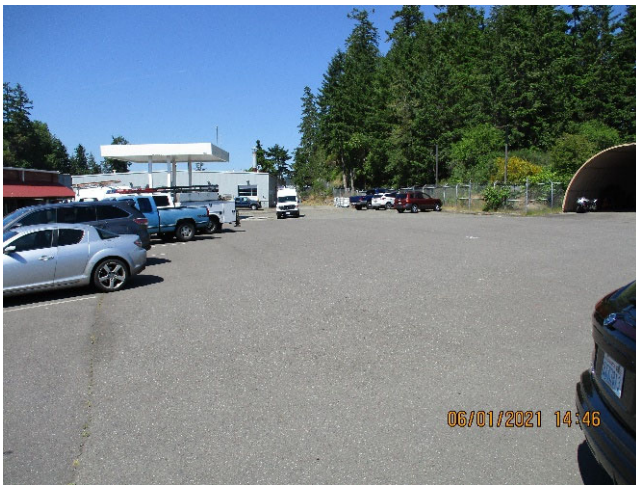
**Photograph 1****File Name:** IMG_0075.JPG**Description:** Parking lot along eastern site boundary, facing north.

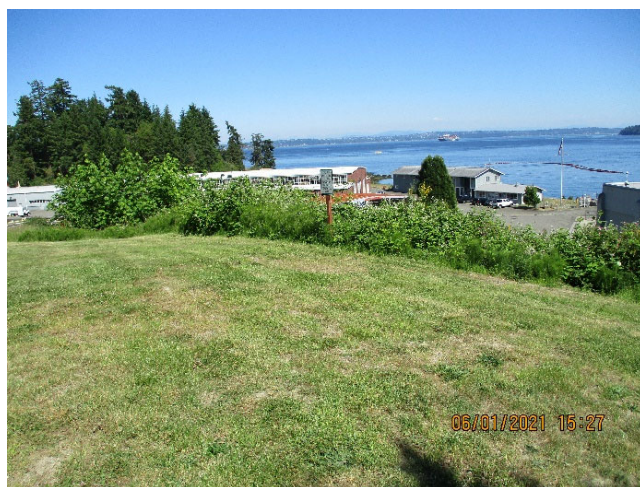
**Photograph 16****File Name:** IMG_0090.JPG**Description:** Location of former Tank 14, outside of site boundary, facing southeast.

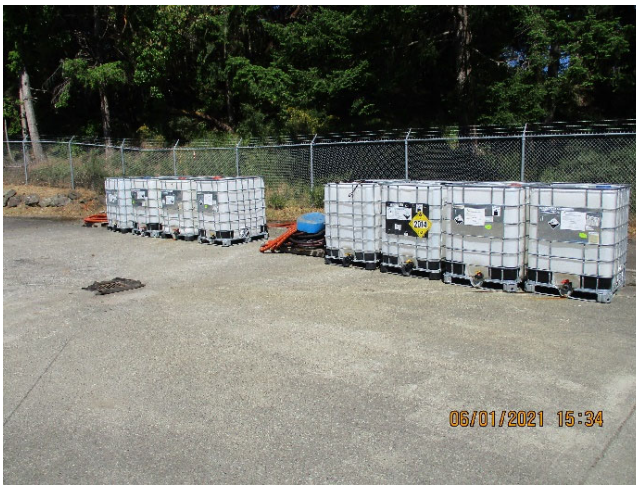
**Photograph 19****File Name:** IMG_0093.JPG**Description:** Chemical totes – ferric sulfate, hydrogen peroxide, liquid caustic soda – outside of site boundary, facing northeast.

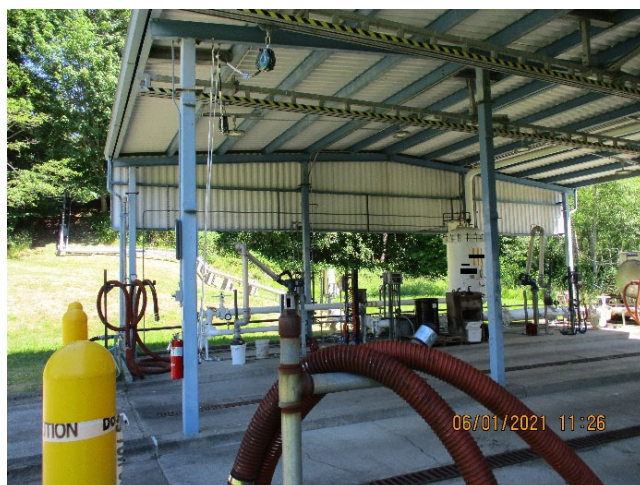
**Photograph 4****File Name:** IMG_0025.JPG**Description:** Oily rag storage (center of photo), facing northeast.

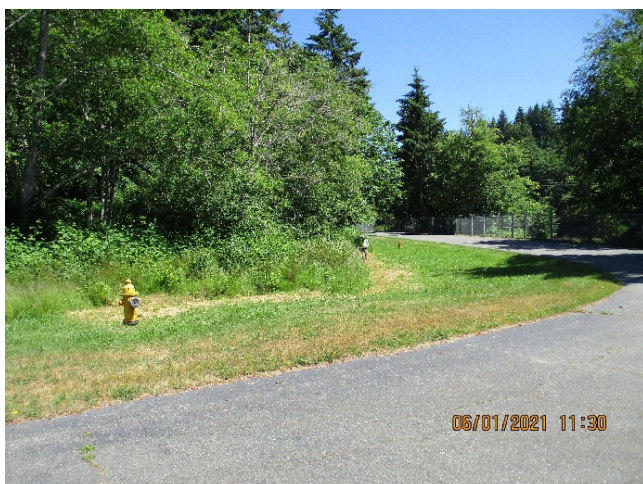
**Photograph 5****File Name:** IMG_0026.JPG**Description:** Southeast boundary of site, facing northeast.

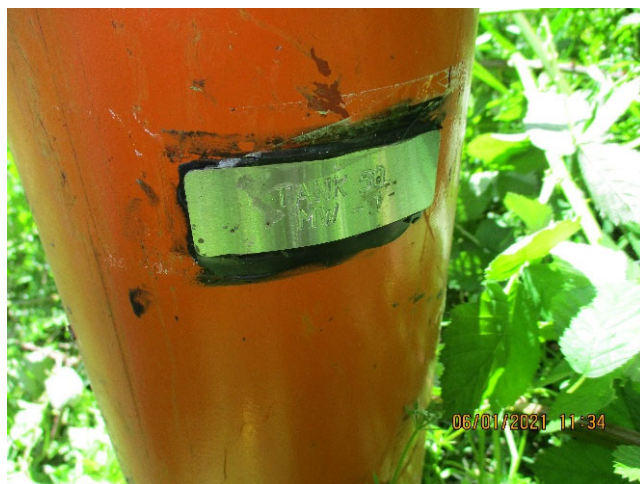
**Photograph 6****File Name:** IMG_0027.JPG**Description:** Monitoring well MW-1, located along the southeastern boundary, facing east.

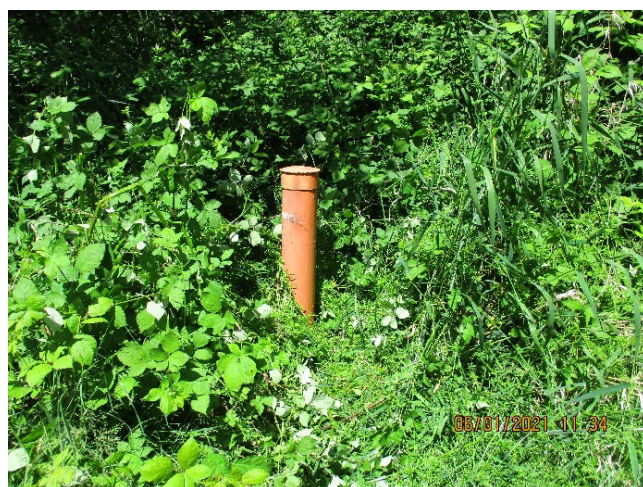
**Photograph 7****File Name:** IMG_0028.JPG**Description:** Monitoring well MW-1, located along the southeastern boundary, facing west.

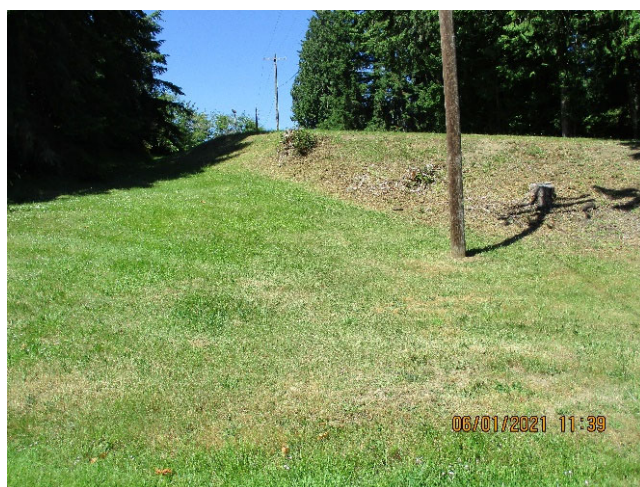
**Photograph 8****File Name:** IMG_0029.JPG**Description:** Northeastern site boundary, facing west.

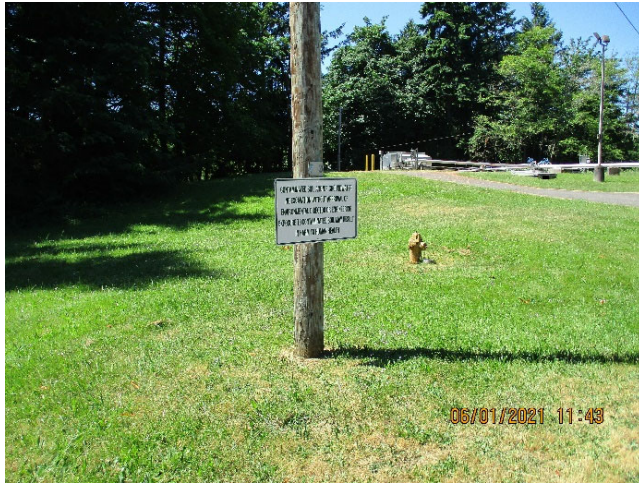
**Photograph 9****File Name:** IMG_0030.JPG**Description:** LUC signage located along the northeast boundary, facing southwest.

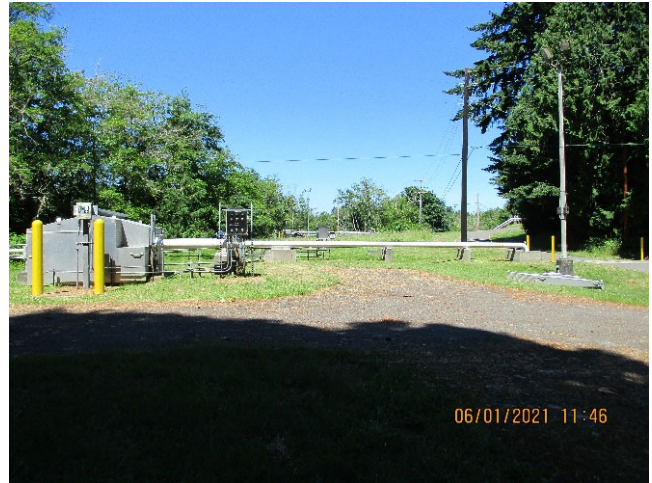
**Photograph 10****File Name:** IMG_0031.JPG**Description:** Tank 50 site overview, facing west.
