2021 Land Use Control Inspections Technical Memorandum

**Sites 302, 303, and 304, and Tank 50
Manchester Fuel Depot, Port Orchard,
Washington**

**United States Department of the Navy
Naval Facilities Engineering Systems Command
Engineering Field Activity, Northwest**

DCN: LBJV-5006-4089-0003

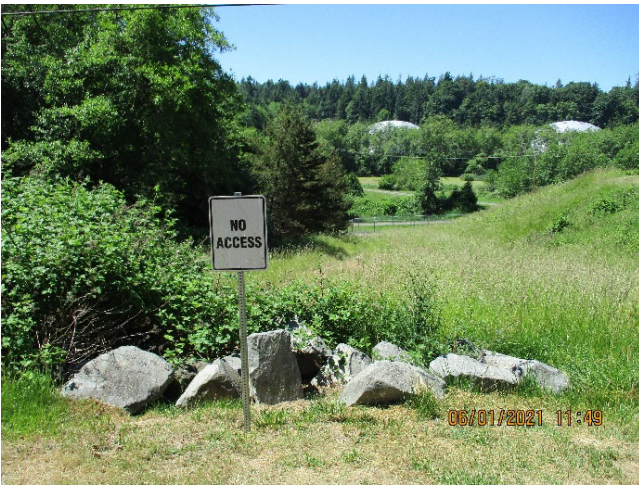
**Photograph 11****File Name:** IMG_0032.JPG**Description:** Former access road forming northwest site boundary, facing southwest.

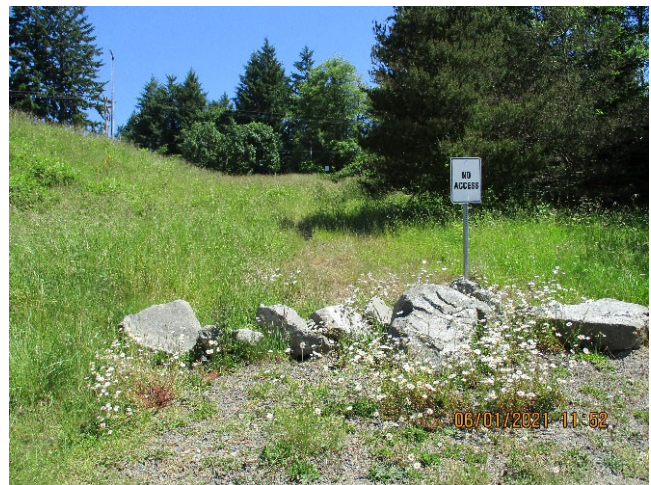
**Photograph 12****File Name:** IMG_0033.JPG**Description:** Former access road forming northwest site boundary, facing northeast.
