**FINAL**  
**2017 LAND USE CONTROL INSPECTION TECHNICAL MEMORANDUM**  
**FLEET LOGISTICS CENTER PUGET SOUND**  
**MANCHESTER FUEL DEPOT**  
**MANCHESTER, WASHINGTON**

**Prepared by**  
**Battelle**  
**Columbus, Ohio**

**Prepared for**  
**Naval Facilities Engineering Command Northwest**  
**Silverdale, Washington**

**October 9, 2017**

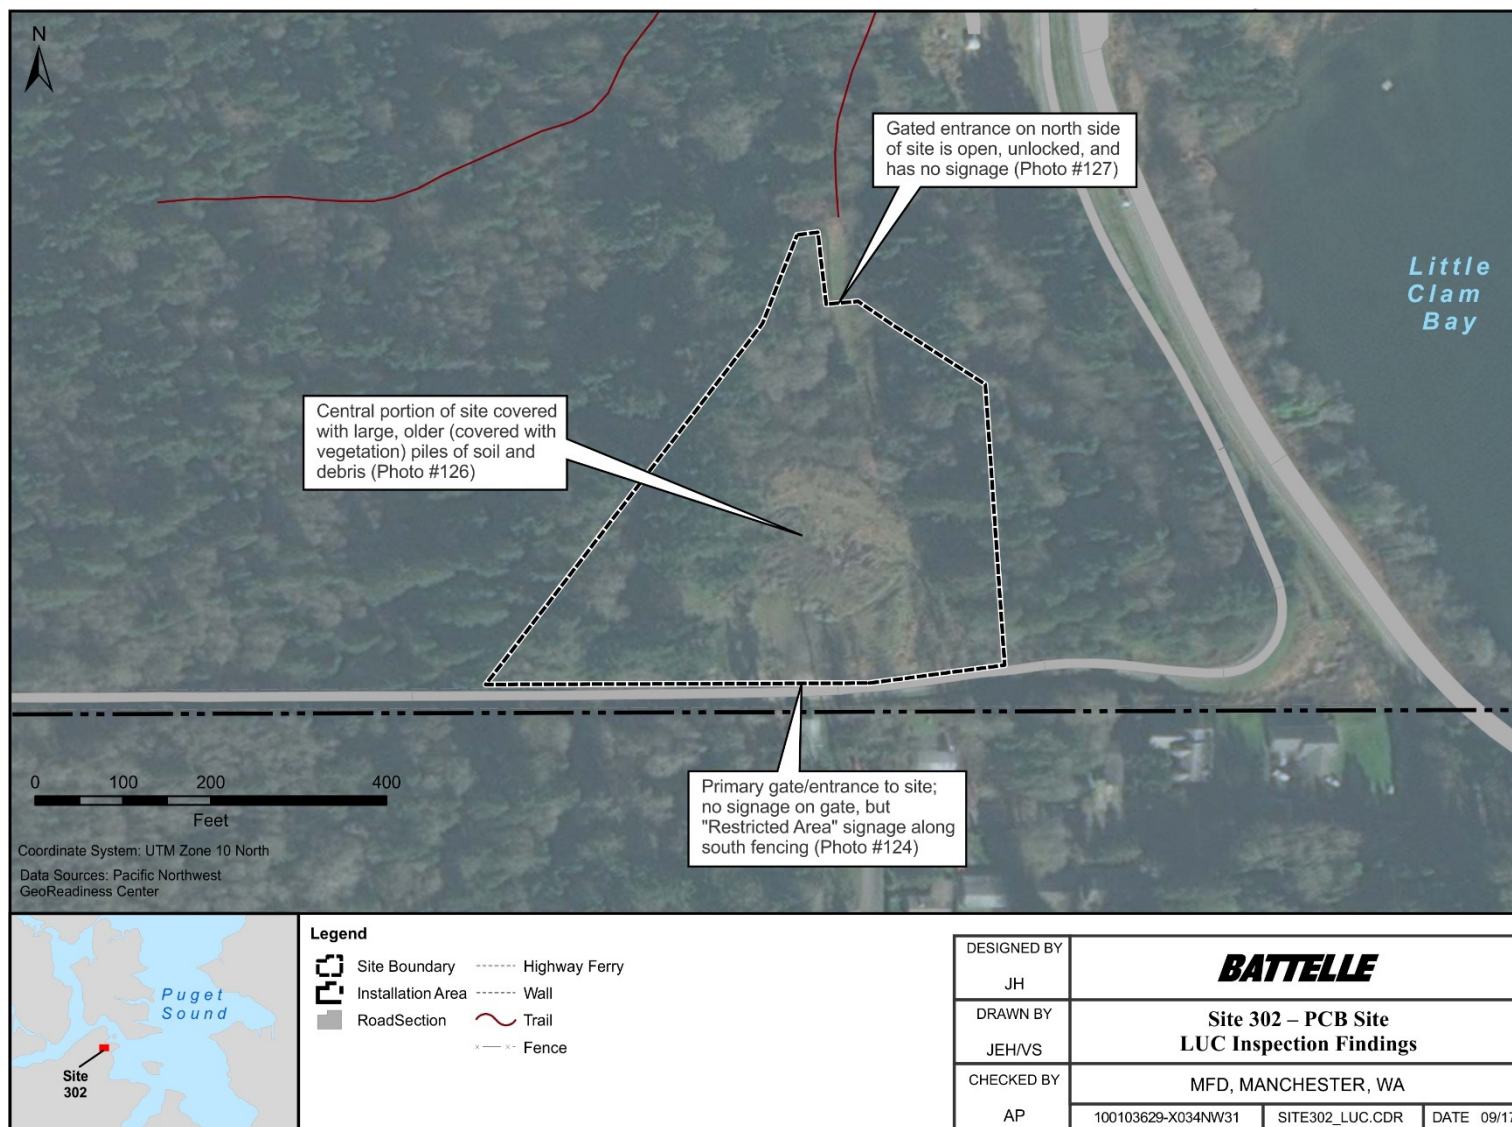
Figure 3. Site 302 – PCB Site LUC Inspection Findings

During the LUC inspection, it was determined that land use remains for industrial purposes and there has been no unauthorized soil excavation or disturbance. The most salient findings were:

The locations of these findings are depicted in Figure 3. The LUC inspection checklist for Site 302 was completed based on these findings/observations and is provided in Appendix A. The field notes and photographs from Site 302 are provided in Appendices C and D, respectively.

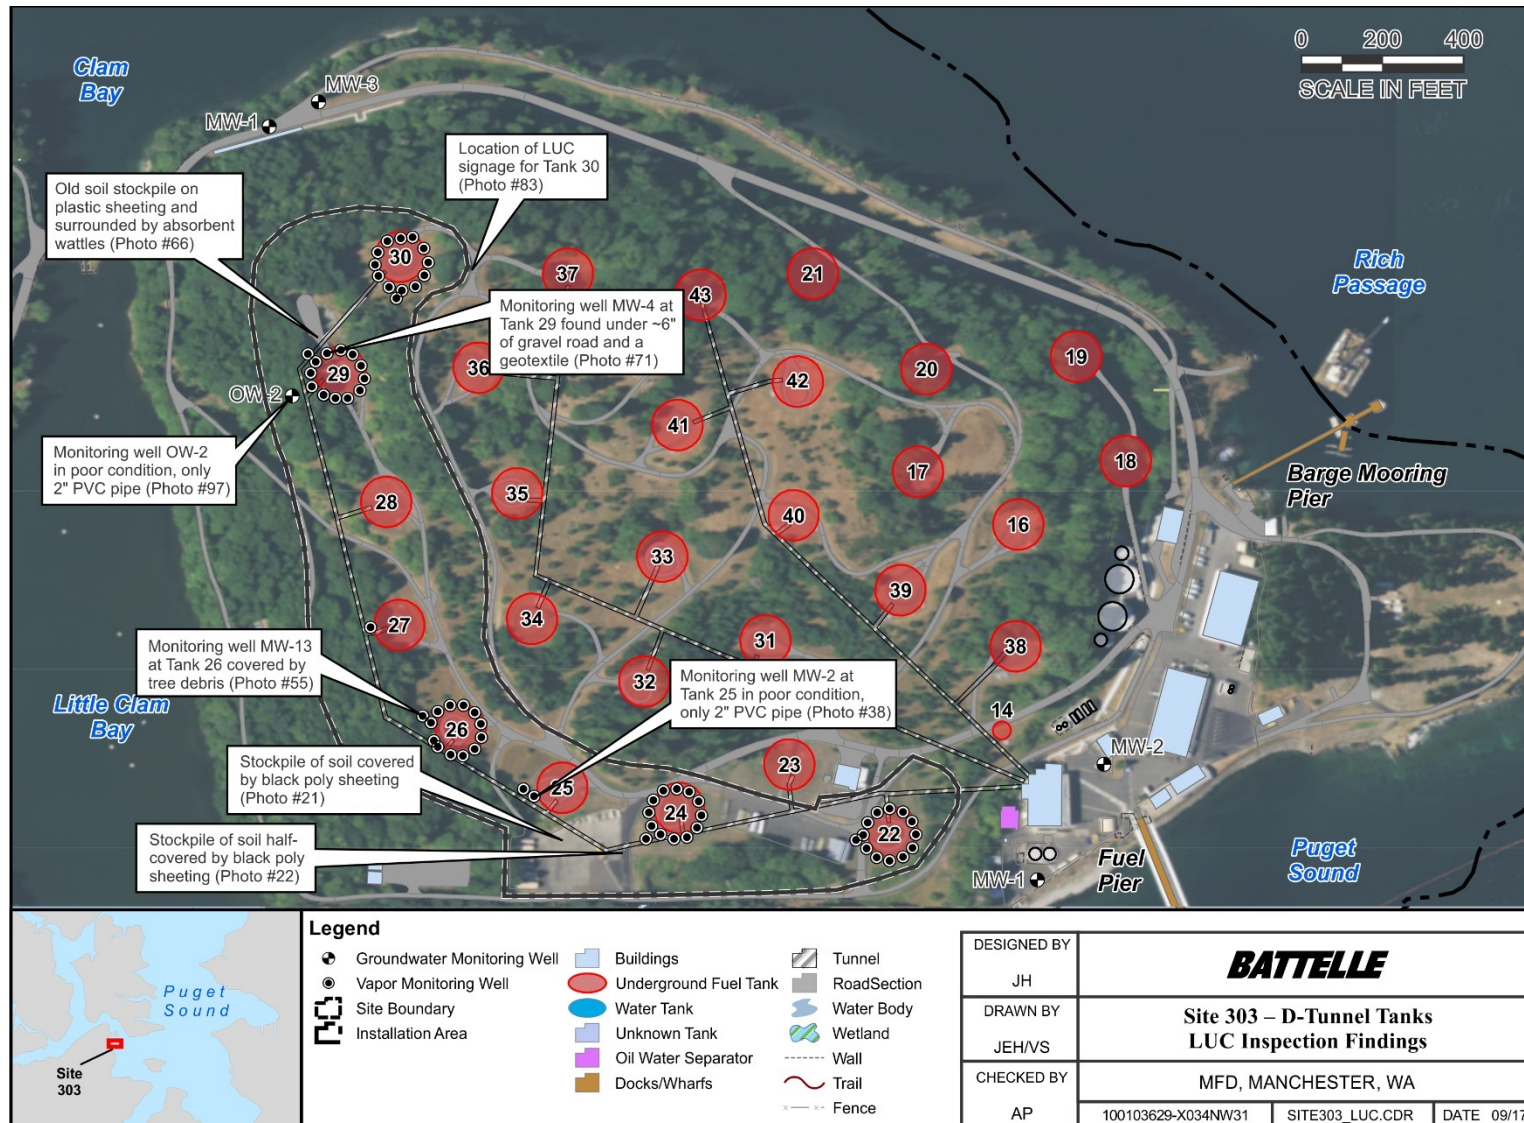
Figure 4. Site 303 – D-Tunnel Tanks LUC Inspection Findings

1. An unmarked stockpile of soil covered by black poly sheeting in the northwest corner of the construction laydown area southwest of Tank 24 (Photo #21).
2. An unmarked stockpile of soil half-covered by black poly sheeting along the eastern boundary of the construction laydown area southwest of Tank 24 (Photo #22).
3. Old stockpile of soil on a tarp and surrounded by absorbent wattles in the laydown area north of Tank 29 (Photo #66).

The locations of these findings are depicted in Figure 4. The LUC inspection checklist for Site 303 was completed based on these findings/observations and is provided in Appendix A. The field notes and photographs from Site 303 are provided in Appendices C and D, respectively. It was also noted that new LUC signage warning against unauthorized excavation was placed at Tanks 22, 24, 25, 26, 27, and 28. Previous LUC signage is still in place at Tanks 29 and 30. To note, the signage at Tank 30 is located at the access road to the tank, not at the tank itself as with other signage (Photo #83). Although not specifically related to the LUCs, there are 17 inadequately labeled 55-gallon drums located along the southern boundary of the construction laydown area southwest of Tank 24 (Photo #20).

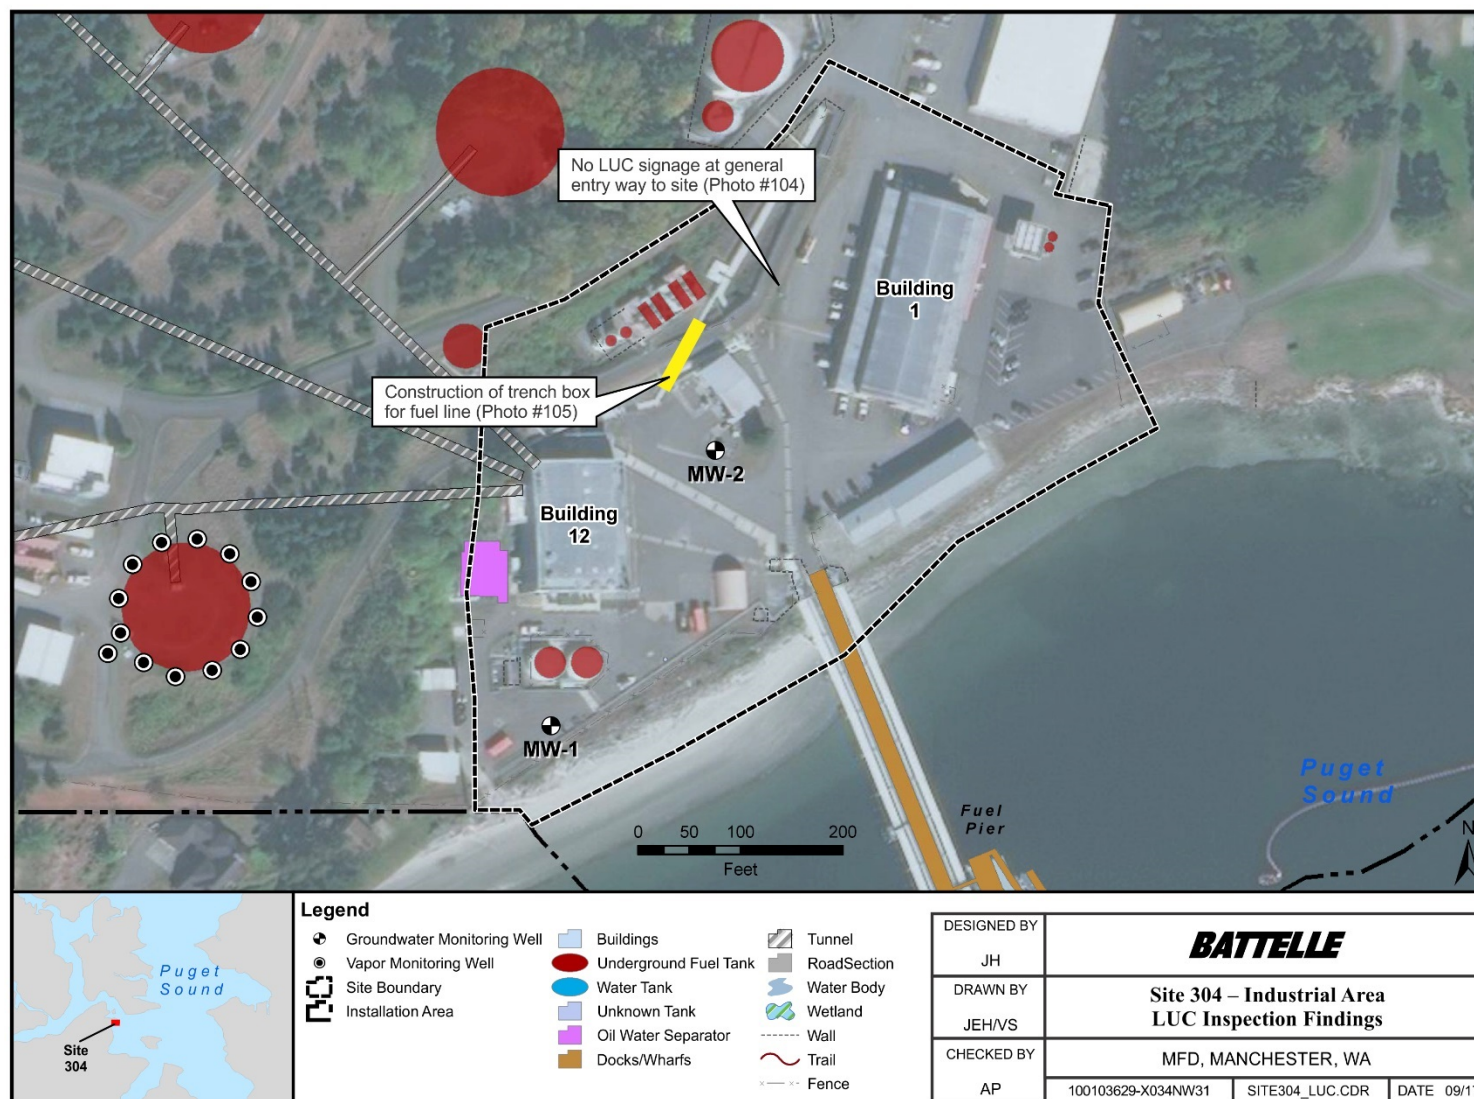
Figure 5. Site 304 – Industrial Area LUC Inspection Findings

1. There is no LUC signage at the general entry way to Site 304 (Photo #104).
2. There is construction of a trench box for a fuel line (i.e., excavation activities; Photo #105).  
However, given the specifications/requirements for this type of work, it is authorized.

The locations of these findings are depicted in Figure 5. The LUC inspection checklist for Site 304 was completed based on these findings/observations and is provided in Appendix A. The field notes and photographs from Site 304 are provided in Appendices C and D, respectively.

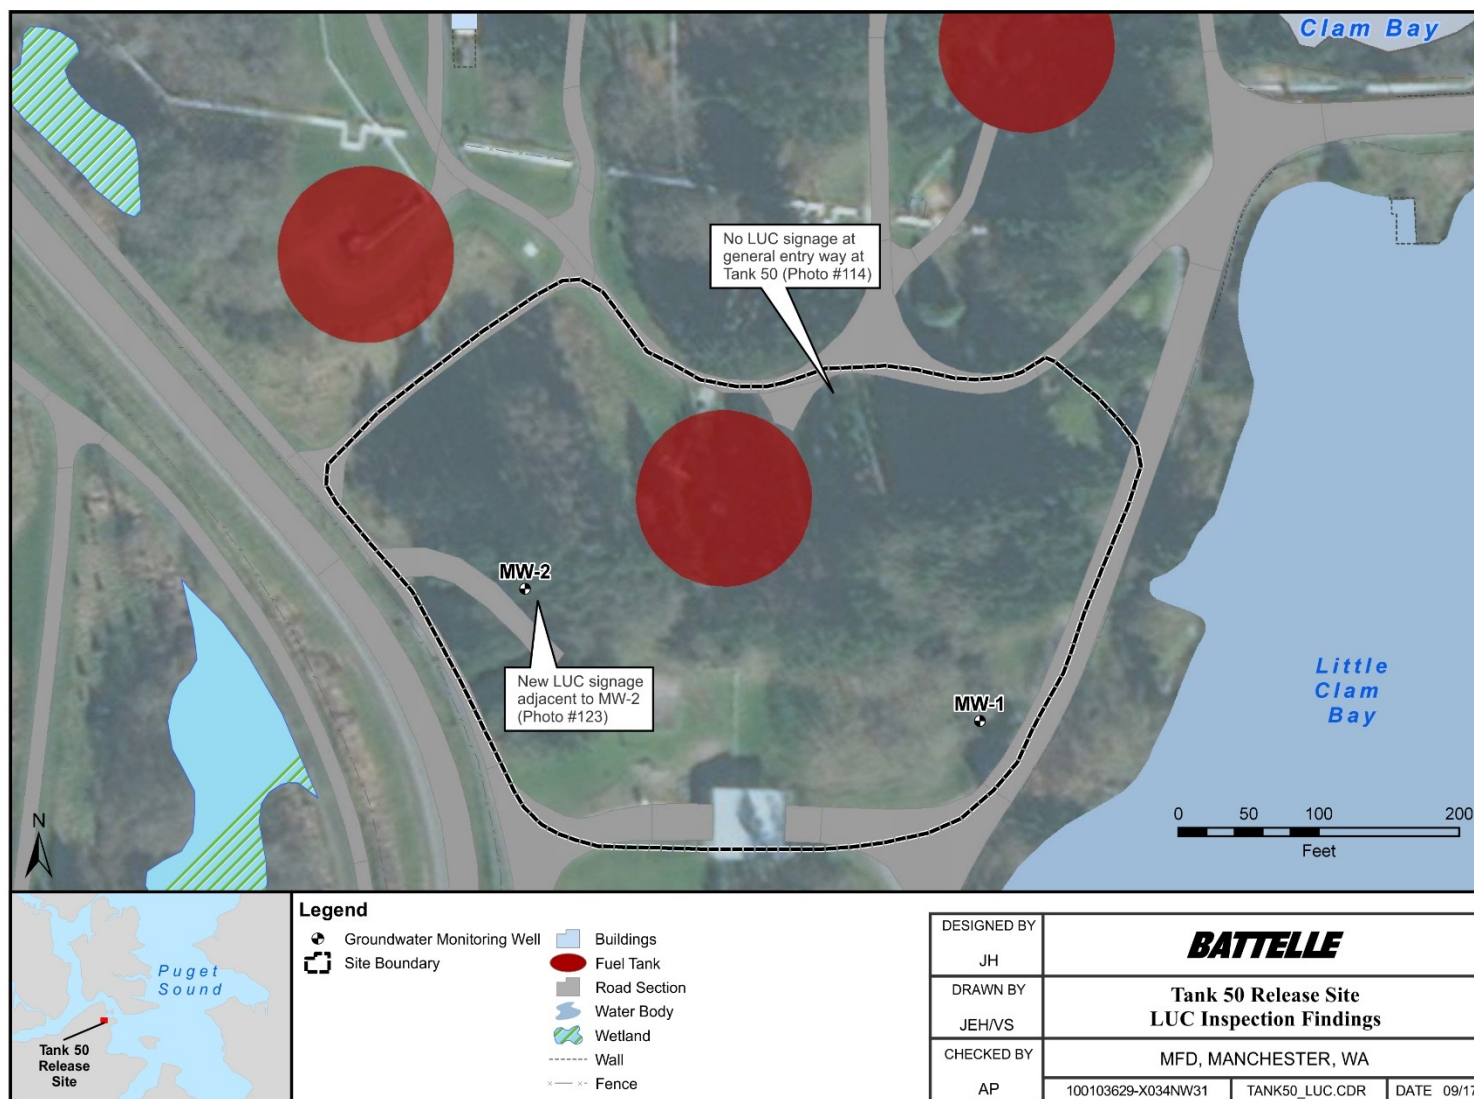
Figure 6. Tank 50 Release Site LUC Inspection Findings

During the LUC inspection, it was determined that remaining areas of concern are identified on facility maps and specified in facility permit instruction (i.e., as it was a recommended update for the Contractor Environmental and Safety Guide [Battelle, 2016a]); land use remains for industrial purposes; no production wells were installed and groundwater was not used (except for monitoring and/or remediation); monitoring wells have been protected; and there has been no unauthorized soil excavation or disturbance. The most salient site finding was:

The location of this finding is depicted in Figure 6. The LUC inspection checklist for Tank 50 was completed based on these findings/observations and is provided in Appendix A. The field notes and photographs from Tank 50 are provided in Appendices C and D, respectively.

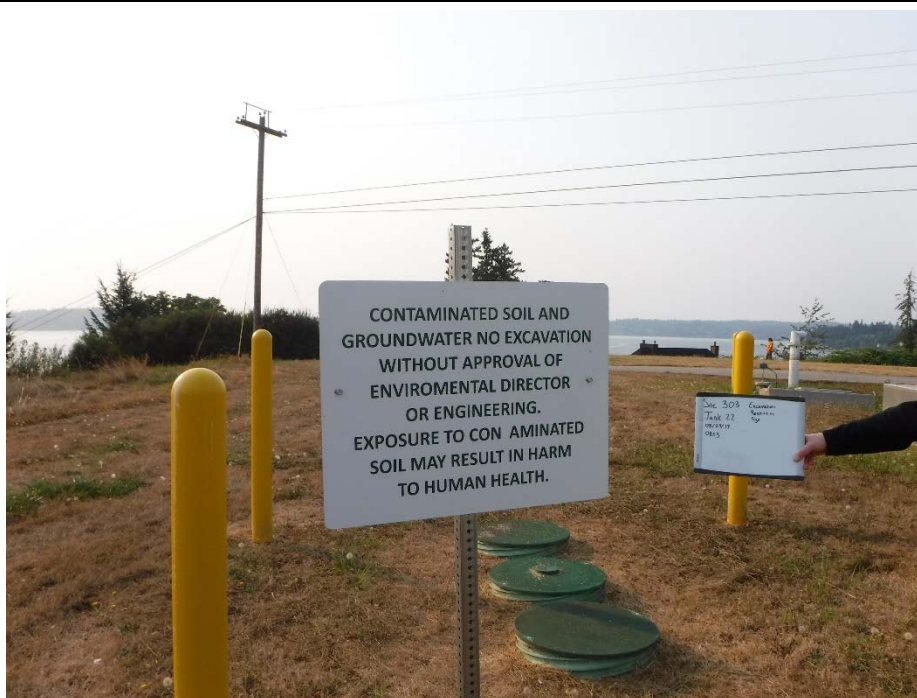
**Photo #2 - Description:** Site 303, Tank 22, new LUC excavation restriction signage

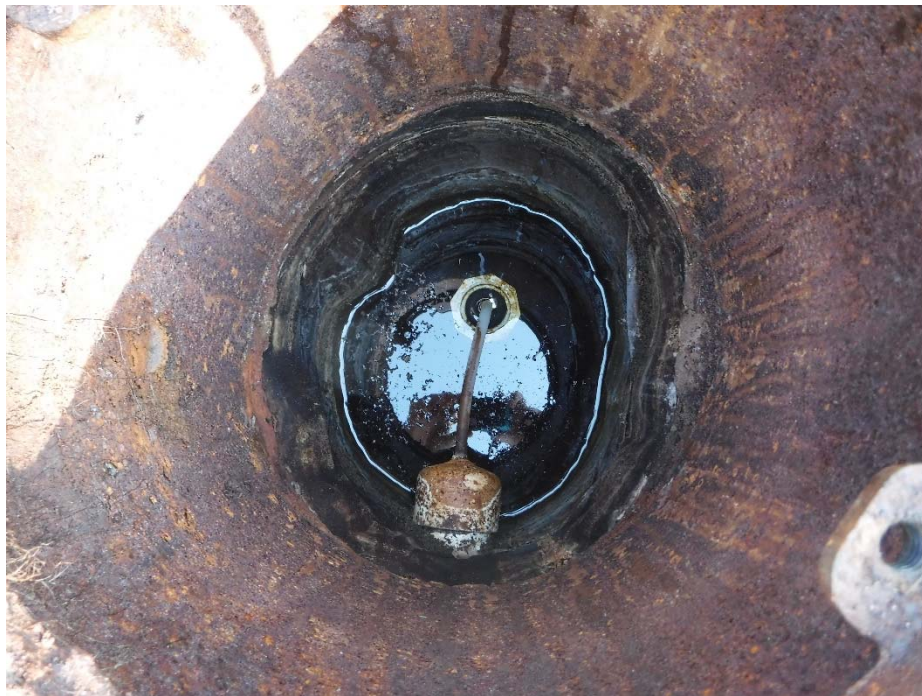
**Photo #16 - Description:** Site 303, Tank 22, MW-13, water in monument up to top of casing, adjacent to Soil Sentry System

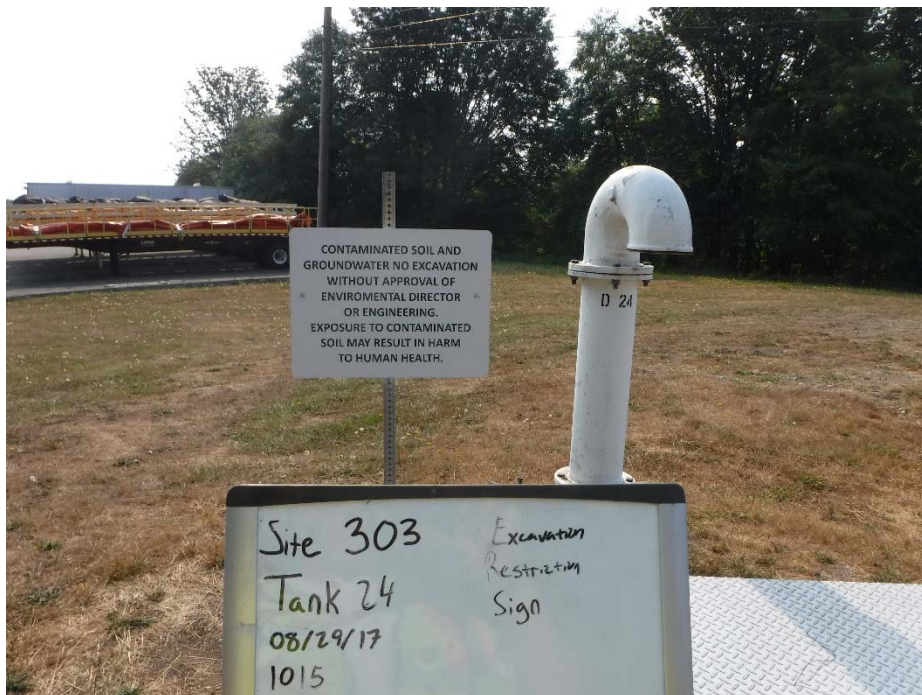
**Photo #18 - Description:** Site 303, Tank 24, new LUC excavation restriction signage

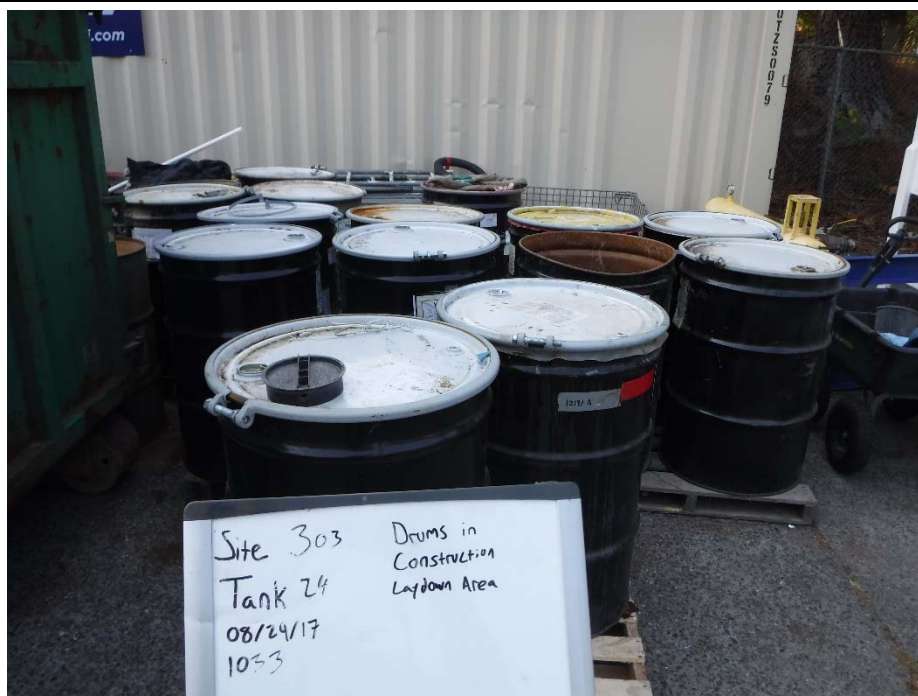
**Photo #20 - Description:** Site 303, 55-gal drums along S boundary of construction laydown area SW of Tank 24

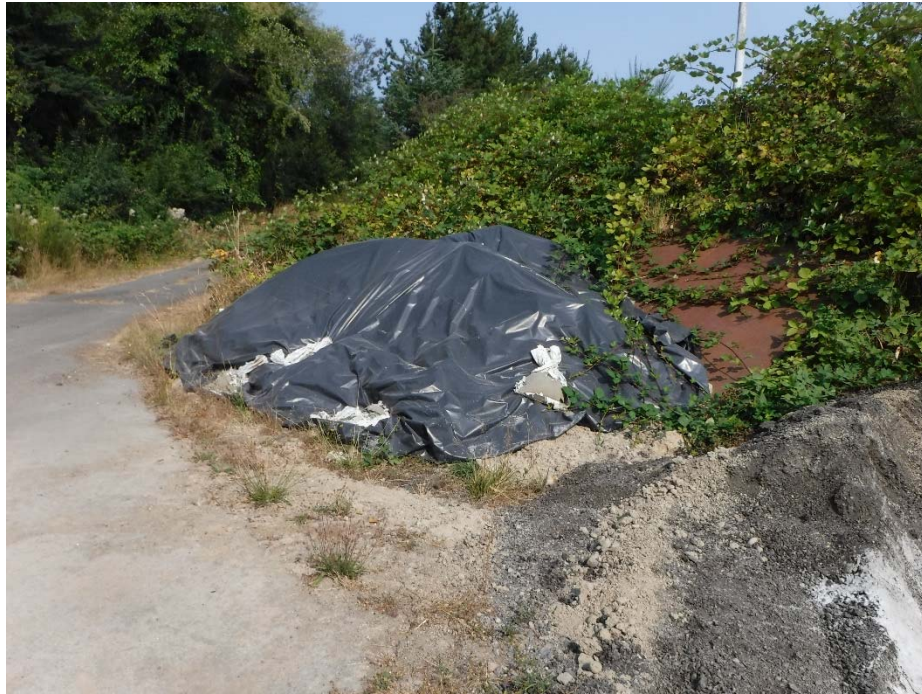
**Photo #21 - Description:** Site 303, soil stockpile with tarp in NW corner of construction laydown area

<b>Site 303 - D-Tunnel Tanks</b>	
An unmarked stockpile of soil covered by black poly sheeting in the northwest corner of the construction laydown area southwest of Tank 24 (Photo #21).	Confirm soil stockpile is authorized reusable material and is located in an approved staging area. Post approval permit from MFD Environmental for staging material at job site.
An unmarked stockpile of soil half-covered by black poly sheeting in the along the eastern boundary of the construction laydown area southwest of Tank 24 (Photo #22).	Confirm soil stockpile is authorized reusable material and is located in an approved staging area. Post approval permit from MFD Environmental for staging material at job site.
Old stockpile of soil on a tarp and surrounded by absorbent wattles in the laydown area north of Tank 29 (Photo #66).	Properly characterize, transport, and dispose of (off site) the soil.

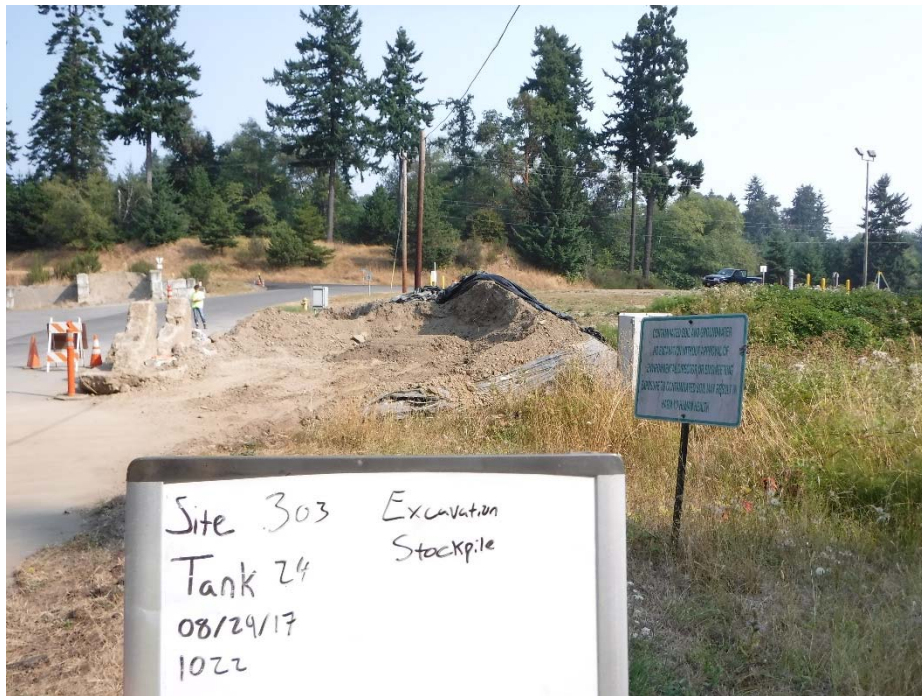
**Photo #22 - Description:** Site 303, excavation stockpile and older excavation restriction signage along E boundary of construction laydown area

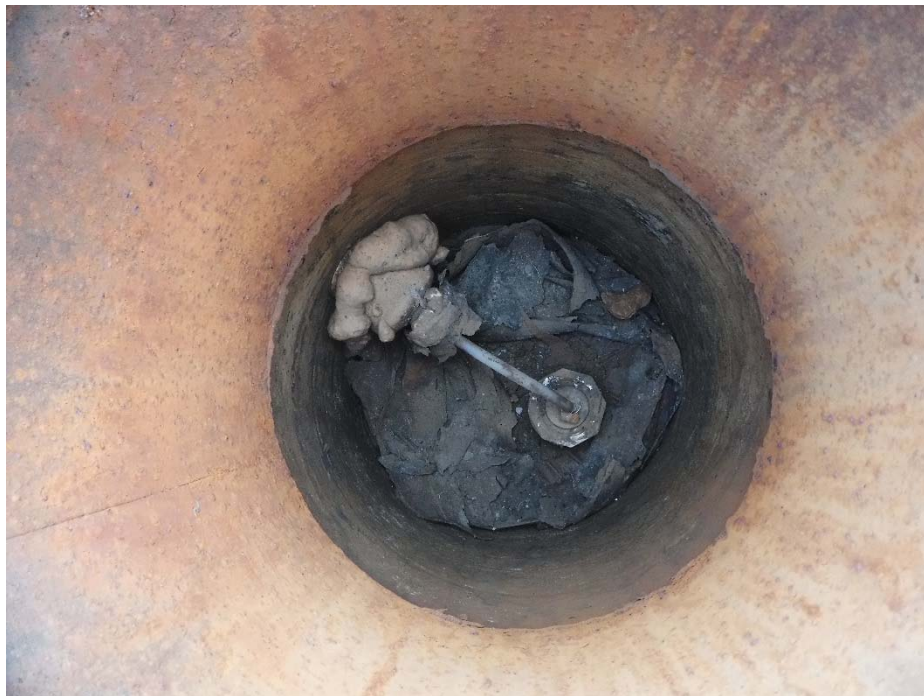
**Photo #24 - Description:** Site 303, Tank 24, MW-2, buried under  
~3 inches of dirt/soil

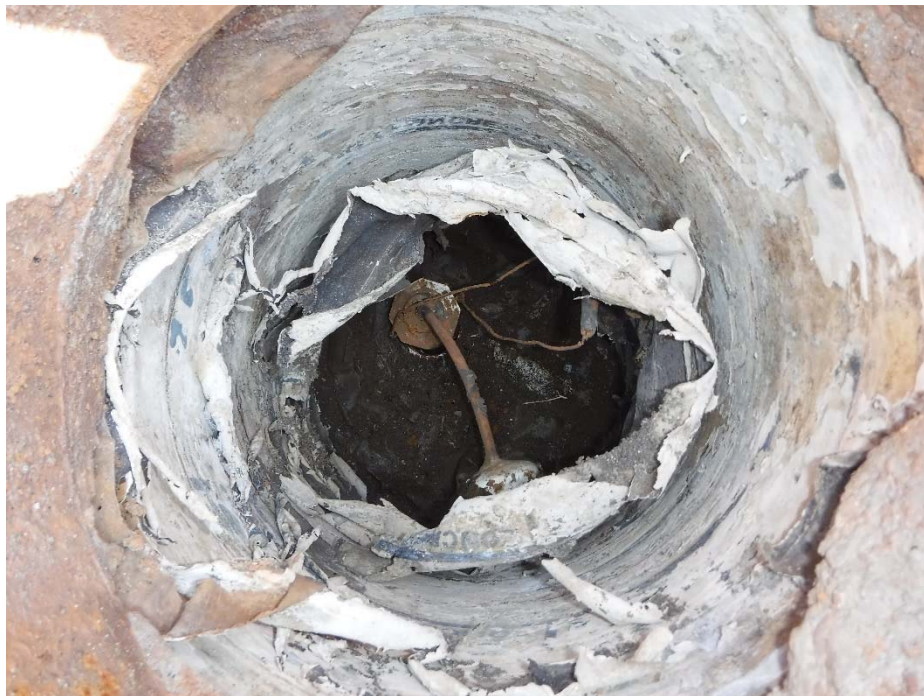
28	Located in middle of road. Well ~3 feet deep in monument.
MW-7	64096.43	371477.90	NA	29	Well fully submerged under water, preventing well condition determination. Some sheen in water.
MW-8	64093.93	371487.30

**Photo #28 - Description:** Site 303, Tank 24, MW-6, located in middle of road, well ~3 feet deep in monument

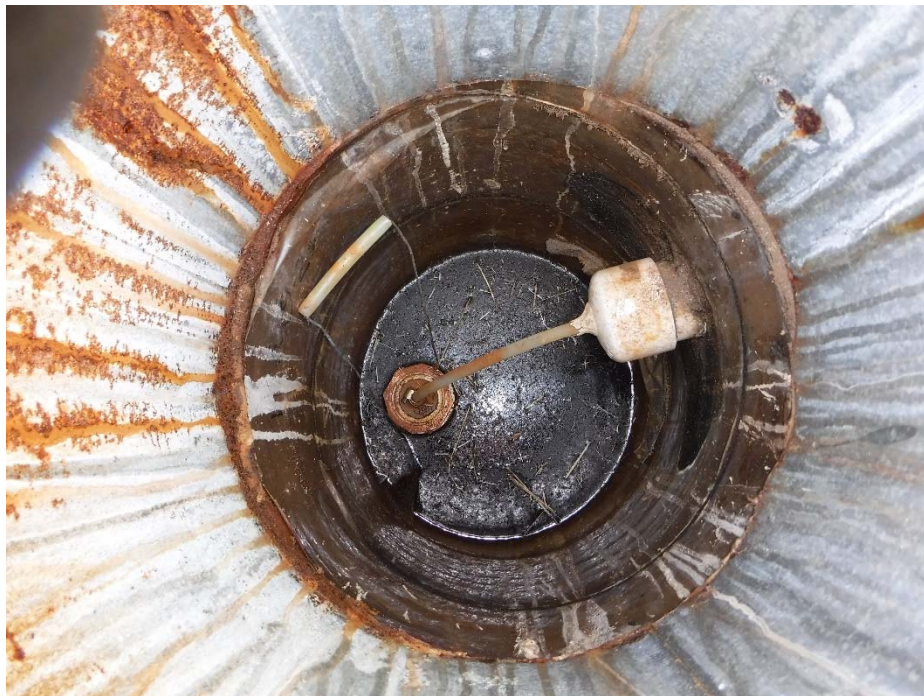
**Photo #30 - Description:** Site 303, Tank 24, MW-8, water in monument

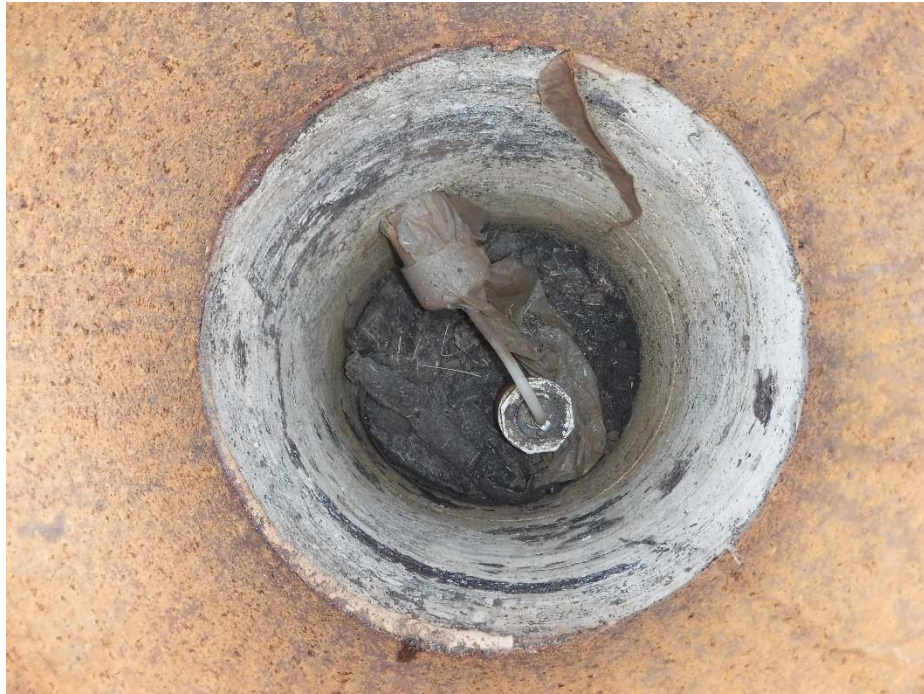
**File Name:** 303-Tank24-MW11-DSCF1676  
**Date Taken:** 08/29/17

**Photo #33 - Description:** Site 303, Tank 24, MW-11

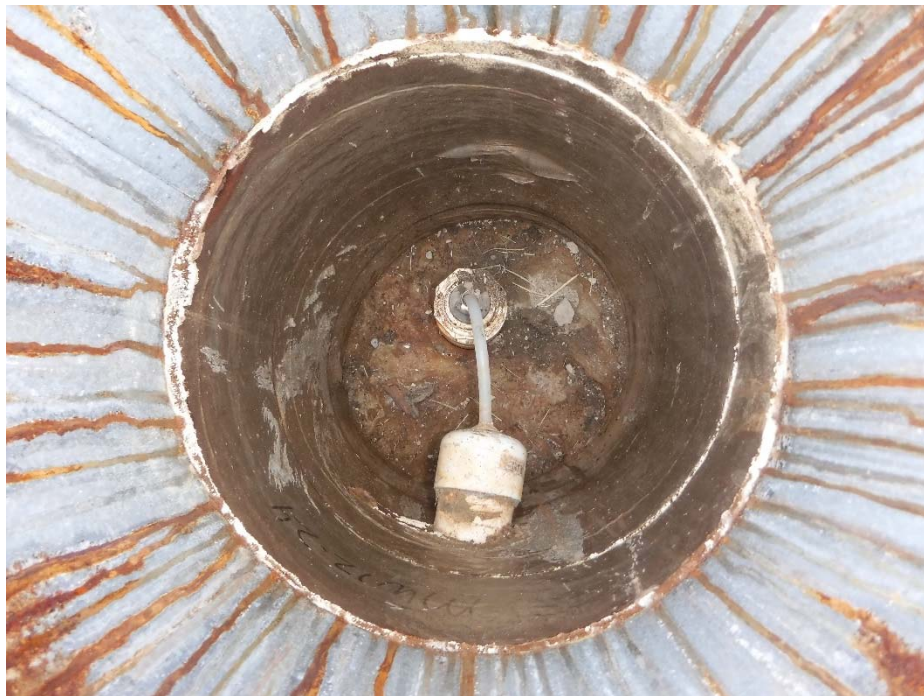
**File Name:** 303-Tank24-MW12-DSCF1678  
**Date Taken:** 08/29/17

**Photo #34 - Description:** Site 303, Tank 24, MW-12

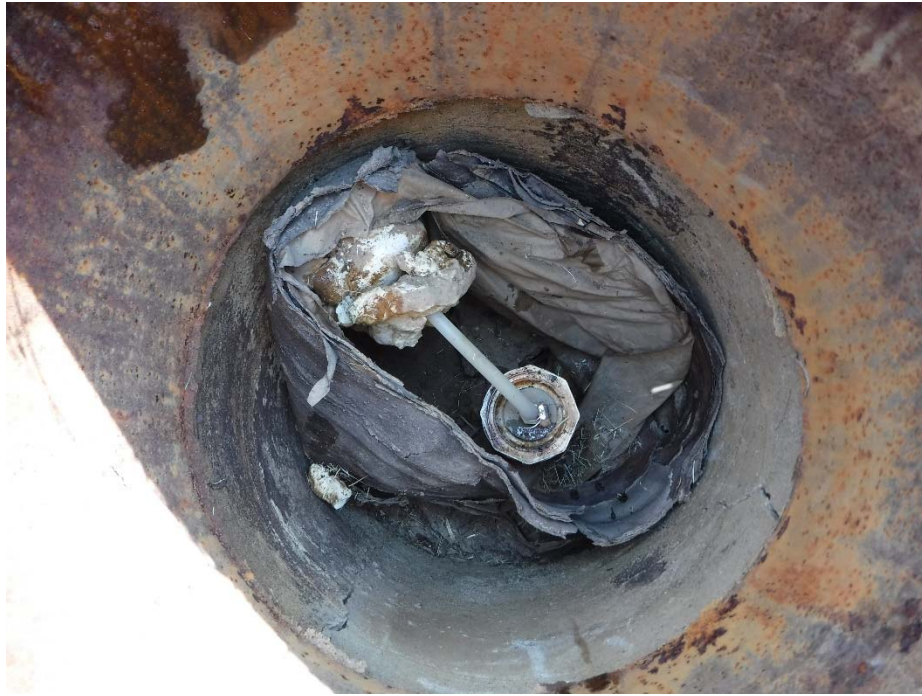
**File Name:** 303-Tank24-MW13-DSCF1687  
**Date Taken:** 08/29/17

**Photo #35 - Description:** Site 303, Tank 24, MW-13, interior lining laying within monument

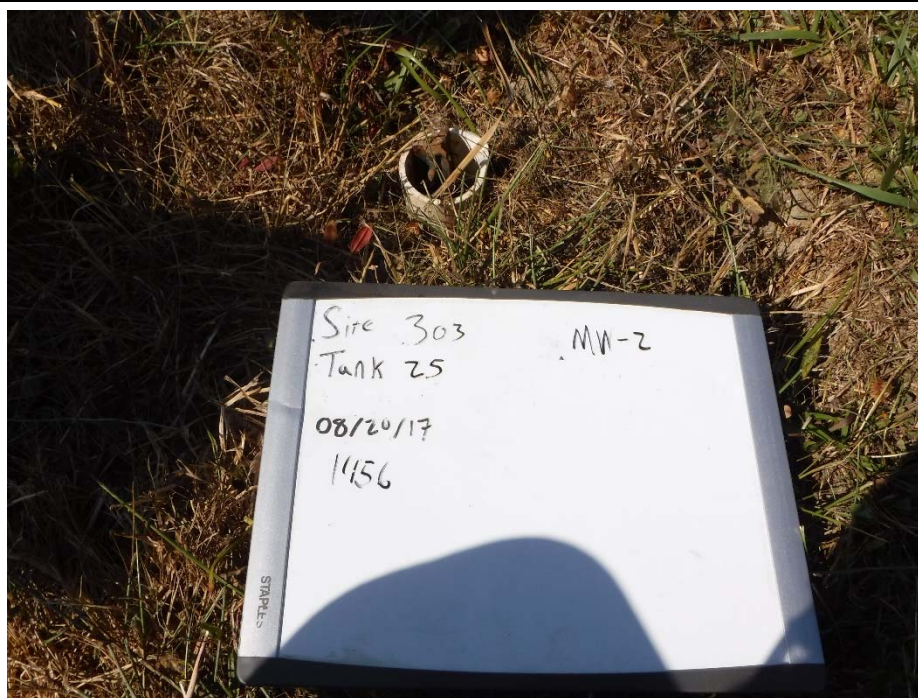
**File Name:** 303-Tank25-MW2-DSCF1732  
**Date Taken:** 08/29/17

<b>Findings</b>	<b>Recommendations</b>
Both vapor monitoring well MW-2 at Tank 25 and groundwater monitoring well OW-2 were found to be in poor condition with only the 2-inch PVC piping or casing exposed at the ground surface (Photos #38 and #97, respectively).	As recommended in the <i>Well Rehabilitation and Decommissioning Study, Fleet Logistics Center Puget Sound Manchester Fuel Depot, Manchester, Washington</i> (Battelle, 2017), vapor monitoring well MW-2 at Tank 25 and groundwater monitoring well OW-2 along with all other monitoring wells within Site 303 will be decommissioned due to the upcoming construction activities. Therefore, it is recommended that the monitoring wells are no longer inspected for general condition and the LUC for protection of existing monitoring wells be discontinued at Site 303. A general condition assessment, depth to water measurement, and depth to product measurement will be collected immediately prior to properly decommissioning each monitoring well.

**Photo #38 - Description:** Site 303, Tank 25, MW-2, only 2-inch PVC piping exposed at ground surface

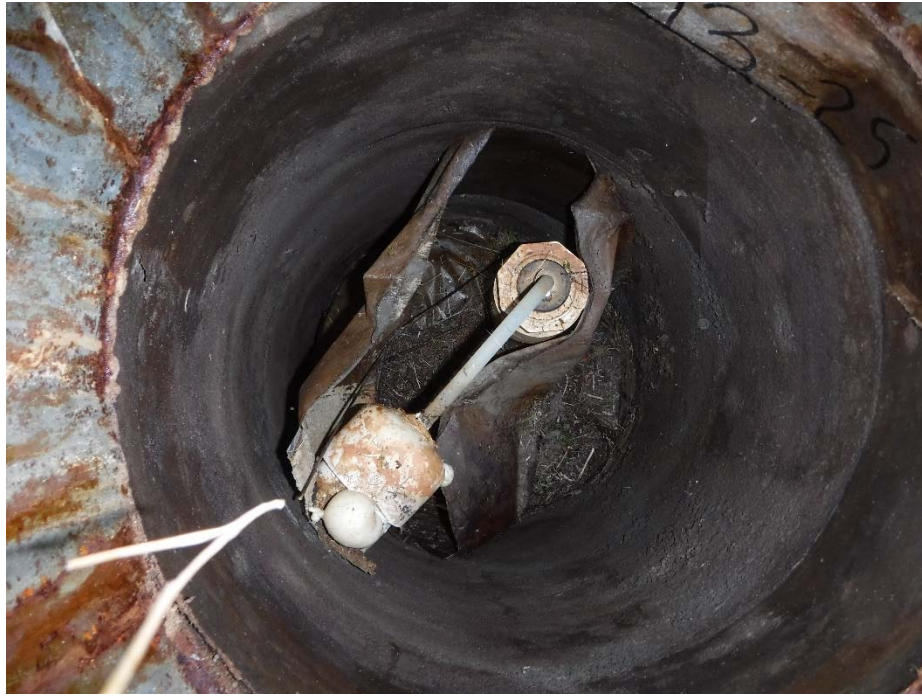
**File Name:** 303-Tank25-MW13-DSCF1735  
**Date Taken:** 08/29/17

**Photo #39 - Description:** Site 303, Tank 25, MW-13, located in tall grass around tank

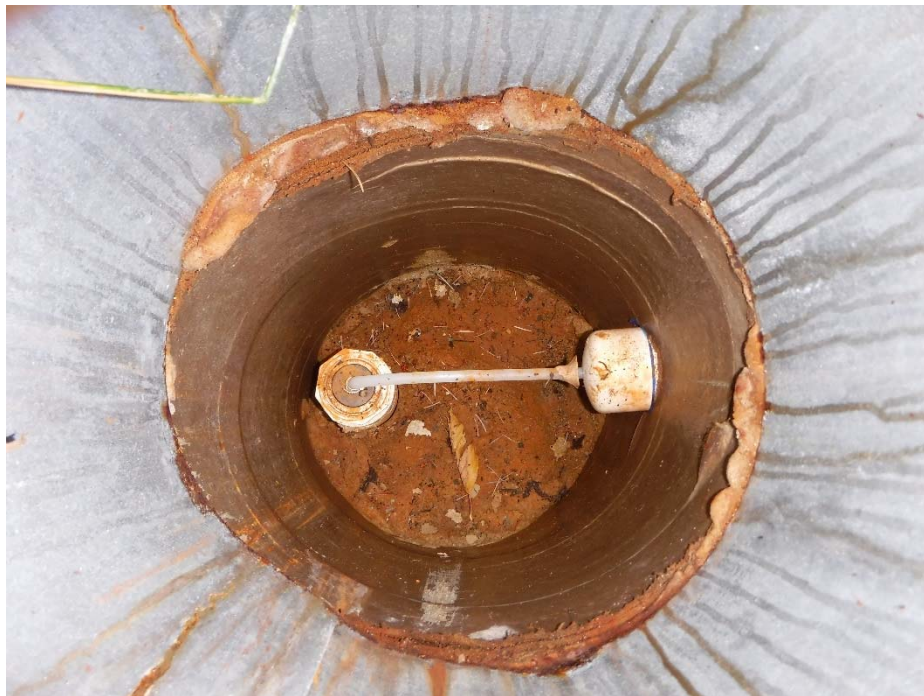
**File Name:** 303-Tank26-MW2-DSCF1719  
**Date Taken:** 08/29/17

**Photo #44 - Description:** Site 303, Tank 26, MW-2, well ~2 feet deep in monument

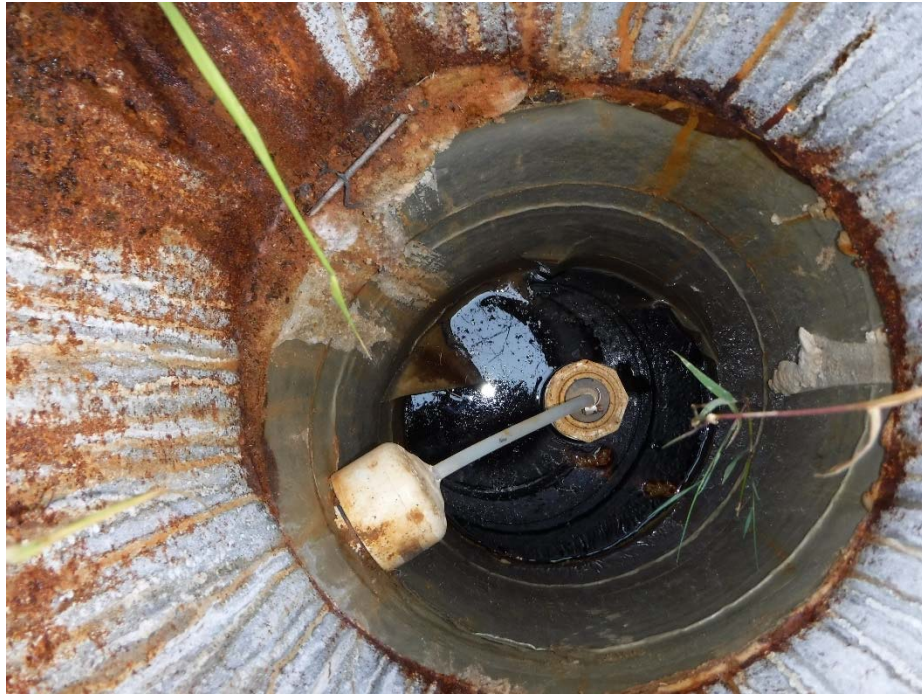
**File Name:** 303-Tank26-MW3-DSCF1717  
**Date Taken:** 08/29/17

**Photo #45 - Description:** Site 303, Tank 26, MW-3, water in monument

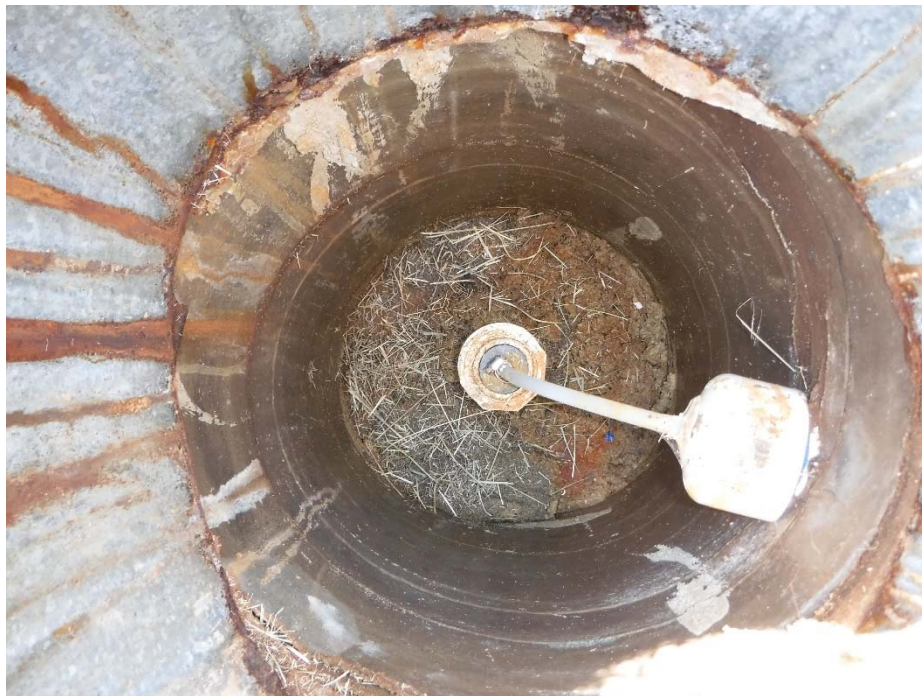
**File Name:** 303-Tank26-MW4-DSCF1715  
**Date Taken:** 08/29/17

**Photo #46 - Description:** Site 303, Tank 26, MW-4, well covered by brush

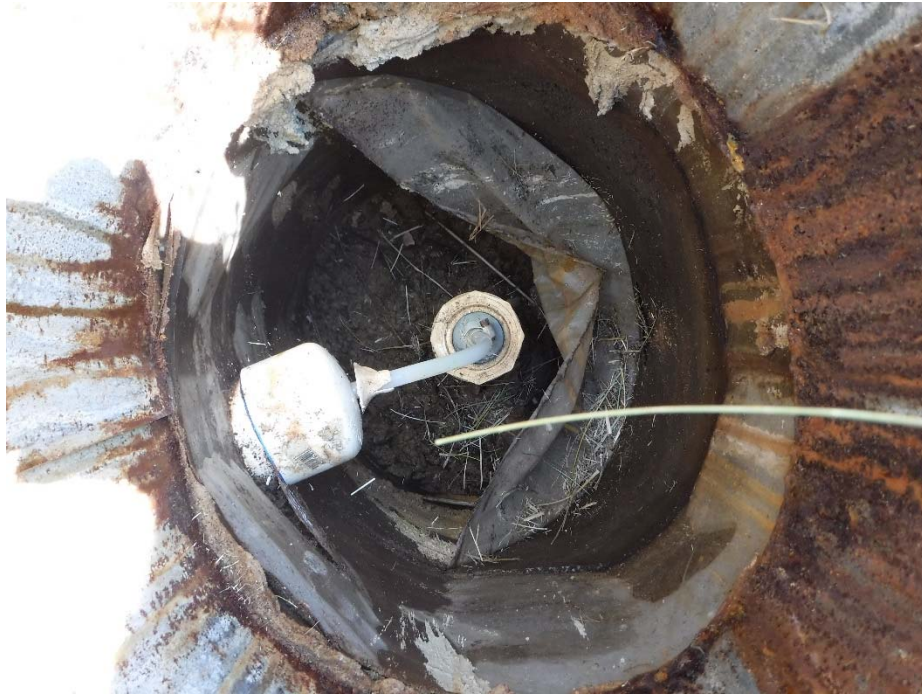
**File Name:** 303-Tank26-MW5-DSCF1713  
**Date Taken:** 08/29/17

**Photo #47 - Description:** Site 303, Tank 26, MW-5, placed cap in well casing

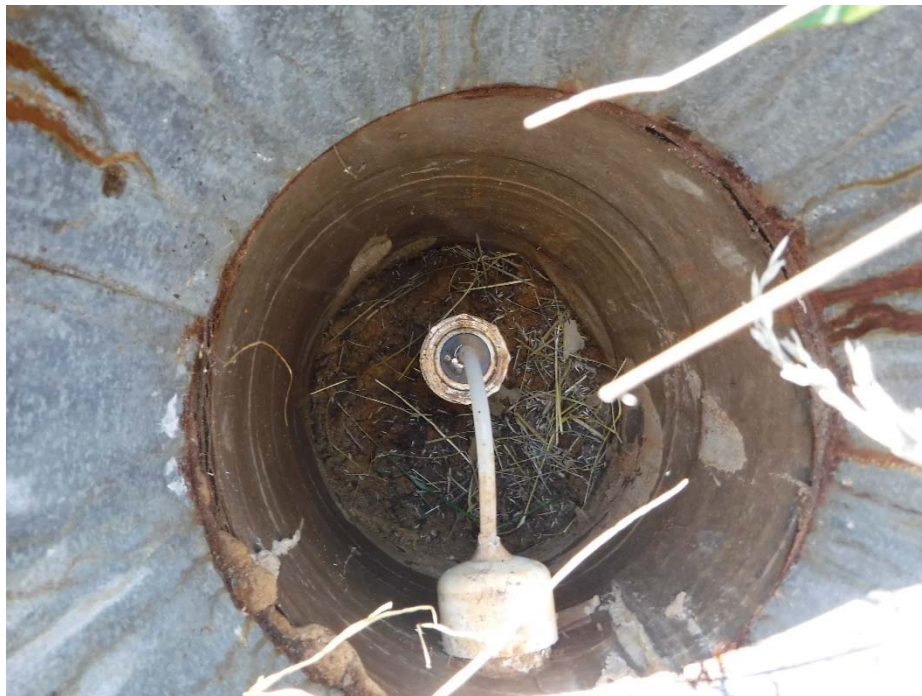
**File Name:** 303-Tank26-MW6-DSCF1711  
**Date Taken:** 08/29/17

**Photo #48 - Description:** Site 303, Tank 26, MW-6, well located in tall grass surrounding tank

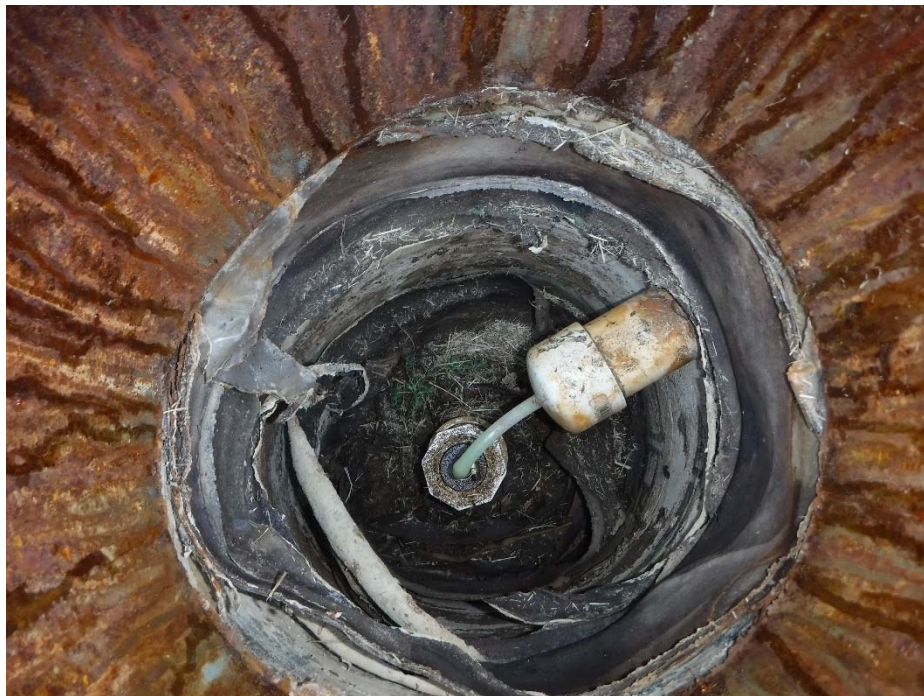
**File Name:** 303-Tank26-MW8-DSCF1707  
**Date Taken:** 08/29/17

**Photo #50 - Description:** Site 303, Tank 26, MW-8, well ID not affixed to well lid, well in middle of road with overgrown vegetation

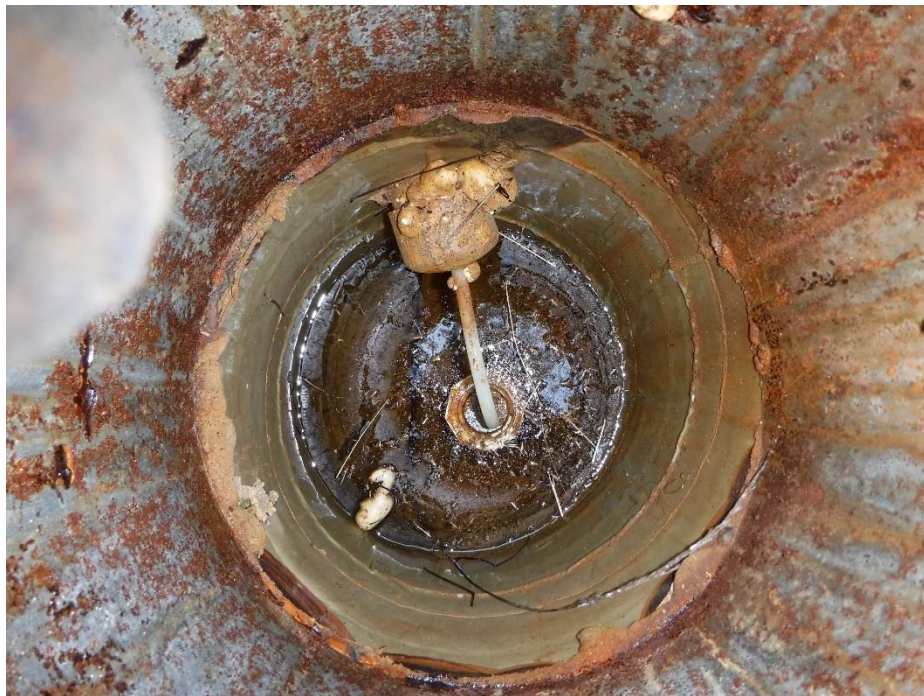
**File Name:** 303-Tank26-MW10-DSCF1727  
**Date Taken:** 08/29/17

**Photo #52 - Description:** Site 303, Tank 26, MW-10, water in monument, slightly above casing

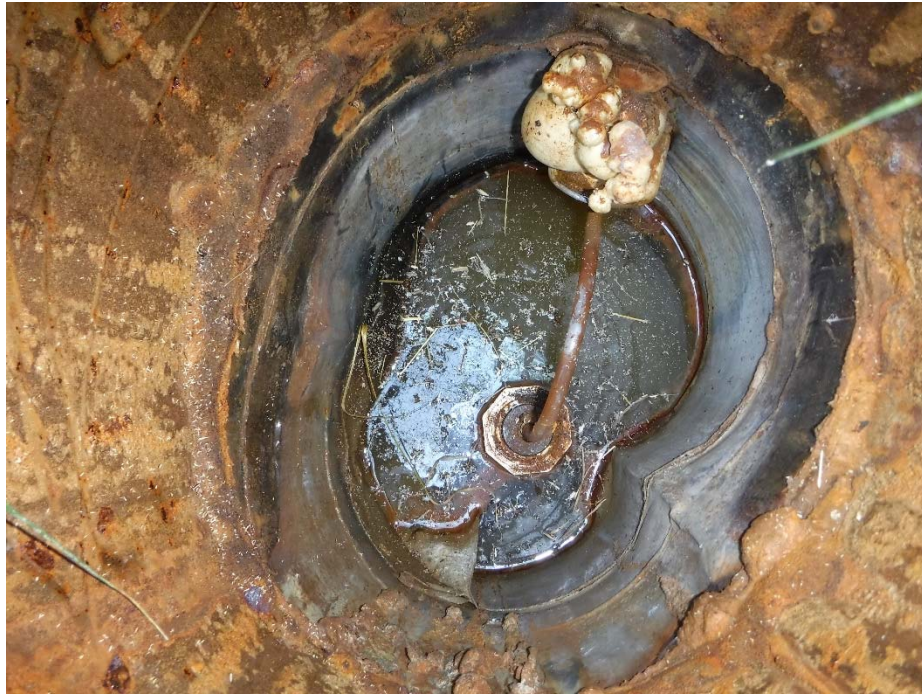
**File Name:** 303-Tank26-MW11-DSCF1725  
**Date Taken:** 08/29/17

**Photo #53 - Description:** Site 303, Tank 26, MW-11, water in monument to top of casing
