**FINAL**  
**2017 LAND USE CONTROL INSPECTION TECHNICAL MEMORANDUM**  
**FLEET LOGISTICS CENTER PUGET SOUND**  
**MANCHESTER FUEL DEPOT**  
**MANCHESTER, WASHINGTON**

**Prepared by**  
**Battelle**  
**Columbus, Ohio**

**Prepared for**  
**Naval Facilities Engineering Command Northwest**  
**Silverdale, Washington**

**October 9, 2017**

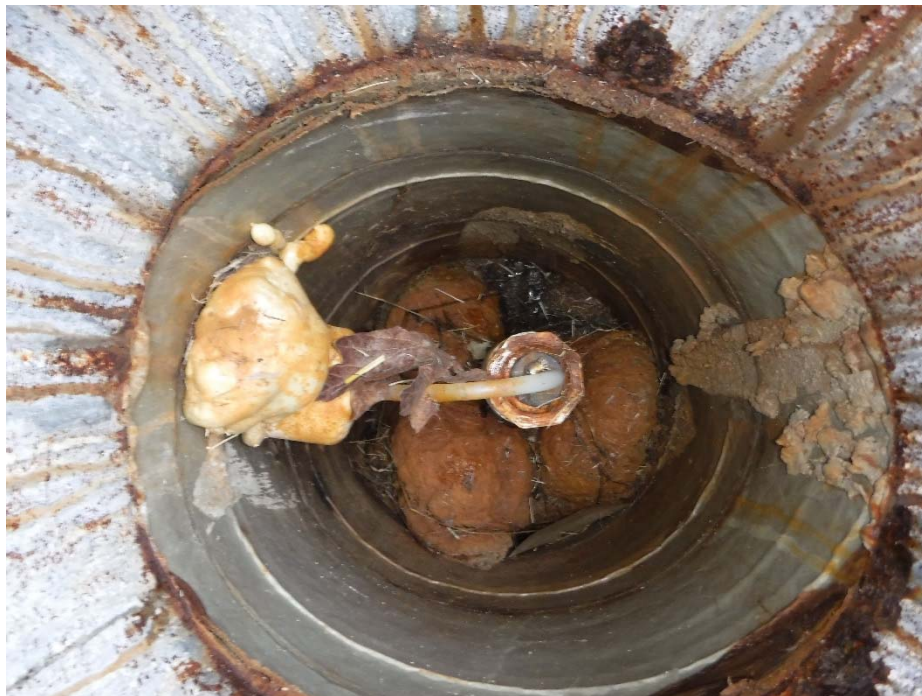
**File Name:** 303-Tank26-MW12-DSCF1723  
**Date Taken:** 08/29/17

**Photo #54 - Description:** Site 303, Tank 26, MW-12, spray foam inside well monument

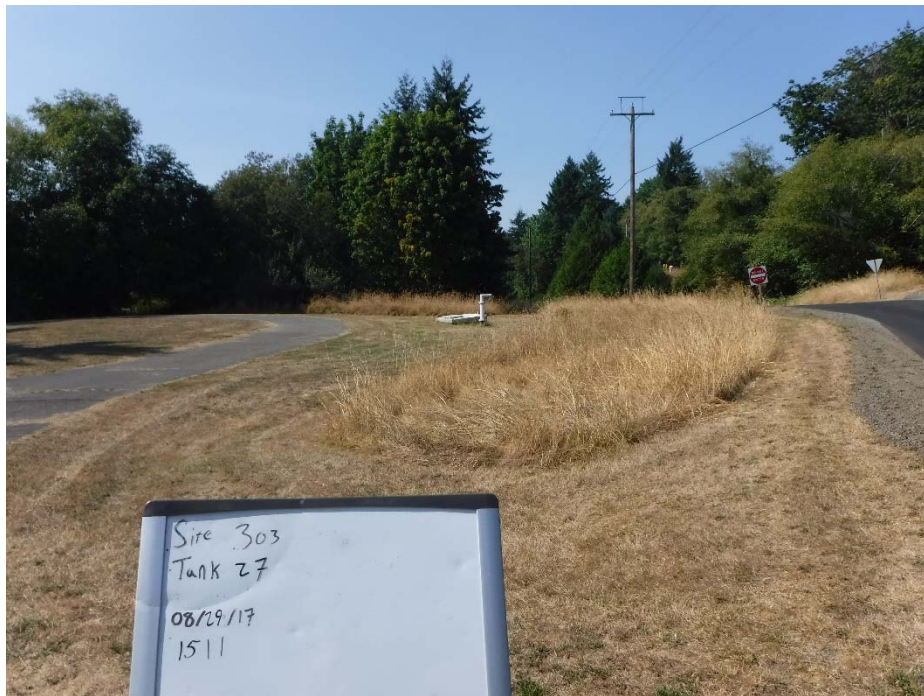
**File Name:** 303-Tank27-DSCF1743  
**Date Taken:** 08/29/17

**Photo #56 - Description:** Site 303, Tank 27, view W across site

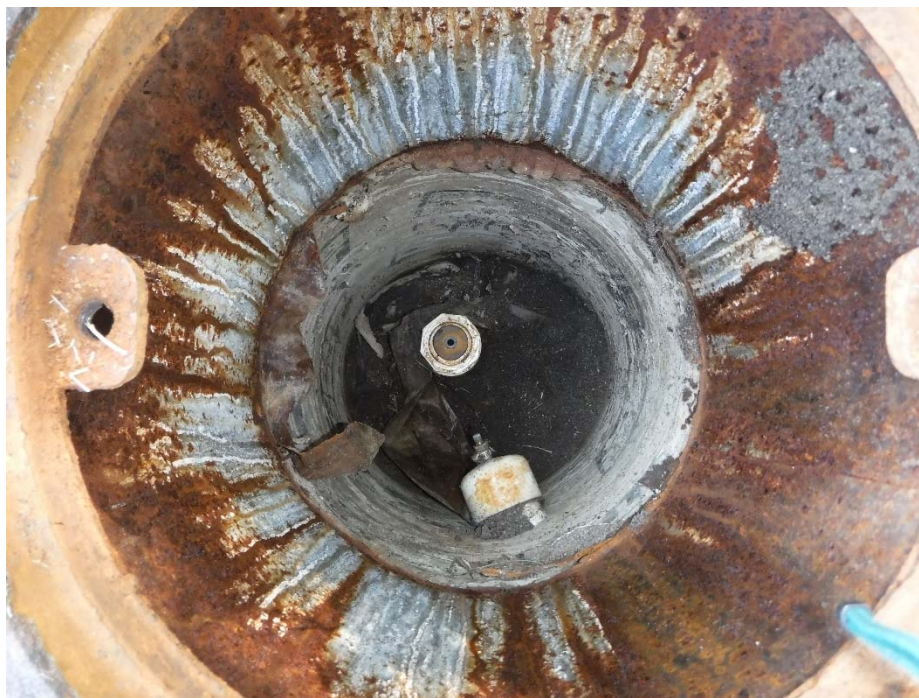
**File Name:** 303-Tank27-MW1-DSCF1746  
**Date Taken:** 08/29/17

**Photo #58 - Description:** Site 303, Tank 27, MW-1, flex tube missing, well not connected to soil sentry system

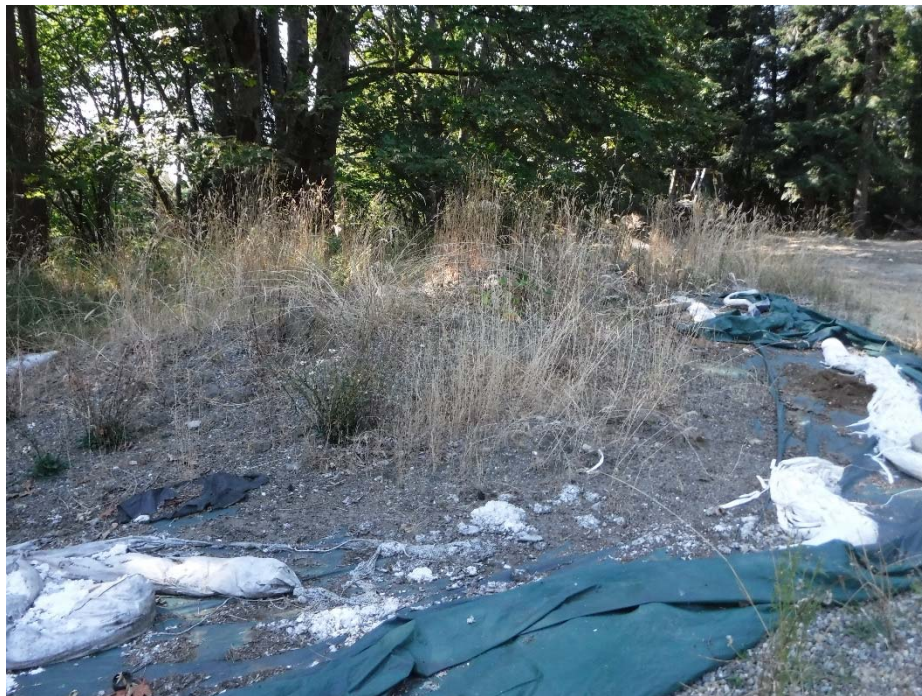
**File Name:** 303-Tank29-DSCF1772  
**Date Taken:** 08/29/17

1. An unmarked stockpile of soil covered by black poly sheeting in the northwest corner of the construction laydown area southwest of Tank 24 (Photo #21).
2. An unmarked stockpile of soil half-covered by black poly sheeting along the eastern boundary of the construction laydown area southwest of Tank 24 (Photo #22).
3. Old stockpile of soil on a tarp and surrounded by absorbent wattles in the laydown area north of Tank 29 (Photo #66).

**Photo #66 - Description:** Site 303, North of Tank 29, old soil stockpile on tarp surrounded by absorbent wattles in construction area

<b>Site 303 - D-Tunnel Tanks</b>	
An unmarked stockpile of soil covered by black poly sheeting in the northwest corner of the construction laydown area southwest of Tank 24 (Photo #21).	Confirm soil stockpile is authorized reusable material and is located in an approved staging area. Post approval permit from MFD Environmental for staging material at job site.
An unmarked stockpile of soil half-covered by black poly sheeting in the along the eastern boundary of the construction laydown area southwest of Tank 24 (Photo #22).	Confirm soil stockpile is authorized reusable material and is located in an approved staging area. Post approval permit from MFD Environmental for staging material at job site.
Old stockpile of soil on a tarp and surrounded by absorbent wattles in the laydown area north of Tank 29 (Photo #66).	Properly characterize, transport, and dispose of (off site) the soil.

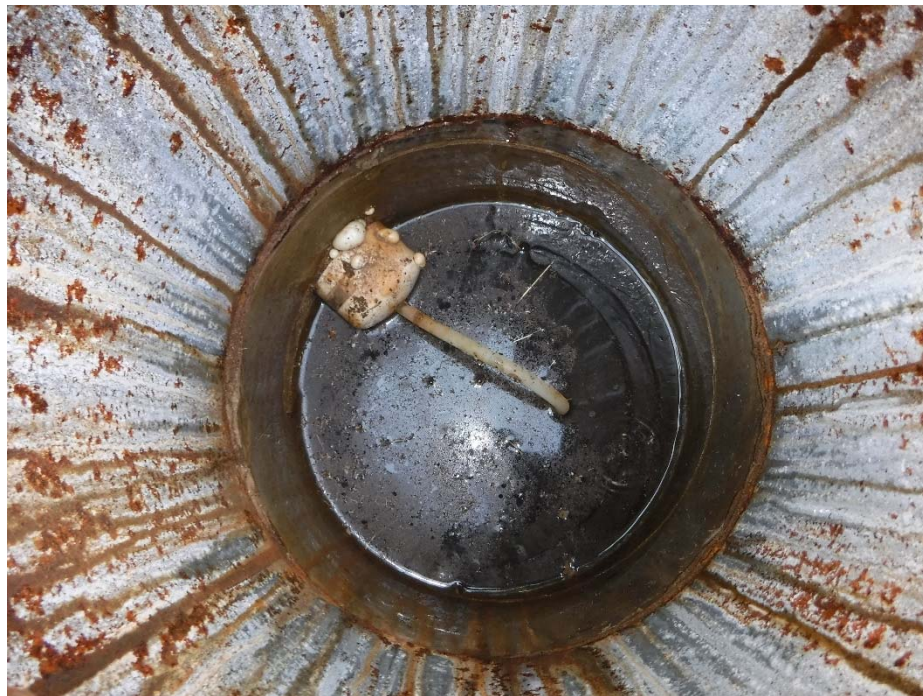
**File Name:** 303-Tank29-MW1-DSCF1788  
**Date Taken:** 08/29/17

**Photo #68 - Description:** Site 303, Tank 29, MW-1, well fully submerged under water

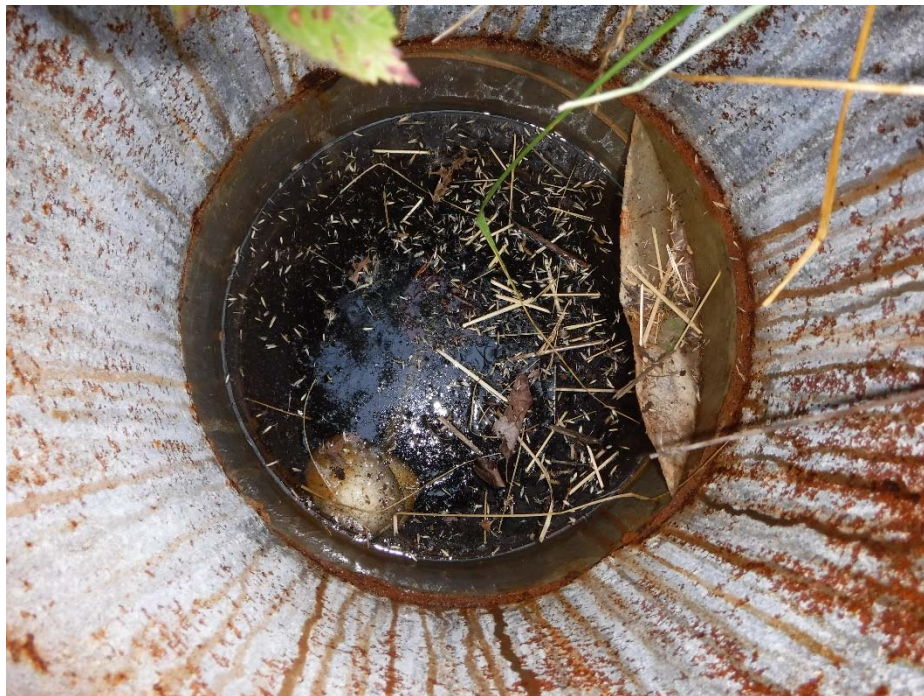
**File Name:** 303-Tank29-MW3-DSCF1782  
**Date Taken:** 08/29/17

**Photo #70 - Description:** Site 303, Tank 29, MW-3, well fully submerged under water

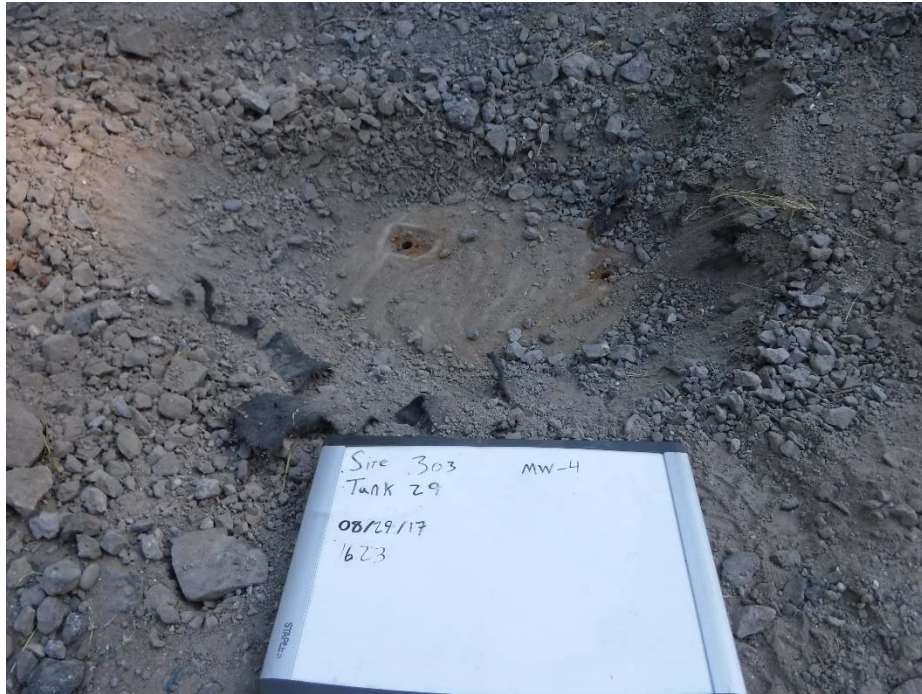
**File Name:** 303-Tank29-MW4-DSCF1779  
**Date Taken:** 08/29/17

During the LUC inspection, MW-4 at Tank 29 was found and inspected (see Table 1, Appendix B, and Photo #71), a vapor monitoring well which was not found during the Well Rehabilitation and Decommissioning Study (Battelle, 2017). Monitoring well MW-13 at Tank 26 could not be found and inspected, most likely because it was covered by recent tree and overgrowth cutting debris (Photo #55). Both vapor monitoring well MW-2 at Tank 25 and groundwater monitoring well OW-2 were found to be in poor condition with only the 2-inch polyvinyl chloride (PVC) piping or casing exposed at the ground surface (Photos #38 and #97, respectively). Although not directly related to the LUCs at Site 303, it should be noted that sheen was observed in the water in monuments for MW-7 at Tank 24, MW-9 at Tank 29, and MW-5 at Tank 30.

**Photo #71 - Description:** Site 303, Tank 29, MW-4, under 6 inches of gravel access road and geotextile

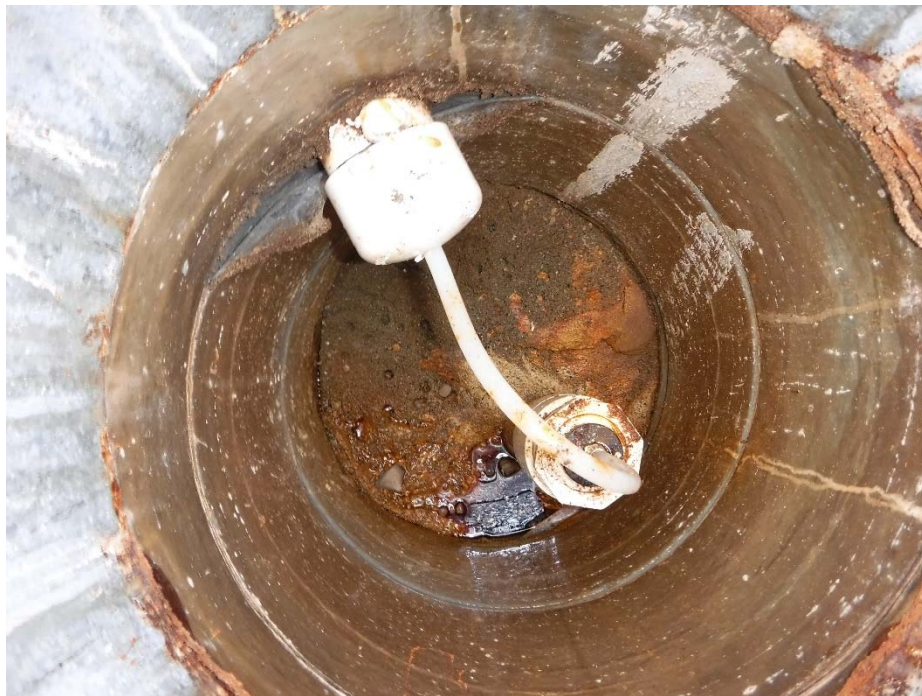
**File Name:** 303-Tank29-MW4-DSCF1834  
**Date Taken:** 08/30/17

**Photo #72 - Description:** Site 303, Tank 29, MW-4, well ID not affixed to well lid

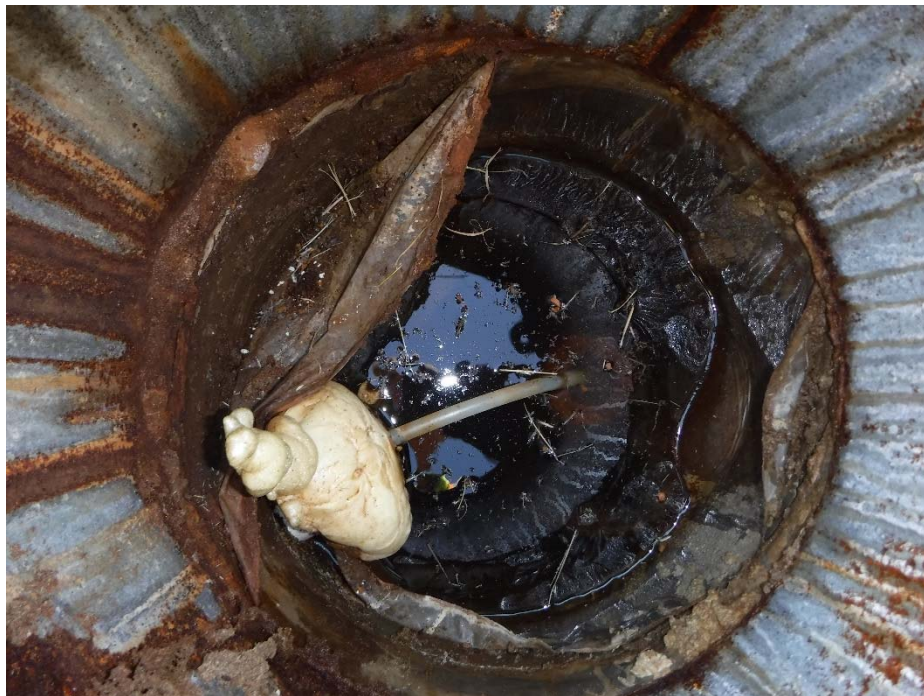
**File Name:** 303-Tank29-MW6-DSCF1776  
**Date Taken:** 08/29/17

**Photo #74 - Description:** Site 303, Tank 29, MW-6, well fully submerged under water

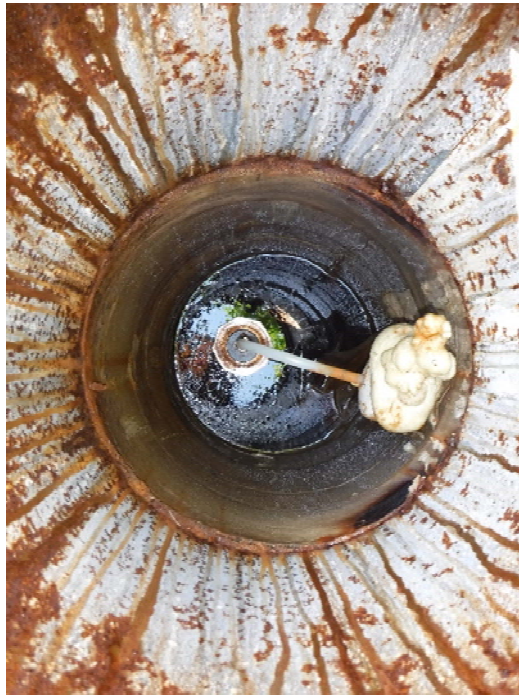
**File Name:** 303-Tank29-MW7-DSCF1774  
**Date Taken:** 08/29/17

**Photo #75 - Description:** Site 303, Tank 29, MW-7, water in monument

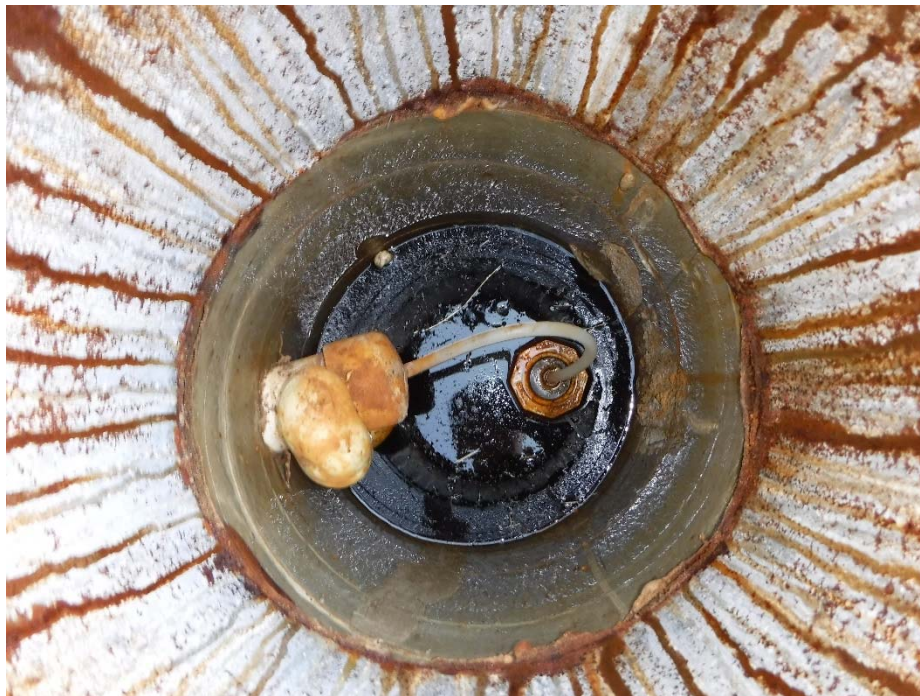
**File Name:** 303-Tank29-MW8-DSCF1798  
**Date Taken:** 08/29/17

**Photo #76 - Description:** Site 303, Tank 29, MW-8, water in monument to top of casing

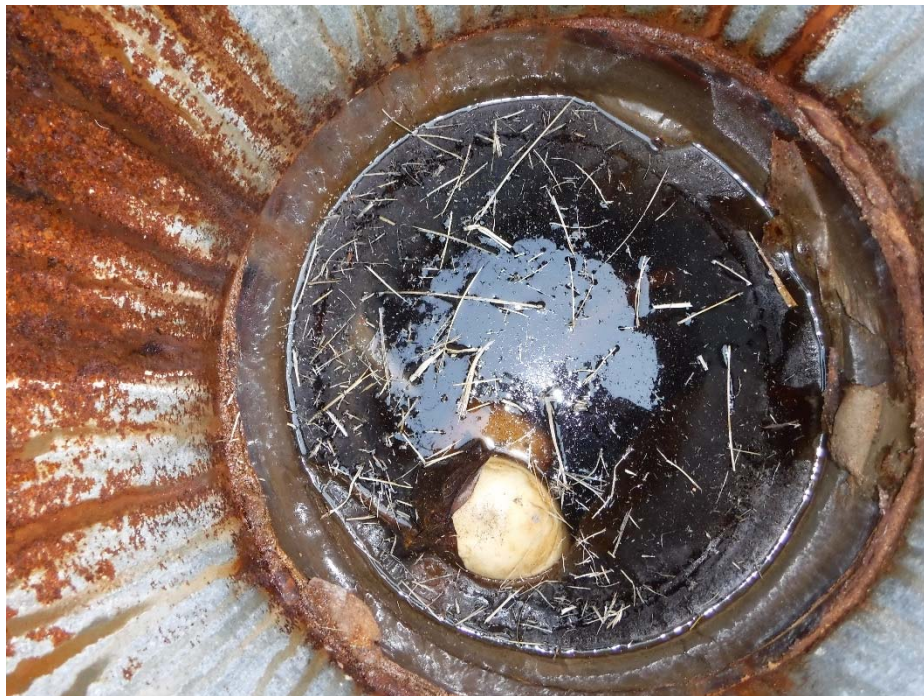
**File Name:** 303-Tank29-MW10-DSCF1794  
**Date Taken:** 08/29/17

**Photo #78 - Description:** Site 303, Tank 29, MW-10, well fully submerged under water

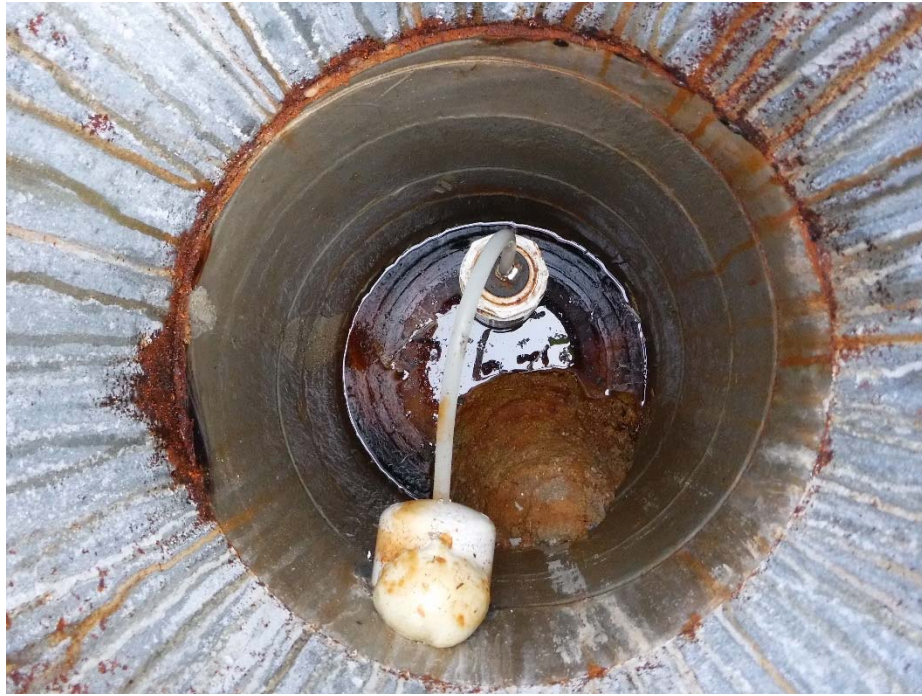
**File Name:** 303-Tank29-MW11-DSCF1792  
**Date Taken:** 08/29/17

**Photo #79 - Description:** Site 303, Tank 29, MW-11, water in monument

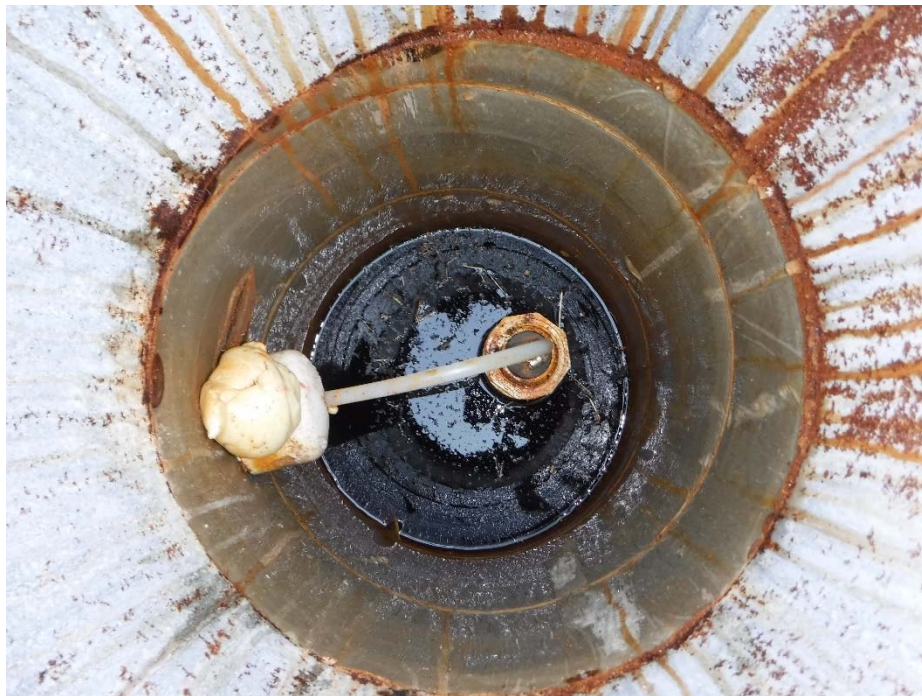
**File Name:** 303-Tank29-MW12-DSCF1790  
**Date Taken:** 08/29/17

**Photo #80 - Description:** Site 303, Tank 29, MW-12, water in monument

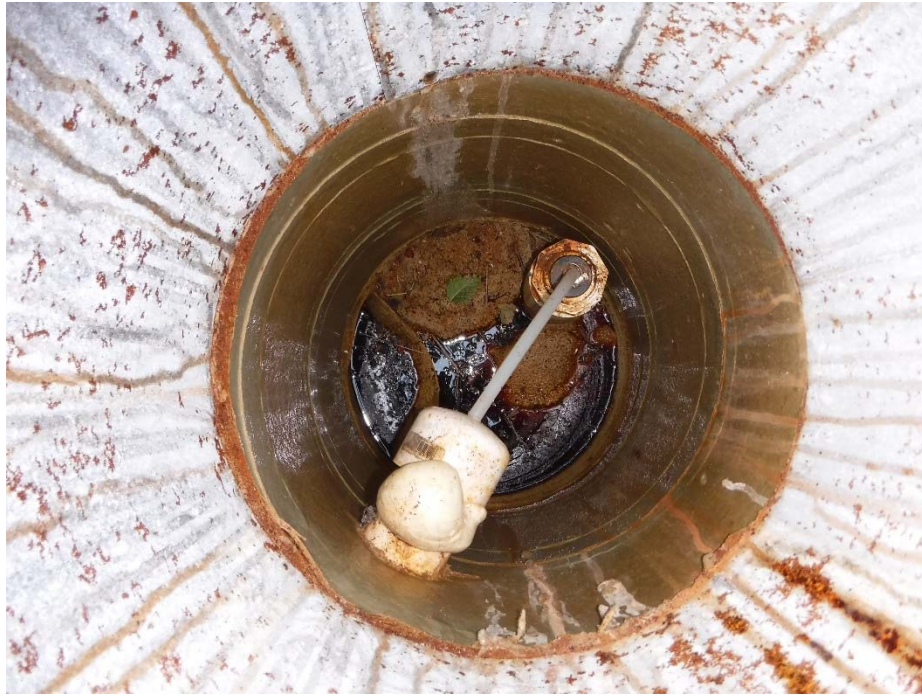
**File Name:** 303-Tank29-MW13-DSCF1786  
**Date Taken:** 08/29/17

**Photo #81 - Description:** Site 303, Tank 29, MW-13, located in brush, water in monument

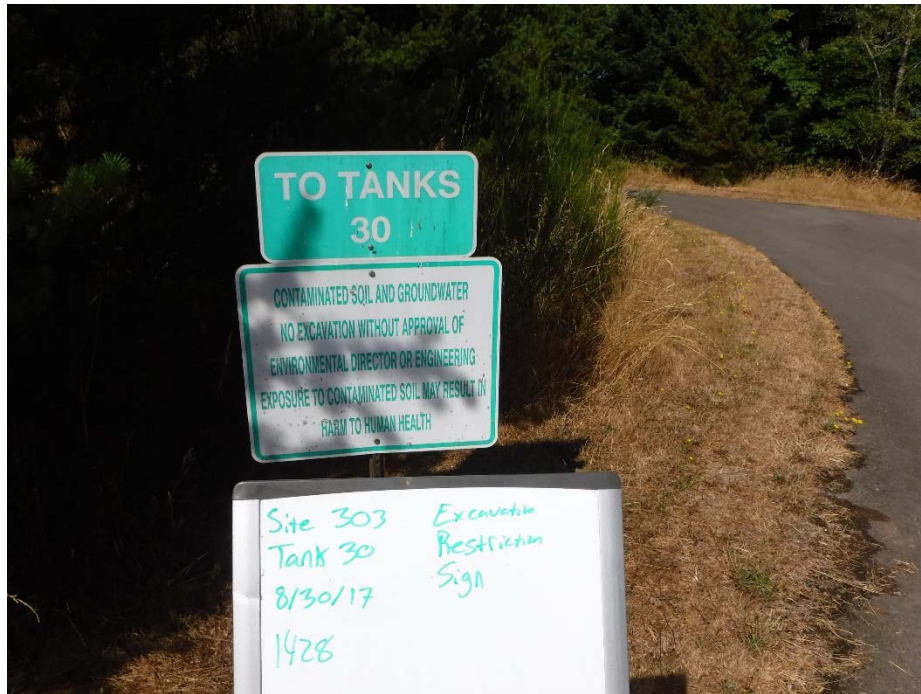
**File Name:** 303-Tank30-Sign-DSCF1916  
**Date Taken:** 08/30/17

**Photo #83 - Description:** Site 303, Tank 30, LUC excavation restriction signage at access road to tank

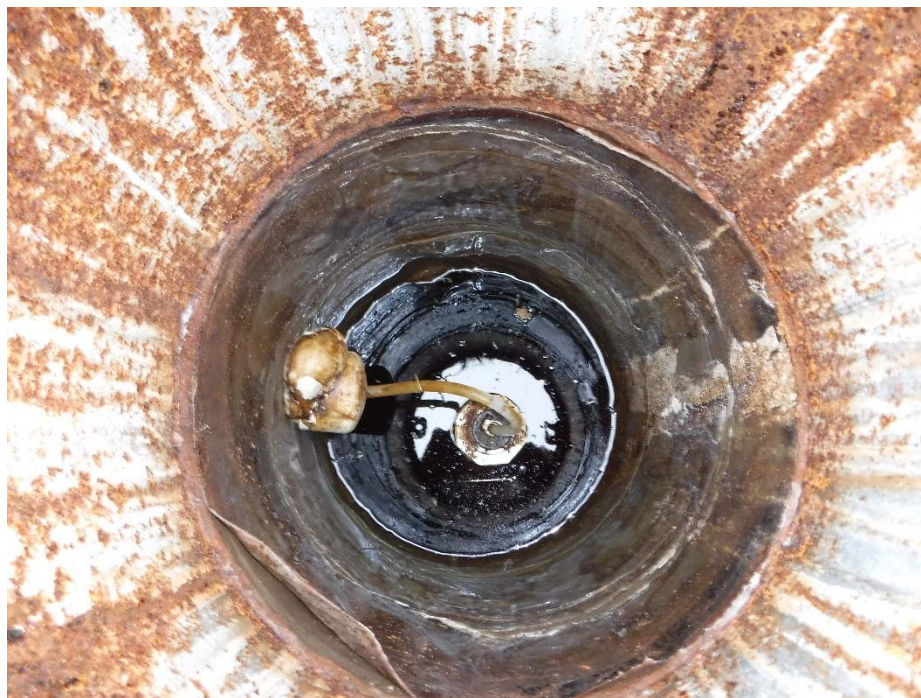
**File Name:** 303-Tank30-MW1-DSCF1808  
**Date Taken:** 08/30/17

**Photo #84 - Description:** Site 303, Tank 30, MW-1, water in monument to top of casing, ID plate not affixed to well lid

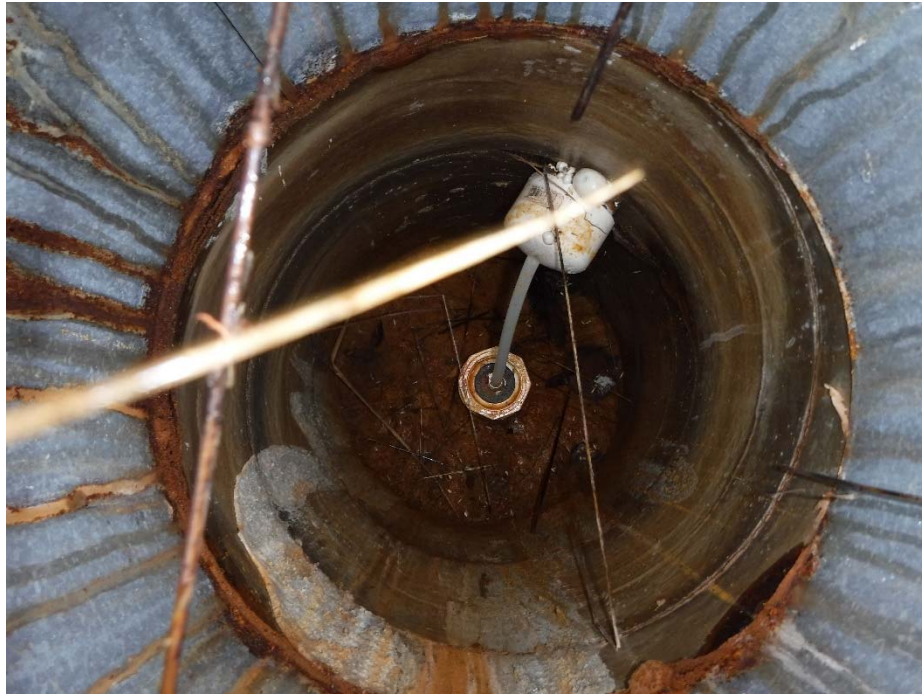
**File Name:** 303-Tank30-MW2-DSCF1806  
**Date Taken:** 08/30/17

**Photo #85 - Description:** Site 303, Tank 30, MW-2, located in tall grass surrounding tank

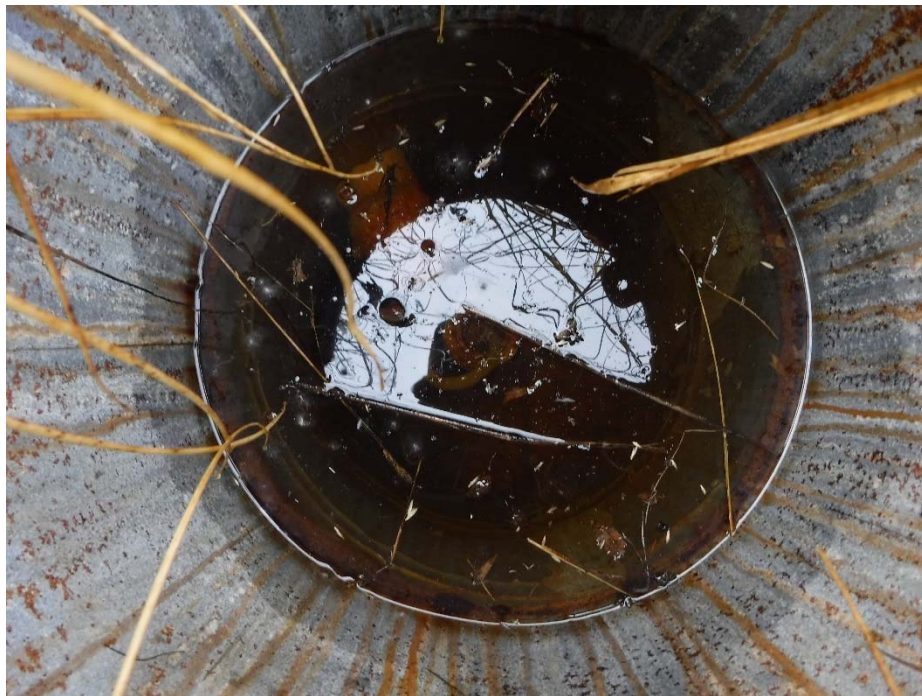
**File Name:** 303-Tank30-MW3-DSCF1804  
**Date Taken:** 08/30/17

**Photo #86 - Description:** Site 303, Tank 30, MW-3, well fully submerged under water, located in tall grass surrounding tank, ID plate not affixed to well lid

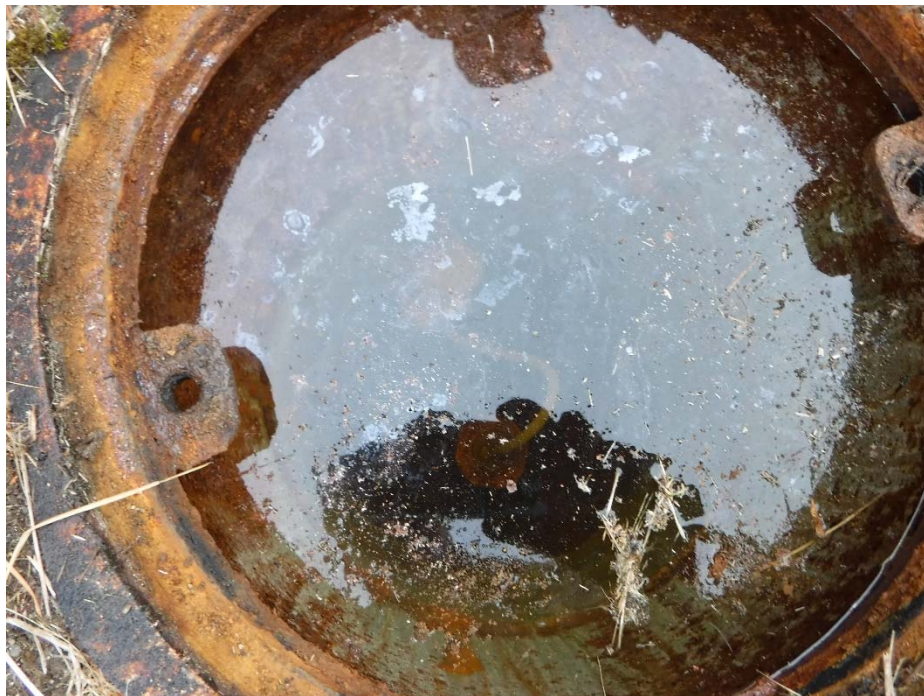
**File Name:** 303-Tank30-MW5-DSCF1800  
**Date Taken:** 08/30/17

**Photo #88 - Description:** Site 303, Tank 30, MW-5, well fully submerged under water, sheen on water

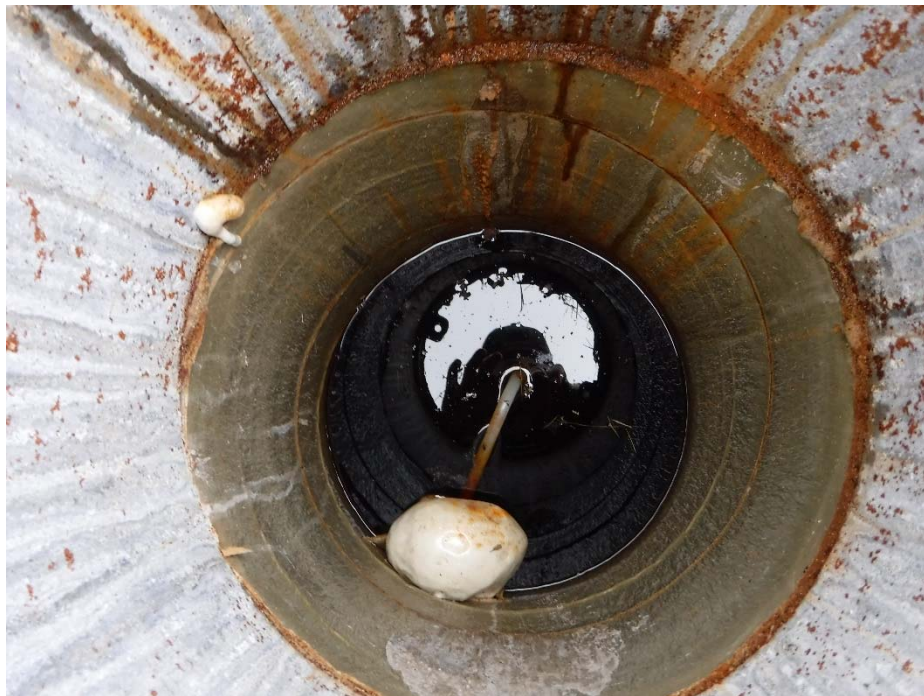
**File Name:** 303-Tank30-MW7-DSCF1822  
**Date Taken:** 08/30/17

**Photo #90 - Description:** Site 303, Tank 30, MW-7, well fully submerged under water

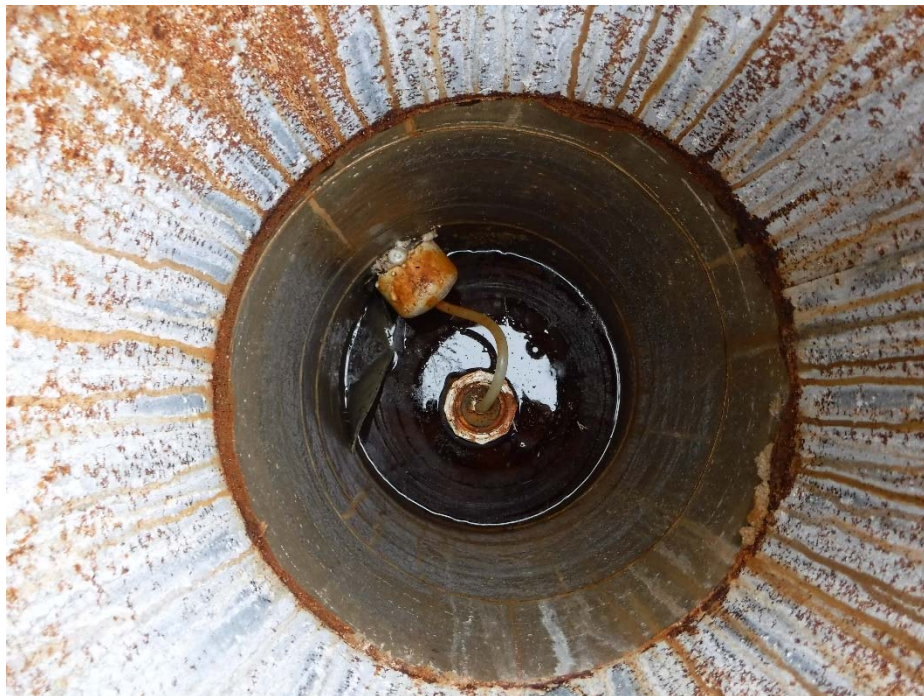
**File Name:** 303-Tank30-MW9-DSCF1818  
**Date Taken:** 08/30/17

**Photo #92 - Description:** Site 303, Tank 30, MW-9, water in monument

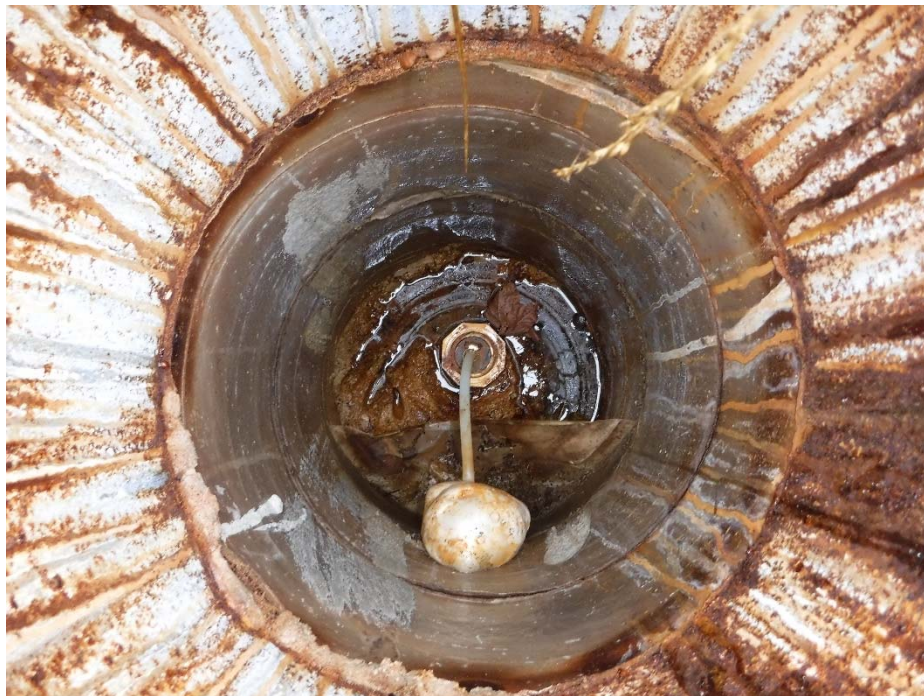
**File Name:** 303-Tank30-MW11-DSCF1814  
**Date Taken:** 08/30/17

**Photo #94 - Description:** Site 303, Tank 30, MW-11, water in monument

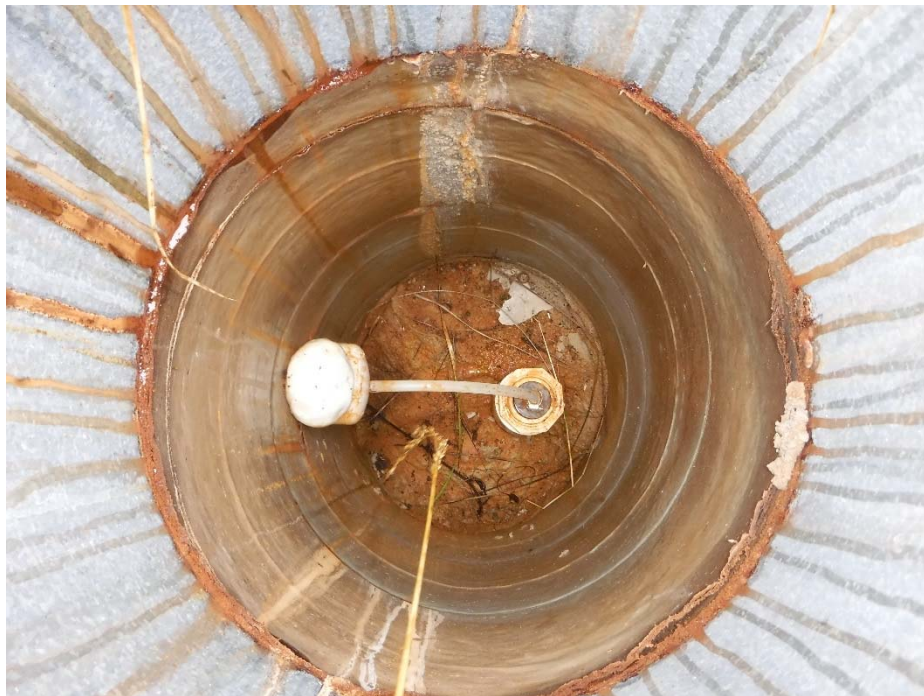
**File Name:** 303-Tank30-MW13-DSCF1812  
**Date Taken:** 08/30/17

**Photo #96 - Description:** Site 303, Tank 30, MW-13, located in tall grass surrounding tank

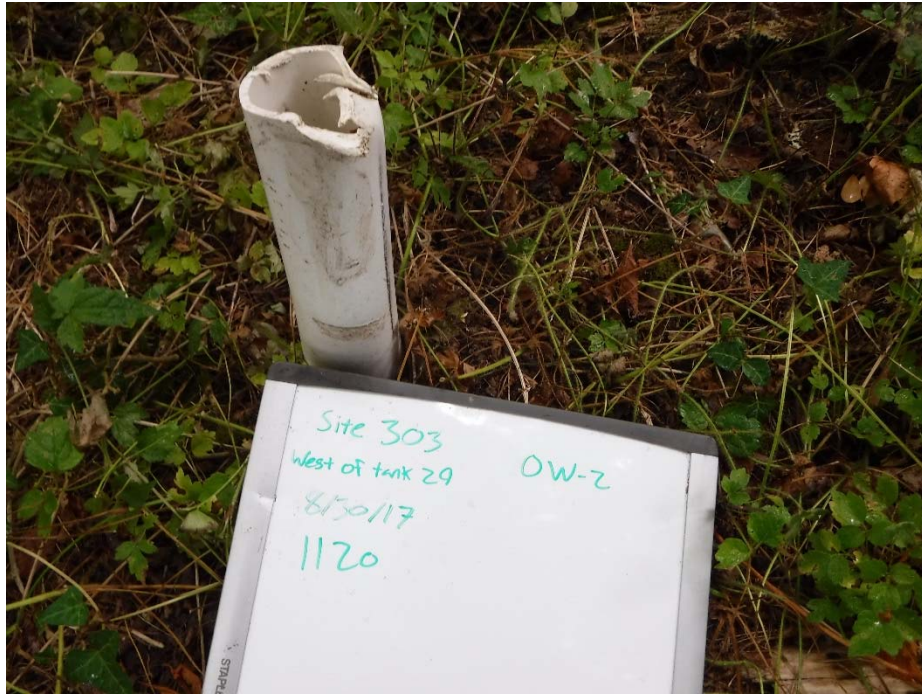
**File Name:** 303-WestTank29-OW2-  
DSCF1835  
**Date Taken:** 08/30/17

**Photo #97 - Description:** Site 303, West of Tank 29, OW-2, only 2-inch PVC piping exposed at ground surface

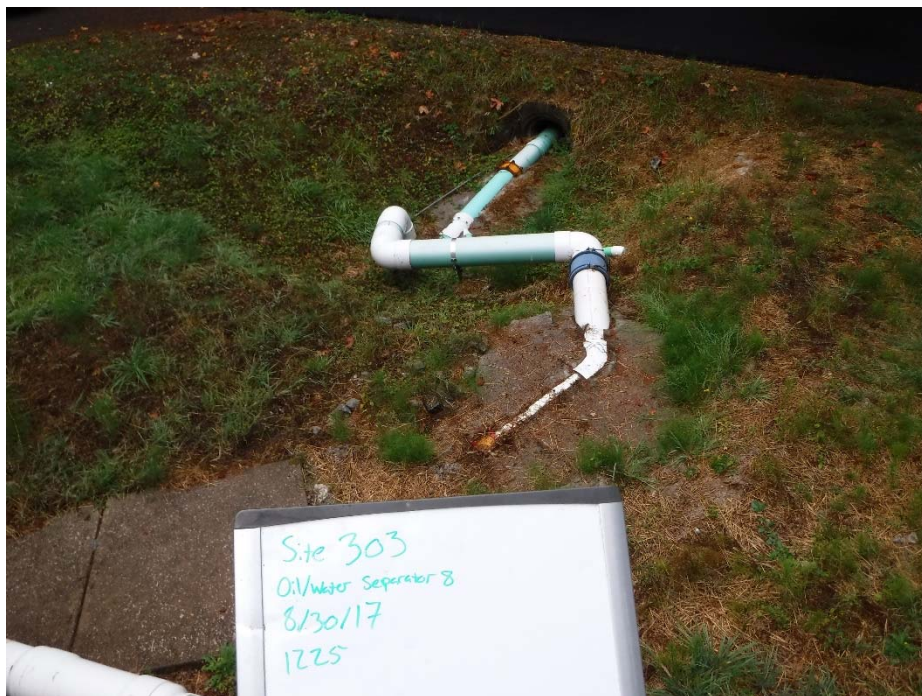
**File Name:** 303-OilWaterSep8-303-  
DSCF1879  
**Date Taken:** 08/30/17

**Photo #98 - Description:** West of Site 303, OWS 8/8A, new effluent plumbing from OWS system

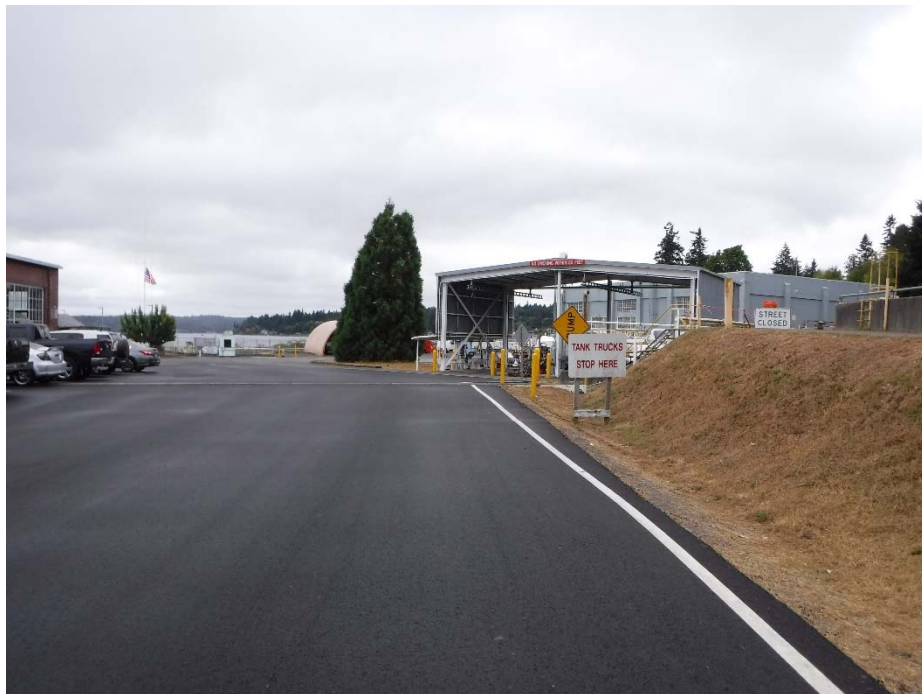
**File Name:** 304-IndustrialArea-DSCF1864  
**Date Taken:** 08/30/17

1. There is no LUC signage at the general entry way to Site 304 (Photo #104).
2. There is construction of a trench box for a fuel line (i.e., excavation activities; Photo #105).  
However, given the specifications/requirements for this type of work, it is authorized.

**Photo #104 - Description:** Site 304, Industrial Area, view SW towards fueling station, general entry way to site

Findings	Recommendations
<i>Site 304 - Industrial Area</i>	
There is no LUC signage at the general entry way to Site 304 (Photo #104).	Add LUC signage at the general entry way to the site.
There is construction of a trench box for a fuel line (i.e., excavation activities; Photo #105).	Post approval permit from MFD Environmental for construction of trench box at job site.
<i>Tank 50 - UST Release Site</i>	
There is no LUC signage at the general entry way to Tank 50 (Photo #114).	Add LUC signage at the general entry way to the site, as it is noted in the <i>Well Installation and Sampling and Analysis Tank No. 50 Fuel Hydrocarbon Leak Assessment, Manchester Fleet and Industrial Supply Center, Manchester, Washington</i> (Hart Crowser, 1998).

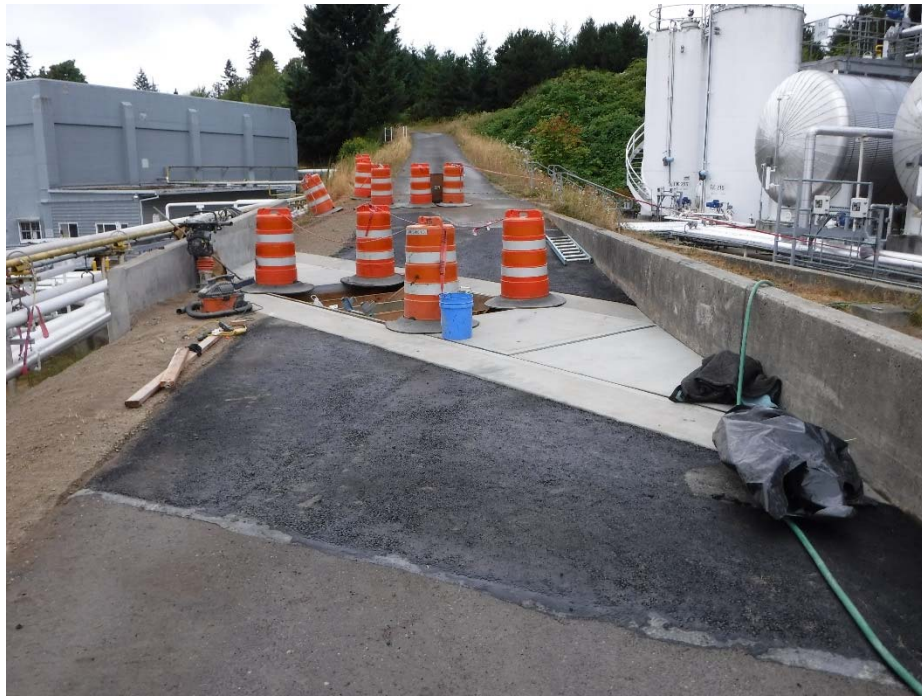
**File Name:** 304-IndustrialArea-DSCF1867  
**Date Taken:** 08/30/17

**Photo #105 - Description:** Site 304, Industrial Area, construction of a trench box for fuel lines

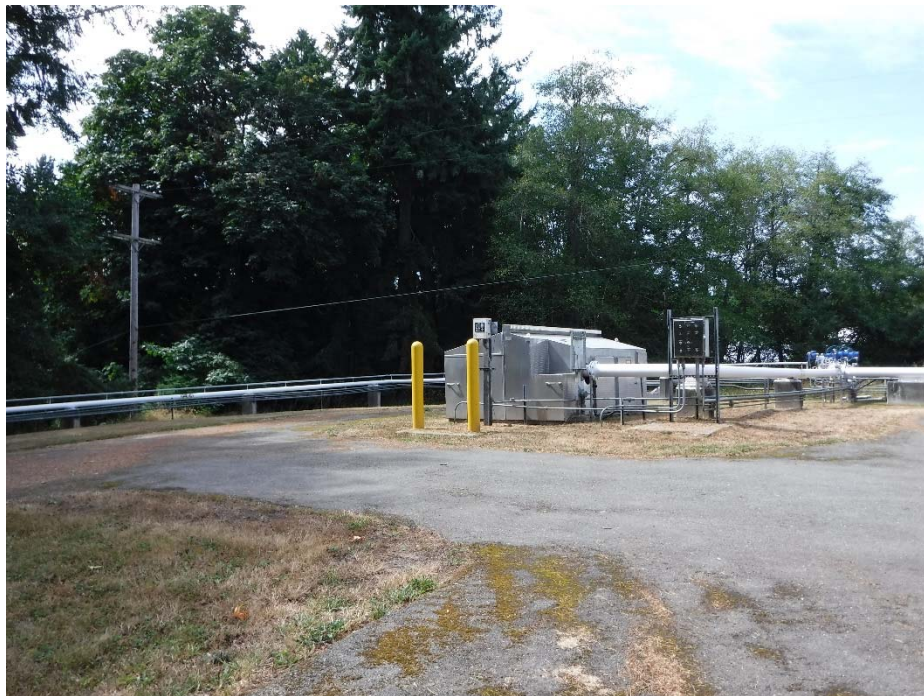
**File Name:** Tank50-DSCF1893  
**Date Taken:** 08/30/17

1. There is no LUC signage at the general entry way to Tank 50 (Photo #114). However, new LUC signage has been installed adjacent to monitoring well MW-2 (Photo #123).

**Photo #114 - Description:** Tank 50 Release Site, view across area above tank

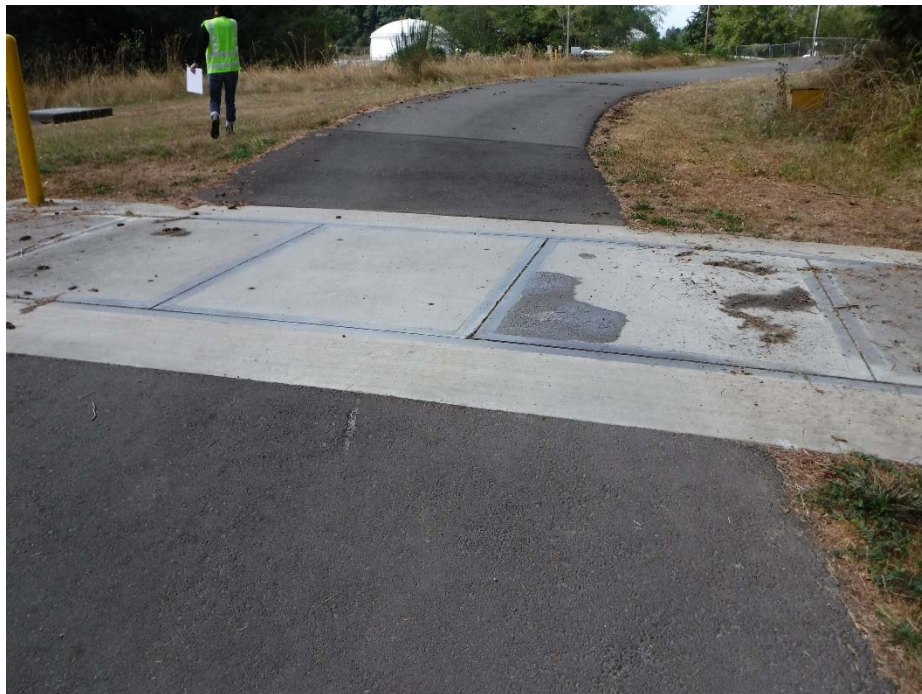
**File Name:** Tank50-DSCF1898  
**Date Taken:** 08/30/17

**Photo #116 - Description:** Tank 50 Release Site, trench box for fuel lines under access road

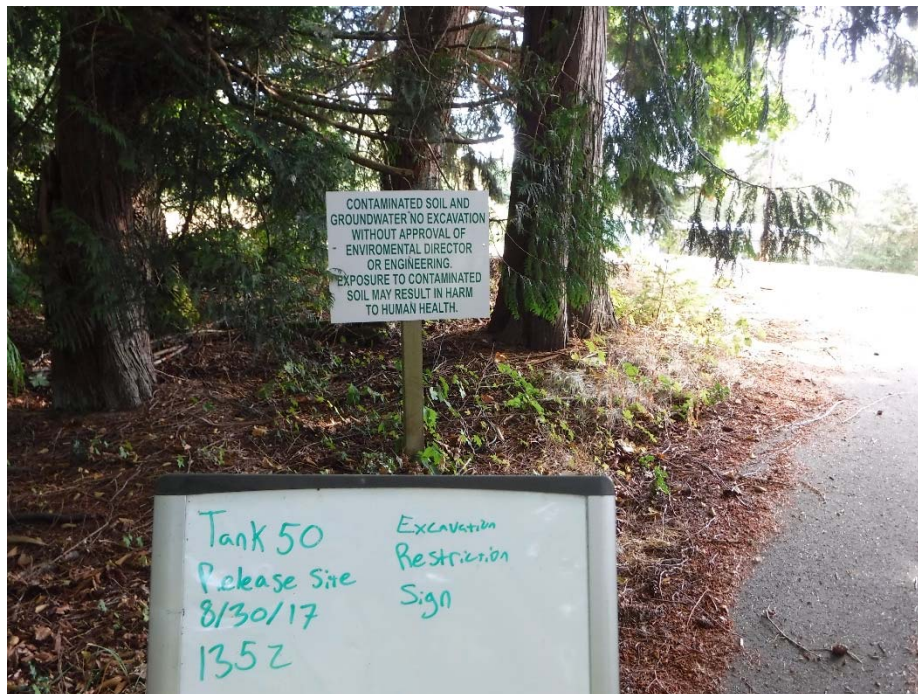
**File Name:** Tank50-Sign-DSCF1905  
**Date Taken:** 08/30/17

**Photo #123 - Description:** Tank 50 Release Site, new LUC excavation restriction signage adjacent to MW-2

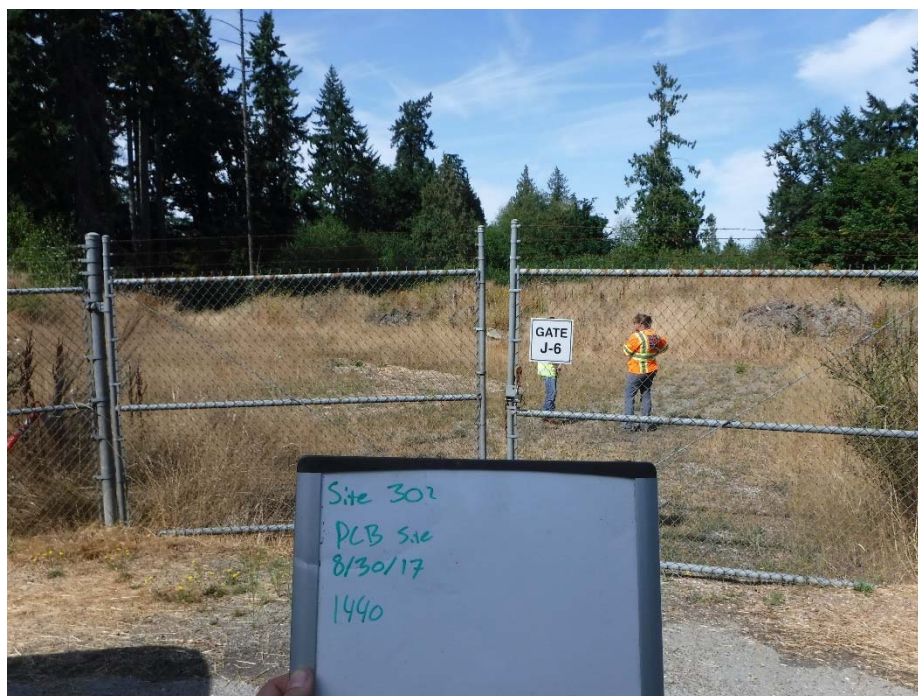
**File Name:** 302-PCBSite-DSCF1917  
**Date Taken:** 08/30/17

1. There is no LUC signage on the primary gate/entrance on the south side of the site (Photo #124). However, there is “Restricted Area” signage along the southern border fencing of the site.
2. The central portion of the site is covered with large, older stockpiles of soil and debris (Photo #126).
3. The gated entrance on the north side of the site is unlocked, open, and has no LUC signage (Photo #127).

**Photo #124 - Description:** Site 302, PCB Site, primary entrance to site with no LUC signage

Findings	Recommendations
<b>Site 302 - PCB Site</b>	
There is no LUC signage on the primary gate/entrance on the south side of the site (Photo #124).	Add "Restricted Area" or LUC signage on the primary gate/entrance along the south side of the site.
The central portion of the site is covered with large, older stockpiles of soil and debris (Photo #126).	Properly characterize the excess soil placed in the central portion of the site. If the soil meets Model Toxic Control Act (MTCA) Method A levels, then use to regrade site and develop vegetative cover. If the soil exceeds MTCA Method A levels, then properly transport and dispose of soil offsite, place clean topsoil cap, and develop vegetative cover as recommended in the <i>Third Five-Year Review</i> (NAVFAC Northwest, 2015).
The gated entrance on the north side of the site is unlocked, open, and has no LUC signage (Photo #127).	Close, lock, and add LUC signage to the gated entrance on the north side of the site.
