**FINAL**  
**2017 LAND USE CONTROL INSPECTION TECHNICAL MEMORANDUM**  
**FLEET LOGISTICS CENTER PUGET SOUND**  
**MANCHESTER FUEL DEPOT**  
**MANCHESTER, WASHINGTON**

**Prepared by**  
**Battelle**  
**Columbus, Ohio**

**Prepared for**  
**Naval Facilities Engineering Command Northwest**  
**Silverdale, Washington**

**October 9, 2017**

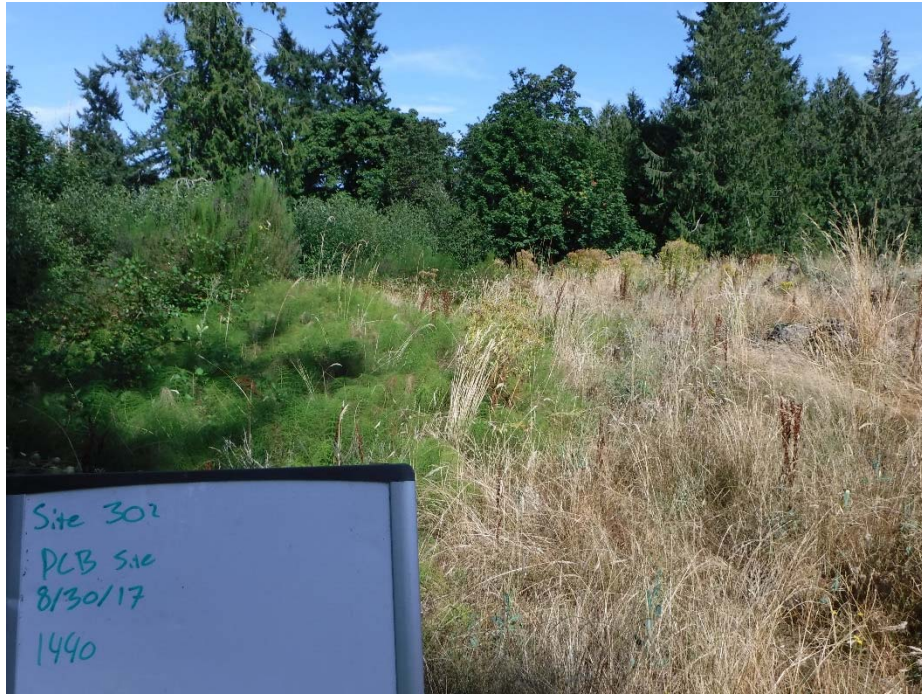
**File Name:** 302-PCBSite-DSCF1920  
**Date Taken:** 08/30/17

**Photo #125 - Description:** Site 302, PCB Site, central portion of site, soil/debris stockpiles overgrown with vegetation (1 of 2)

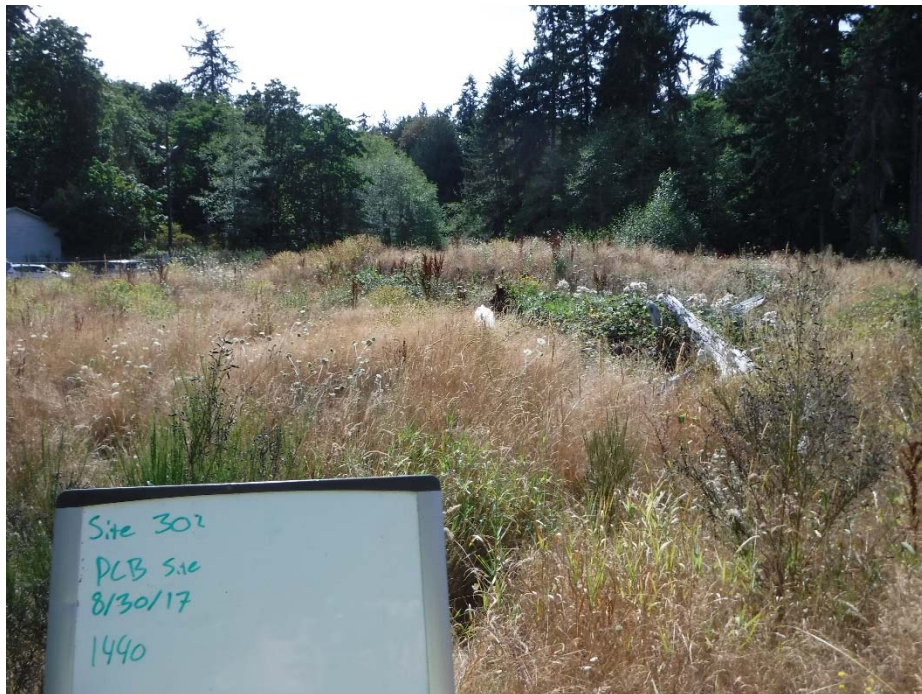
**File Name:** 302-PCBSite-DSCF1922  
**Date Taken:** 08/30/17

1. There is no LUC signage on the primary gate/entrance on the south side of the site (Photo #124). However, there is “Restricted Area” signage along the southern border fencing of the site.
2. The central portion of the site is covered with large, older stockpiles of soil and debris (Photo #126).
3. The gated entrance on the north side of the site is unlocked, open, and has no LUC signage (Photo #127).

**Photo #126 - Description:** Site 302, PCB Site, central portion of site, soil/debris stockpiles overgrown with vegetation (2 of 2)

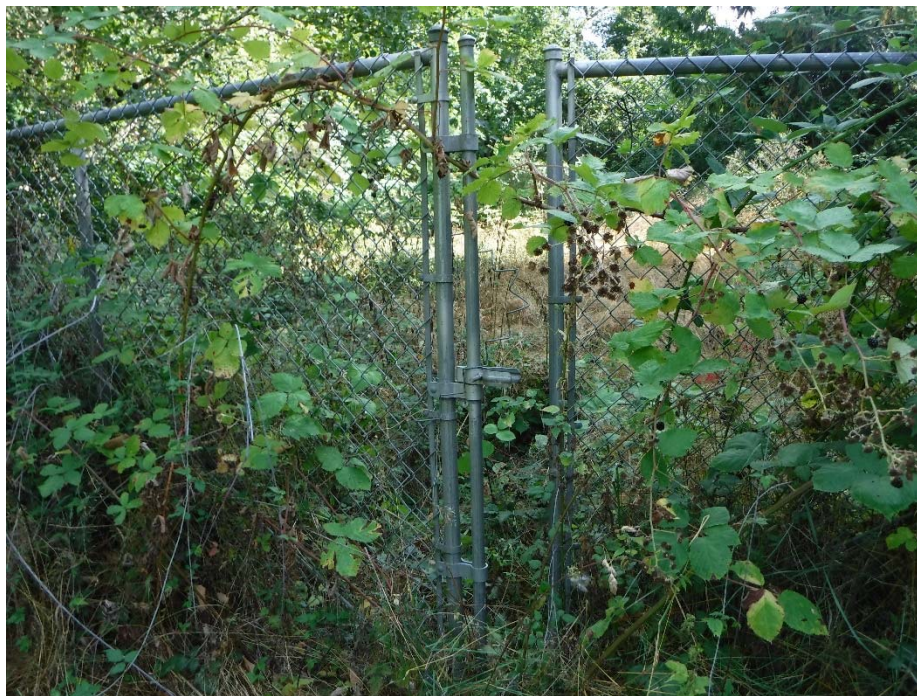
**File Name:** 302-PCBSite-DSCF1926  
**Date Taken:** 08/30/17

**Photo #127 - Description:** Tank 50 Release Site, gate on N side of site opened, unlocked, and with no LUC signage

Findings	Recommendations
<b>Site 302 - PCB Site</b>	
There is no LUC signage on the primary gate/entrance on the south side of the site (Photo #124).	Add "Restricted Area" or LUC signage on the primary gate/entrance along the south side of the site.
The central portion of the site is covered with large, older stockpiles of soil and debris (Photo #126).	Properly characterize the excess soil placed in the central portion of the site. If the soil meets Model Toxic Control Act (MTCA) Method A levels, then use to regrade site and develop vegetative cover. If the soil exceeds MTCA Method A levels, then properly transport and dispose of soil offsite, place clean topsoil cap, and develop vegetative cover as recommended in the <i>Third Five-Year Review</i> (NAVFAC Northwest, 2015).
The gated entrance on the north side of the site is unlocked, open, and has no LUC signage (Photo #127).	Close, lock, and add LUC signage to the gated entrance on the north side of the site.
