SITE HAZARD ASSESSMENT

Worksheet 1: Summary Score Sheet

SITE NAME: Duwamish Waterway Park

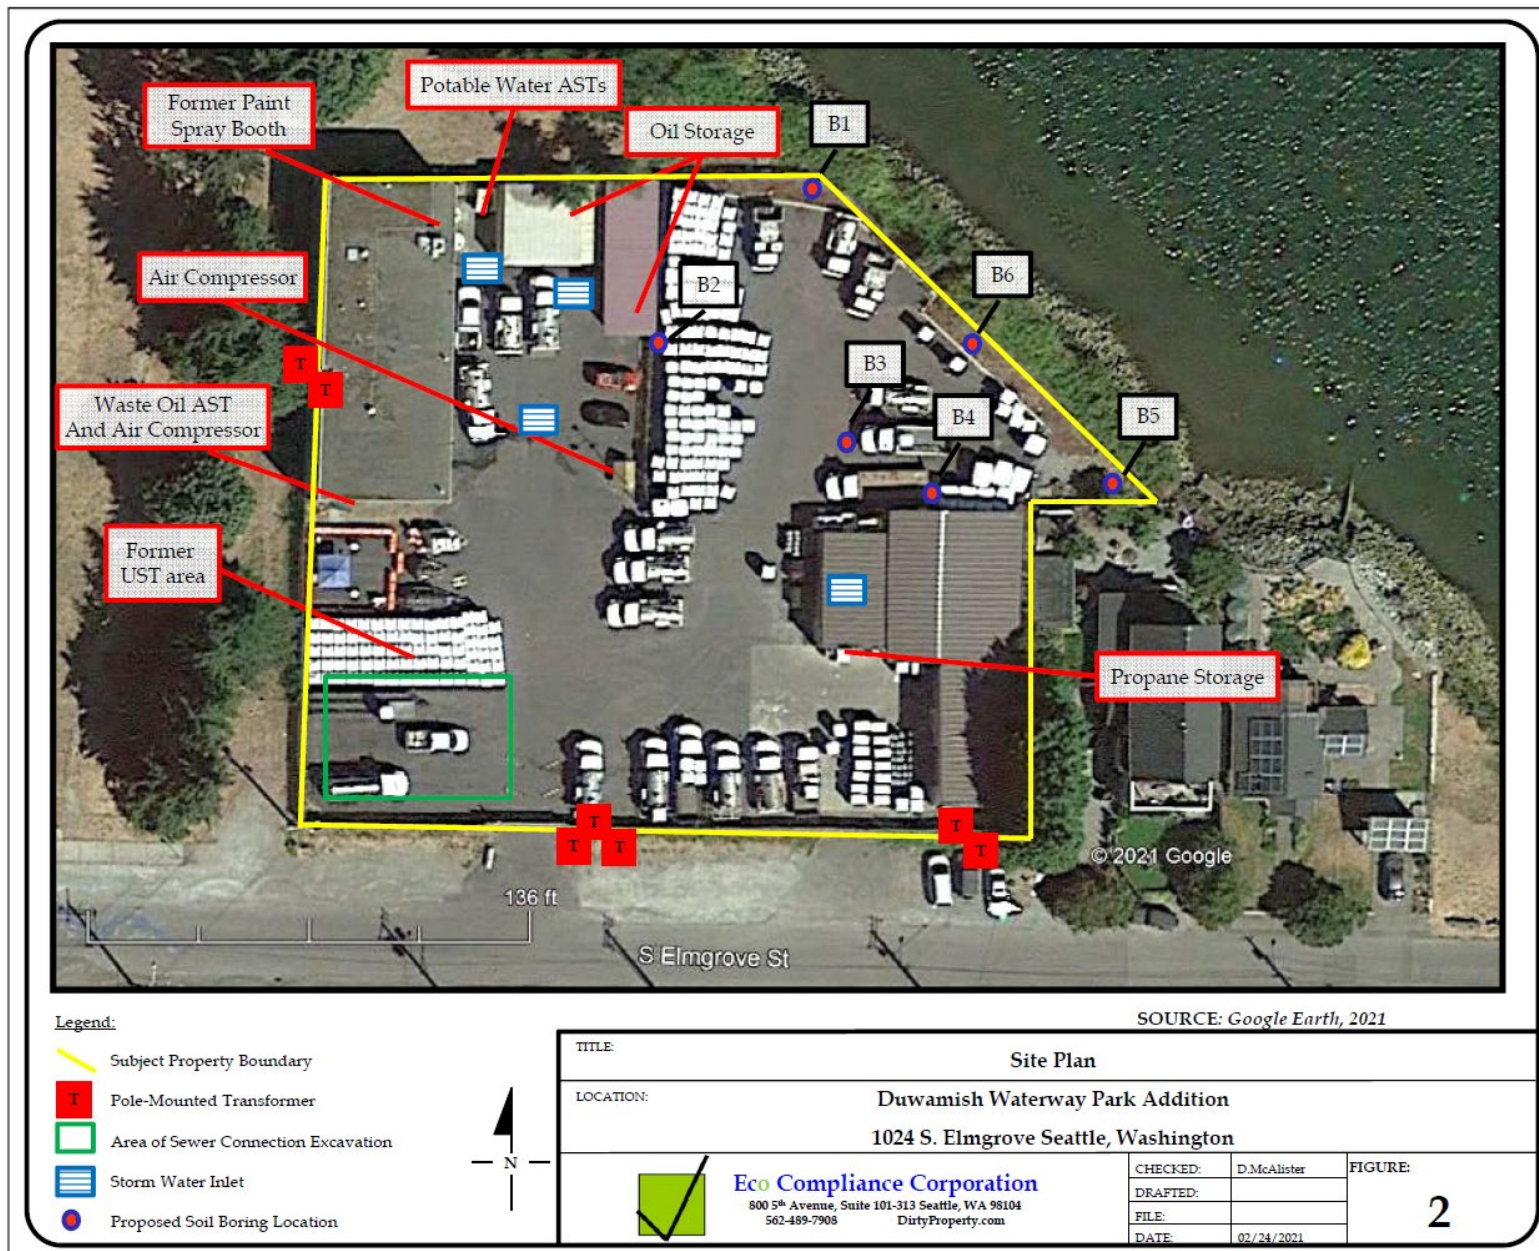
Eco Compliance Corporation completed a Phase II Environmental Site Assessment in 2021 for SPR. This report included limited sampling, focused on soil characterization in areas where dredged material from the Lower Duwamish Waterway may have been placed (Figure 7). Samples were analyzed for a variety of contaminants, including metals, carcinogenic PAHs (cPAHs), polychlorinated biphenyls (PCBs), and petroleum. Arsenic and

Figure 7. Locations of more recent soil sampling on the Park Addition property. Locations were selected to evaluate possible impacts from placement of dredged material from the Lower Duwamish Waterway on the property. Figure from Eco Compliance Corporation (2021) Phase II.

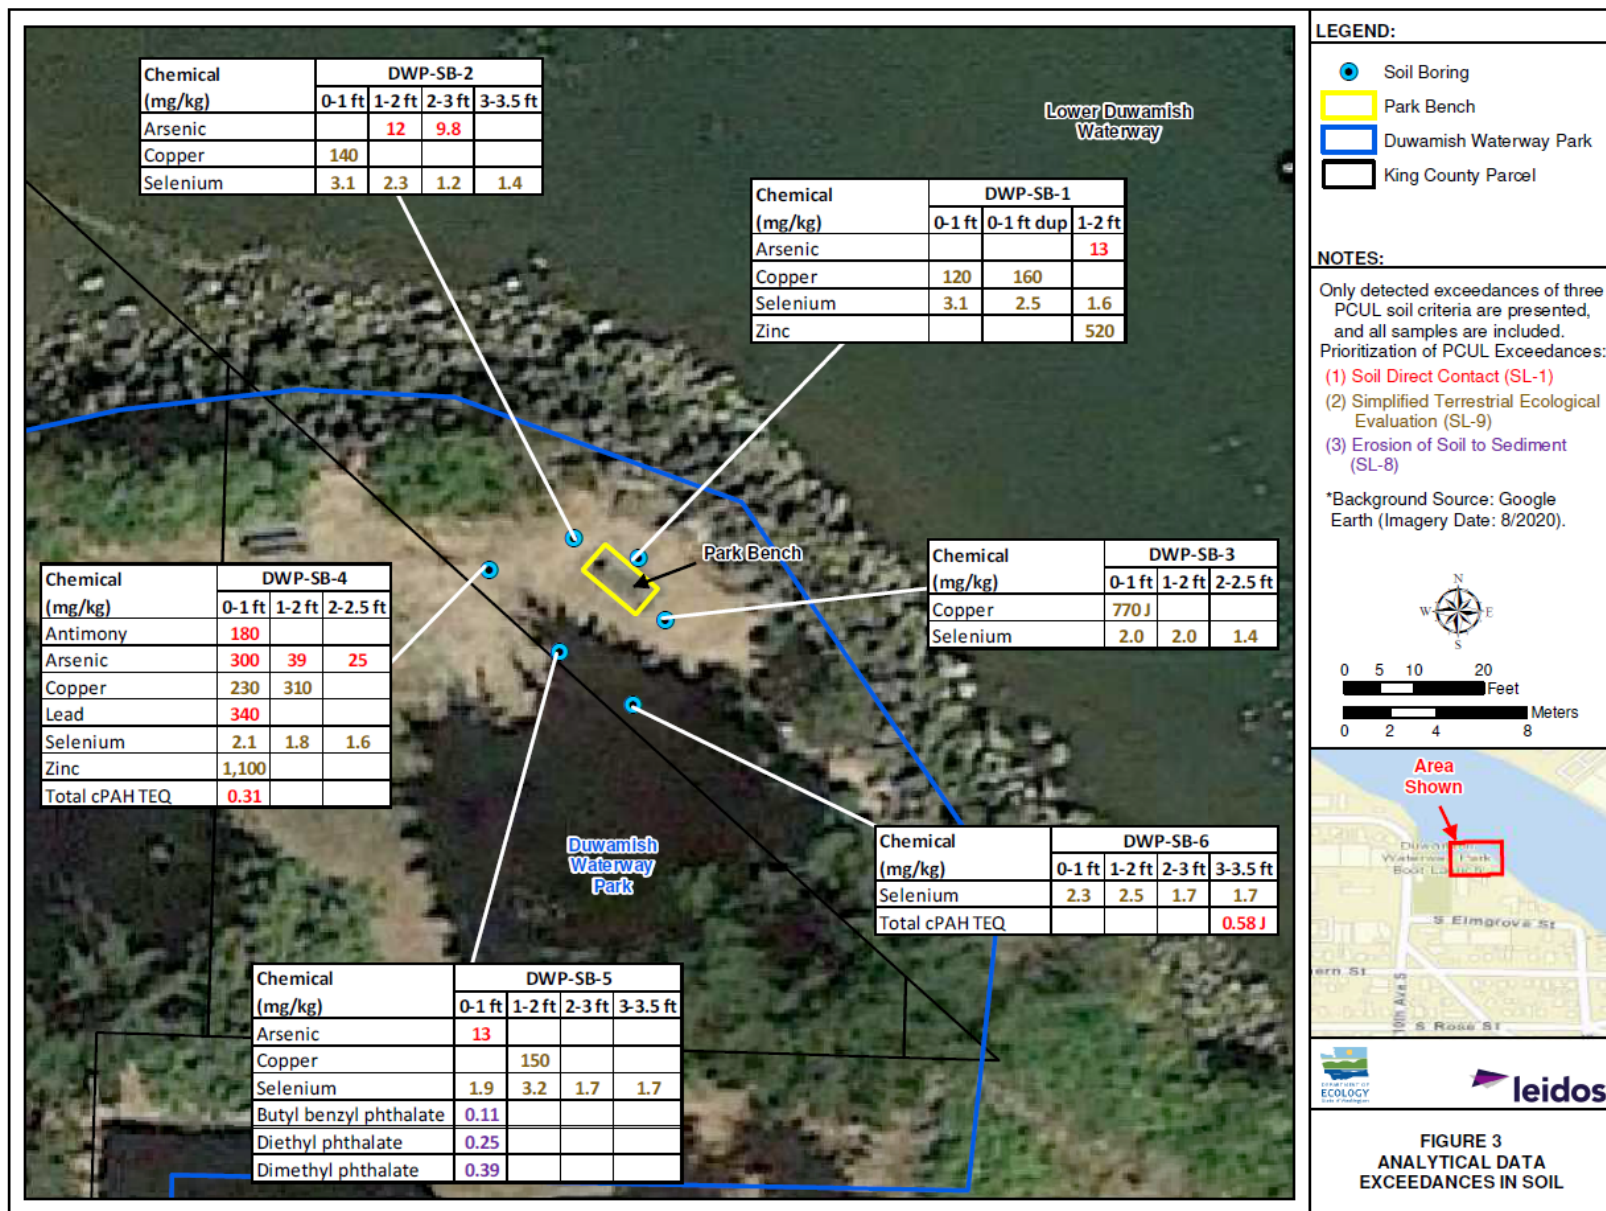
Leidos, on behalf of Ecology, sampled the area in the northeast portion of the Park that is within the operational area of the Park but outside of tax parcel boundaries in 2021. This area is not included within a tax parcel, but is part of the operational area of the Park. Soil samples from this area were analyzed for PCBs, metals, petroleum, cPAHs, semivolatile organic compounds, and total organic carbon (Figure 9). Chemicals exceeding a screening level in at least one sample included arsenic, copper, lead, selenium, zinc, and cPAHs.

Figure 9. Locations of samples collected by Leidos in the northeast area of the Park on land outside tax parcel boundaries. Figure from Leidos (2021) Data Summary Report.

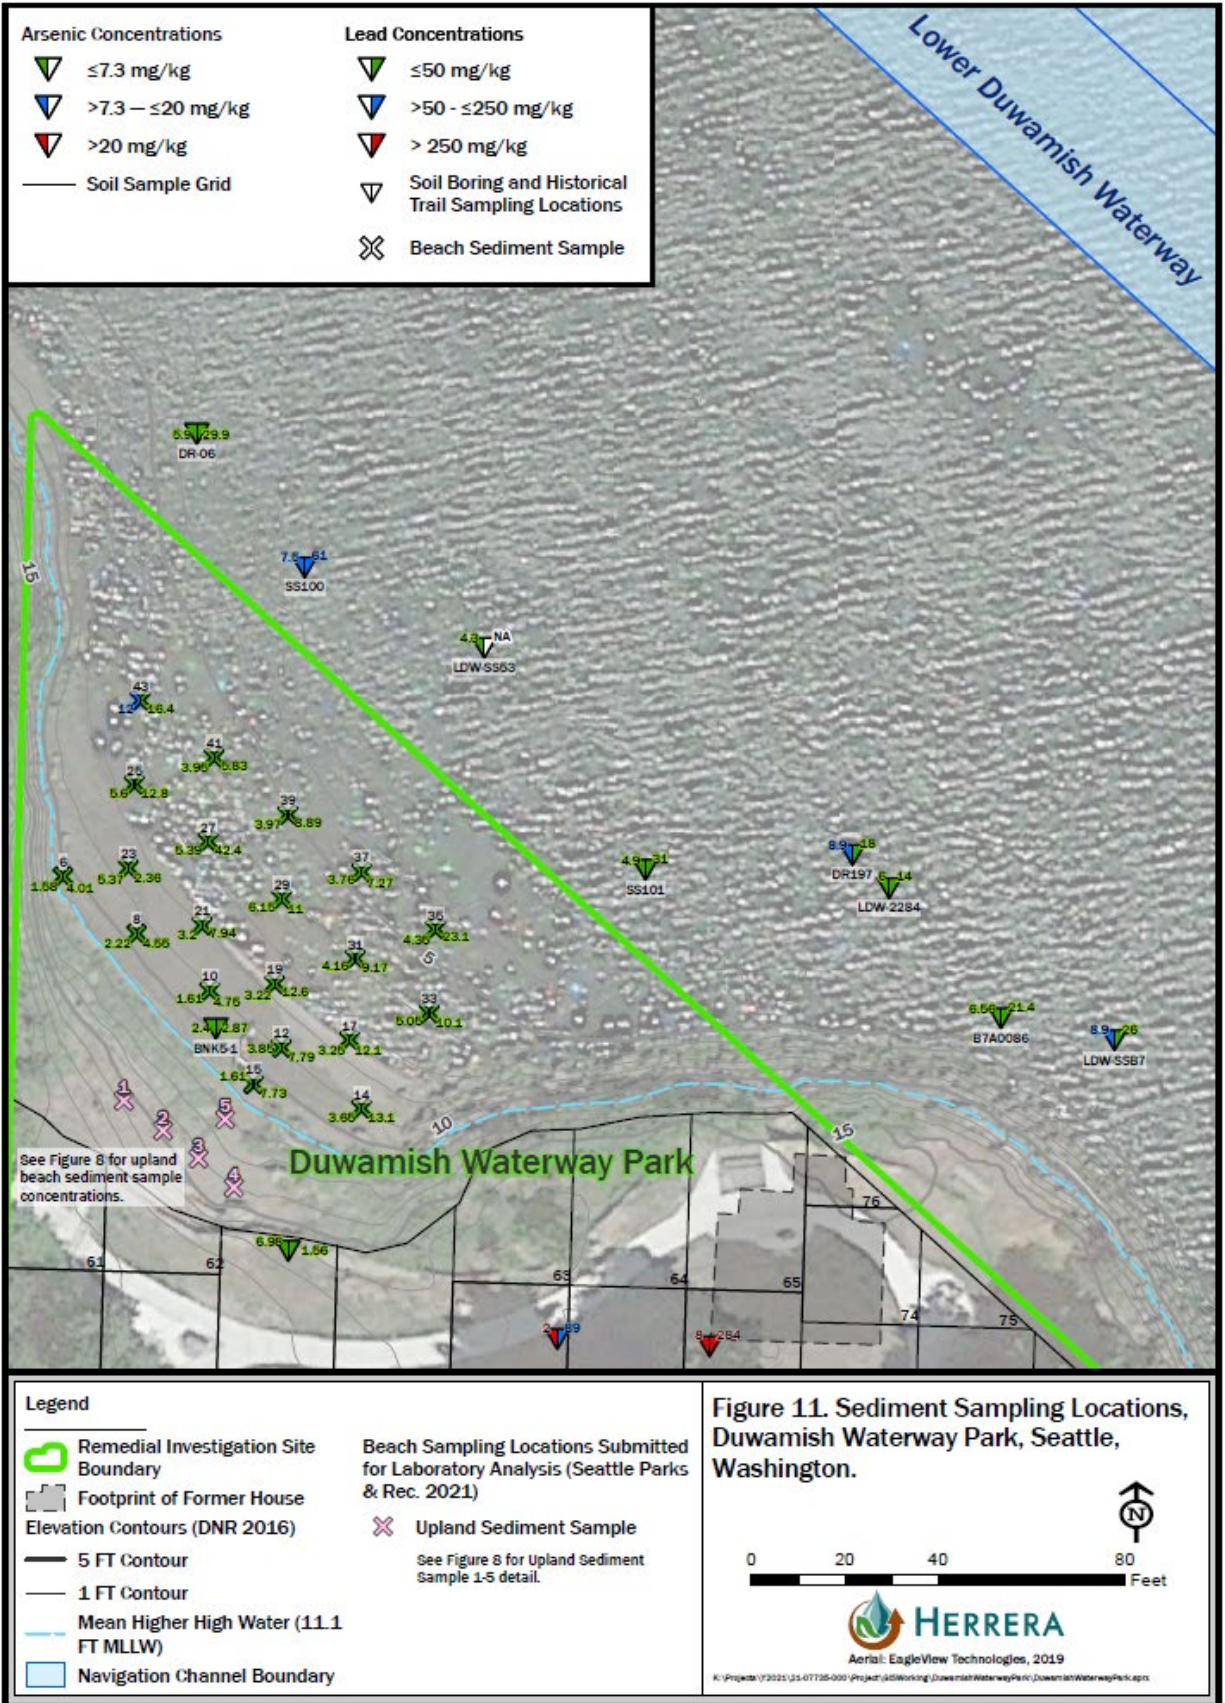
Sampling in the Beach area of the Park was done in October 2021. This included two sampling events that targeted different parts of the Beach. The first sampling event involved collecting five samples from the Upper Beach, the open area for water access that is farther from the Duwamish and above the mean higher high water mark. That distinction is important for determining whether soil or sediment screening levels apply. cPAHs were present in these samples above the applicable soil screening level. The second sampling event included collecting samples in the Lower Duwamish Waterway from the area of that is accessible from the Beach area at low tide. Forty-three surface (depth of 0-10 centimeters) samples were collected using sediment collection techniques, and 25 of these samples were analyzed for metals, semivolatile organic compounds, PCBs, and total organic carbon. Based on locations, results of 20 of these samples were compared to sediment screening levels and the other 5 were compared to soil screening levels. All sampling locations are shown on Figure 10. A variety of chemicals exceeded screening levels for at least one sample in the Beach area, including cPAHs, bis (2-ethylhexyl) phthalate, hexachlorobenzene, arsenic, copper, and lead.

Figure 10. Locations of samples collected in the Beach area of the Park. From Herrera (2022) RI/FS Work Plan.
