REMEDIAL INVESTIGATION REPORT

Site Name: **Lake Chelan Community Hospital -
New Construction**

Prepared By:
Dave Schettler, P.E.
Construction Special Inspections
1250 N Wenatchee Ave Suite H135
Wenatchee, WA 98801

Date: **Pre-Final Draft 11/22/2022**

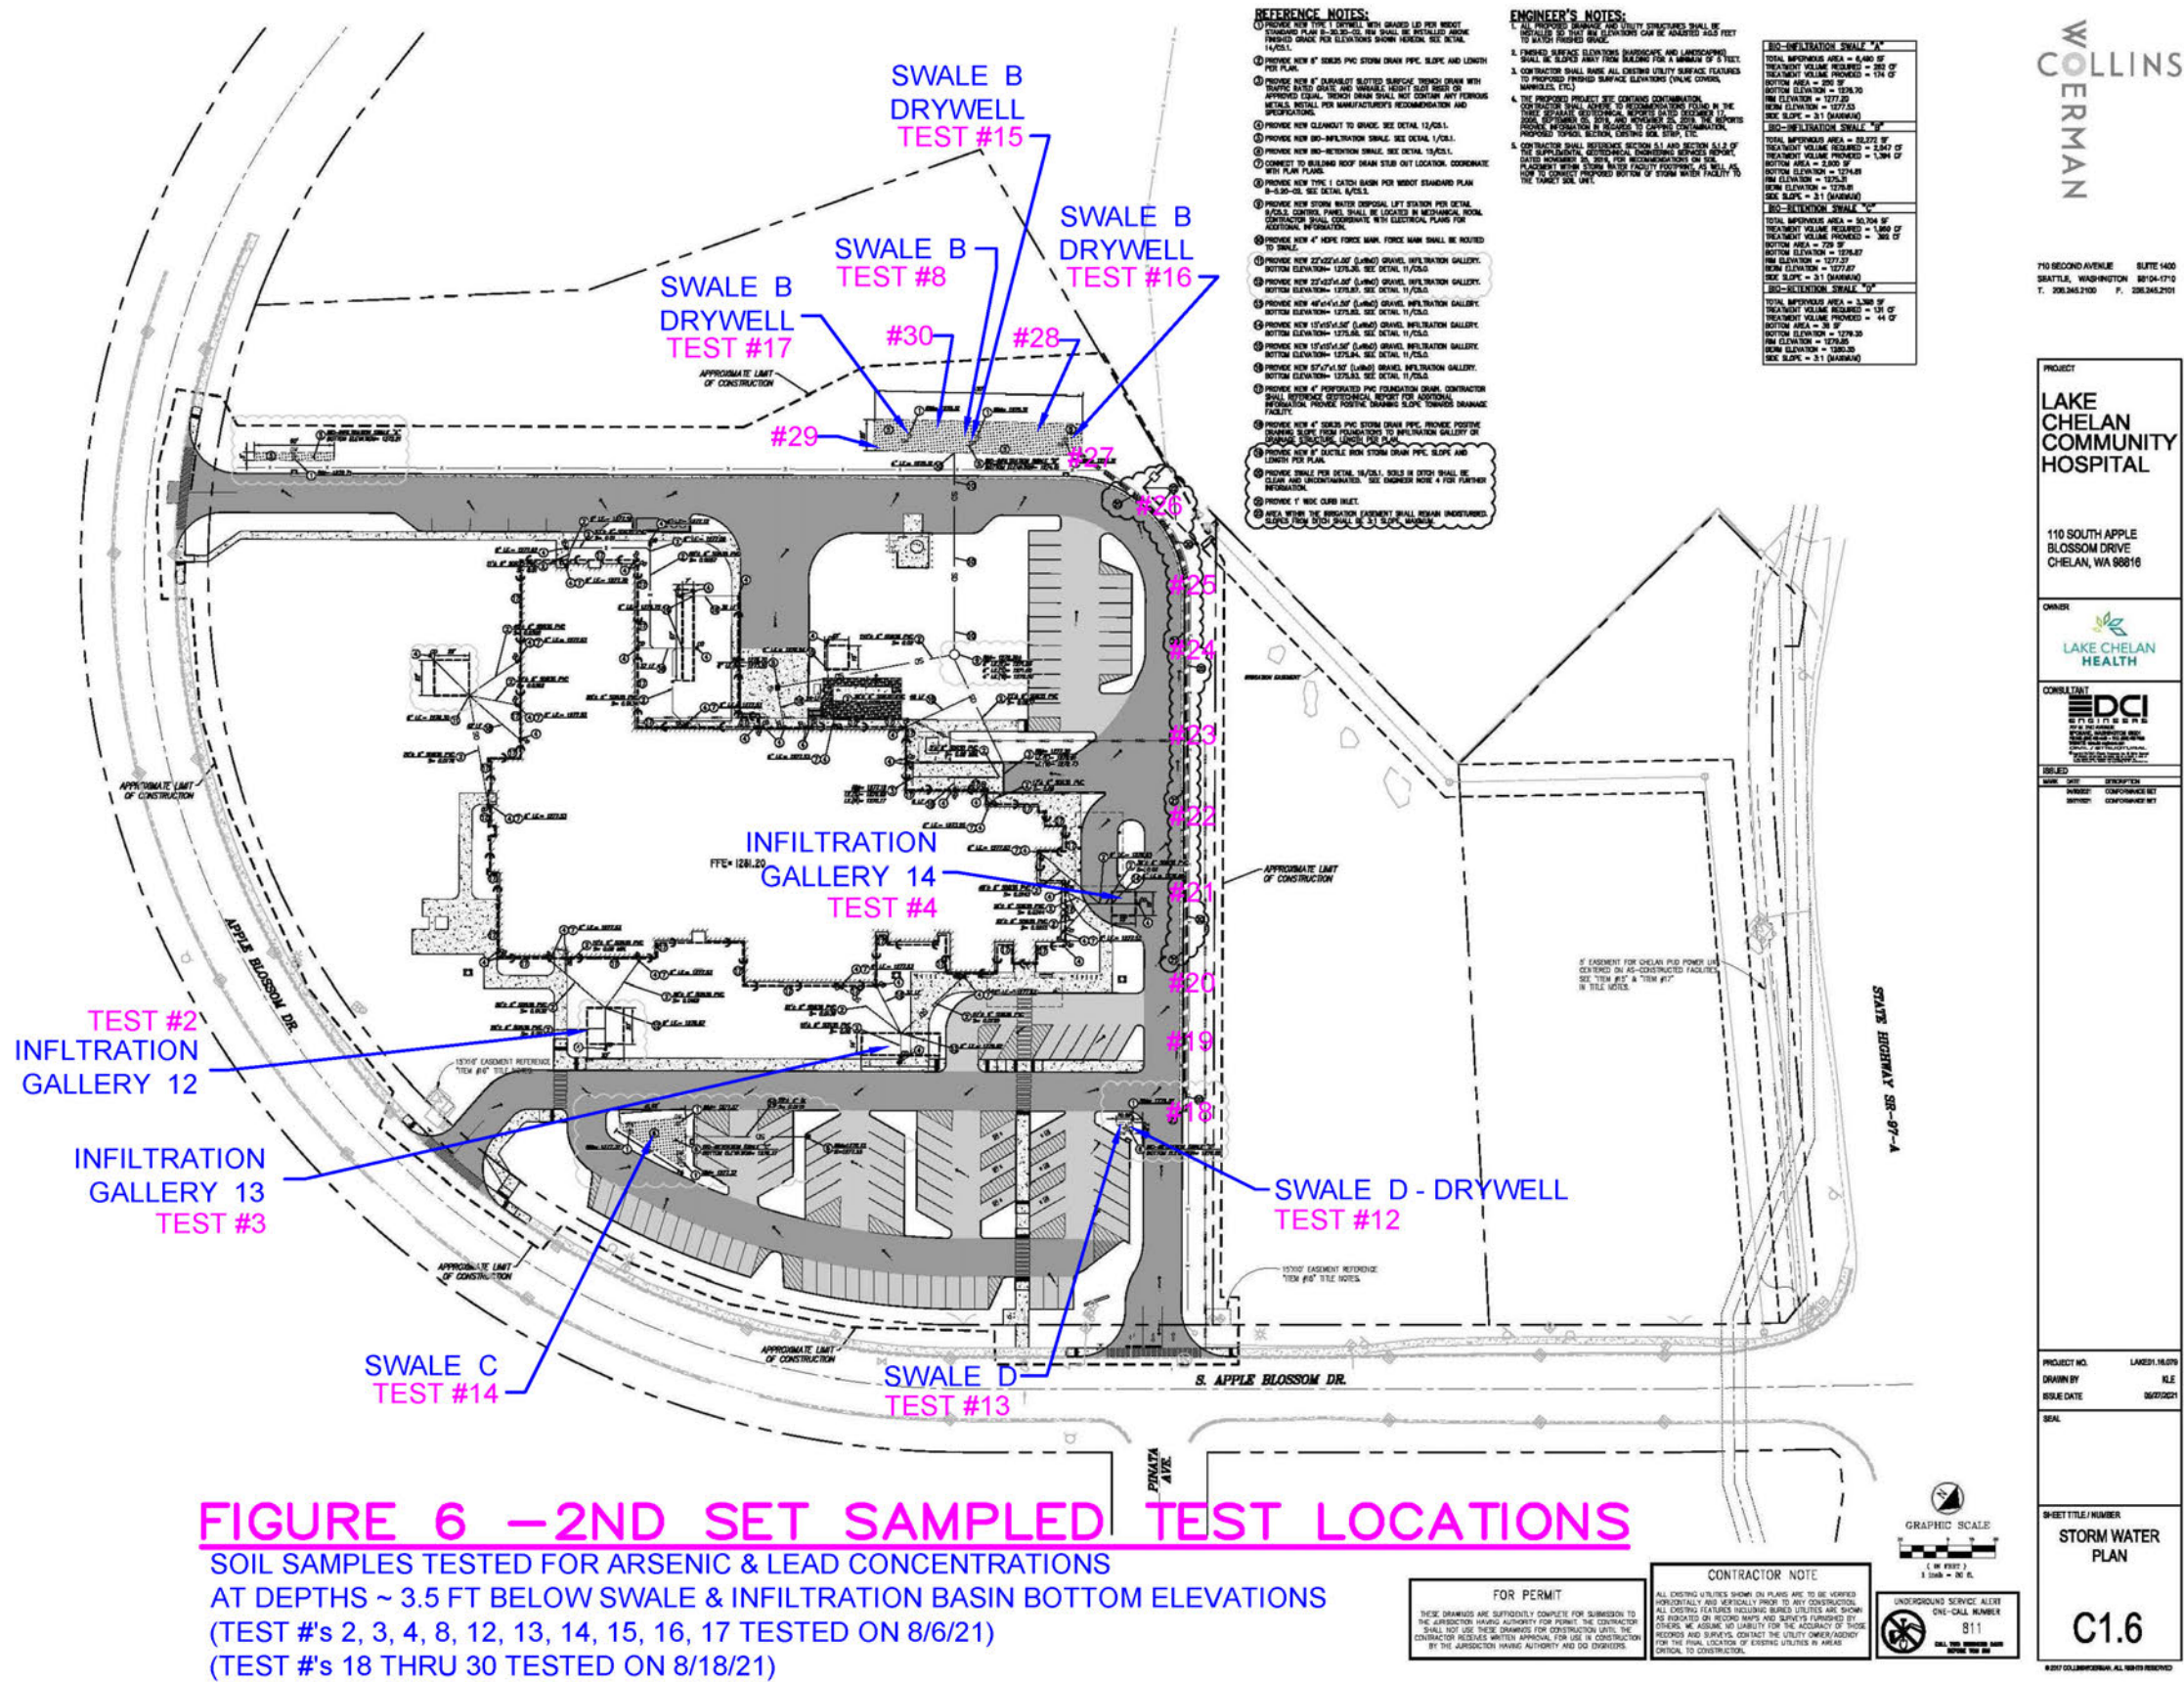
FIGURE 6

The sampling data presented in **Figures 6, 7, and 8** show the different depths and locations sampled below the areas of concern for the stormwater infiltration features.
