Gas Works Sediment Area

Joint Source Control Evaluation

Appendix A Shoreline Facilities Evaluation

ECOLOGY REVIEW DRAFT

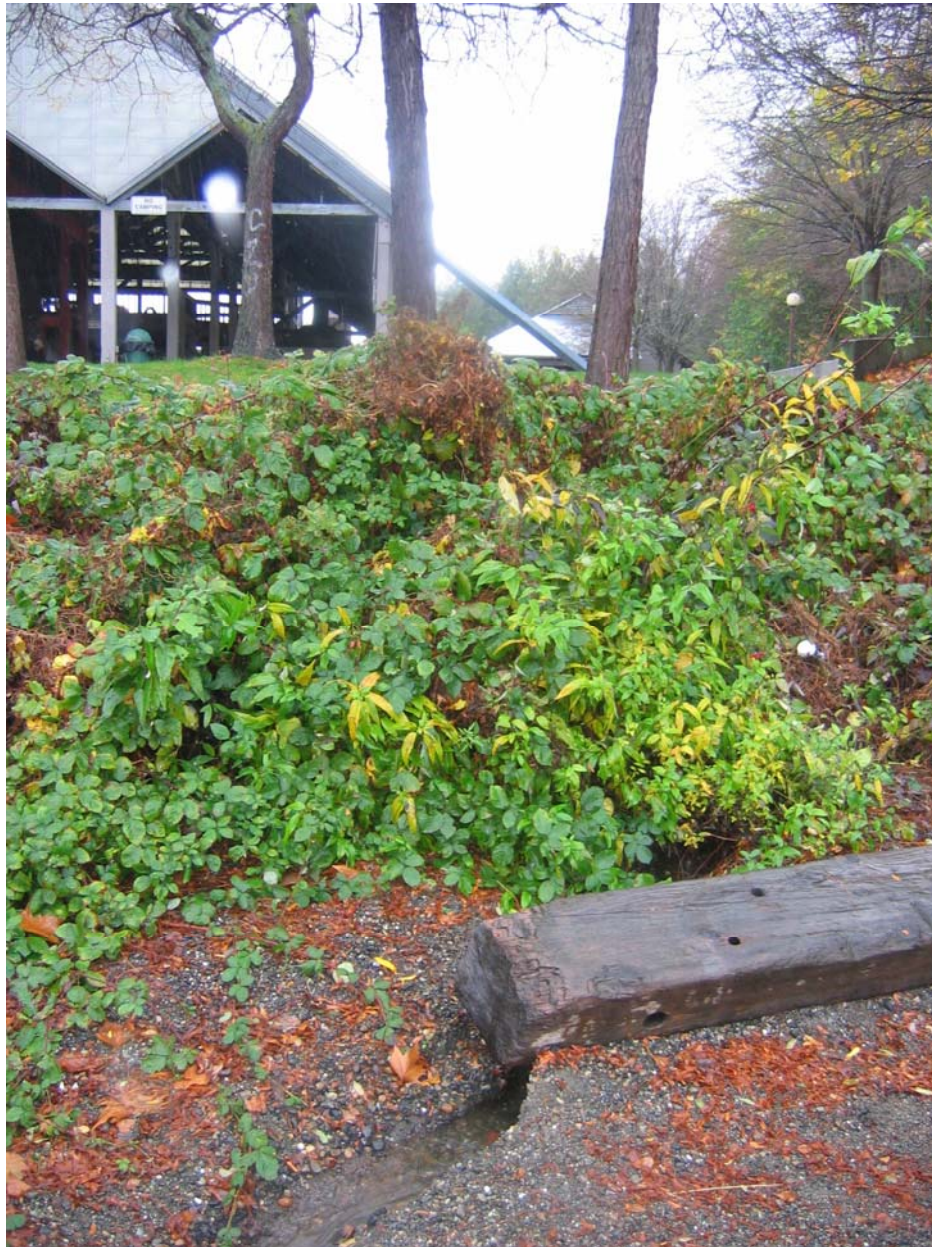
Photo 2: Discharge from Outfall B during a storm, November 2006.

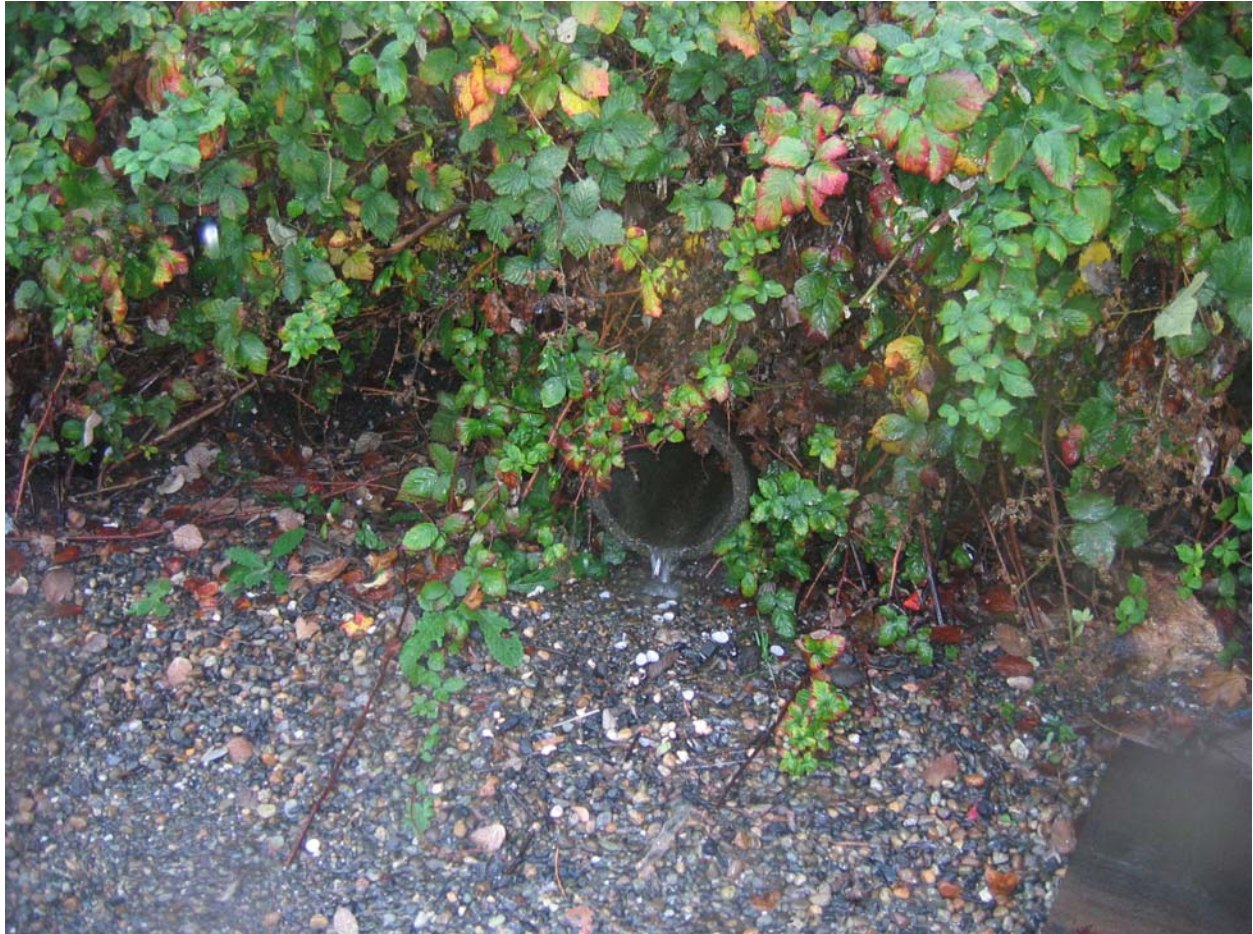
Photo 3: Outfall C during a storm, November 2006.

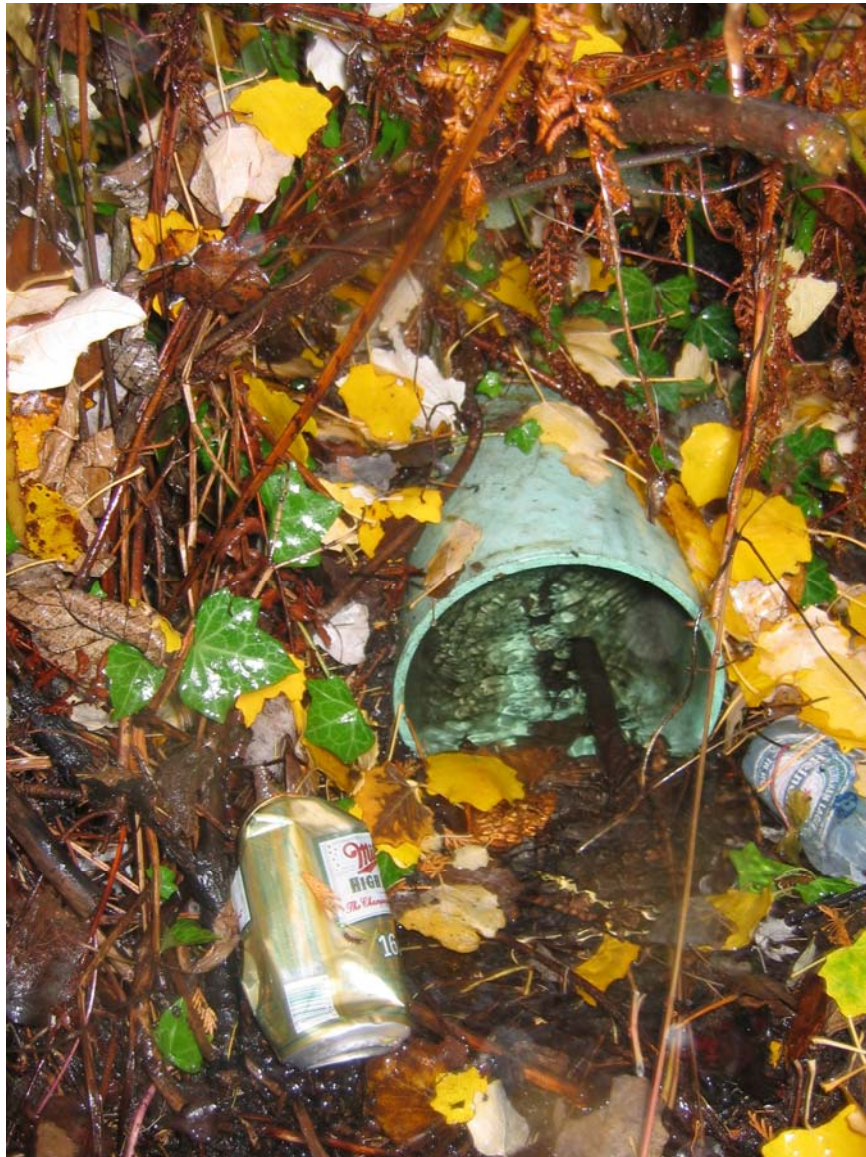
Photo 6: Waterway #19 Outfall from Culvert near Shoreline during a Storm, November 2006

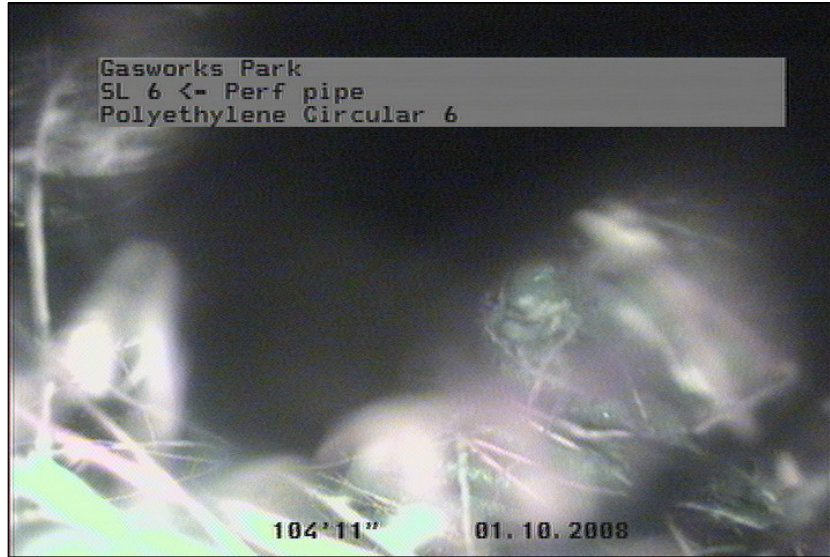
Photo: SL 6_Perf pipe_100108_141203_A.JPG, VCR #: GS-10.1.08
104.95FT, Roots Fine Barrell, from 12 to 12 o'clock, within 8
inches of joint: YES

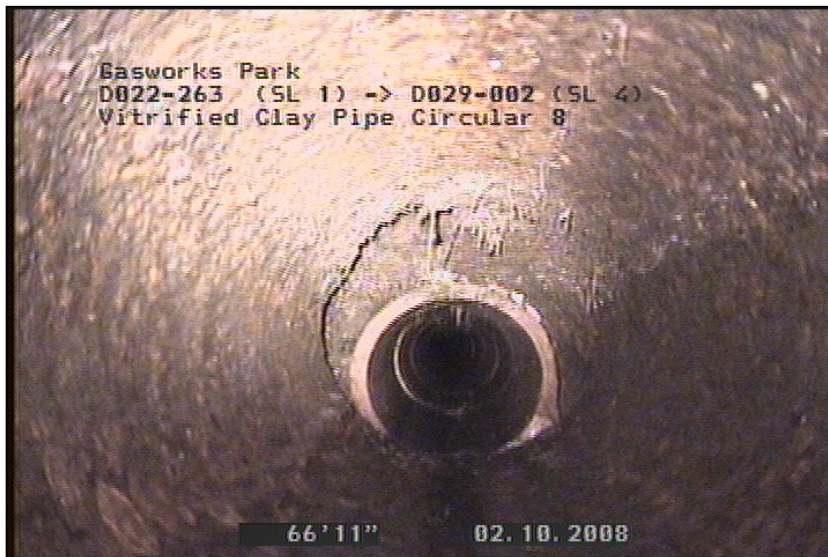
Photo: D022-263 (SL 1)_D029-002 (SL 4)_100208_093301_A.JPG,
 VCR #: GS-10.1.08
 66.88FT, Material Change, Steel pipe, REMARK:

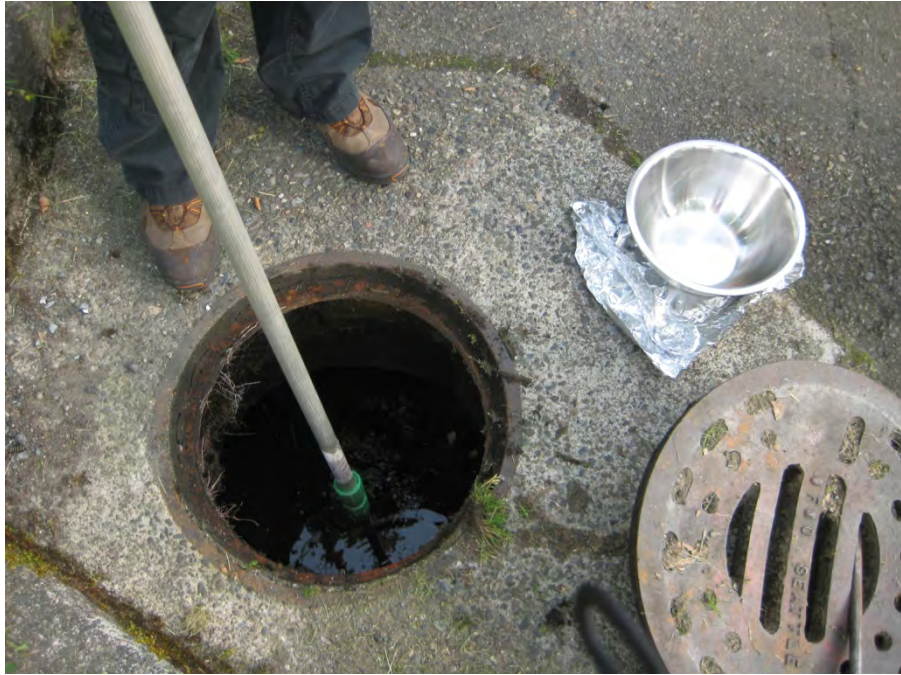
Photo 3. SPU staff sampling Catch Basin PA-CB-02 in Gas Works Park parking area.

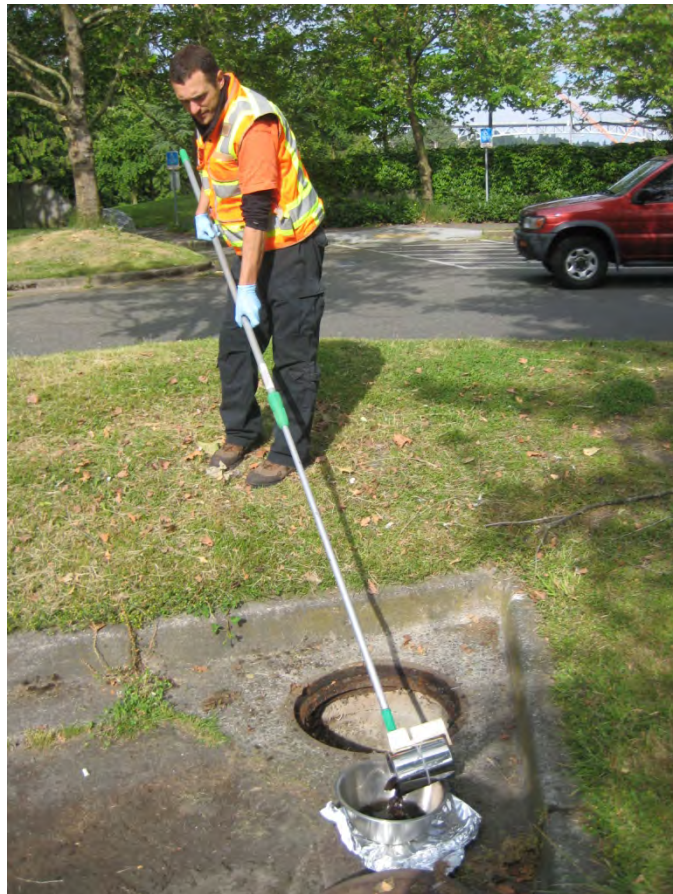
Photo 4. SPU staff sampling Catch Basin PA-CB-02 in Gas Works Park parking area.

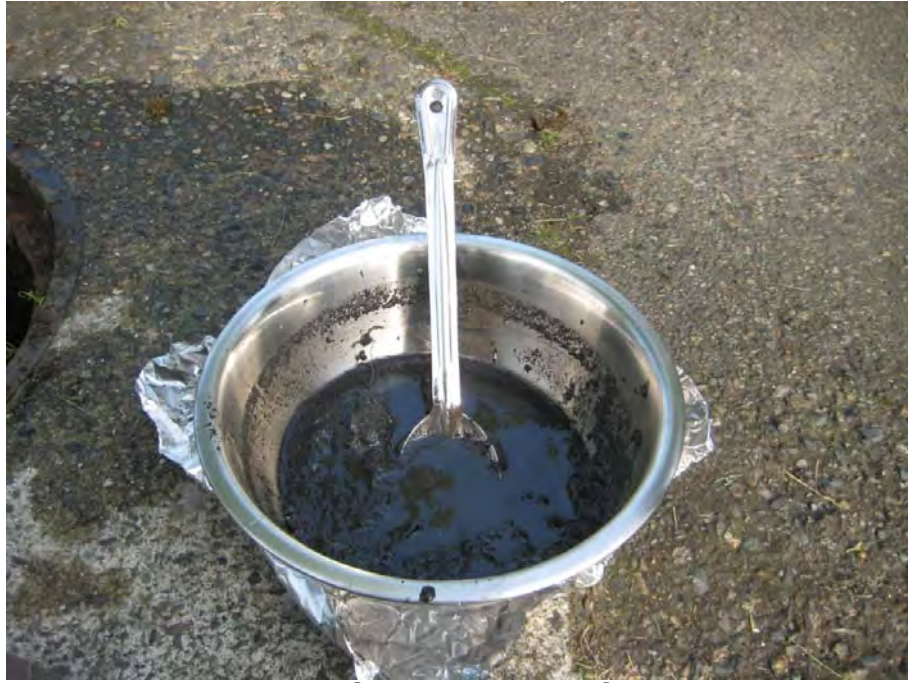
Photo 5. Solids sample, PA-CB-02.

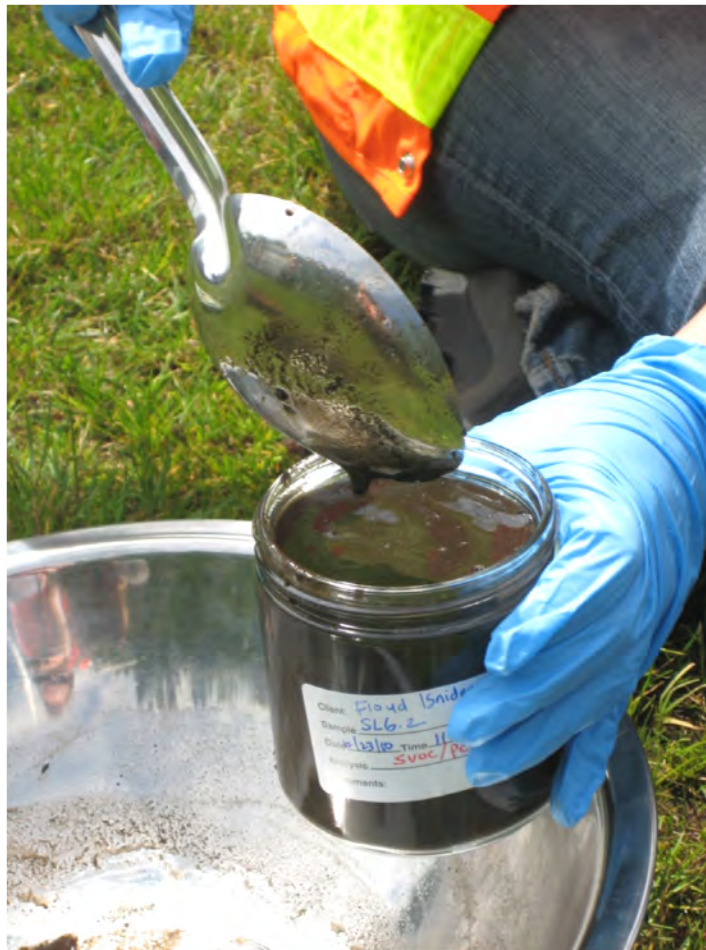
Photo 6. Floyd|Snider staff sampling Catch Basin SL6.2 in Gas Works Park.

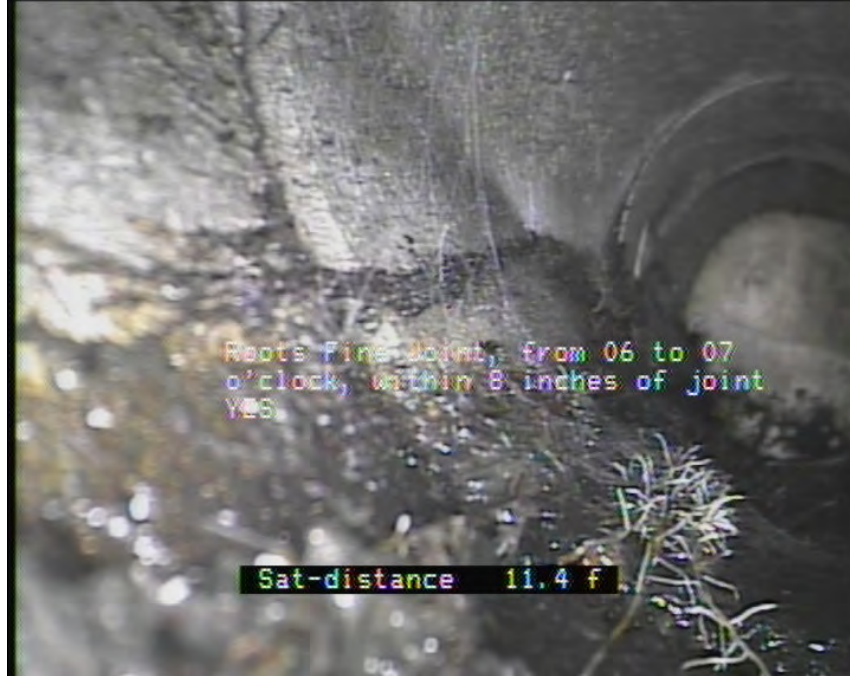
Photo: PA-CB-07_Discharge Point095728_25062010_A.JPG, VCR No.: Floyd/Gas Works 06.25.2010
11.4FT, Roots Fine Joint, from 06 to 07 o'clock, within 8 inches of joint:
YES

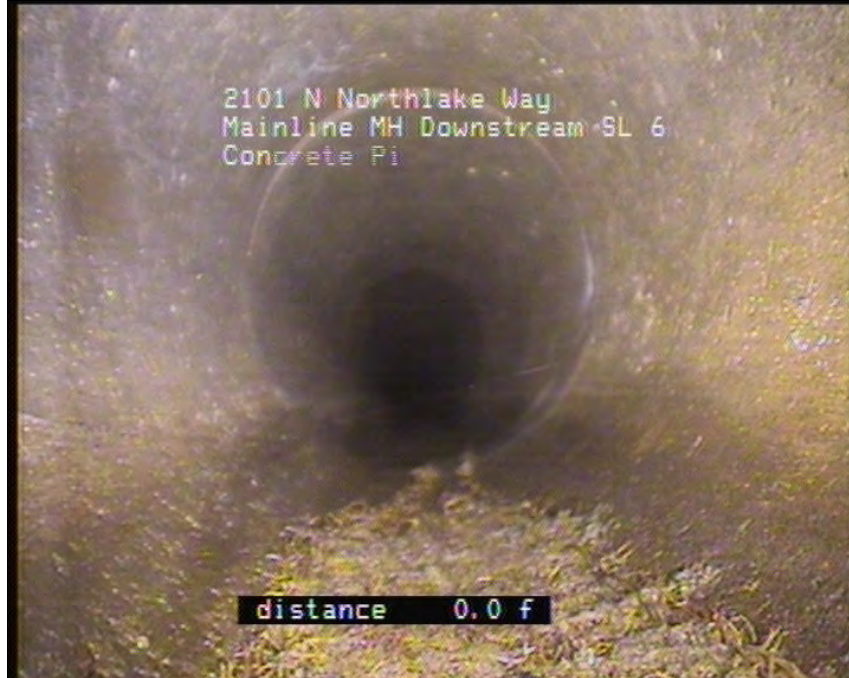
Photo: Mainline MH_SL 6101118_25062010_A.JPG, VCR No.: Floyd/Gas Works 06.25.2010
OFT, Roots Fine Joint, from 05 to 07 o'clock, within 8 inches of joint:
YES / In MH

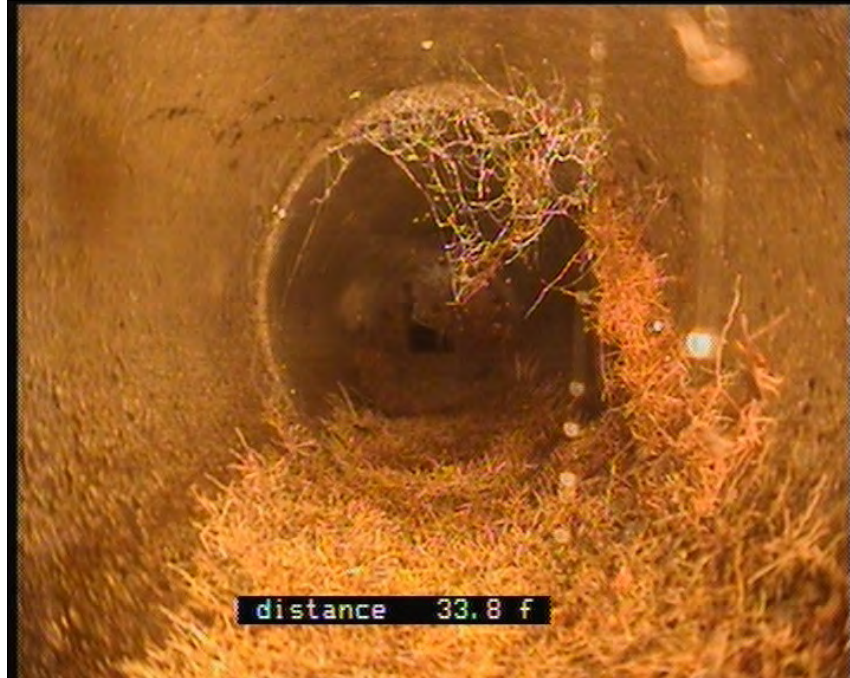
Photo: PA-CB-01_Mainline MH2111028_25062010_A.JPG, VCR No.:
Floyd/Gas Works 06.25.2010
33.8FT, Roots Fine Barrell, from 04 to 07 o'clock, Start

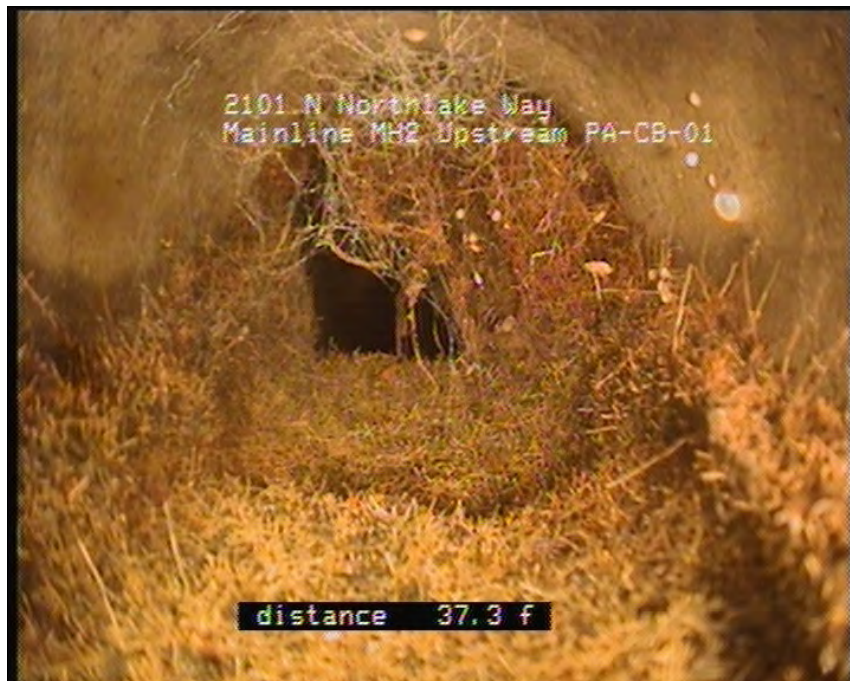
Photo: PA-CB-01_Mainline MH2111128_25062010_A.JPG, VCR No.:
Floyd/Gas Works 06.25.2010
37.3FT, Roots Ball Barrell, from 02 to 09 o'clock, 50 %, within 8 inches
of joint: YES, Start

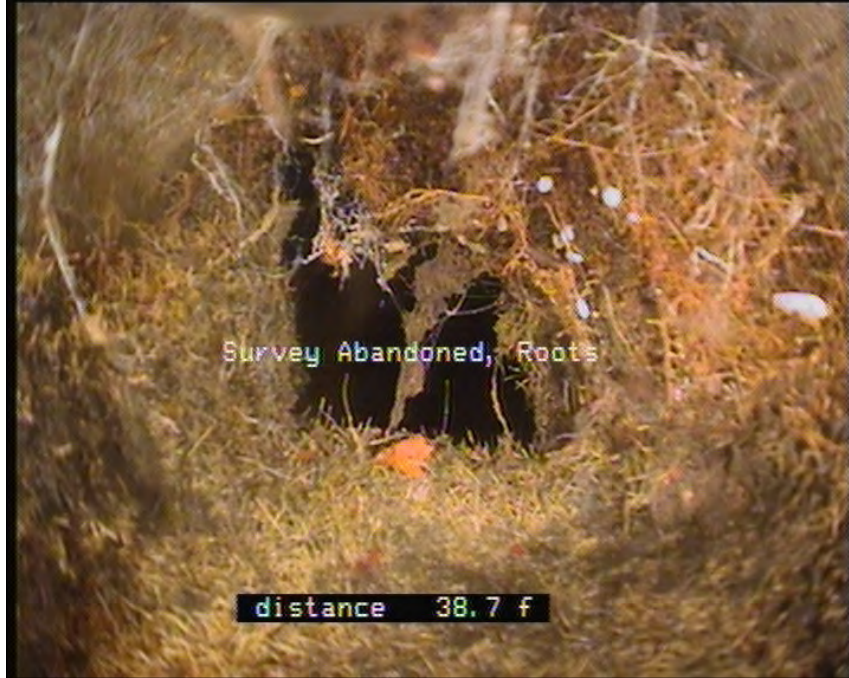
Photo: PA-CB-01_Mainline MH2111230_25062010_A.JPG, VCR No.:
Floyd/Gas Works 06.25.2010
38.7FT, Survey Abandoned / Roots

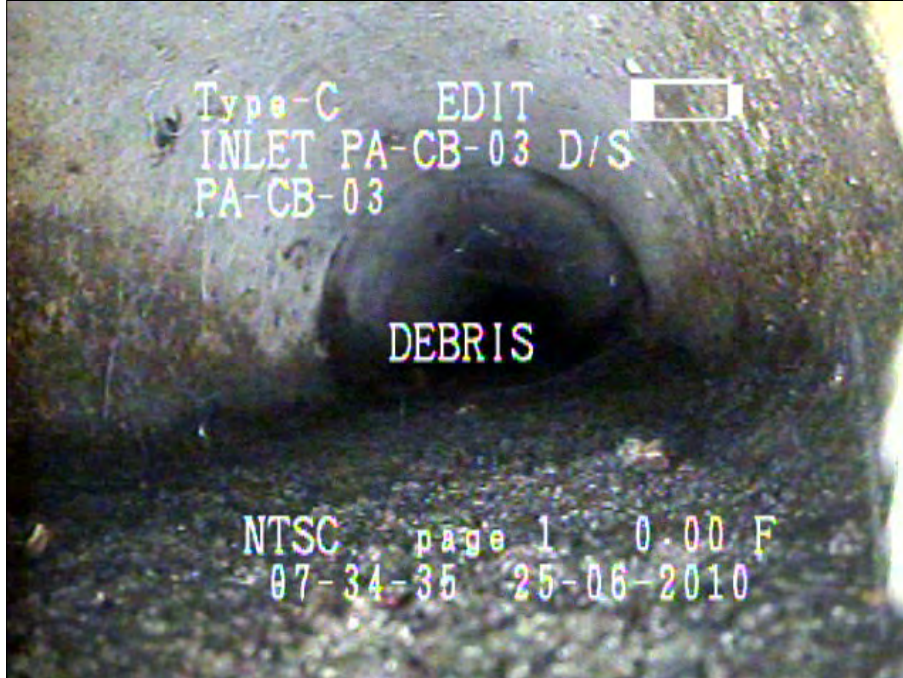
Photo: Inlet PA-CB-03_PA-CB-03041601_28062010_A.jpg, VCR No.: Floyd/Gas Works 06.25.2010
0FT, Deposits Settled Fine, 5 %of cross sectional area, from 05 to 07 o'clock, , within 8 inches of joint: YES, Start

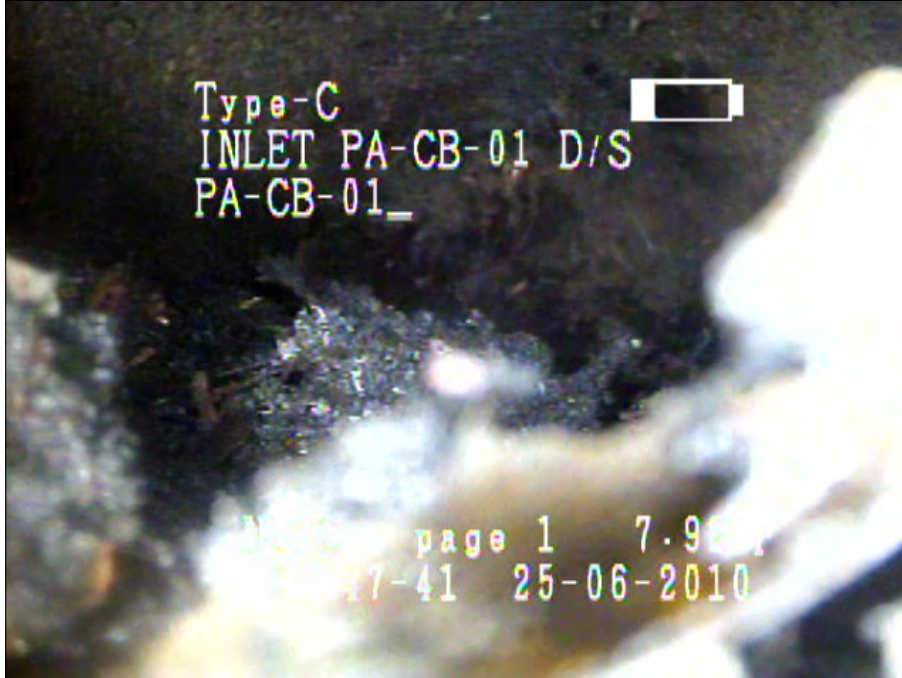
Photo: Inlet PA-CB-01_PA-CB-01042535_28062010_A.jpg, VCR No.:
 Floyd/Gas Works 06.25.2010
 0FT, Deposits Settled Fine, 20 %of cross sectional area, from 03 to
 09 o'clock, , within 8 inches of joint: YES

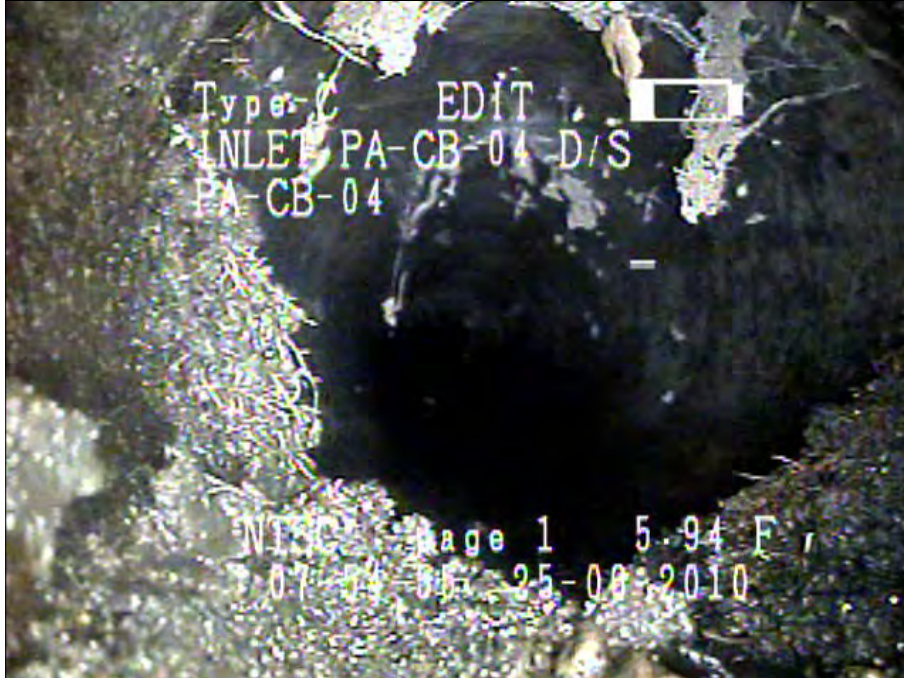
Photo: Inlet PA-CB-04_PA-CB-04043034_28062010_A.jpg, VCR No.:
 Floyd/Gas Works 06.25.2010
 5.59FT, Roots Fine Joint, from 03 to 09 o'clock, within 8 inches of joint:
 YES

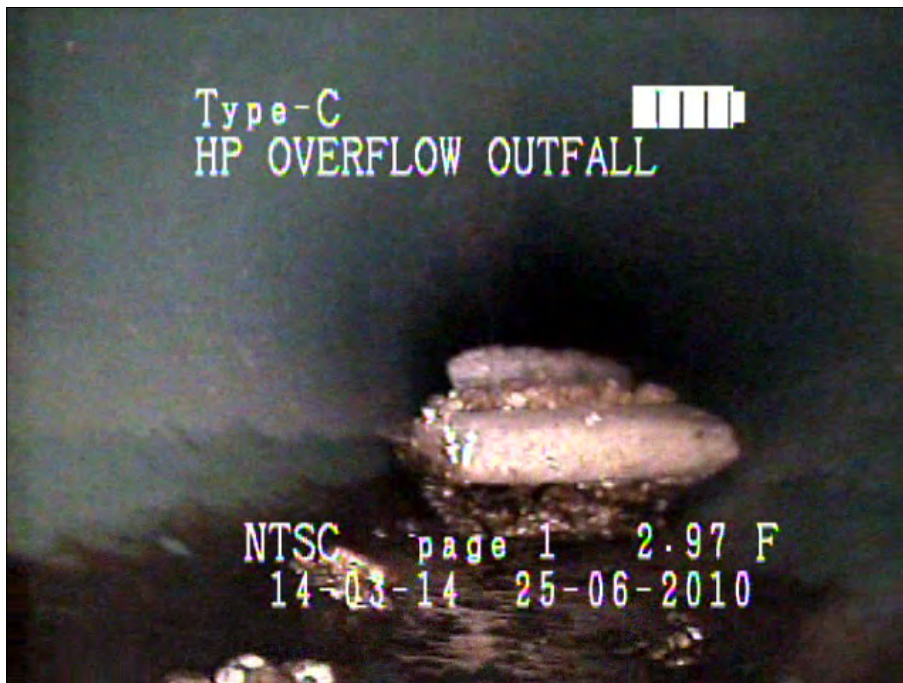
Photo: HP-CB-01_HP Over flow081251_30062010_A.jpg, VCR No.: Floyd/Gas Works 06.25.2010
5.6FT, Obstacles Rocks, 20 %of cross sectional area, from 04 to 08 o'clock

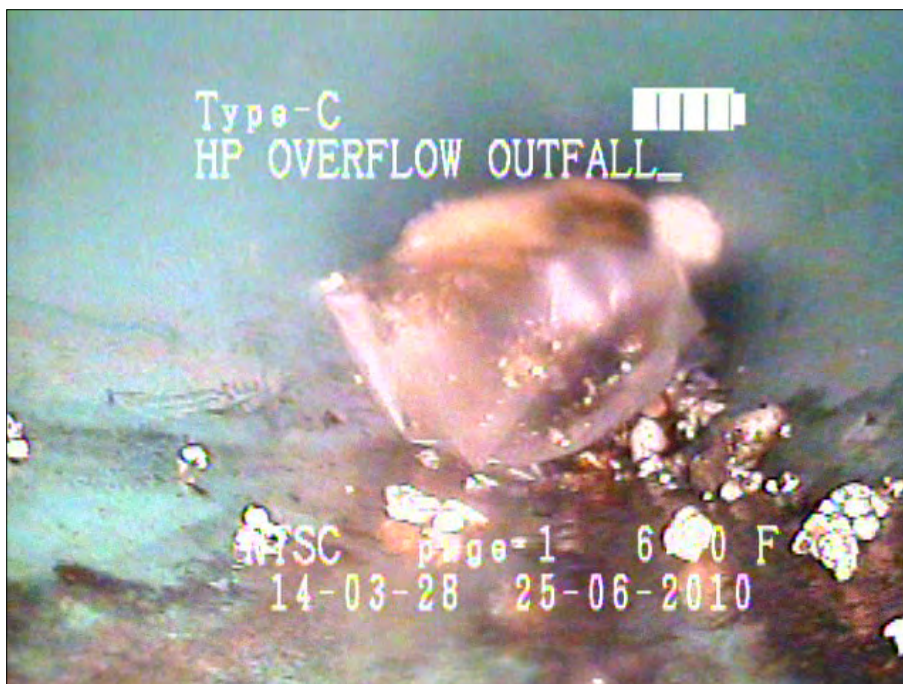
Photo: HP-CB-01_HP Over flow081359_30062010_A.jpg, VCR No.: Floyd/Gas Works 06.25.2010
5.6FT, Obstacles Other, 25 %of cross sectional area, from 04 to 08 o'clock / Plastic bag

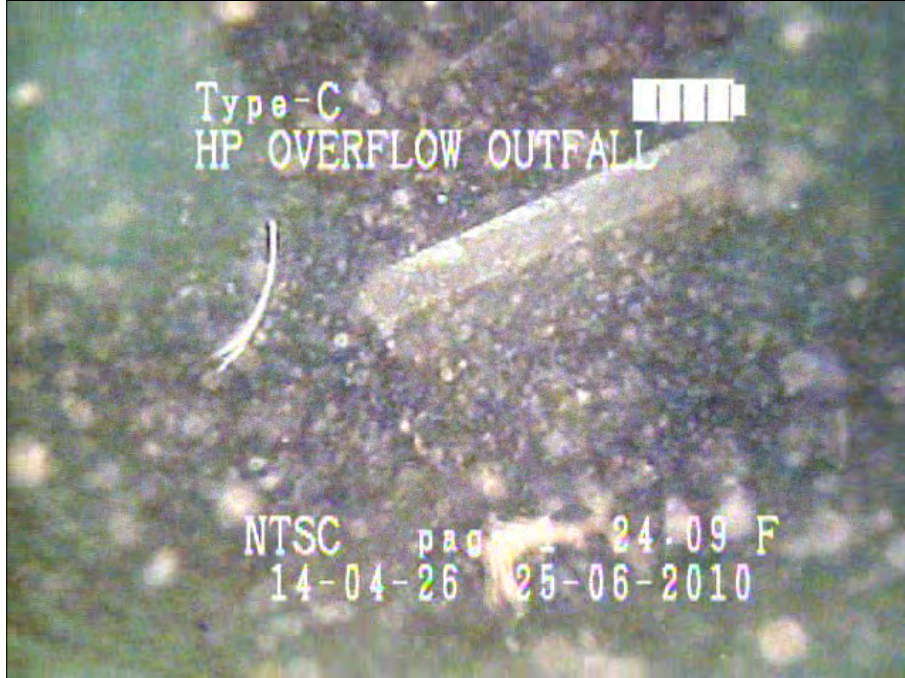
Photo: HP-CB-01_HP Over flow081441_30062010_A.jpg, VCR No.: Floyd/Gas Works 06.25.2010
24.1FT, Obstacles Other, 15 %of cross sectional area, from 10 to 02 o'clock / Wood

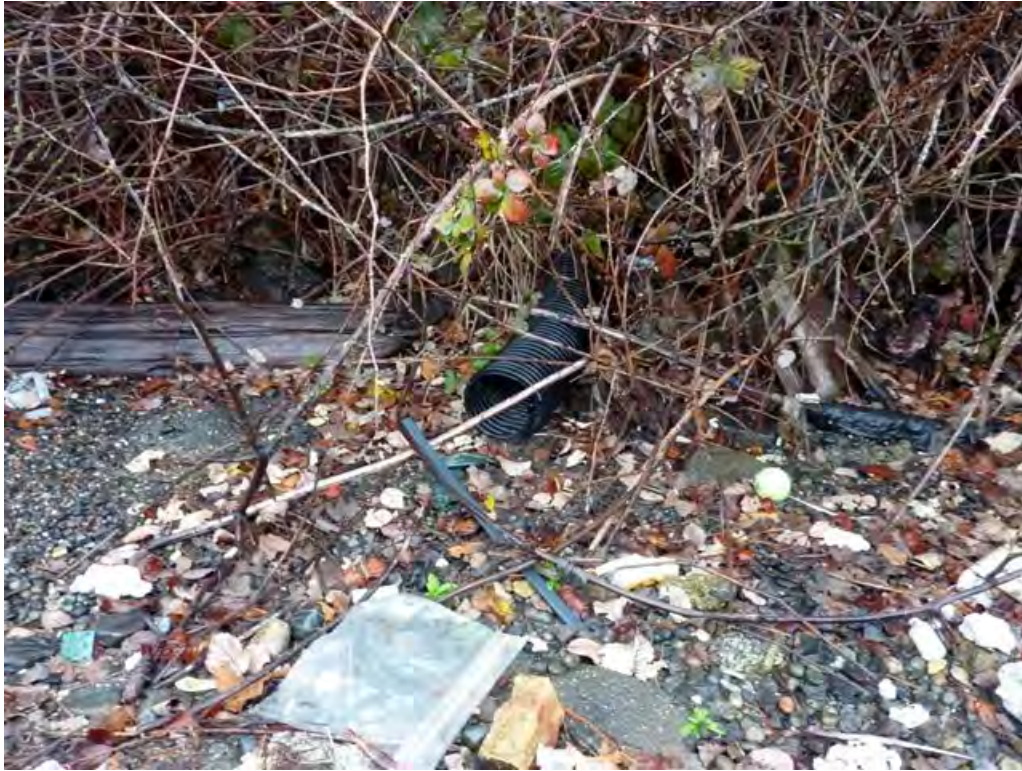
Photograph 1. Kite Hill Outfall looking north. January 1, 2010.

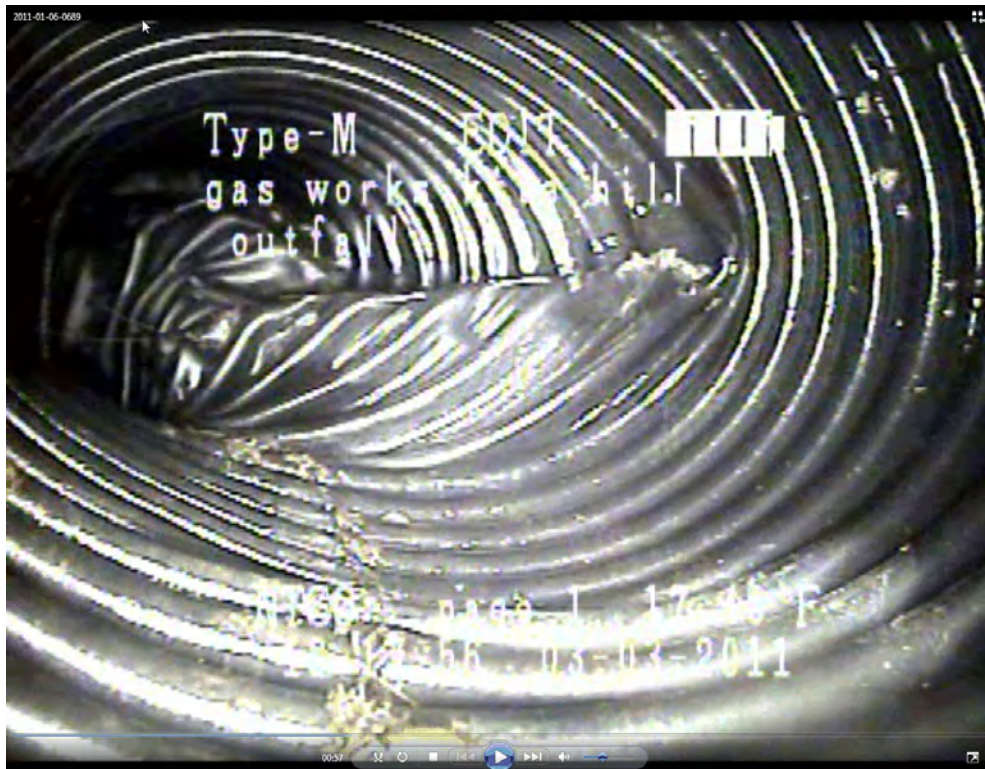
Photograph 2. Video capture of crushed pipe 20 feet from Kite Hill Outfall. January 5, 2011.

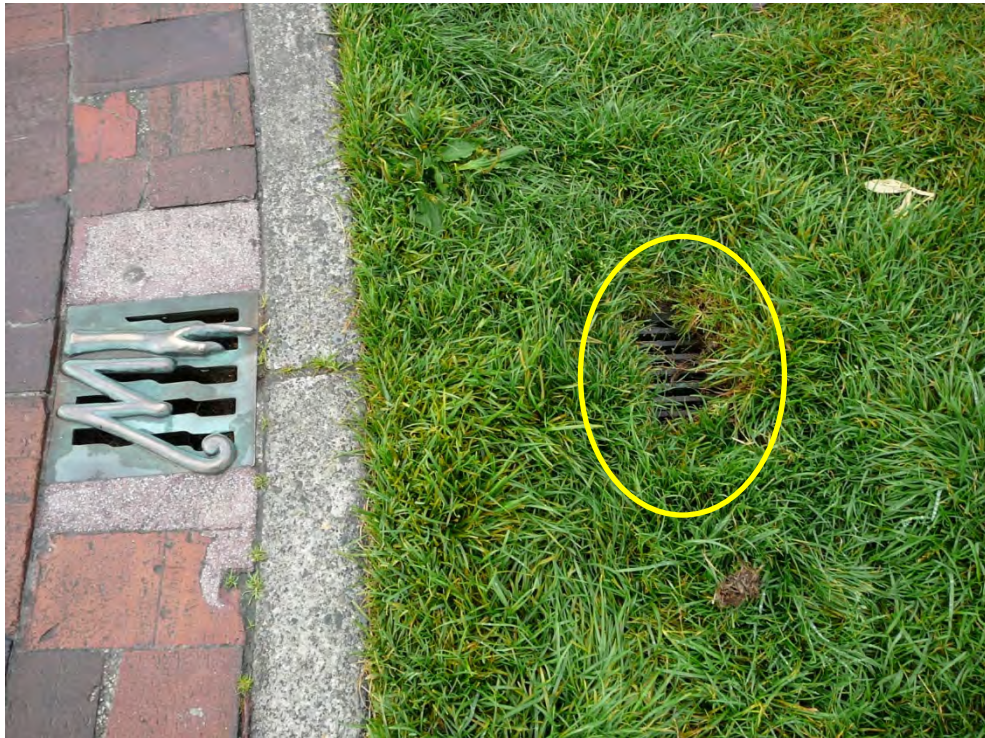
- **Kite Hill Manhole to Western Inlet.** A 6-inch PVC pipe that comes from the Western Inlet, which is in the grass just to the west of the West marker on the sundial on top of Kite Hill. There was no evidence that the West marker, which appeared to be a stormwater inlet, is connected to this inlet. At 17 feet from the manhole, the Western Inlet was reached. This run appeared to be in reasonable shape with no tears or cracks. This run is identified as Section No. 23 in the inspection report.

Photograph 4. Western Inlet on Kite Hill. August 22, 2011.

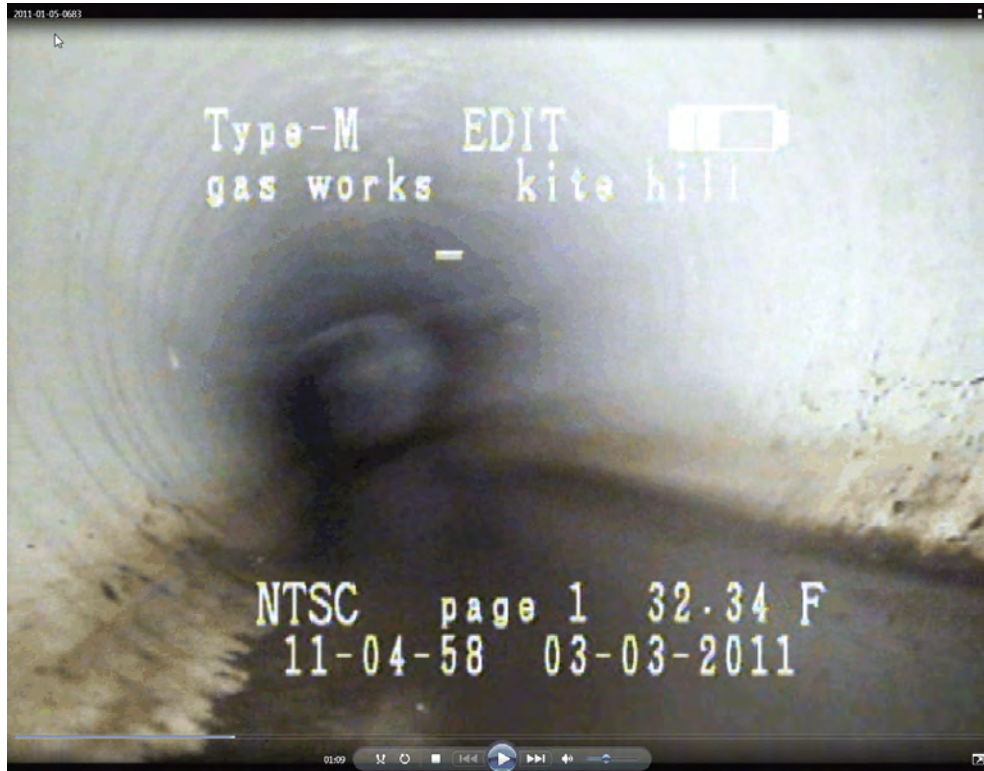
Photograph 5. Video capture of Kite Hill Manhole to Eastern Inlet. January 5, 2011.

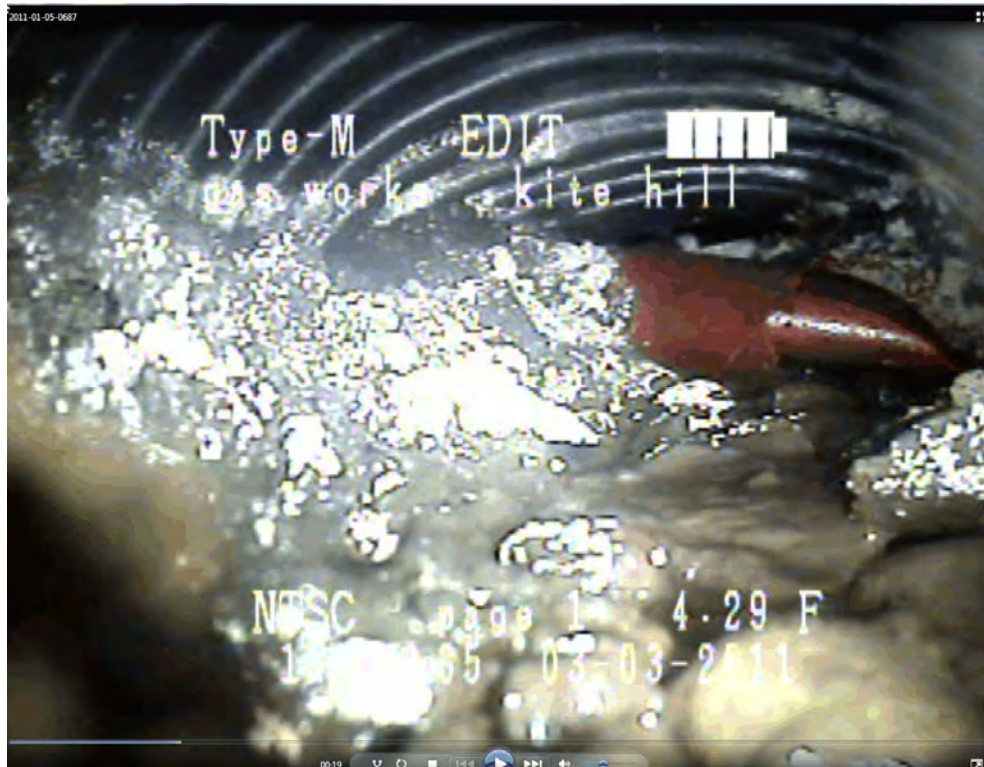
Photograph 6. Video capture of Kite Hill Manhole to completely filled Northern Inlet. January 5, 2011.

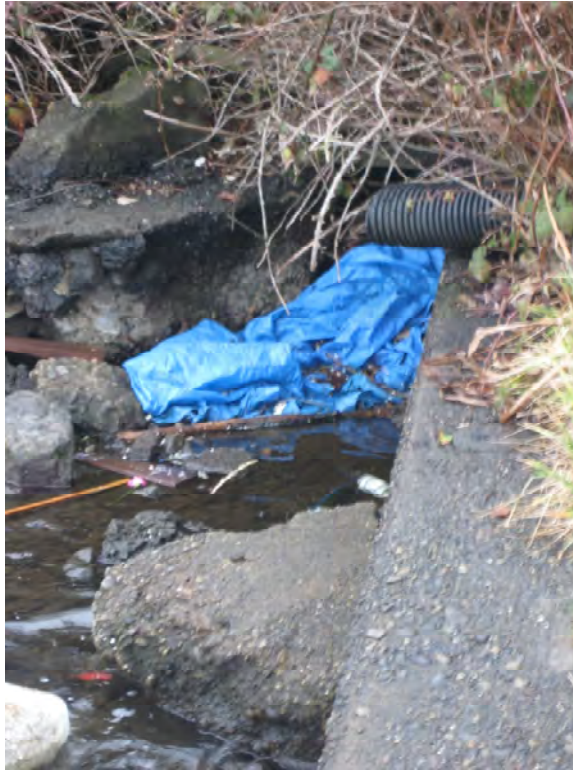
Photograph 7. Outfall F looking north. January 5, 2011.

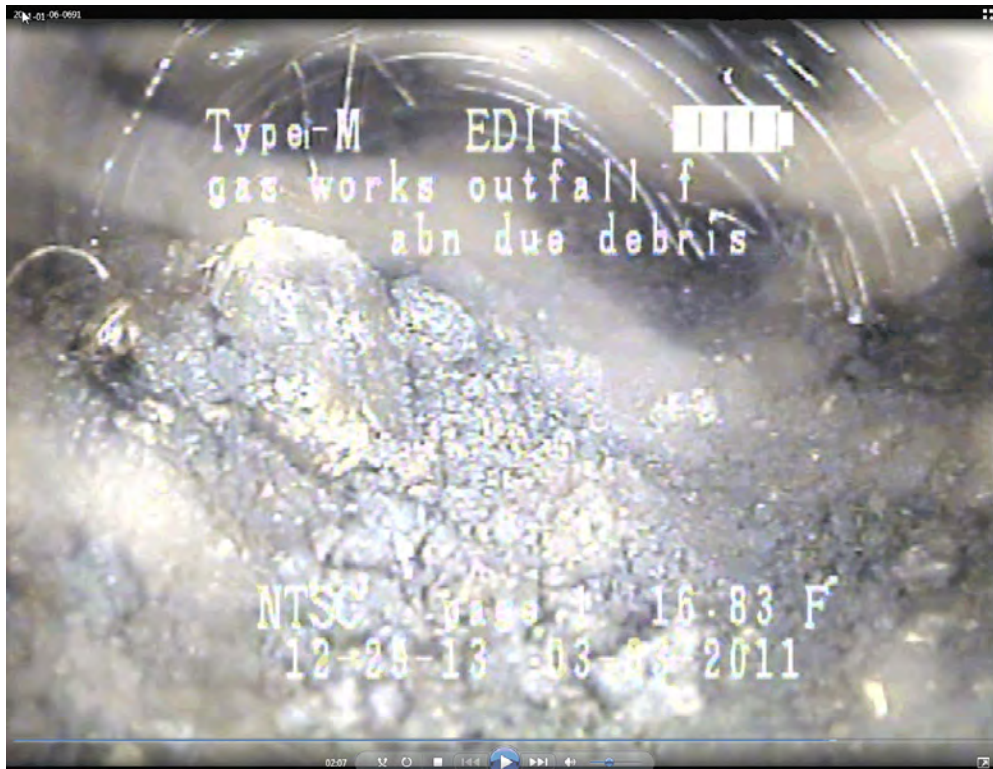
- **Outfall F Upstream.** Outfall F is a 6-inch corrugated ABS pipe. The camera went approximately 18 feet before the pipe was 100 percent filled with dirt and the inspection was abandoned. It was noted by Pete Rude of Seattle Public Utilities that he has never observed flow from Outfall F during several storms and based on the blockage observed during the video inspection it is unlikely that this pipe is operational. This run is identified as Section No. 26 in the inspection report.

Photograph 8. Video capture of filled pipe 18 feet from Outfall F. January 5, 2011.

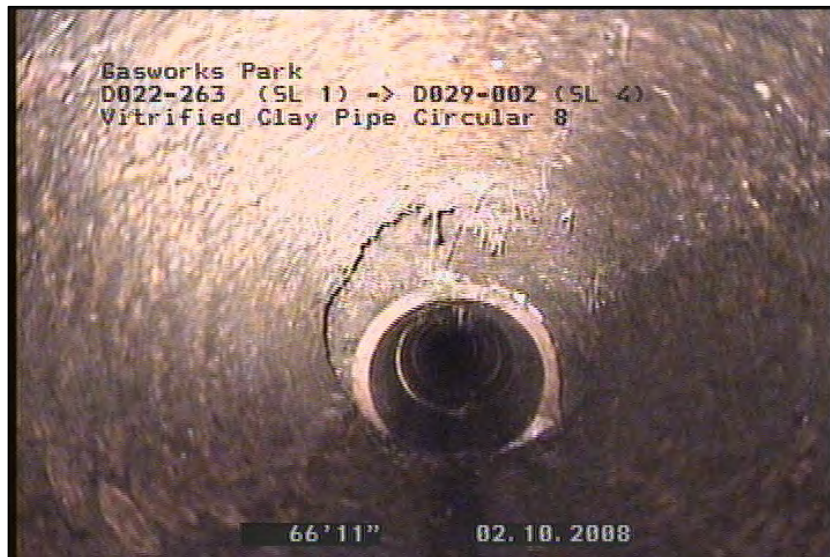
Photo: D022-263 (SL 1)_D029-002 (SL 4)_100208_093301_A.JPG,
 VCR #: GS-10.1.08
 66.88FT, Material Change, Steel pipe, REMARK:

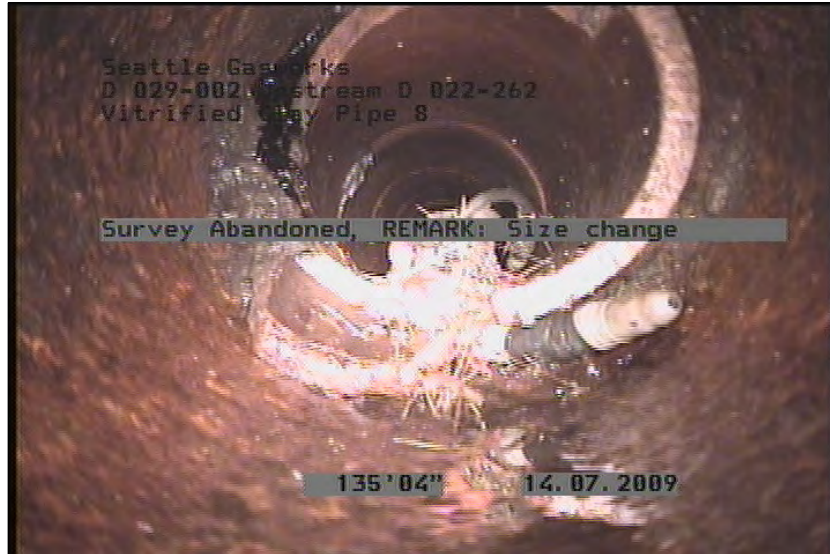
Photo: D 022-262 _D 029-002_071409_103532_A.JPG, 00:07:17
 135.37FT, Survey Abandoned, REMARK: Size change

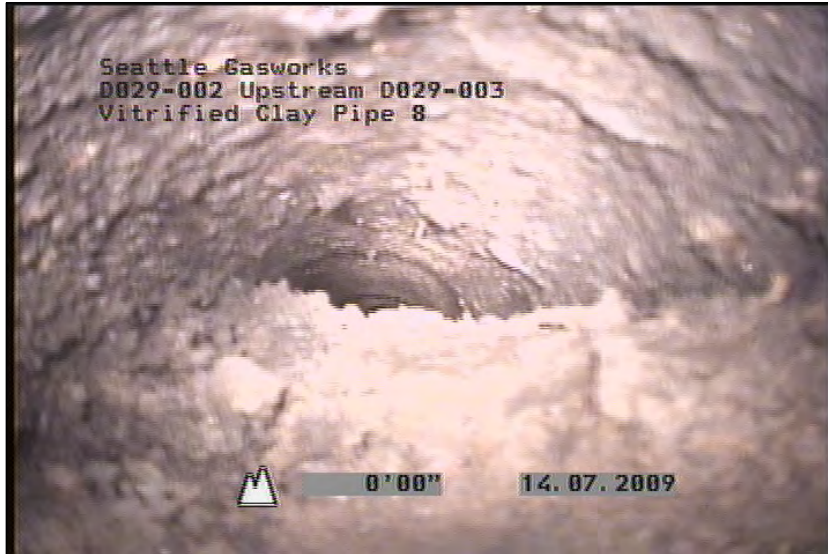
Photo: D029-003_D029-002_071409_112611_A.JPG, 00:00:23
0FT, Deposits Settled Fine, 80 %of cross sectional area, from 02
to 10 o'clock, within 8 inches of joint: YES

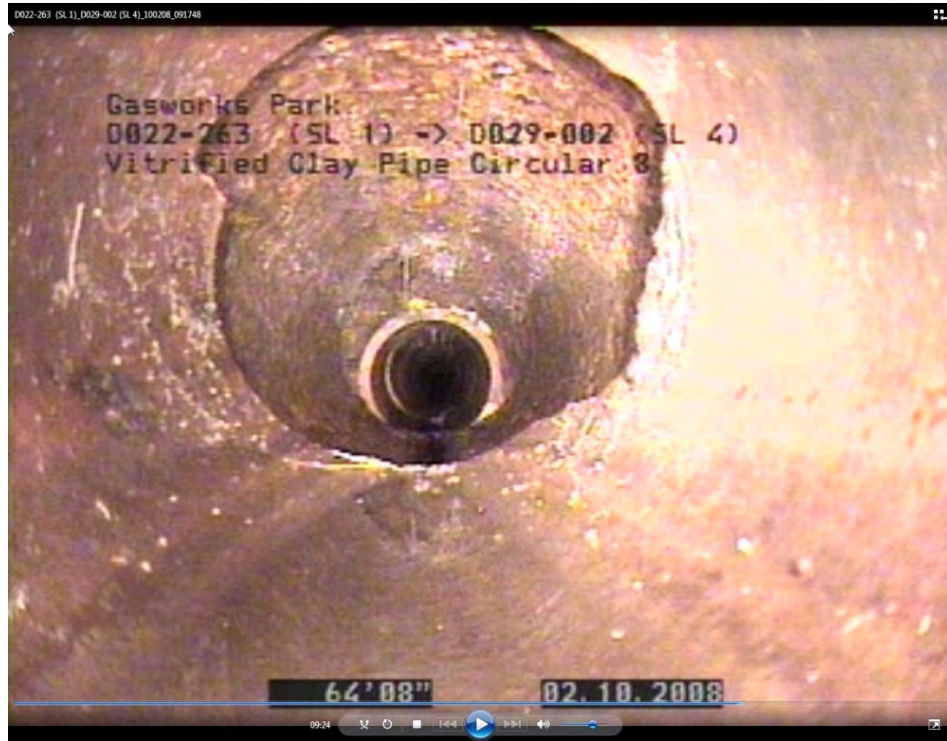
Photograph 1. SL 1 to SL 4, pipe change at 65 feet from SL 1.

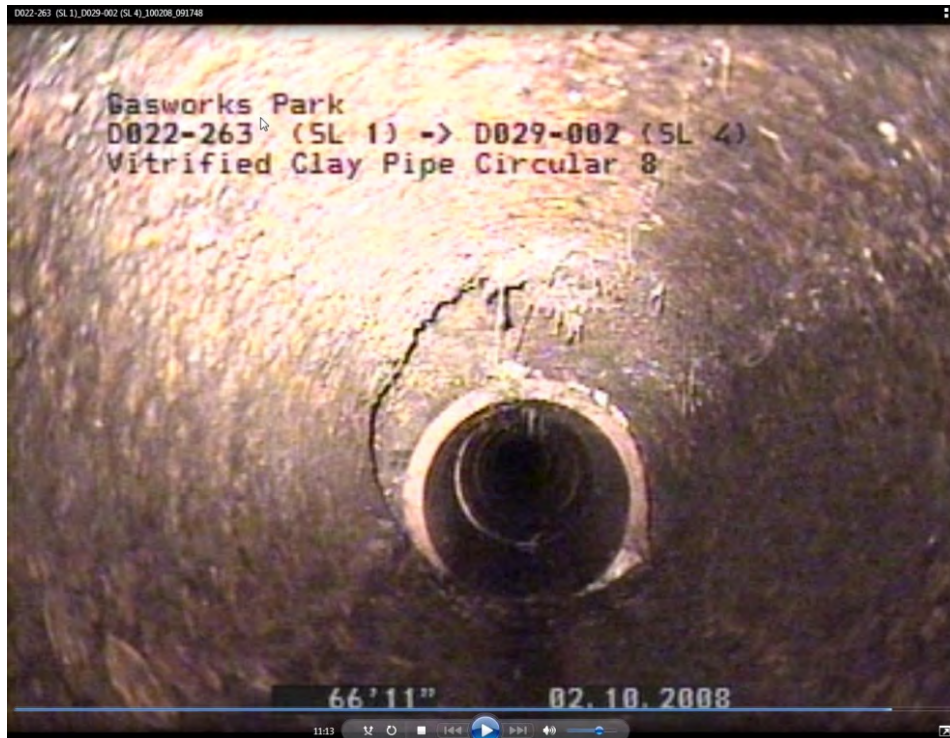
Photograph 2. SL 1 to SL 4, pipe change at 66 feet from SL 1.

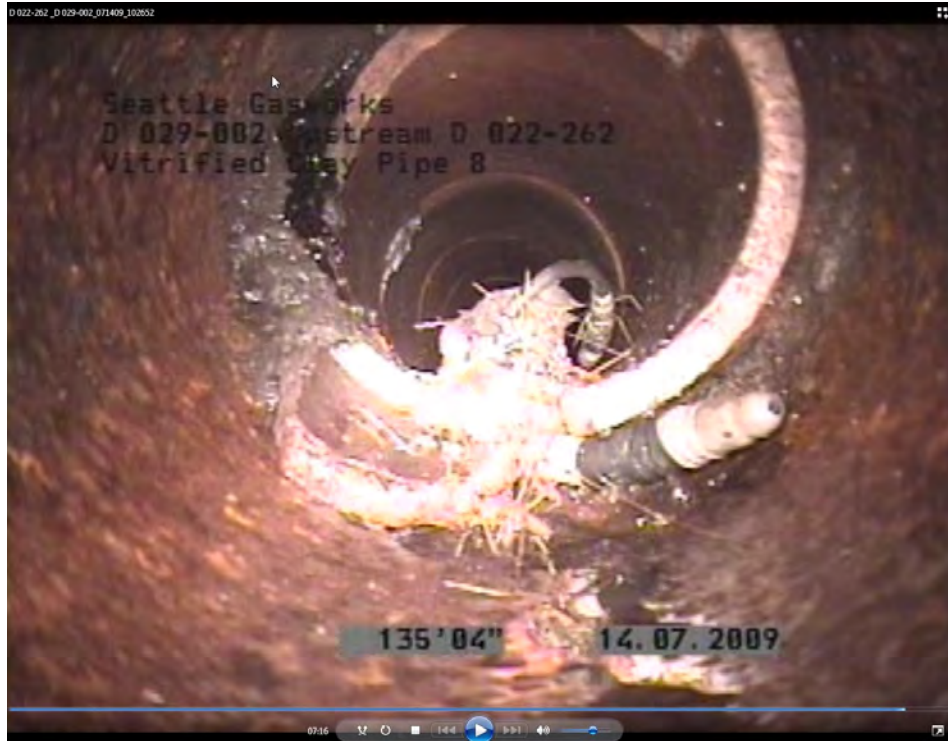
Photograph 3. SL 4 to SL 1, pipe change at 135 feet from SL 4.
