Gas Works Sediment Area

Joint Source Control Evaluation

Appendix A Shoreline Facilities Evaluation

ECOLOGY REVIEW DRAFT

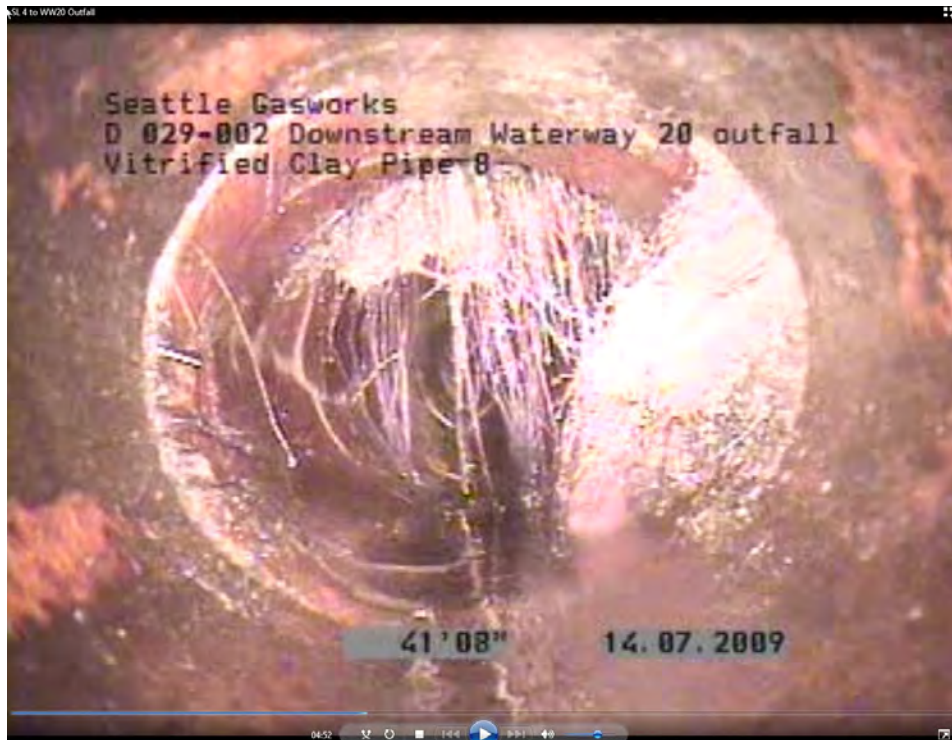
Photograph 4. SL 4 to WW20 Outfall, roots and soil intrusion at 41 feet from SL 4.

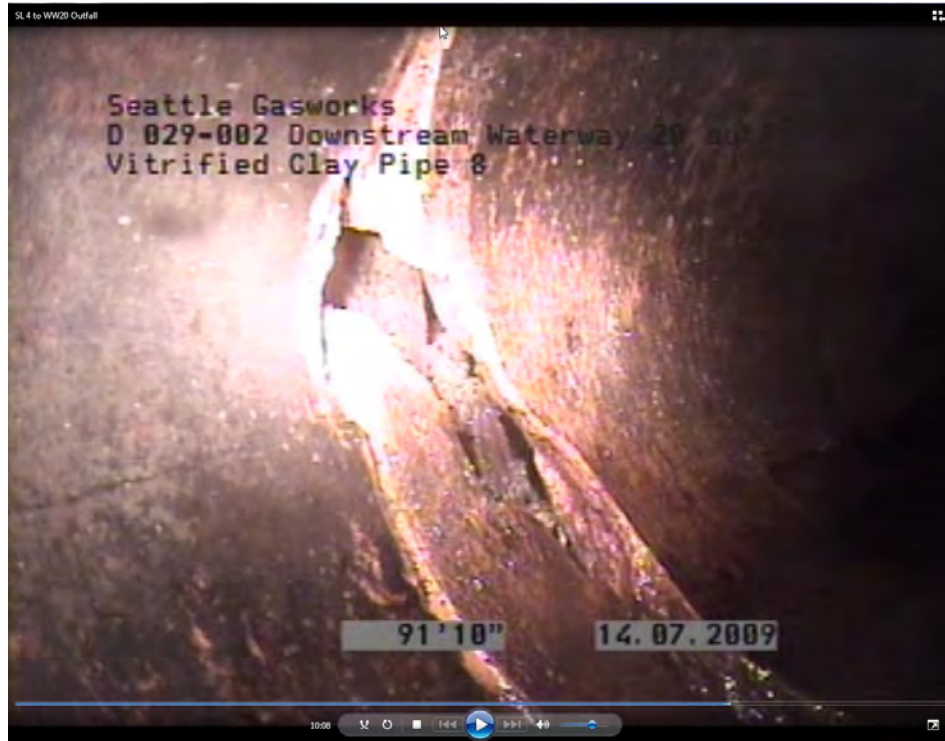
Photograph 5. SL 4 to WW20 Outfall, hole at 91 feet from SL 4.

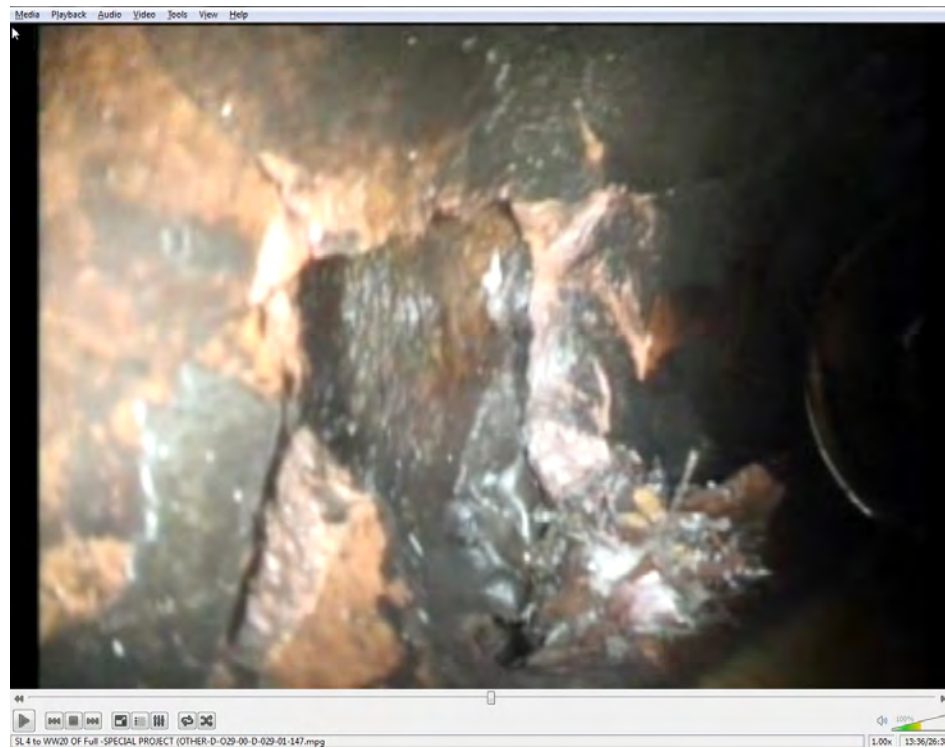
Photograph 6. SL 4 to WW20 Outfall, hole at ~94 feet from SL 4.

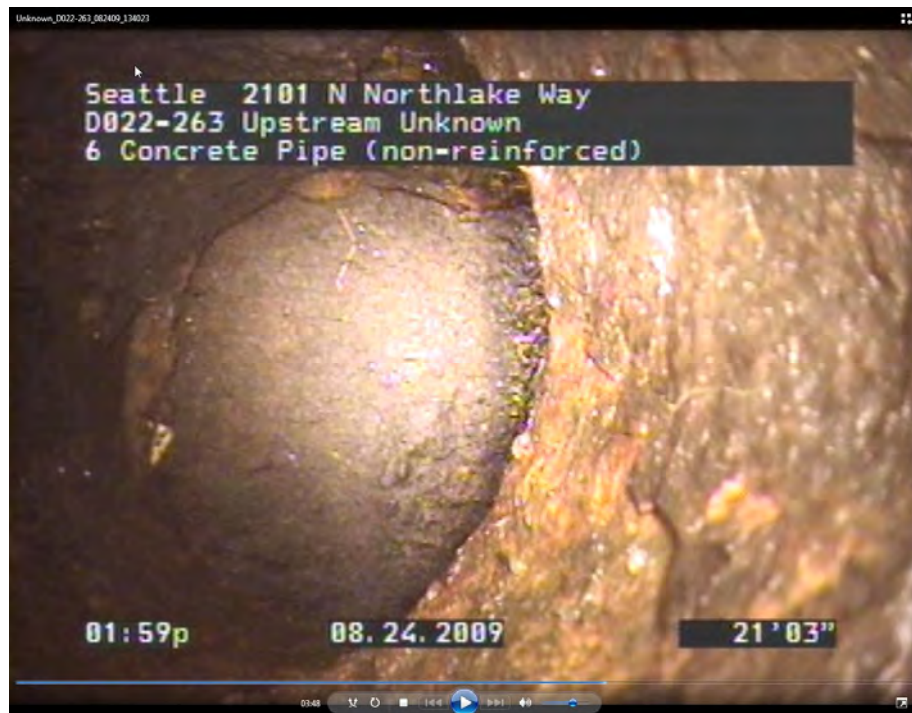
Photograph 8. SL 1 to PE, mid-point structure.

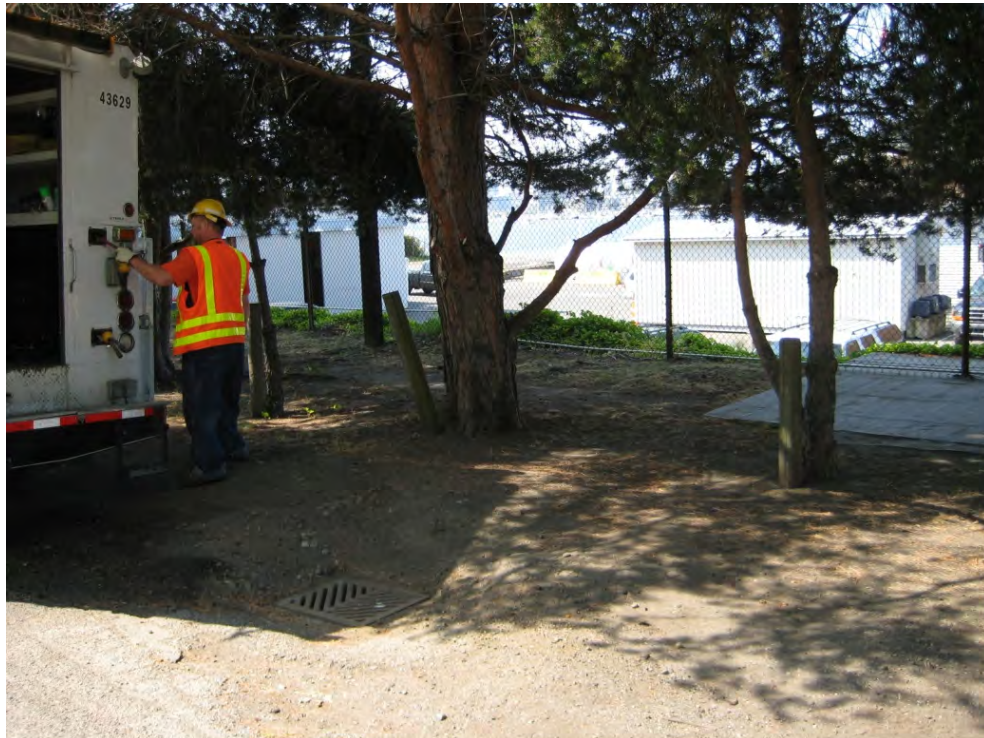
Photograph 10. Inlet on North Northlake Way.
